Bridge Inspection Reports and Work History Summaries

**NY33 BRIDGE CONDITION VERIFICATION 2023
KENSINGTON EXPRESSWAY PROJECT
PIN 5512.52
CITY OF BUFFALO, ERIE COUNTY
BIN 1022609**

STRUCTURE: BIN 1022609 - Best Street on NY33 Kensington Expressway

STRUCTURE TYPE: Four (4) span Steel, Multi-Stringer (12 beams) structure with concrete abutments founded on piles and 3-six column piers with spread footings. Year Built: 1959

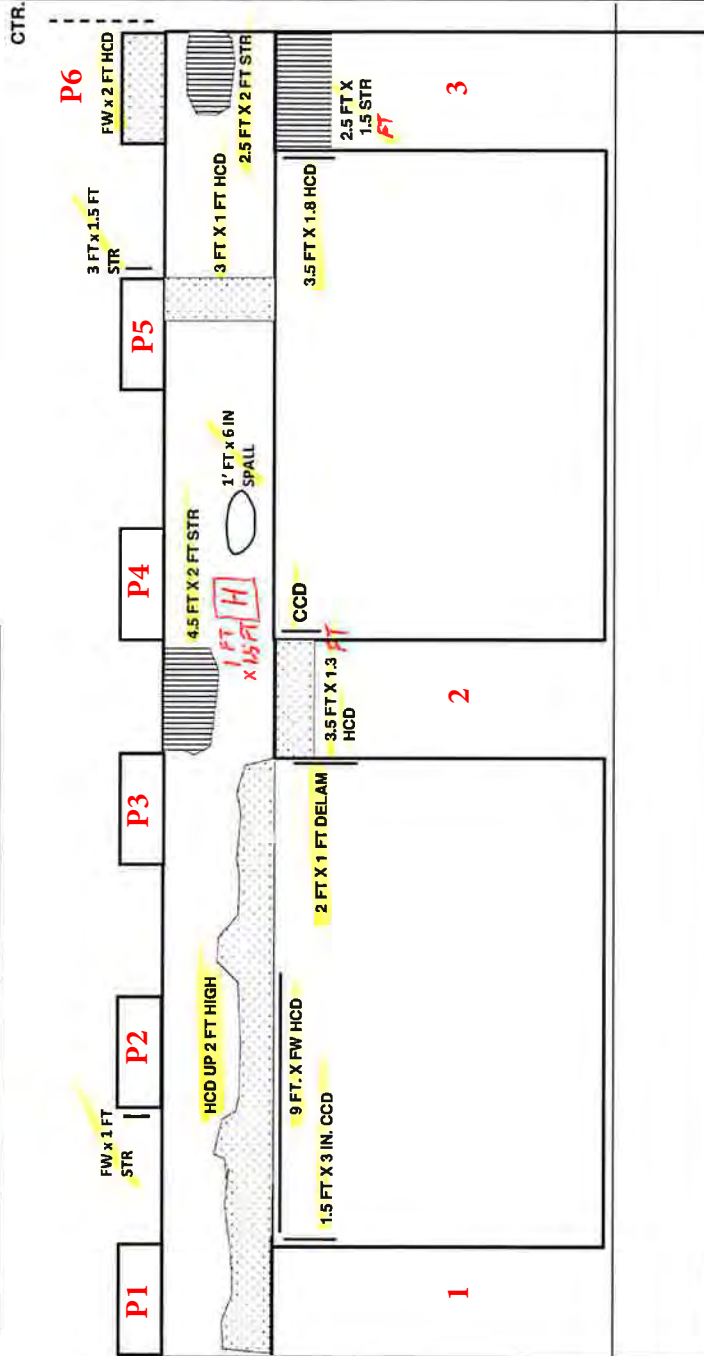
PIER 1 BEGIN LEFT FACE
 DETERIORATION DOC.

Sketch Description: Pier PR-1 Deterioraton - Begin Left Face

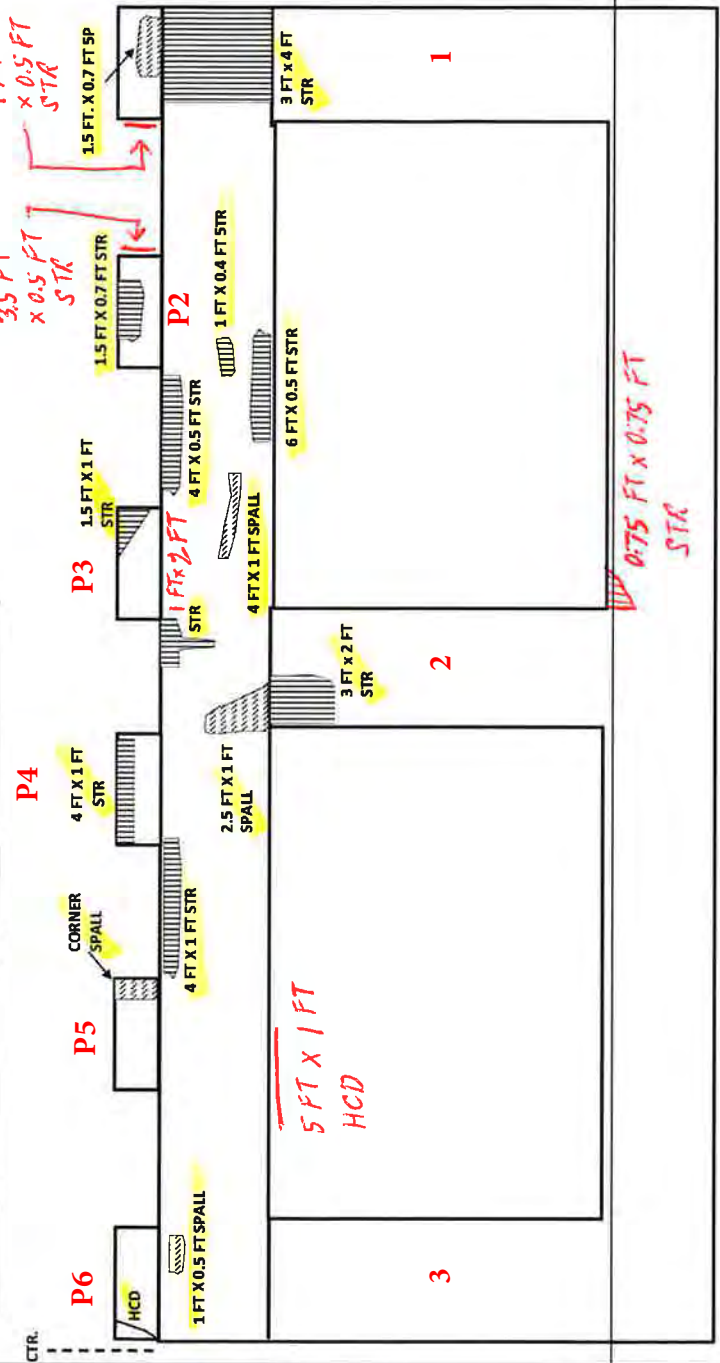
Sketch Description: Pier PR-1 Deterioraton - End Left Face

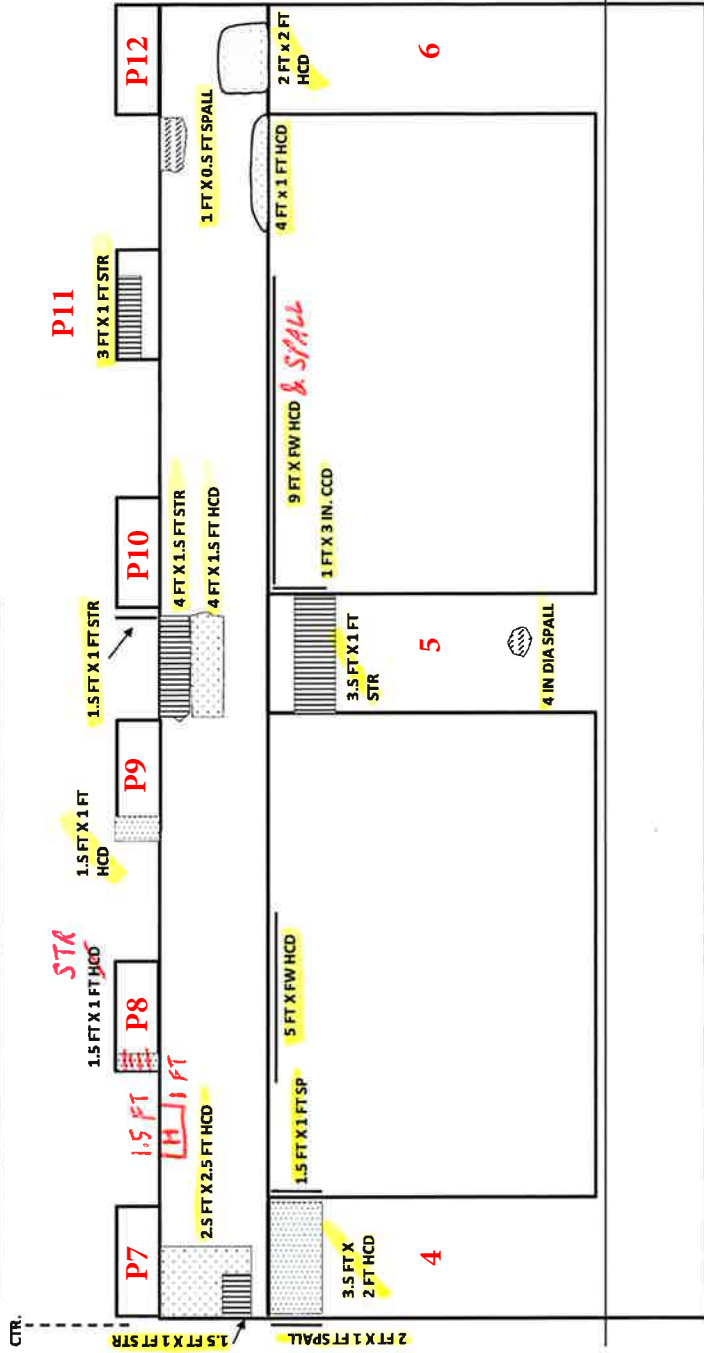
PIER 1 BEGIN RIGHT FACE
 DETERIORATION DOC.

Sketch Description: Pier PR-1 Deterioraton - Begin Right Face

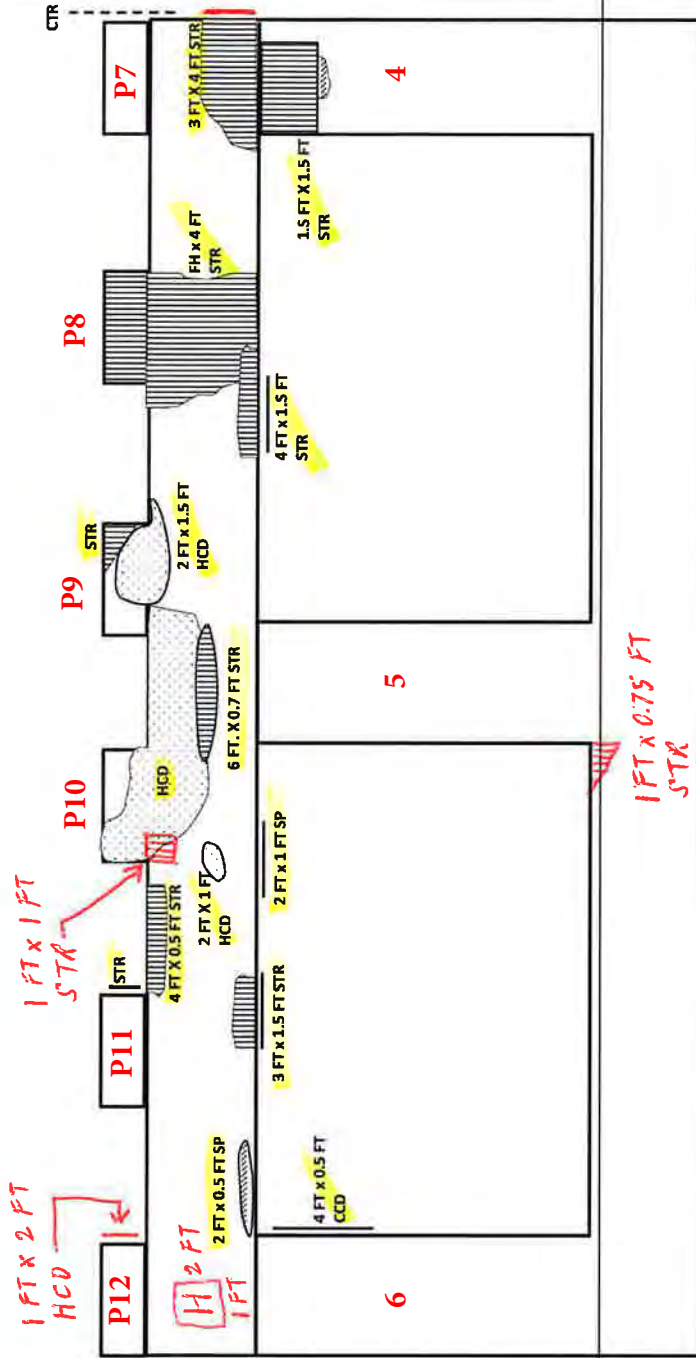
PIER 1 END FACE (RIGHT HALF)
 DETERIORATION DOC.

Sketch Description: Pier PR-1 Deterioraton - End Right Face

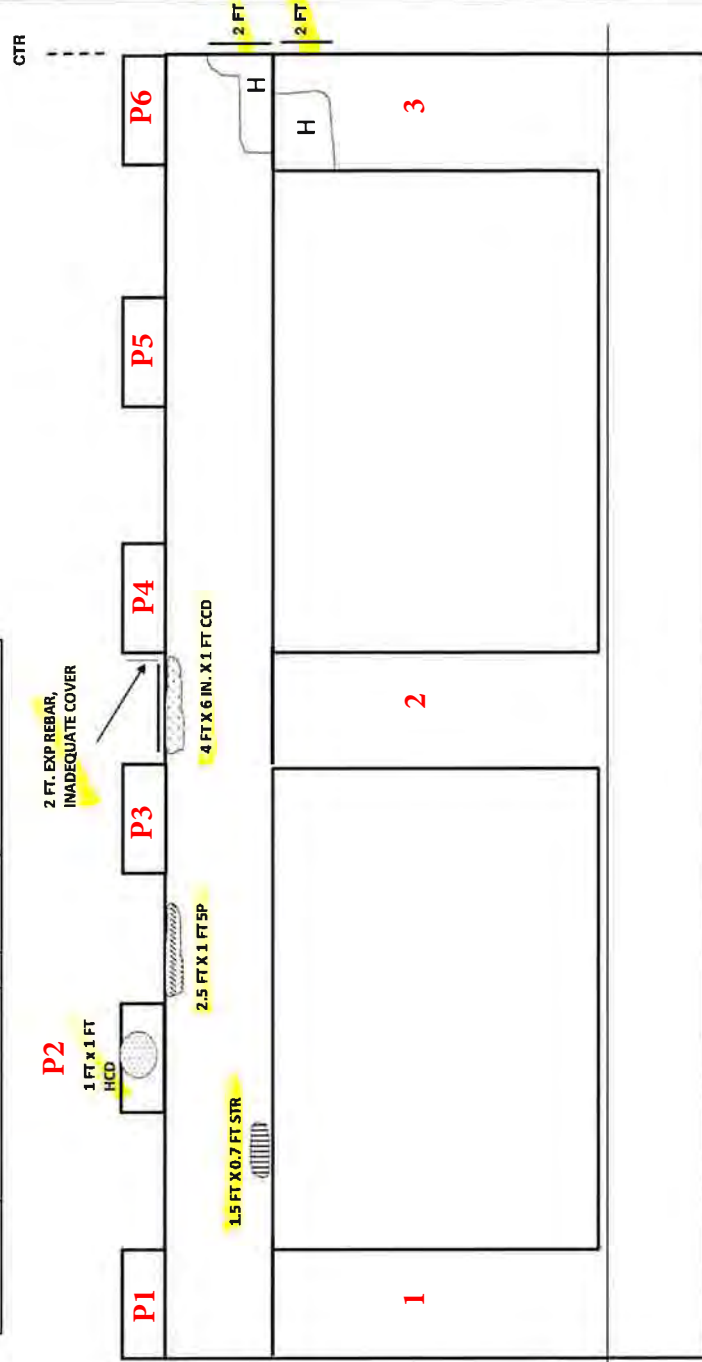
PIER 2 BEGIN LEFT FACE
 DETERIORATION DOC.

Sketch Description: Pier PR-2 Deterioraton - Begin Left Face

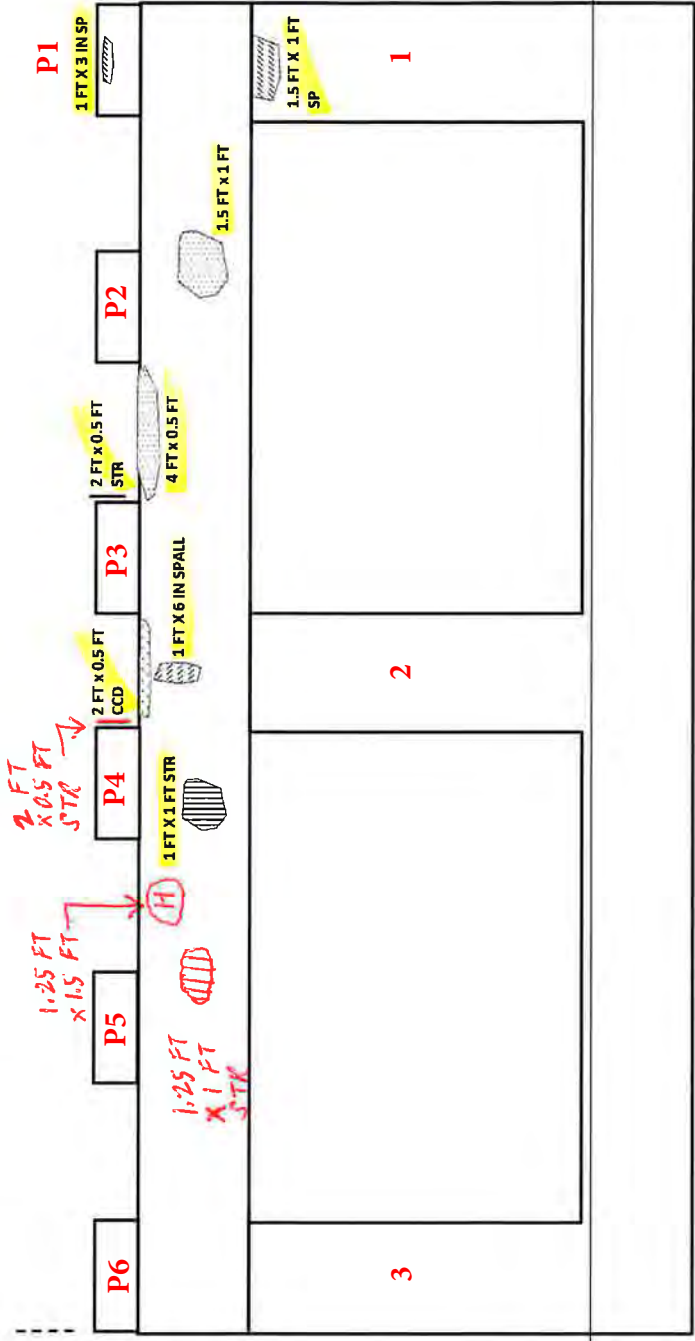
PIER 2 END FACE (LEFT HALF)
 DETERIORATION DOC.

Sketch Description: Pier PR-2 Deterioraton - End Left Face

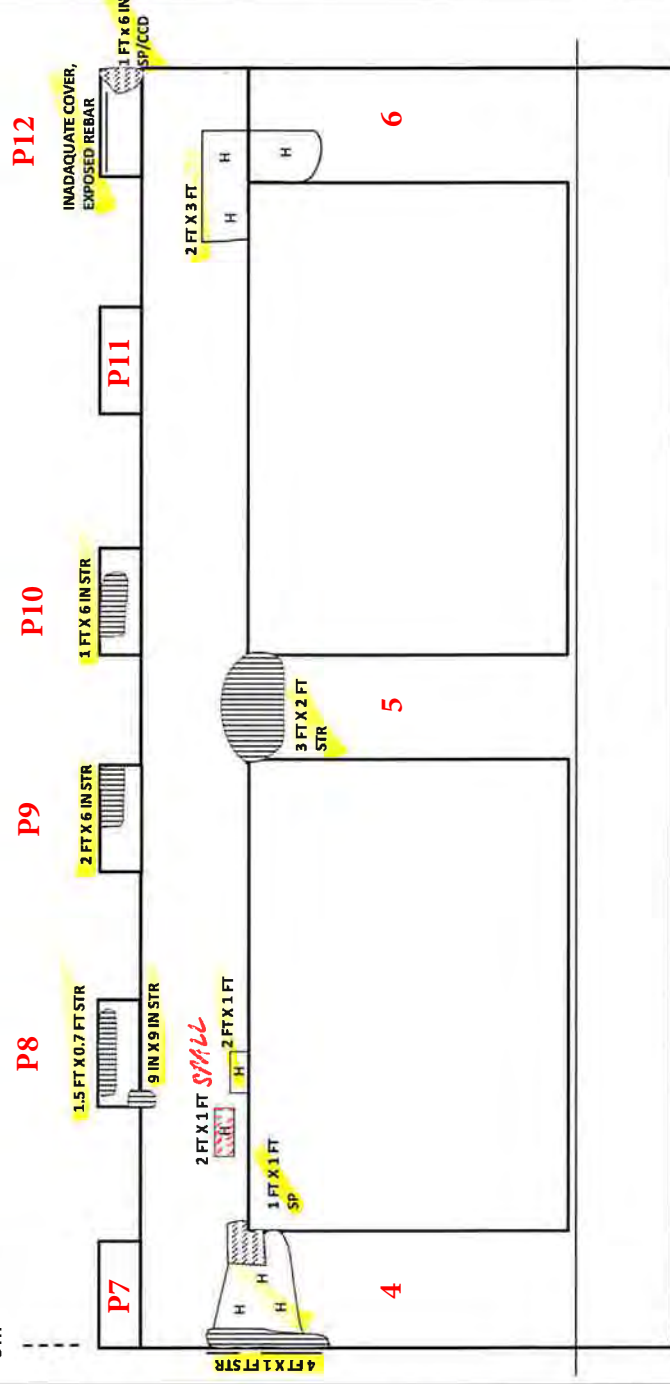
PIER 2 BEGIN RIGHT FACE
 DETERIORATION DOC.

Sketch Description: Pier PR-2 Deterioraton - Begin Right Face

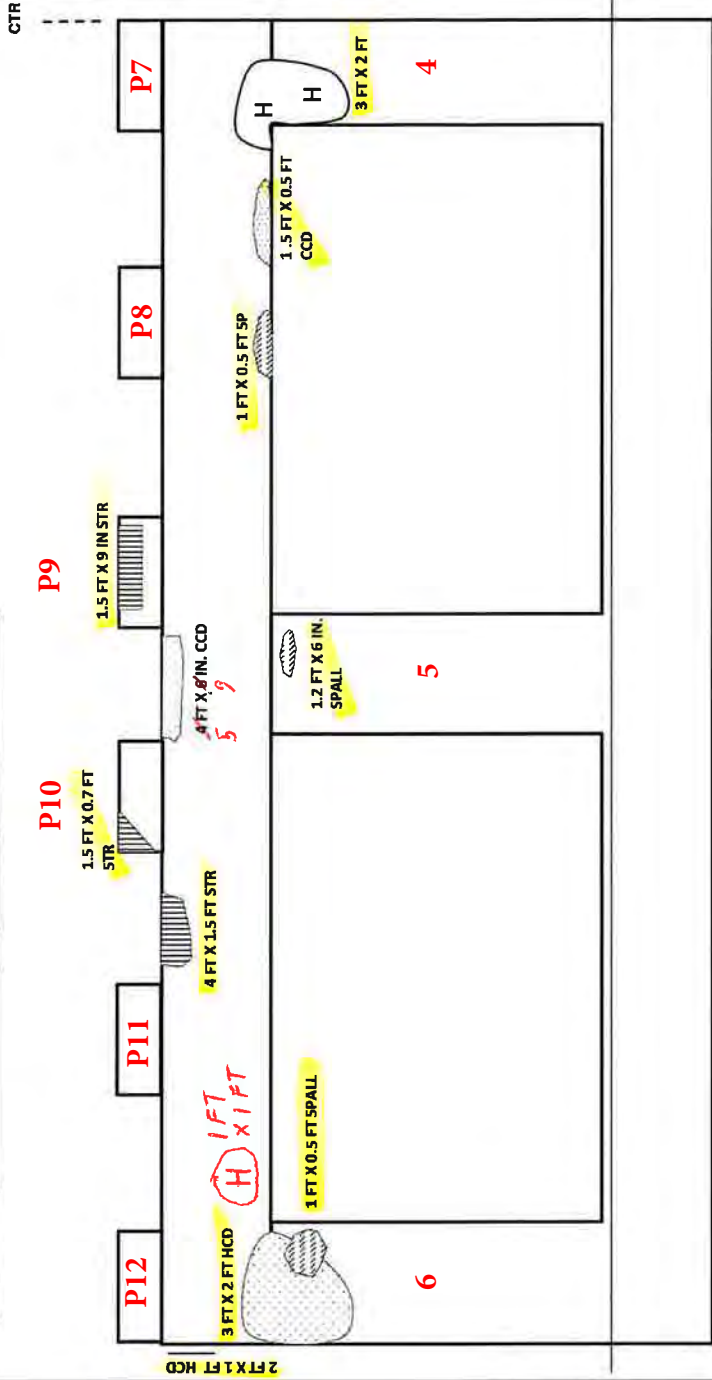
PIER 2 END FACE (RIGHT HALF)
 DETERIORATION DOC.

Sketch Description: Pier PR-2 Deterioraton - End Right Face

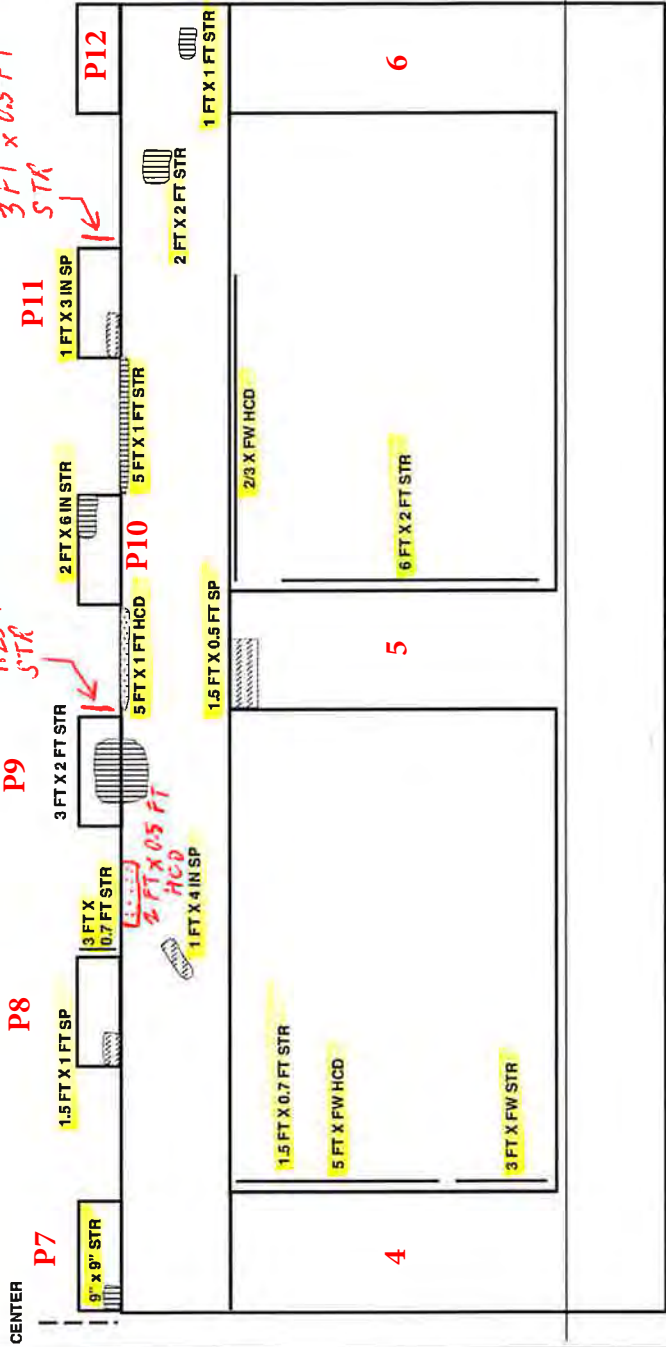
PIER 3 BEGIN RIGHT FACE
 DETERIORATION DOC.

Sketch Description: Pier PR-3 Deterioraton - Begin Right Face

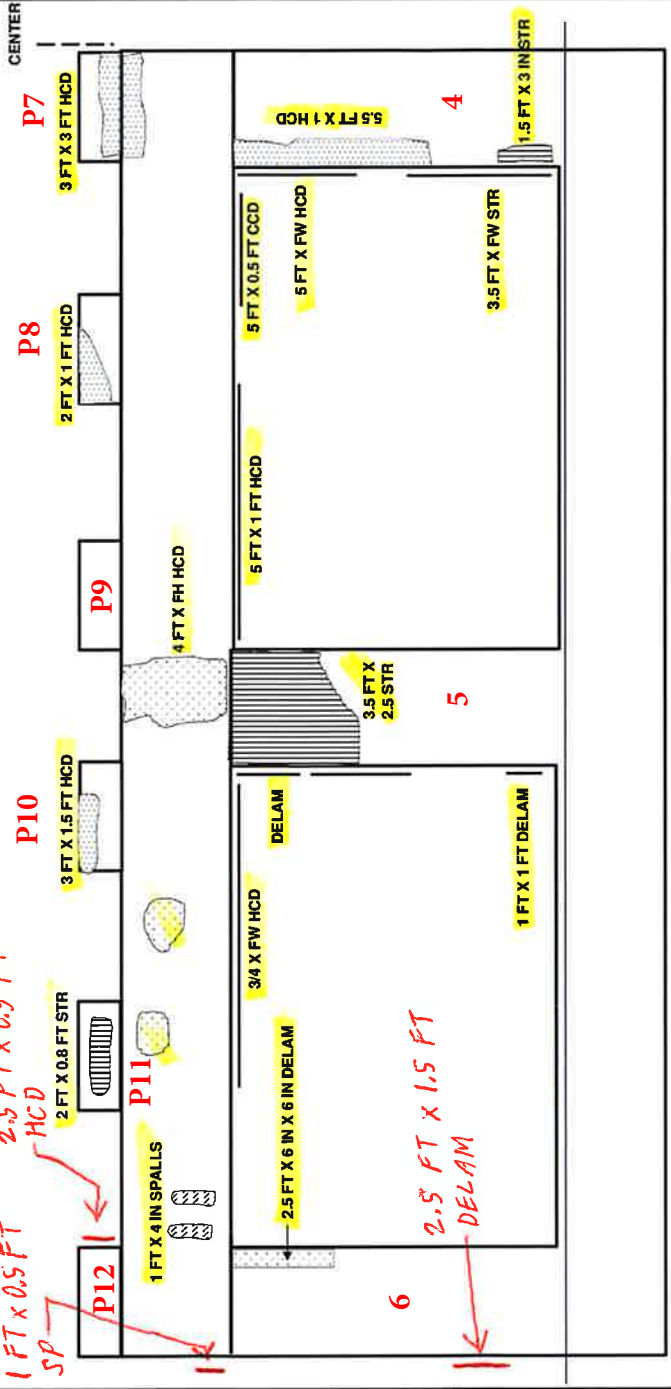
PIER 3 END FACE (RIGHT HALF)
 DETERIORATION DOC.

Sketch Description: Pier PR-3 Deterioraton - End Right Face

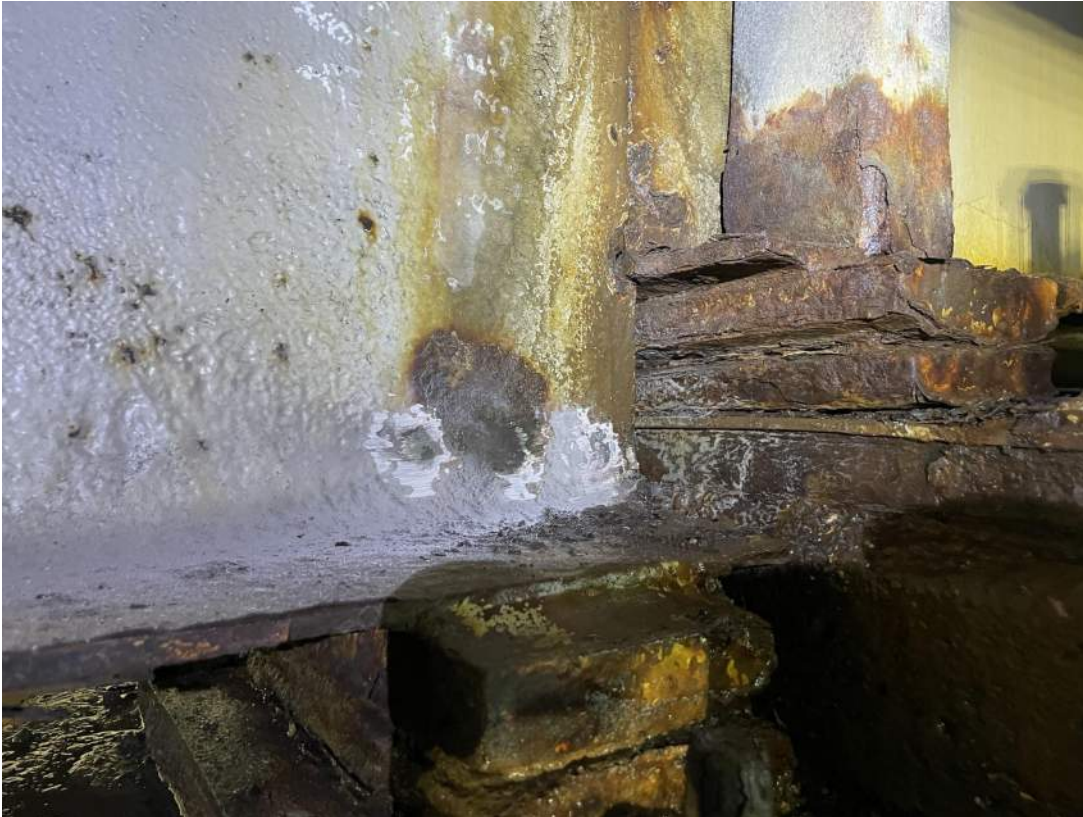
PHOTO 17

LOCATION:
G6 IN SPAN 3 AT
PIER

DESCRIPTION:
HEAVILY RUSTED
AND
OVEREXTENDED
EXPANSION
BEARING

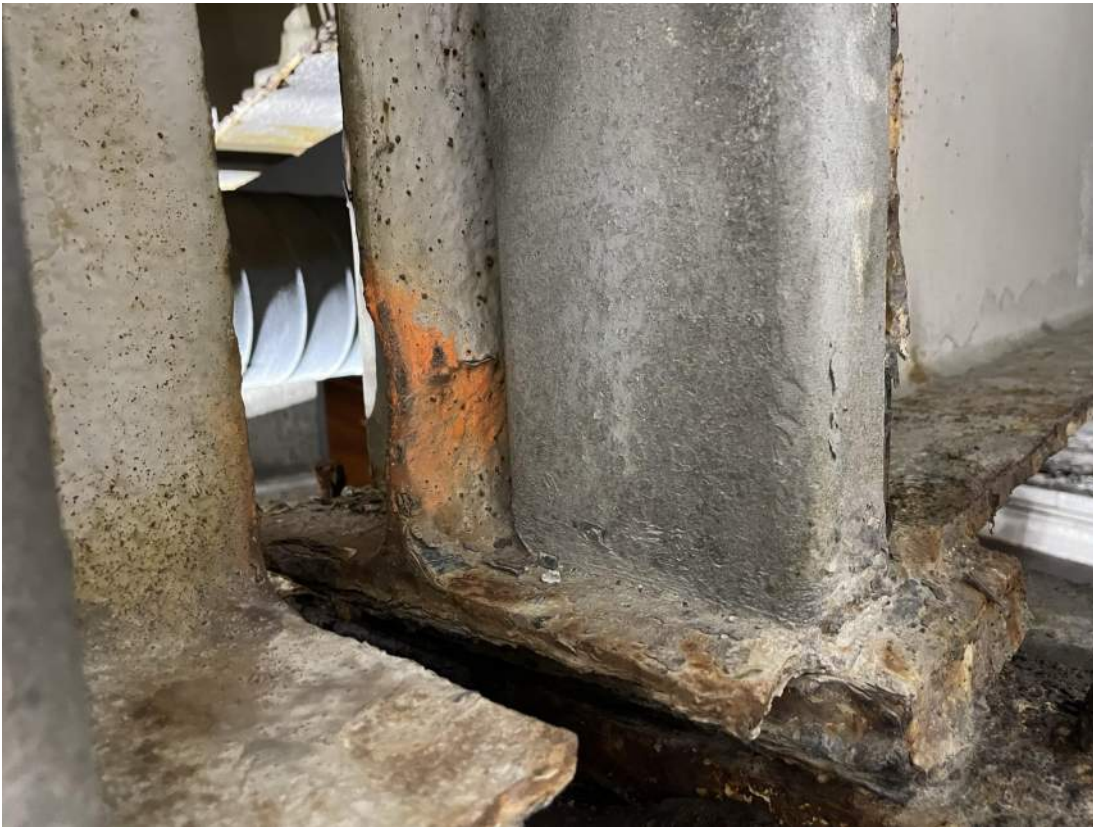
PHOTO 19

LOCATION:
G6 IN SPANS 2 & 3 AT
PIER

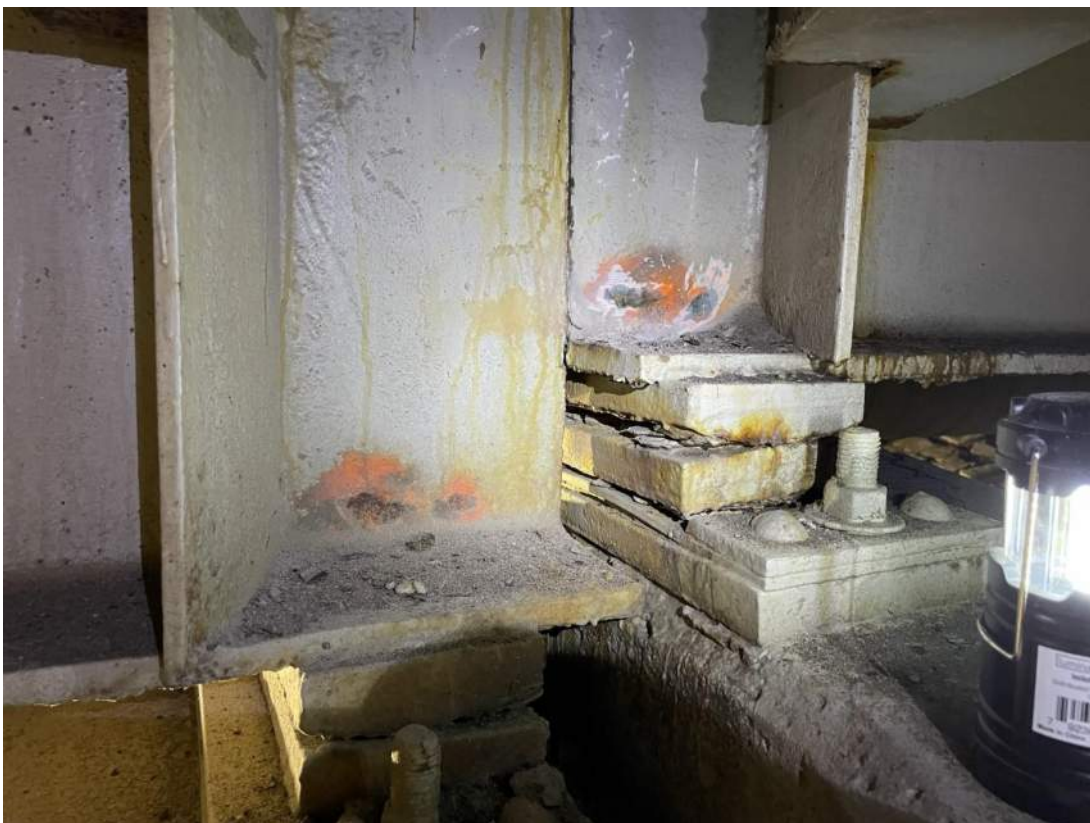
PHOTO 26

LOCATION:
G8 IN SPANS 3 & 4 AT
PIER

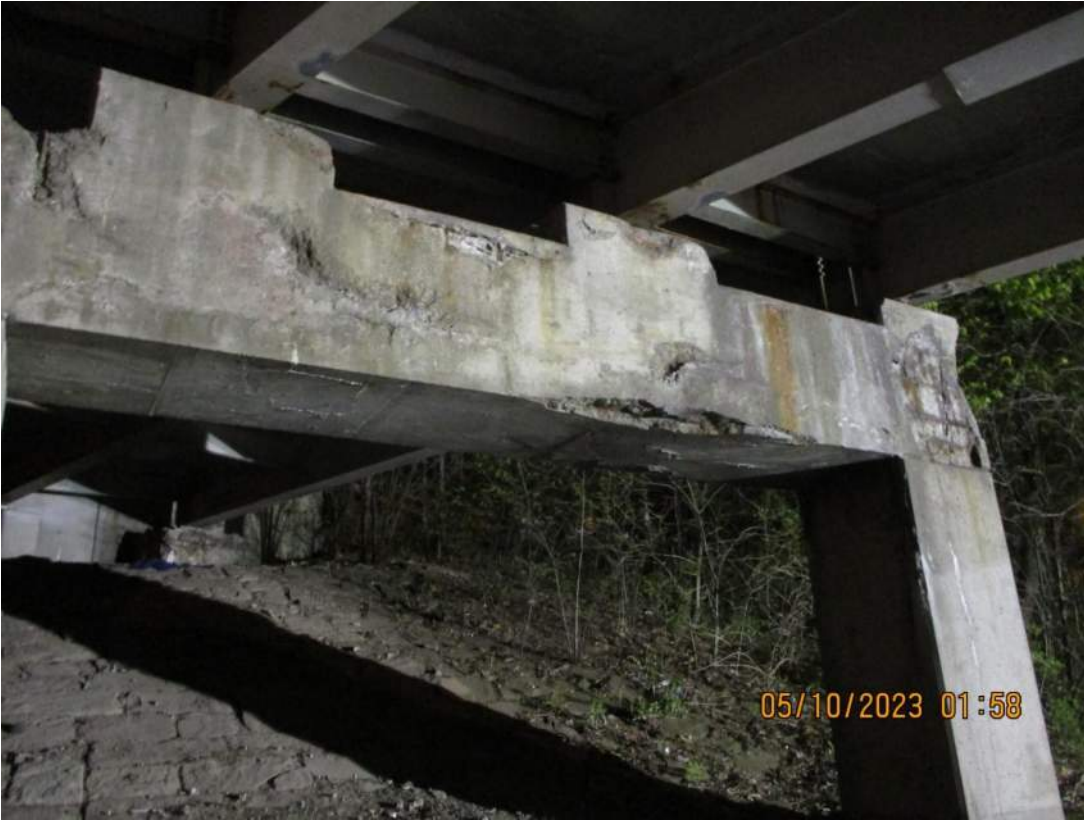
PHOTO 39

LOCATION:
PIER 1 END LEFT
FACE LOOKING
WEST

DESCRIPTION:
SPALLS TO
CORRODED REBAR
ON FACES OF PIER
CAP; TYPICAL FOR
ALL PIERS

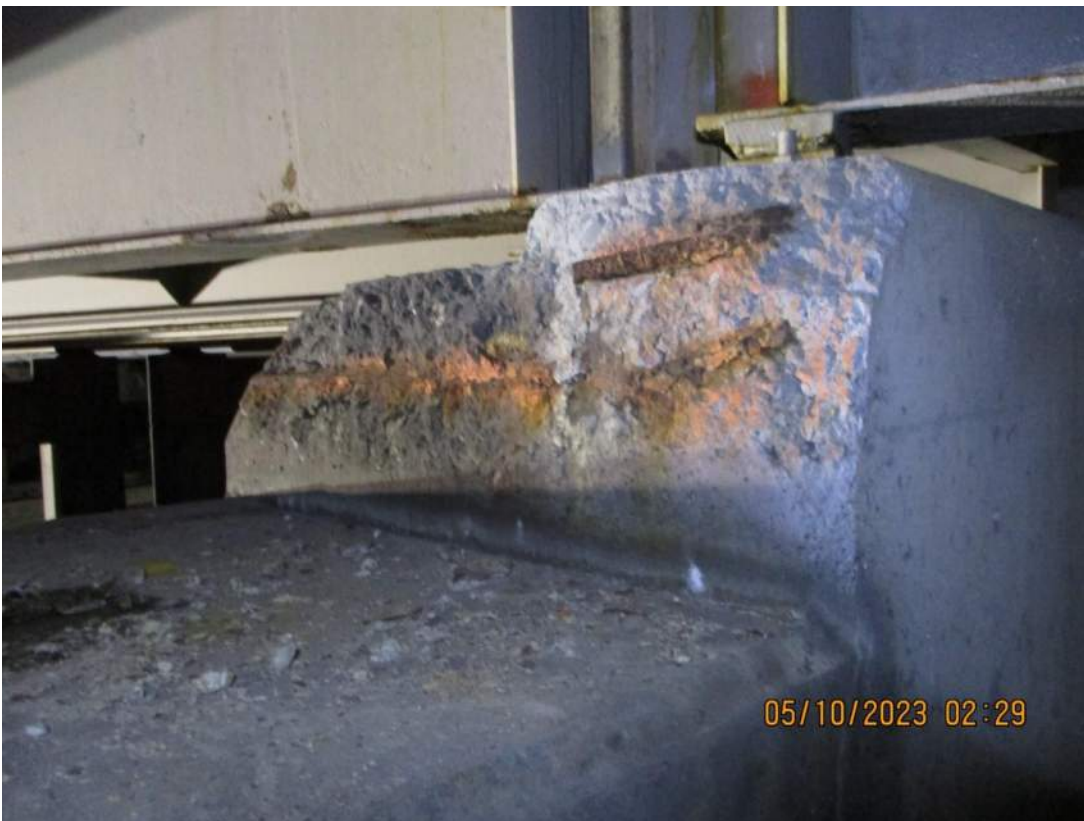
PHOTO 40

LOCATION:
PIER PEDESTAL 2 ON
PIER 1 LOOKING
SOUTH

DESCRIPTION:
SPALLS TO
CORRODED REBAR
ON PEDESTAL

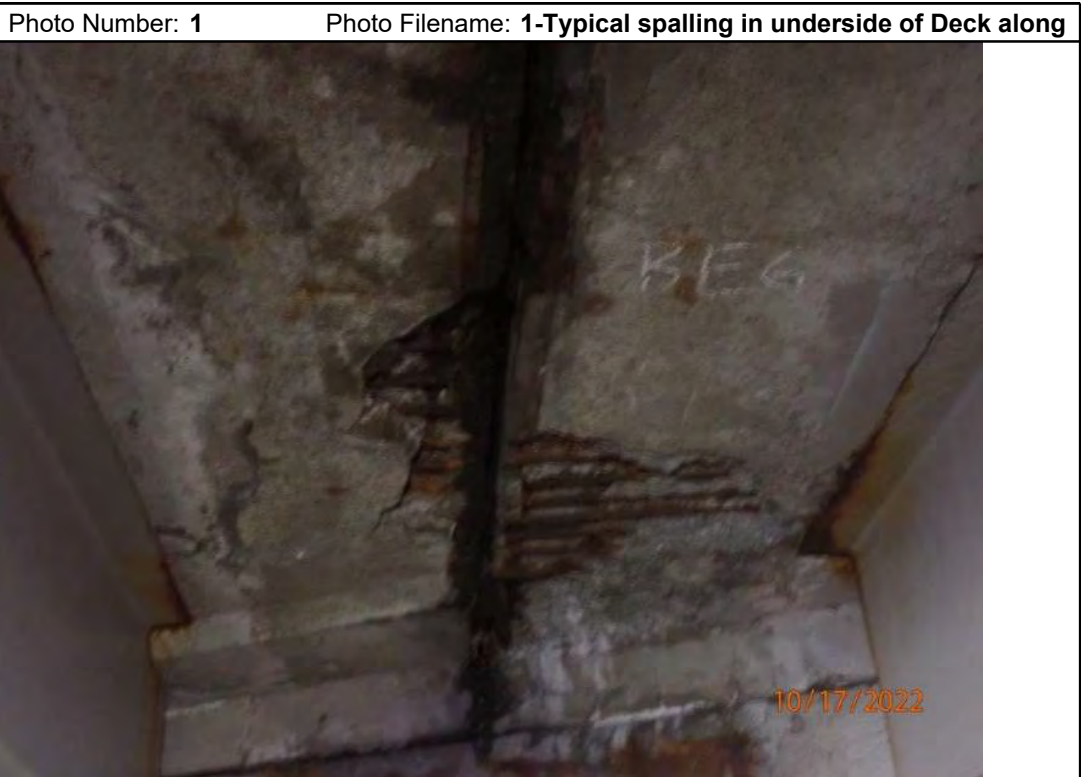
Attachment Description:
Typical spalling in underside of Deck along median joint (Begin Span 1 shown looking toward Begin)

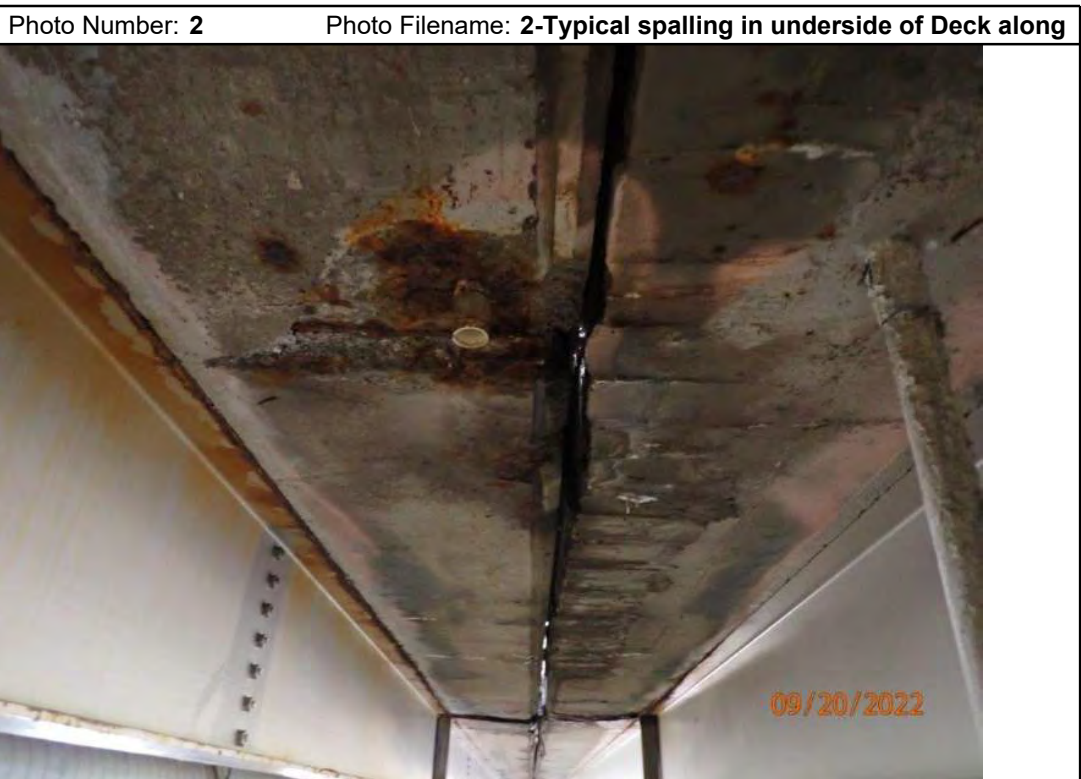
Attachment Description:
Typical spalling in underside of Deck along median joint (1/3-Span 4 shown looking toward Begin)

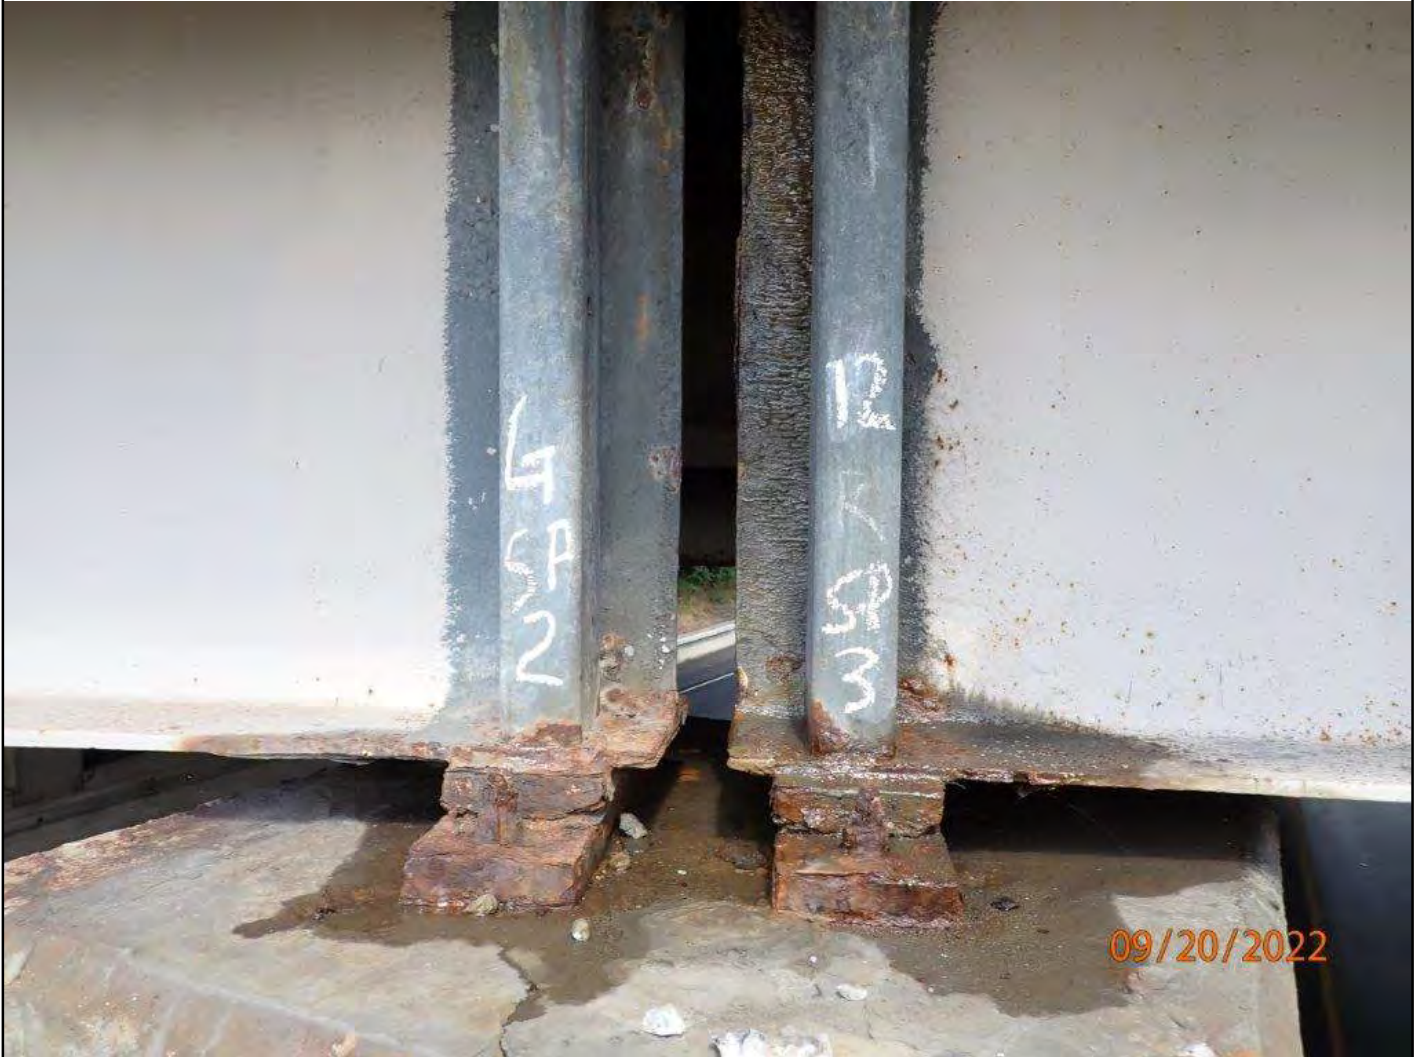
Photo Number: 4

Attachment Description: Typical box section repair (Right side of Girder G-12 shown over Pier PR-2 looking Left)

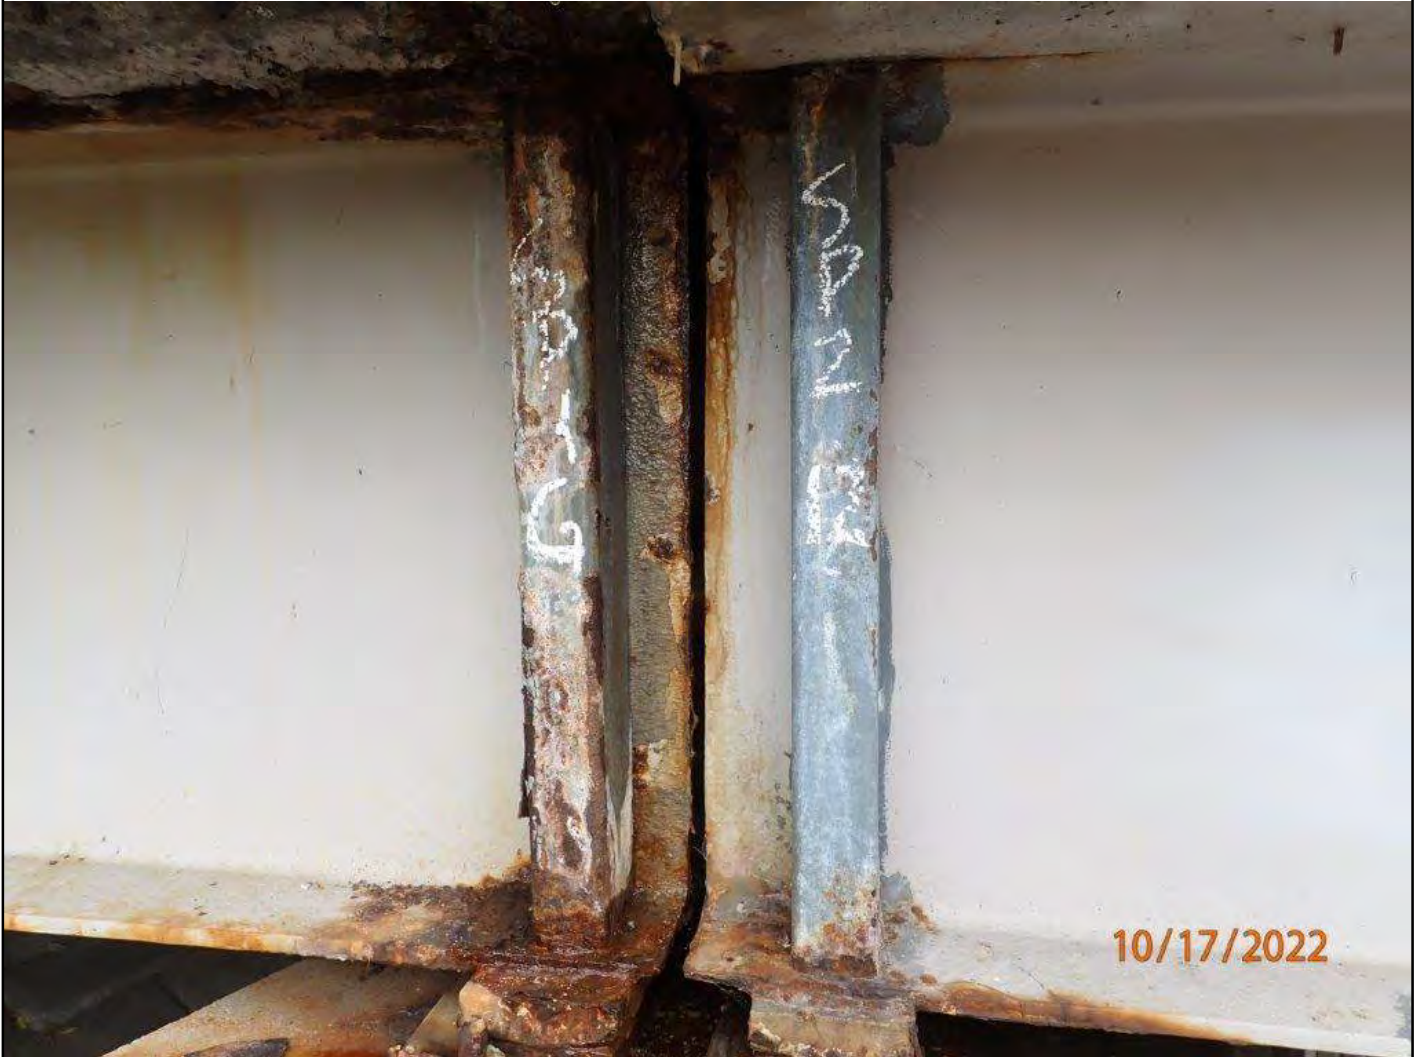
Photo Number: 4

Attachment Description: Typical box section repair (Right side of G-12 shown over PR-1)

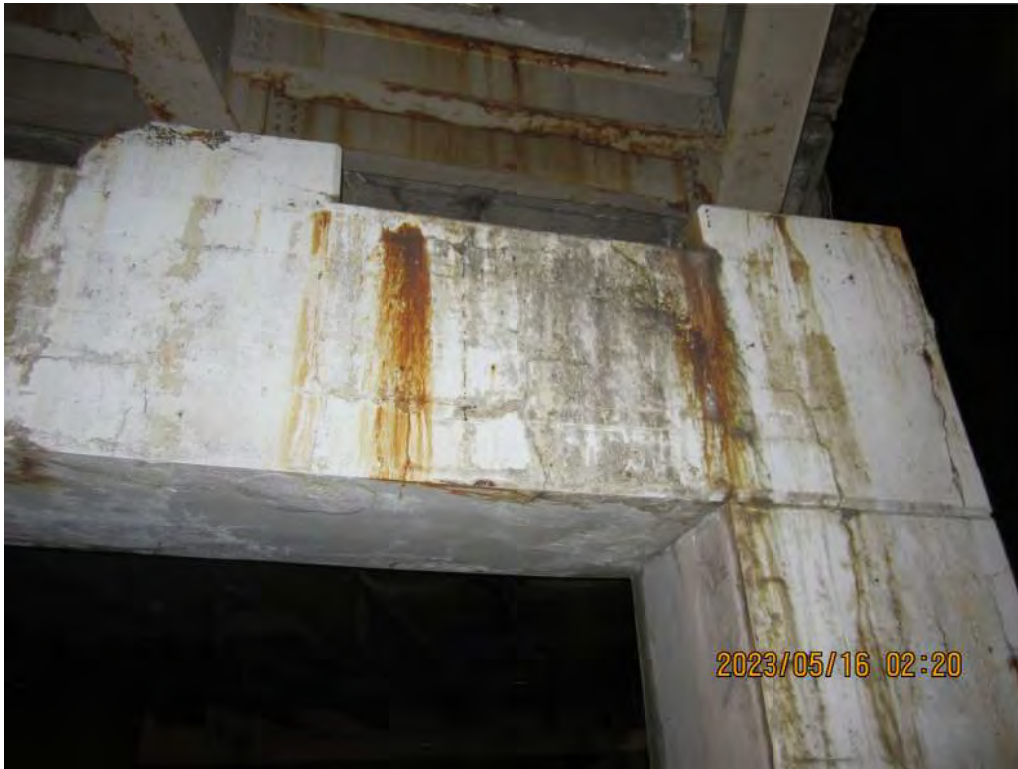
PHOTO 9

LOCATION:
PIER FROM SPAN 2

DESCRIPTION:
CRACKS TO CONCRETE
PIER WITH RUST
STAINING

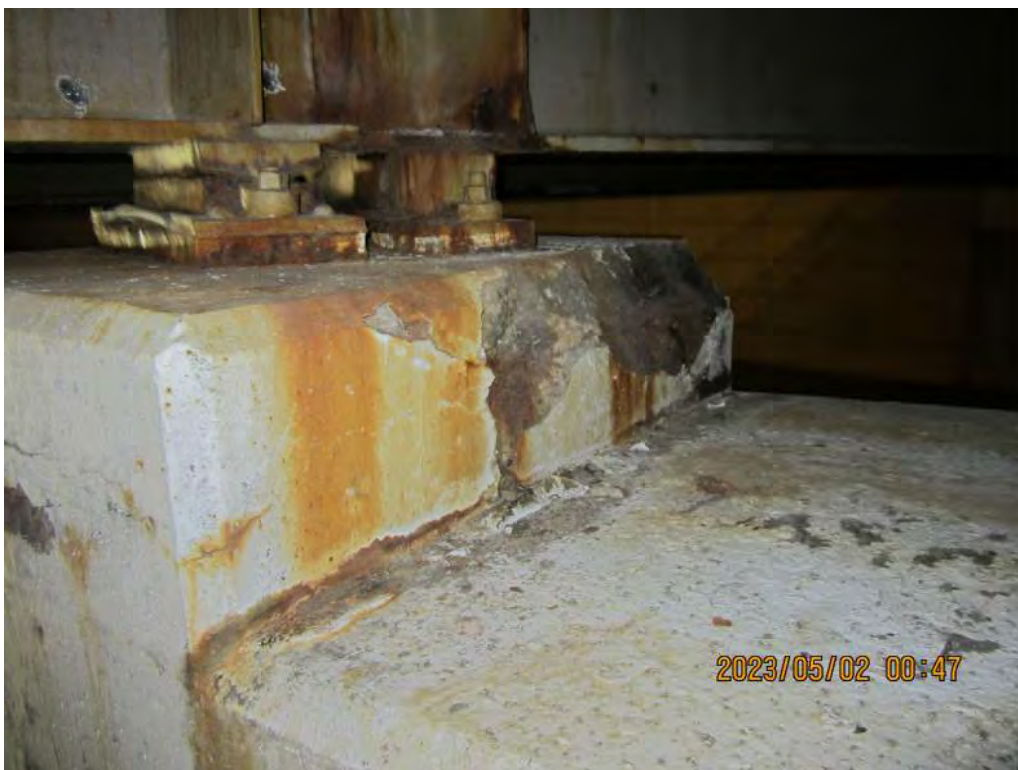
PHOTO 10

LOCATION:
PIER PEDESTAL

DESCRIPTION:
SPALLS ON CONCRETE
PIER PEDESTAL

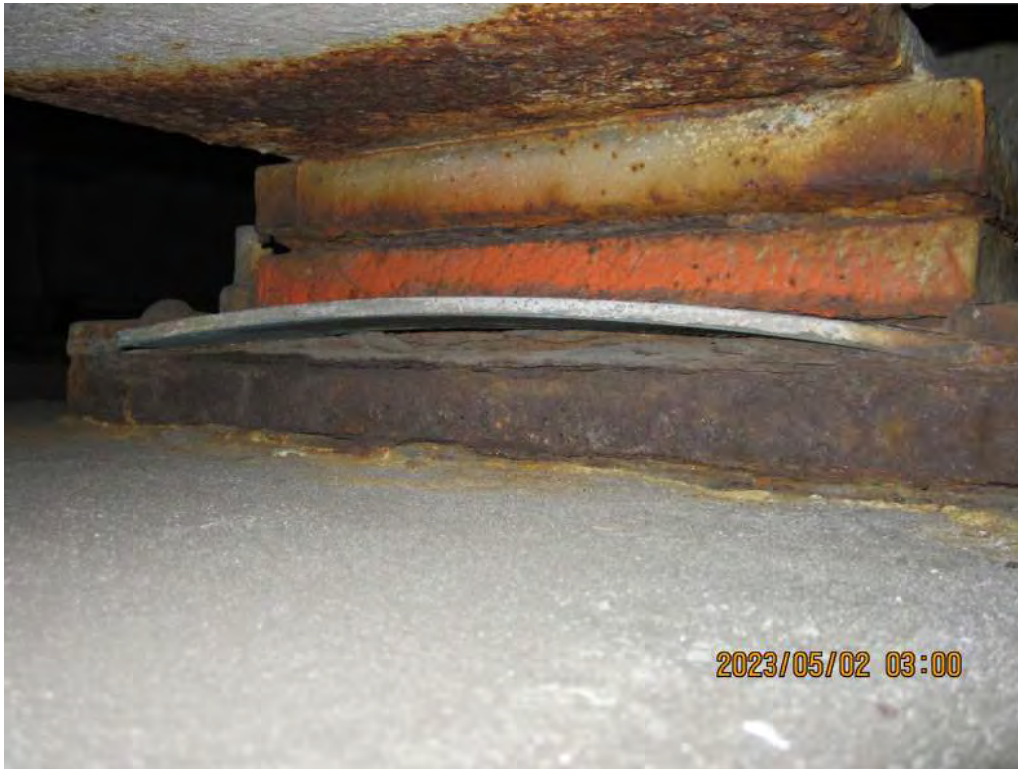
PHOTO 3:

LOCATION:
G4 IN SPAN 2 AT PIER

DESCRIPTION:
TYPICAL BEARING
CONDITION, PLATE
BOWED UPWARDS

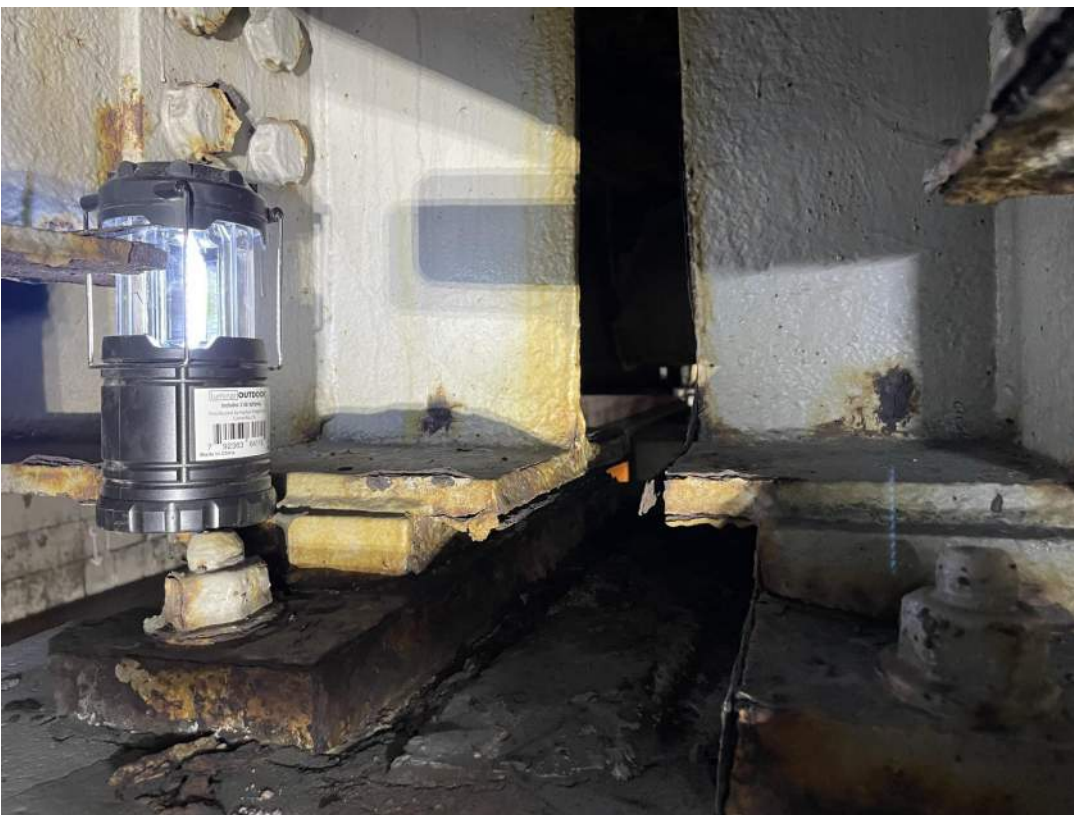
PHOTO 2

LOCATION:
G4 IN SPANS 1 & 2 AT
PIER

DESCRIPTION:
TYPICAL BEARING
AND GIRDER END
CONDITIONS
