Bridge Inspection Reports and Work History Summaries

**NY33 BRIDGE CONDITION VERIFICATION 2023
KENSINGTON EXPRESSWAY PROJECT
PIN 5512.52
CITY OF BUFFALO, ERIE COUNTY
BIN 1022609**

STRUCTURE: BIN 1022609 - Best Street on NY33 Kensington Expressway

STRUCTURE TYPE: Four (4) span Steel, Multi-Stringer (12 beams) structure with concrete abutments founded on piles and 3-six column piers with spread footings. Year Built: 1959

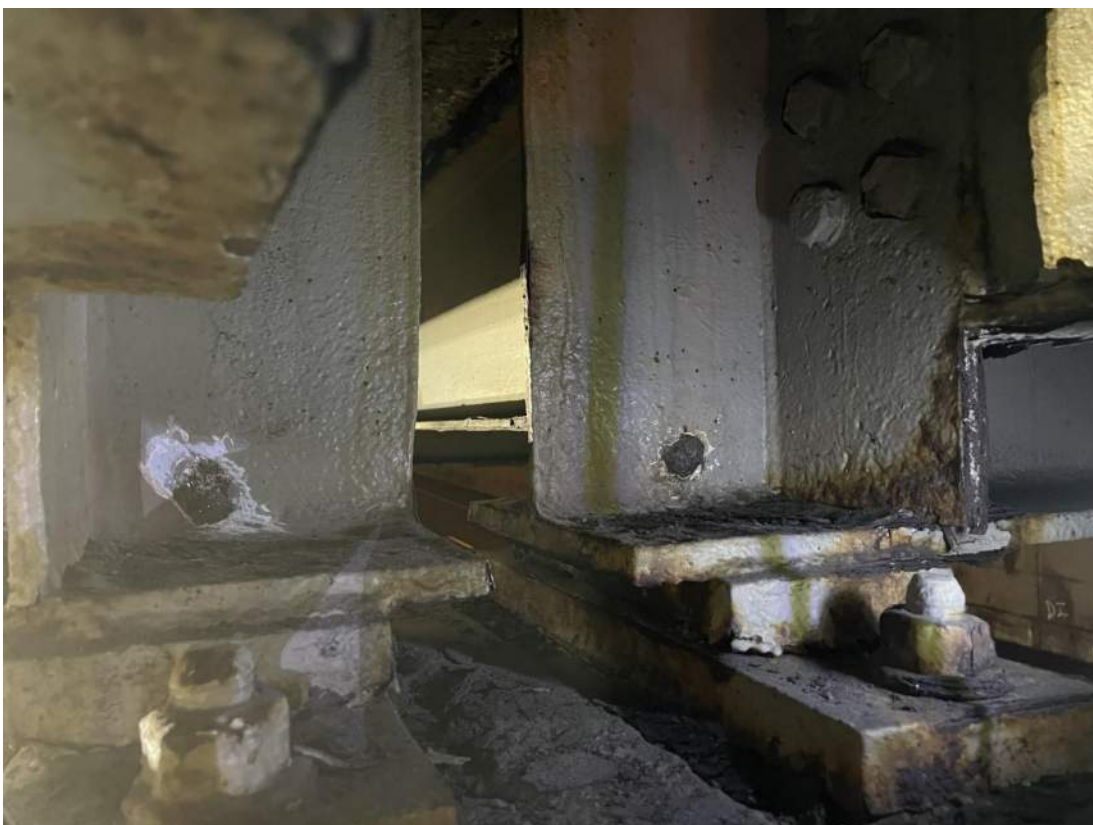
PHOTO 6

LOCATION:
G8 IN SPANS 1 & 2 AT
PIER

DESCRIPTION:
TYPICAL GIRDER
END CONDITION

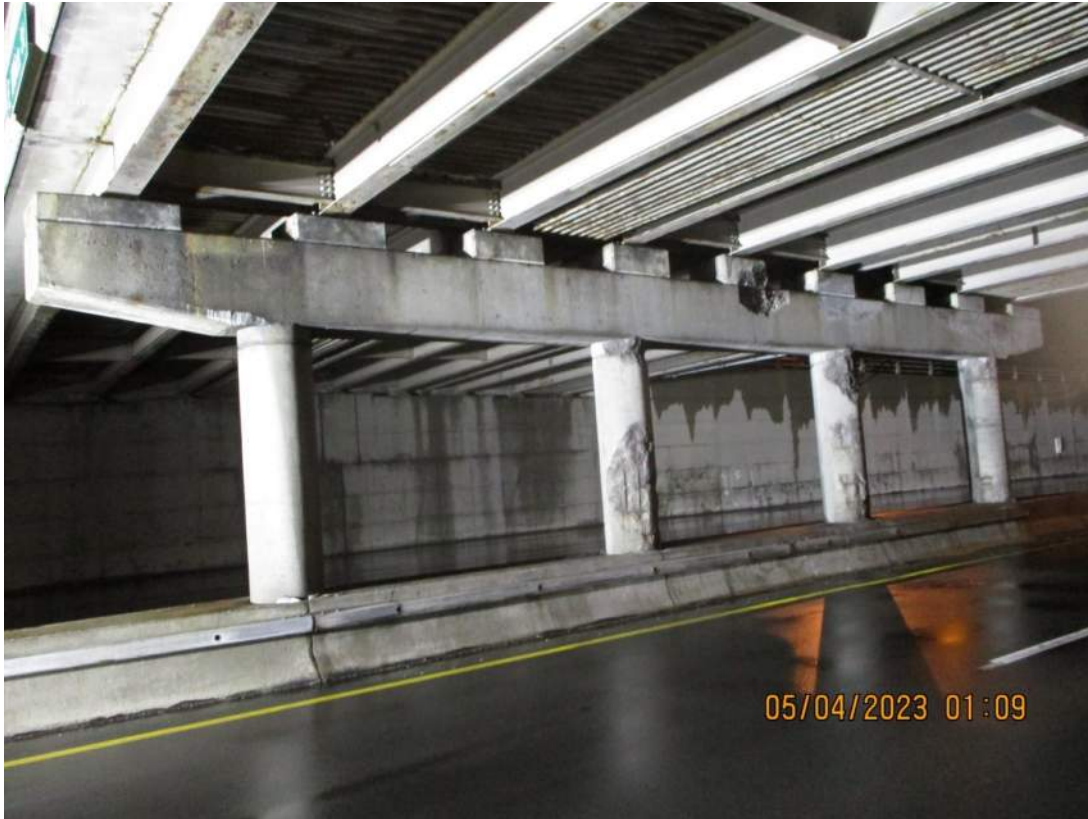
PHOTO 7

LOCATION:
PIER BEGIN FACE
LOOKING WEST

DESCRIPTION:
GENERAL SPALLING
CONCRETE
CONDITIONS;
TYPICAL FOR BOTH
FACES

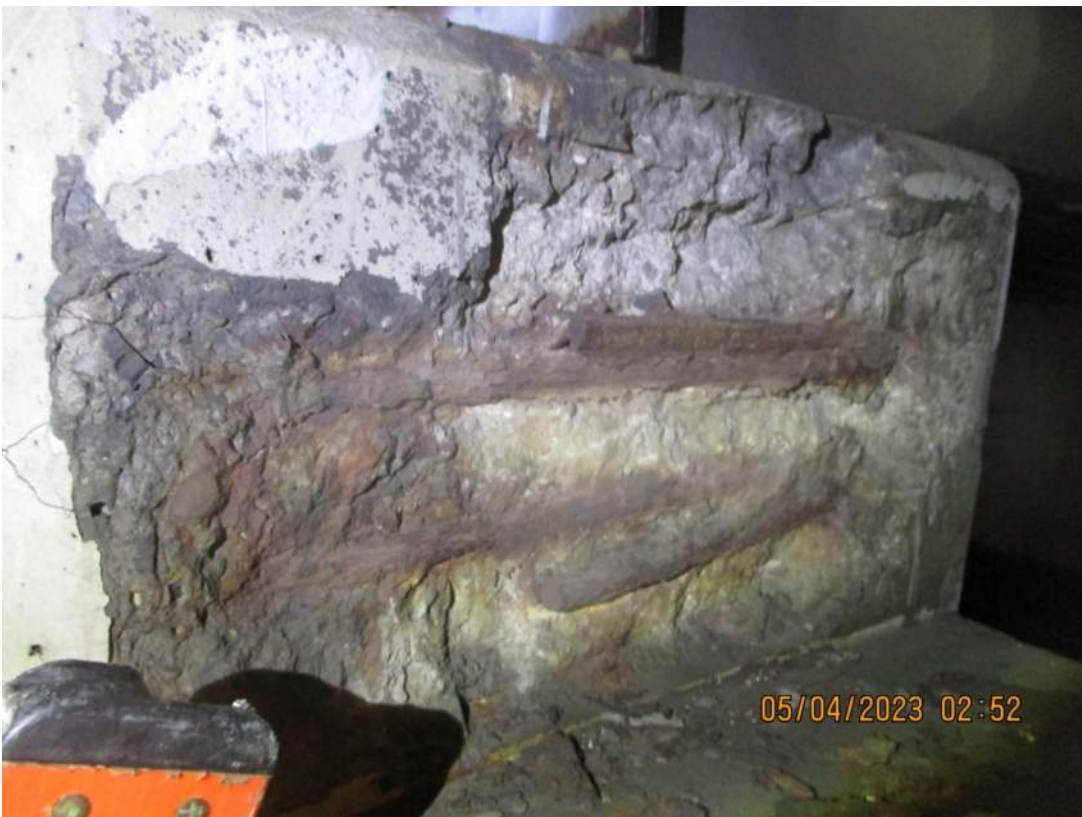
PHOTO 10
LOCATION: PEDESTAL P6 LOOKING SOUTH
DESCRIPTION: SPALLS TO CORRODED REBAR ON PEDESTAL

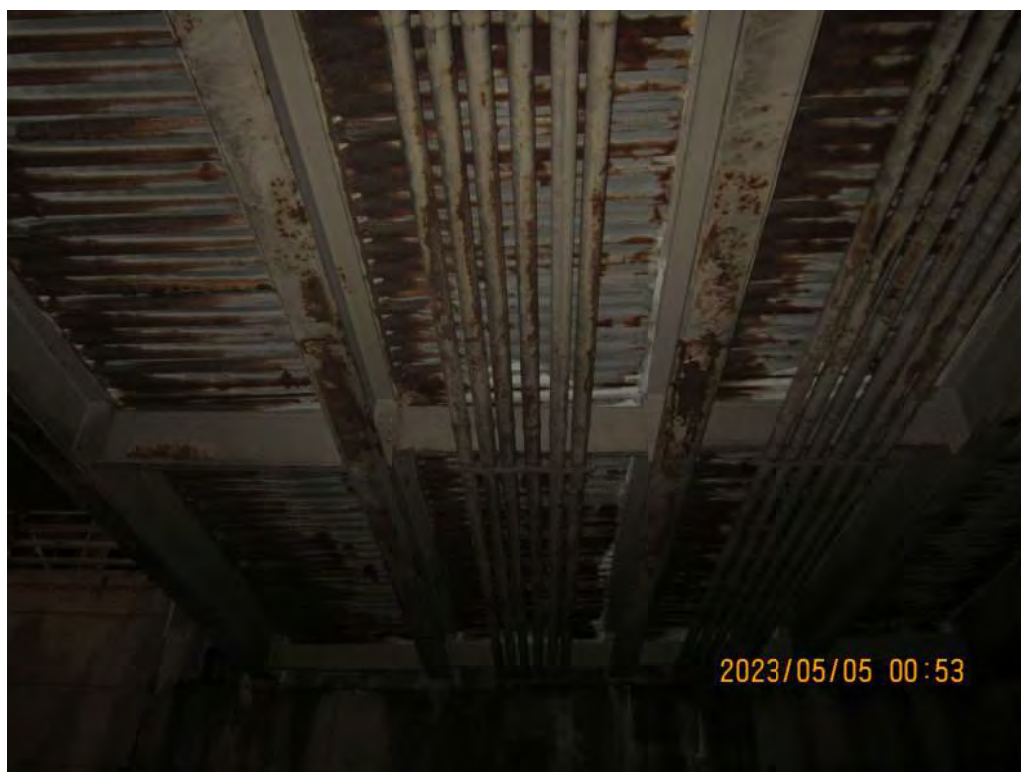
PHOTO 8:
LOCATION:
UNDERSIDE OF DECK IN
SPAN 2
DESCRIPTION:
TYPICAL DECK
CONDITION PHOTO,
SIGNIFICANT RUSTING
TO STAY-IN-PLACE
FORMS
