# **Appendix A5**

## Retaining Wall Inspection Reports

**NY33 RETAINING WALL CONDITION EVALUATION 2023**  
**KENSINGTON EXPRESSWAY PROJECT**  
**PIN 5512.52**  
**CITY OF BUFFALO, ERIE COUNTY**  
**RETAINING WALL 1**

# PIN 5512.52 – NY33 RETAINING WALL CONDITION EVALUATION 2023 FIELD INSPECTION SUMMARY

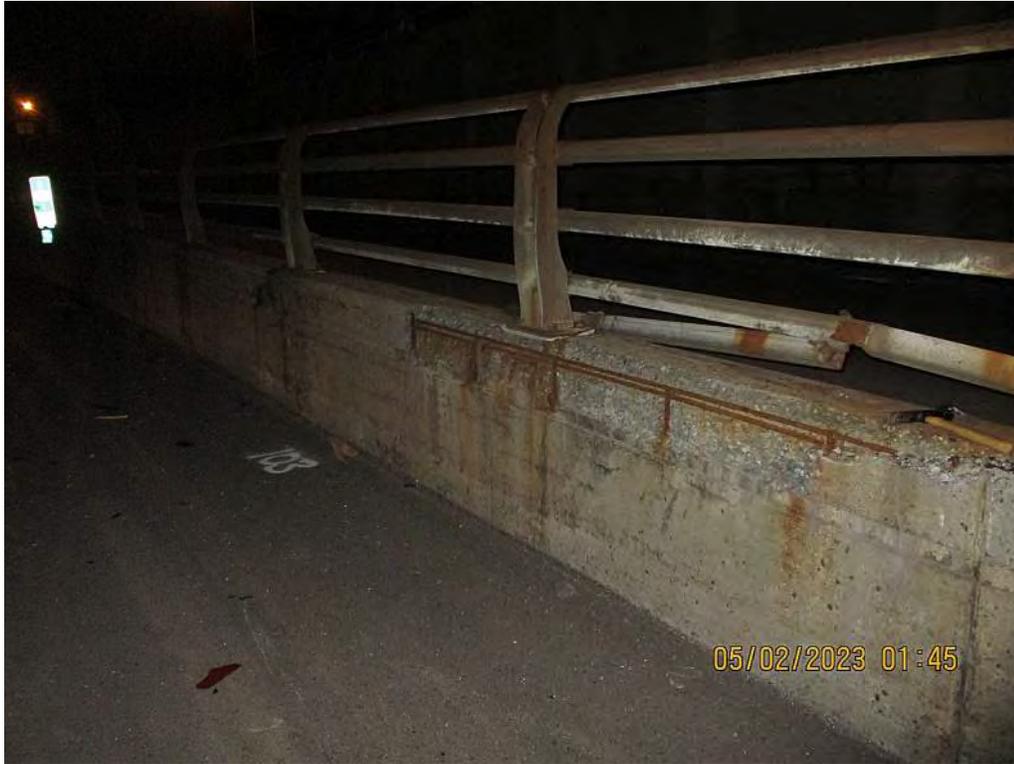
PHOTO 1  
PANEL 103  
Description:  
The railing coping concrete and the underlying wall face are spalled 1" deep with exposed rebar. Rebar exhibits approximately 15% section loss. The remaining coping concrete is delaminated. The wall face has minor map-cracking with efflorescence and rust staining.  
The bottom steel bridge rail tube is broken and detached from the railing post.

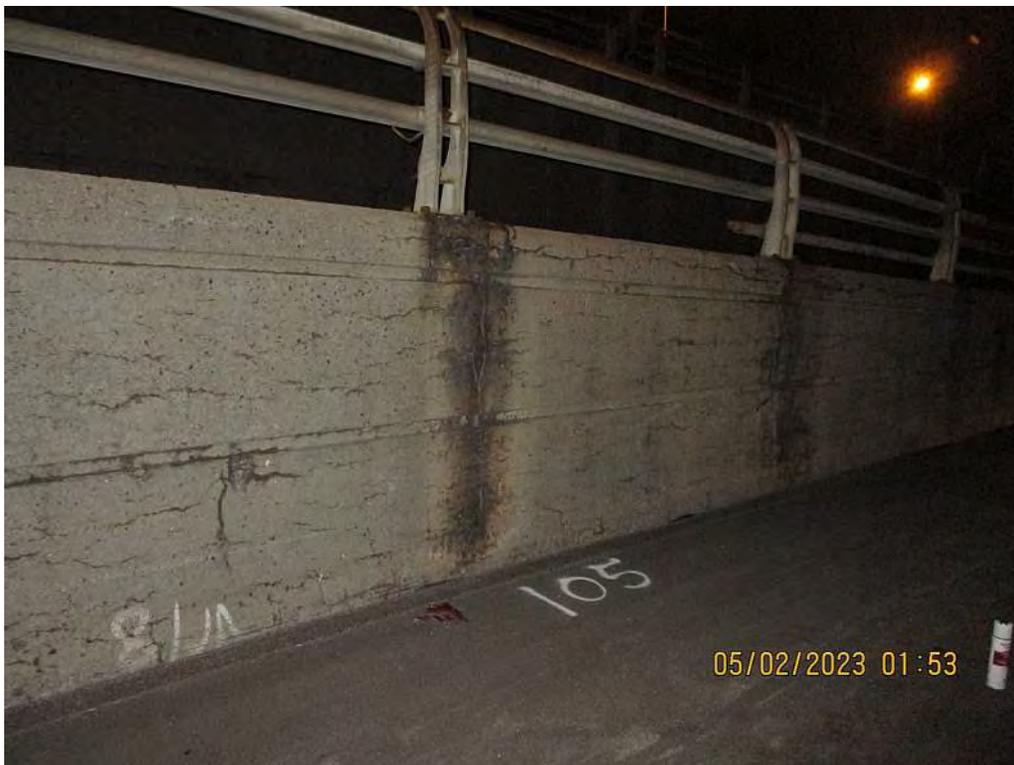
PHOTO 2  
PANEL 105  
Description:  
The wall railing system coping is cracked at mid-height. The crack is 80% of the wall panel length. The wall face has minor map-cracking with staining.  
There are two (2) full height vertical cracks in the wall face under two of the railing posts. There is map-cracking and delamination of the concrete approximately 12 inches wide adjacent to the crack over 50% of length.  
The bottom steel bridge rail tube is missing from the railing posts.

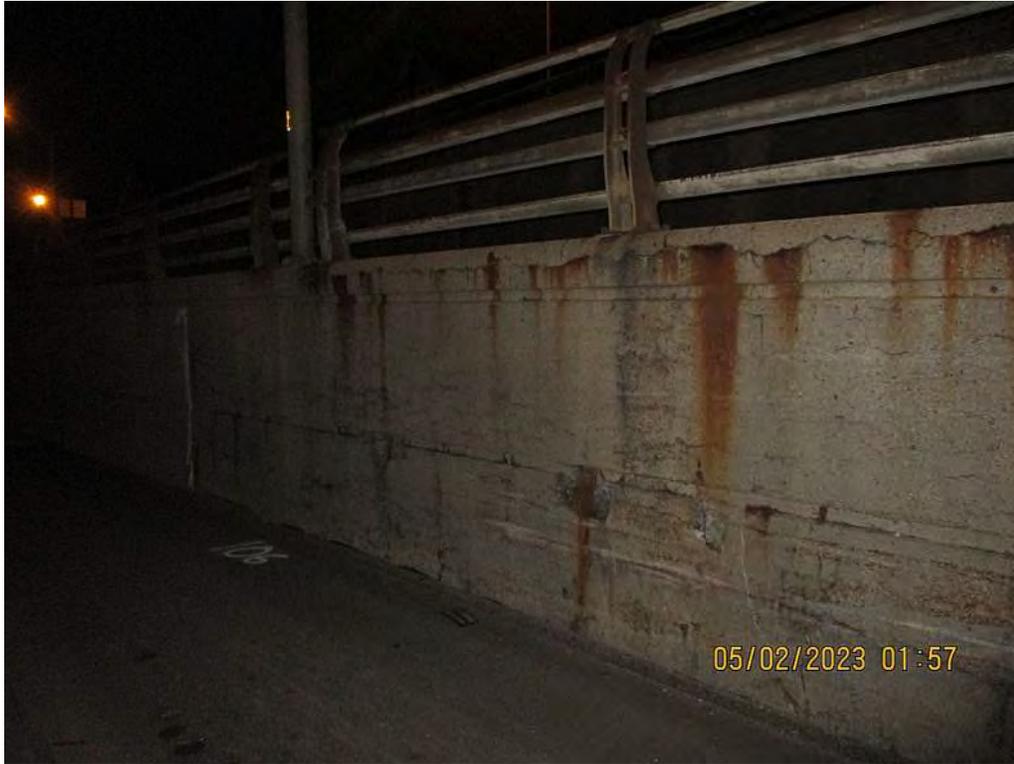
PHOTO 3  
PANEL 106

The wall railing system coping is cracked at mid-height. The crack is approximately 80% of the wall panel length.

The wall face has minor map-cracking with staining. There are two (2) spall areas with exposed rebar (rebar section loss is 30%) at the first chamfer line at 12 ft. and 19 ft. from the panel begins. There is map-cracking and delamination of the concrete approximately 3 ft by 3 ft adjacent to the end panel joint.

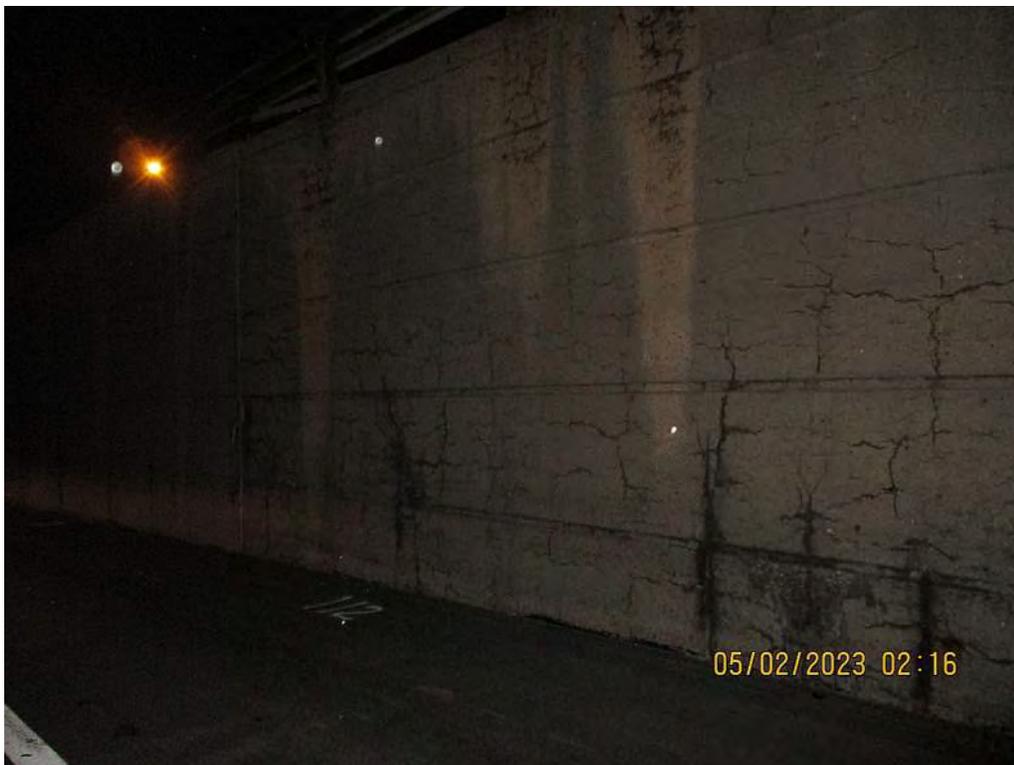
PHOTO 4  
PANEL 112

The wall railing system coping is cracked under the railing posts. The wall face is map-cracked with staining.

There are multiple vertical cracks in the wall face mirroring the underlying vertical reinforcing.

Concrete spalls and delamination are found between 5 ft and 9 ft from the roadway surface.

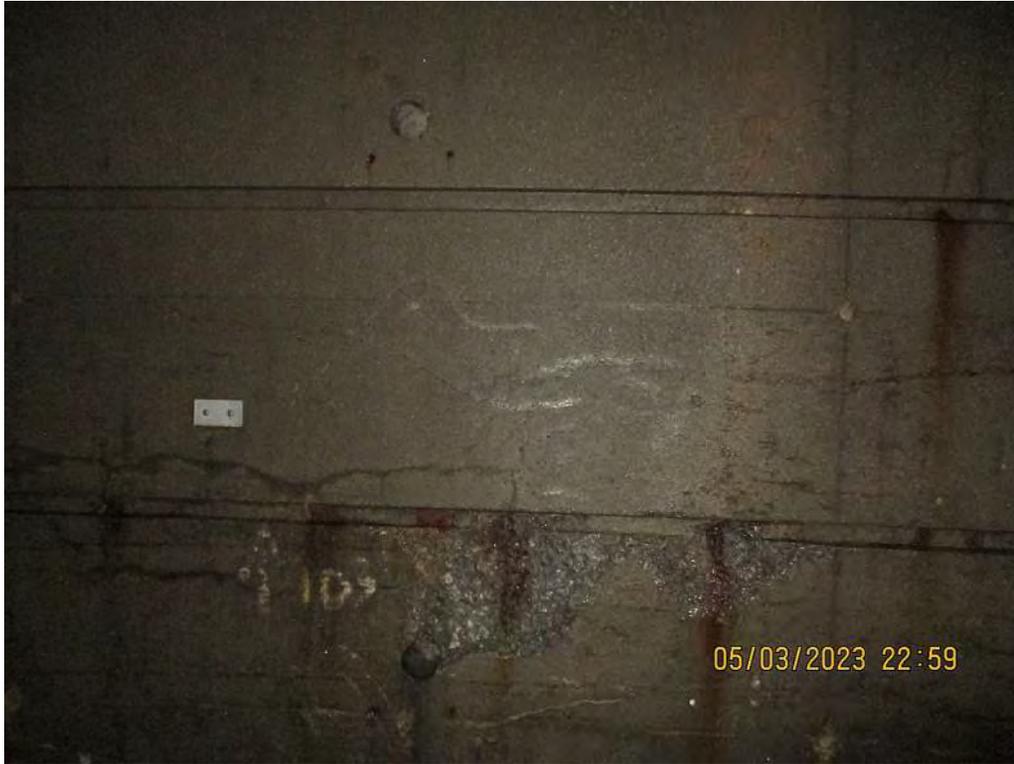
PHOTO 5  
PANEL 120  
Description:  
The lower 4 ft of the wall surface is spalled and delaminated over 50% of the area.  
The multiple spalls have exposed rebar.  
There is a half height vertical crack in the wall face at 13 ft from the panel begin.

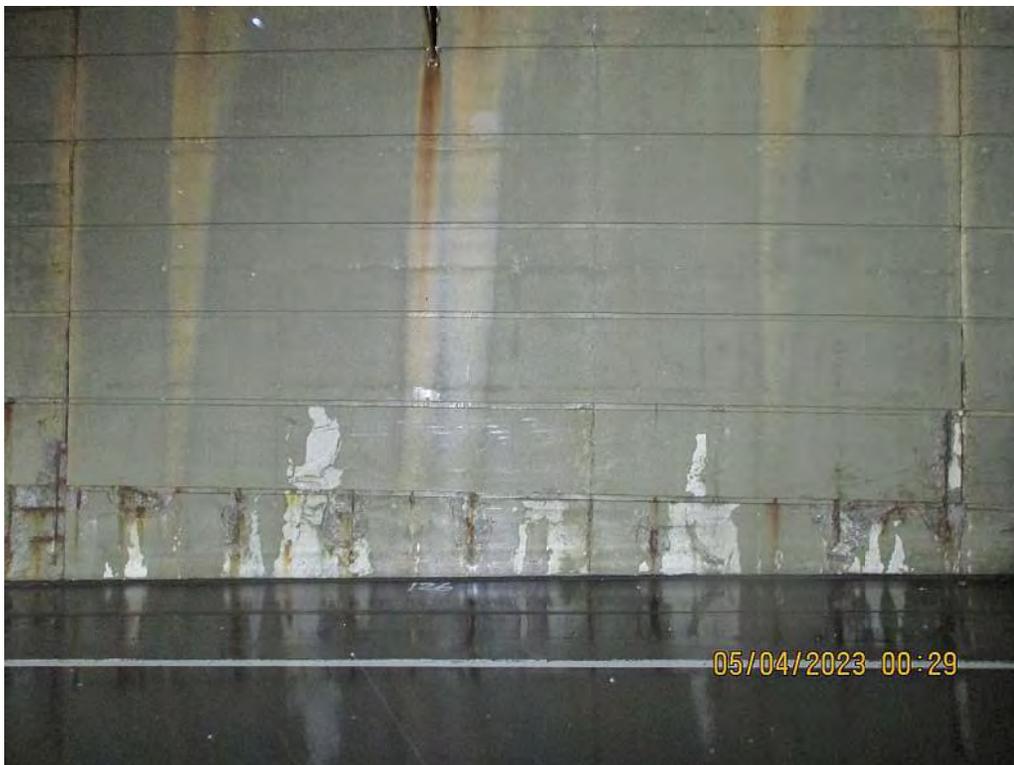
PHOTO 6  
PANEL 126  
Description:  
There is a full height vertical crack in the wall face near mid span. The lowest panel has cracking mirroring the underlying vertical reinforcement. The lower two panels are cracked, spalled and delaminated over 60% of the area. the remainder of the wall is in good condition.

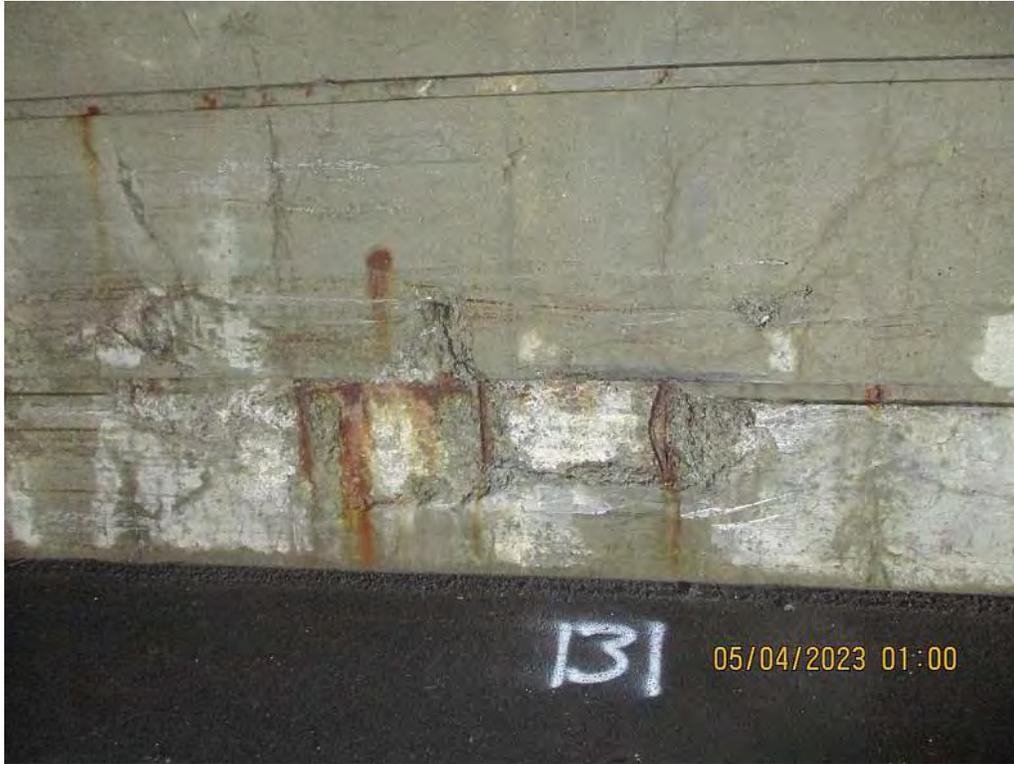
PHOTO 7

The bottom three wall panels are delaminated over most of their area. The begin wall joint is delaminated approximately two-thirds the wall height by one foot wide. The lowest panel has a large spall with exposed rebar (rebar has 60% section loss).

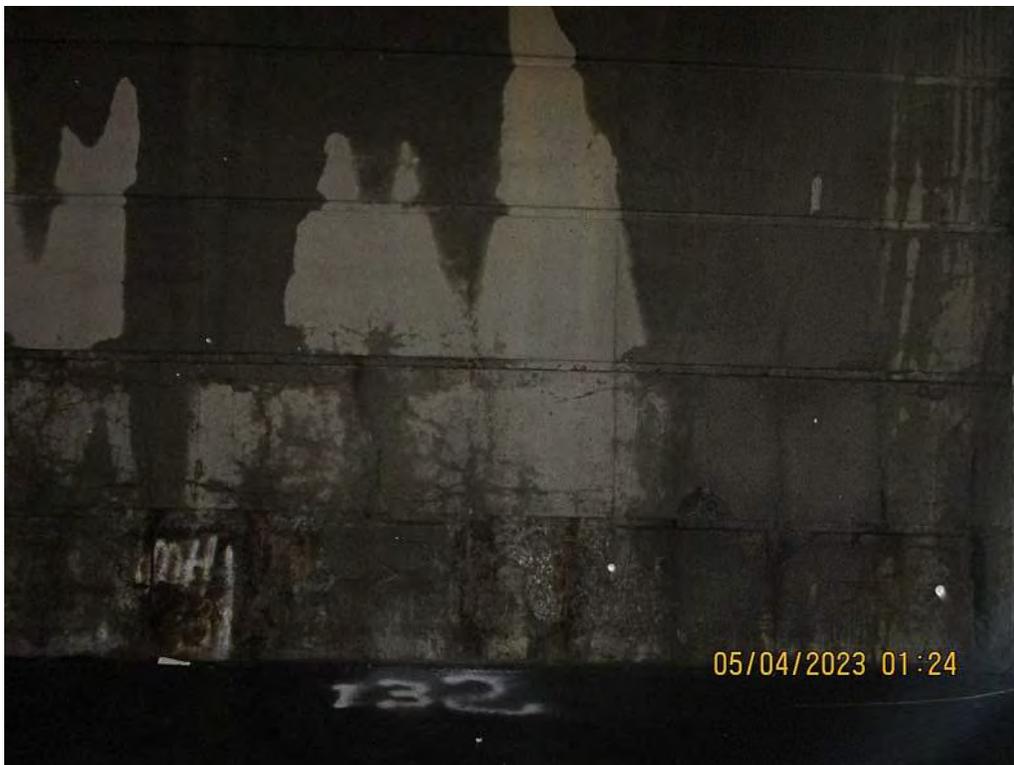
PHOTO 8

The bottom wall panel is spalled over 30% of its area with exposed rebar, and is 100% delaminated. The second panel is map-cracked and delaminated over 20% of its area.

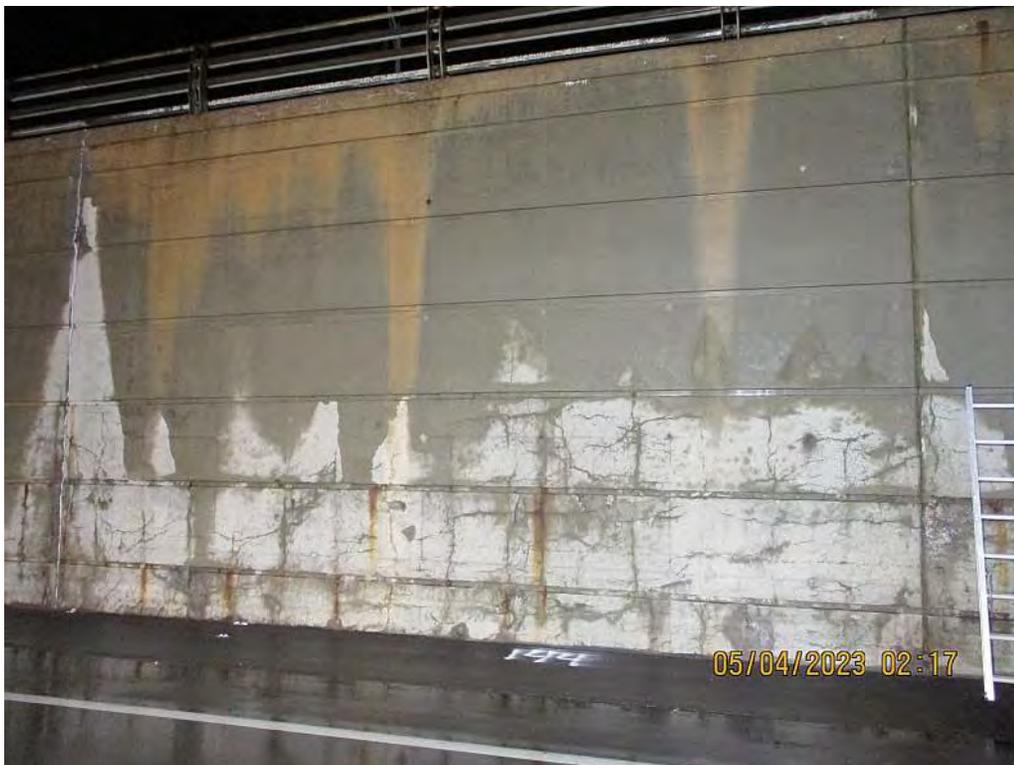
PHOTO 10  
PANEL 144

The lower three sections of the wall are heavily map-cracked with rust staining. The wall face has vertical cracking at 2-foot intervals. This mirrors the underlying rebar placement.

The wall railing system coping is map cracked with efflorescence under the railing posts.

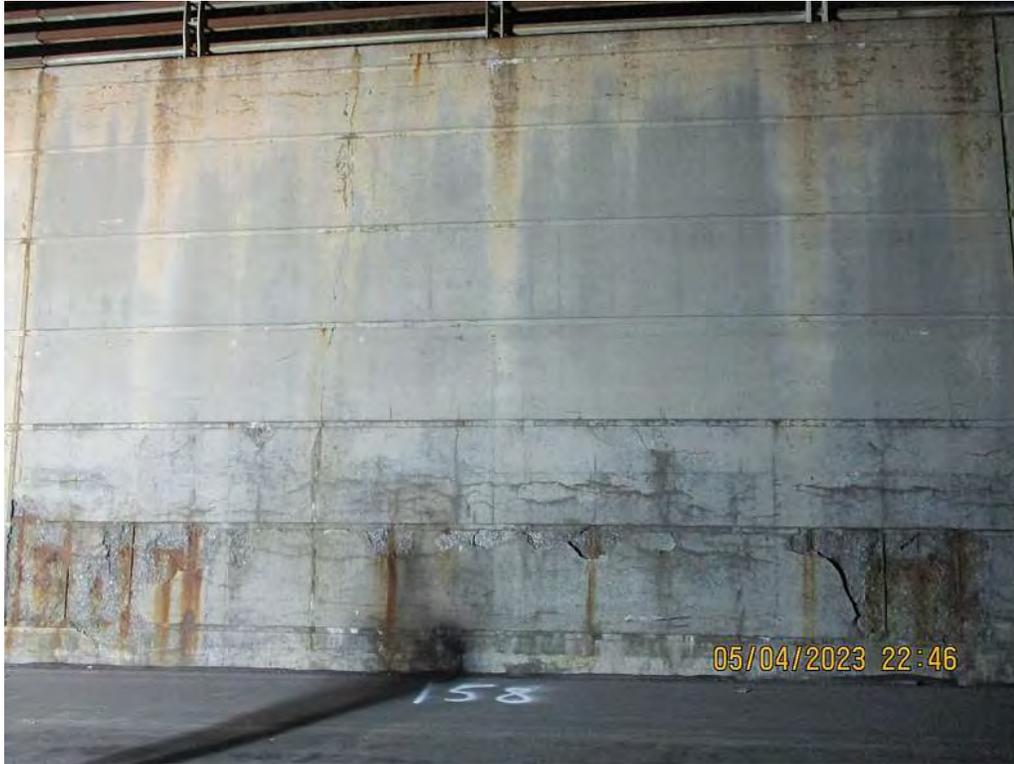
PHOTO 11

The lower three sections of the wall are heavily map-cracked with rust staining and some efflorescence.

There is a full height crack at 17 ft from the panel begin. The concrete adjacent to each wall joint is heavily delaminated and spalled. with exposed rebar (rebar is exhibiting 25% section loss).

The lowest wall section is 90% delaminated (where not spalled), section 2 is 30% delaminated and section 3 exhibits 50% delamination.

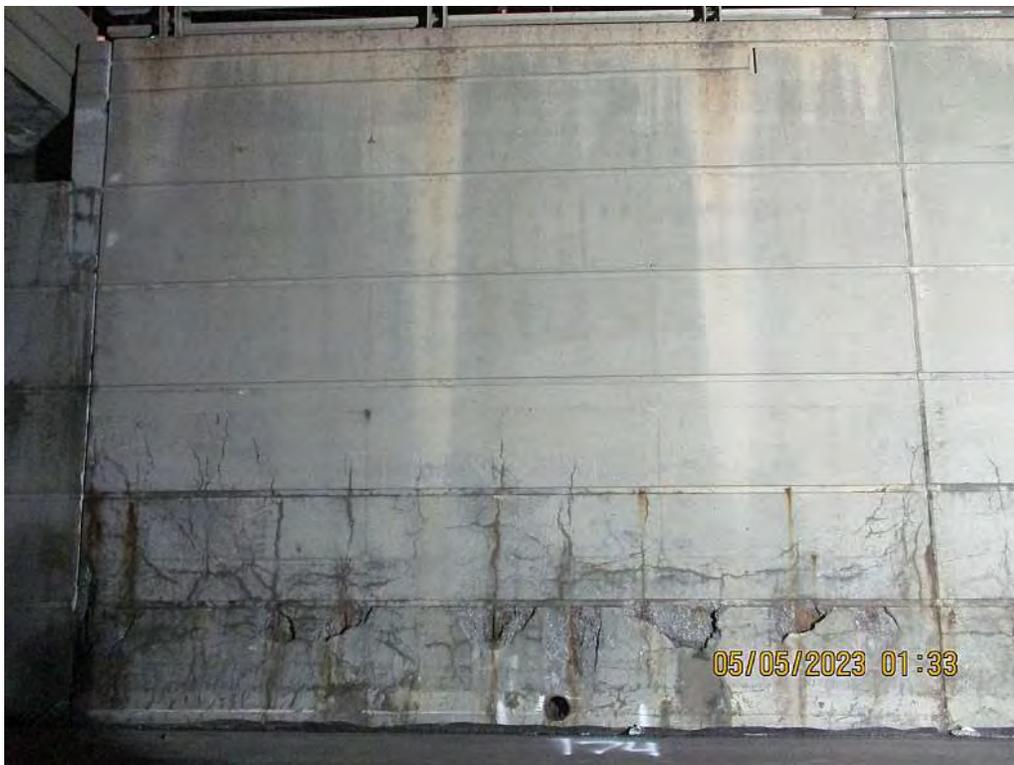
PHOTO 14  
PANEL 174  
Description:  
The bottom wall section is heavily delaminated, spalled and map cracked over 90% of its area. The map cracking is at 2-foot intervals mirroring the underlying rebar placement.  
Section 2 is delaminated and map cracked over 75% of its area.  
Section 3 exhibits vertical cracking and map cracking in its lower half.

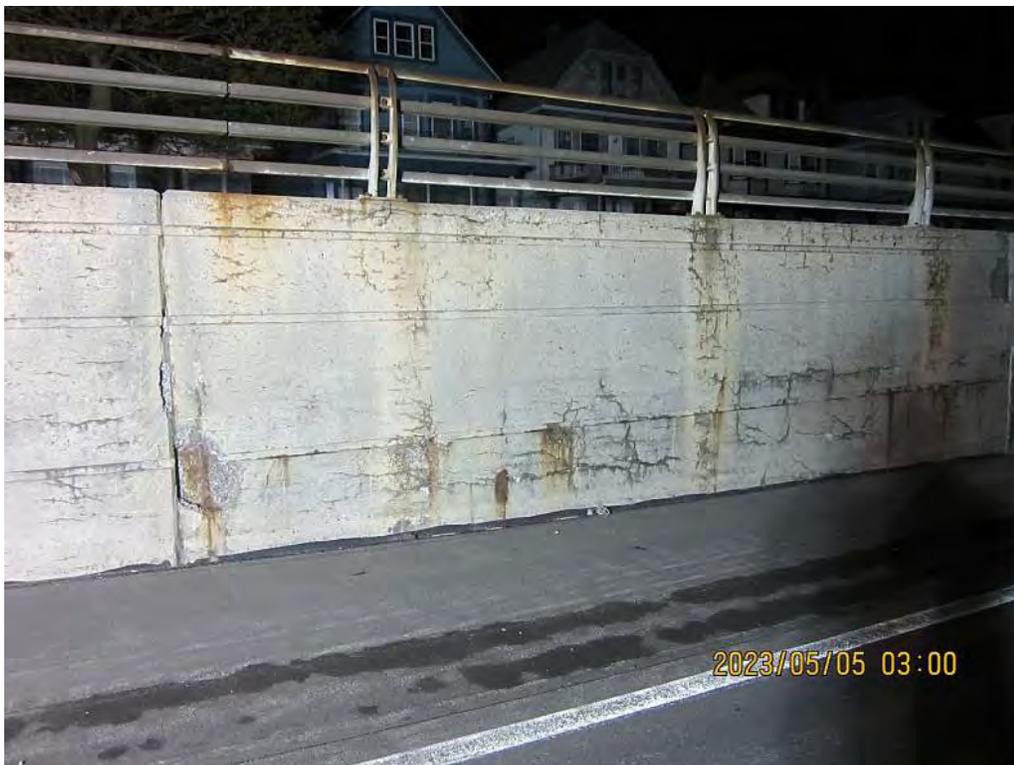
PHOTO 18  
PANEL 190  
Description:  
The bottom wall section is heavily delaminated, spalled and map cracked. The map cracking is at 2-foot intervals mirroring the underlying rebar placement.  
Section 2 is map cracked over 35% of its area.  
Section 3 exhibits map cracking throughout.  
The wall railing system coping is cracked at mid-height. The crack is full length with staining.

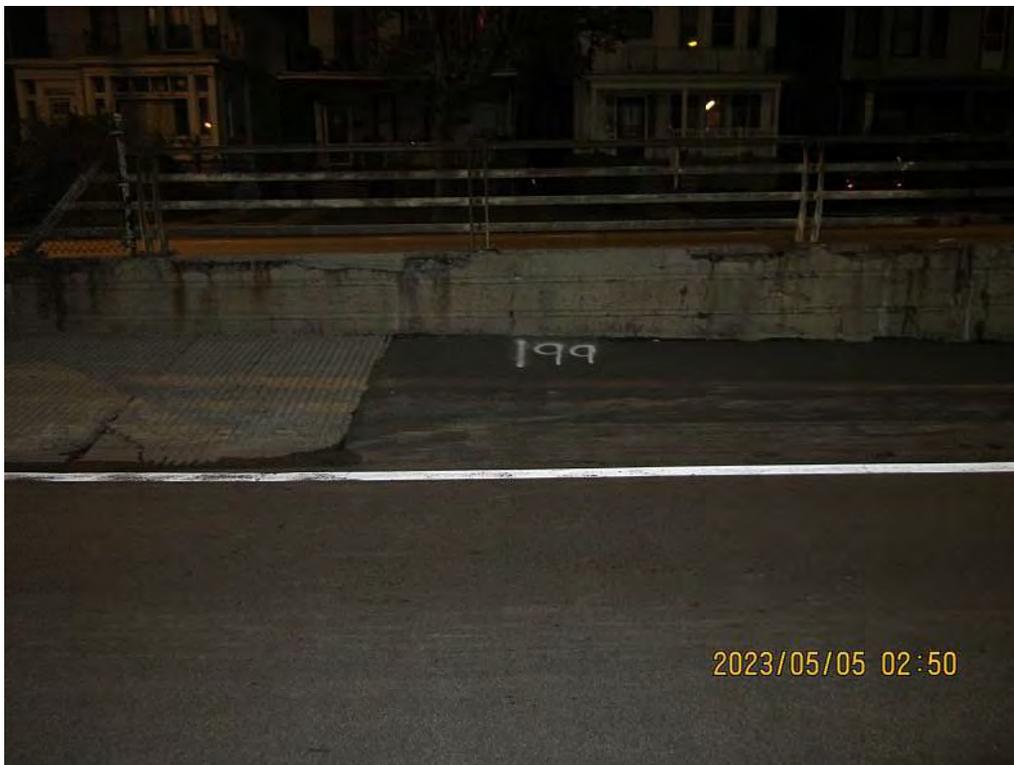
PHOTO 20  
PANEL 199

The wall panel is heavily delaminated and map cracked throughout.

The wall railing system coping is cracked and delaminated full length.

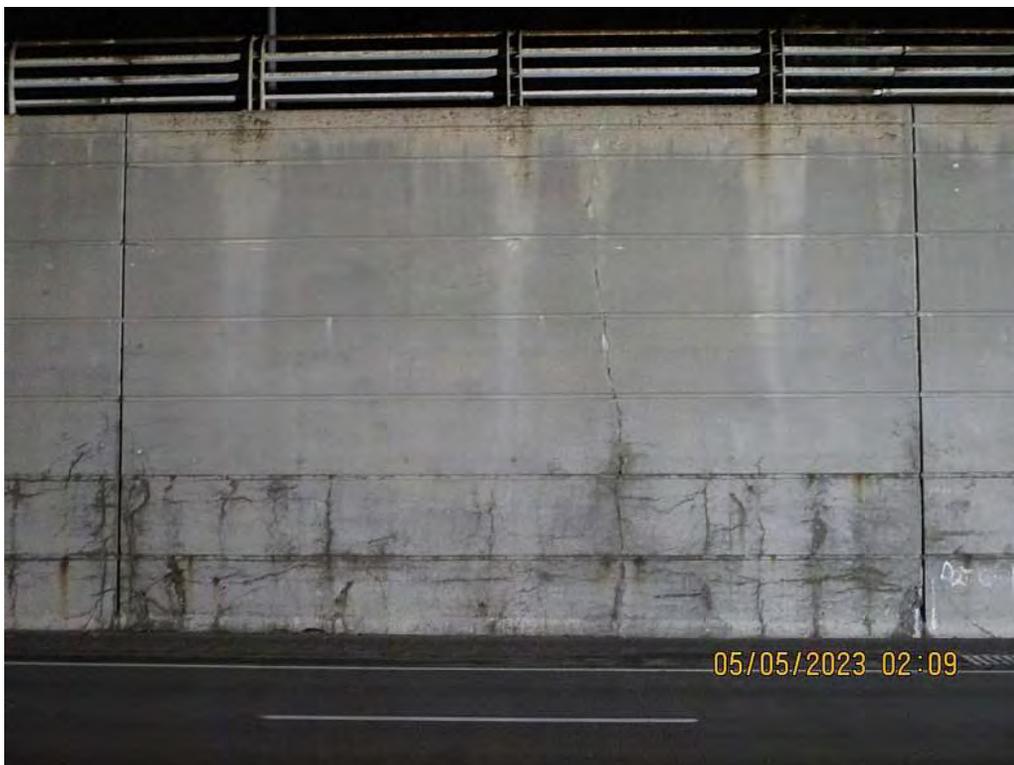
PHOTO 8  
PANEL 256  
Description:  
Map cracking under rail posts, typical.  
Full-height vertical crack with efflorescence near midspan of the panel.  
Map cracking bottom 2 panels with a few rust stains. Bottom panel 100% delaminated, second panel 75% delaminated.  
A few small spalls, most significant is in lower right corner of panel.

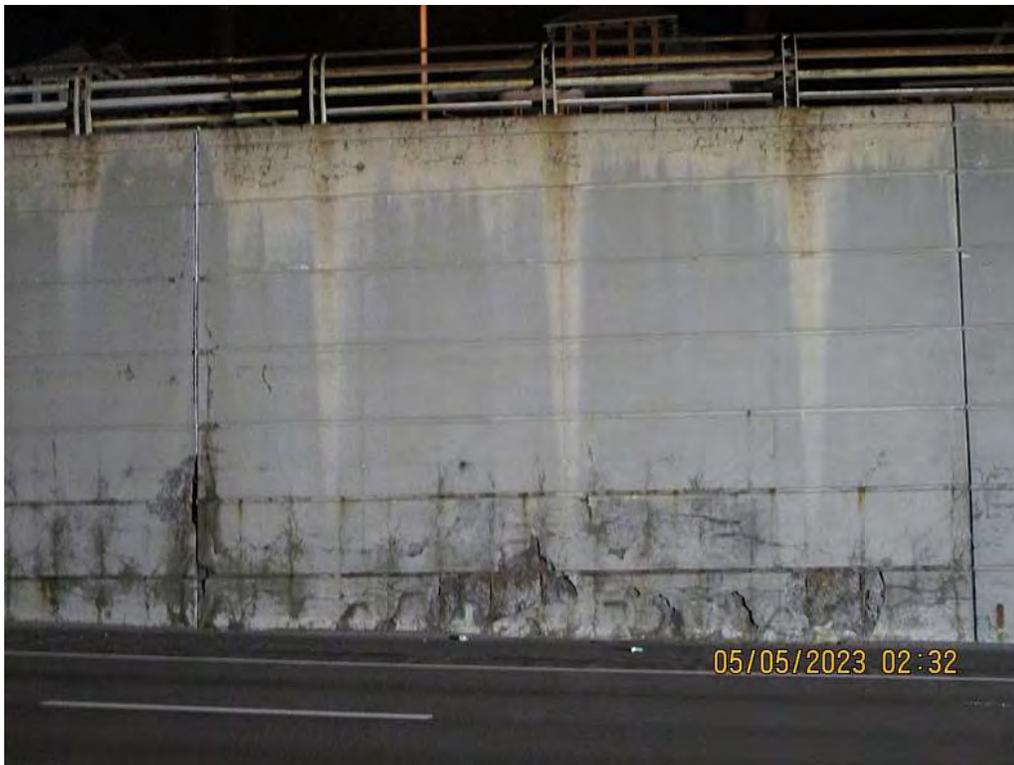
PHOTO 16  
PANEL 213  
Description:  
Map cracking on top panel and coping.  
Map cracking on bottom 2 panels. Map cracking continues up to the fourth panel near the left joint. Bottom 3 panels are 100% delaminated.  
There is a 15' crack near the left joint.
