# Asbestos-Containing Materials Inspection

**BIN 1022609**  
**Best Street over**  
**Kensington Expressway (Rt. 33)**  
**City of Buffalo,**  
**Erie County, New York**

**New York State Department of Transportation Region 5**  
**100 Seneca Street**  
**Buffalo, NY 14203**

**August 2023, Revised September 2023**

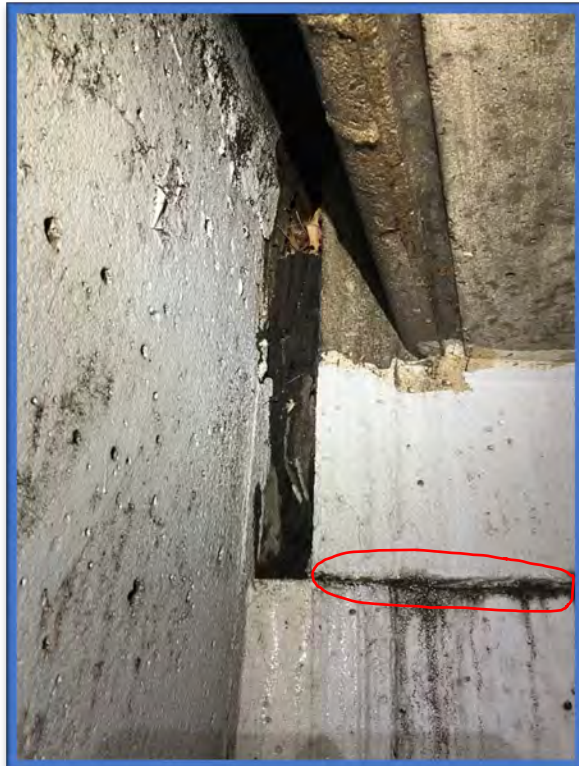
Photo 8 – Compressed asbestos sheet packing located on the abutment shelf at the bridge was previously confirmed as an ACM and visually observed during this inspection of the Dodge Street Bridge over Kensington Expressway (Route 33) (BIN 1022610).

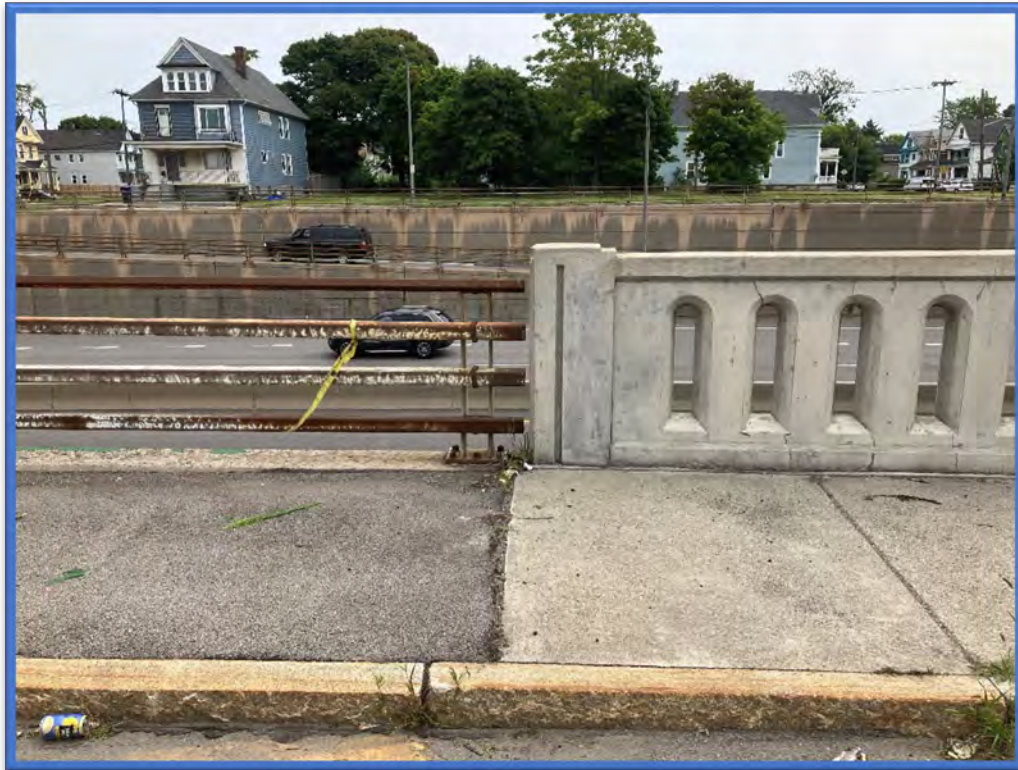
Photo 9 – Asbestos-containing railing post base caulk is associated with all of the metal guiderails located on top of the northern retaining walls. No asbestos-containing caulk is associated with the new decorative concrete guide rails located on top of the southern retaining walls.

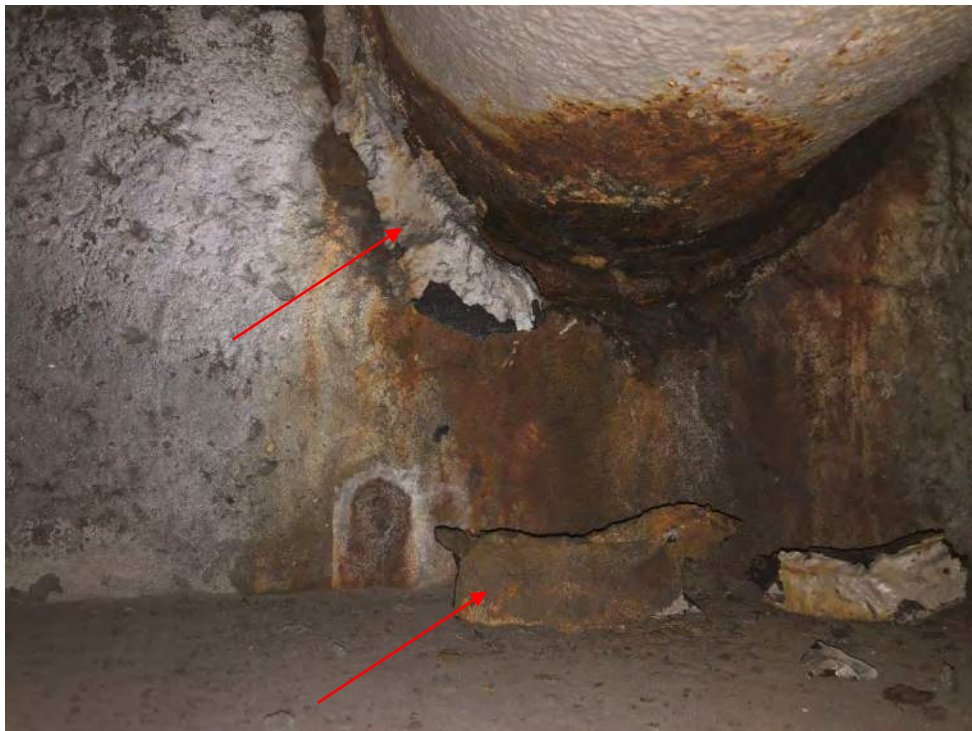
**Photo 6** – View of the degraded asbestos-containing packing/sealant associated with the gas utility conduit at the west abutment of BIN 1022630.

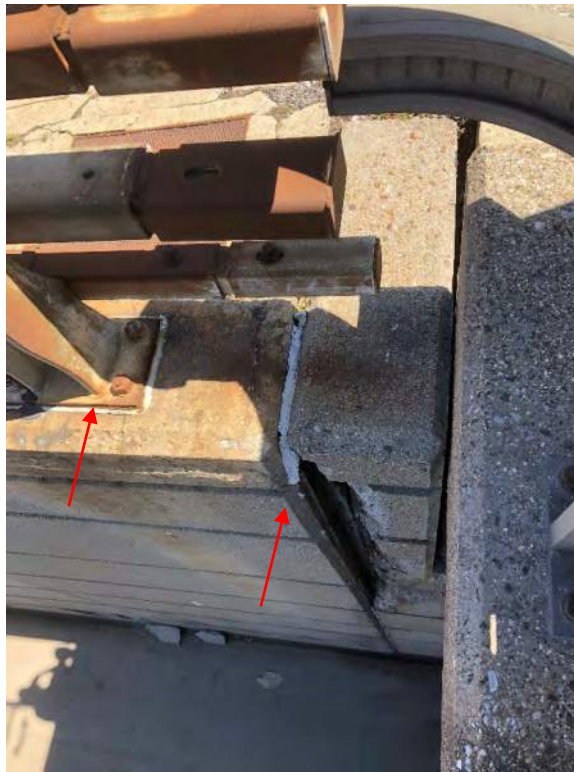
**Photo 7** – View facing east at the northeast corner of BIN 1022630 and the retaining wall. The retaining wall grey caulk and the retaining wall guide rail post base grey caulk have both been identified as an ACM. The retaining wall caulk is degraded in places.

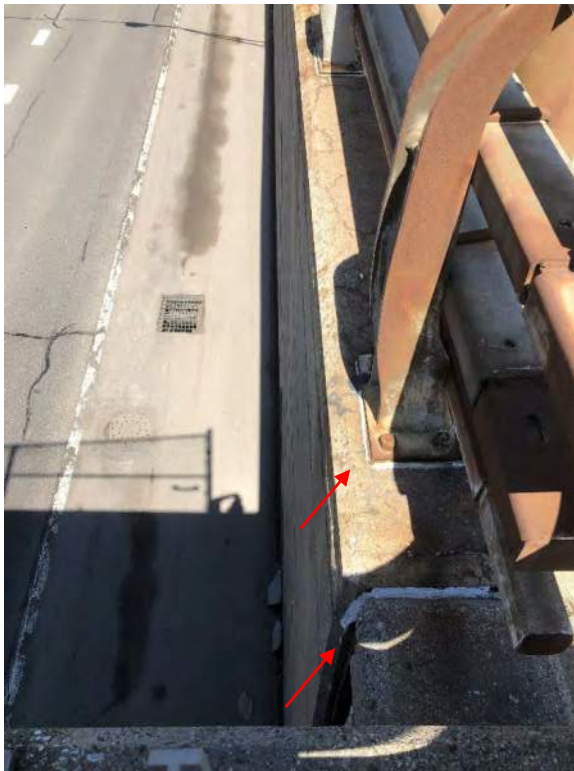
**Photo 8** – View facing north at the northeast corner of BIN 1022630 and the retaining wall. The retaining wall grey caulk and the retaining wall guide rail post base grey caulk have both been identified as an ACM.
