Appendix A4

Bridge Inspection Reports and Work History Summaries

**NY33 BRIDGE CONDITION VERIFICATION 2023
KENSINGTON EXPRESSWAY PROJECT
PIN 5512.52
CITY OF BUFFALO, ERIE COUNTY
BIN 1022609**

STRUCTURE: BIN 1022609 - Best Street on NY33 Kensington Expressway

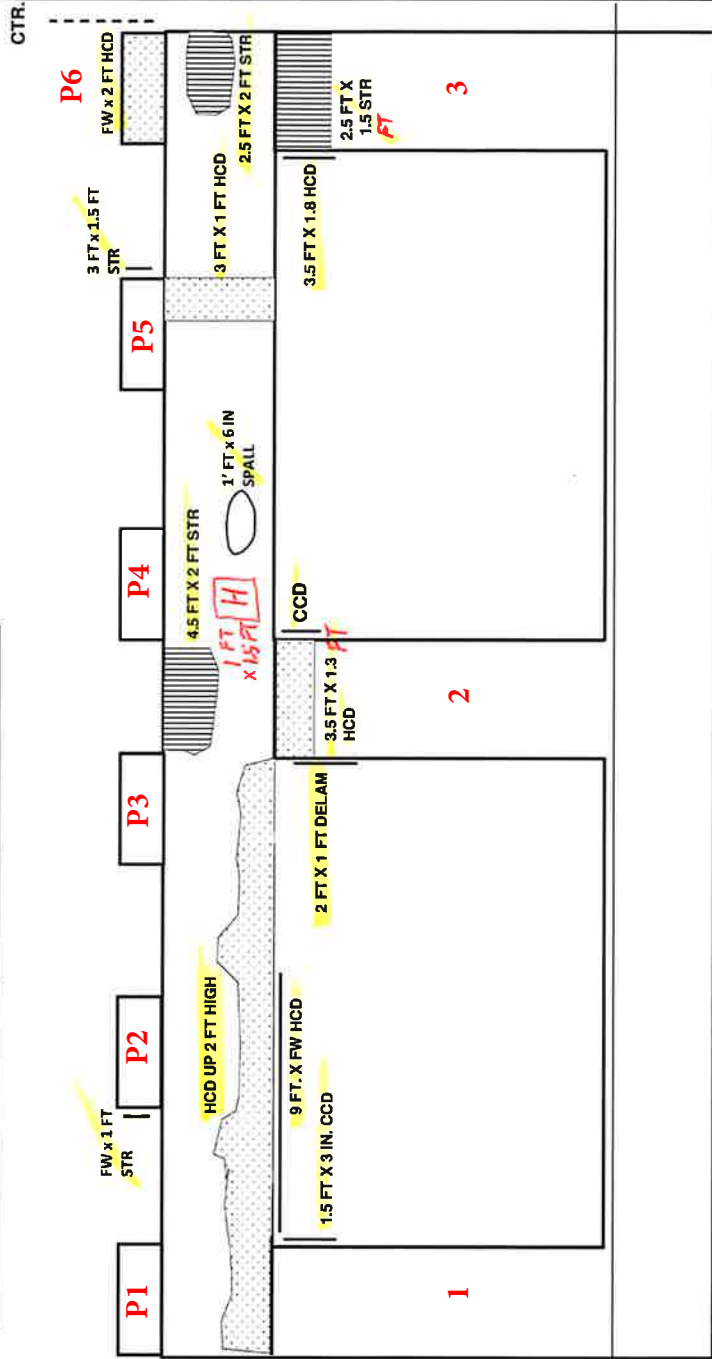
PIER 1 BEGIN LEFT FACE
 DETERIORATION DOC.

Sketch Description: Pier PR-1 Deterioraton - Begin Left Face

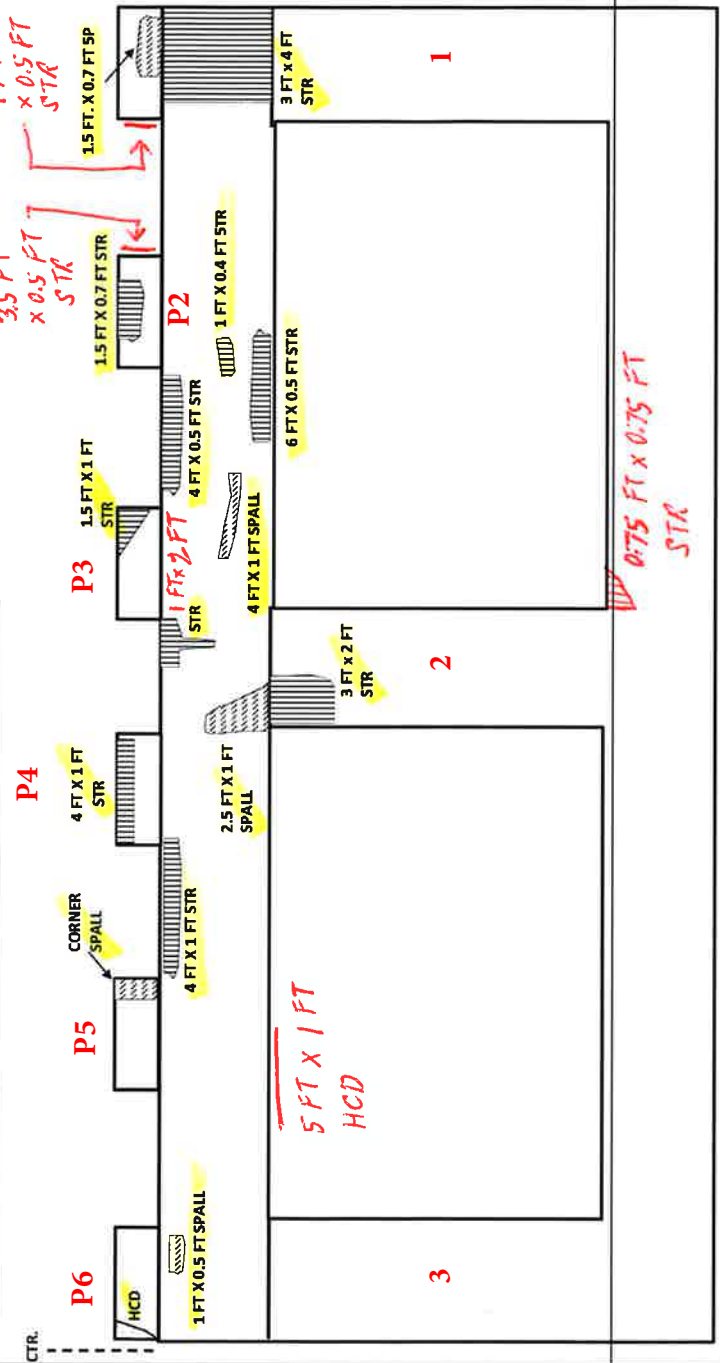
PIER 1 END FACE (LEFT HALF)
 DETERIORATION DOC.

Sketch Description: Pier PR-1 Deterioraton - End Left Face

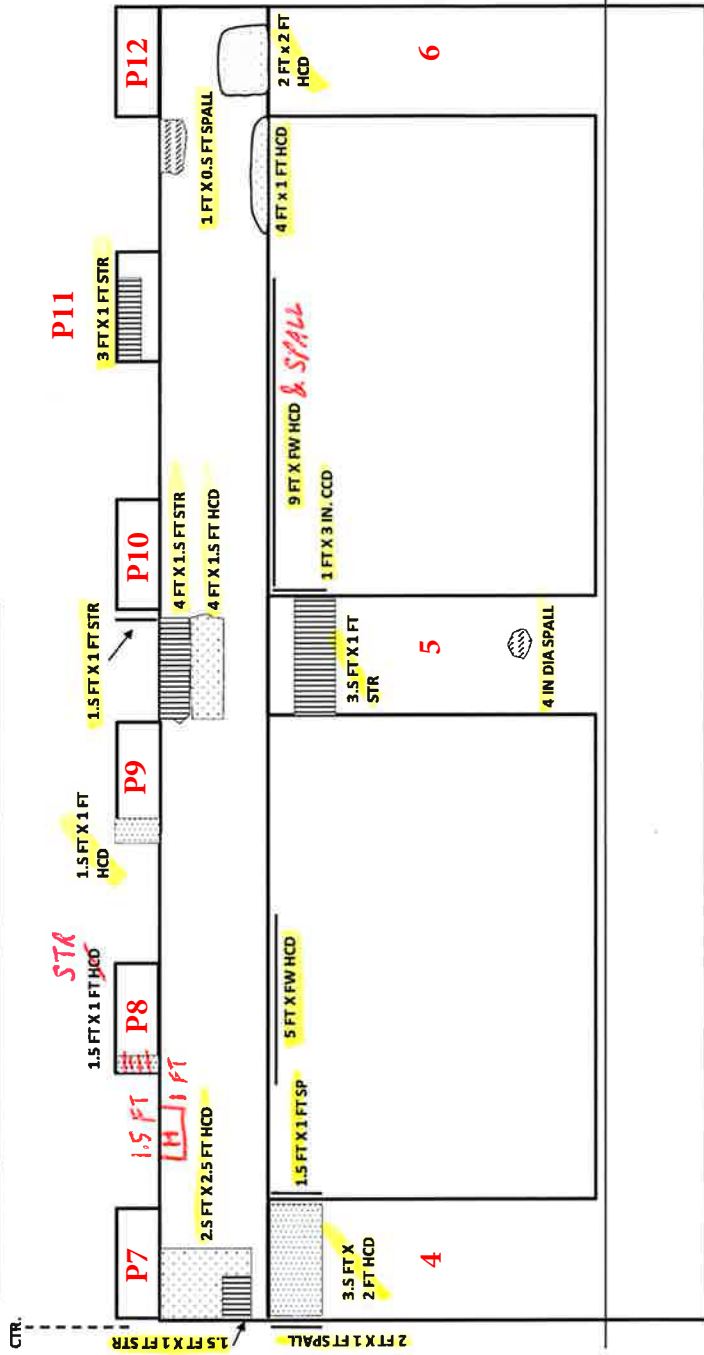
PIER 1 BEGIN RIGHT FACE
 DETERIORATION DOC.

Sketch Description: Pier PR-1 Deterioraton - Begin Right Face

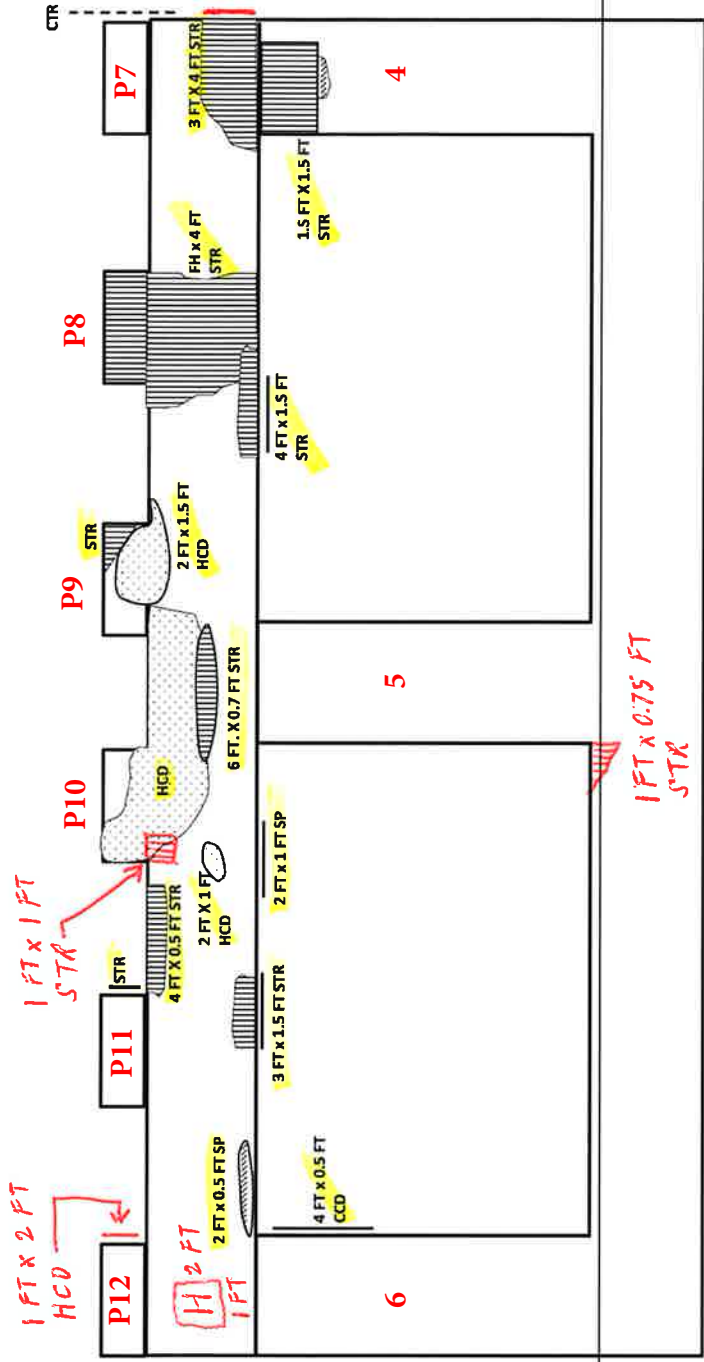
PIER 1 END FACE (RIGHT HALF)
 DETERIORATION DOC.

Sketch Description: Pier PR-1 Deterioraton - End Right Face

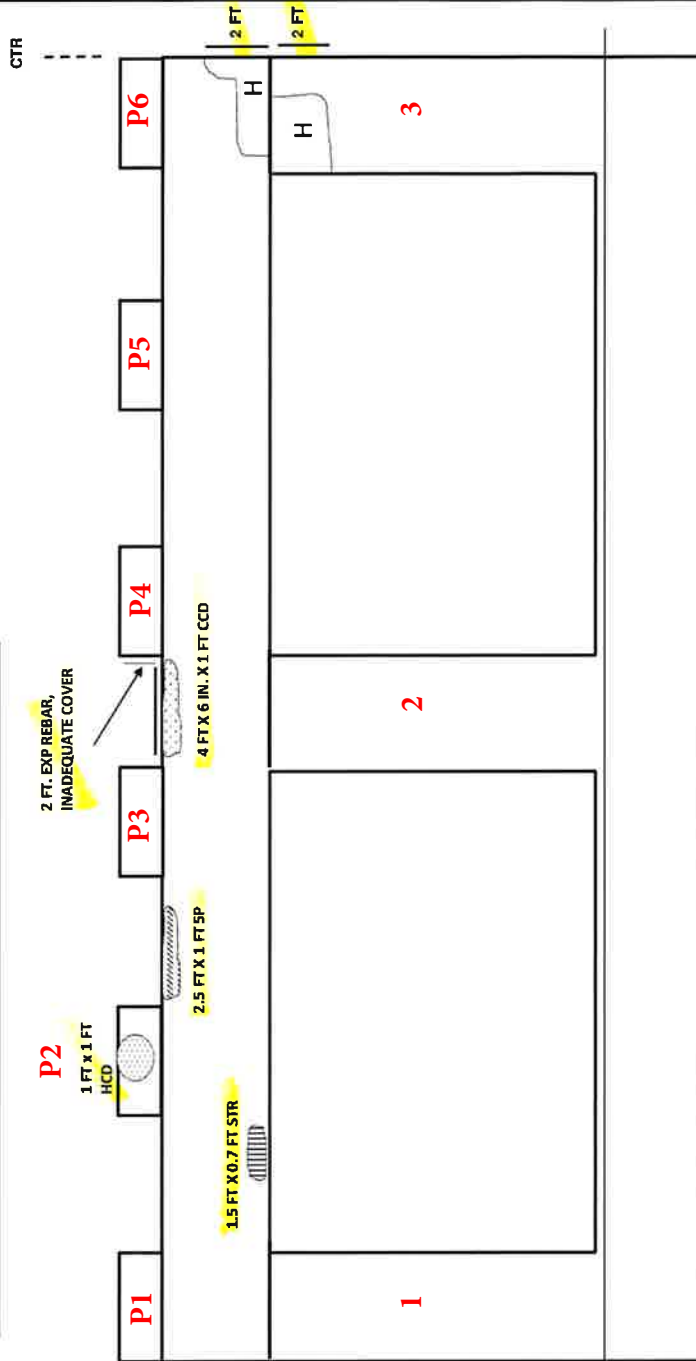
PIER 2 BEGIN LEFT FACE
 DETERIORATION DOC.

Sketch Description: Pier PR-2 Deterioraton - Begin Left Face

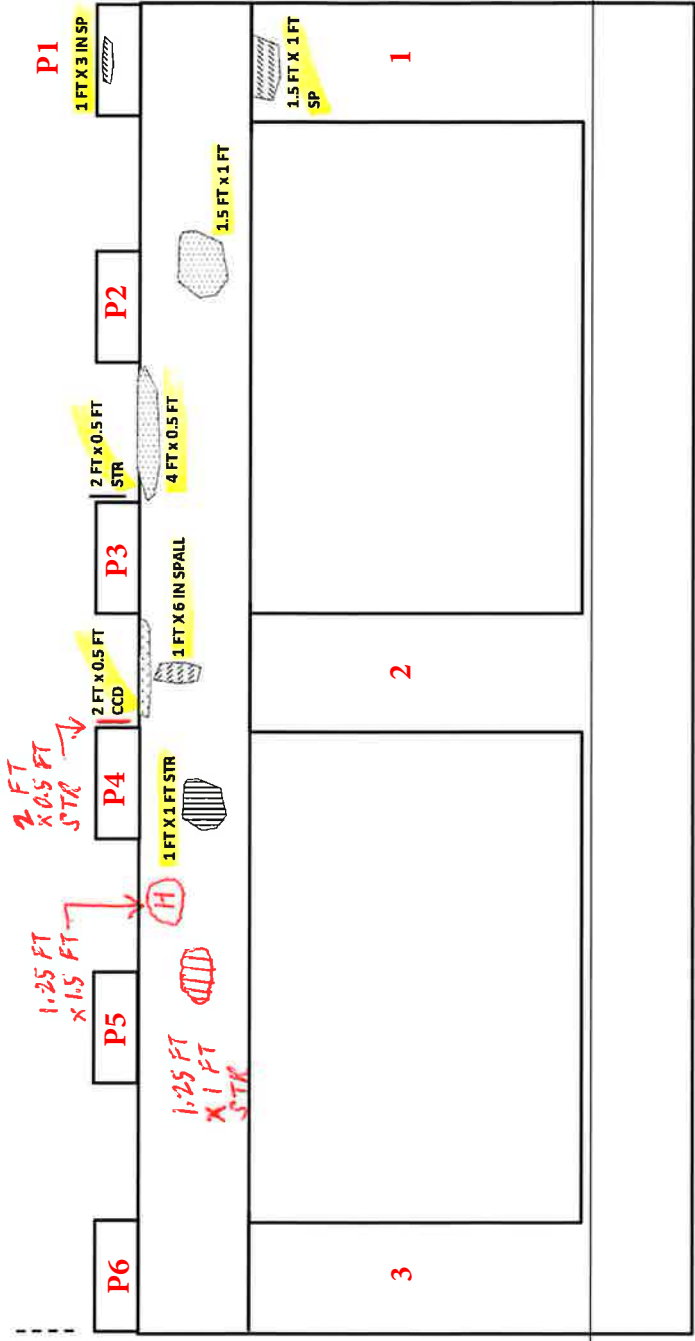
PIER 2 END FACE (LEFT HALF)
 DETERIORATION DOC.

Sketch Description: Pier PR-2 Deterioraton - End Left Face

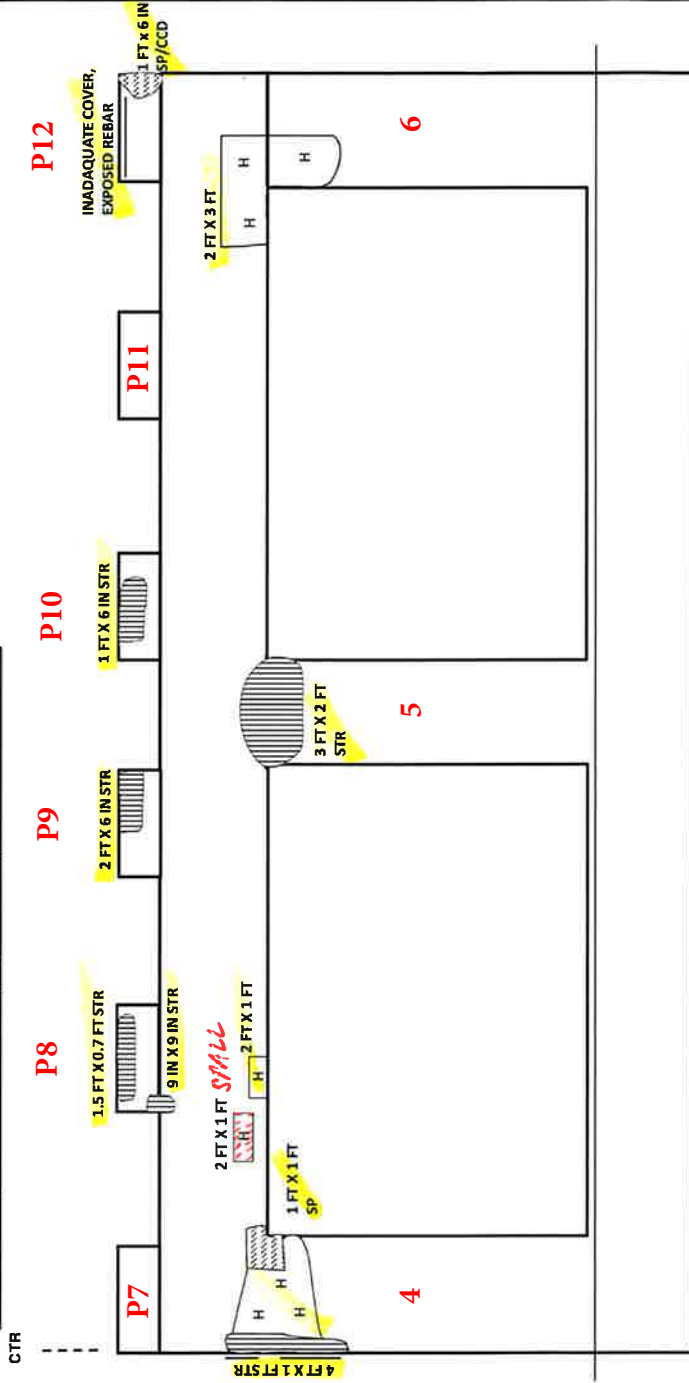
PIER 2 BEGIN RIGHT FACE
 DETERIORATION DOC.

Sketch Description: Pier PR-2 Deterioraton - Begin Right Face

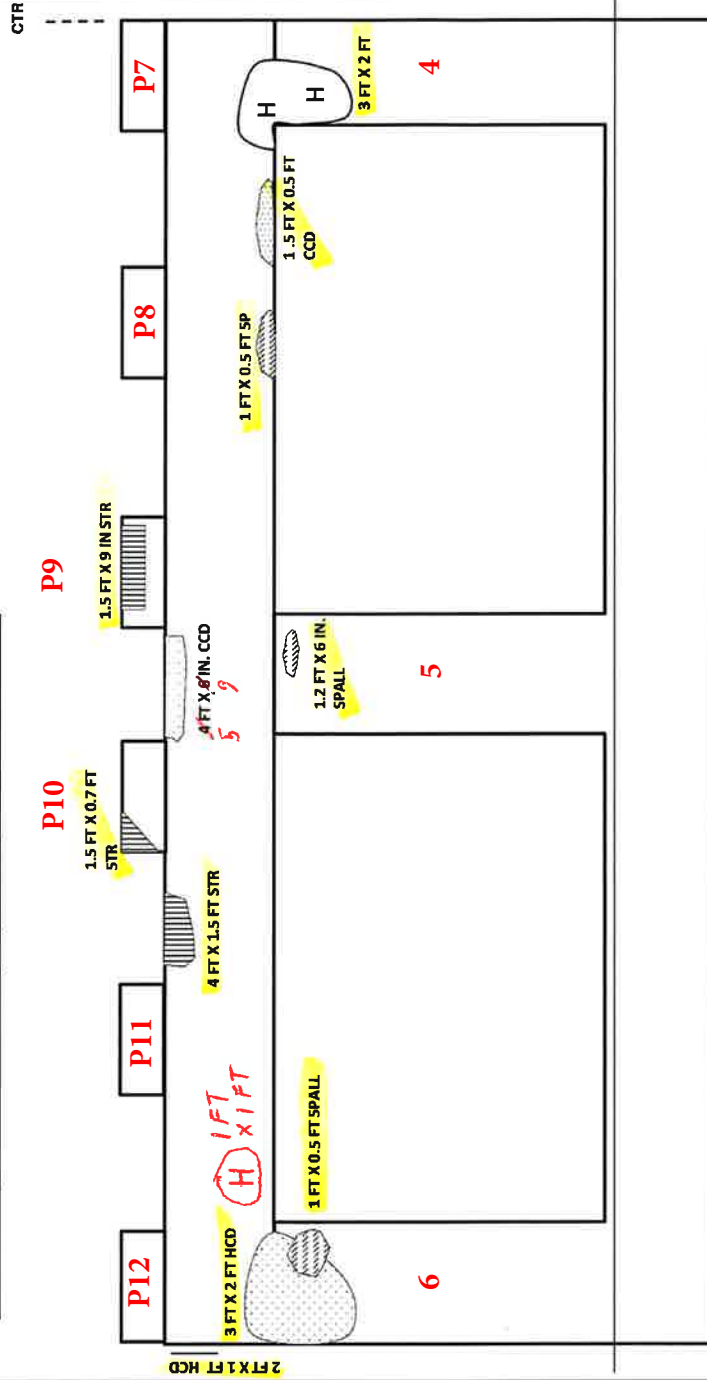
PIER 2 END FACE (RIGHT HALF)
 DETERIORATION DOC.

Sketch Description: Pier PR-2 Deterioraton - End Right Face

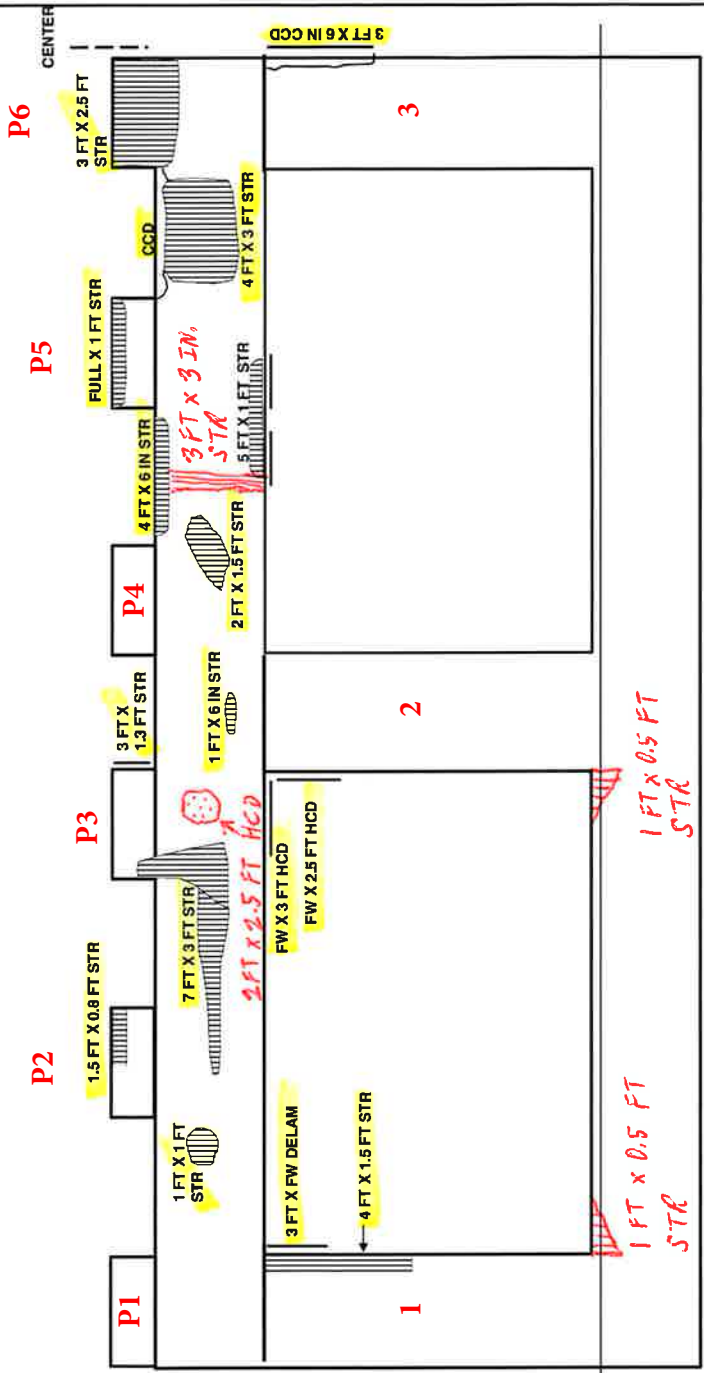
PIER 3 BEGIN LEFT FACE
 DETERIORATION DOC.

Sketch Description: Pier PR-3 Deterioraton - Begin Left Face

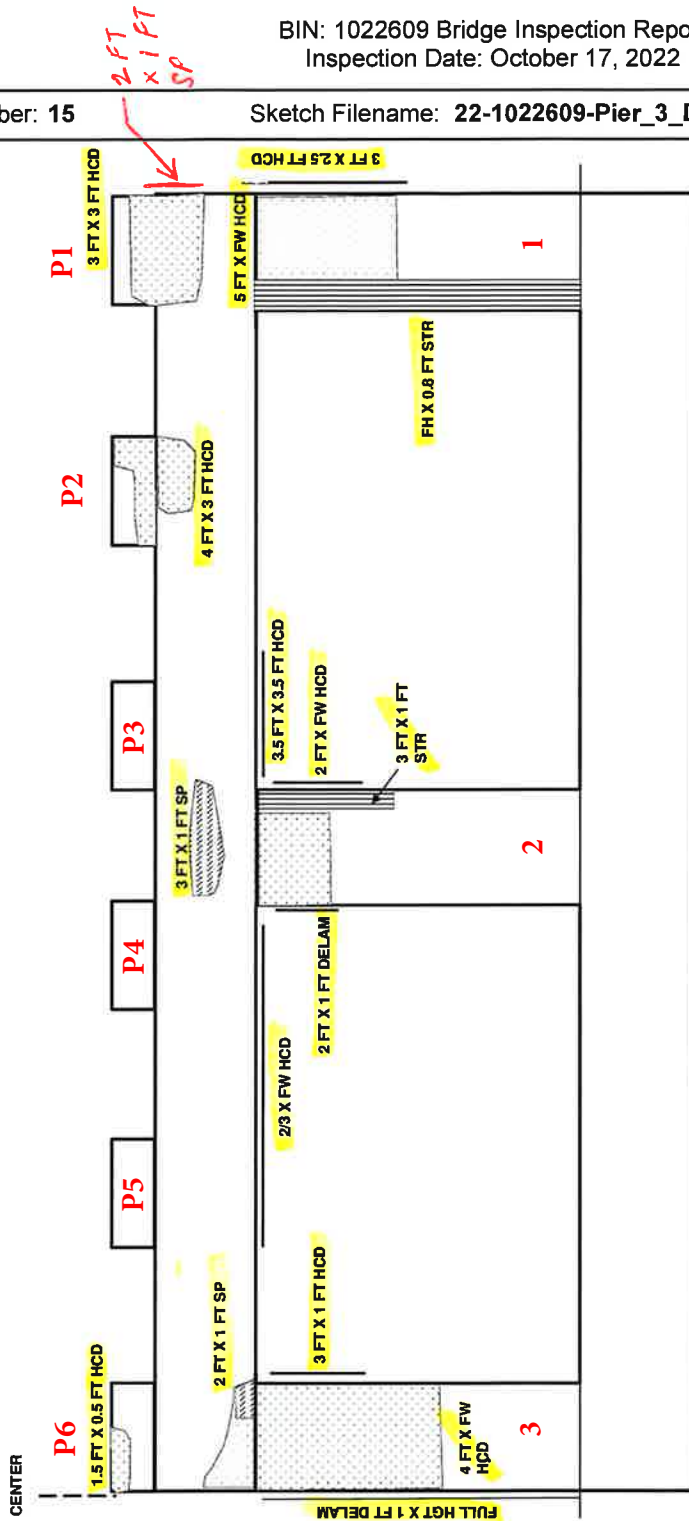
PIER 3 END FACE (LEFT HALF)
 DETERIORATION DOC.

Sketch Description: Pier PR-3 Deterioraton - End Left Face

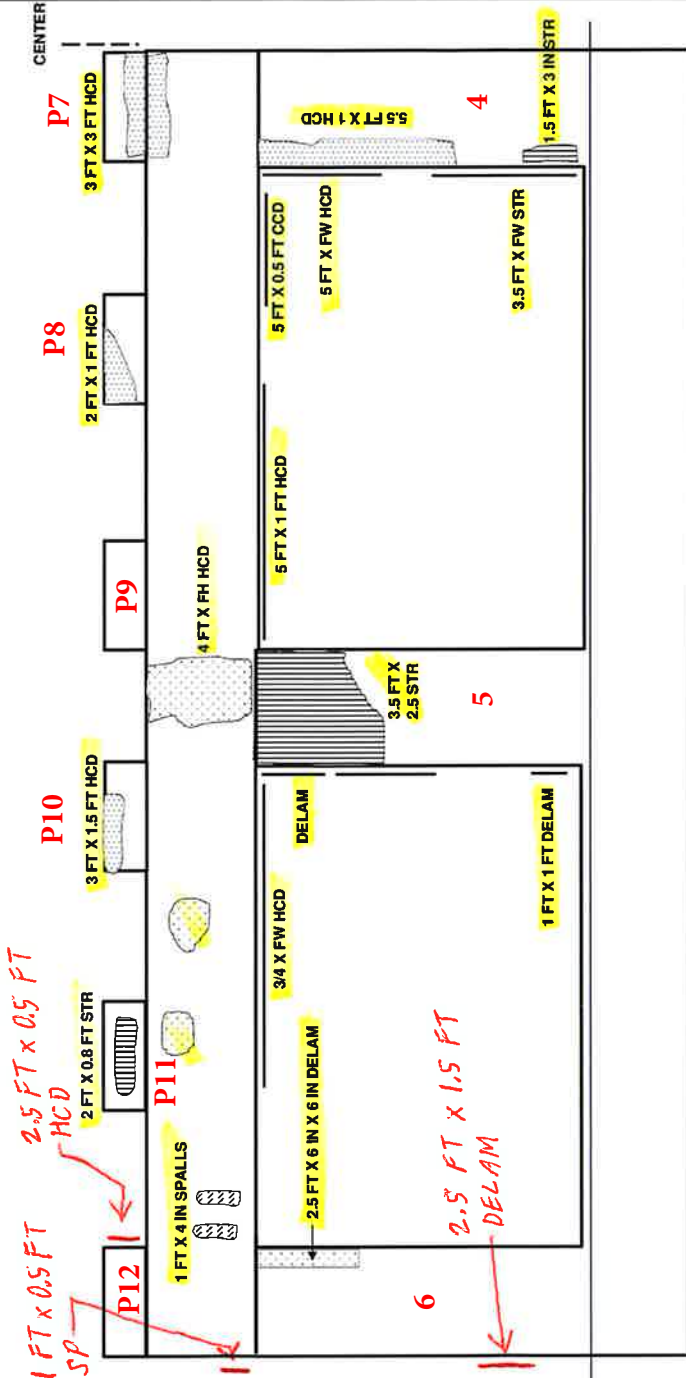
PIER 3 END FACE (RIGHT HALF)
 DETERIORATION DOC.

Sketch Description: Pier PR-3 Deterioraton - End Right Face

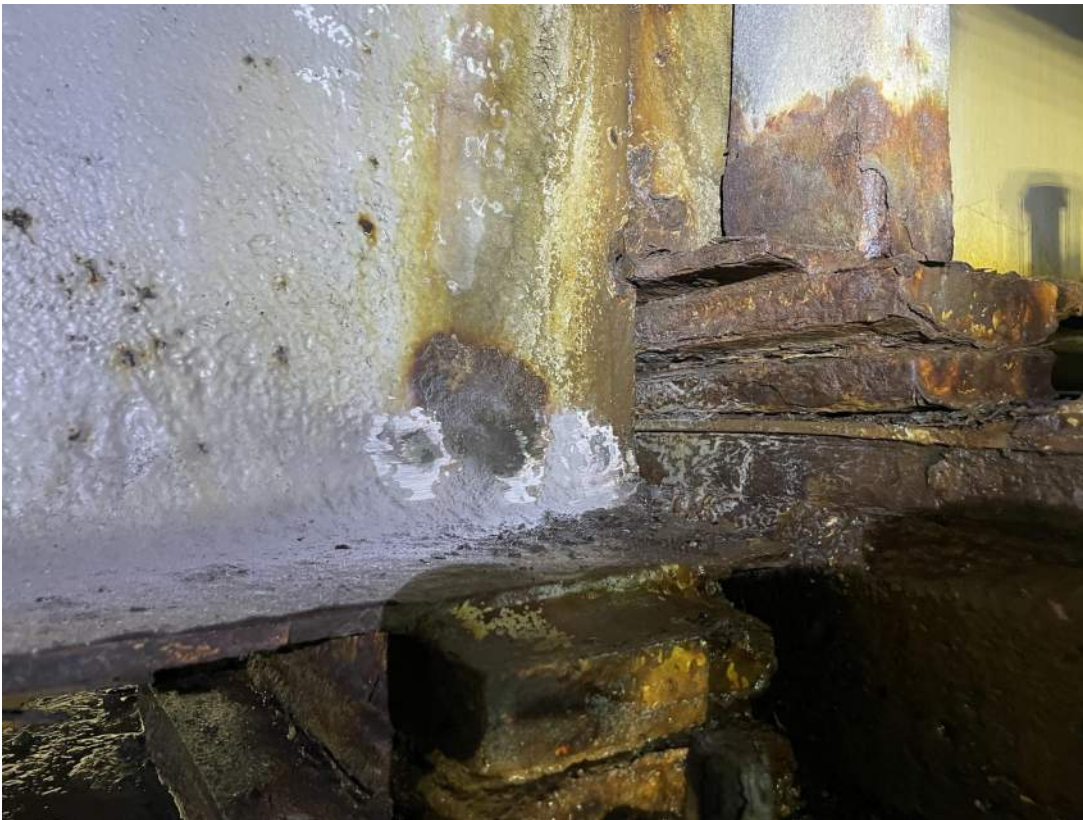
PHOTO 17

- Several expansion bearings had pack rust noted between plates causing the sliding bronze plates to bow upwards in the center and likely cause the bearing to not function as originally designed. In the 2022 inspection report, this condition was reported as Poor (CS3) for all 48 expansion bearings.

- Numerous expansion bearings were found to be overextended at Piers 1 & 3. In some cases, the ends of the girders between Spans 1&2, including G5, G8, G11 and between Spans 3 & 4, including G5, G7, G8 are in contact with each other, and no acting as originally designed.

DESCRIPTION:
HEAVILY RUSTED
AND
OVEREXTENDED
EXPANSION
BEARING

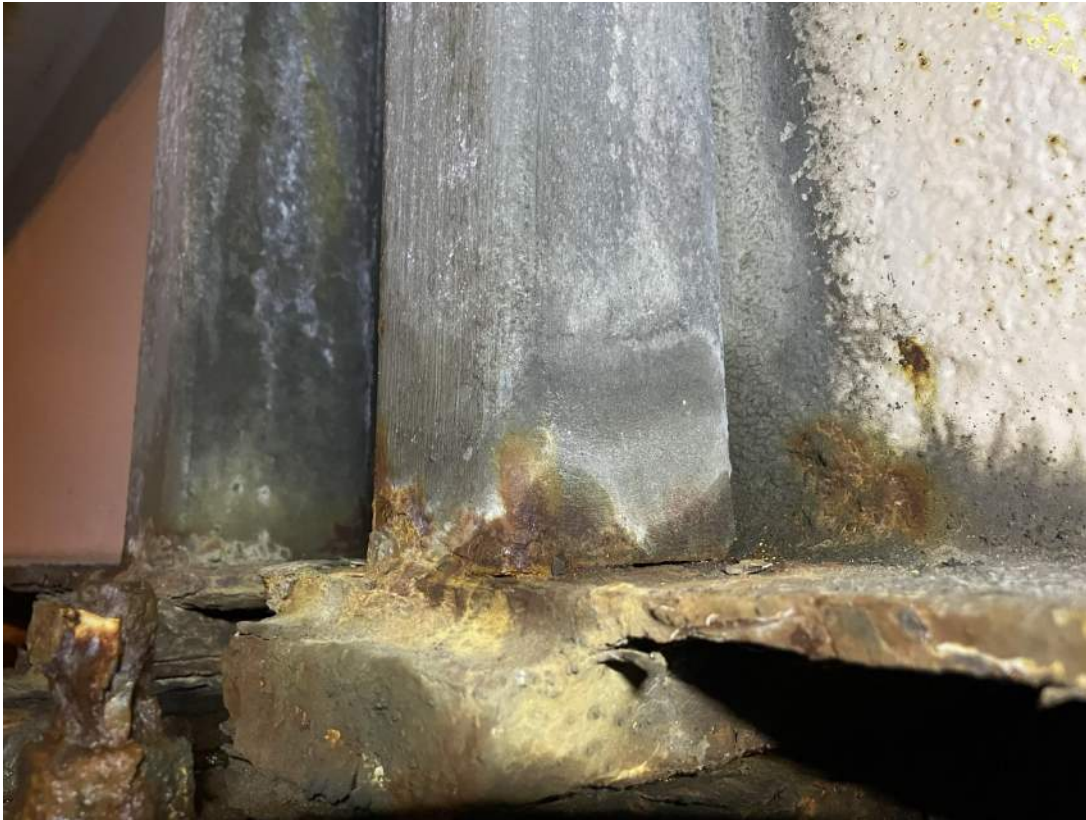
PHOTO 35

DESCRIPTION:
BEARING
CONDITIONS WITH
PREVIOUSLY
INSTALLED TUBE
STIFFENER

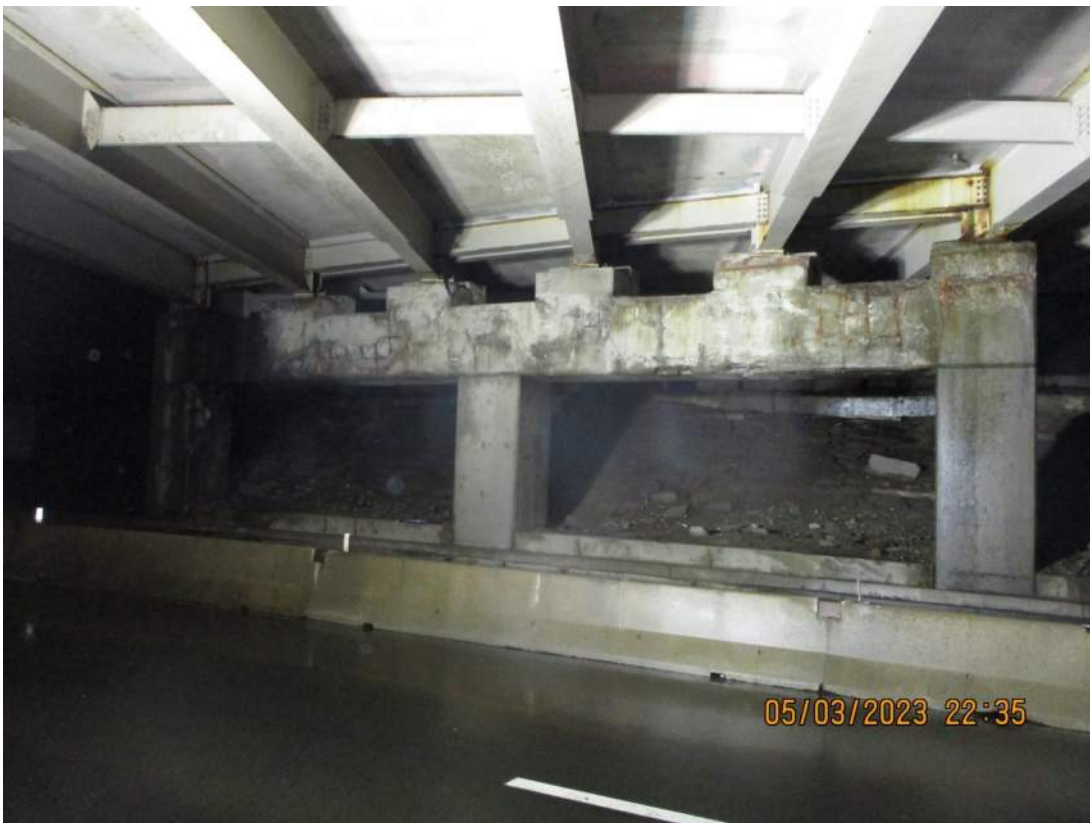
PHOTO 36

- Piers – The pier caps & columns and pedestals were observed, sounded, and found to be in Fair to Poor condition with significant distress noted. There are some additional notes in deterioration from the 2022 inspection report. Several locations of severe spalling to exposed rebar are evident across the faces of the columns, pier caps and girder pedestals. Numerous locations of hollow and heavily cracked and delaminated concrete are also evident throughout these locations. Refer completed field sheets attached to this report for additional details.

DESCRIPTION:
GENERAL SPALLING
CONCRETE
CONDITIONS;
TYPICAL FOR ALL
PIERS

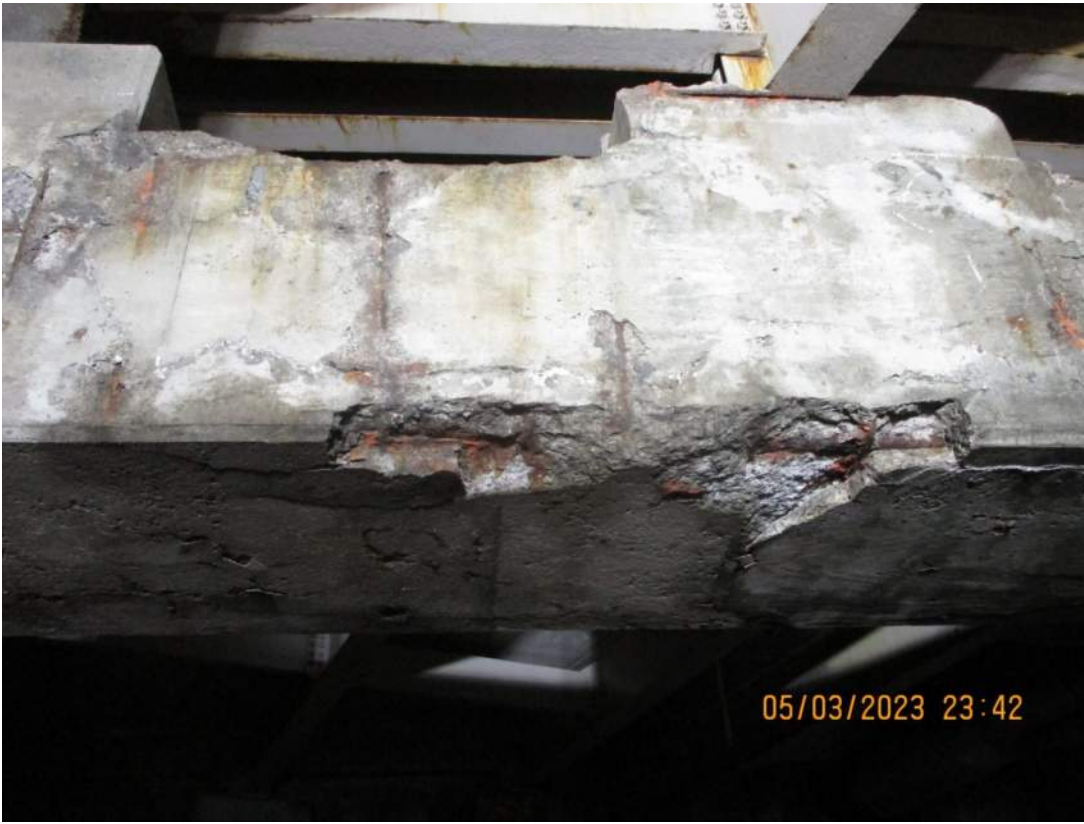
PHOTO 37

DESCRIPTION:
SPALLS TO
CORRODED REBAR
ON FACES OF PIER
CAP; TYPICAL FOR
ALL PIERS

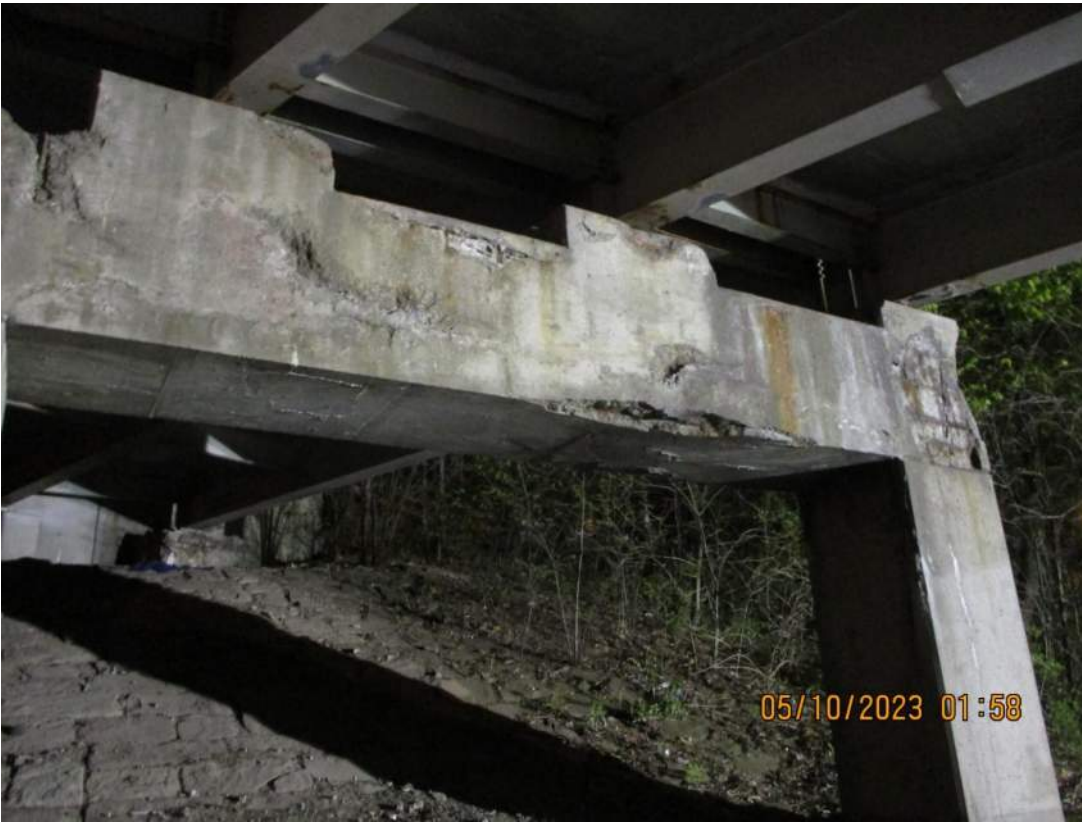
PHOTO 39

DESCRIPTION:
SPALLS TO
CORRODED REBAR
ON FACES OF PIER
CAP; TYPICAL FOR
ALL PIERS

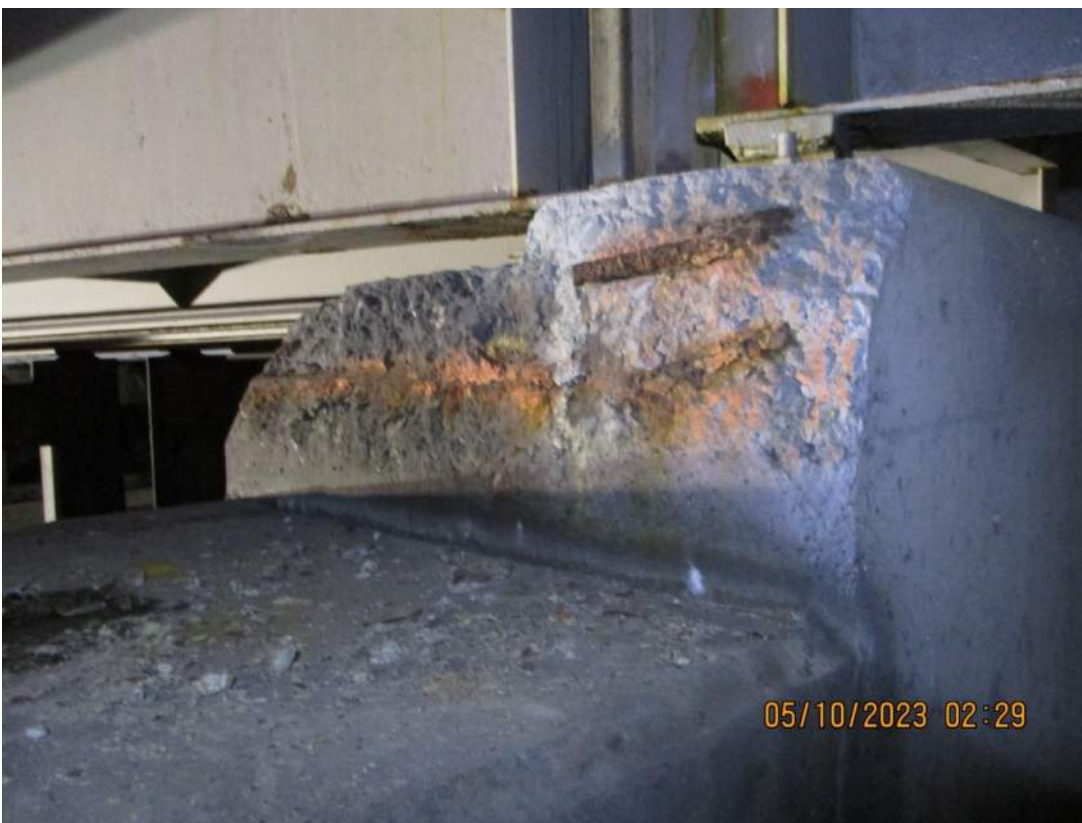
PHOTO 40

DESCRIPTION:
SPALLS TO
CORRODED REBAR
ON PEDESTAL

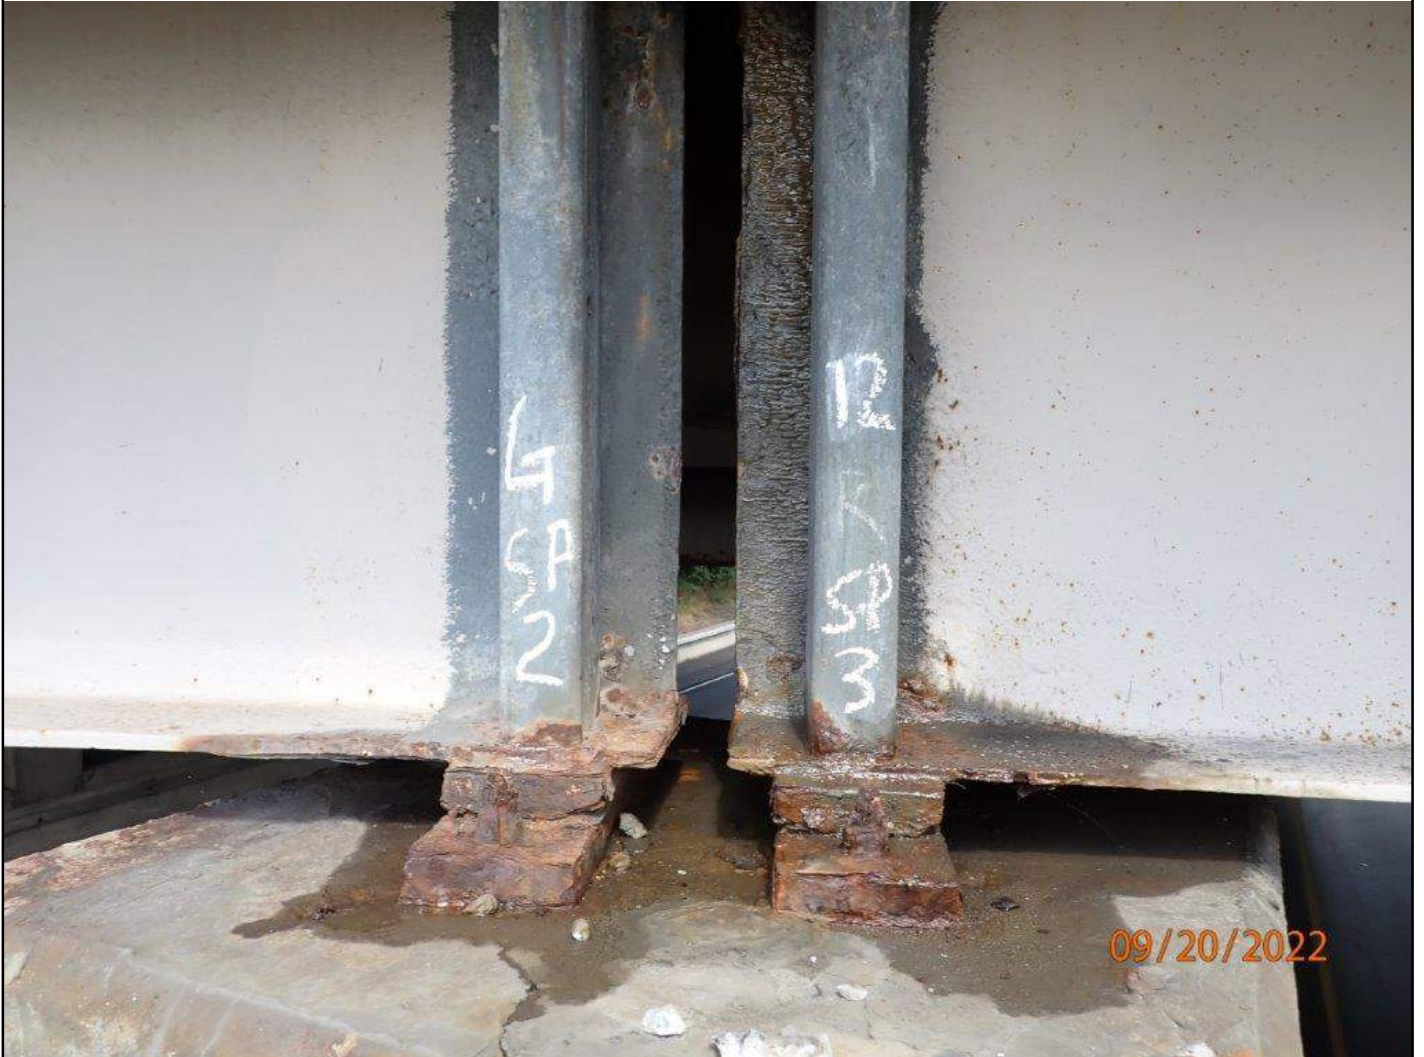
Photo Number: 4

Attachment Description: Typical box section repair (Right side of Girder G-12 shown over Pier PR-2 looking Left)

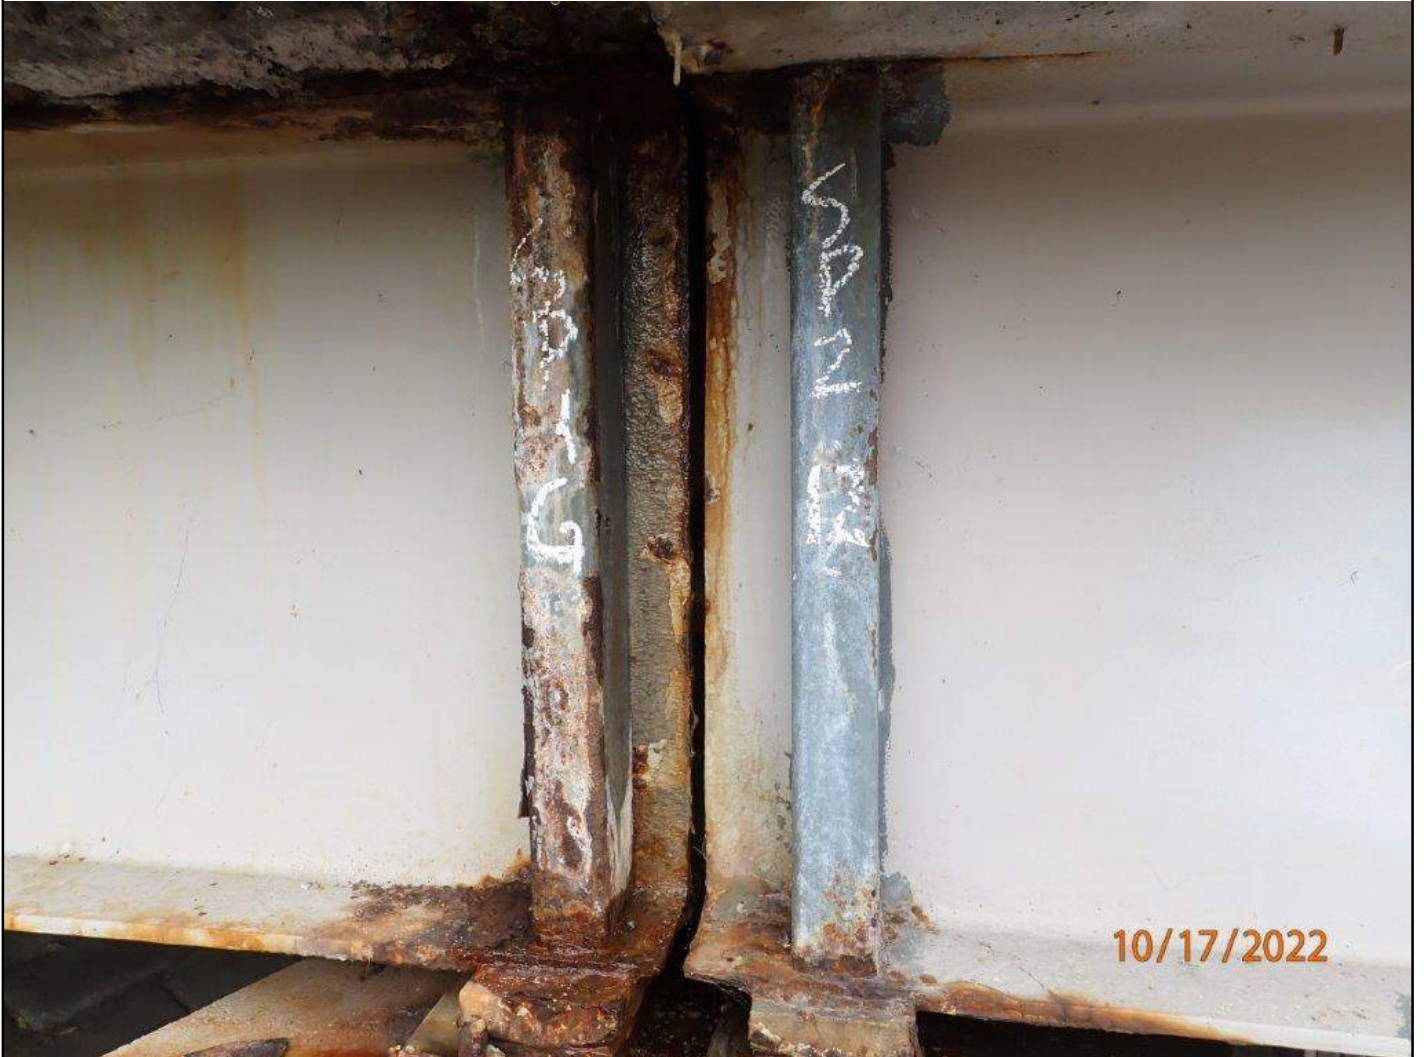
Attachment Description: Typical box section repair (Right side of G-12 shown over PR-1)

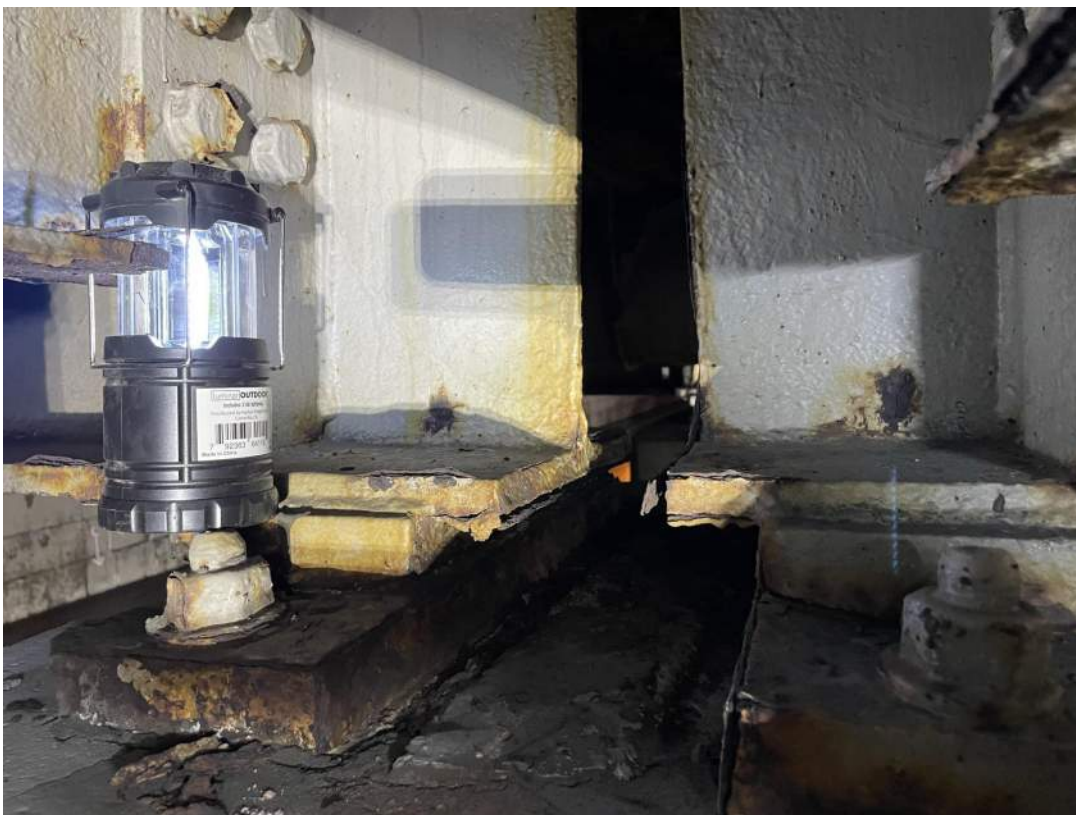
PHOTO 2

DESCRIPTION:
TYPICAL BEARING
AND GIRDER END
CONDITIONS

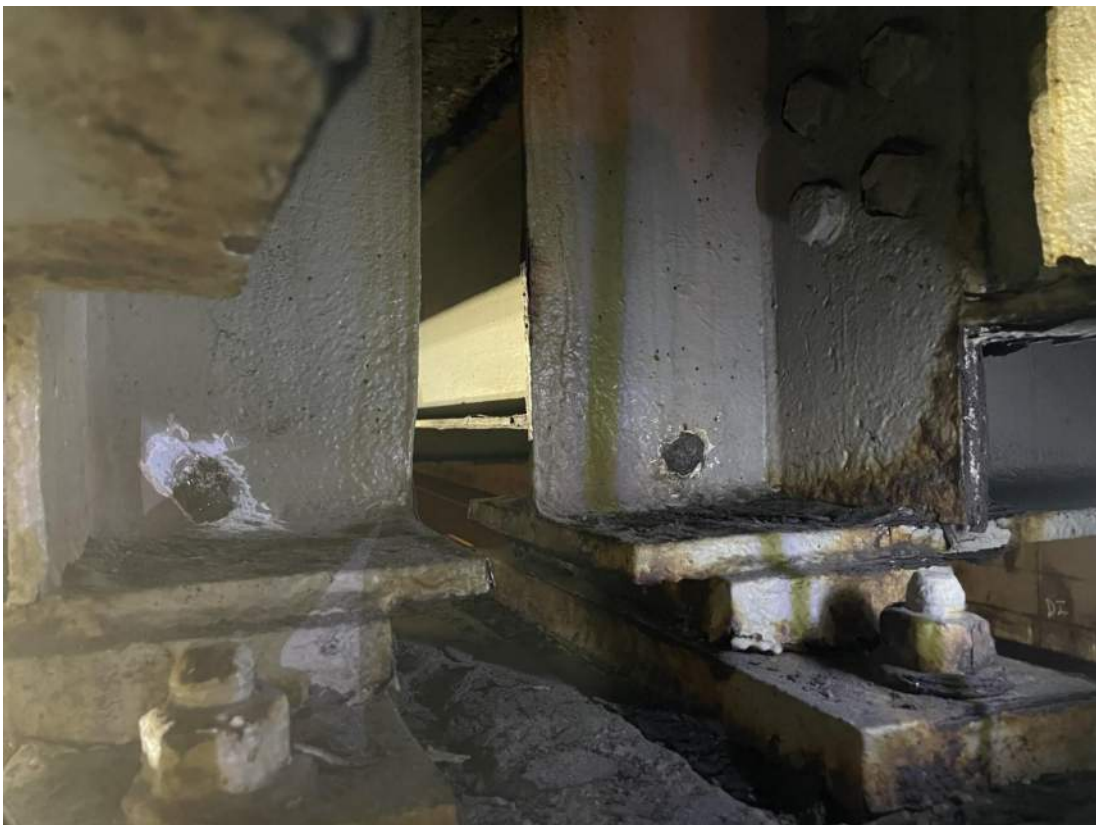
PHOTO 6

DESCRIPTION:
TYPICAL GIRDER
END CONDITION

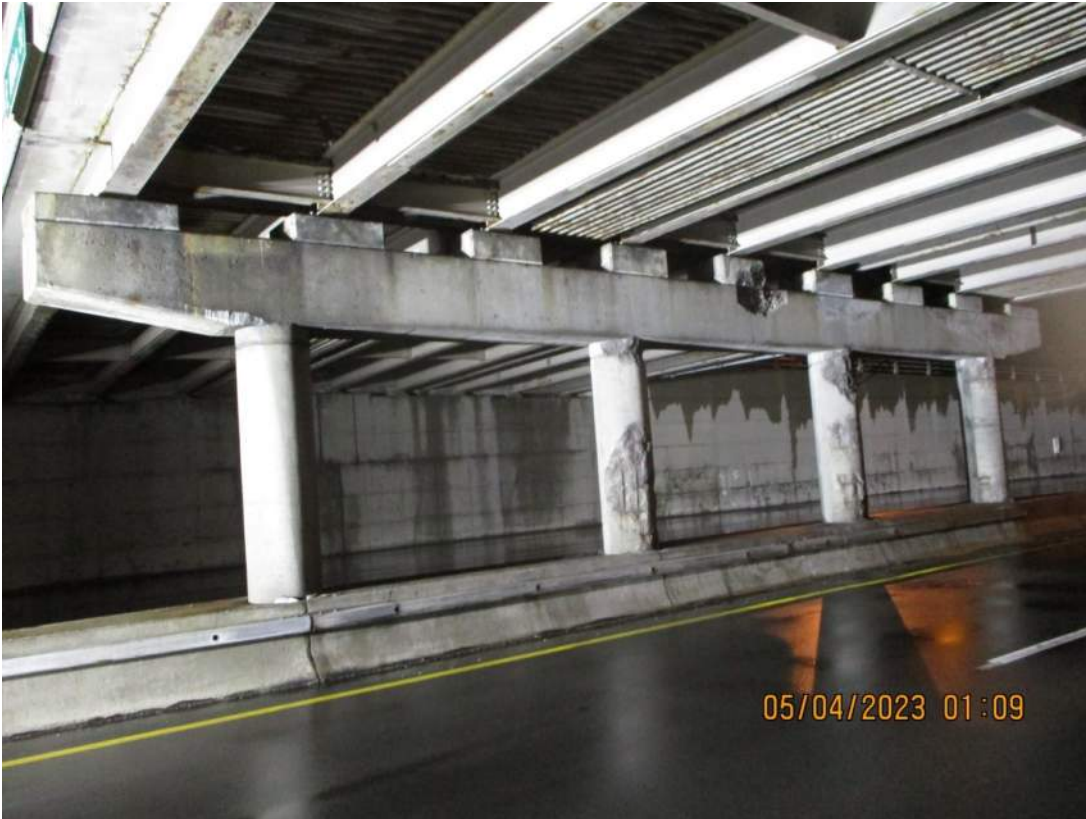
PHOTO 7

DESCRIPTION:
GENERAL SPALLING
CONCRETE
CONDITIONS;
TYPICAL FOR BOTH
FACES
