Appendix A4

Bridge Inspection Reports and Work History Summaries

**NY33 BRIDGE CONDITION VERIFICATION 2023
KENSINGTON EXPRESSWAY PROJECT
PIN 5512.52
CITY OF BUFFALO, ERIE COUNTY
BIN 1022609**

STRUCTURE: BIN 1022609 - Best Street on NY33 Kensington Expressway

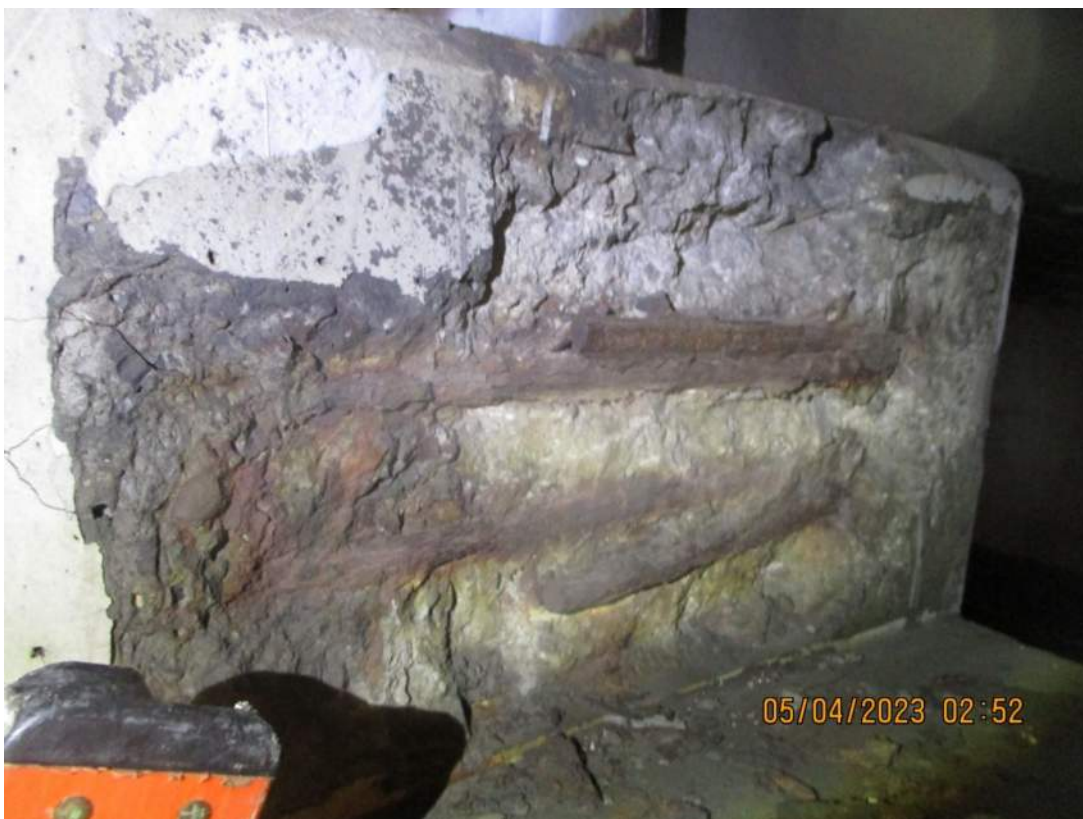
PHOTO 10
LOCATION: PEDESTAL P6 LOOKING SOUTH
DESCRIPTION: SPALLS TO CORRODED REBAR ON PEDESTAL

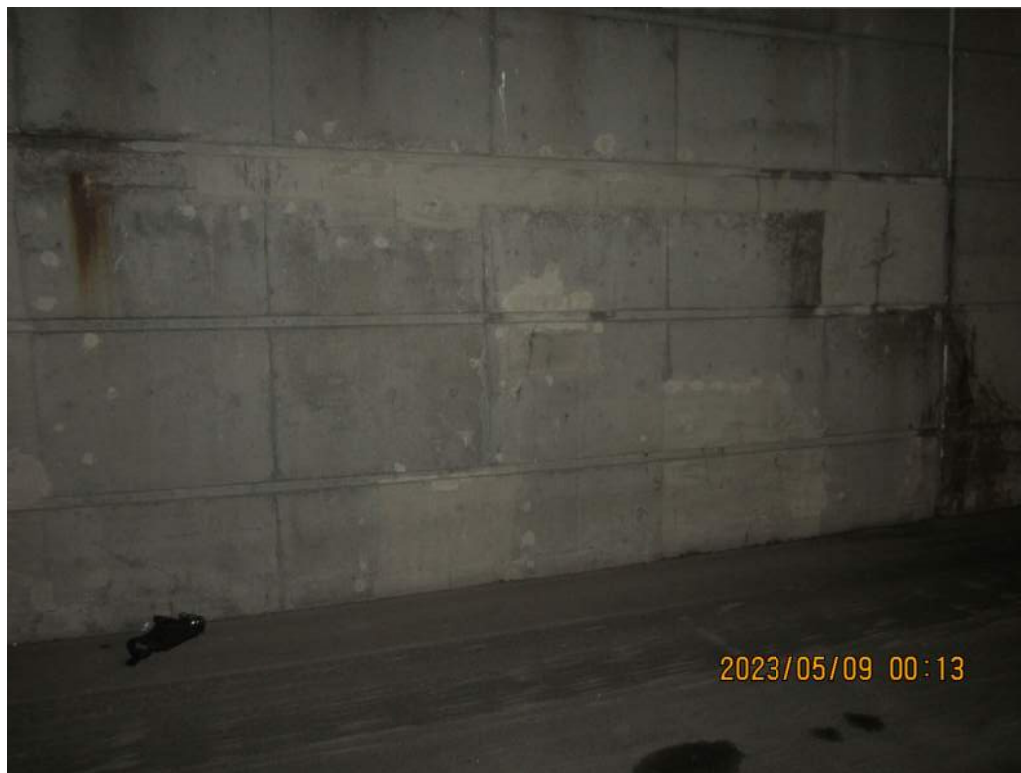
PHOTO 5:

DESCRIPTION:
GENERAL CONDITION
PHOTO

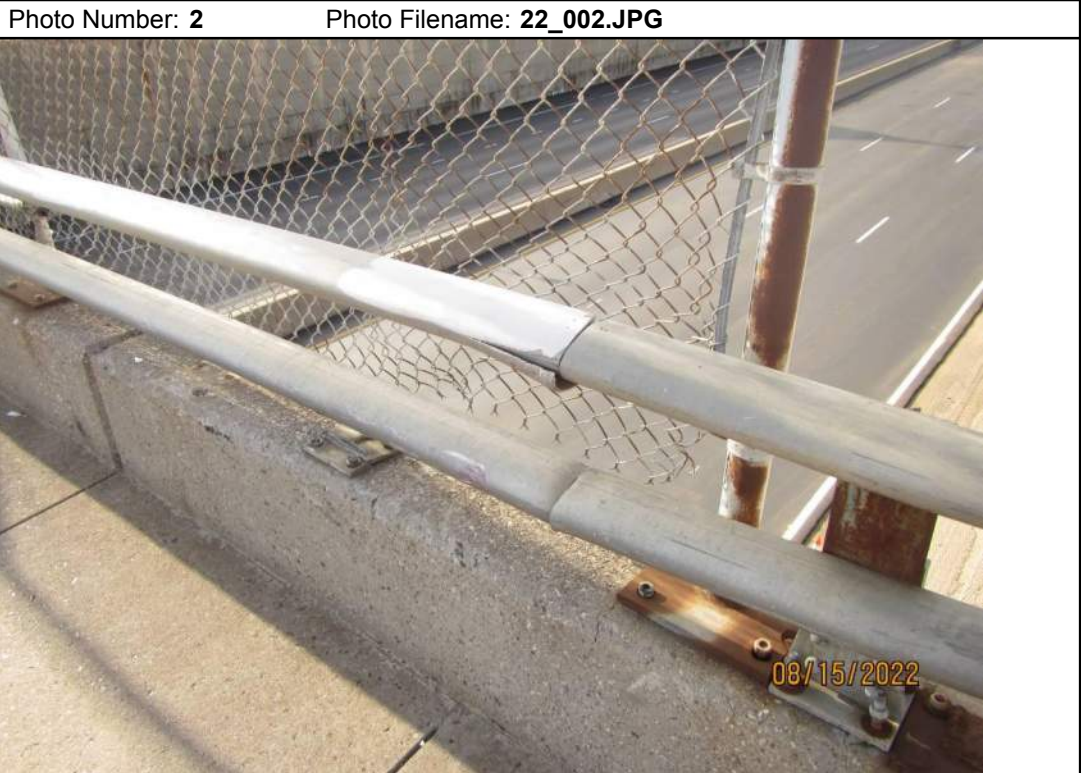
Attachment Description:
(NSCO) Pedestrian Fence,
Begin Span 1, Right,
Bottom Rail Disconnected
from Post
