Asbestos-Containing Materials Inspection

BIN 1022609
Best Street over
Kensington Expressway (Rt. 33)
City of Buffalo,
Erie County, New York

PIN – 5512.52.123

Watts Project No. 20220255

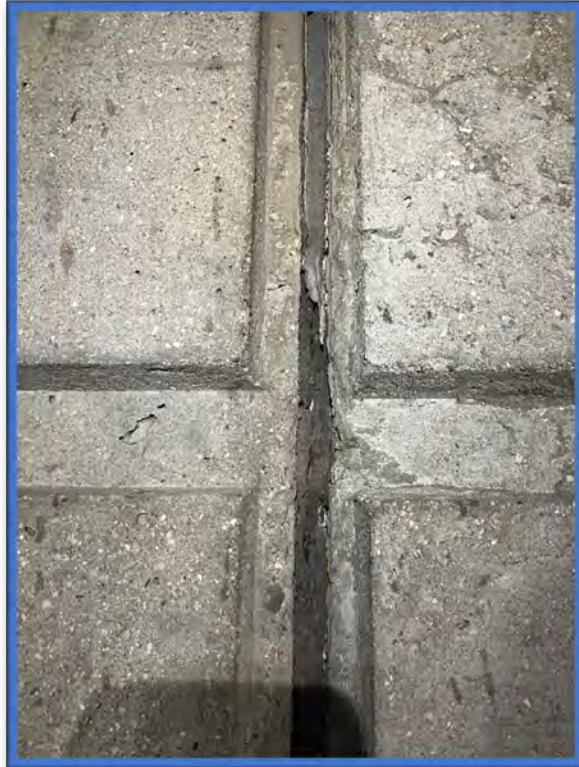
Photo 7 – View of the dark grey asbestos-containing caulking observed within the expansion joint at the Dodge Street Bridge over Kensington Expressway (Route 33) (BIN 1022610).

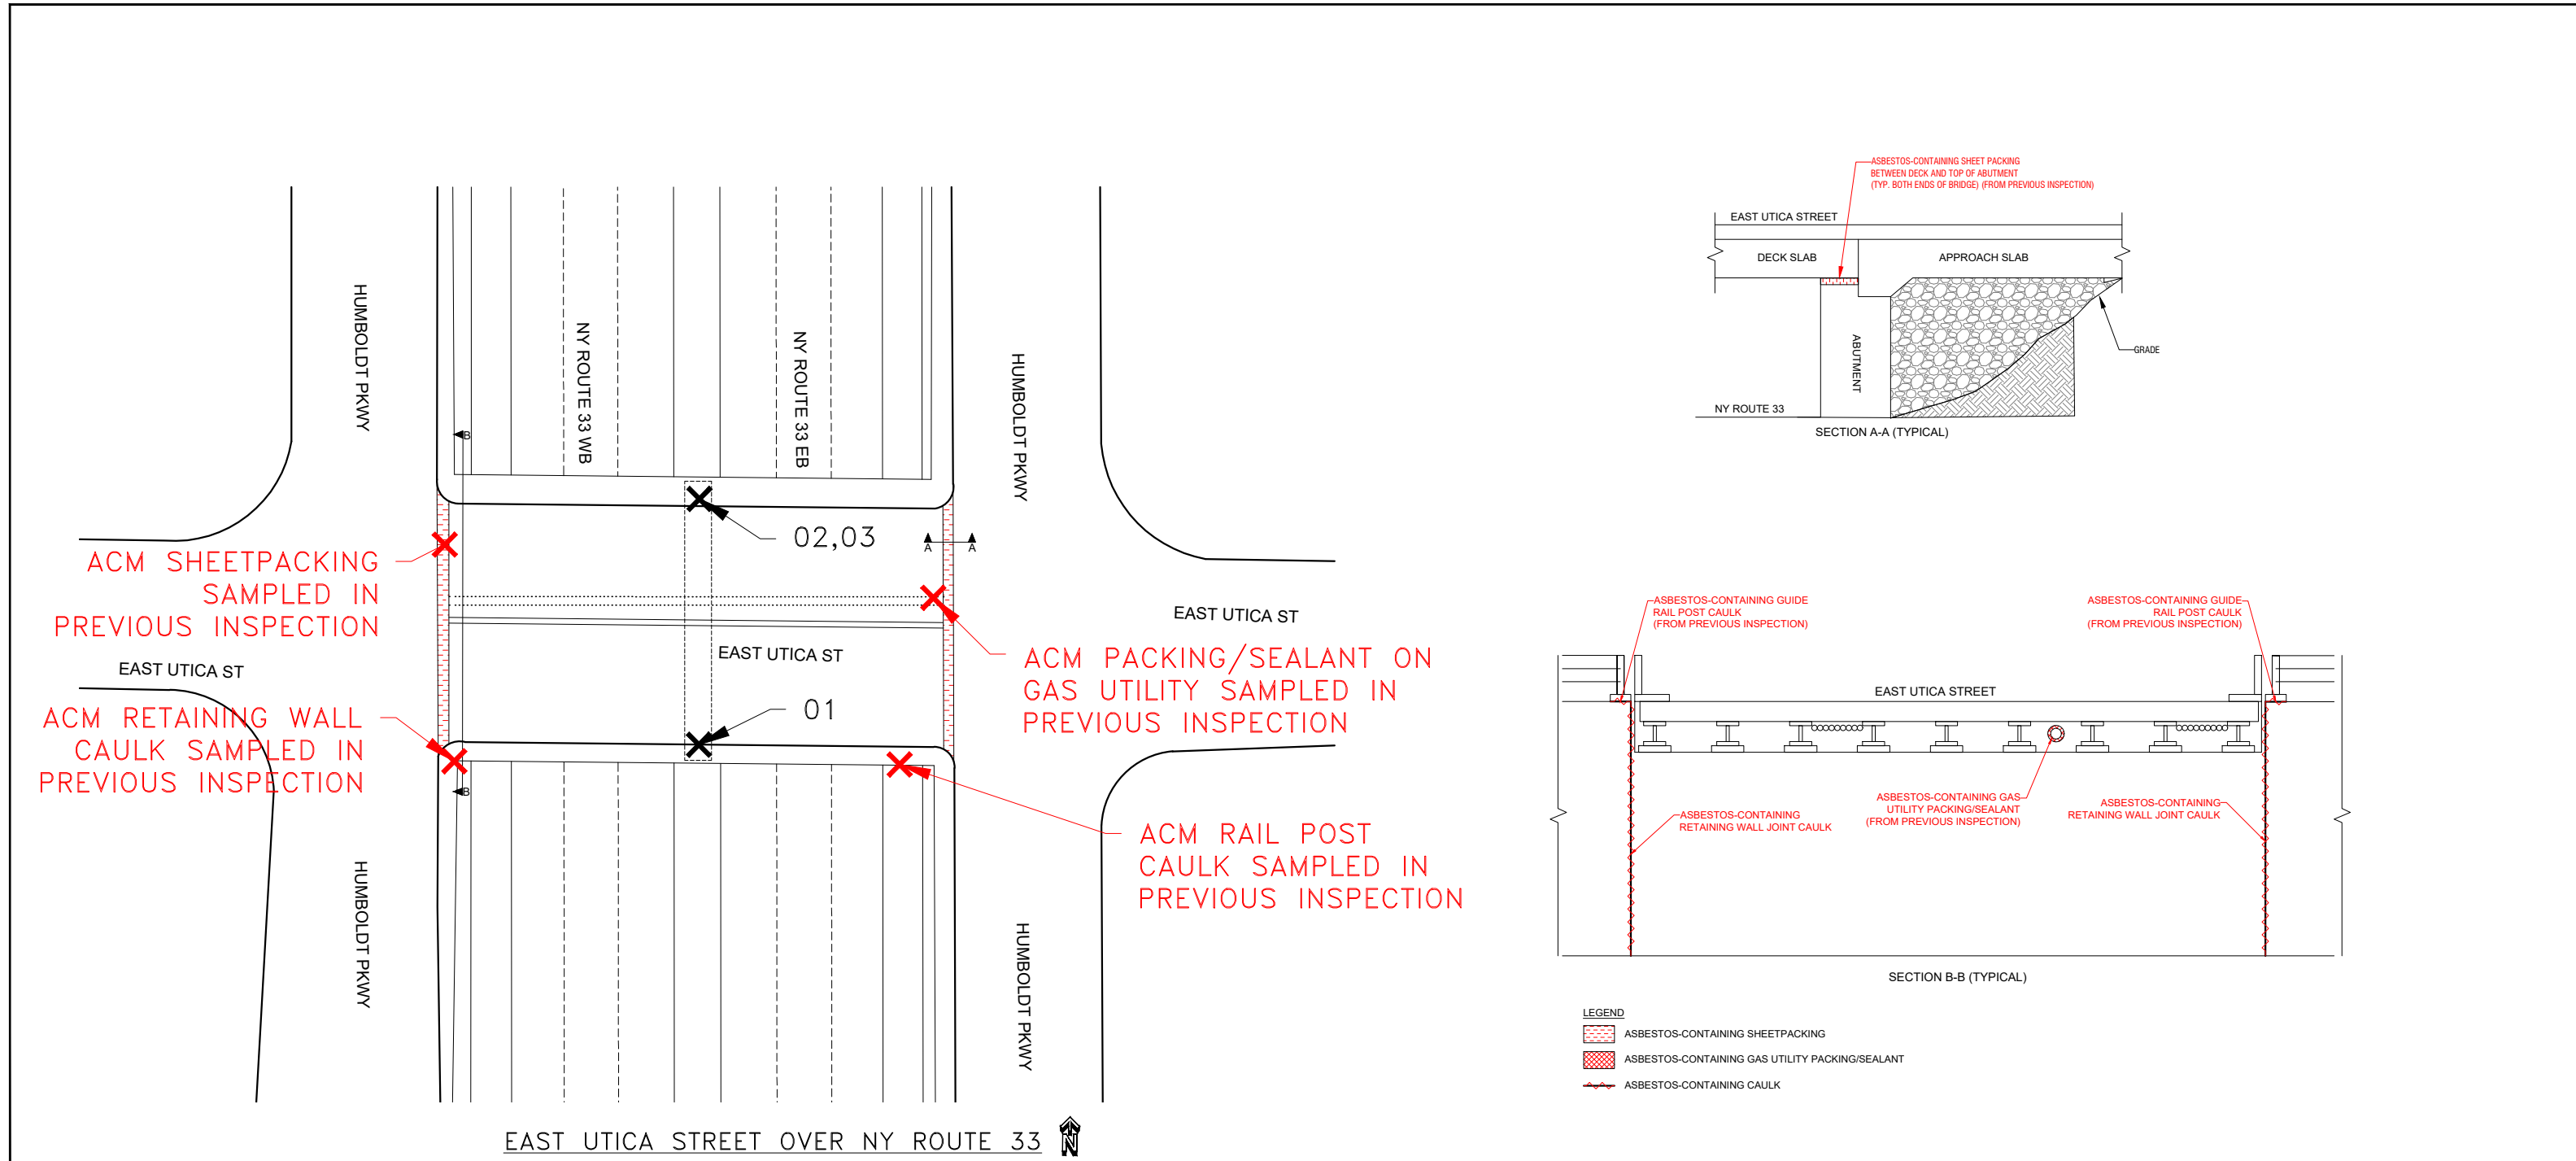
FIGURE 2
 ASBESTOS BULK SAMPLE LOCATIONS
 BIN 1022630

SAMPLES ARE PREFIXED BY 1022630-
 SAMPLES WERE COLLECTED ON JUNE 3, 2023.
 X INDICATES APPROXIMATE SAMPLE LOCATION
 X SAMPLE NUMBERS IN RED WERE IDENTIFIED TO BE ACM.

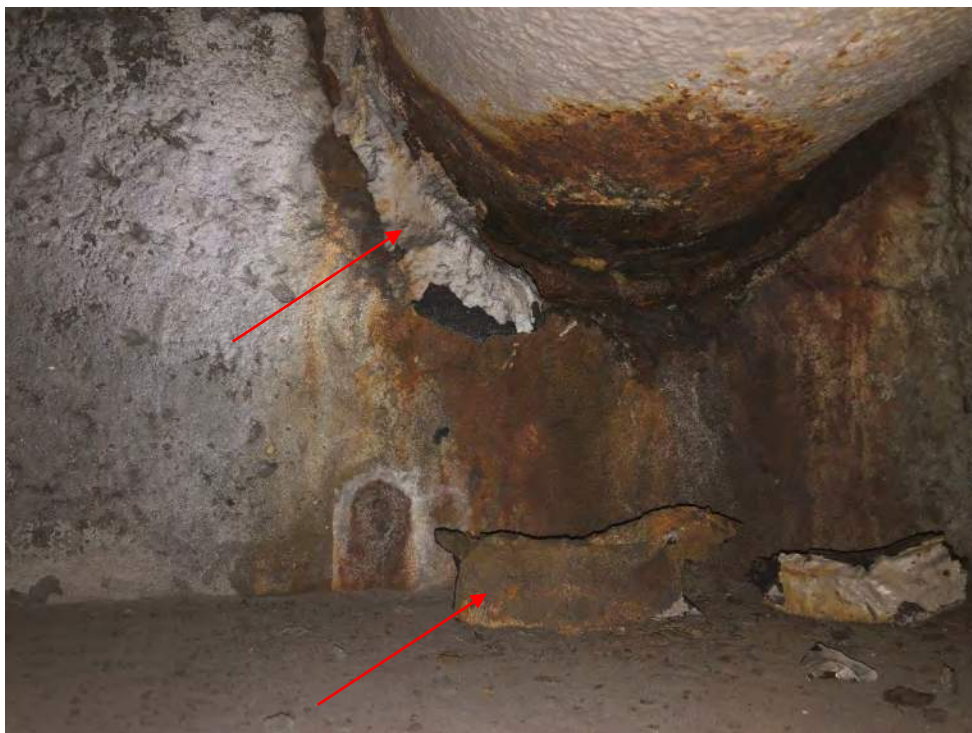
Photo 5 – View of the 12” metal conduit associated with the 8” gas utility line where it penetrates the east abutment of BIN 1022630. The packing/sealant around the perimeter of the 12” conduit where it penetrates each abutment has been identified as an ACM.

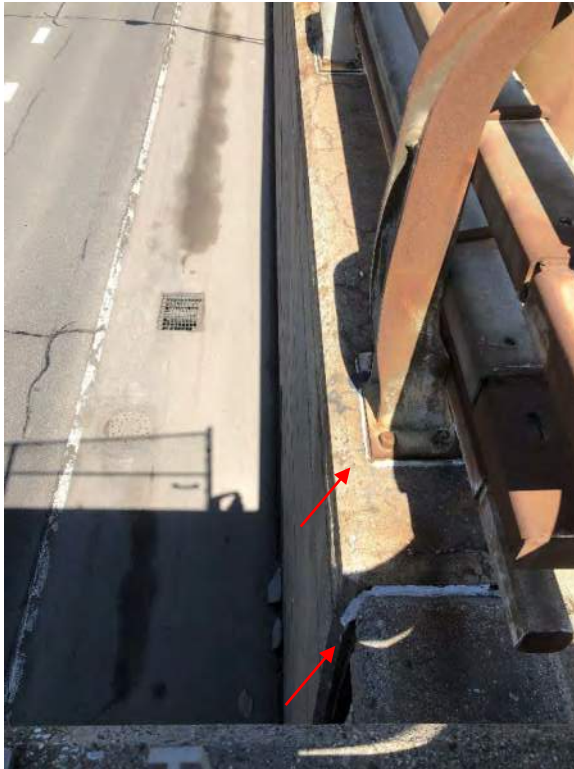
Photo 7 – View facing east at the northeast corner of BIN 1022630 and the retaining wall. The retaining wall grey caulk and the retaining wall guide rail post base grey caulk have both been identified as an ACM. The retaining wall caulk is degraded in places.

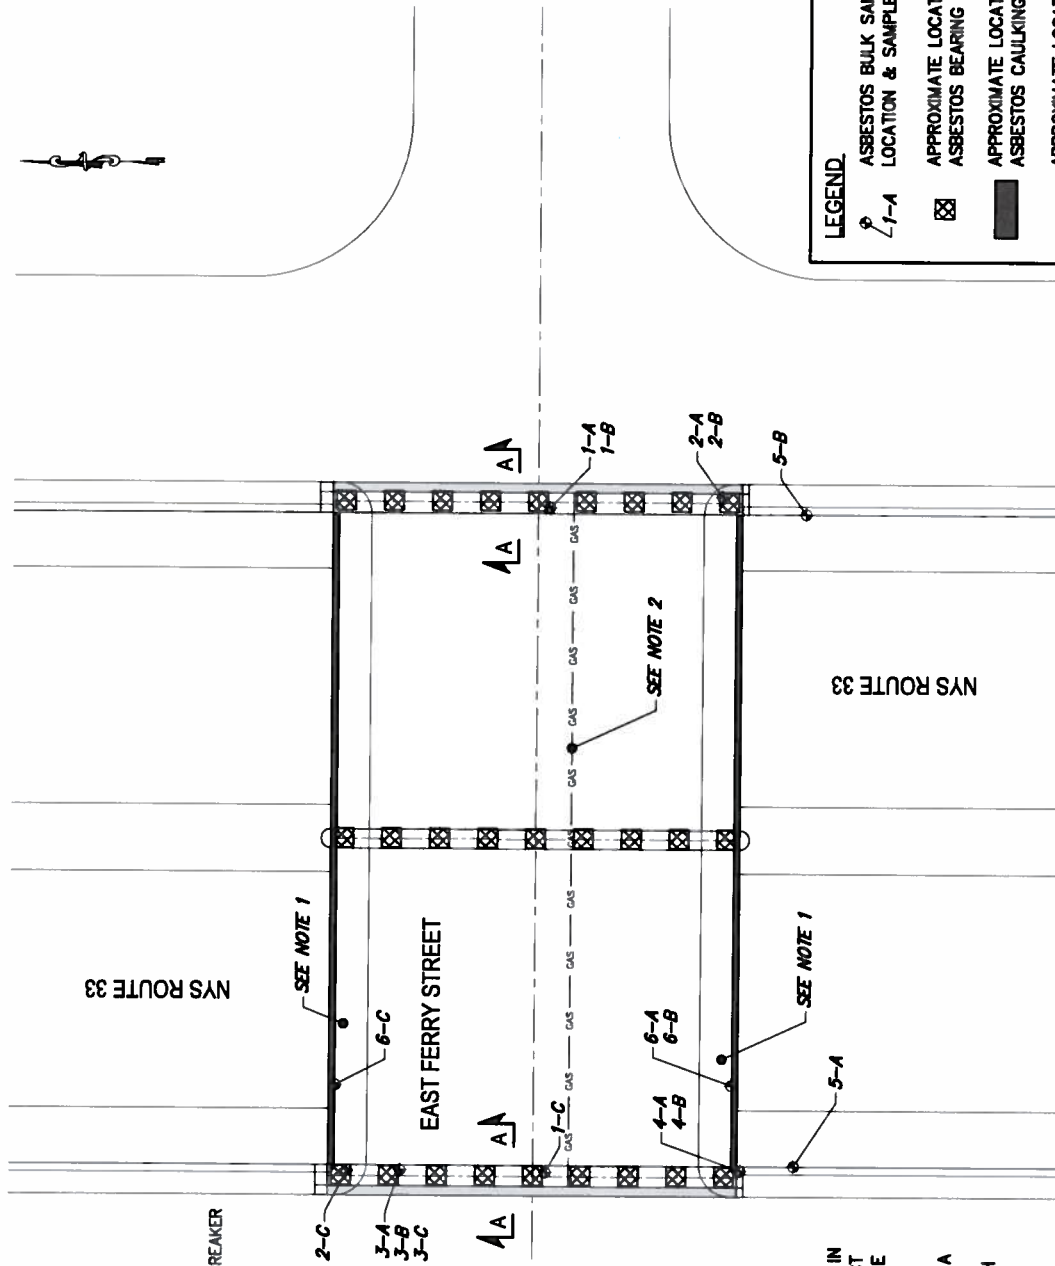
- NOTE.**
- RECORD PLANS INDICATE STEEL CONDUITS ARE BURIED IN THE NORTH AND SOUTH CONCRETE SIDEWALKS. SUSPECT ASBESTOS SEALING COMPOUND MAY BE LOCATED IN THE EXPANSION SLEEVES.
 - RECORD PLANS INDICATE AN 8-INCH GAS LINE SET IN A 12-INCH CASING ALONG THE SOUTH SIDE OF BIN 1022640. THE 8-INCH GAS LINE MAY BE COATED WITH A SUSPECT ASBESTOS TAR COATING.
