Appendix A5

Retaining Wall Inspection Reports

NY33 RETAINING WALL CONDITION EVALUATION 2023
KENSINGTON EXPRESSWAY PROJECT
PIN 5512.52
CITY OF BUFFALO, ERIE COUNTY
RETAINING WALL 1

PIN 5512.52 – NY33 RETAINING WALL CONDITION EVALUATION 2023 FIELD INSPECTION SUMMARY

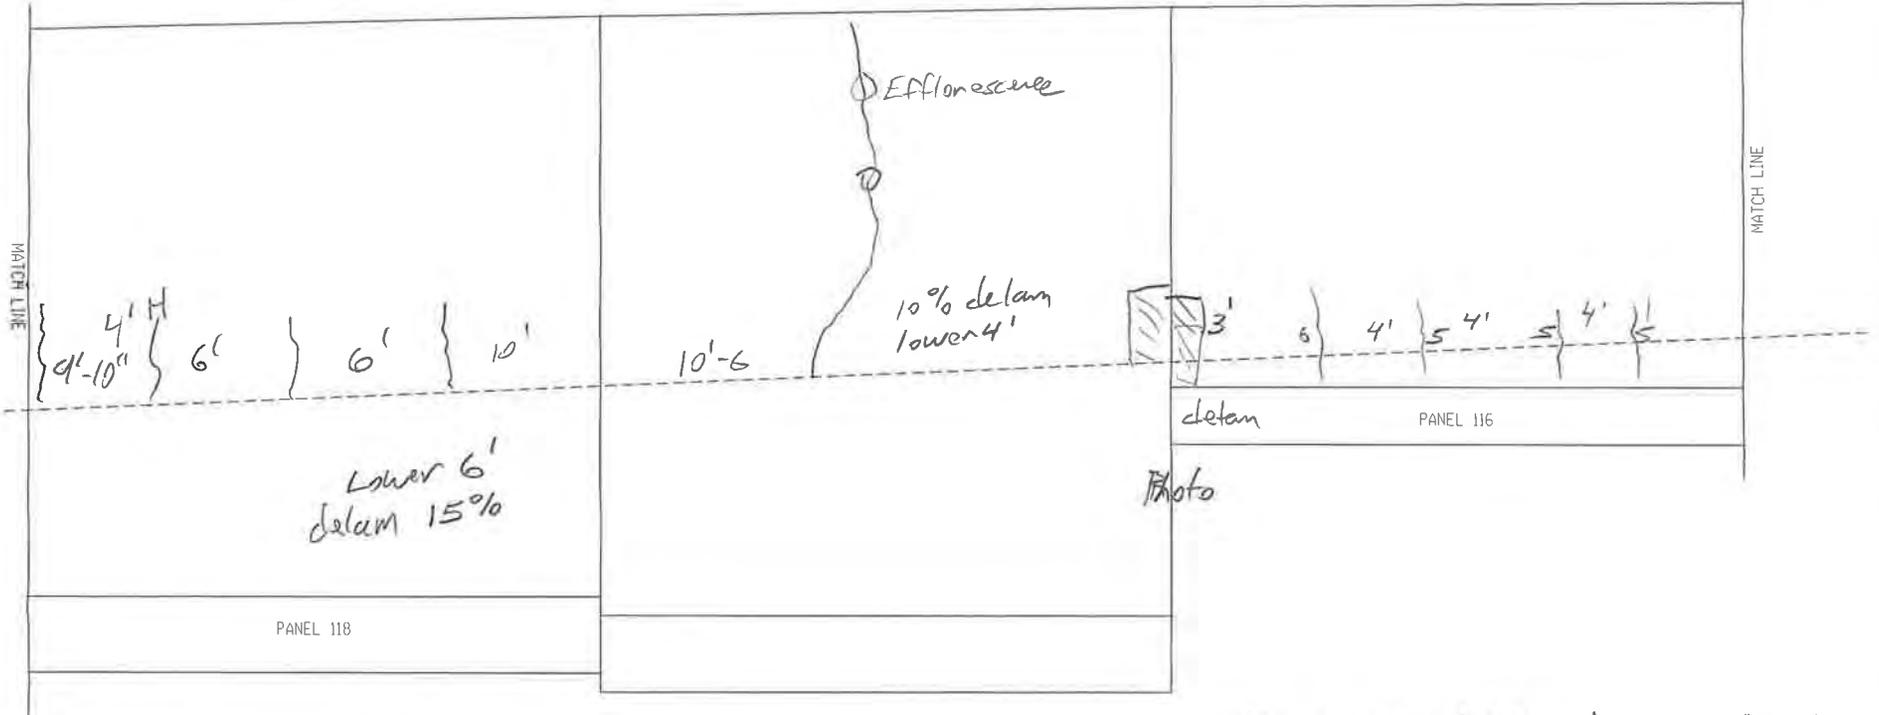
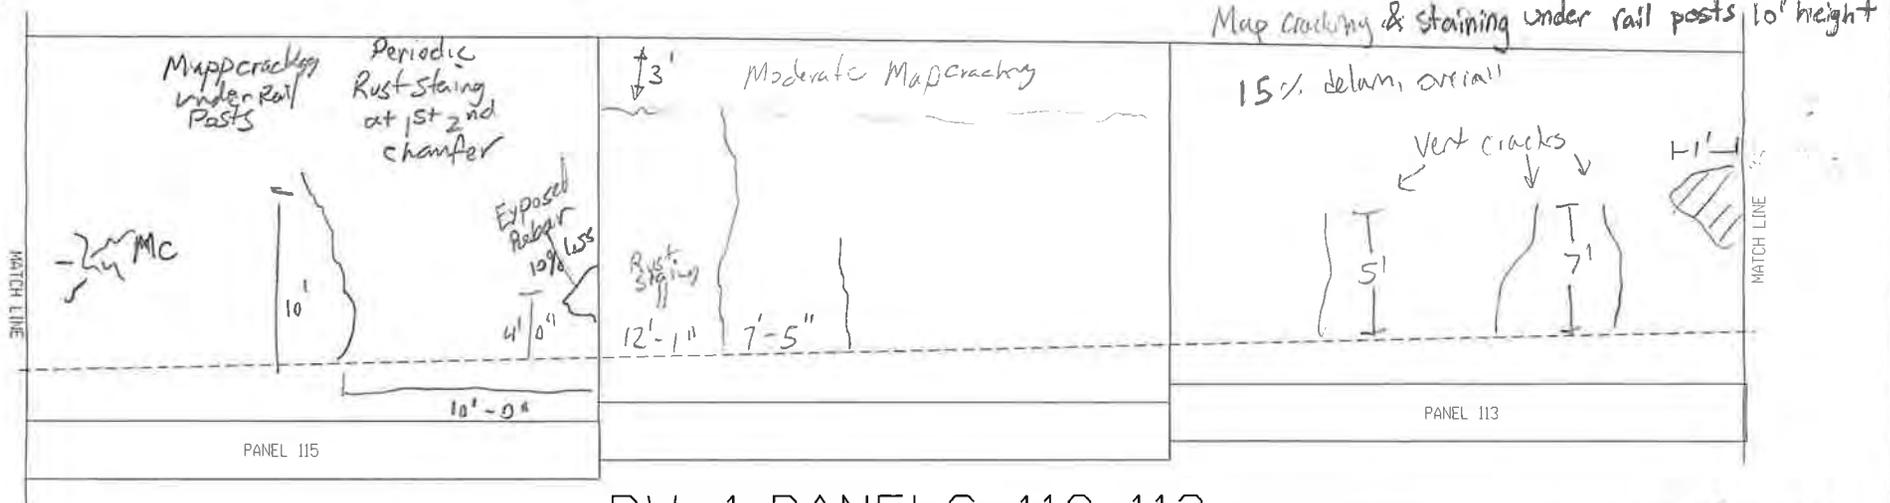
RW 1 PANELS 118-113

Coping - Crack @ mid height - full length (top)

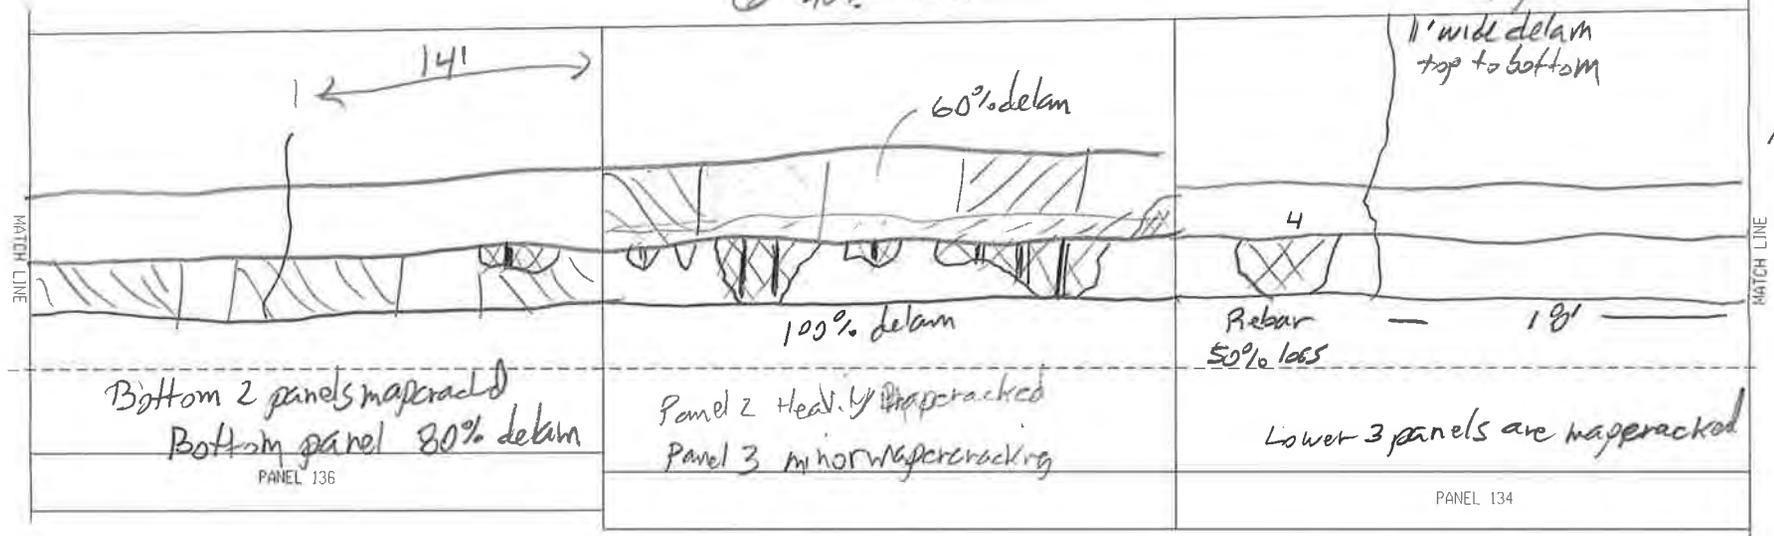
RW 1 PANELS 139-134

Mapcracked 1-2
① delam & spalled 70%
② 40% delam

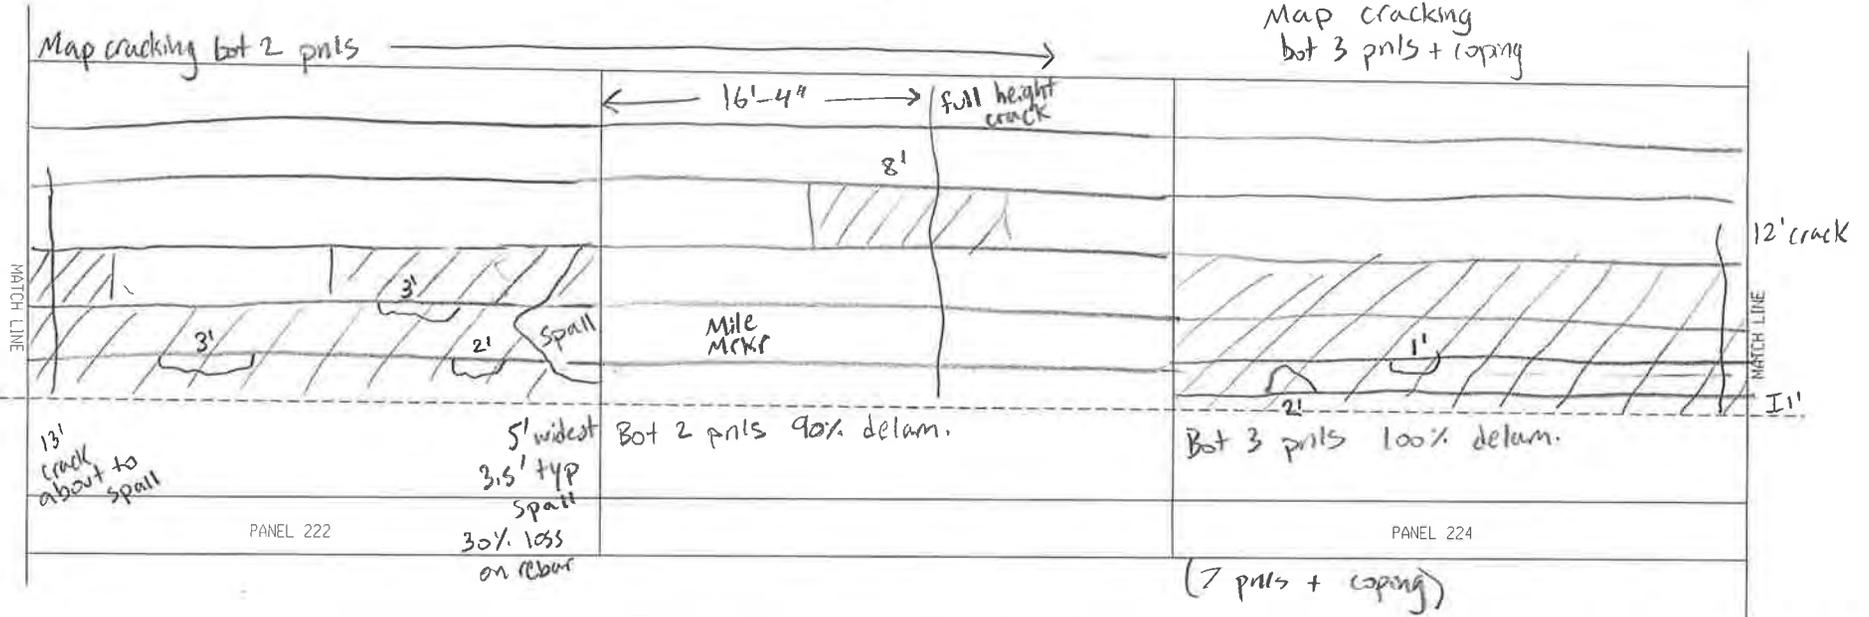
RW 2 PANELS 219-224

Map cracking bot 2 pnls

Map cracking bot 3 pnls + coping

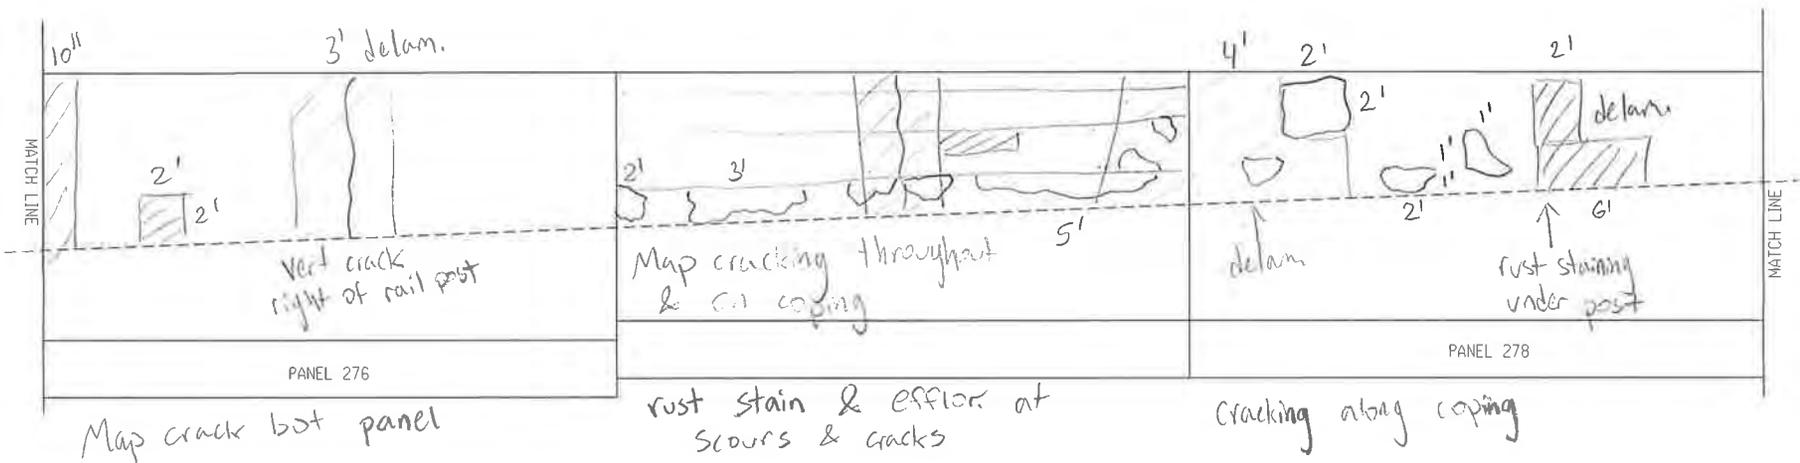
RW 2 PANELS 273-278

Map cracking at joint

Bot panel 70% delam

• Map crack on 3rd panel

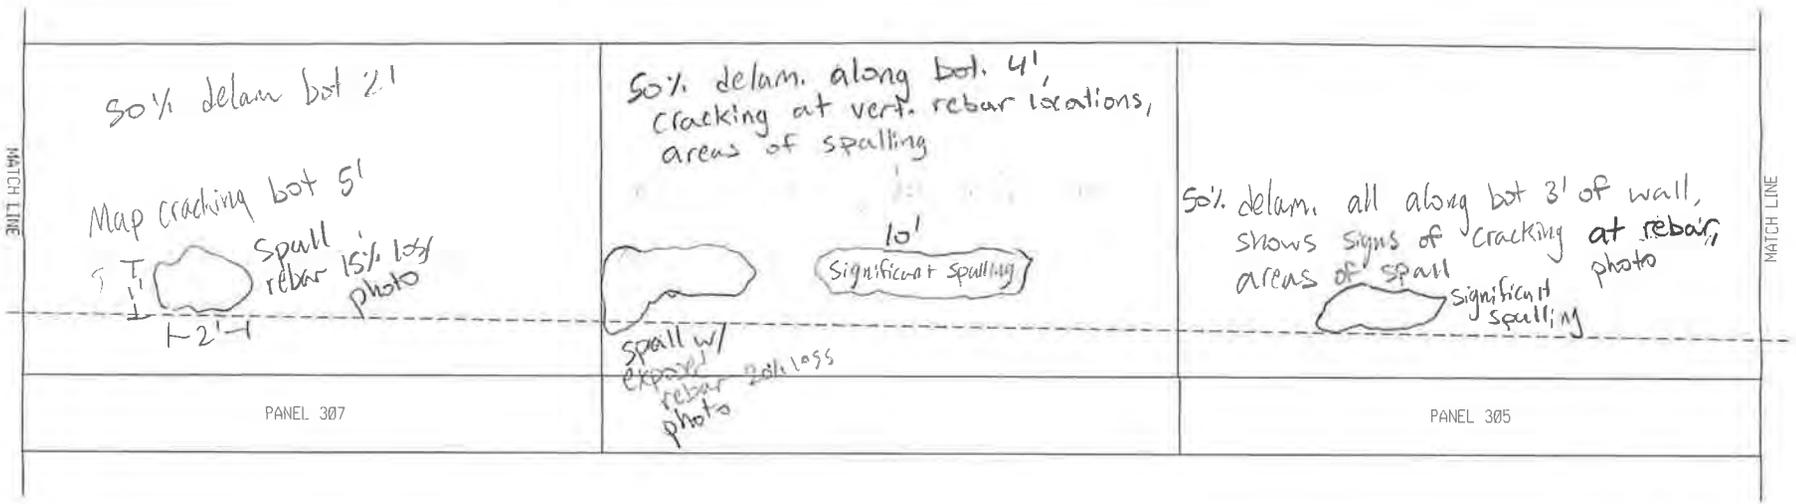
RW 3 PANELS 310-305

Bot 2.5' 30% to 40% delam.

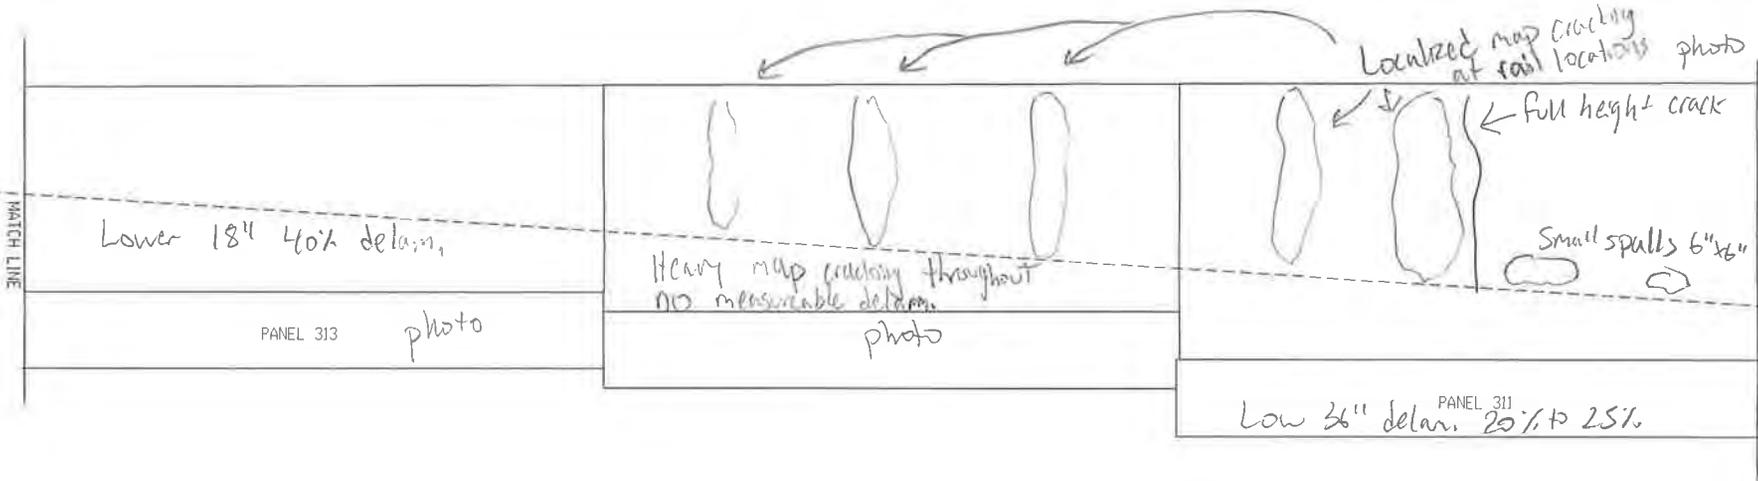
RW 3 PANELS 319-311

2' spall/delam. @ joint

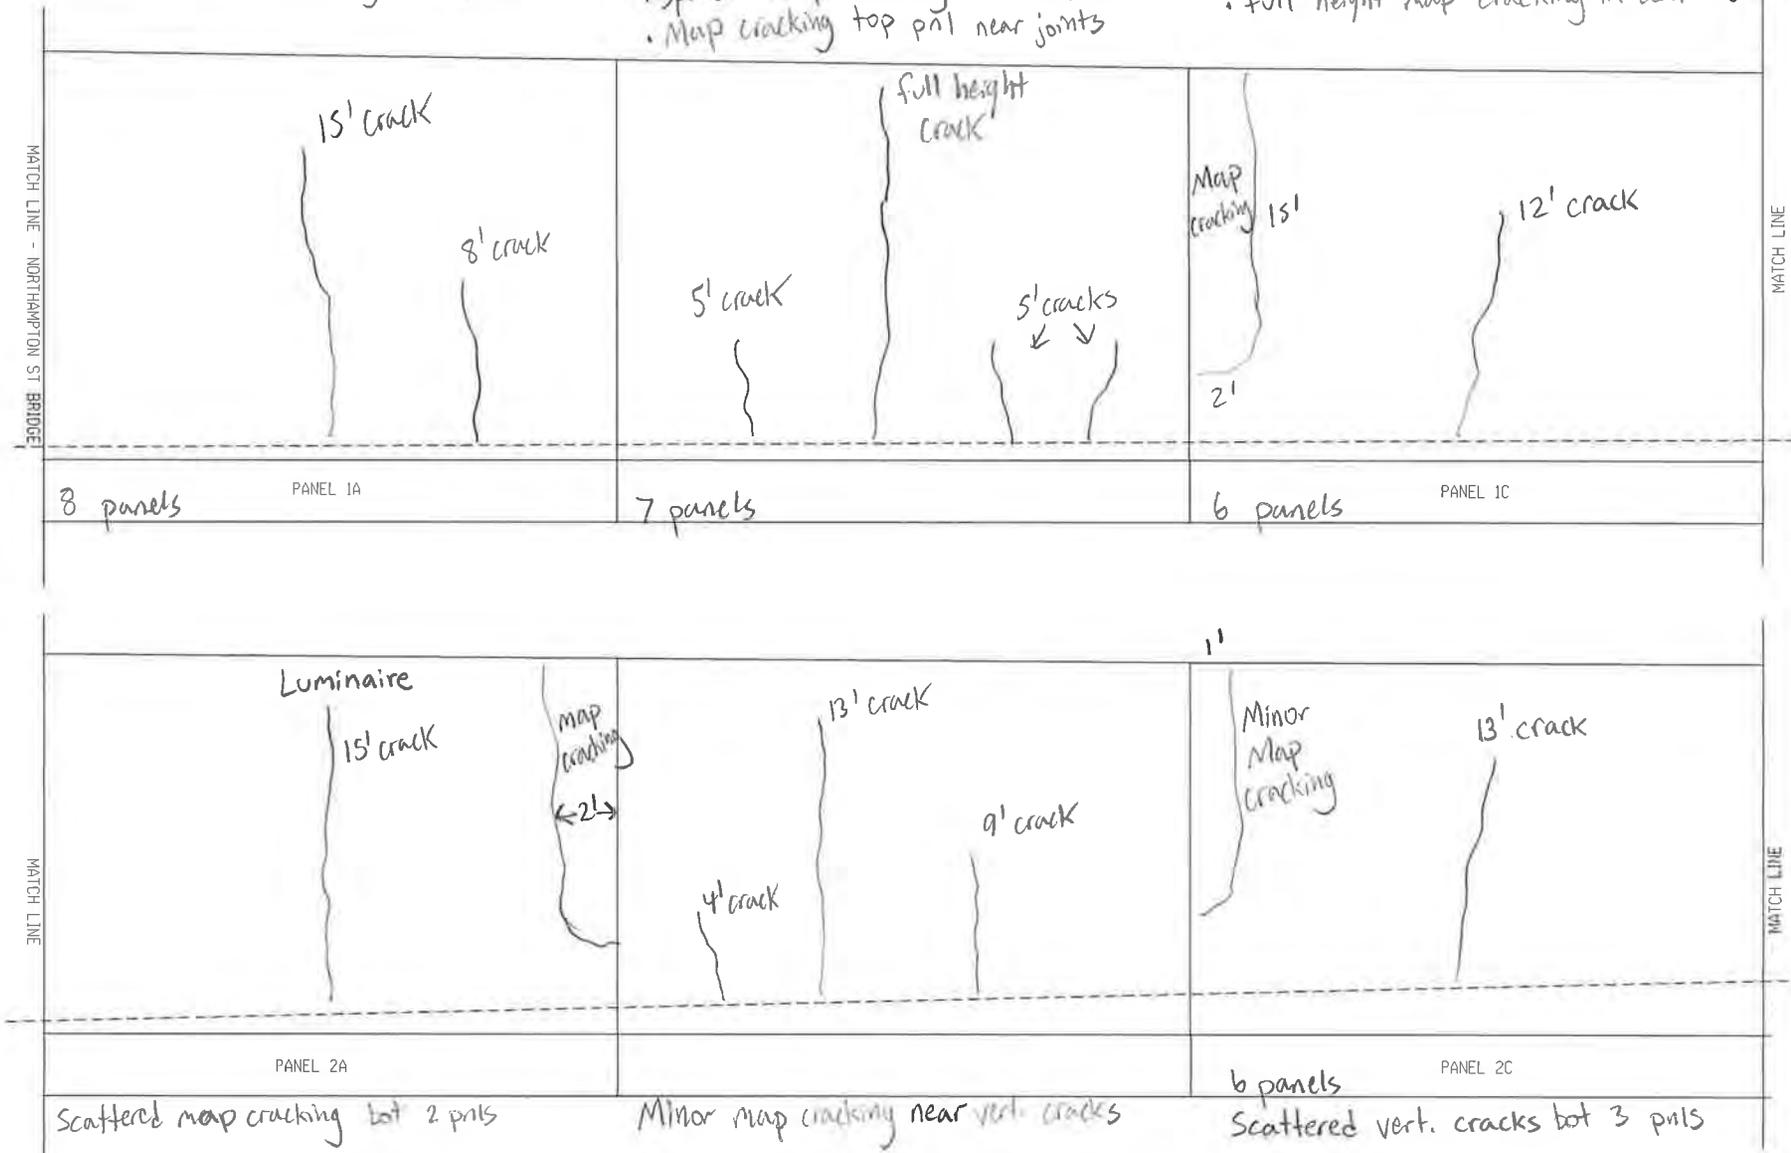
RW 10 PANELS 1A-2C

Scattered vert cracks bot 2 pnls
Full height map cracking in center 6'

delaminated

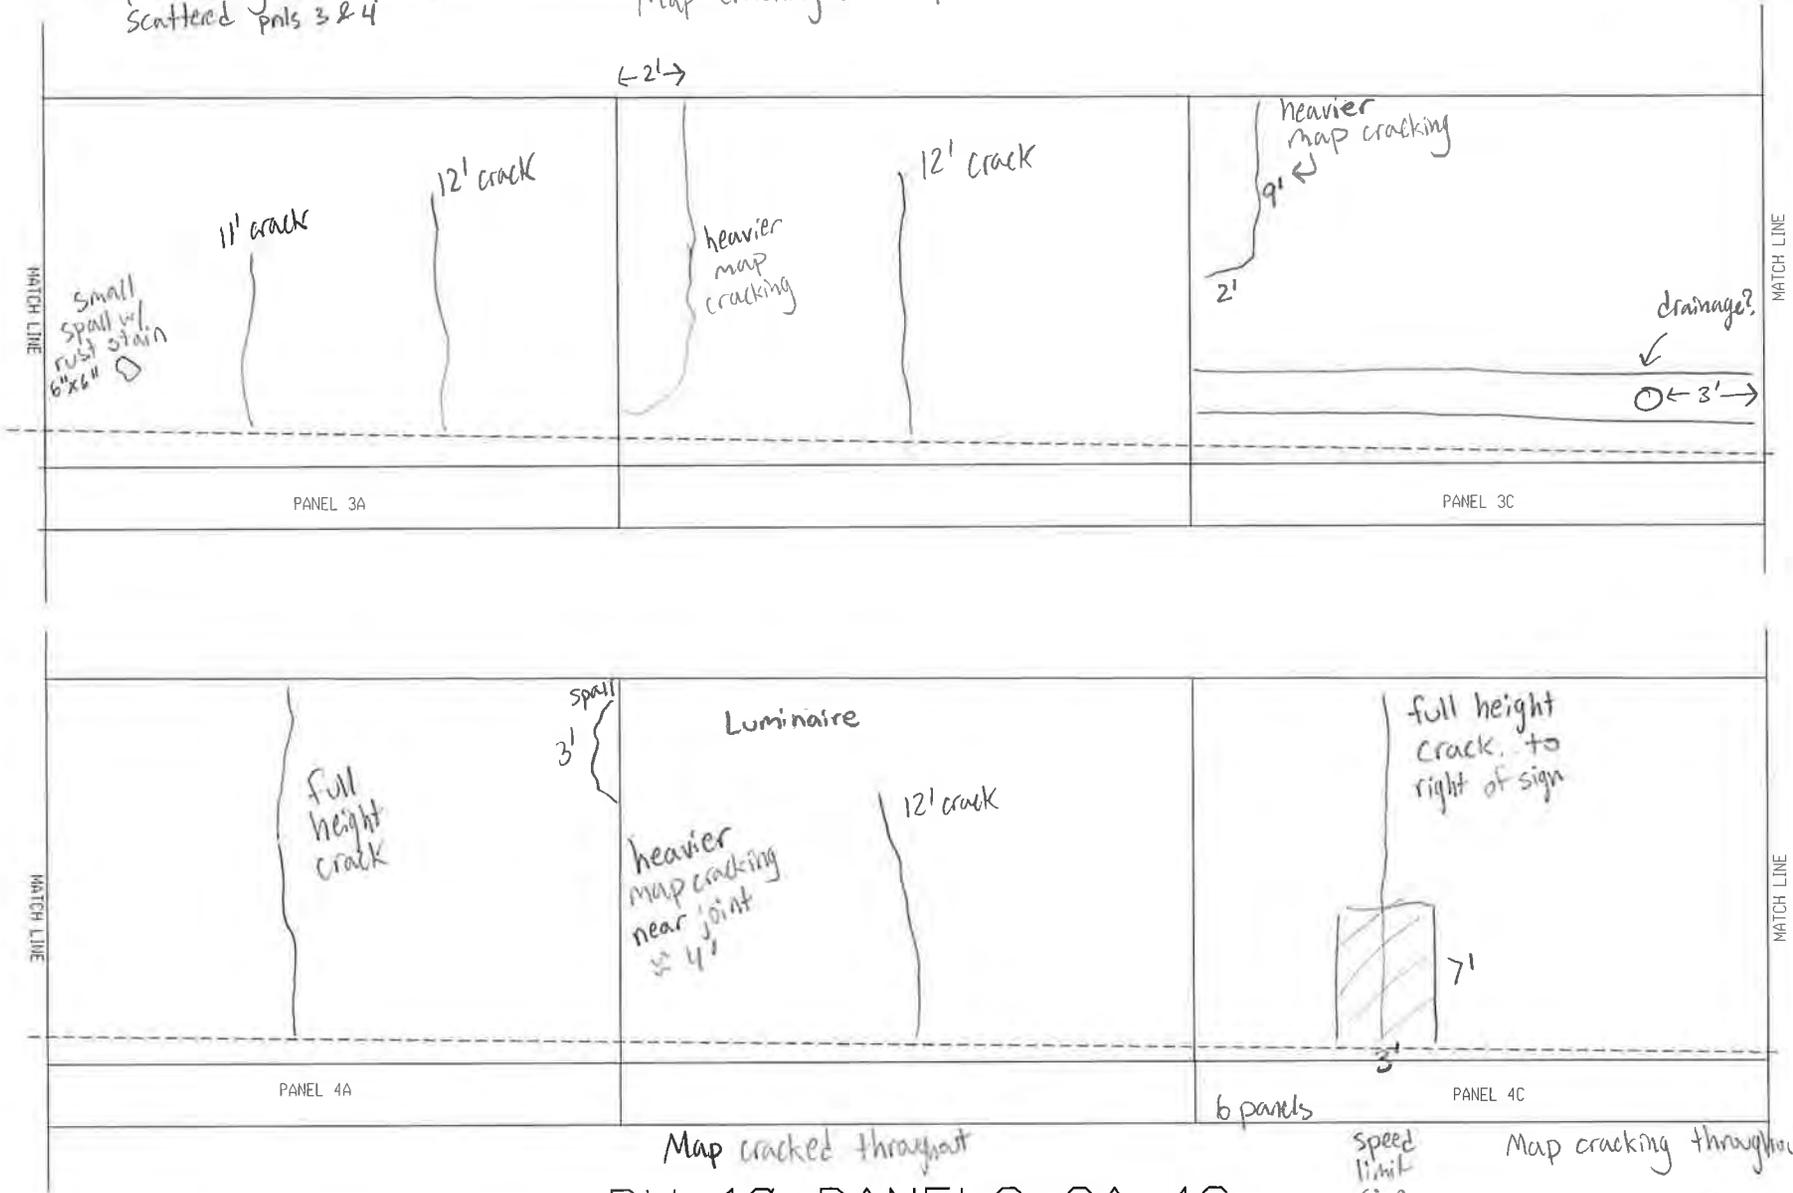
Scattered vert. cracks on bot 3 pnts

Map cracked throughout
RW 10 PANELS 3A-4C

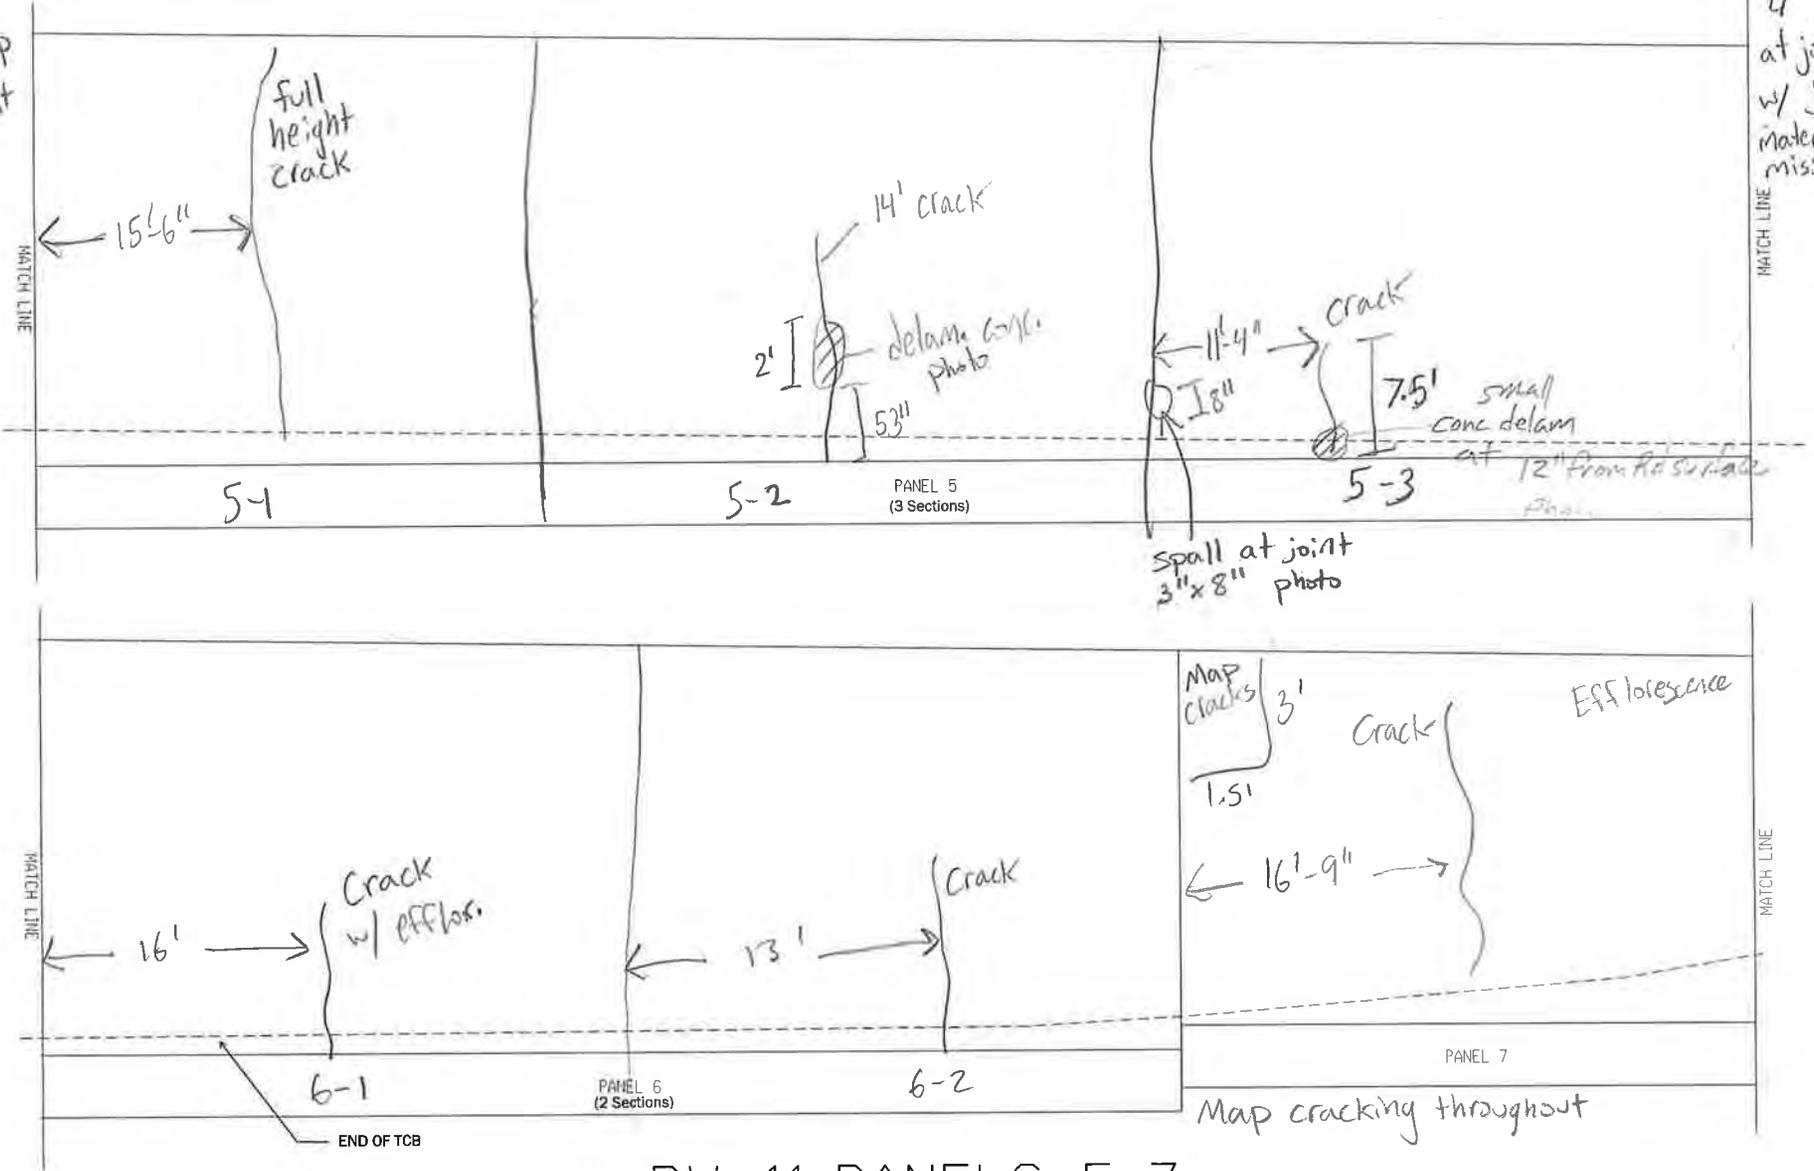
RW 11 PANELS 5-7

3/4" gap at joint w/ joint material missing
