Bridge Inspection Reports and Work History Summaries

**NY33 BRIDGE CONDITION VERIFICATION 2023
KENSINGTON EXPRESSWAY PROJECT
PIN 5512.52
CITY OF BUFFALO, ERIE COUNTY
BIN 1022609**

STRUCTURE: BIN 1022609 - Best Street on NY33 Kensington Expressway

STRUCTURE TYPE: Four (4) span Steel, Multi-Stringer (12 beams) structure with concrete abutments founded on piles and 3-six column piers with spread footings. Year Built: 1959

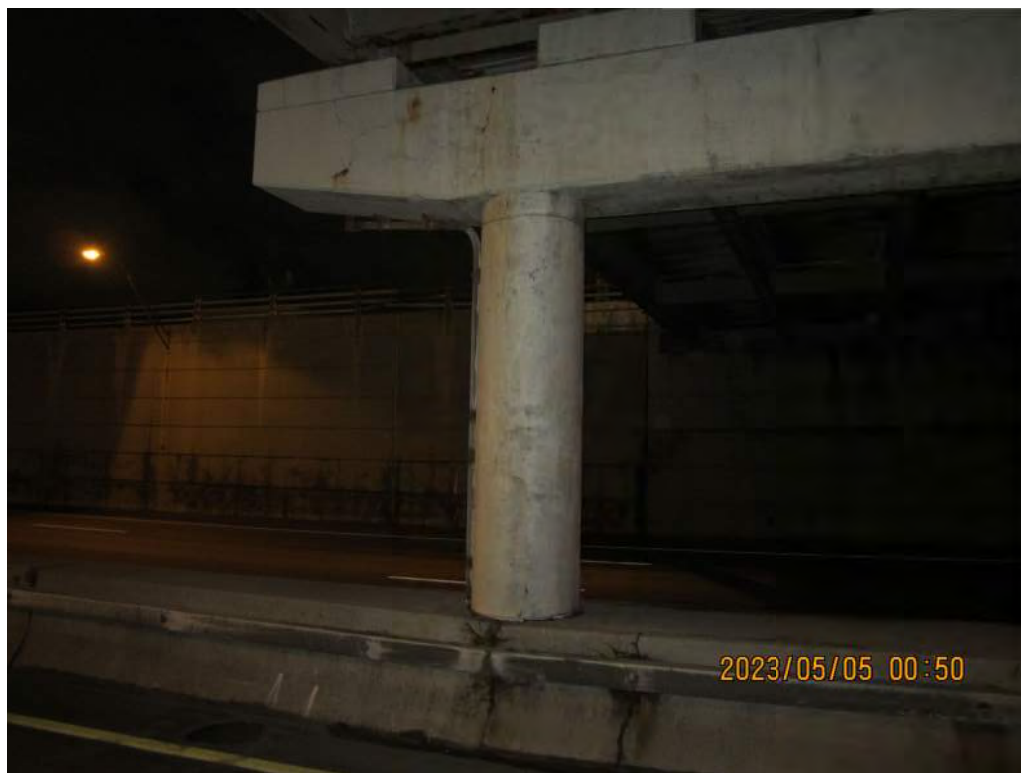
PHOTO 7:
LOCATION:
PIER
DESCRIPTION:
GENERAL CONDITION
PHOTO
