# **Appendix A5**

## Retaining Wall Inspection Reports

**NY33 RETAINING WALL CONDITION EVALUATION 2023**  
**KENSINGTON EXPRESSWAY PROJECT**  
**PIN 5512.52**  
**CITY OF BUFFALO, ERIE COUNTY**  
**RETAINING WALL 1**

# PIN 5512.52 – NY33 RETAINING WALL CONDITION EVALUATION 2023 FIELD INSPECTION SUMMARY

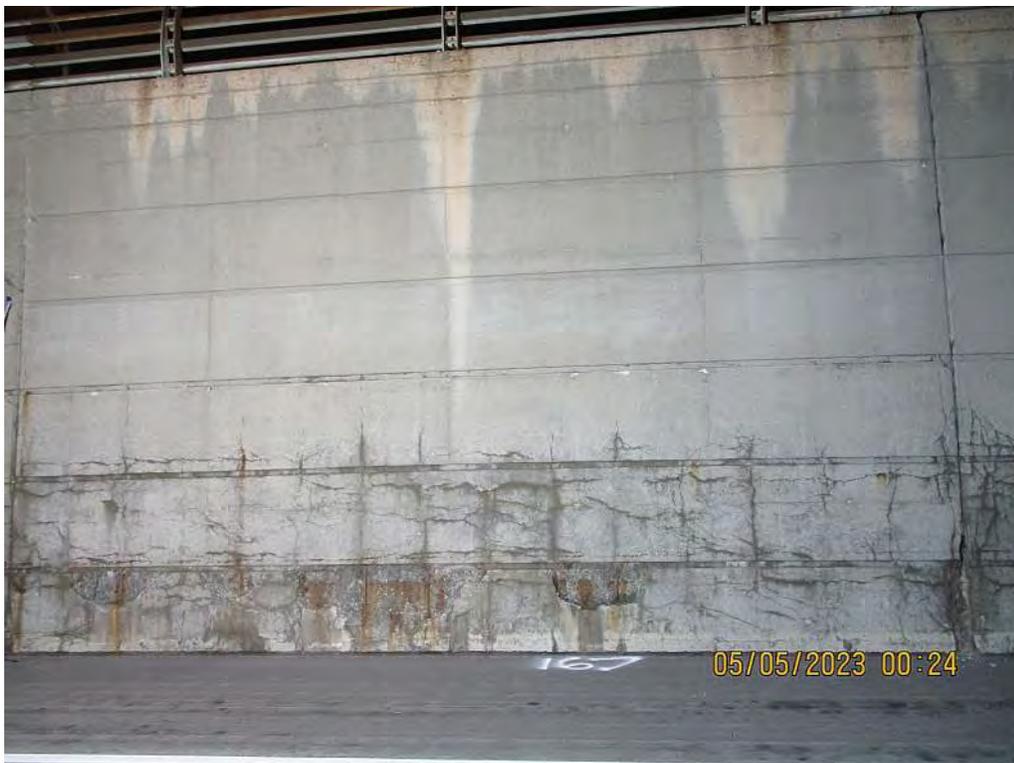
PHOTO 12

There is a full height crack at 17 ft from the panel begin. The concrete adjacent to each wall joint is heavily delaminated and spalled. with exposed rebar (rebar is exhibiting 25% section loss).

The lowest wall section is 90% delaminated (where not spalled), section 2 is 30% delaminated and section 3 exhibits 50% delamination.

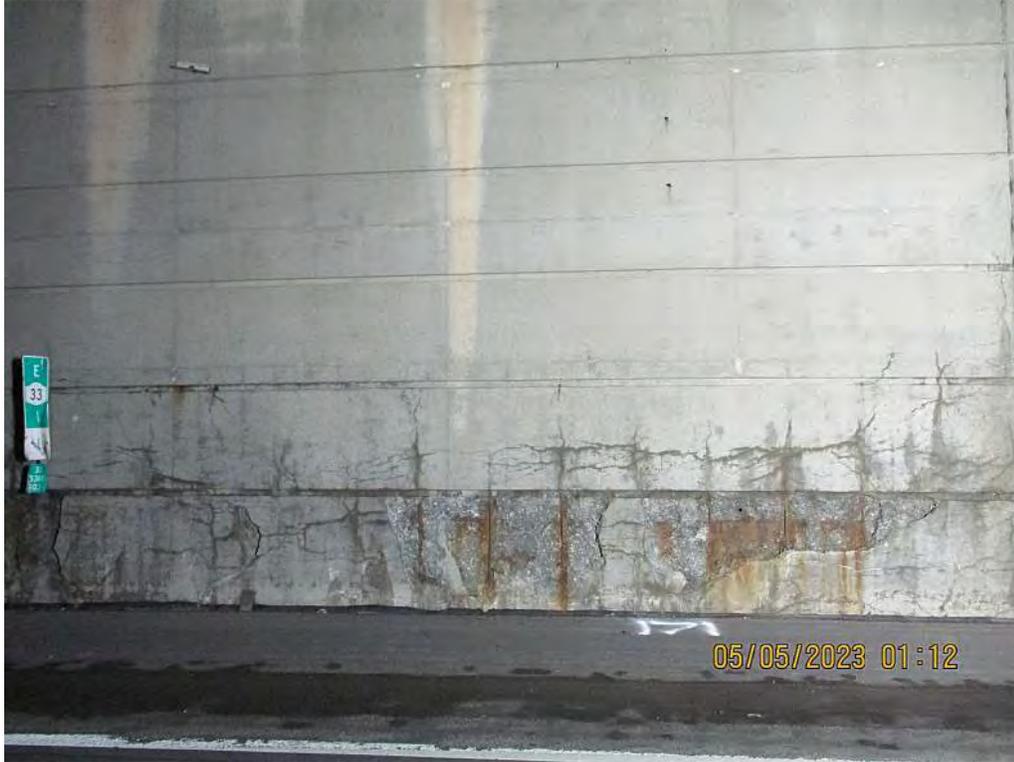
PHOTO 13  
PANEL 171  
Description:  
The bottom wall section is heavily delaminated, spalled and map cracked. The map cracking is at 2-foot intervals mirroring the underlying rebar placement. Section 2 is delaminated and map cracked over 60% of its area. Section 3 is delaminated approximately 3 ft at both ends of the wall adjacent to the joint with other panels. Section 4 is delaminated for 3 ft from at the end wall joint.

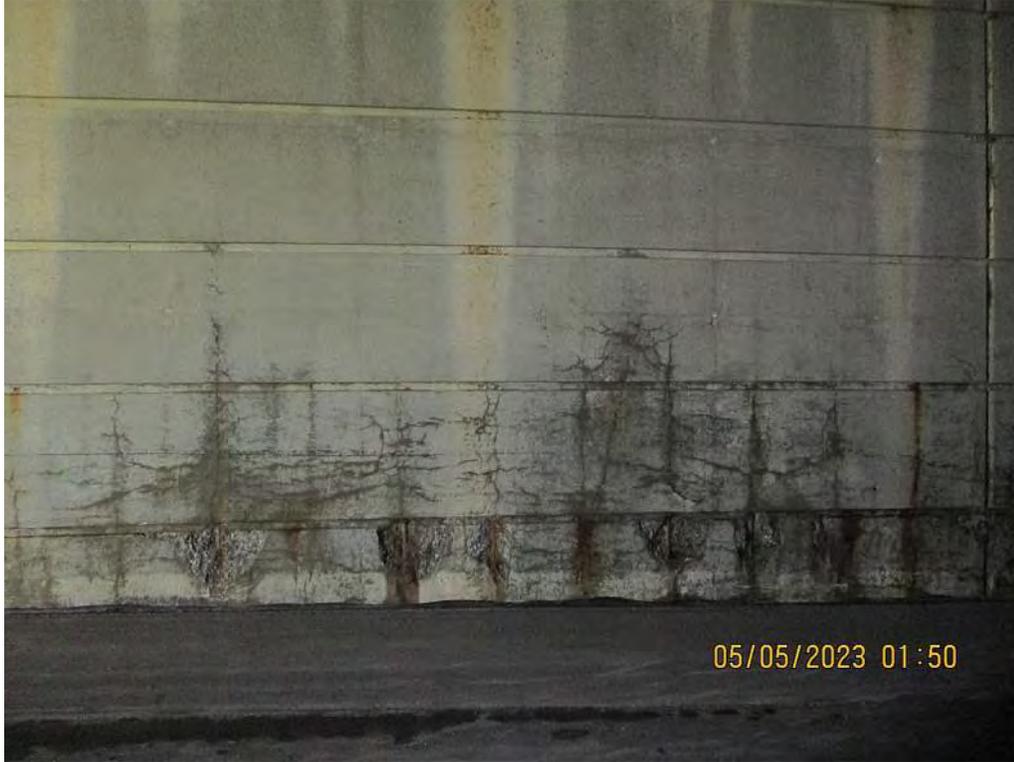
PHOTO 15  
PANEL 176

The bottom wall section is heavily delaminated, spalled and map cracked over 80% of its area. The map cracking is at 2-foot intervals mirroring the underlying rebar placement.

Section 2 is delaminated and map cracked over 50% of its area. Section 3 is map cracked with several vertical cracks in the concrete surface.

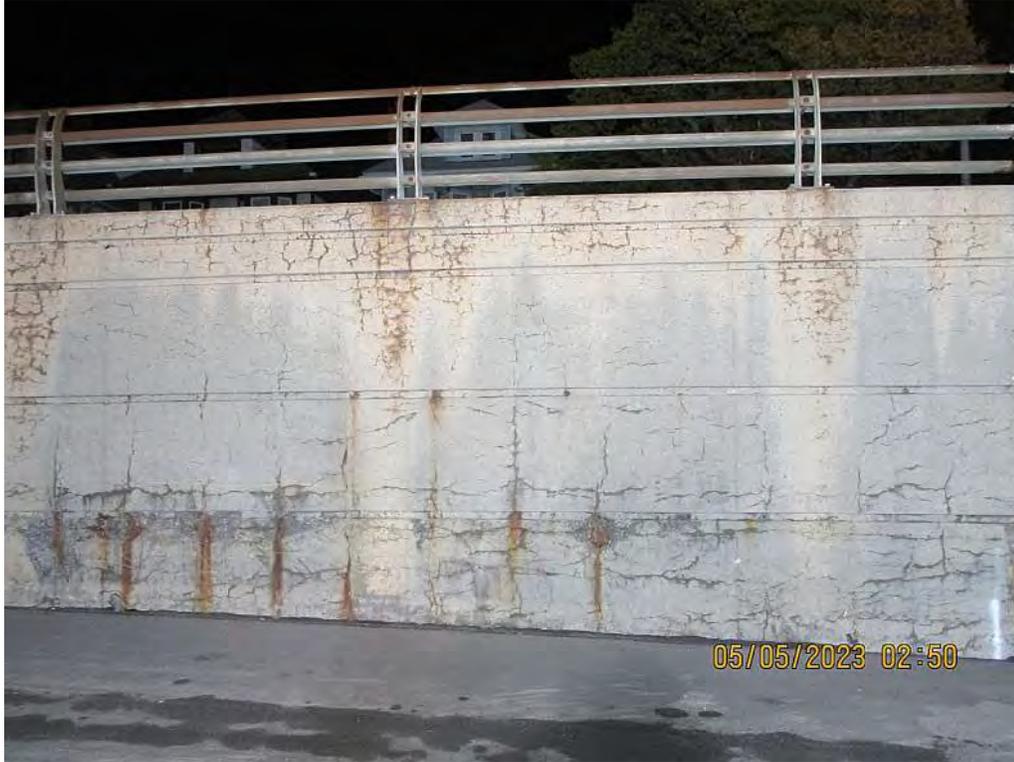
PHOTO 17  
PANEL 178  
Description:  
The bottom wall panel is heavily delaminated and map cracked throughout. The map cracking is at 2-foot intervals mirroring the underlying rebar placement. Section 2 and 3 are delaminated and map cracked over 50% of their areas.  
The wall railing system coping is map cracked and delaminated over 30% of its surface. The map cracked areas are stained with rust and some efflorescence.

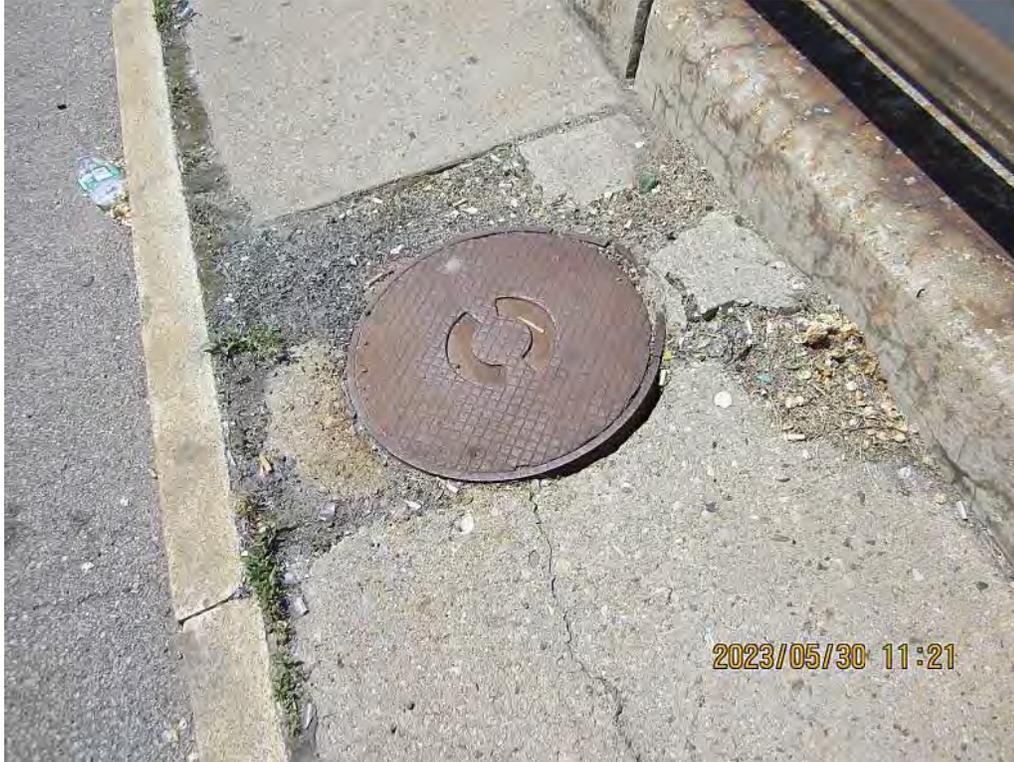
PHOTO 21  
PANEL 130 (Back side of coping)

Description:  
Safety walk is broken, cracked, and heaved around the manhole.  
Map cracking is present on the rail coping, typical for entire wall.

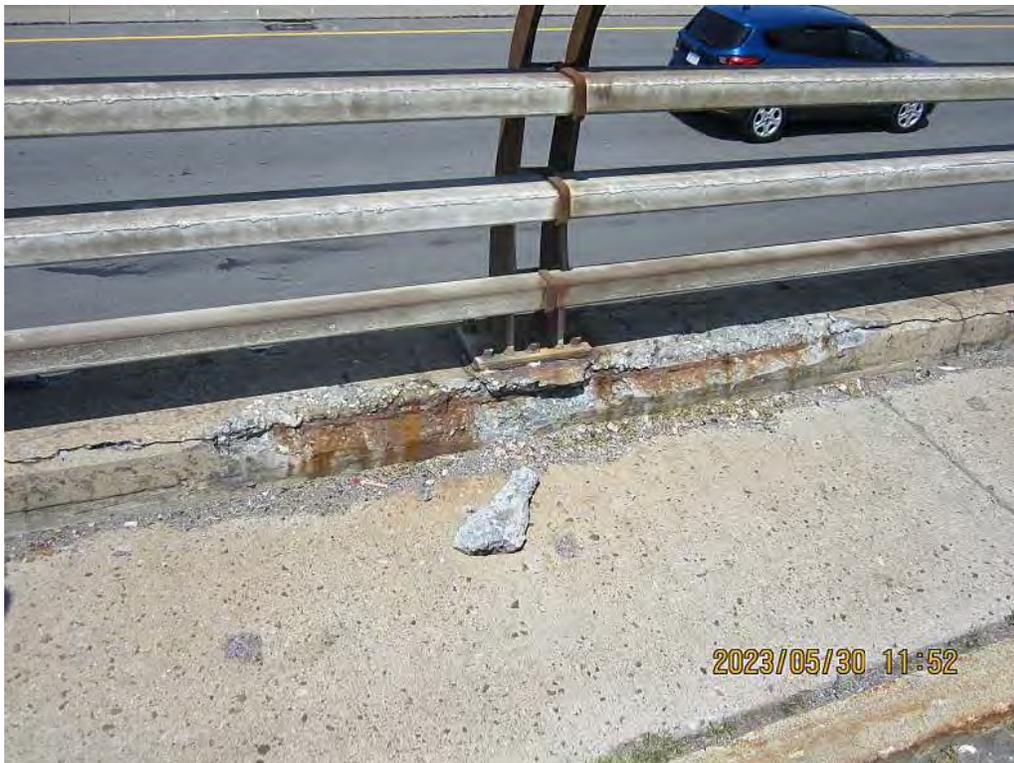
PHOTO 22  
Back of coping (somewhere between Panel 185 and 193)

Description:  
Singular spall area under rail post on back side of coping. The longitudinal rebar is exposed.

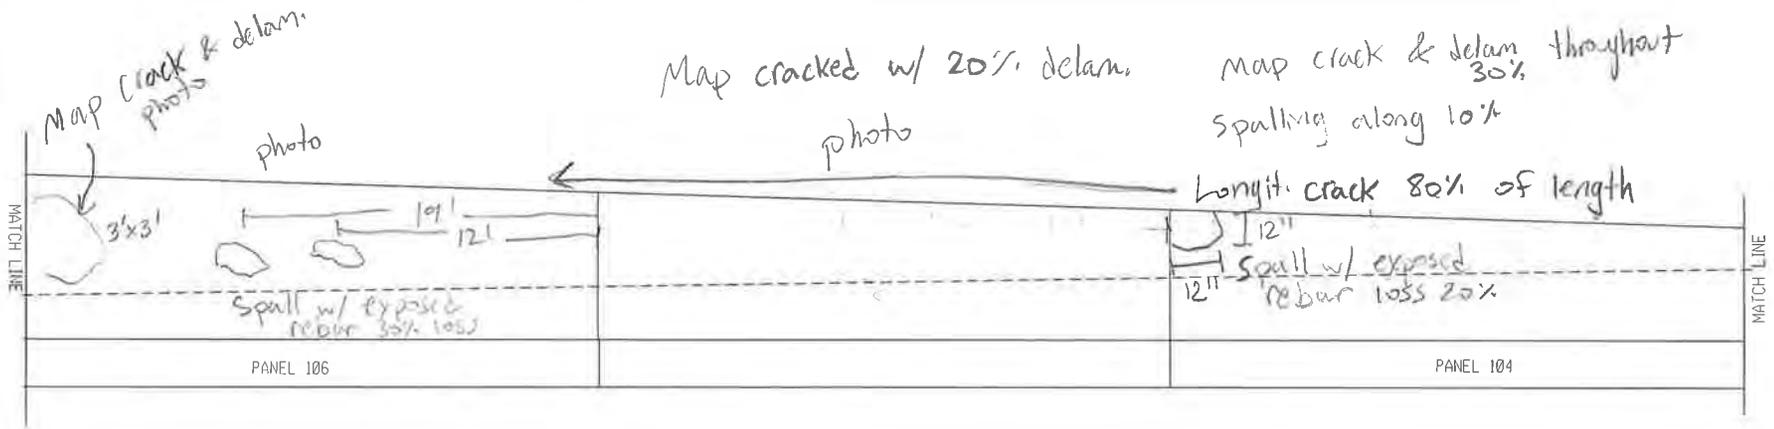
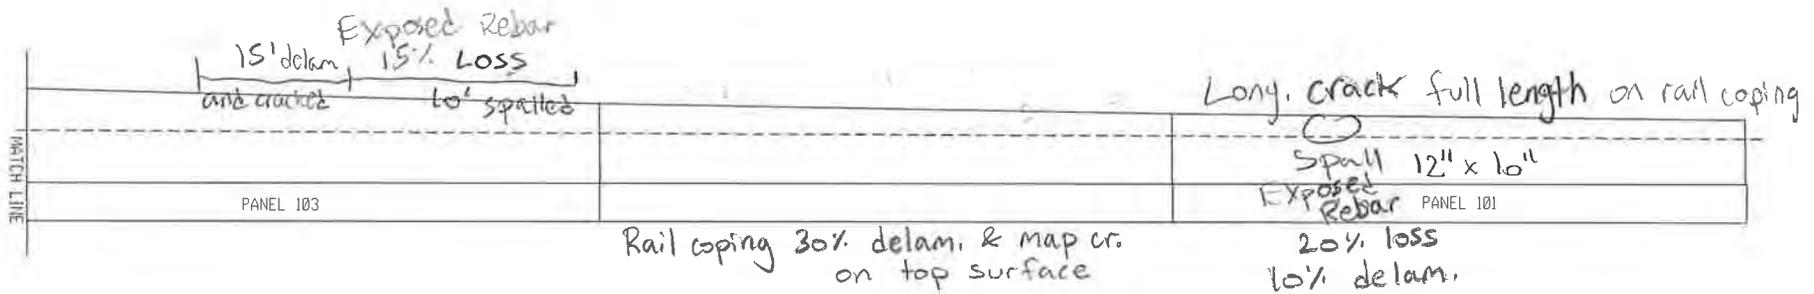
RW 1 PANELS 106-101

General: Map cracking on coping

delaminated

Map cracking under rail posts

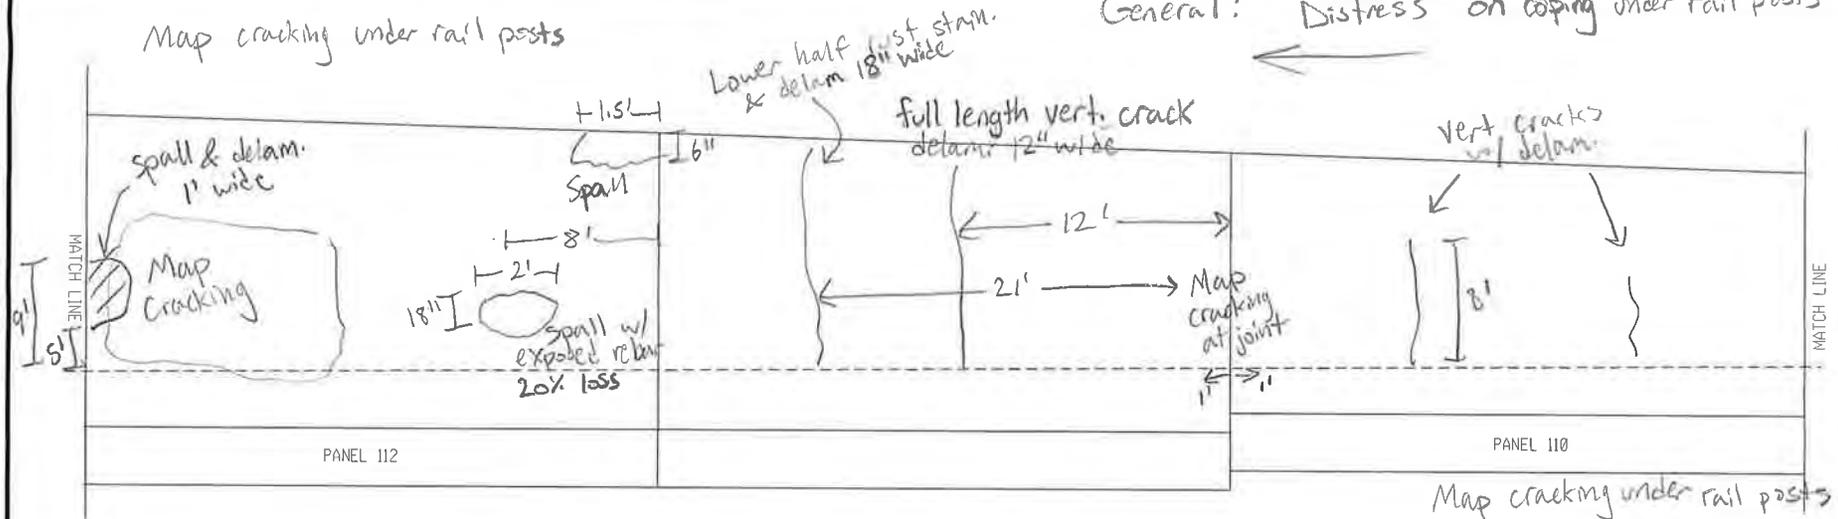
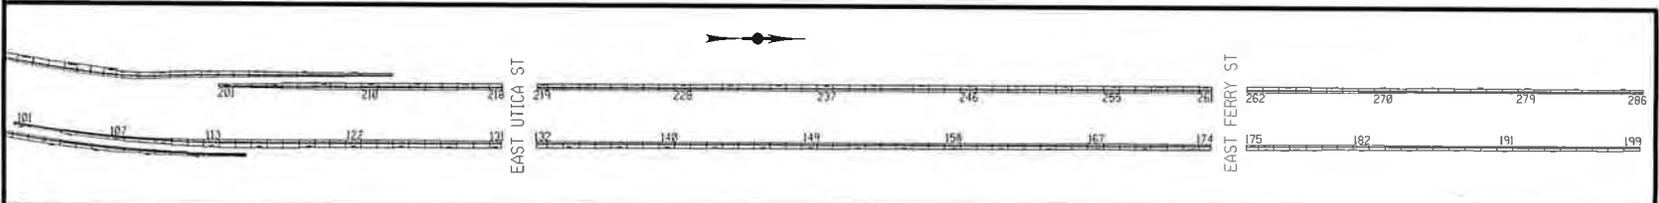
### RW 1 PANELS 112-107

General: Distress on coping under rail posts

10% delam. throughout map cracked throughout more so at rail posts

spall under rail post

General: Map cracking on coping

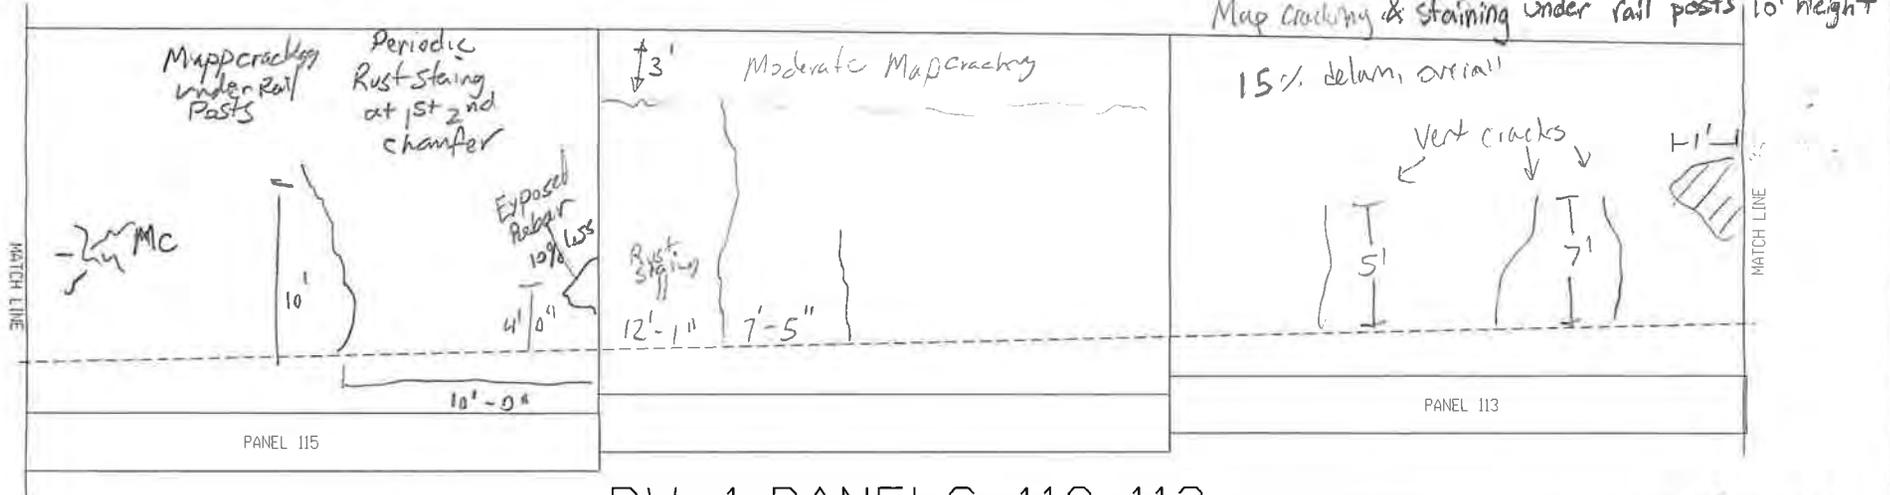
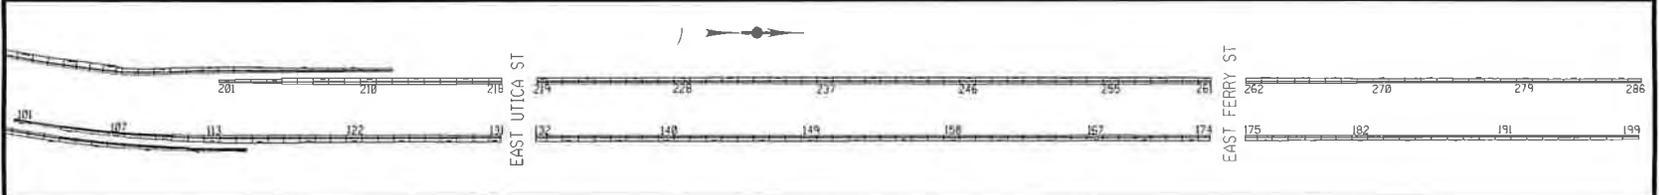
RW 1 PANELS 118-113

Coping - Crack @ mid height - full length (top)

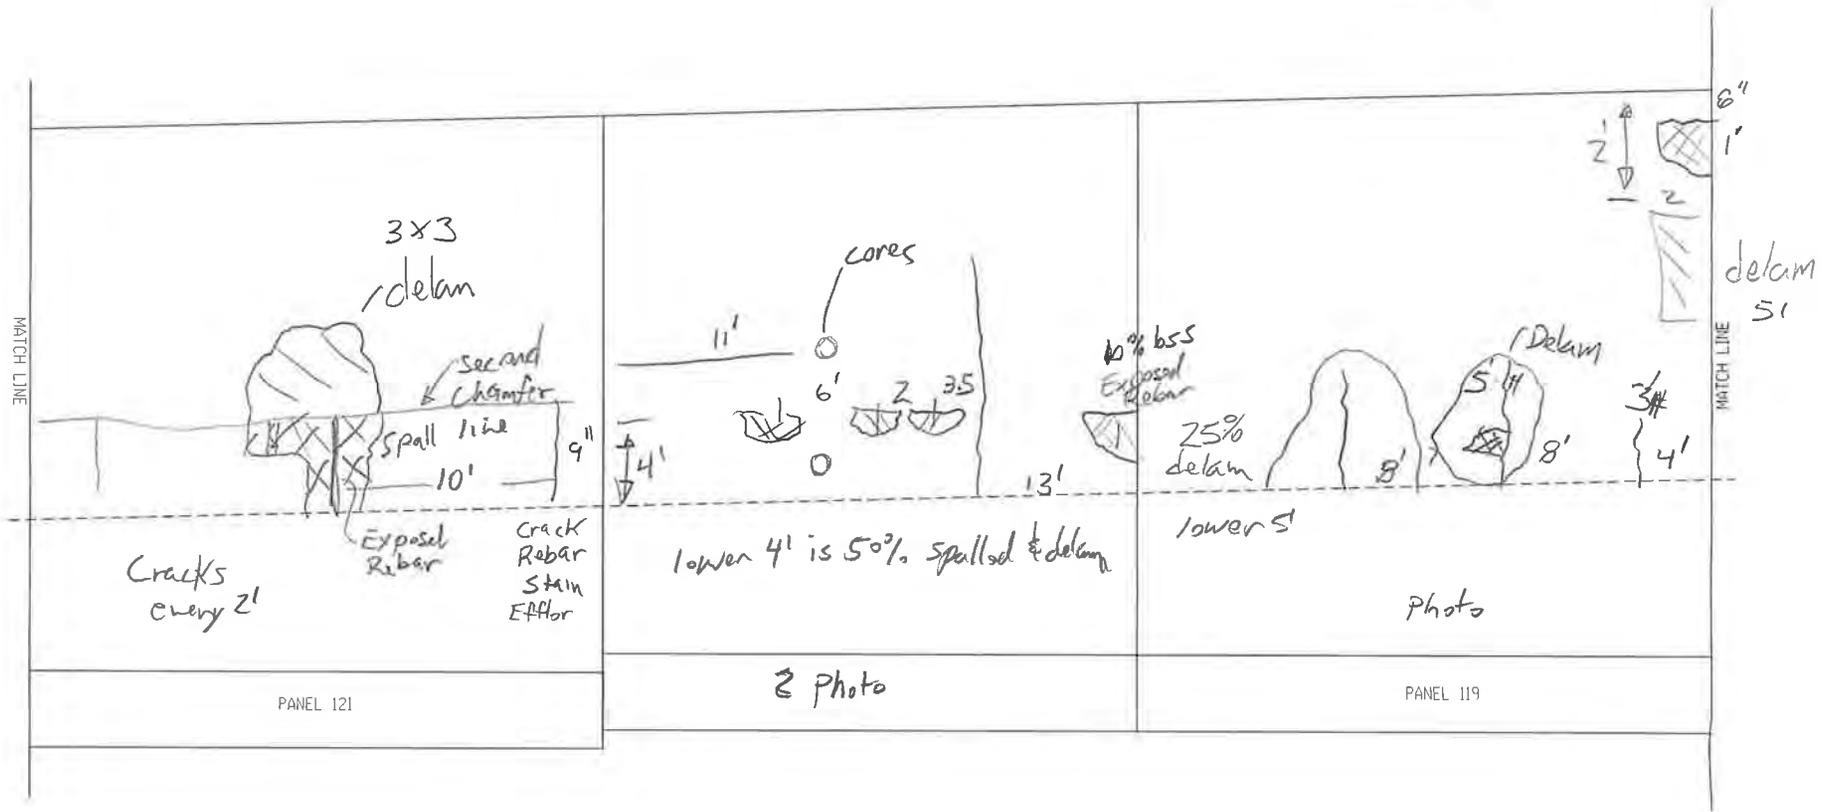
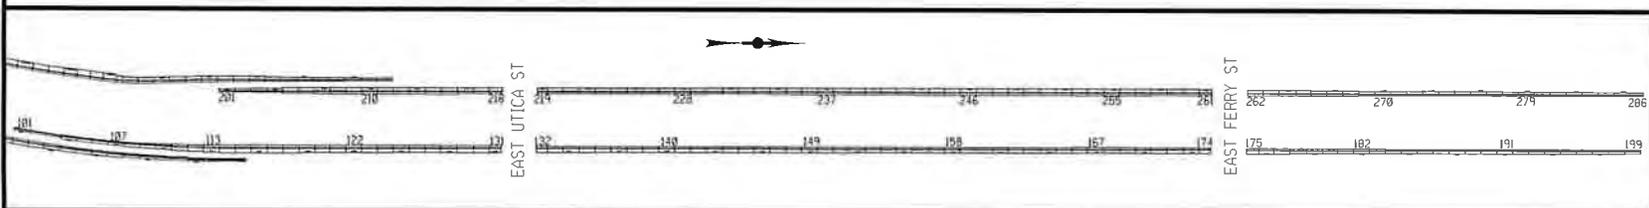
RW 1 PANELS 121-119

119 has light  
can be viewed  
from face

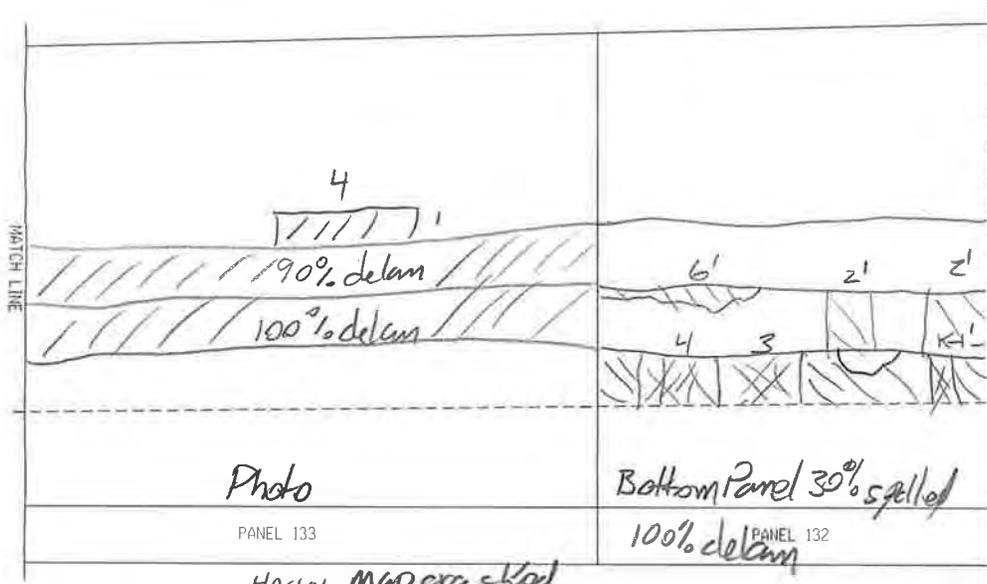
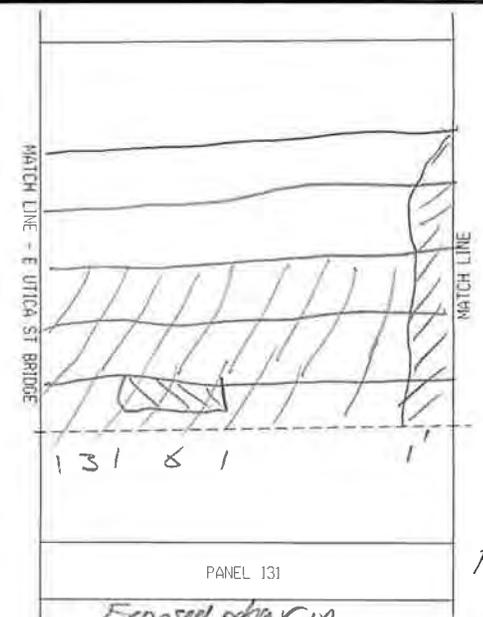
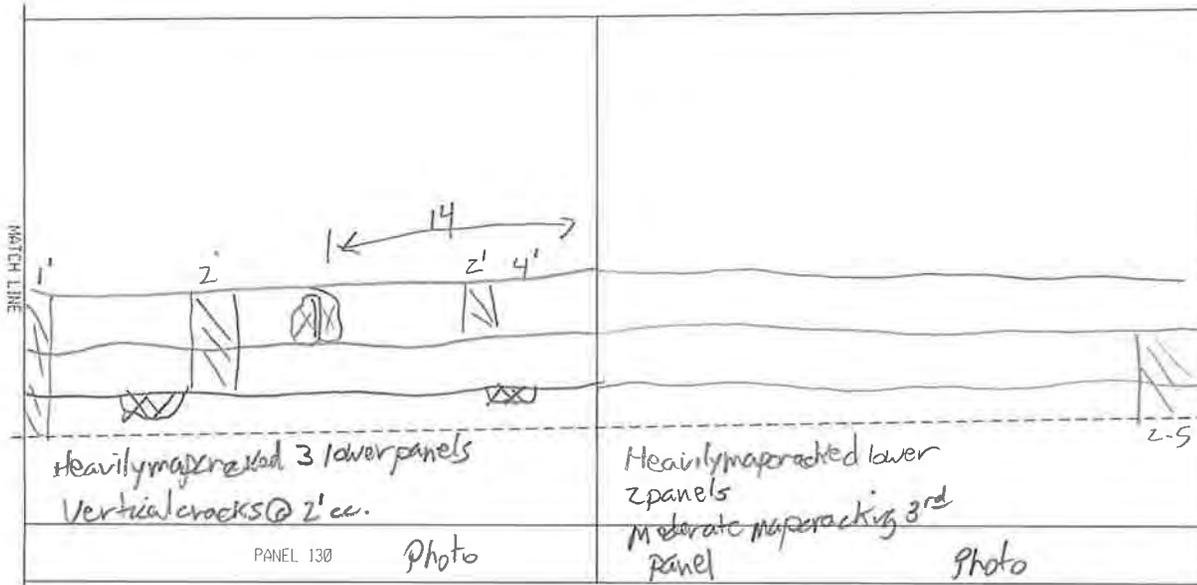
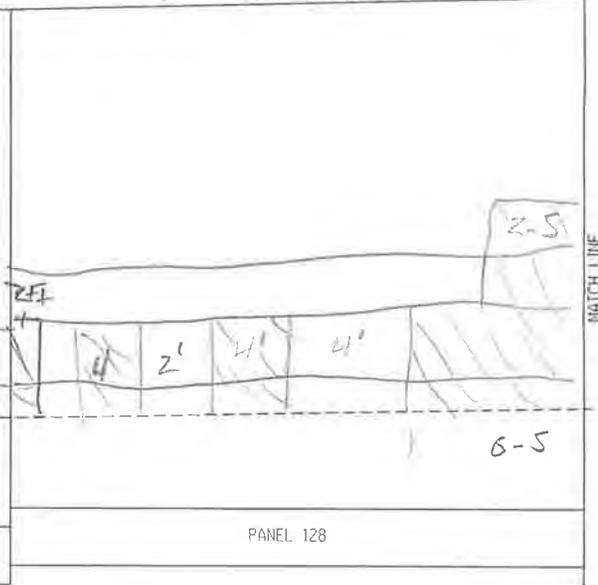
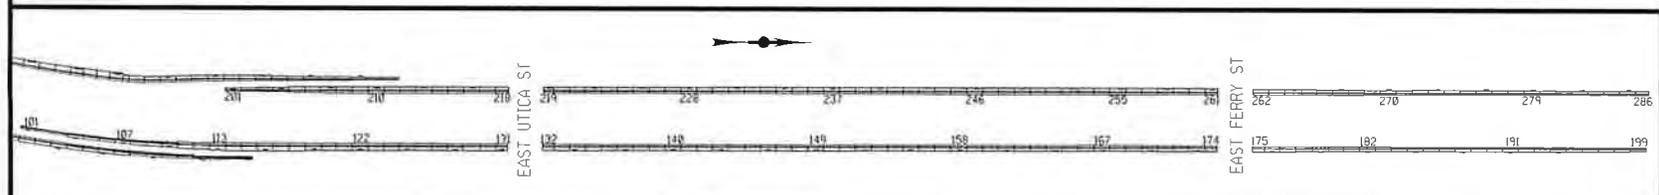
RW 1 PANELS 133-128

13% delam  
6% delam

Exposed rebar in  
spill 60' section

Heavily mapcracked 3 lower panels  
Vertical cracks @ 2' cc.

Heavily mapcracked lower  
2 panels  
Moderate mapcracking 3rd  
panel

2.5% delam

6.5% delam

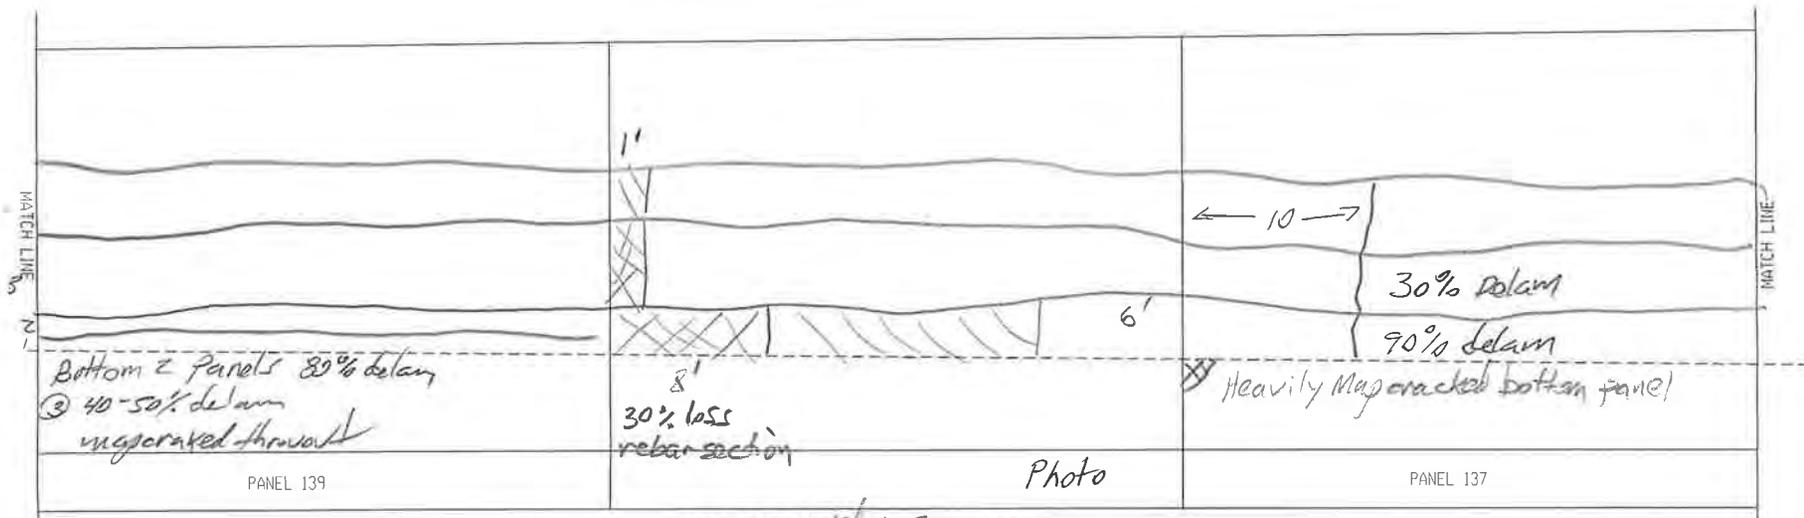
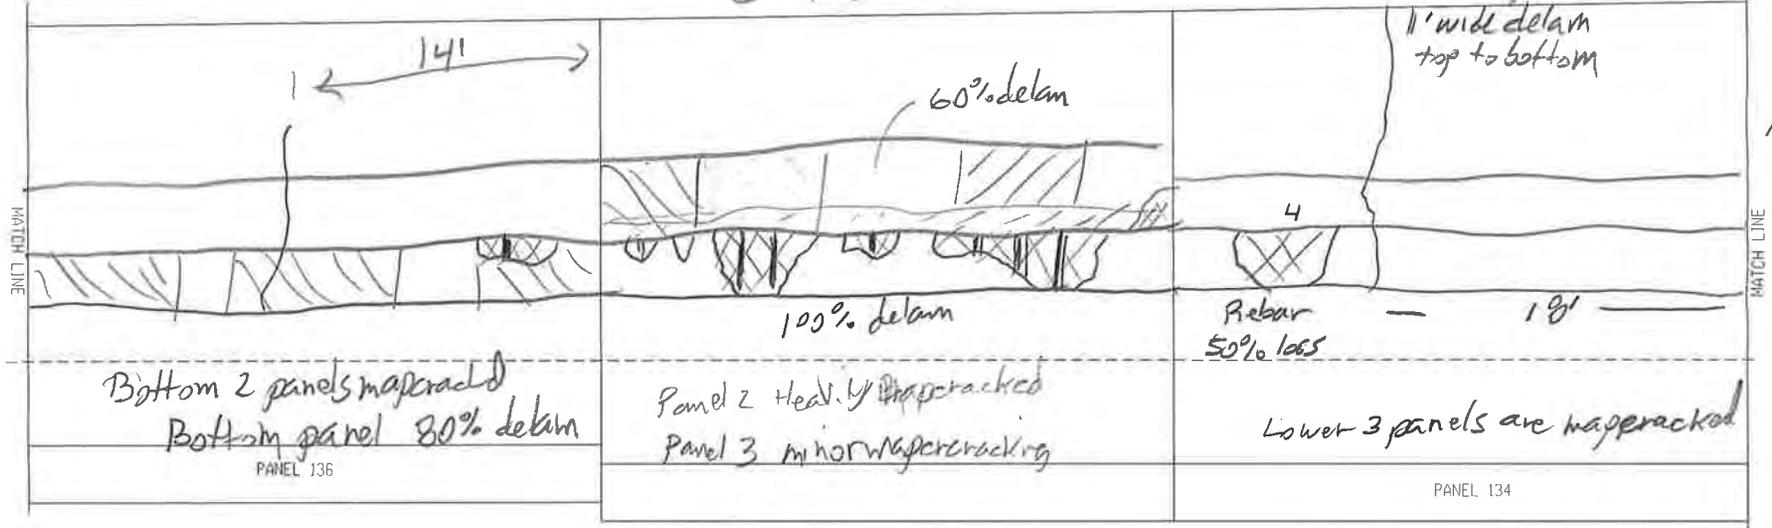
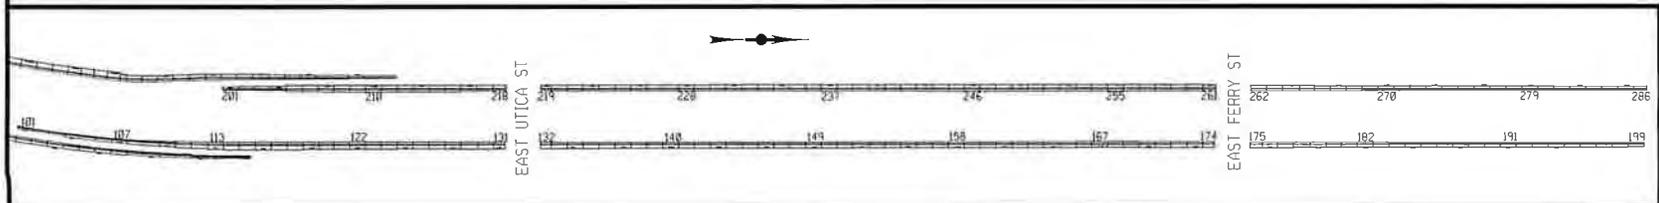
RW 1 PANELS 139-134

Photo  
 Mapcracked 1-2  
 ① delam & spalled 70%  
 ② 40% delam

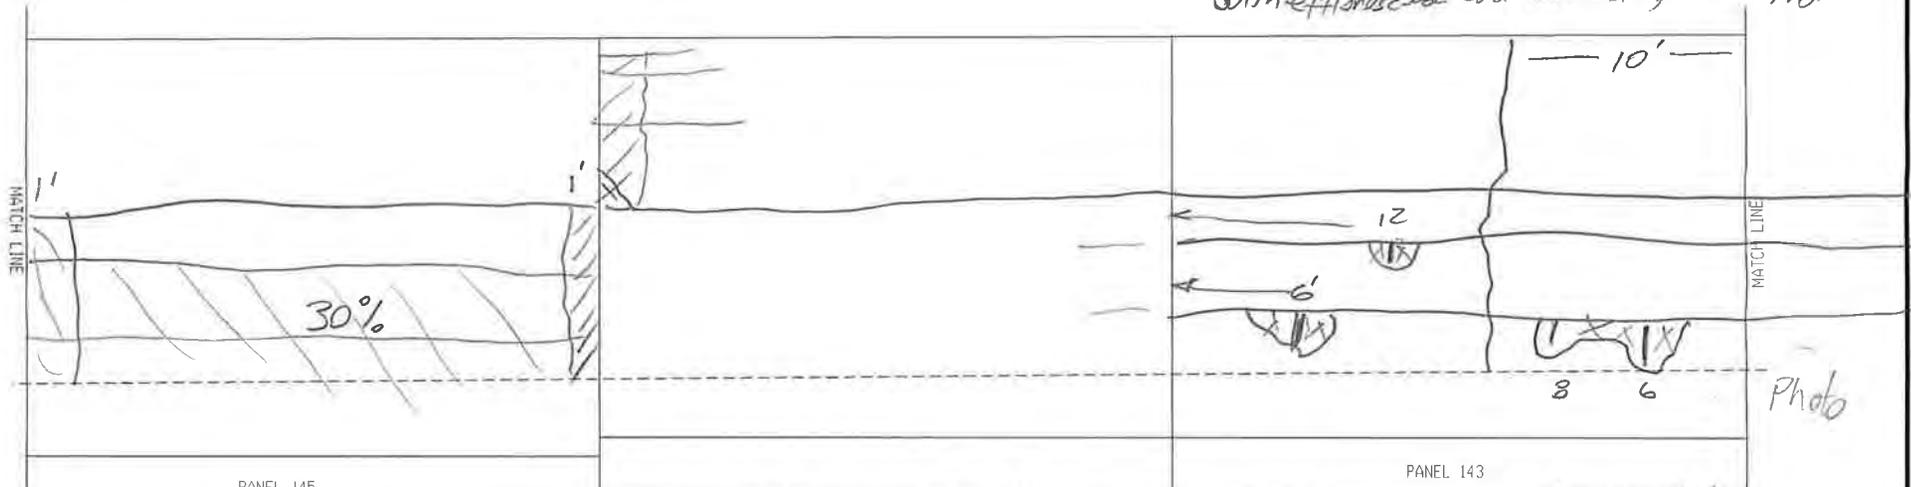
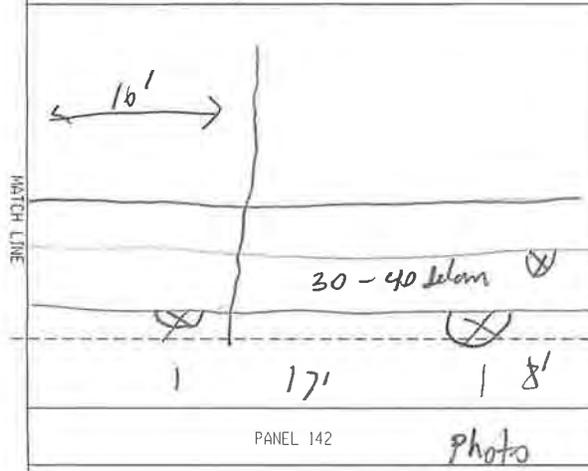
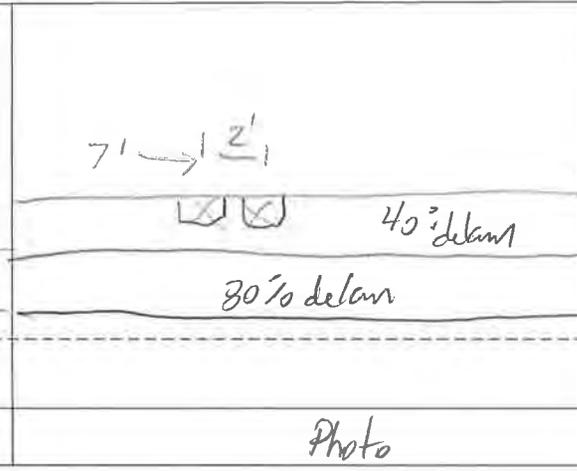
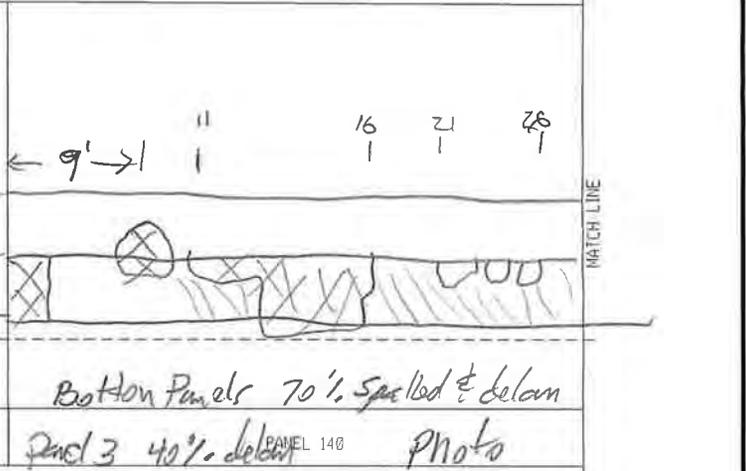
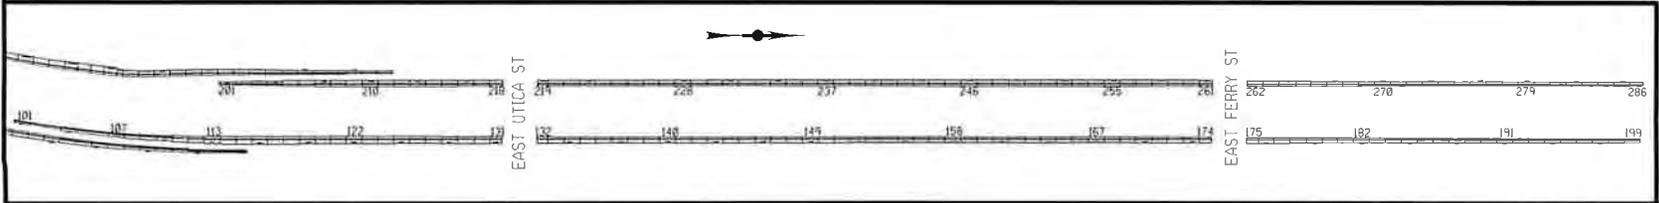
RW 1 PANELS 145-140

Rail coping cracked at mid height with efflorescence and rust staining Photo

Bottom 2 panels heavily mapcracked cracking every 2 ft at rebar lines Rust staining throughout

Heavily Mapcracked with cracking at rebar lines 60-70% delam Photo

Bottom 2 panels heavily mapcracked 70% delam Panel 3 - 25% delam

Panel 1 & 2 Heavy mapcracking Photo

Bottom Panels 70% spalled & delam Panel 3 40% delam with mapcracking Photo

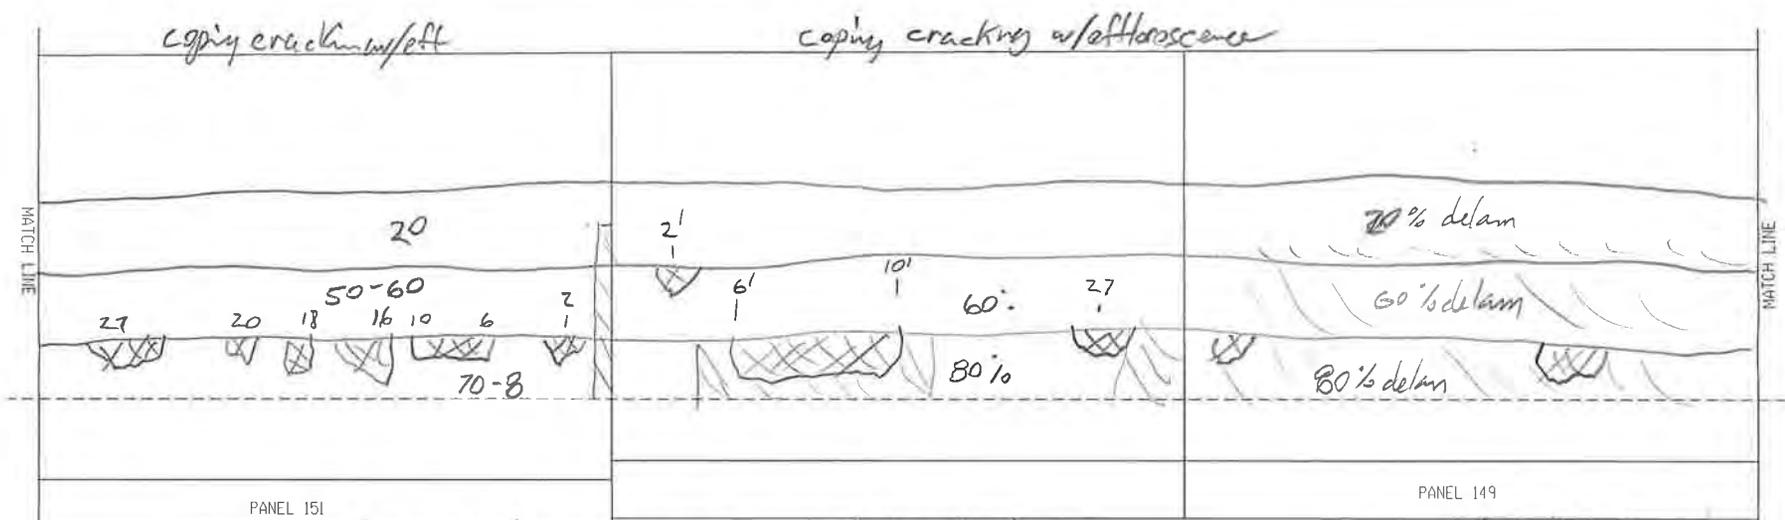
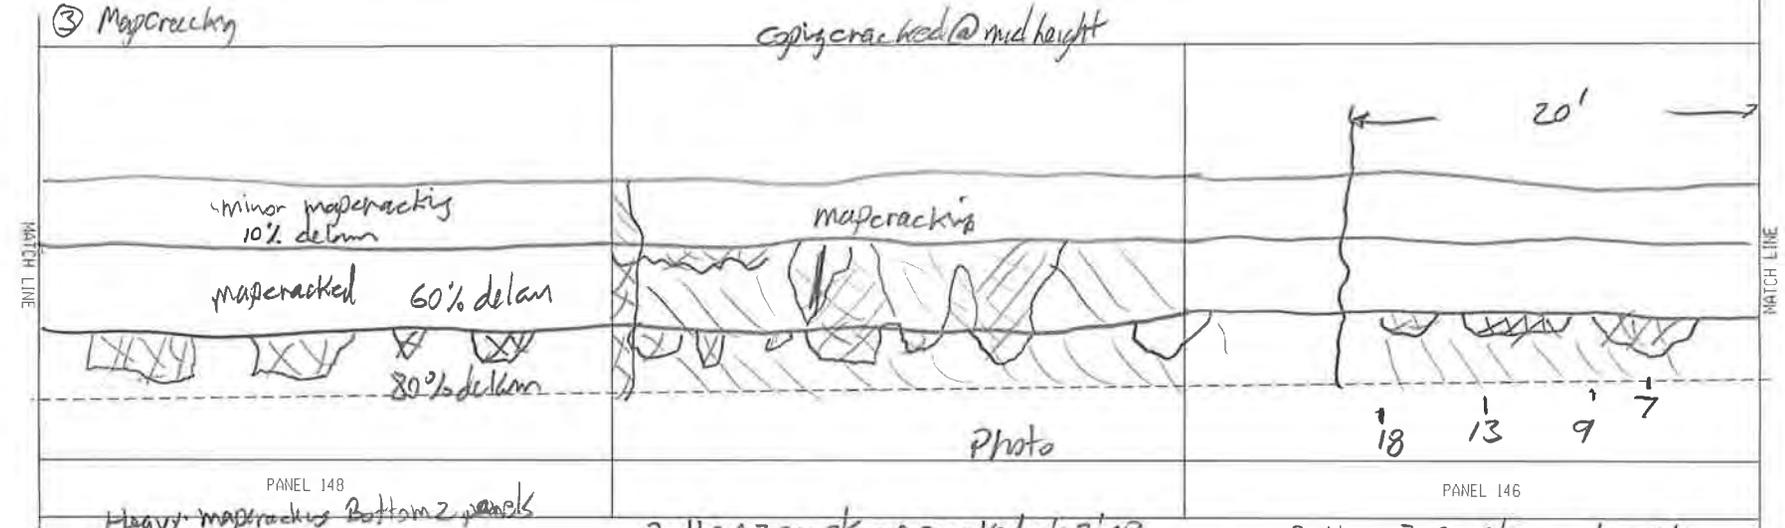
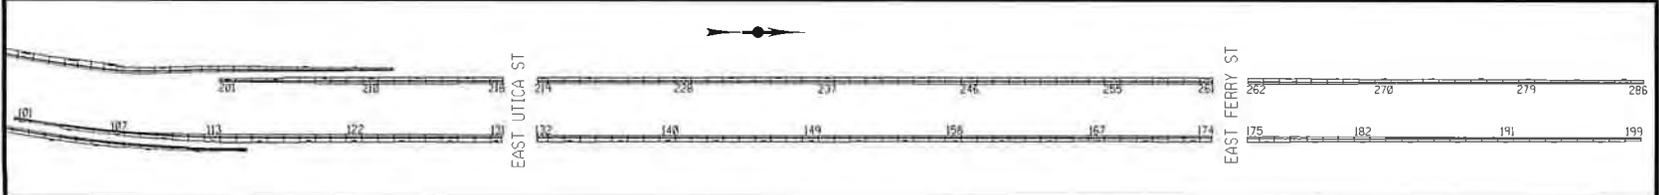
RW 1 PANELS 151-146

①② Heavily mapcracked and spalled with extensive delam

③ Mapcracking

② Mapcracked through out Photo

Heavily mapcracked bottom 2 panels 3 minor mapcracking

Heavy mapcracking Bottom 2 panels

Bottom 2 panels are cracked at 2' sp with spally delam, rust staining 75% delam

Panel 3 light mapcracking 20% delam

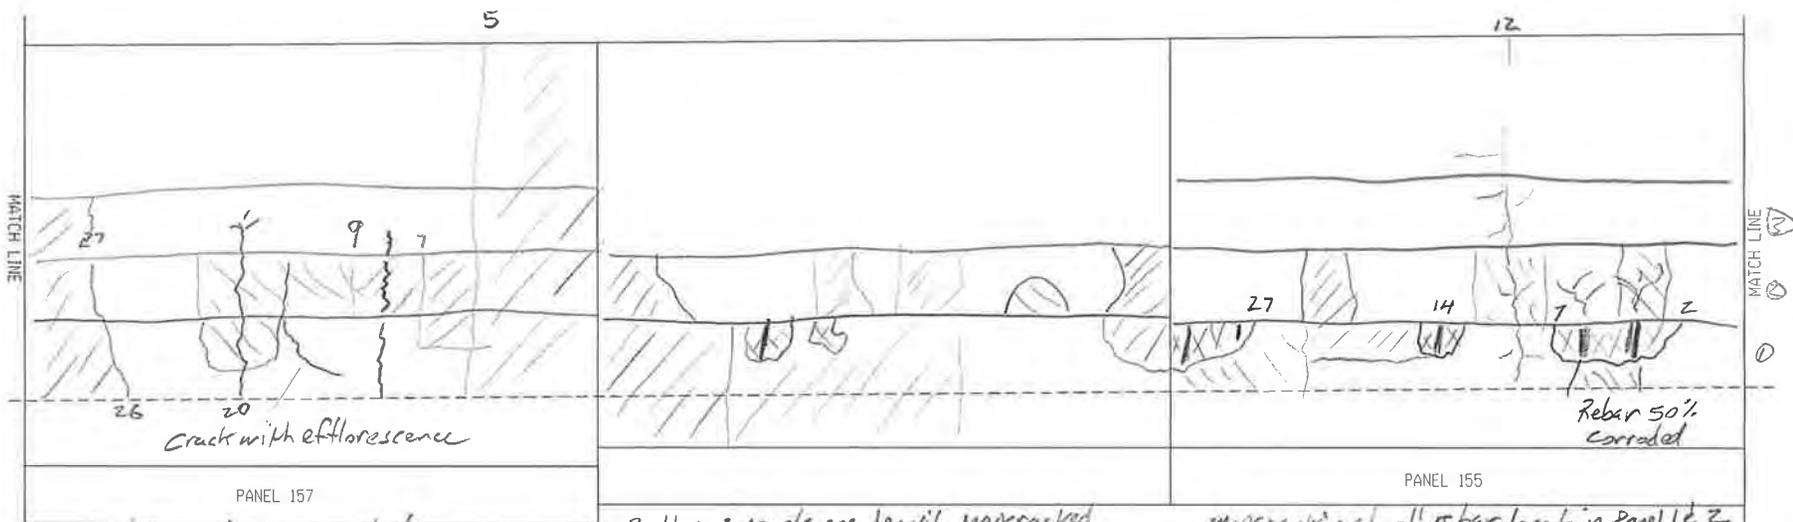
PANEL 157  
 Panel 1 & 2 heavily mapcracked  
 ① 60% delam  
 ② 70% delam  
 ③ 20% delam

Mapcracking at all rebar location Panel 1 & 2  
 ① is 50% delam  
 ② 40%  
 ③ 20%

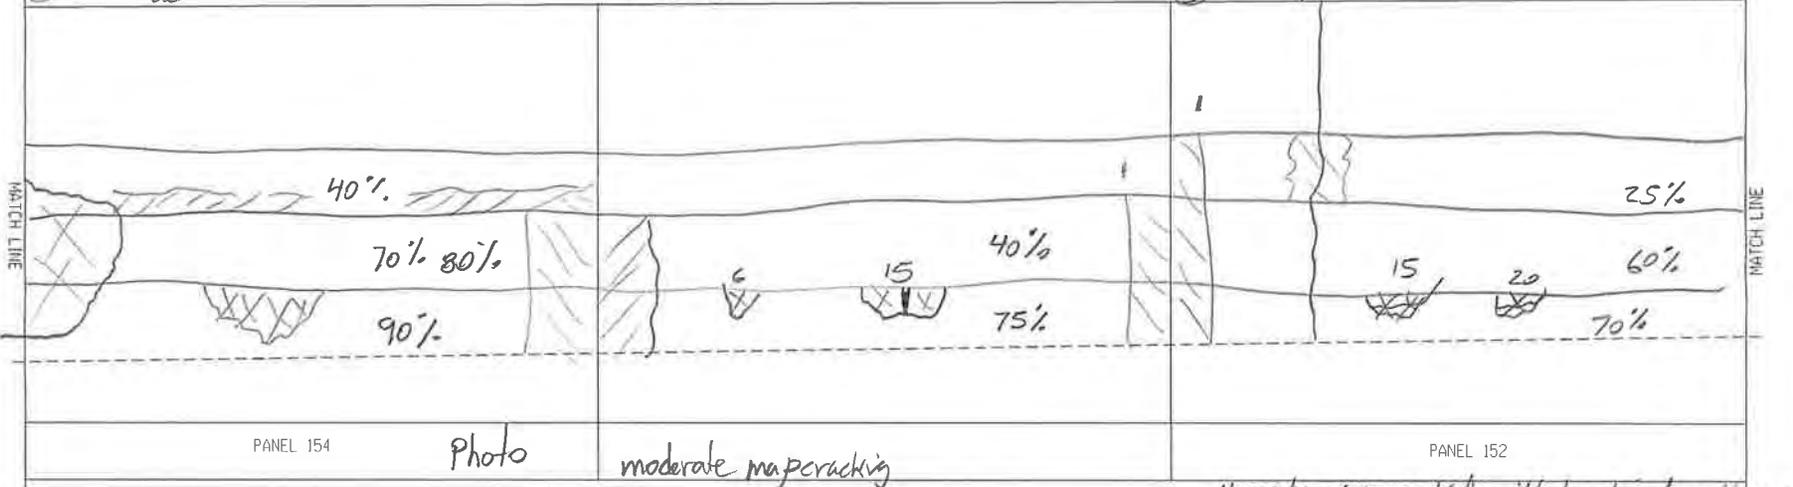
PANEL 154  
 Panel 1 & 2 heavily mapcracked with spalling  
 & del delam

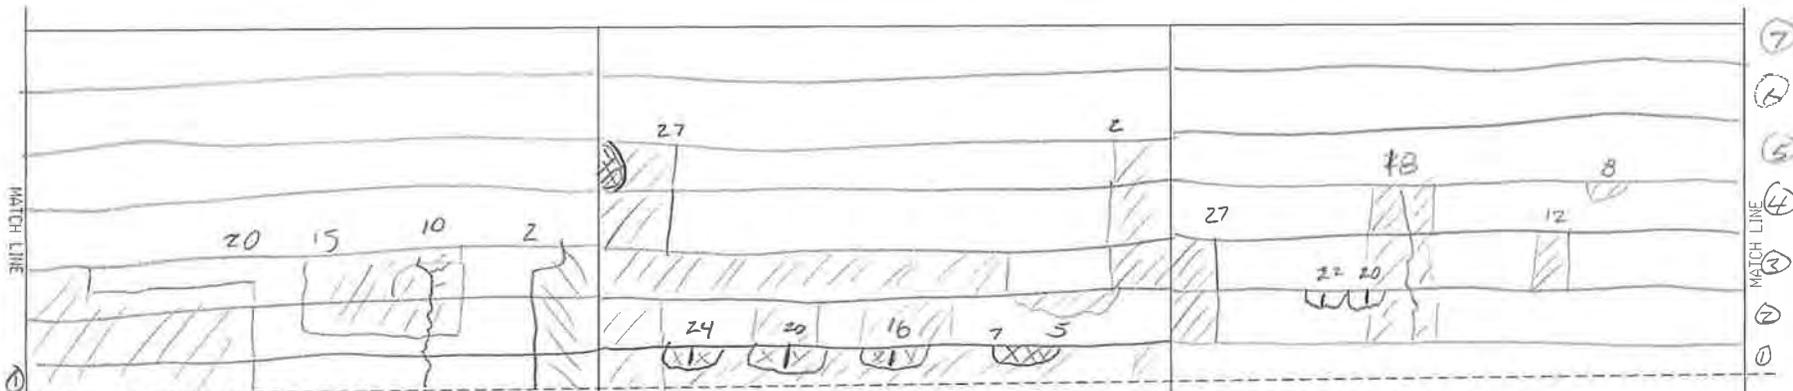
PANEL 163

delam ① 40% ② 50% ③ 50%

Bottom 3 panels are Heavily mapcracked with spalling and exposed rebar and rust staining  
Cracking follow rebar pattern rebar section loss 30%

Bottom 3 panels are heavily mapcracked with rust staining
