# **Appendix A5**

## Retaining Wall Inspection Reports

**NY33 RETAINING WALL CONDITION EVALUATION 2023**  
**KENSINGTON EXPRESSWAY PROJECT**  
**PIN 5512.52**  
**CITY OF BUFFALO, ERIE COUNTY**  
**RETAINING WALL 1**

# PIN 5512.52 – NY33 RETAINING WALL CONDITION EVALUATION 2023 FIELD INSPECTION SUMMARY

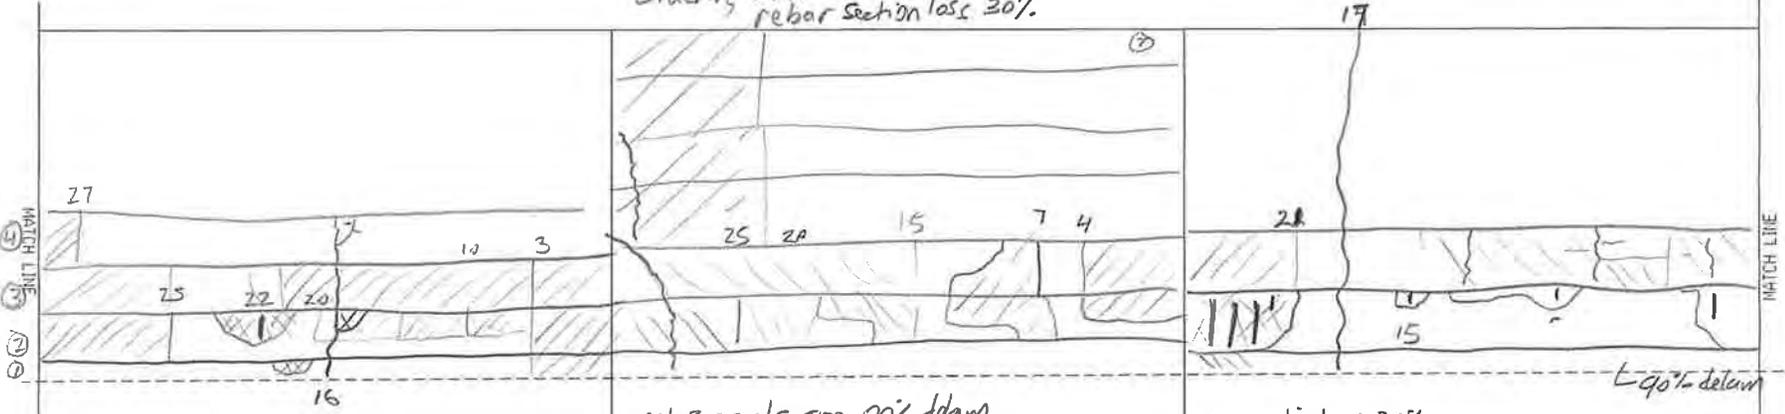
PANEL 160

3 lower panels are heavily mapcracked with rust staining  
panels ①②③ 80% delam Photo

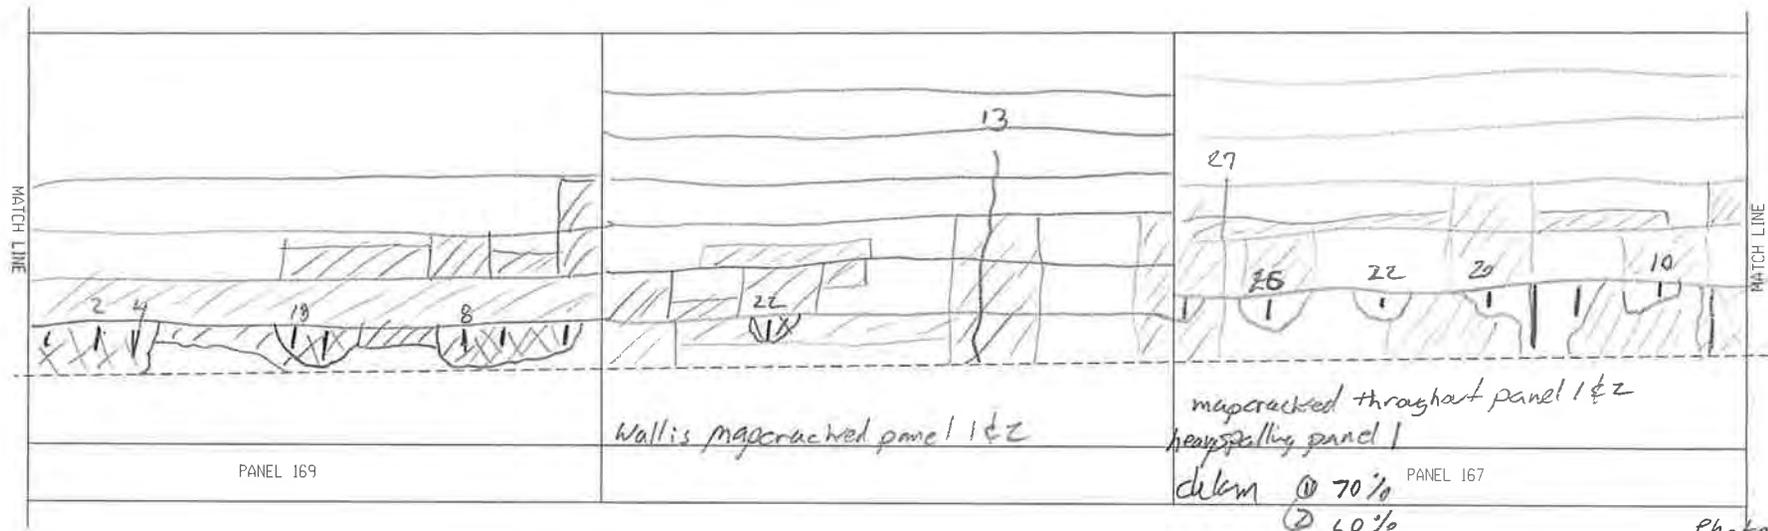
PANEL 169

Wall is moderately rebarcracked panel 1 & 2

rebarcracked throughout panel 1 & 2  
heavily spalling panel 1

- delam
- ① 70%
  - ② 60%
  - ③ 40%

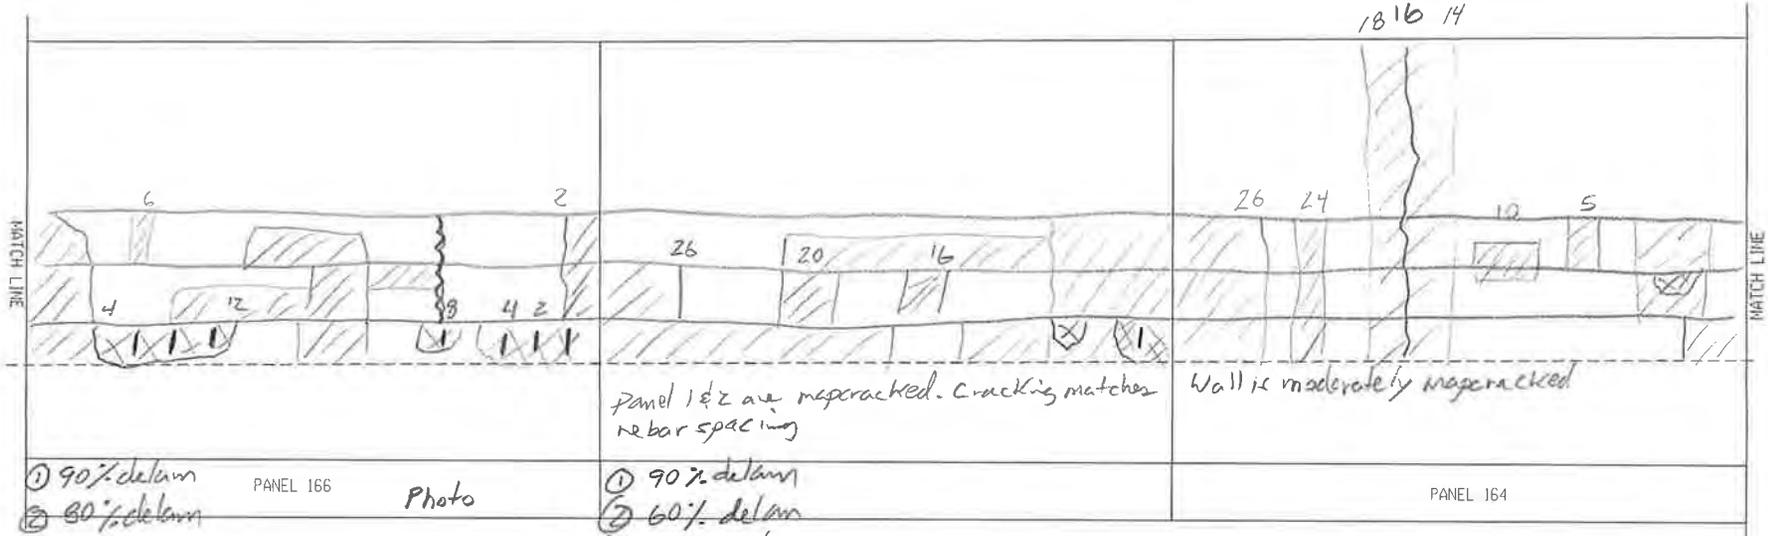
PANEL 166

Panel 1 & 2 are rebarcracked. Cracking matches rebar spacing

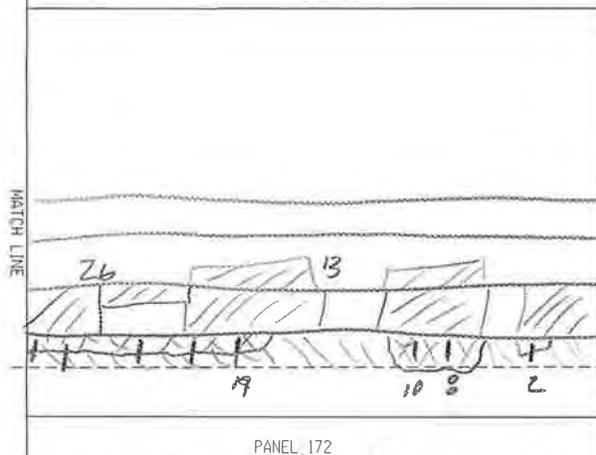
Heavy spalling delam and mapcracking  
 ① 90% delam  
 ② 70% delam  
 ③ 20% delam

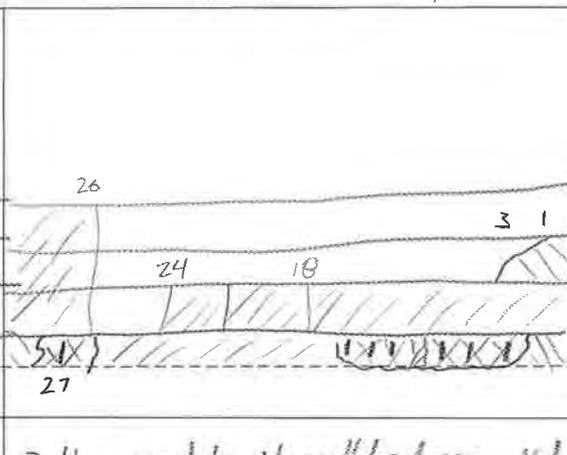
Bottom panel heavily spalled and mapcracked mapcracking mirrors rebar placement Photo

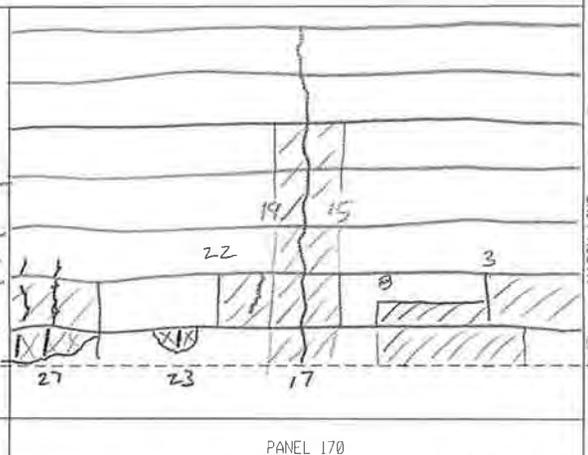
Lower 2 panels are mapcracked & spalled exposing some rebar. Core is delam  
 ① 60% delam  
 ② 60% delam  
 ③ 20% delam

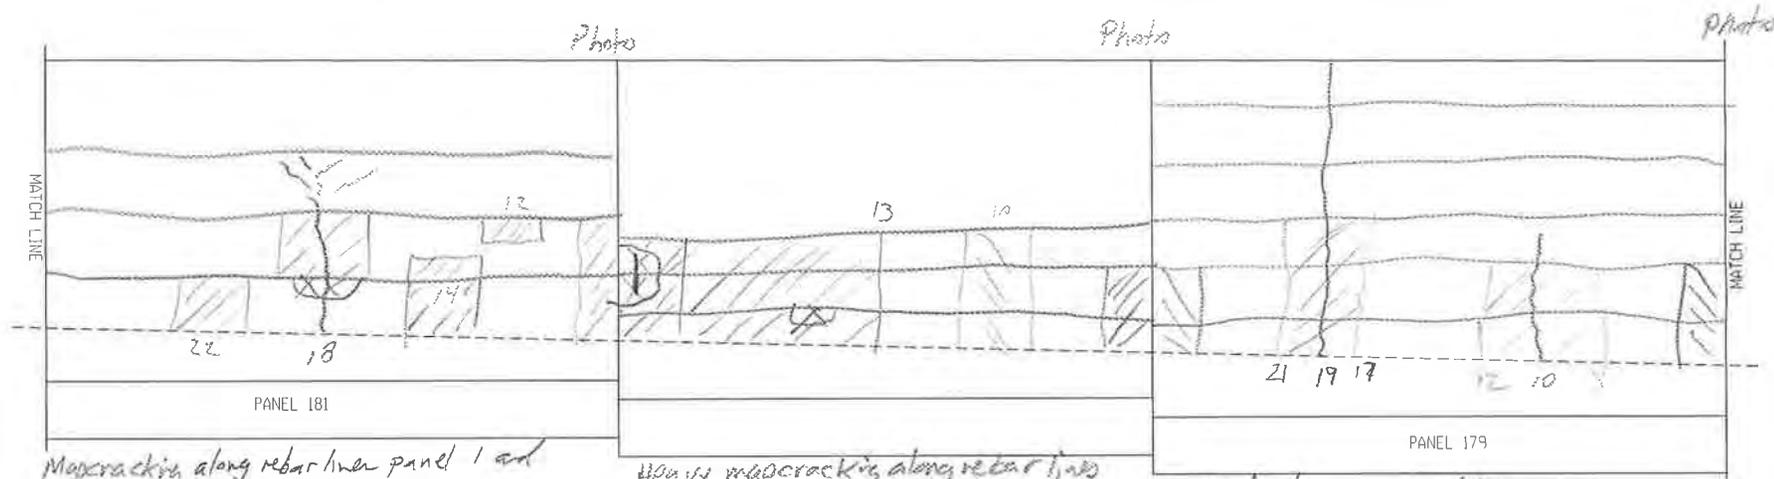
Mapcracking along rebar lines panel 1 and some panel 2  
 ① 30%  
 ② 25%

Heavy mapcracking along rebar lines on lower 2 panels - moderate on 3rd panel  
 ① 50% delam ③ 35%  
 ② 50% delam

Moderate mapcracking  
 ① 50% delam ③ 10% delam  
 ② 50% delam

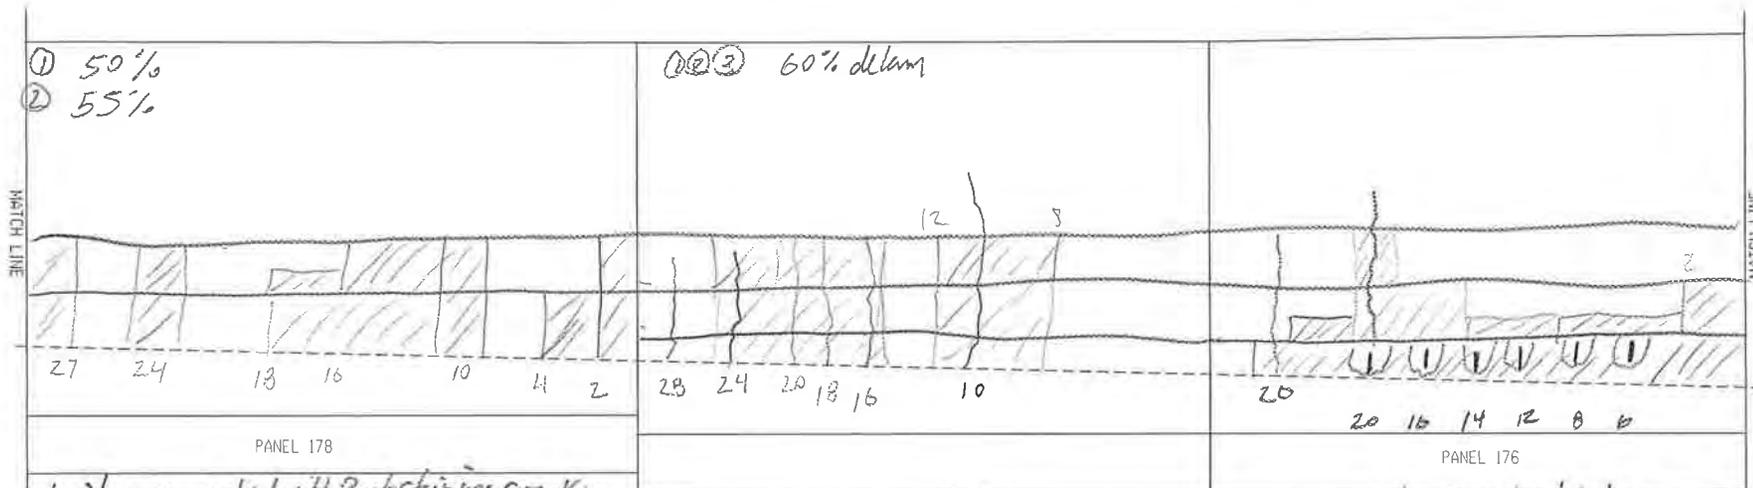
① 50%  
 ② 55%

①②③ 60% delam

Heavily mapcracked with rust staining, crack in mirrors vertical rebar spacing - cracks every 2 ft.

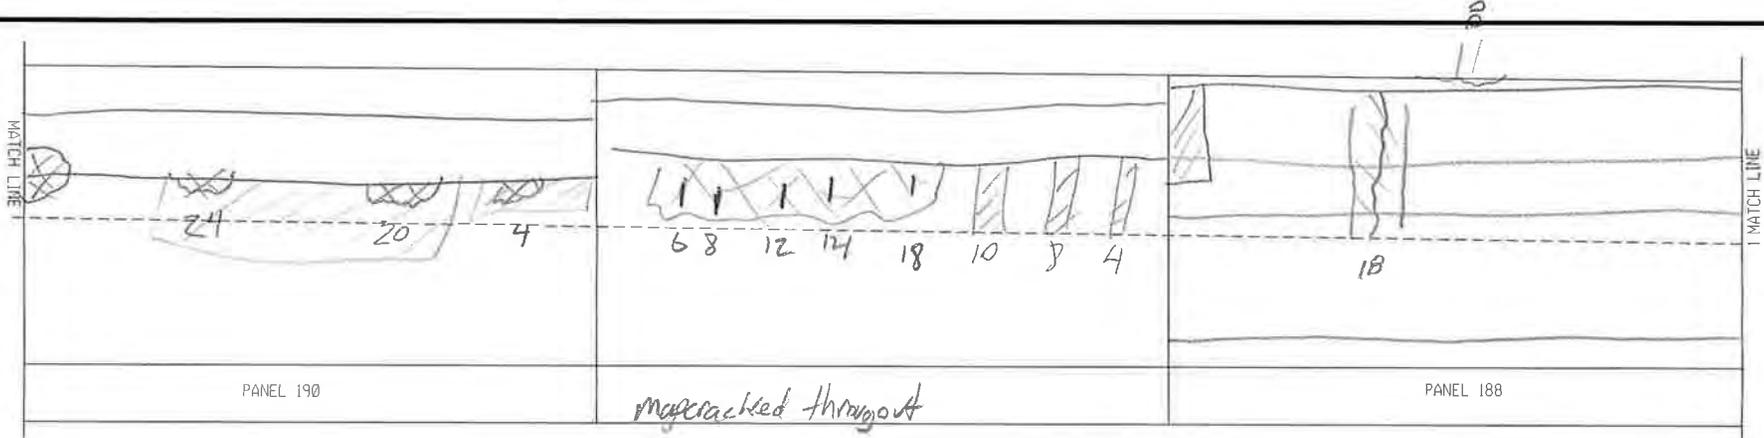
PANEL 190

*mapcracked throughout*

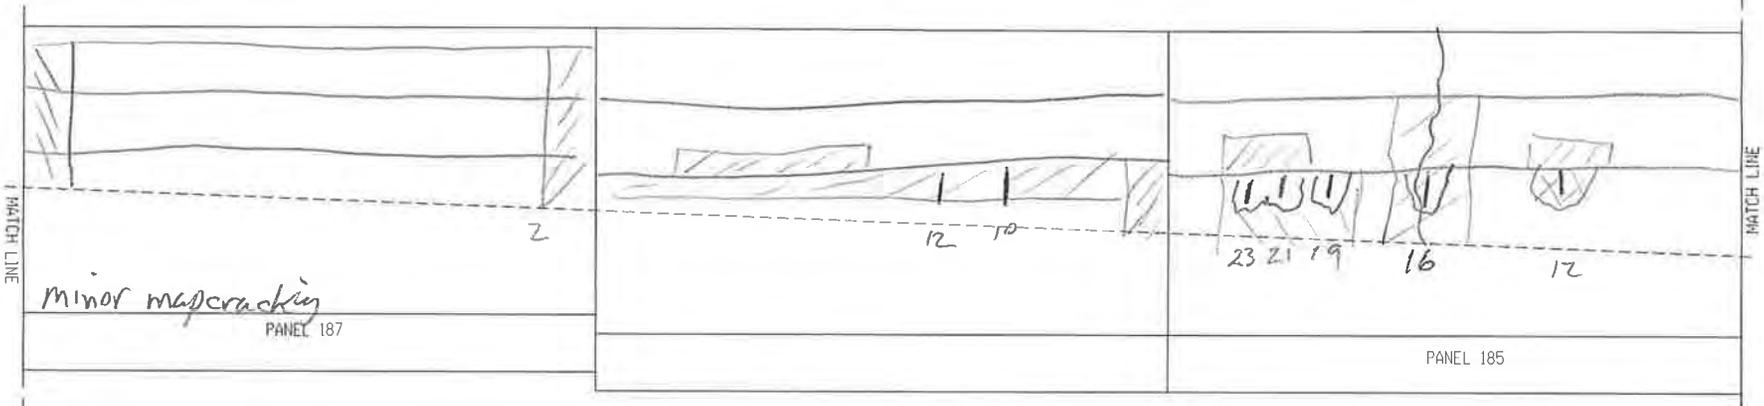
*minor mapcracking*

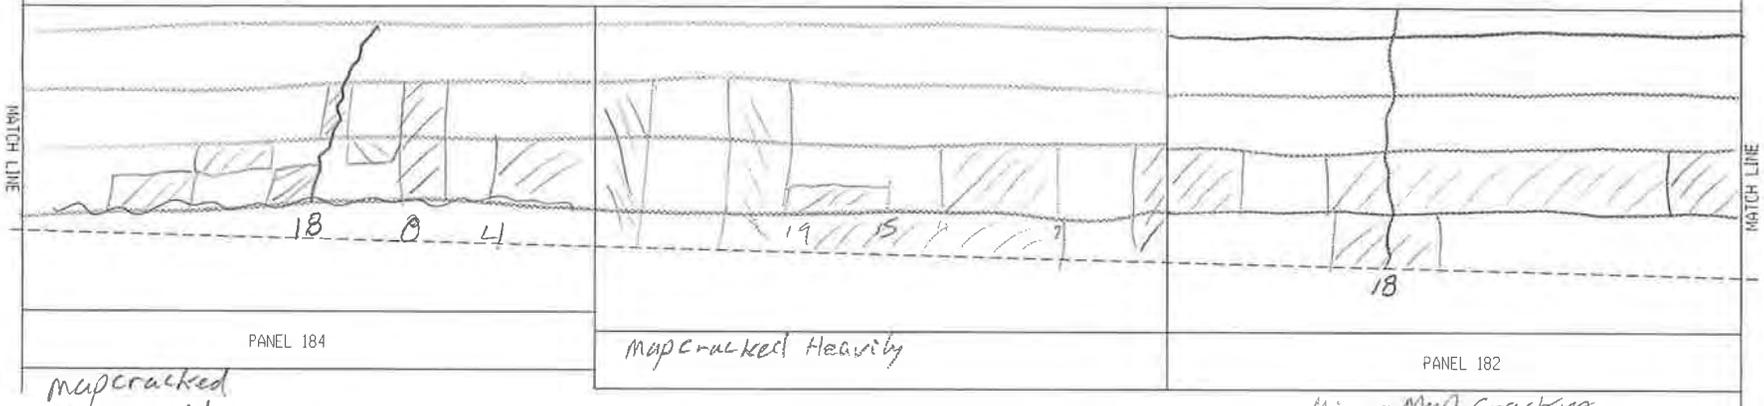
*mapcracked*  
 Ⓚ 60% - delam  
 Ⓚ 20% - delam

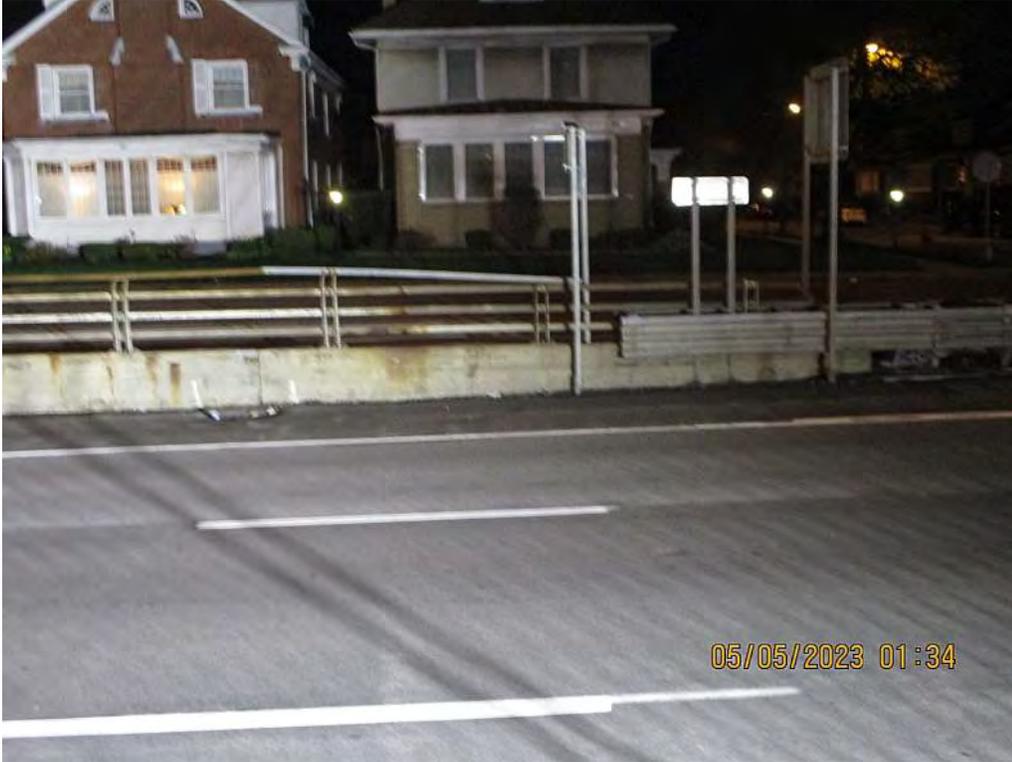
PHOTO 1  
PANEL 286  
Description:  
End of RW2.  
Map cracking and rust staining on rail coping.

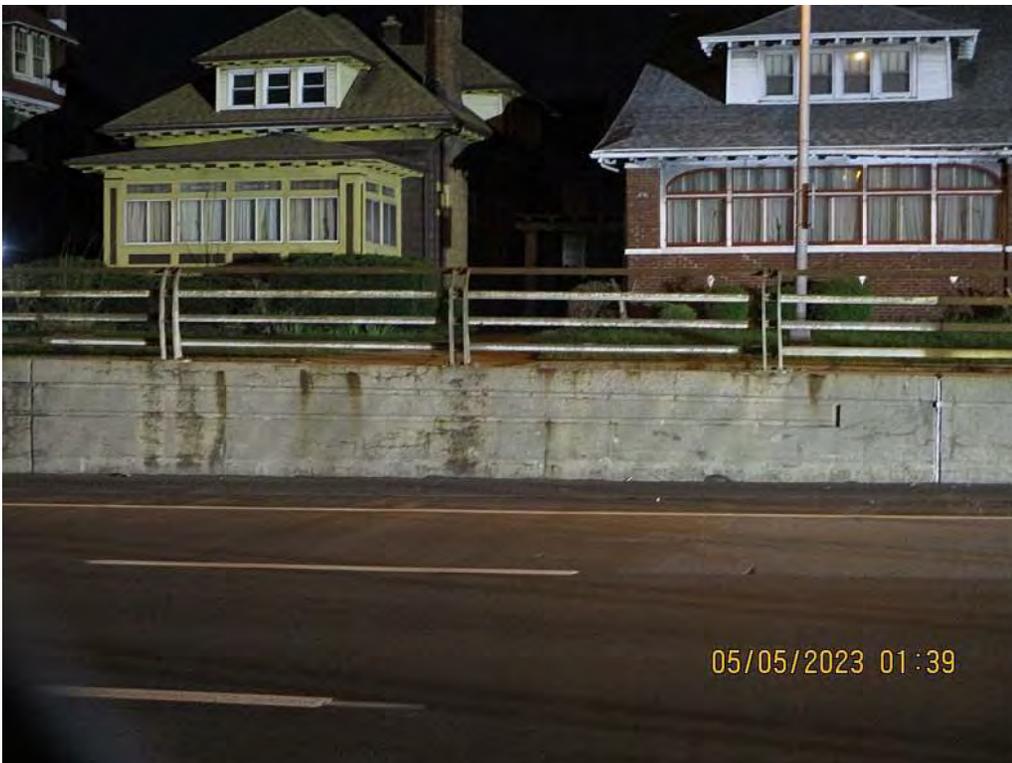
PHOTO 2  
PANEL 283  
Description:  
Map cracking and rust staining on rail coping.  
Map cracking with efflorescence throughout. More concentrated map cracking under rail posts, typical.  
Delamination in top half of panel for 1' from right joint.  
Similar for panels 285-279. Panels 285 and 282-280 have spalls as well.

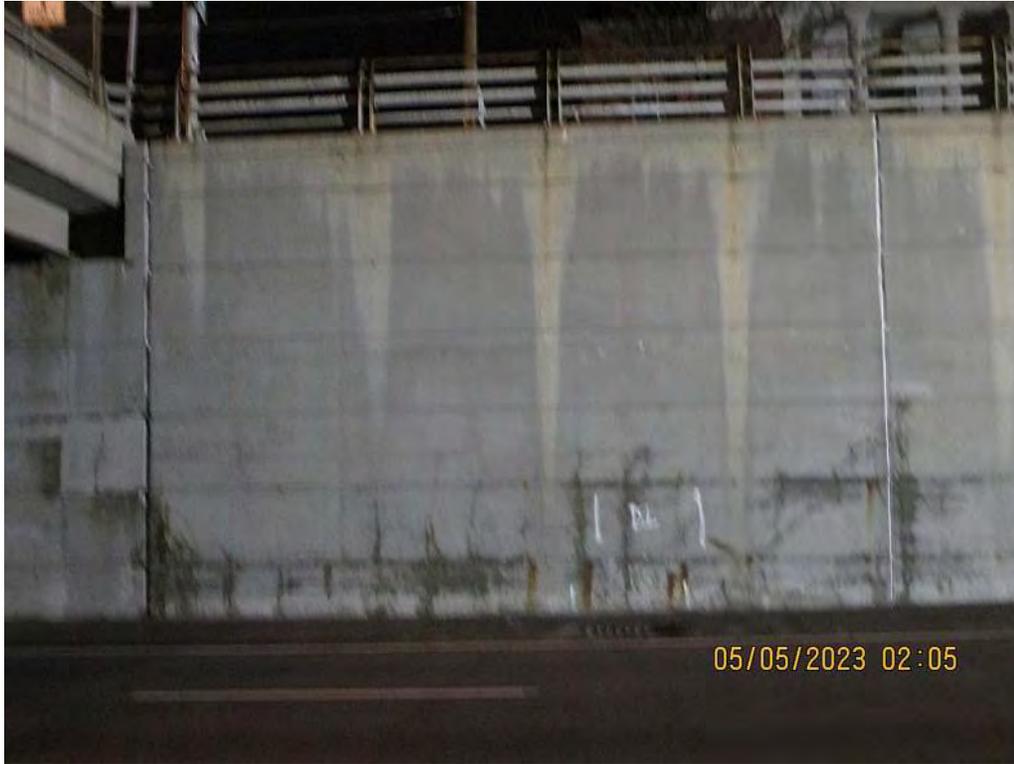
PHOTO 5

Map cracking under rail posts, typical.

Bottom 2 panels are map cracked with rust staining and 50%-60% delamination. Some cracks extend into the third panel which is 20% delaminated.

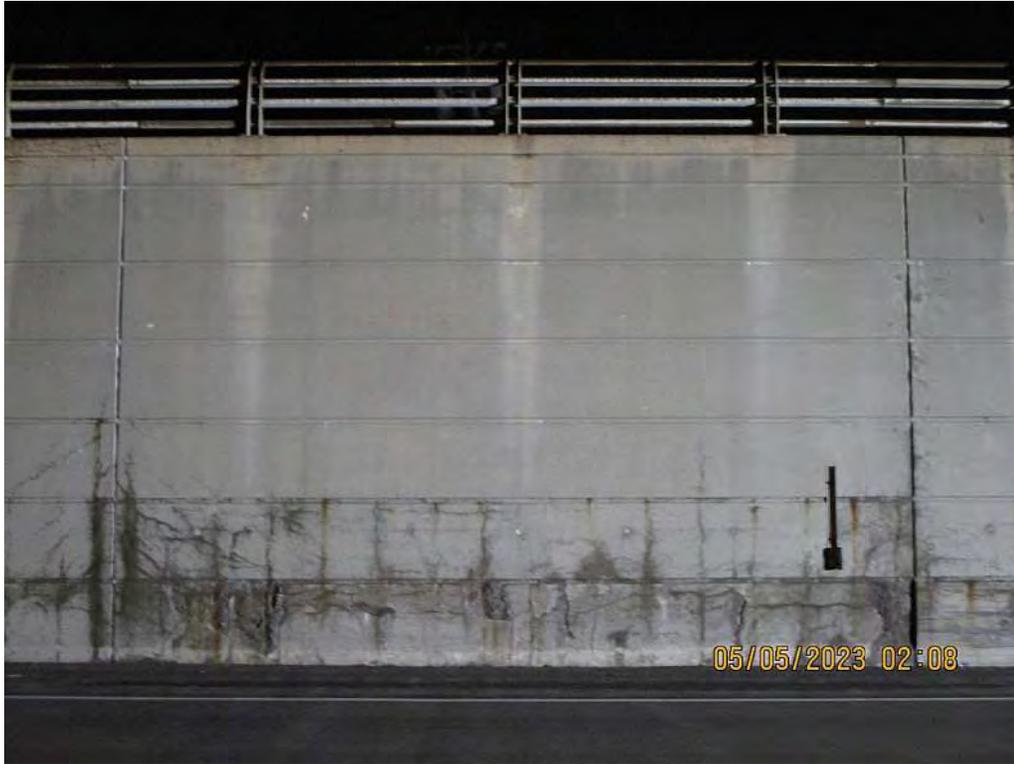
PHOTO 7  
PANEL 258  
Description:  
Map cracking bottom 2 panels with 40% delamination. Map cracks extend into third panel near left joint.  
Several large spalls on bottom panel with exposed rebar.

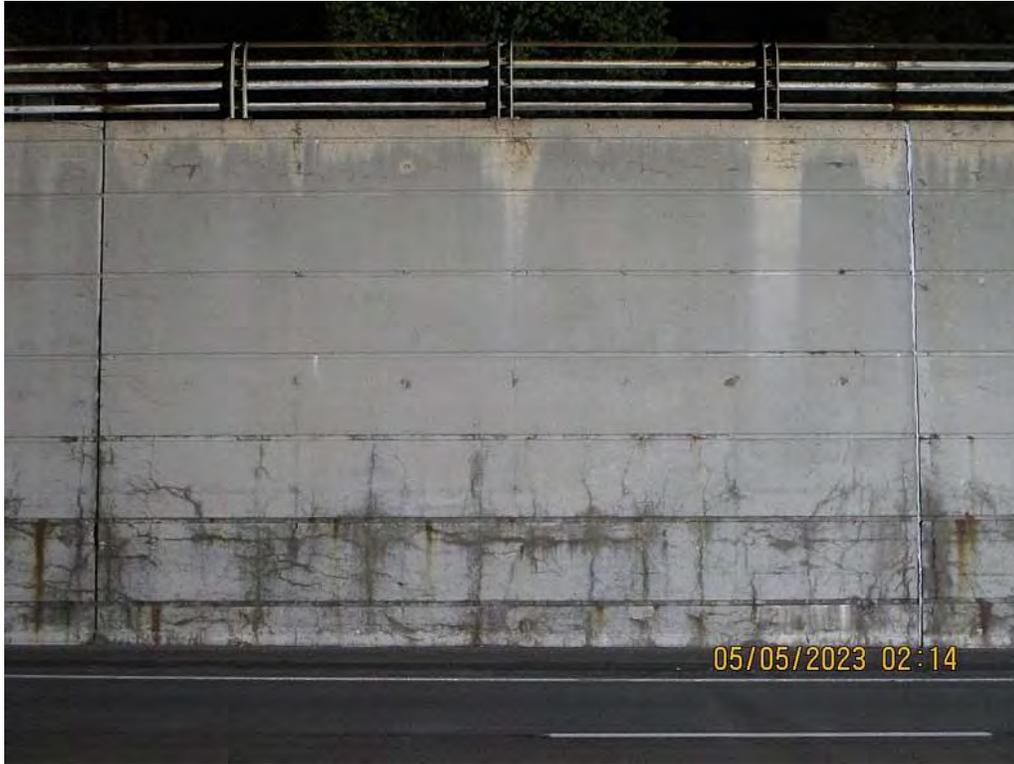
PHOTO 9  
PANEL 248  
Description:  
Map cracking under rail posts, typical.  
Map cracked bottom 2 panels with 90%-100% delamination. Less severe map cracking on third panel with delamination for 6' from right joint.  
Scattered map cracking on top 4 panels.  
There is a spill on the second panel.

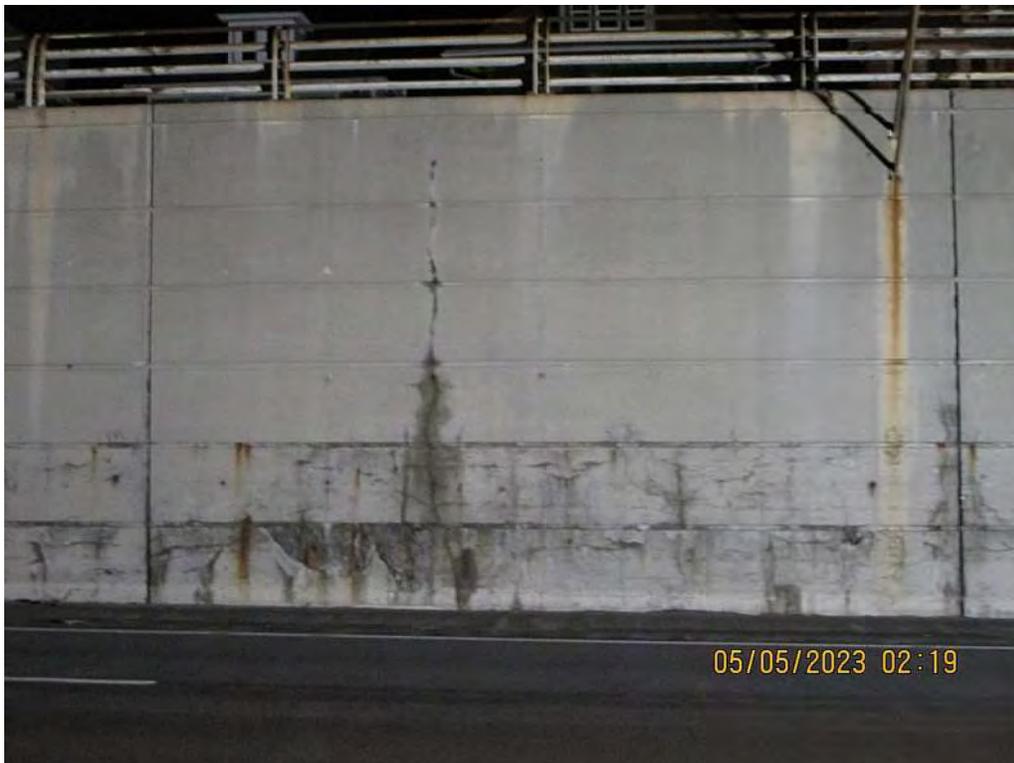
PHOTO 10  
PANEL 238  
Description:  
Full-height vertical crack with efflorescence.  
Bottom 2 panels map cracked with 90%-100% delamination. Some delamination extends into third panel as well.  
Large spill with exposed rebar on bottom panel.  
Rust staining under luminaire and a few isolated stains throughout.

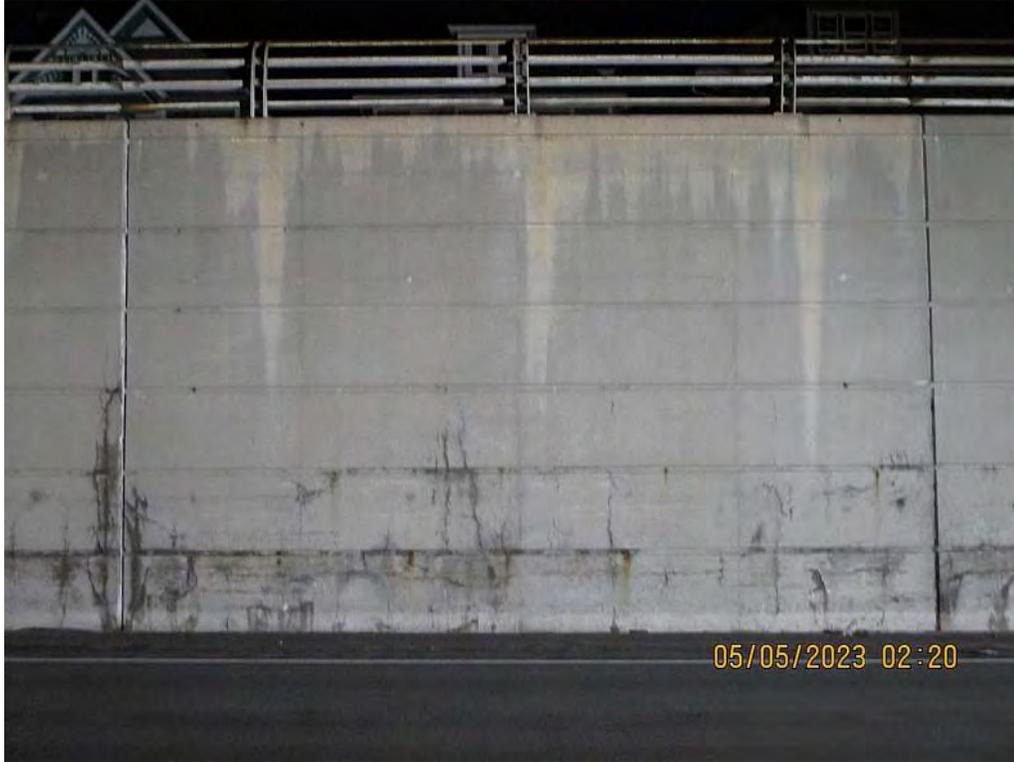
PHOTO 11  
PANEL 237  
Description:  
Map cracked on bottom 3 panels with areas of rust staining and efflorescence.  
Delaminated 100% on bottom panel, 70% on second panel, and 15% on third panel.  
There is a spall on the right side of the bottom panel.  
Similar to panels 236 and 234.

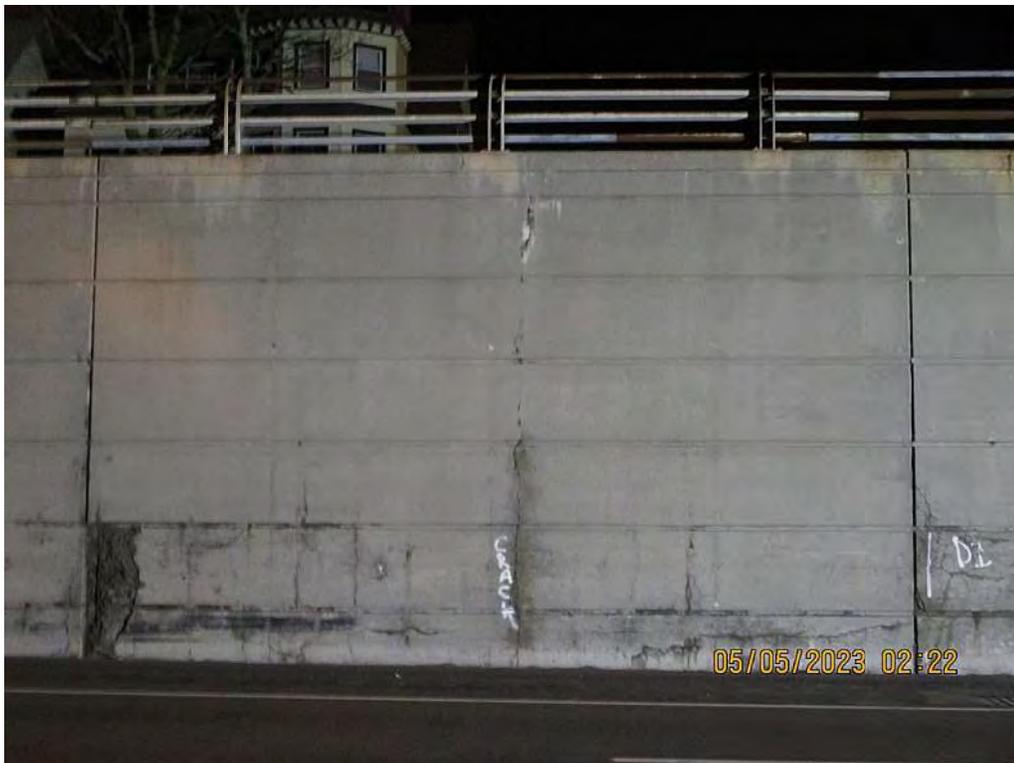
PHOTO 12  
PANEL 232  
Description:  
Map cracked on bottom 2 panels with some vertical cracks extending into the third panel. There are isolated rust stains.  
Full height vertical crack at midspan of the panel with efflorescence.  
Large spall on bottom two panels at left joint. The spall has exposed rebar.  
Similar to panels 235, 223, and 220.

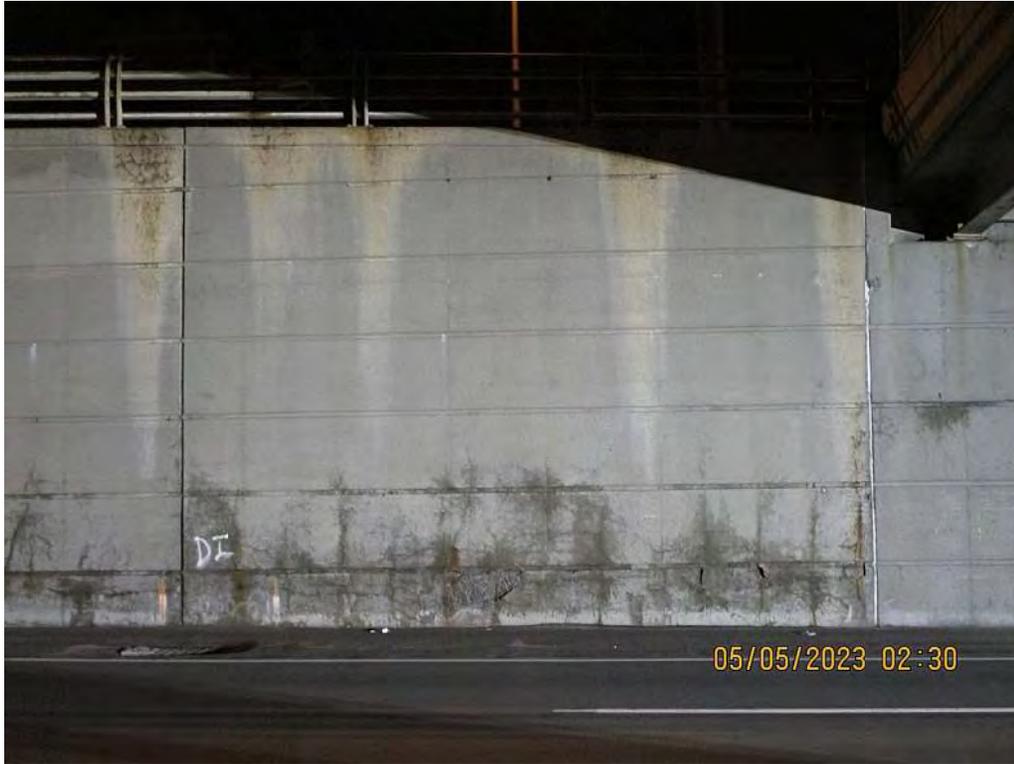
PHOTO 15  
PANEL 218  
Description:  
Left of East Utica St bridge west abutment.  
There is map cracking on the bottom 2 panels throughout and bottom 3 panels near the joints. Panels 1 and 2 are 100% delaminated and panel 3 is 90% delaminated.  
Scattered areas of rust staining are present.  
There are a few spalls on the bottom panel.

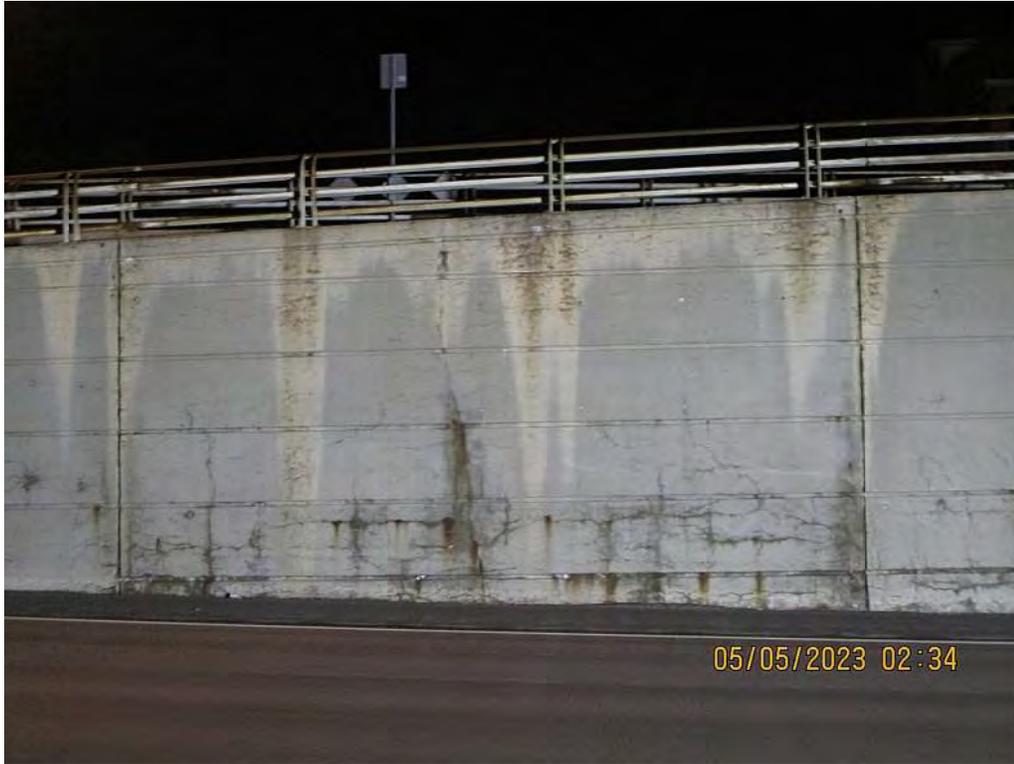
PHOTO 17  
PANEL 208

Bottom 2 panels are 100% delaminated with rust staining and efflorescence. Panel 3 is 60% delaminated.

There is a full height crack at midspan of the panel with rust staining and efflorescence.

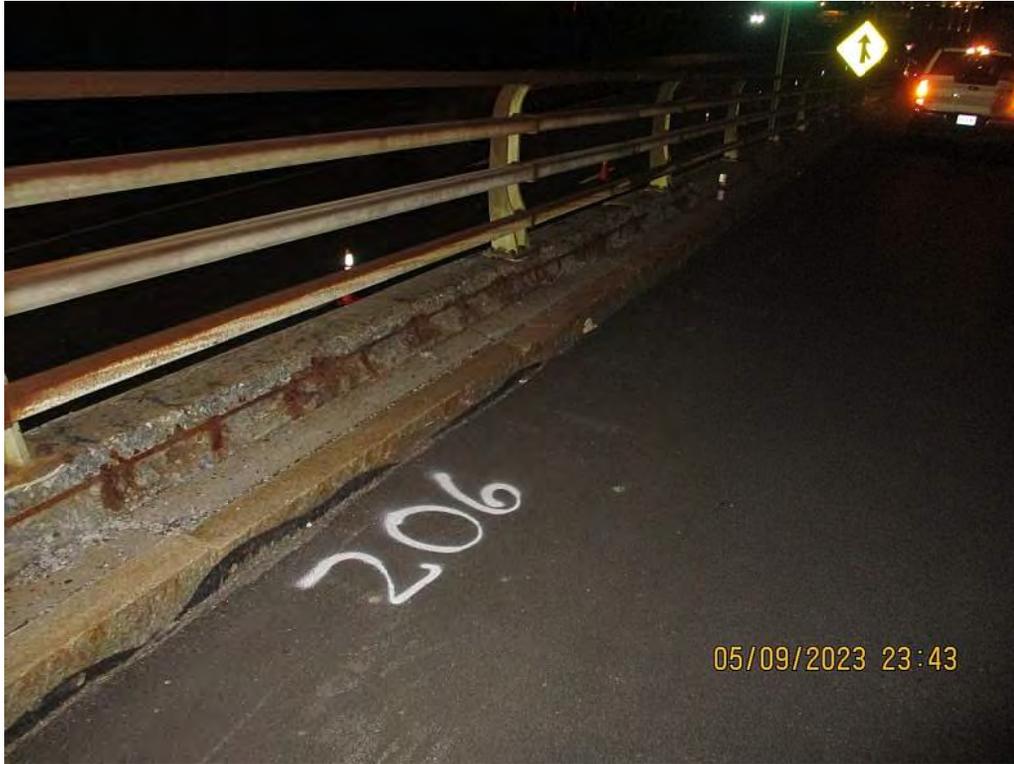
PHOTO 21  
PANEL 206 (Back Side of Coping)

Back of coping is spalled with exposed longitudinal rebar and rust staining.

Top of coping is map cracked.

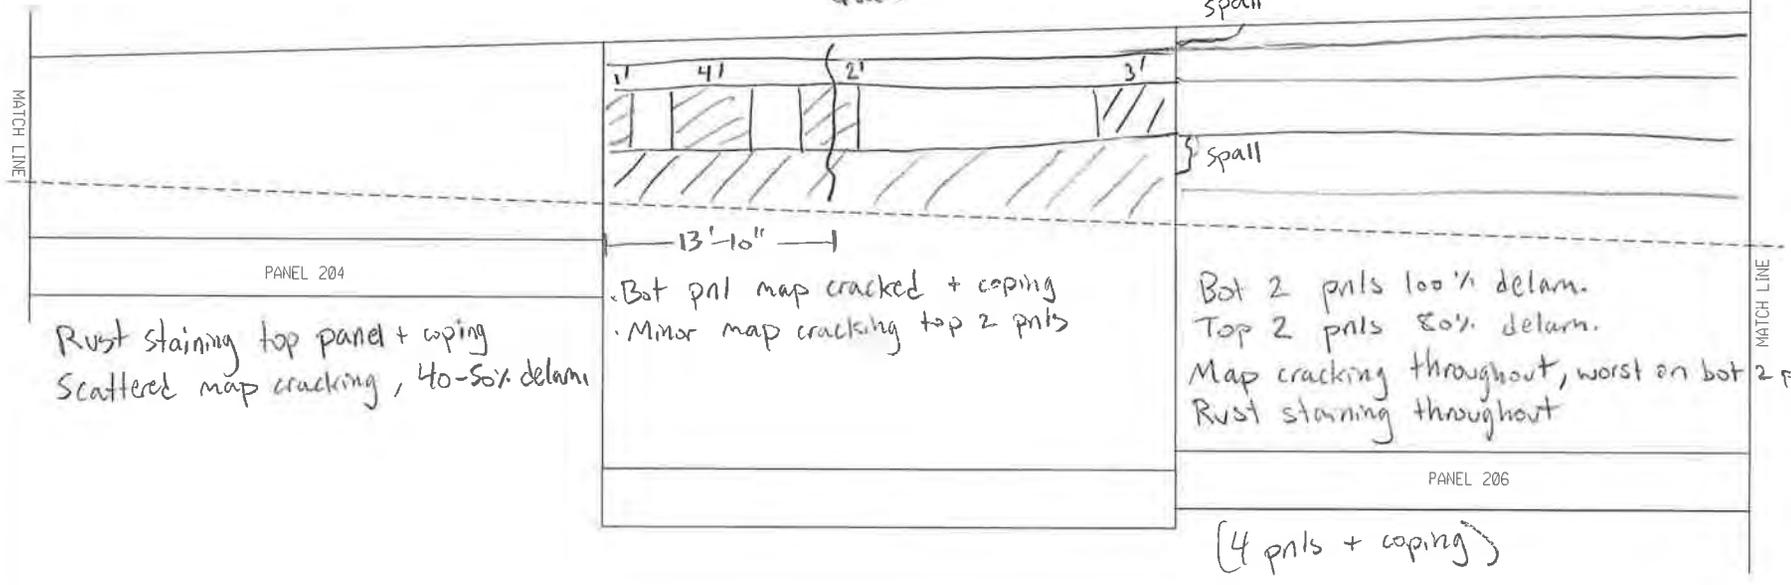
Rust staining top panel + coping  
Scattered map cracking, 40-50% delam

- Bot pnl map cracked + coping
- Minor map cracking top 2 pnls

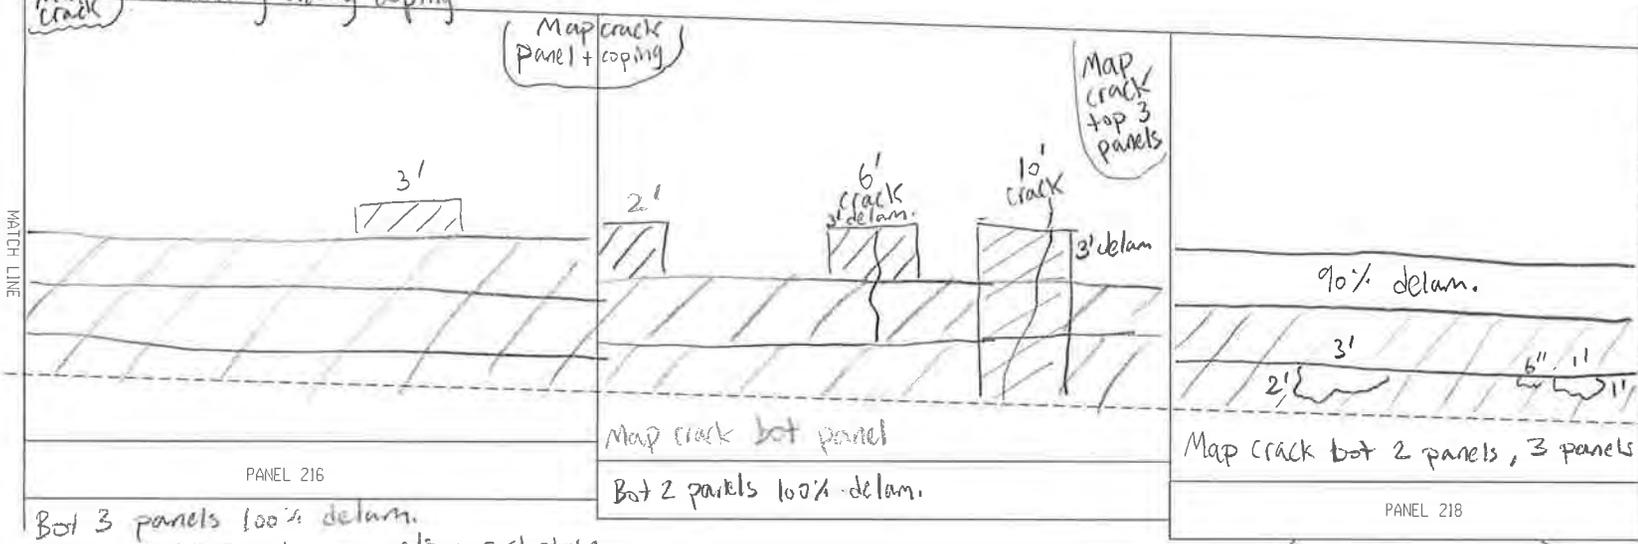
RW 2 PANELS 213-218 (7 panels + coping)

Map cracking bot 2 panels

Map crack Cracking along coping

Bot 3 panels 100% delam.  
Map cracking Bot 2 panels + rust stain

Bot 2 panels 100% delam.

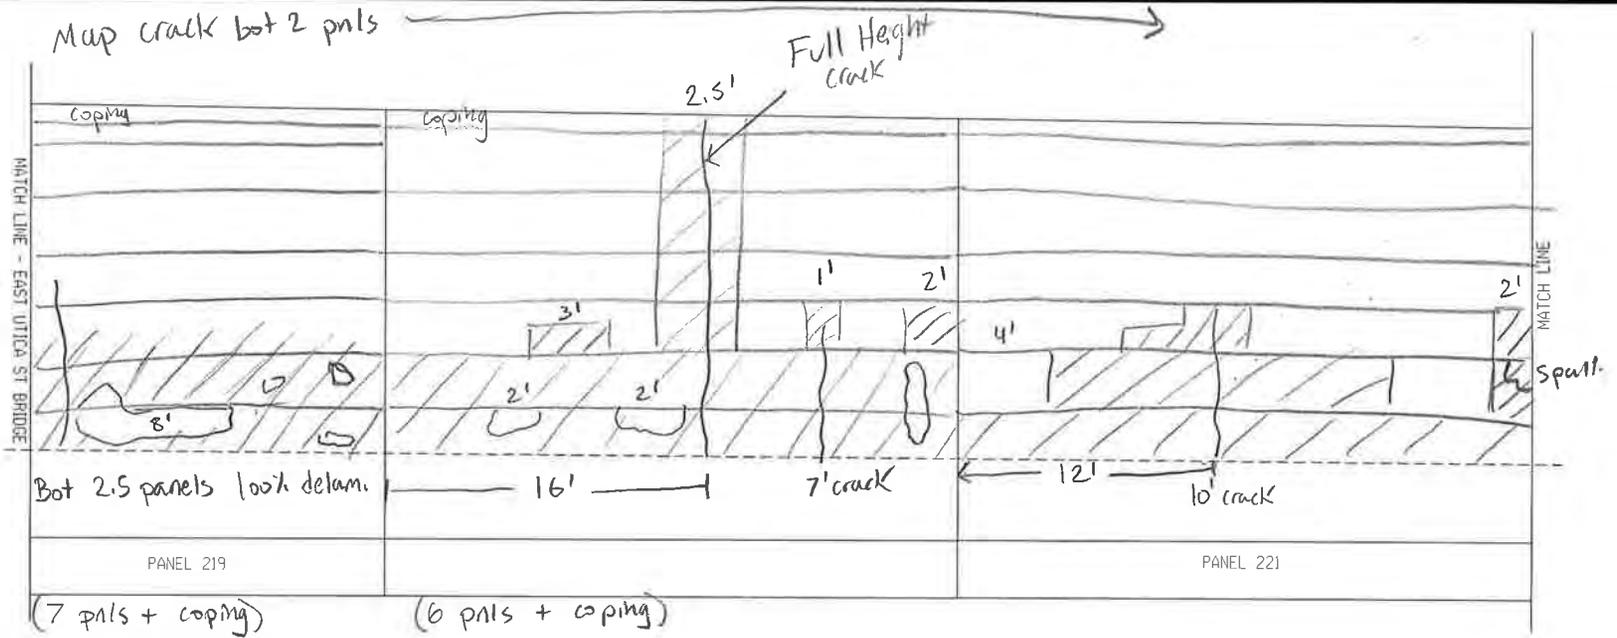
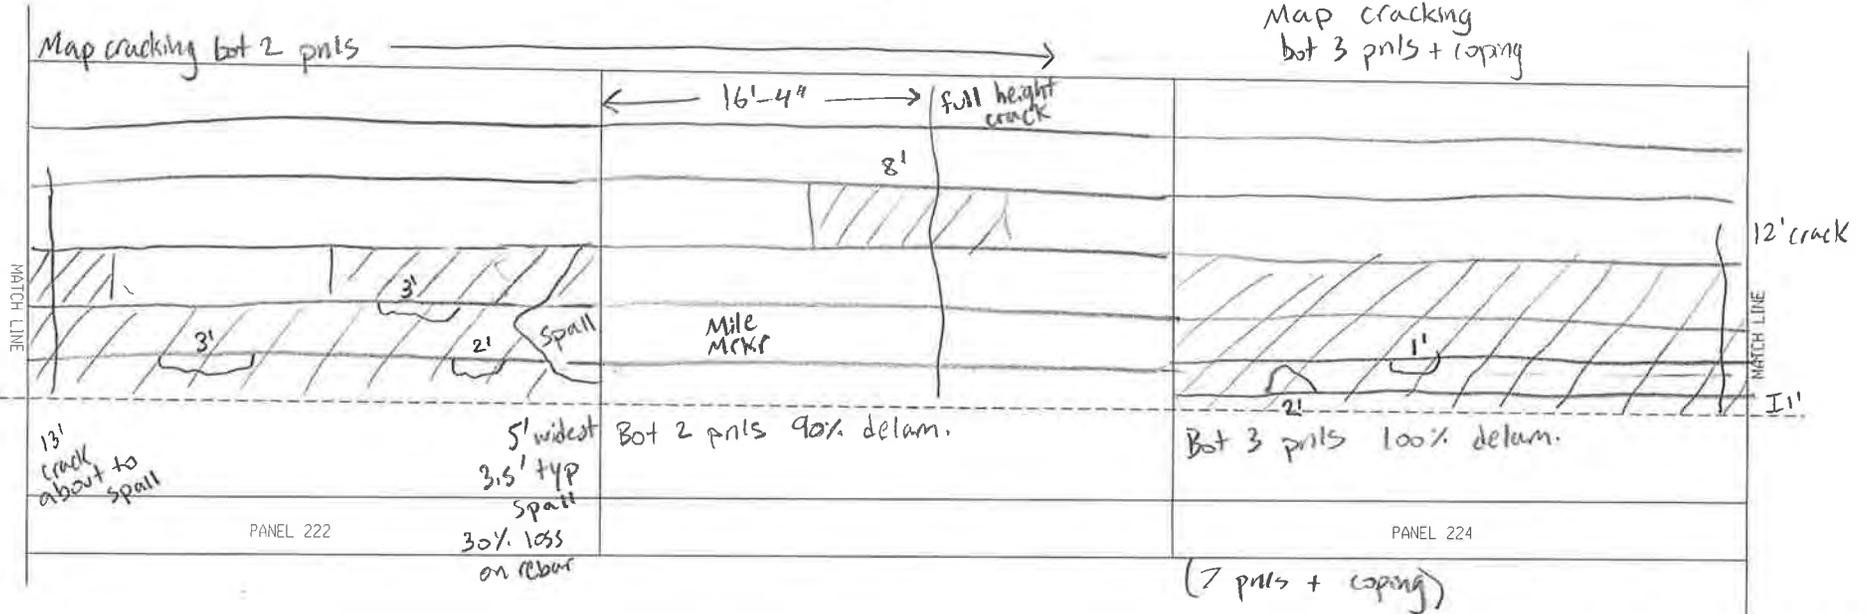
RW 2 PANELS 219-224

Map crack bot 2 pnls

10' crack

Map cracking bot 2 pnls

Map cracking bot 3 pnls + coping

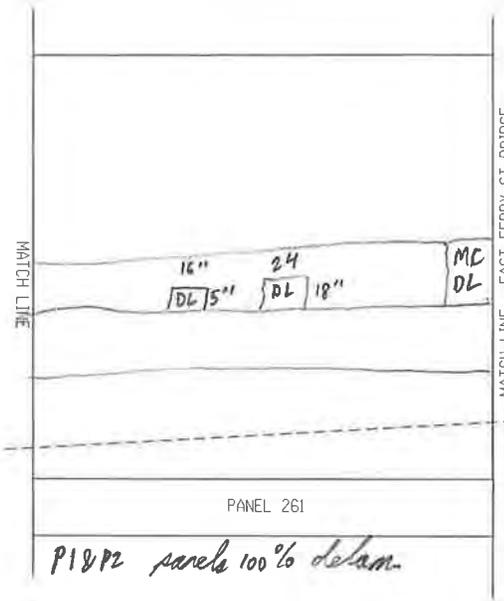
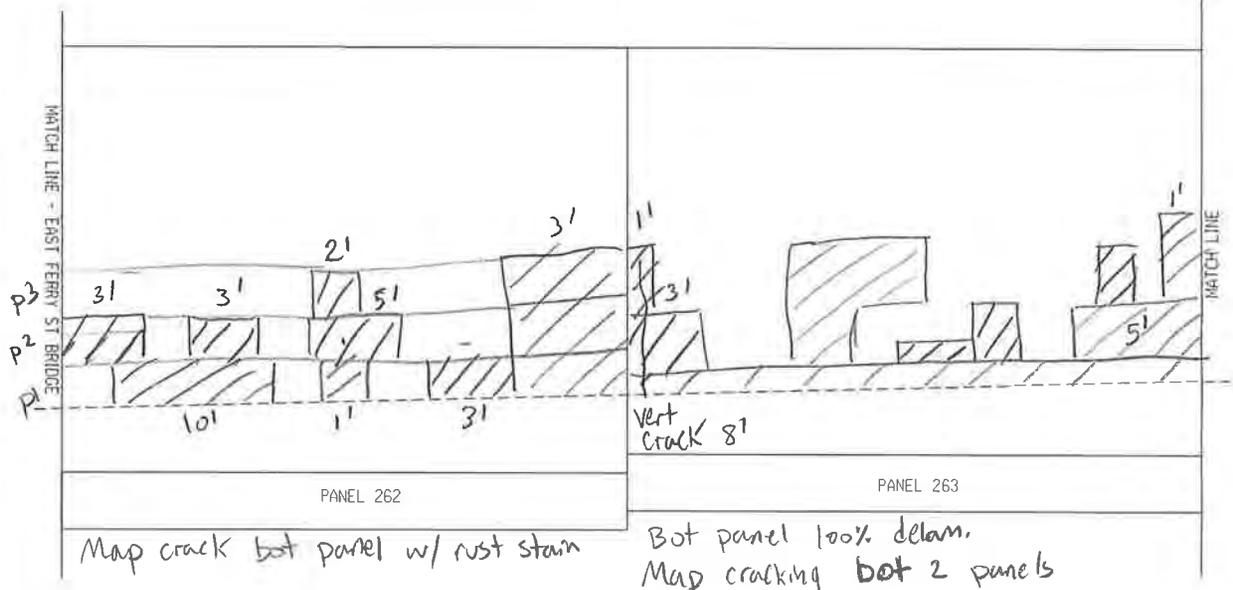
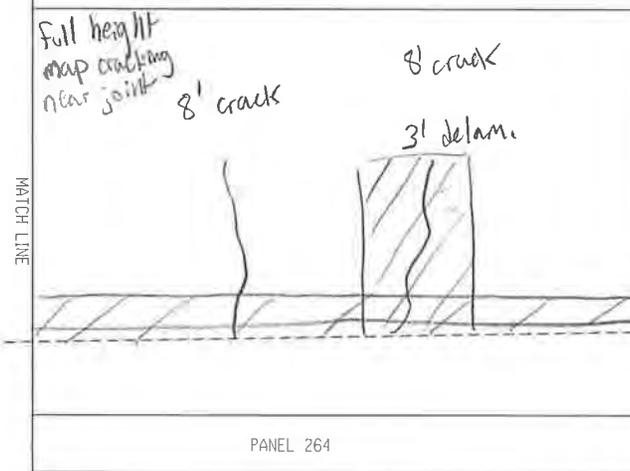
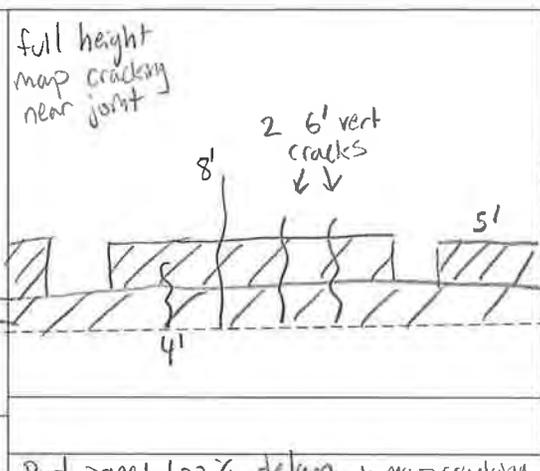
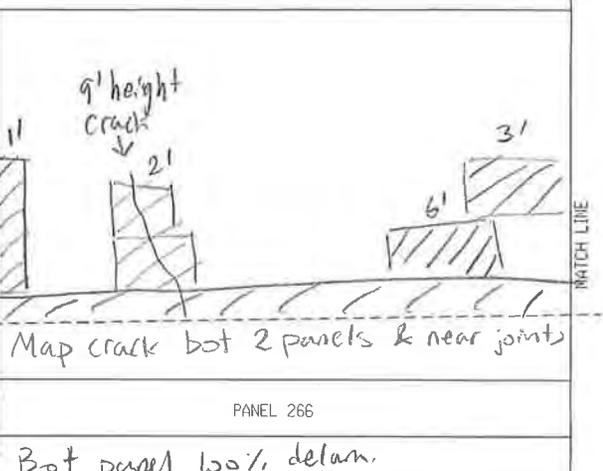
RW 2 PANELS 261-266

P1 & P2 panels 100% delam.

Map crack bot panel w/ rust stain

Bot panel 100% delam. Map cracking bot 2 panels

7 panels + coping  
Bot 2 panels 100% delam. + map cracking + rust stain

Bot panel 100% delam. + map cracking

Bot panel 100% delam.
