# **Appendix A5**

## Retaining Wall Inspection Reports

**NY33 RETAINING WALL CONDITION EVALUATION 2023**  
**KENSINGTON EXPRESSWAY PROJECT**  
**PIN 5512.52**  
**CITY OF BUFFALO, ERIE COUNTY**  
**RETAINING WALL 1**

# PIN 5512.52 – NY33 RETAINING WALL CONDITION EVALUATION 2023 FIELD INSPECTION SUMMARY

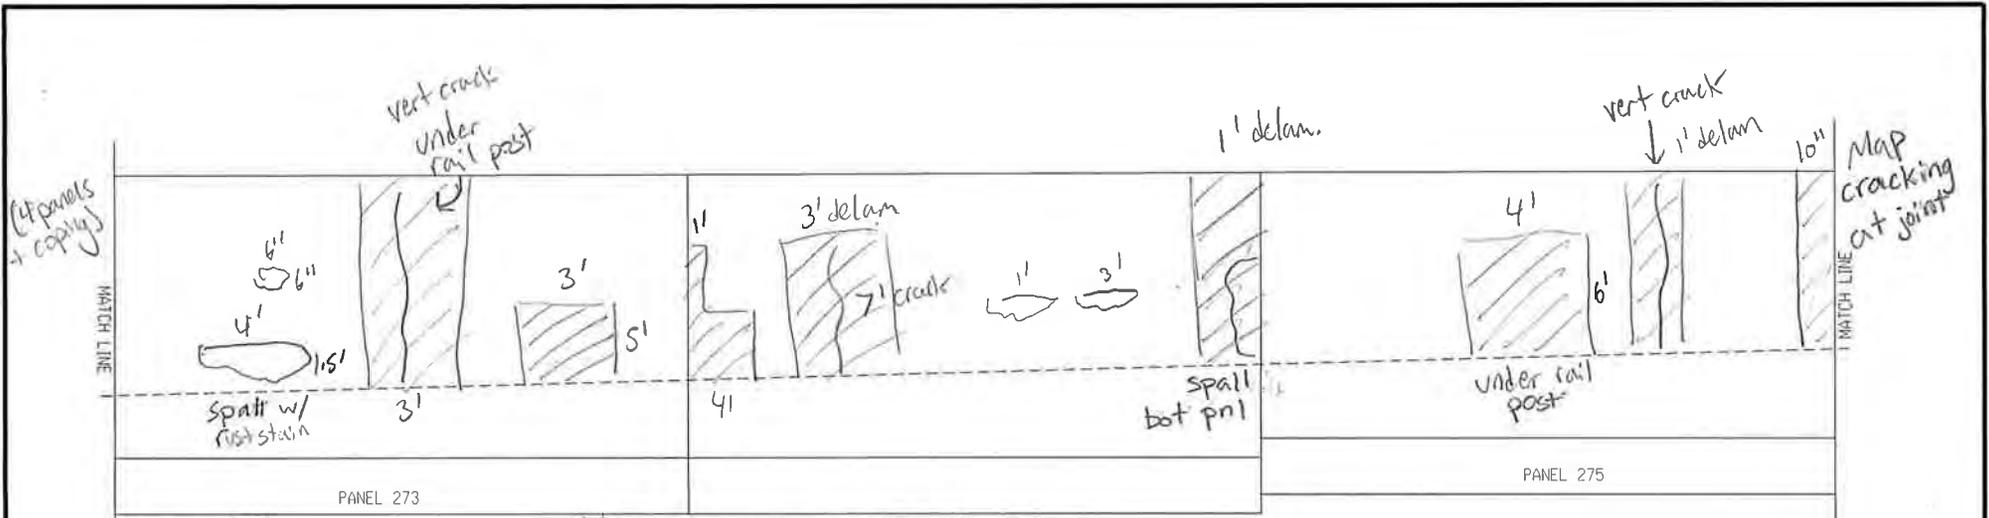
### RW 2 PANELS 273-278

Map cracking at joint

Bot panel 70% delam

• Bot 2 panels 100% delam. w/ Map crack & rust stain

• Map crack on 3rd panel

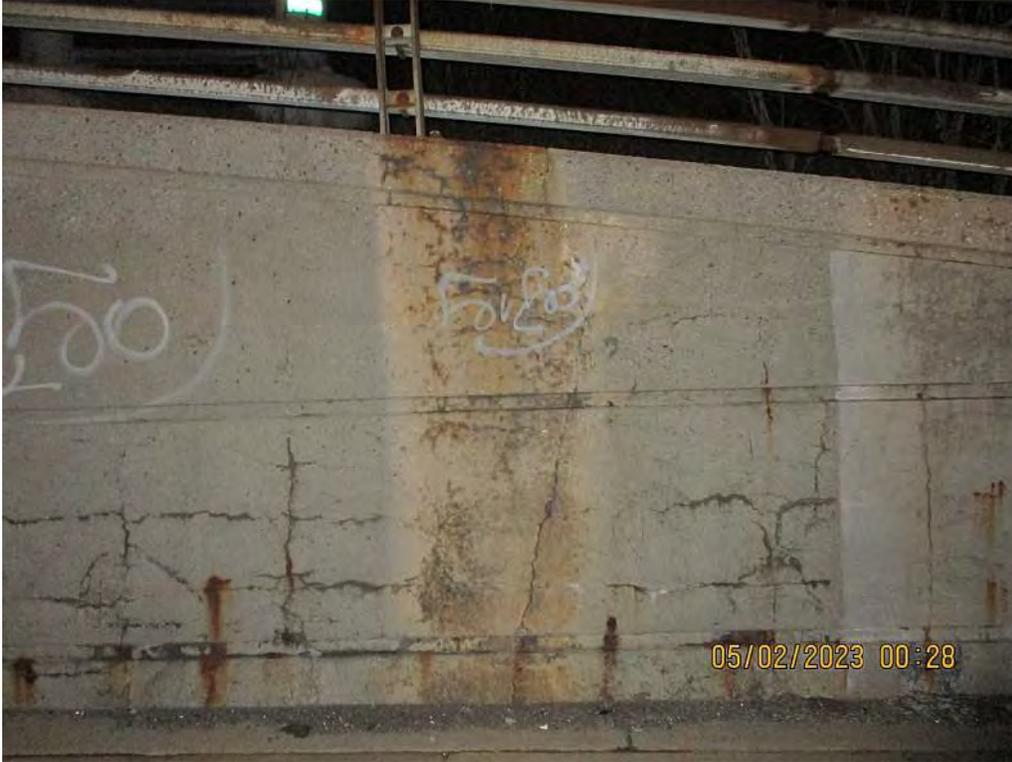
PHOTO 1  
PANEL 302  
Description:  
Full-height crack to right of rail post. Rust staining and map cracking under rail post typical throughout the wall. Map cracking and rust staining on bottom 2 panels.

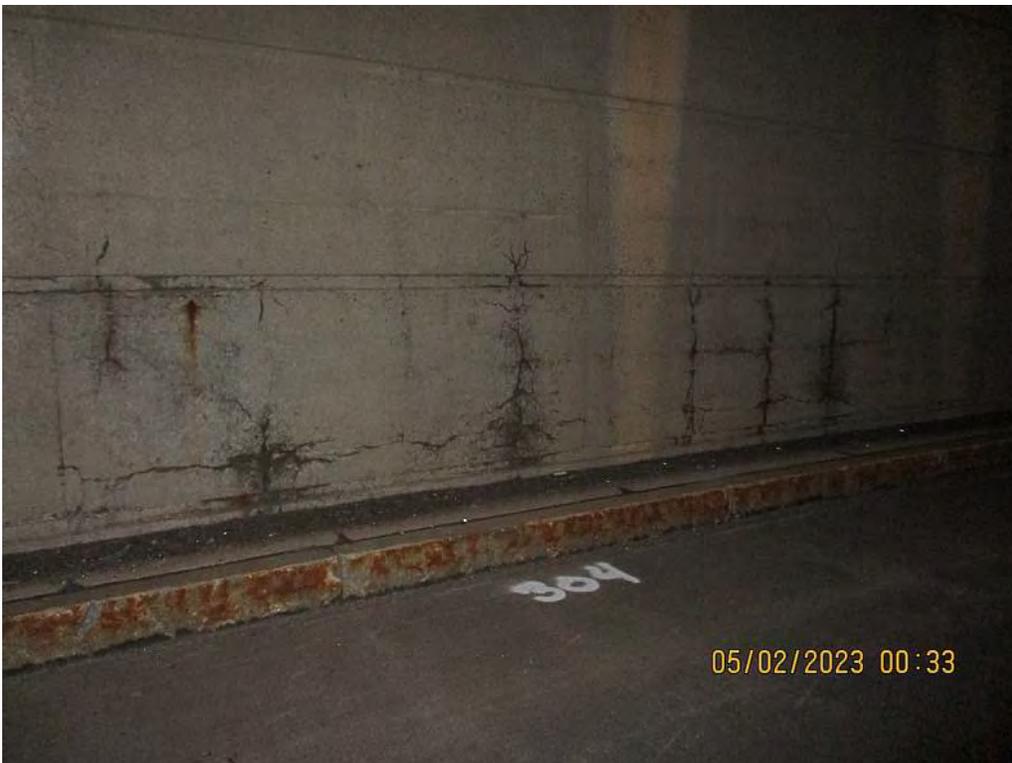
PHOTO 2  
PANEL 304  
Description:  
Vertical cracking at many vertical rebar locations in bottom panel, typical throughout the wall. Minor map cracking is present as well. Bottom 1' of the wall is delaminated.

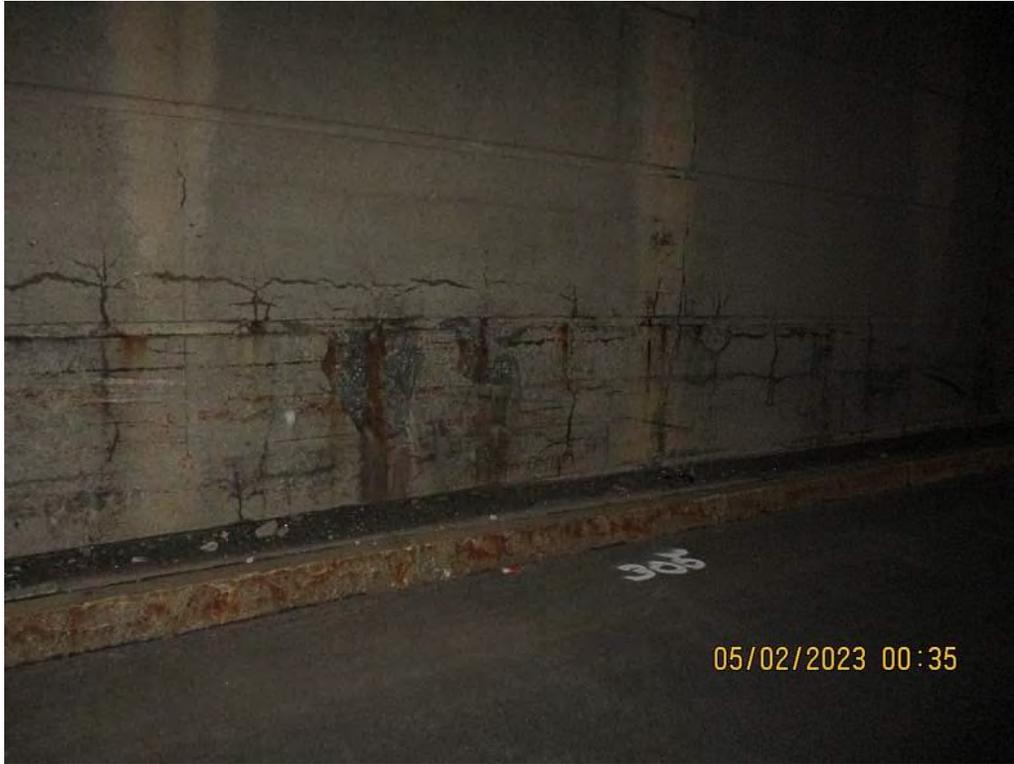
PHOTO 3

Bottom panel of wall is 50% delaminated. Map cracking is present on the bottom 4' of the wall and is most concentrated near rebar locations. Rust staining at some rebar locations is typical for most of the wall.

Spalls with exposed rebar similar to spalls on panels 308 and 307.

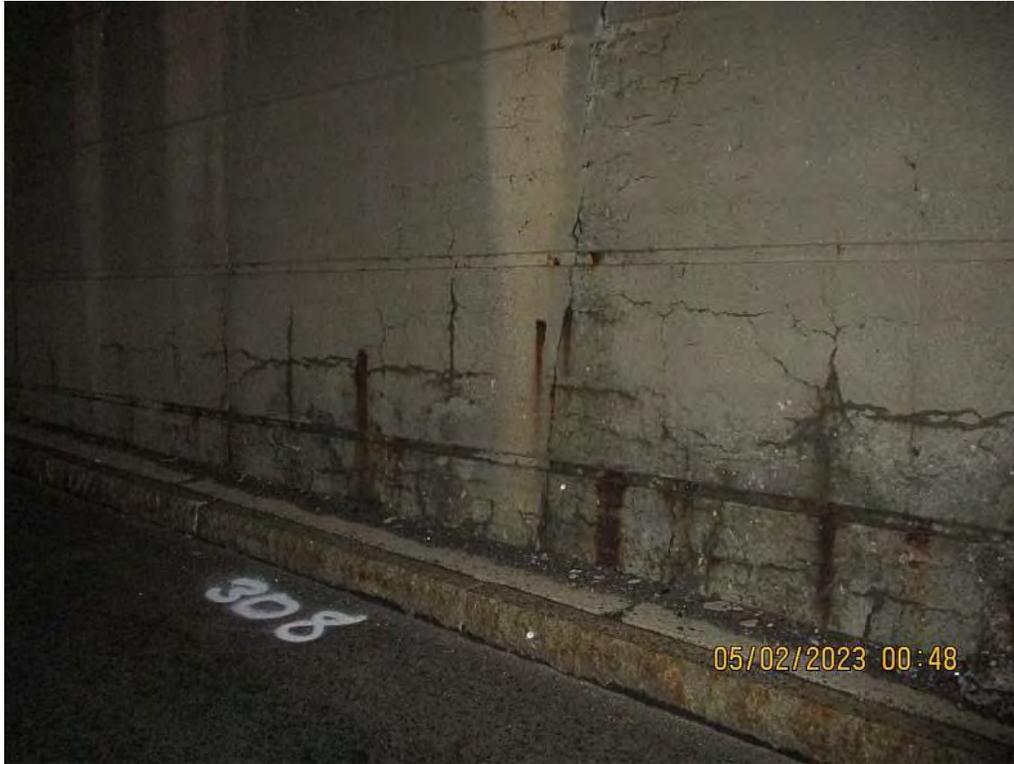
PHOTO 5

Full-height vertical crack with efflorescence and map cracking on either side.

Bottom 2.5' is 30% to 40% delaminated. The bottom 2 panels have significant map cracking and rust staining. Panel 307 is similar without the rust staining.

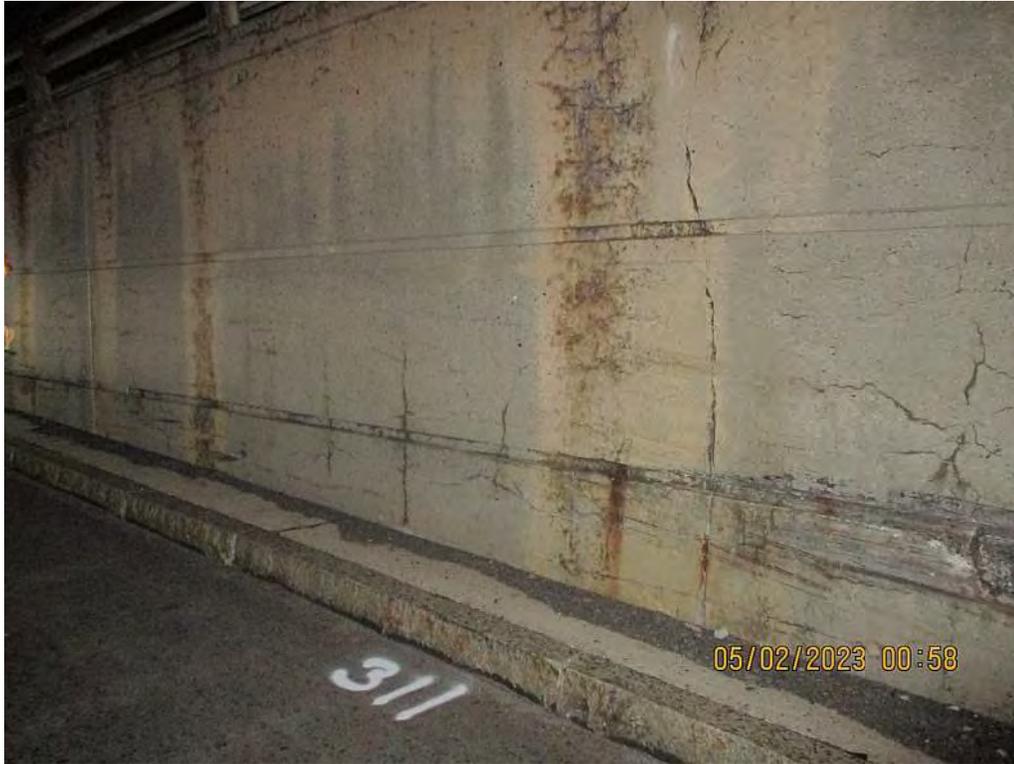
PHOTO 7

Localized map cracking and staining under rail posts for full-height, same for panel 312.

Scattered map cracking throughout.

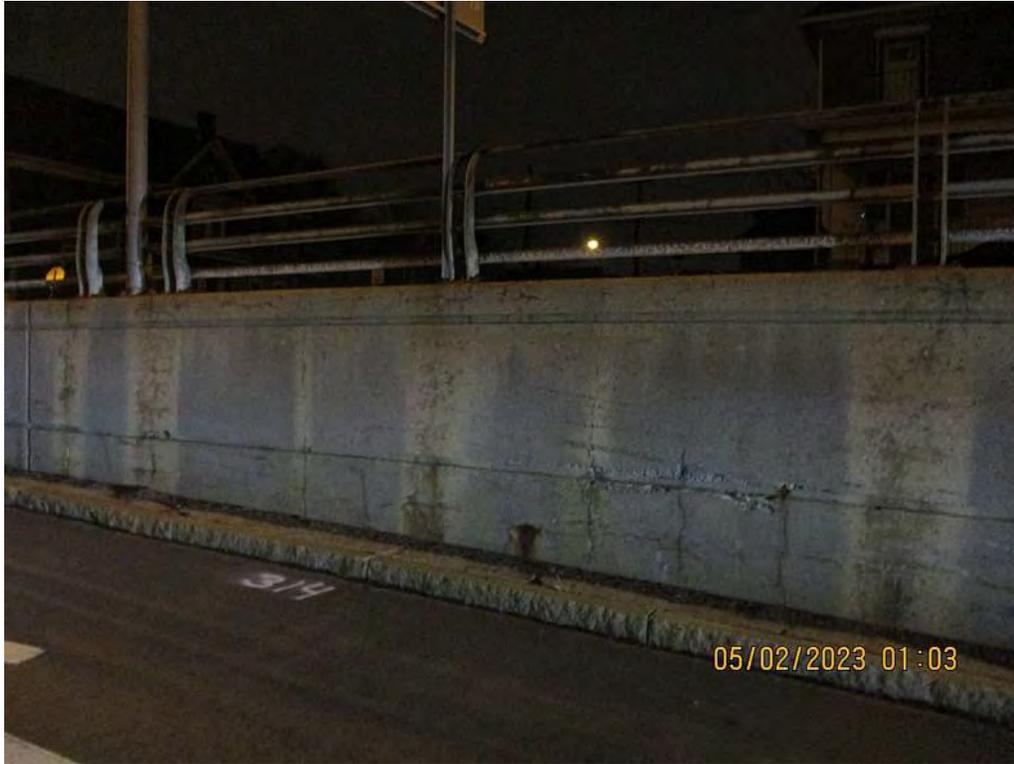
PHOTO 9

Minor spalling in the chamfer between panels.

Conditions similar for panels 313 to 317.

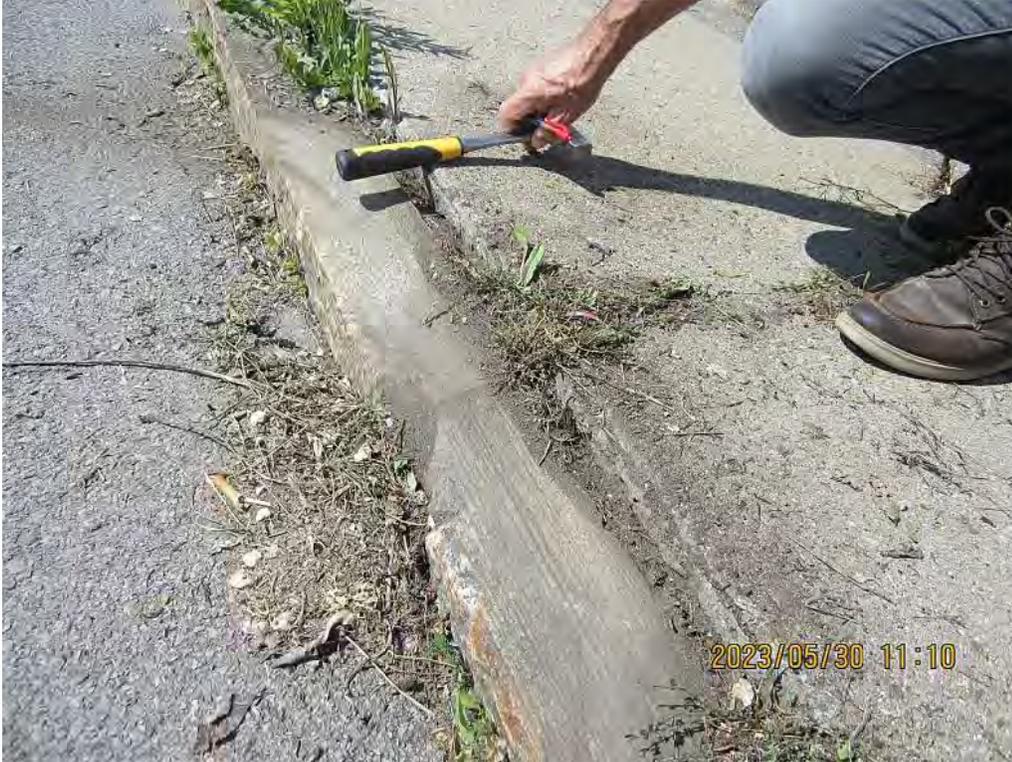
**PHOTO 11**  
Safety walk behind wall

**Description:**  
The safety walk and curb are misaligned. The safety walk has settled at the retaining wall back face, rotating the safety walk to be higher than the curb.

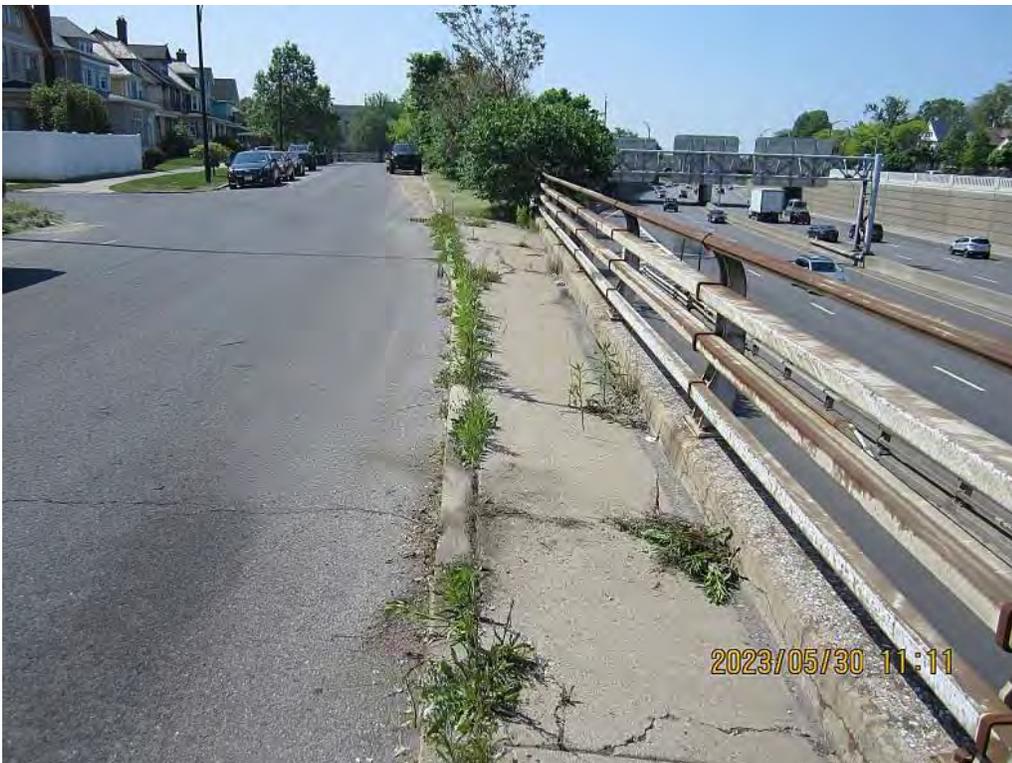
**PHOTO 12**  
Safety walk behind wall

**Description:**  
The safety walk, across from Gerard Place, is sloped toward the back of the retaining wall for approximately 25 ft.  
The curb and safety walk are misaligned with the curb being below the edge of sidewalk.  
The coping has a mid-height longitudinal crack.

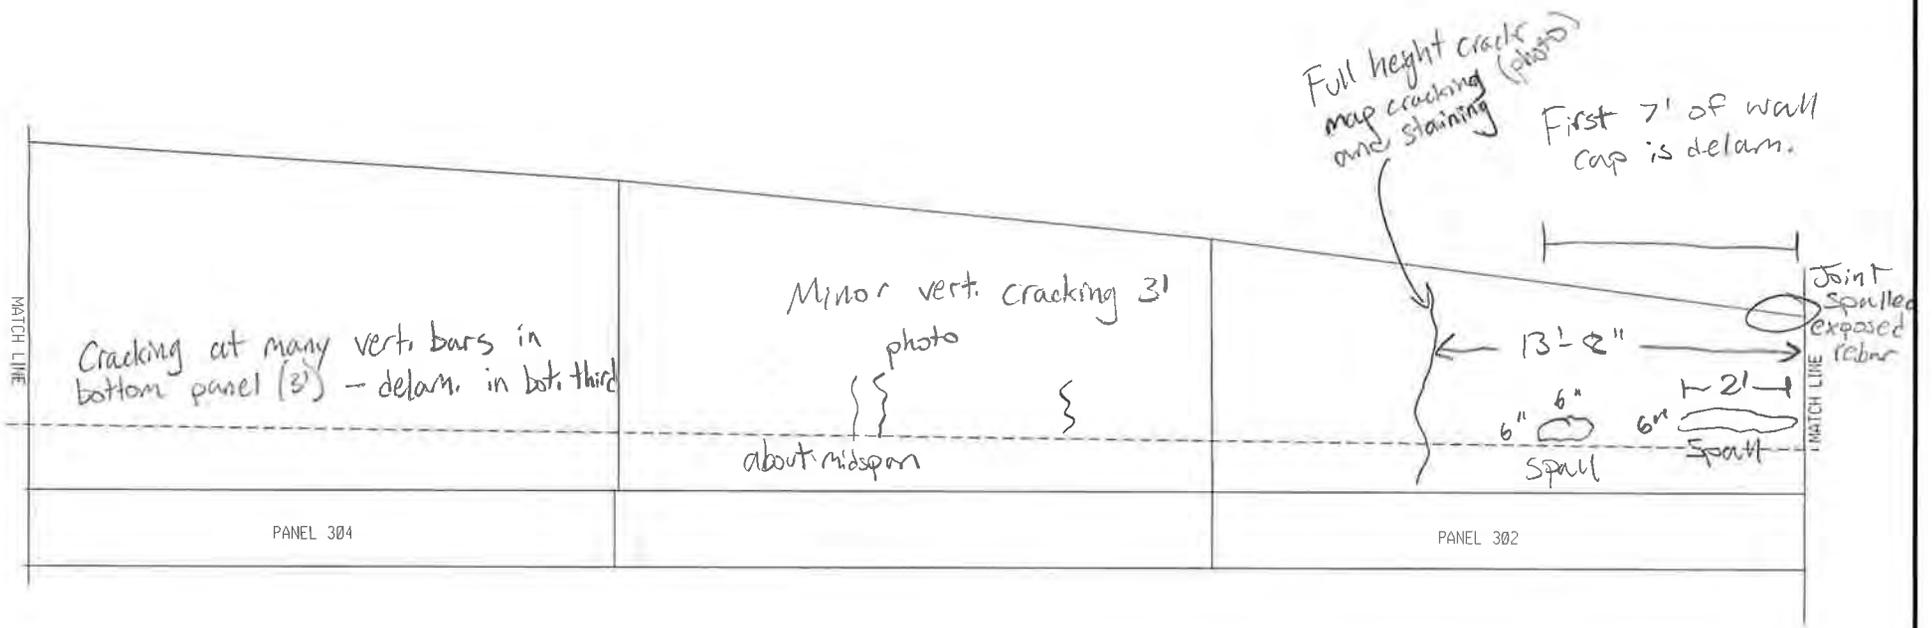
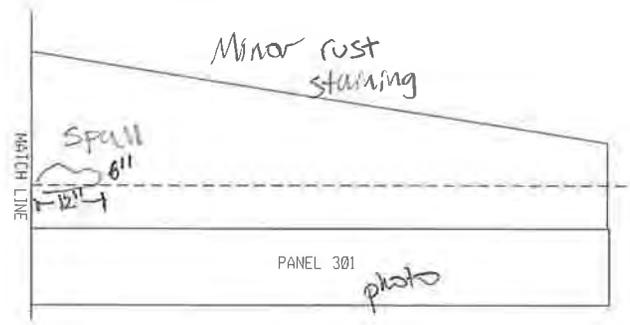
RW 3 PANELS 304-301

Bot 30" 10% delam. & map cracking

Map cracking 5' x 5' photo

Bot 2.5' 30% to 40% delam.

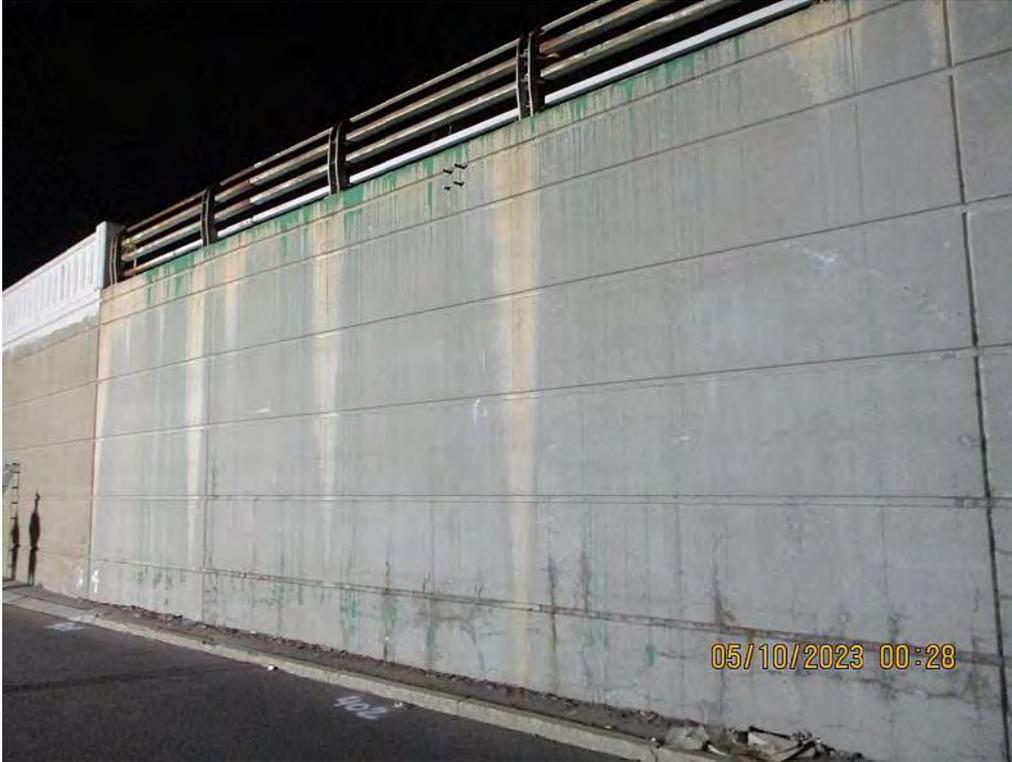
PHOTO 1  
PANEL 401-402  
Description:  
Start of RW4. Connects to RW10.  
Bottom 2 panels are 80% to 100% delaminated with map cracking and some rust staining. Map cracking extends into bottom 4 panels near joints.

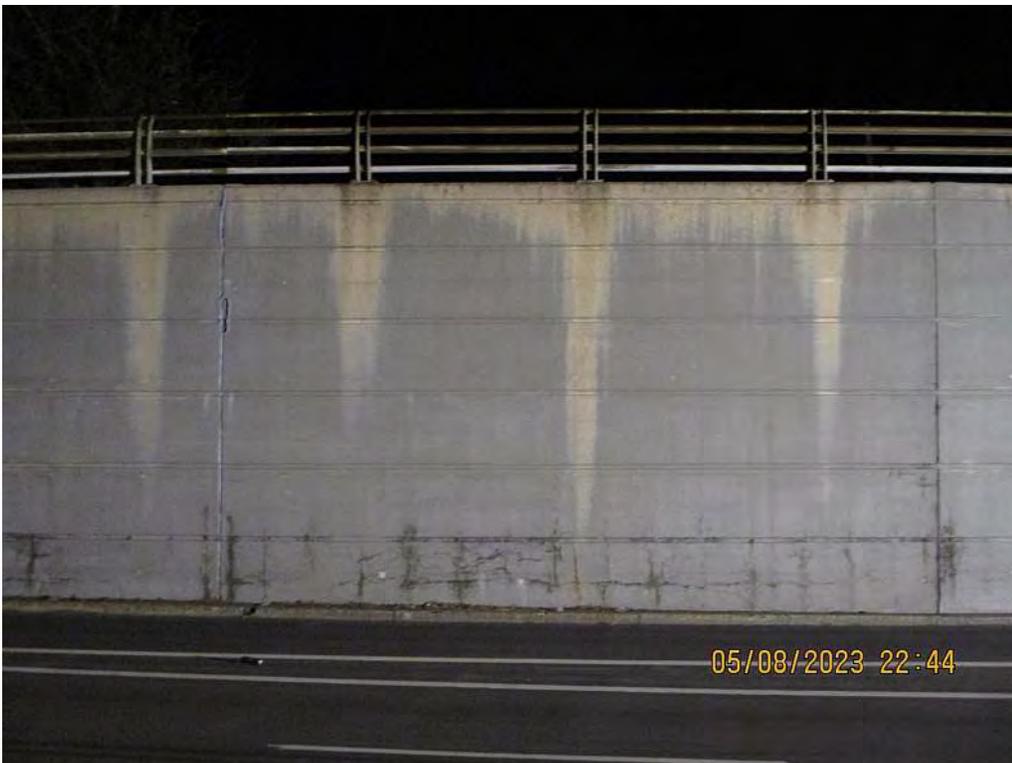
PHOTO 2  
PANEL 404  
Description:  
Bottom panel is delaminated 70% with map cracking and scattered rust stains. Second panel from bottom is 15% delaminated.  
There is a 12' high crack around midspan, with delamination 1.5' wide.  
Conditions are similar for panel 403.

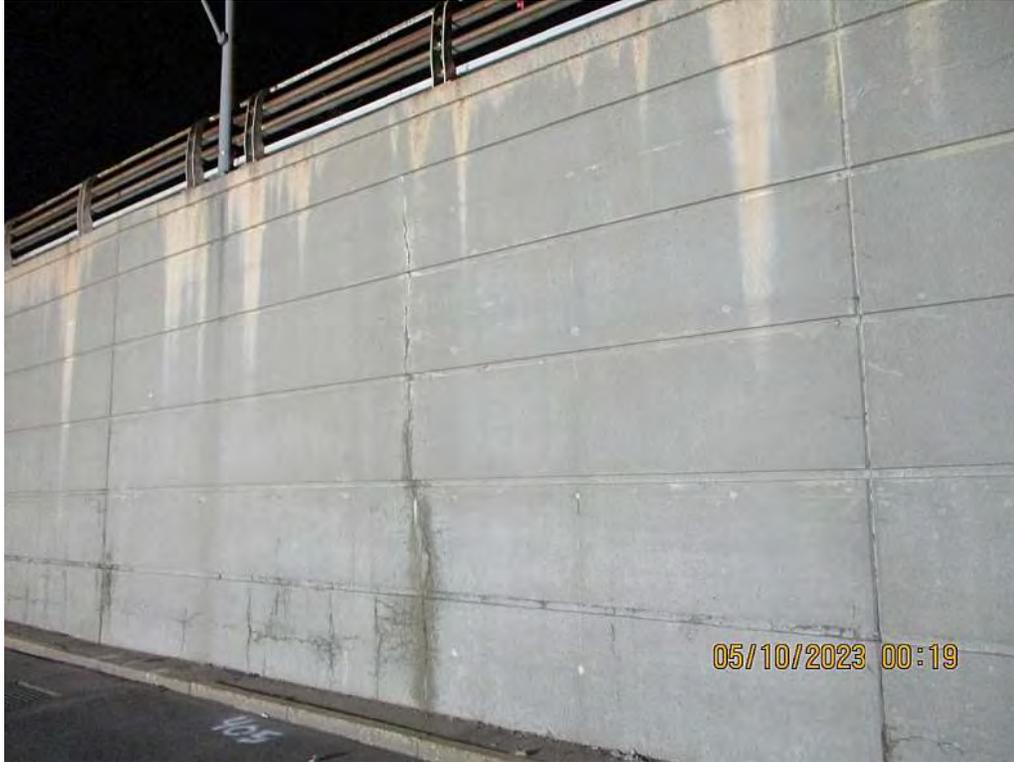
PHOTO 3  
PANEL 405  
Description:  
Full-height crack with efflorescence. Map cracking on 1.5' either side for full height. Delaminated on either side for bottom 9'.  
Bottom panel has map cracking and 50% delamination. Delamination extends into second panel near left joint.

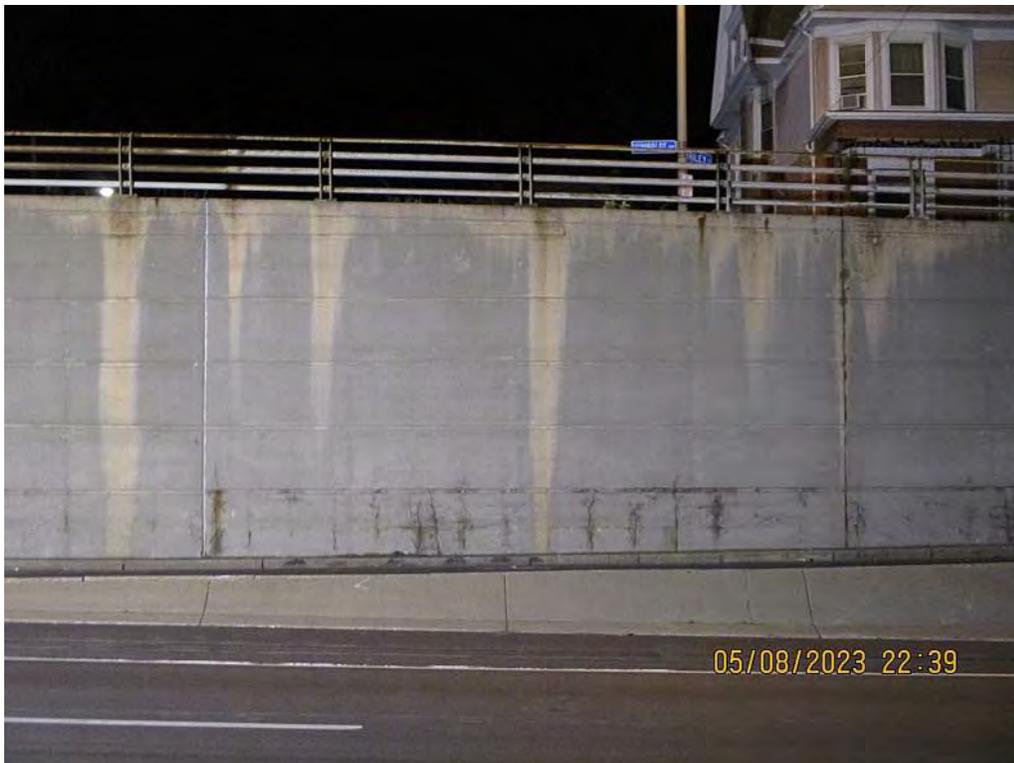
PHOTO 4  
PANEL 407  
Description:  
Map cracking and delamination on bottom panel, more concentrated at rebar locations. A few vertical cracks extend into the second and third panels with delamination on either side.  
Map cracking on the rail coping is typical for about half of the panels on RW4.

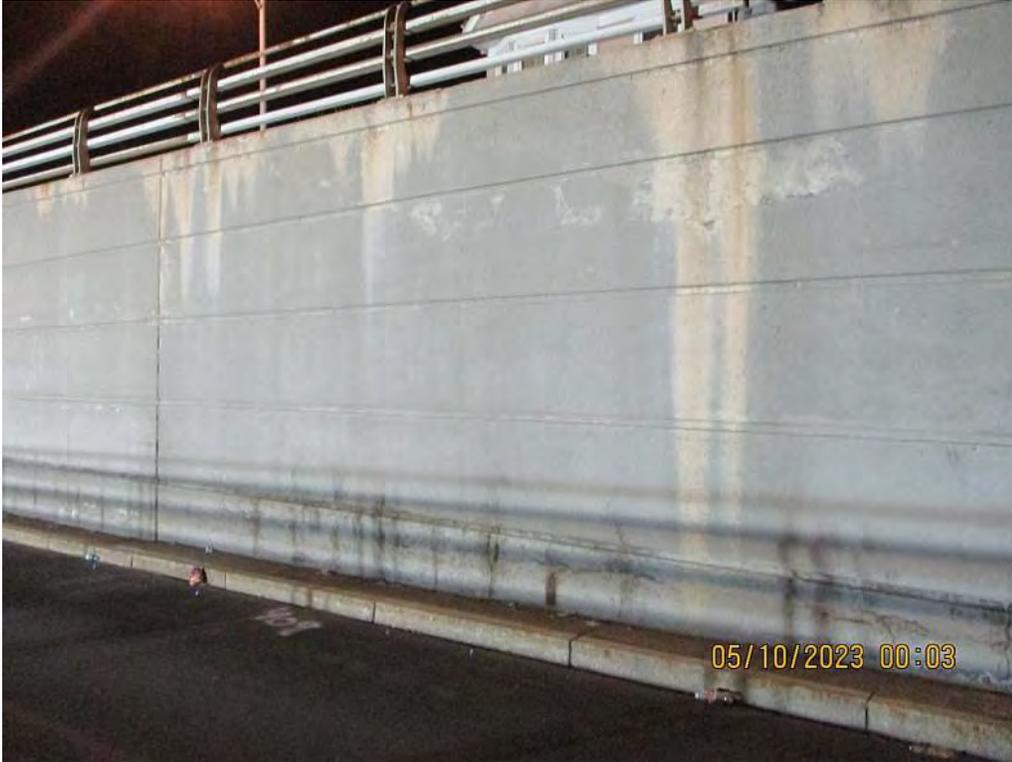
PHOTO 5  
PANEL 409  
Map cracking on bottom panel and coping with scattered rust stains. Map cracking extends full height near the left joint. There is a 4' wide area of map cracking in the second panel from the top.  
To the left of the map cracking, there is a 12' high vertical crack with 1' wide delamination on the bottom 3 panels.  
Bottom panel is 100% delaminated with a small spall.

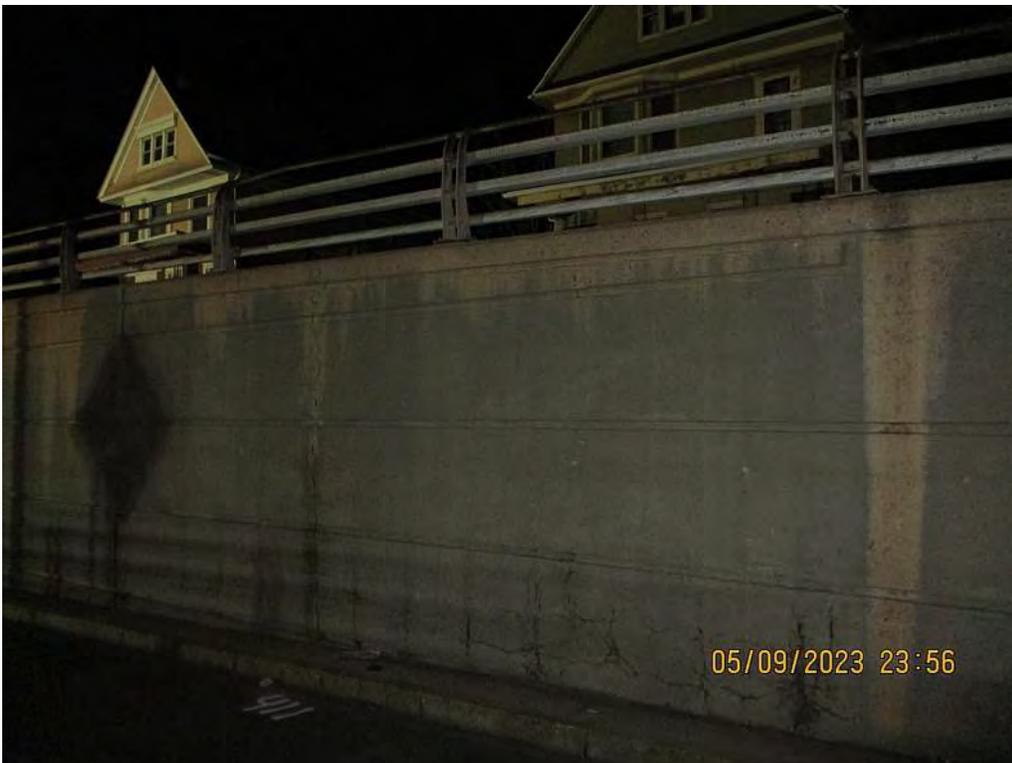
PHOTO 6  
PANEL 411  
Description:  
Map cracking and 75% delamination on bottom panel.  
Full-height crack with 1' wide delamination at 10' from left joint.

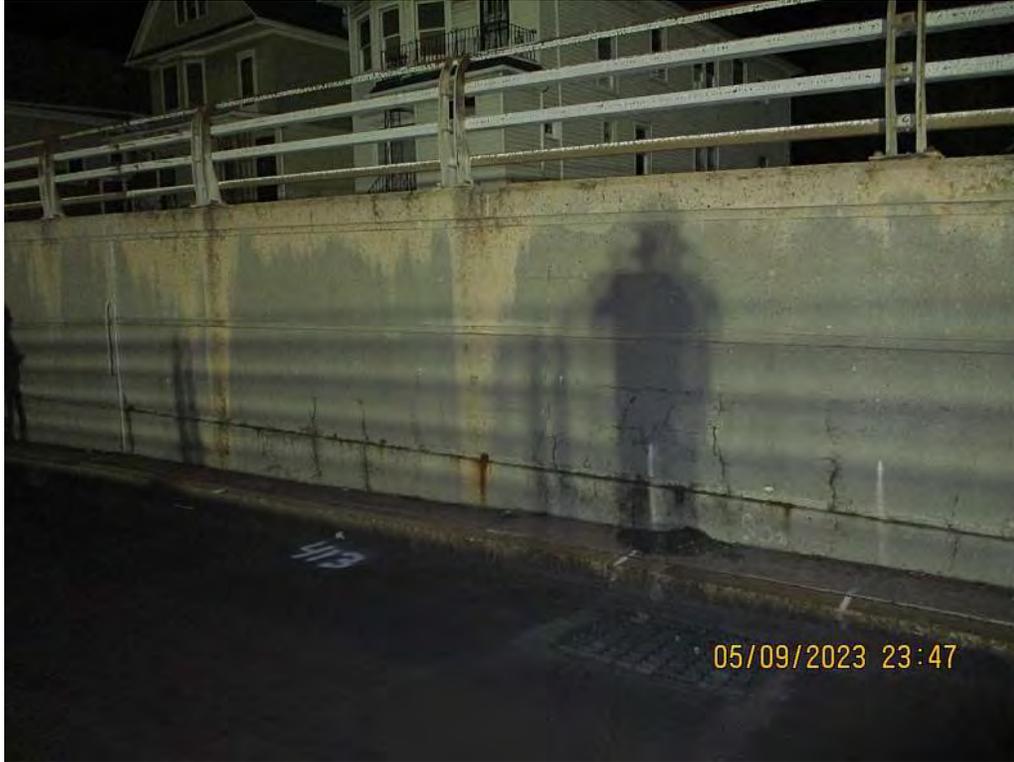
PHOTO 7  
PANEL 413  
Description:  
Map cracking on bottom 2 panels and coping.  
Rust staining and delamination on bottom panel.  
Panel 412 is similar, without rust stains.

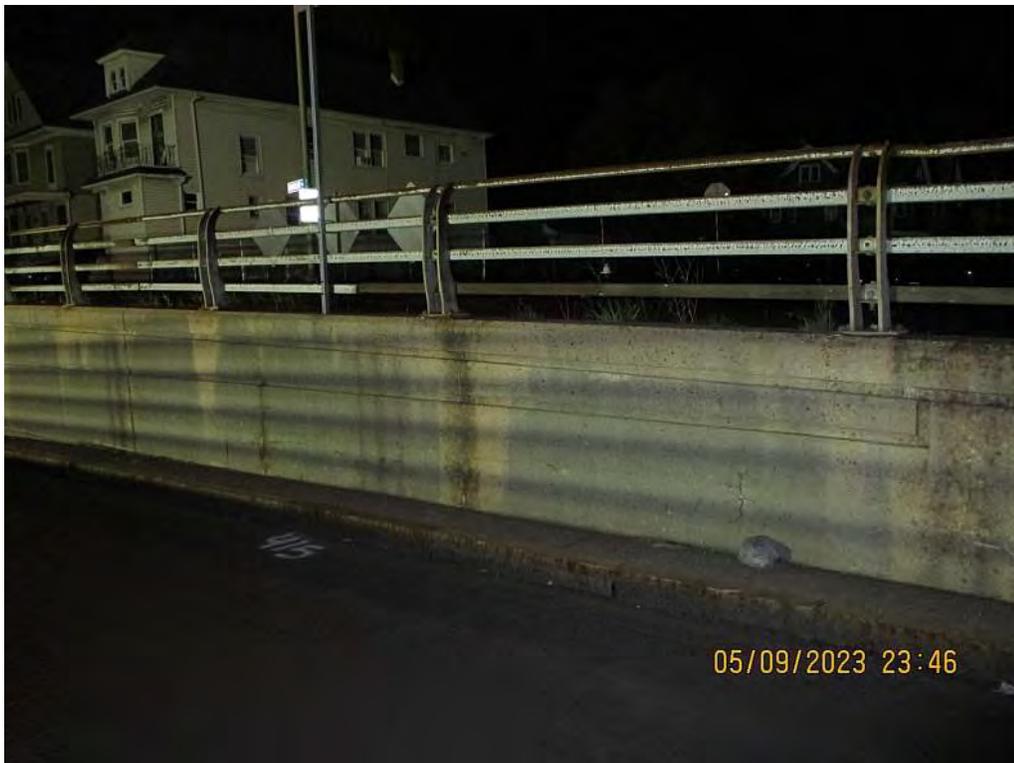
PHOTO 8  
PANEL 415  
Description:  
Scattered map cracking on bottom panel and coping.  
Two full height cracks with 2' wide delamination and minor efflorescence.  
Conditions similar for panel 414.

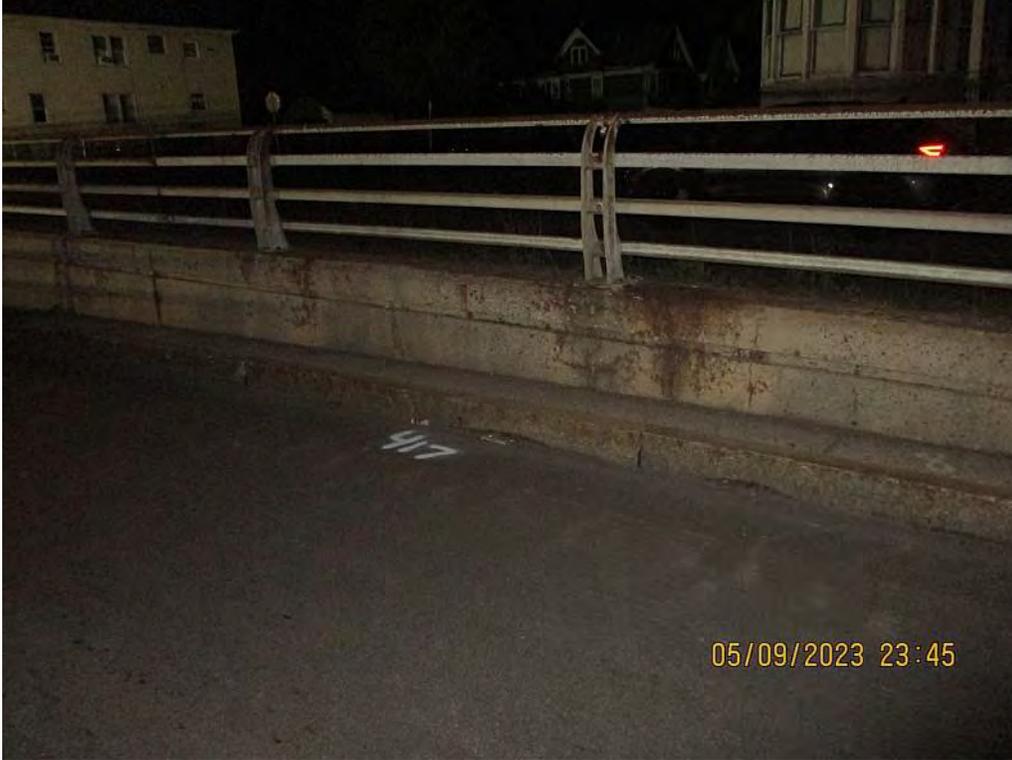
PHOTO 9

Map cracking and rust staining throughout, heaviest near rail posts.

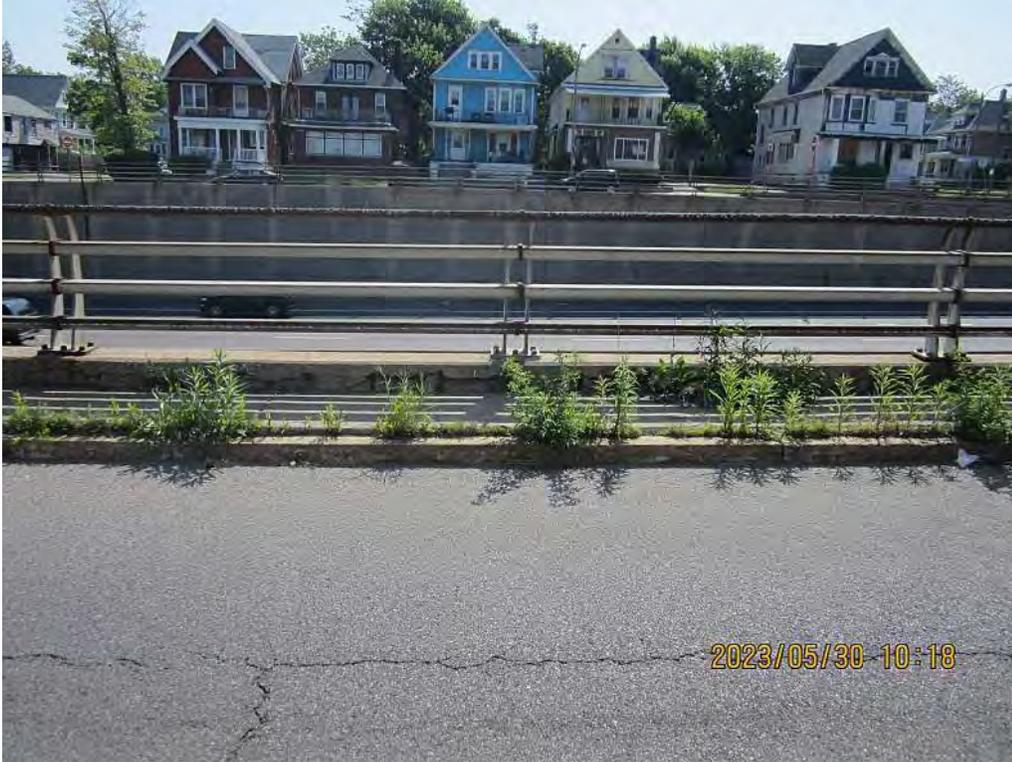
**PHOTO 11**  
Rail Coping (Backside) along Humbolt Parkway

**Description:**  
There is a longitudinal crack at mid-height of the coping for the entire length of the wall.  
The coping is 20% delaminated.  
Spalls with exposed rebar are present over 20% of the area.

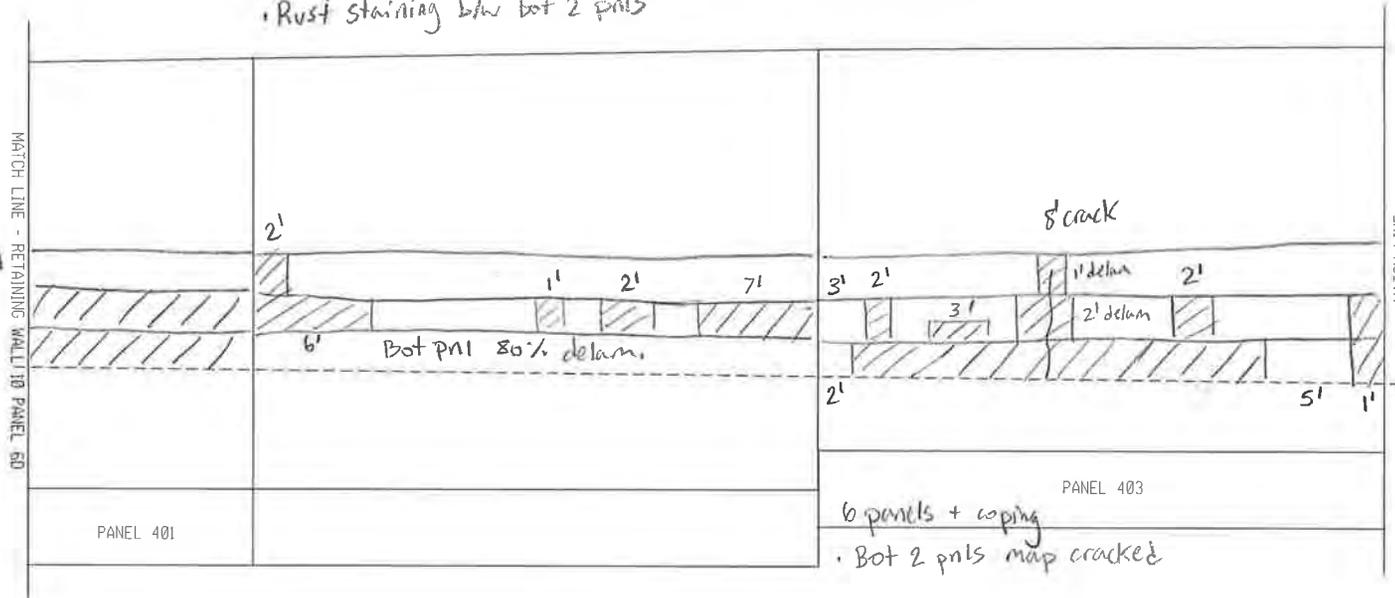
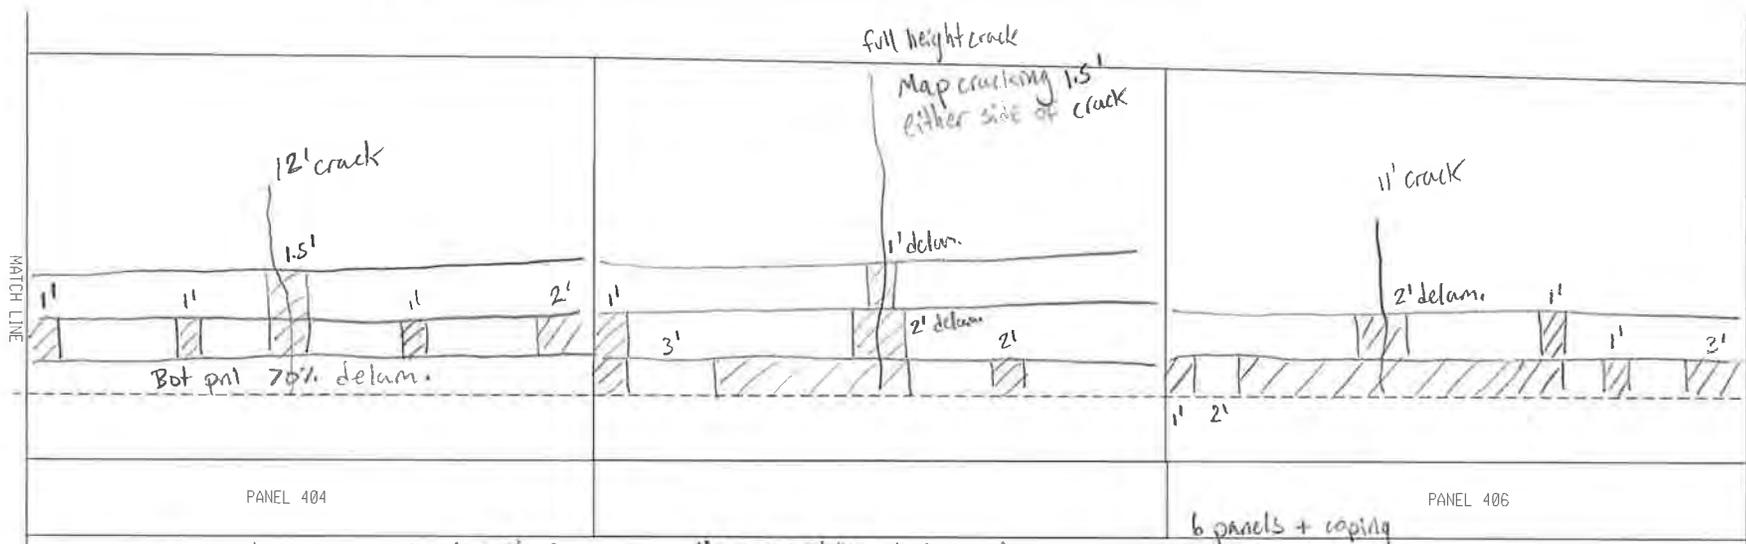
RW 4 PANELS 401-406

- Map crack bot 2 pnls, bot 4 near joints
- Rust staining b/w bot 2 pnls

Scattered map cracking bot pnl

full height crack

Map cracking 1.5' either side of crack

Map cracking bot pnl, scattered rust stain

Map cracking bot pnl

Map cracking bot pnl + coping

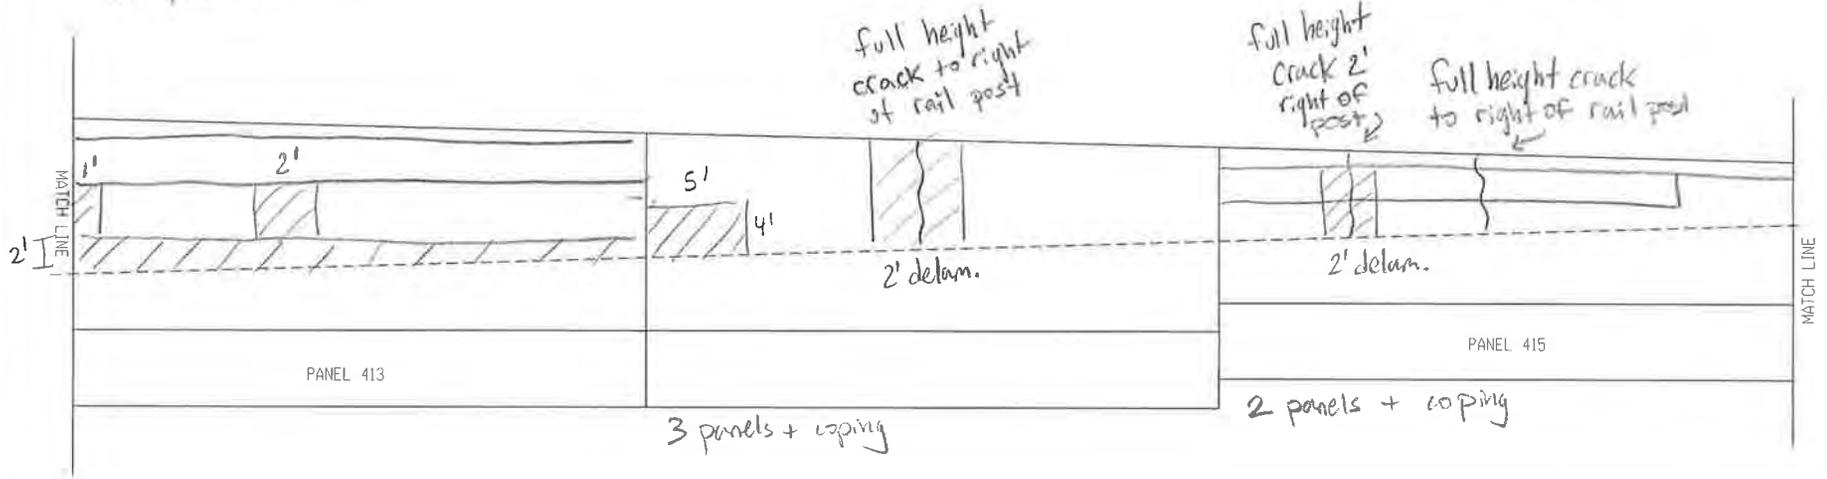
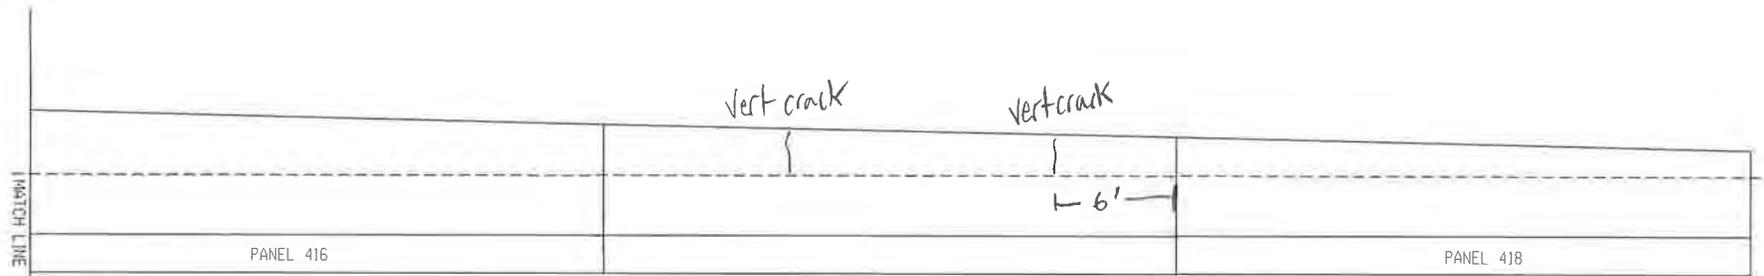
### RW 4 PANELS 413-418

- Map cracking bot 2 panels + coping
- Rust staining bot panel
- Bot panel 100% delam.

- Scattered map cracking on bot 2 panels, worst near joints

- Map cracking on coping
- Scattered map cracking on bot panel

- Longit. crack on coping + map cracking
- Map cracking under rail posts to ground

Map cracking

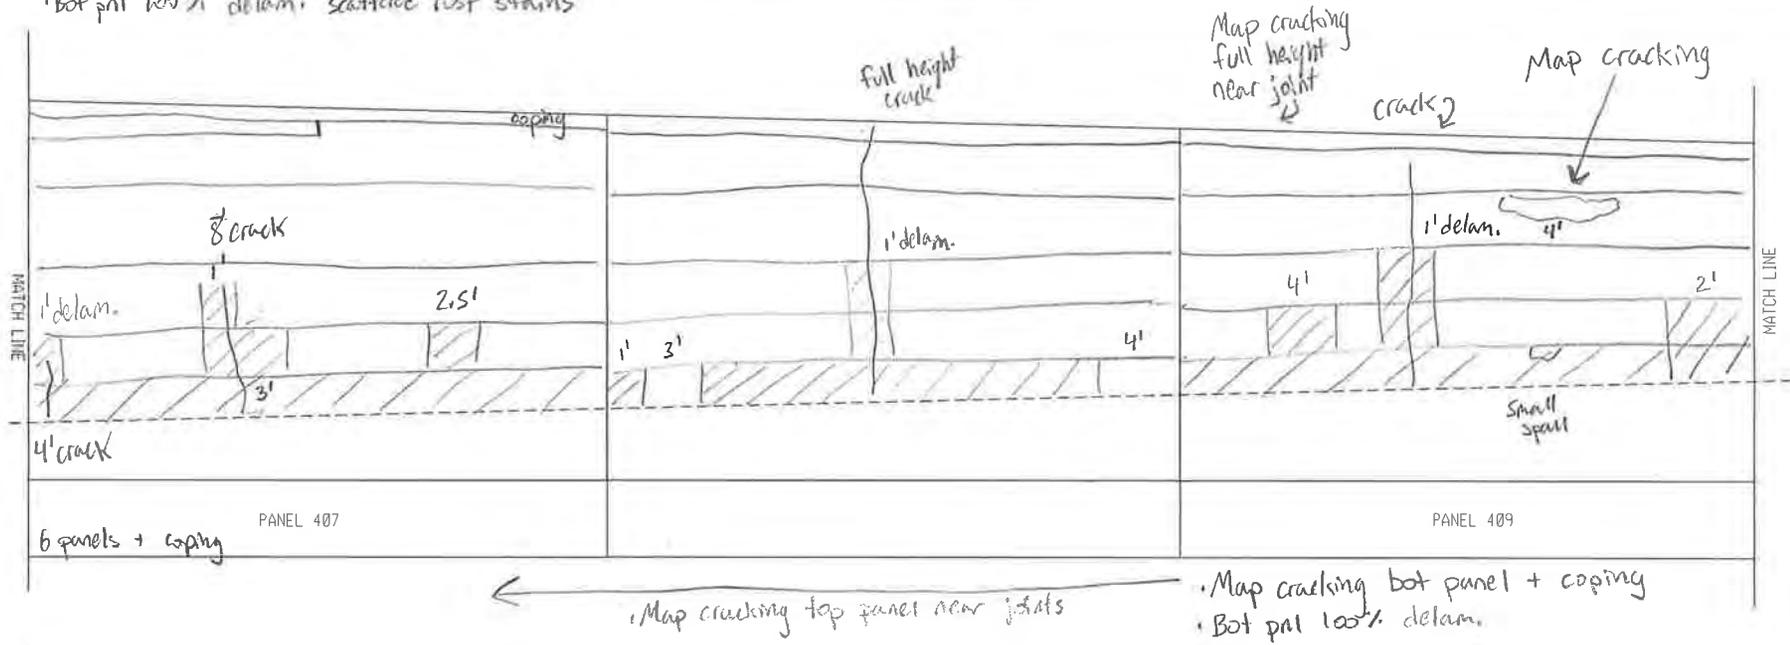
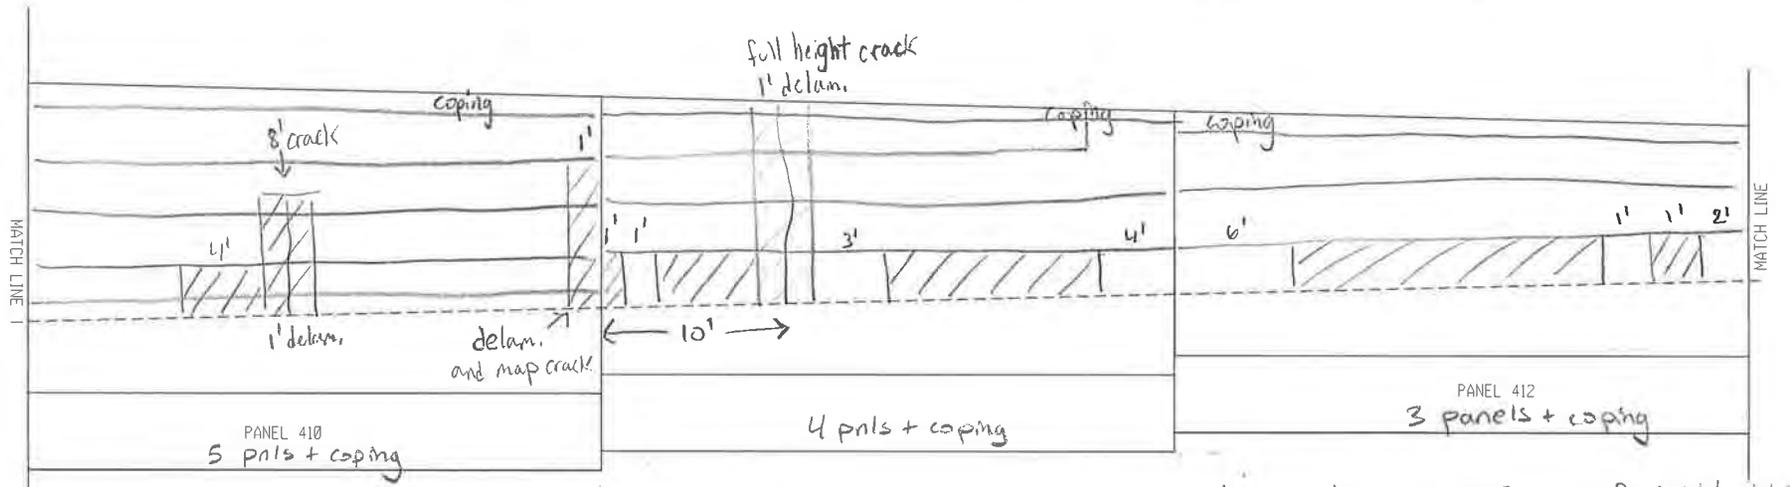
RW 4 PANELS 407-412

• Bot pnl 100% delam. scattered rust stains

← Map cracking top panel near joints

• Map cracking bot panel + coping  
• Bot pnl 100% delam.

scattered map cracking bot 2 panels + coping

Map cracking bot panel

• Map cracking bot 1.5 pnls, full height at joints
