# **Appendix A5**

## Retaining Wall Inspection Reports

**NY33 RETAINING WALL CONDITION EVALUATION 2023**  
**KENSINGTON EXPRESSWAY PROJECT**  
**PIN 5512.52**  
**CITY OF BUFFALO, ERIE COUNTY**  
**RETAINING WALL 1**

# PIN 5512.52 – NY33 RETAINING WALL CONDITION EVALUATION 2023 FIELD INSPECTION SUMMARY

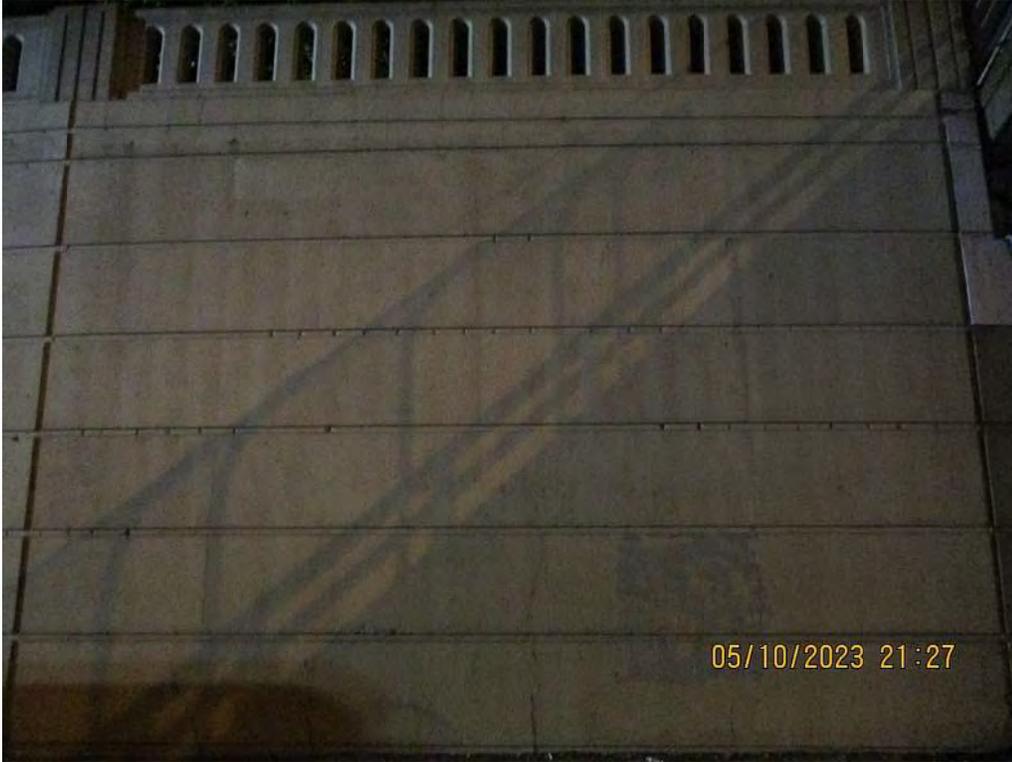
PHOTO 1  
PANEL 7C

Minor map cracking on bottom two panels and coping. Cracking on coping is similar for most of RW8.

Rust staining present at vertical rebar location in between most panel chamfers.

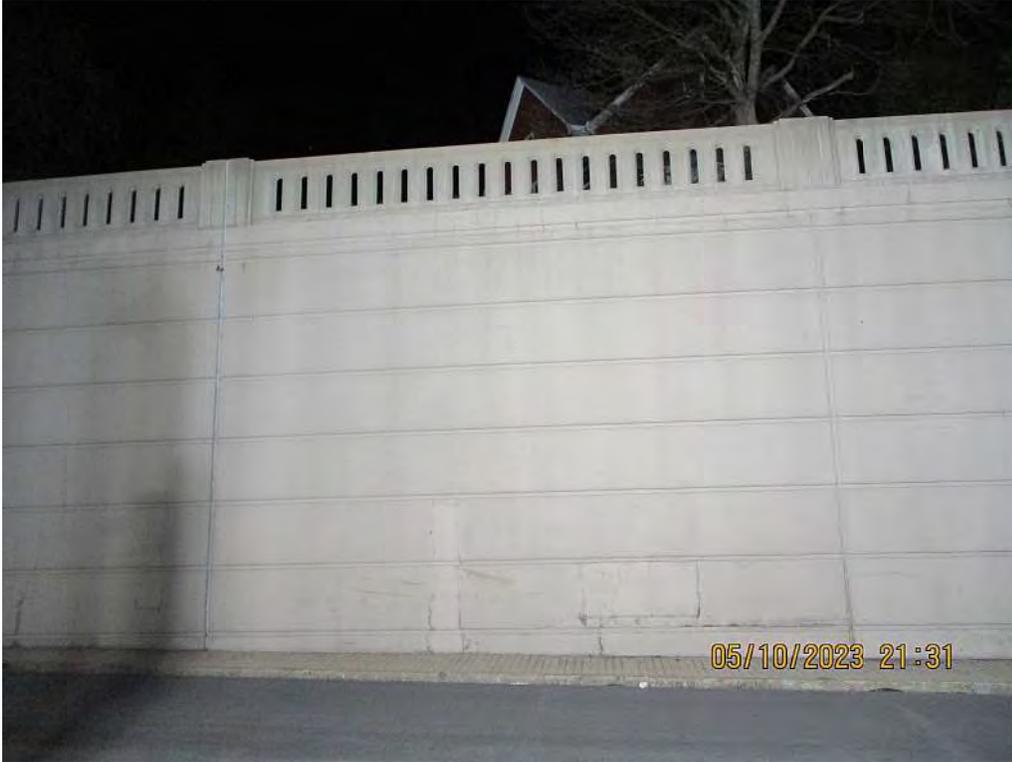
PHOTO 3  
PANEL 6A

Minor cracking on bottom two panels and coping. Similar for 6B and 5C.

One of the repaired areas is cracking.

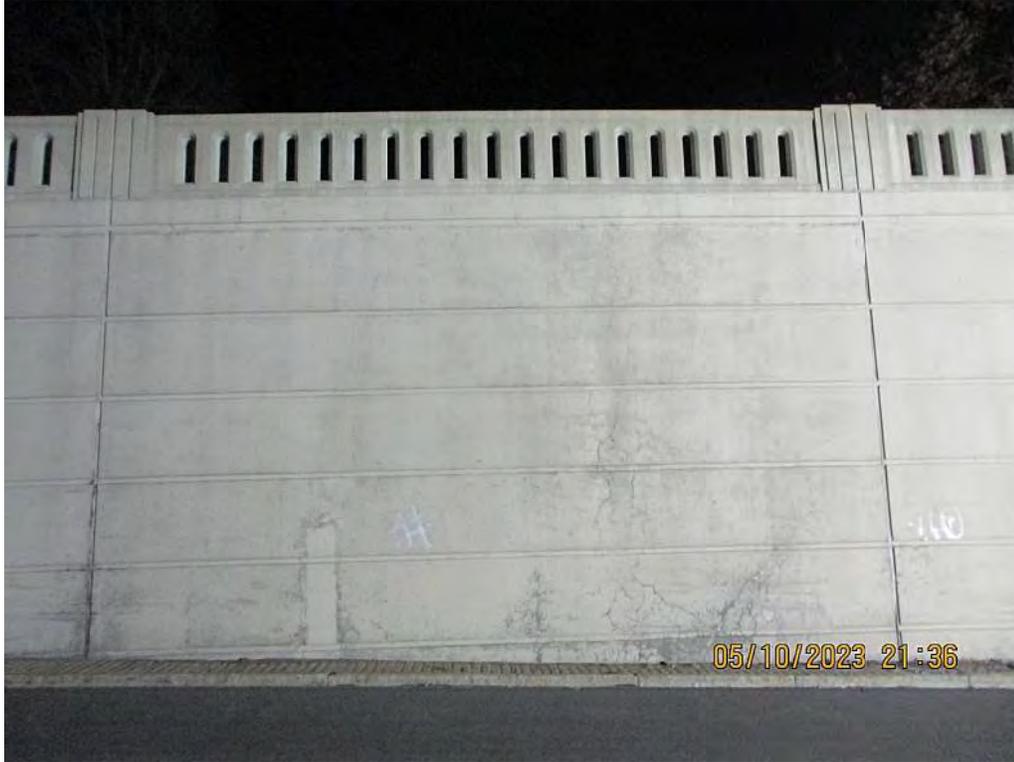
PHOTO 5  
PANEL 4B

Minor cracking on coping, typical.

The top panel has areas of spalling on the edge below the coping.

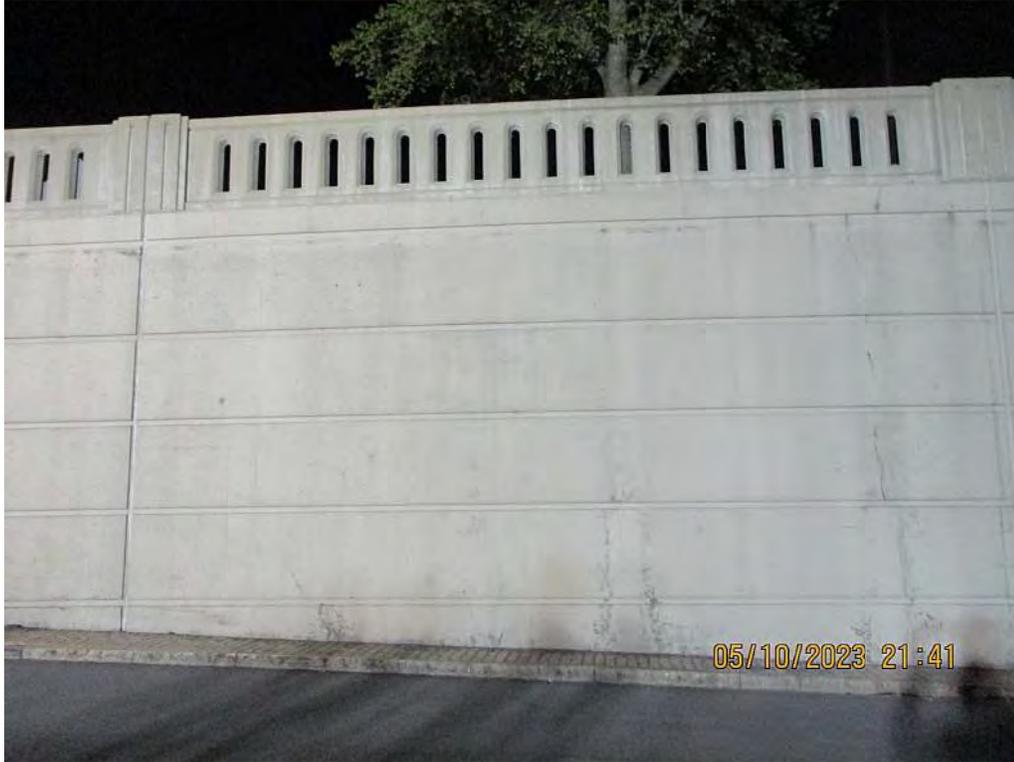
PHOTO 7  
PANEL 4A.1

Above the repaired area near the right joint, there is a 9' vertical crack that extends to the coping.

The top panel has areas of spalling on the edge below the coping.

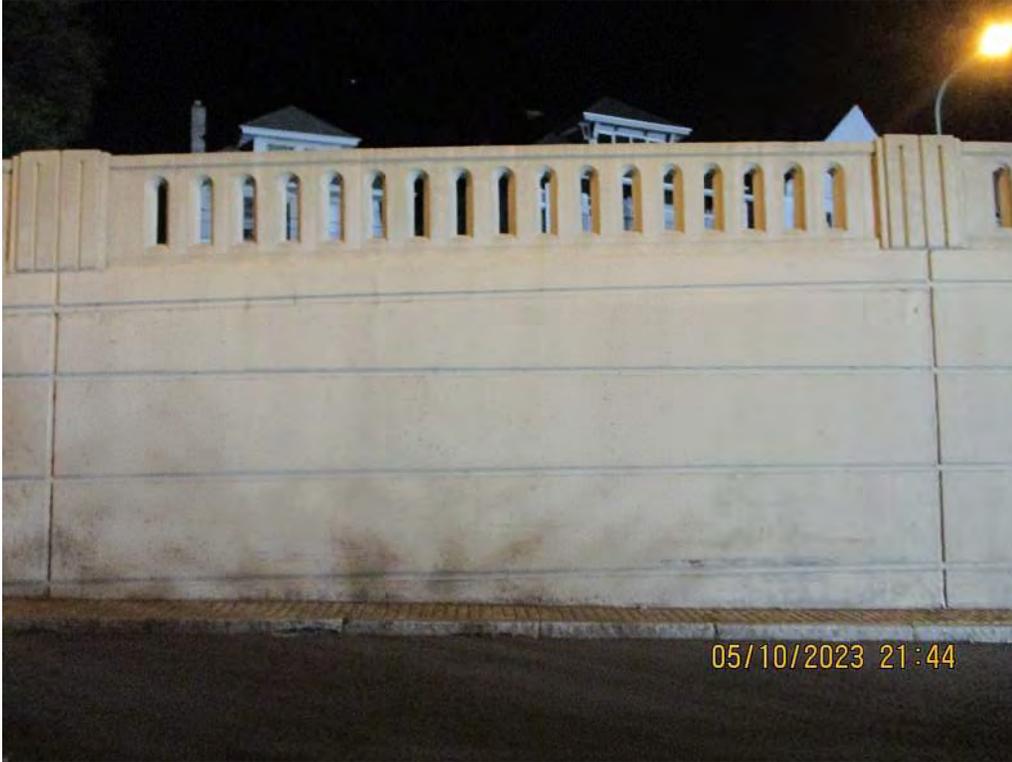
PHOTO 9  
PANEL 2C  
Description:  
Minor cracking on coping, typical.  
Isolated map cracking near bottom of left joint. Continues onto Panel 2B.

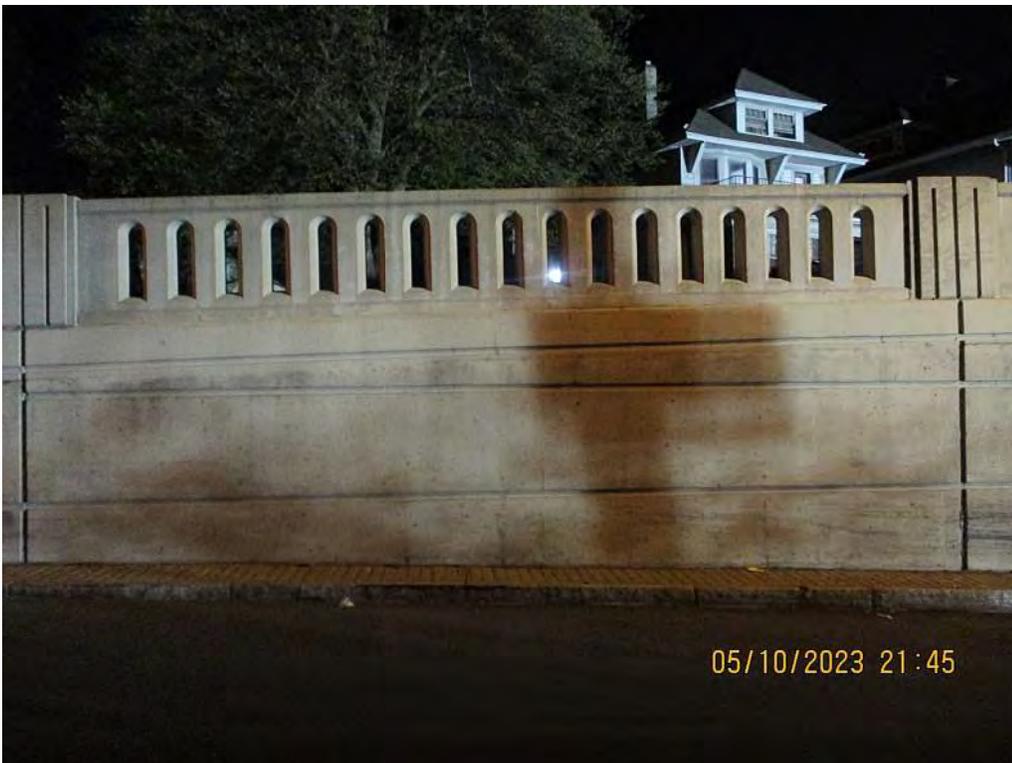
PHOTO 10  
PANEL 2A  
Description:  
Minor cracking on coping, typical.  
Scattered vertical crack throughout.

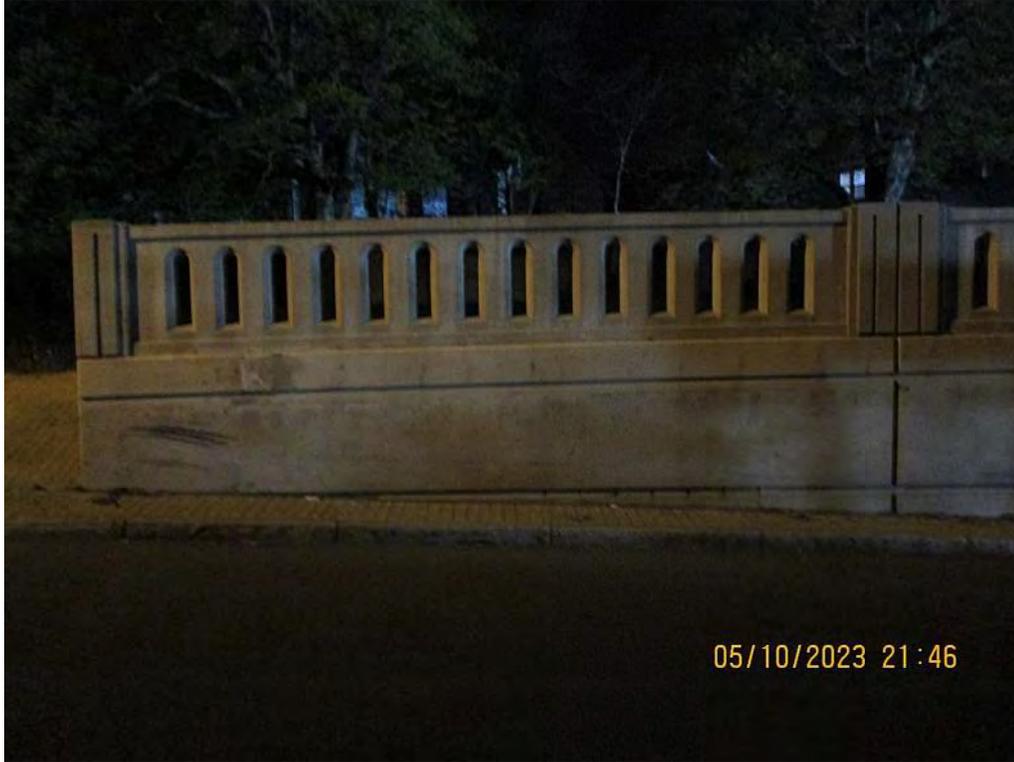
PHOTO 11  
PANEL 1A  
Description:  
End of RW8.  
Minor cracking on coping, typical.  
Rust staining present at vertical rebar locations in lower chamfer.

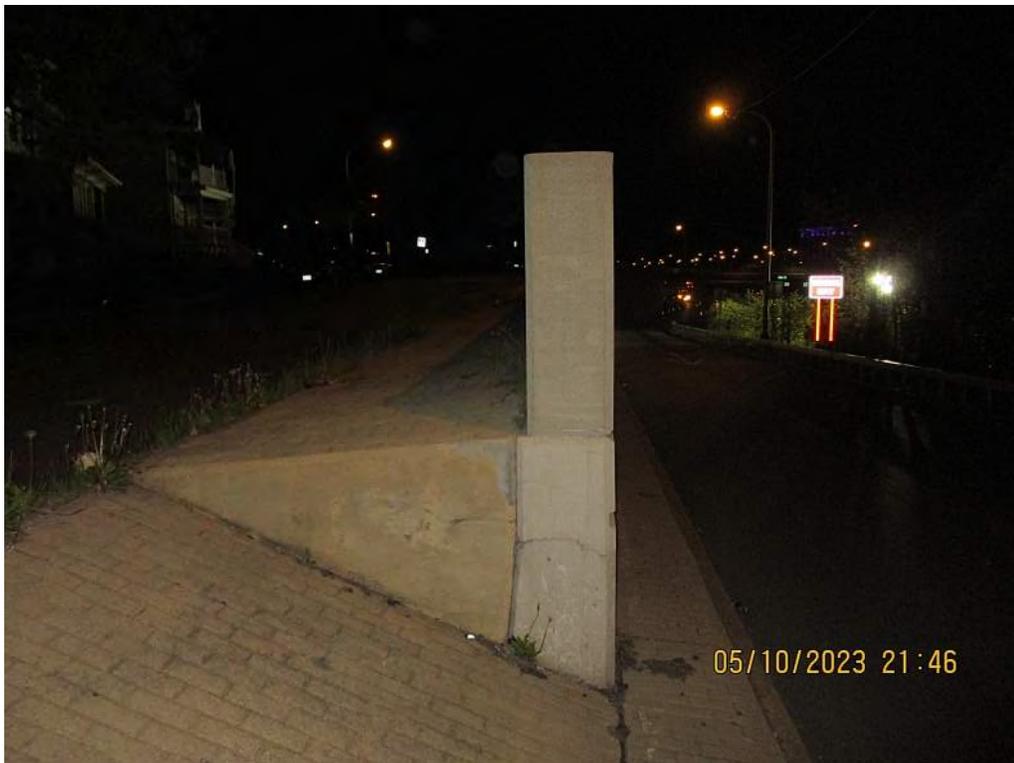
PHOTO 12  
PANEL 1A (END)  
Description:  
Full depth longitudinal crack right below coping for full length of panel.  
Fill behind wall is in good condition.

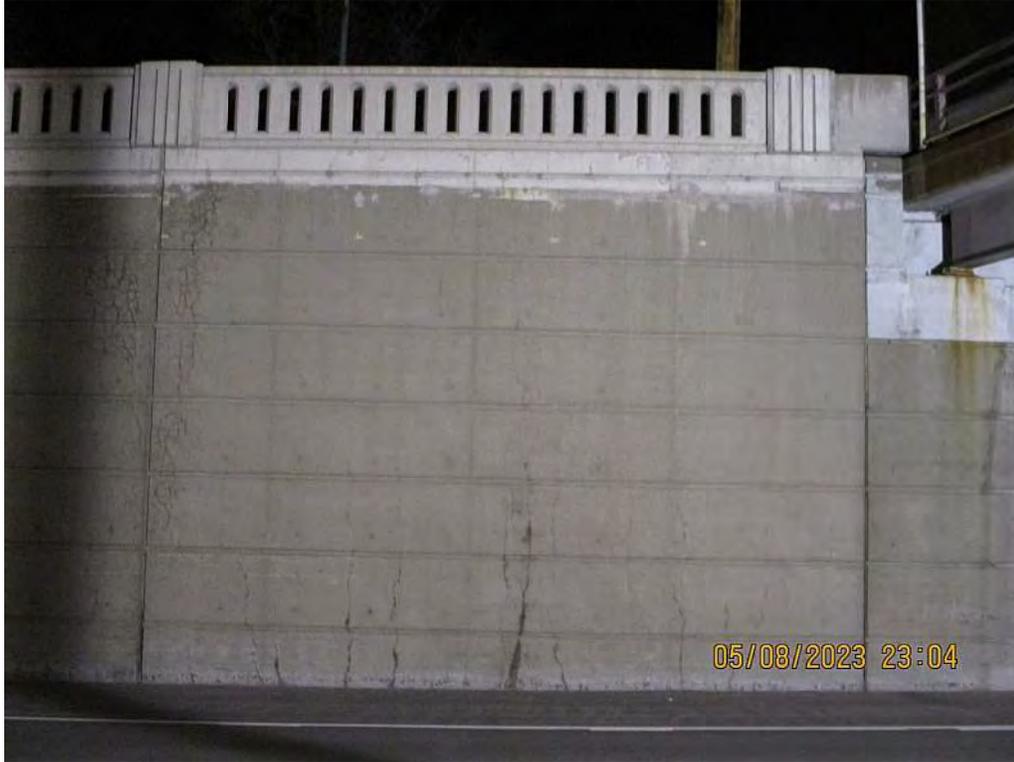
PHOTO 1  
PANEL 8.3  
Description:  
End RW9. Right of Northampton St bridge west abutment.  
Staining on top panel is typical for all panels.  
Scattered vertical cracks on the bottom three panels.  
Map cracking is present in the top 5 panels near the left joint for 3'.  
There is a 16' vertical crack at midspan of the panel.

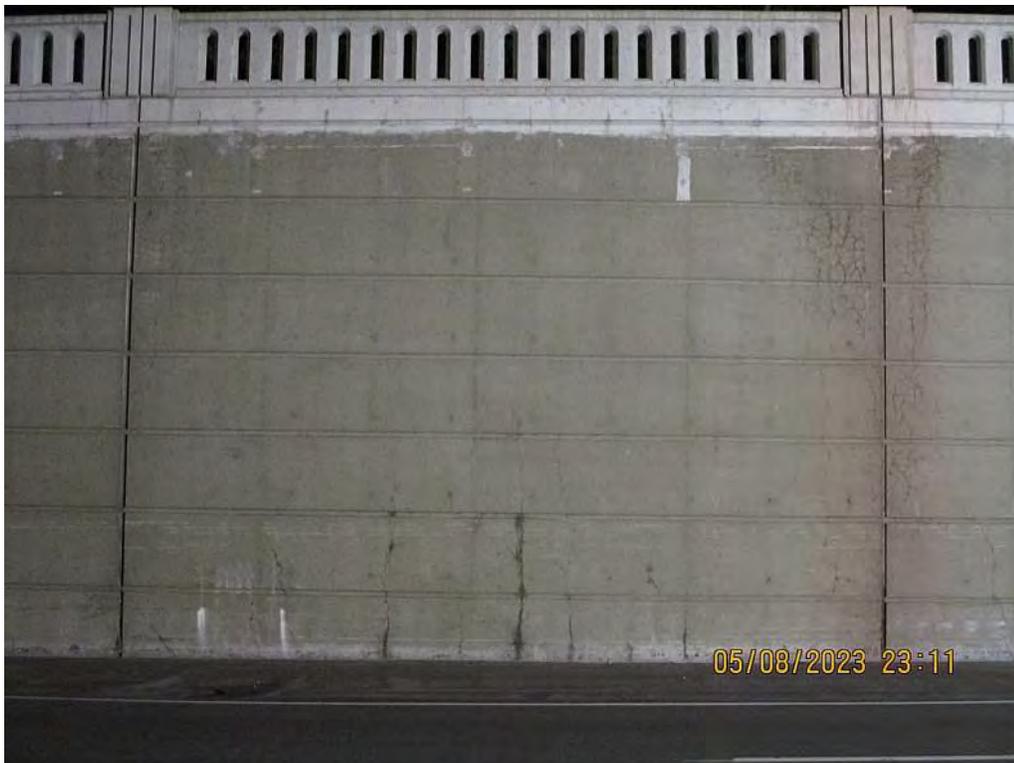
PHOTO 2  
PANEL 8.2  
Description:  
Staining on top panel is typical for all panels.  
Scattered map cracking on the bottom three panels.  
Map cracking is present for 3' to 5' from the right joint for the full height. Also, for 3' from the left joint for the top three panels.  
There is a 13' vertical crack at midspan of the panel.  
Panels 8.1 and 7.2 are similar with smaller areas of map cracking.

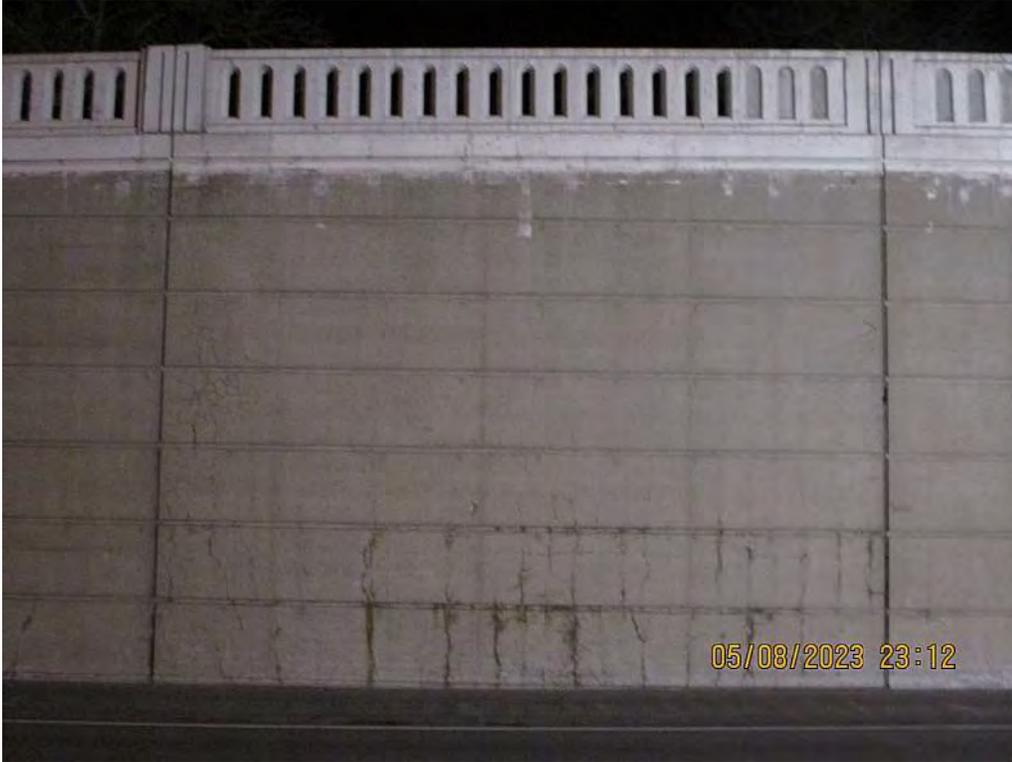
PHOTO 3  
PANEL 7.3  
Description:  
Staining on top panel is typical for all panels.  
There is map cracking and 70% delamination on the bottom three panels. Map cracking reaches higher near the joints - 5 panels near the right joint, and full height near the left joint.

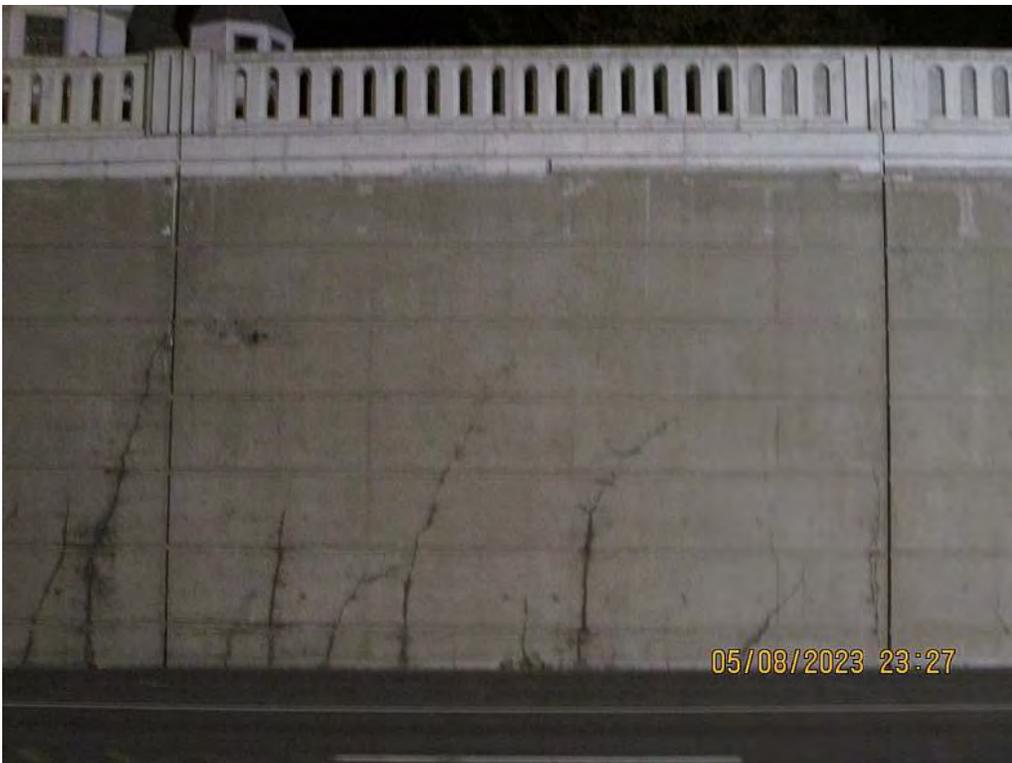
PHOTO 4  
PANEL 5.3  
Description:  
There are several long vertical / right leaning cracks. Longest is 14'. There is some map cracking near these long cracks and in bottom panel.  
The 7' crack near the right joint is delaminated.  
There is a 1' spall in the fifth panel from the bottom.  
Panel 6.3 is similar without spalls.

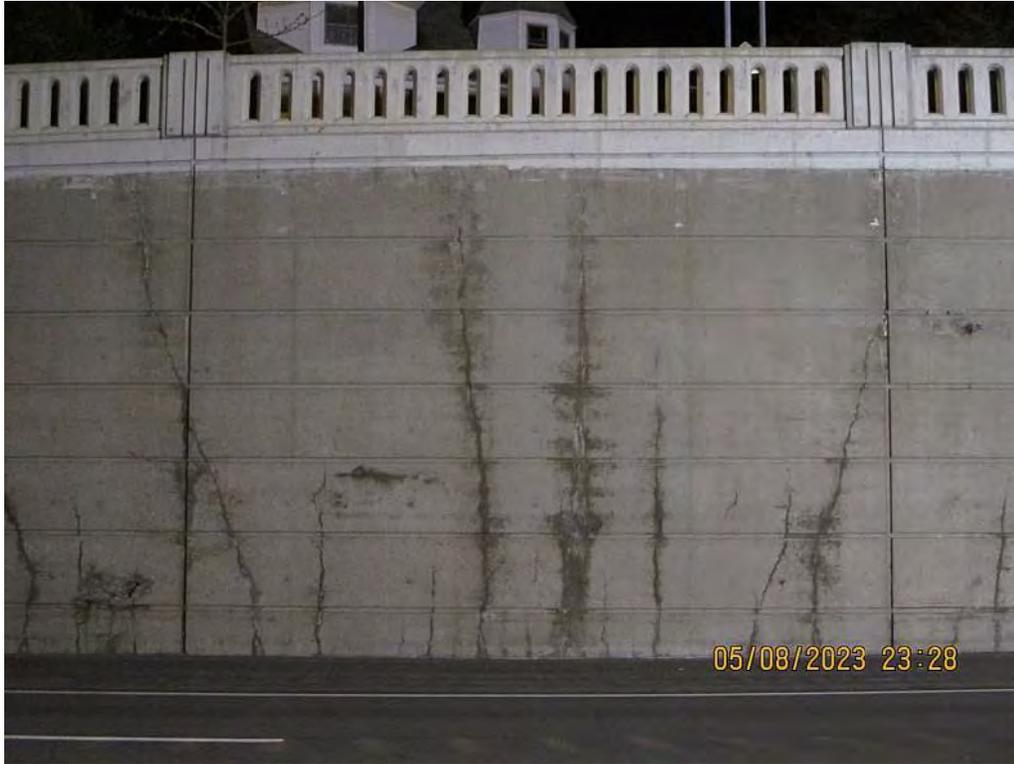
PHOTO 5

There are a few isolated areas of delamination.

Panel 6.2 is similar without spalls

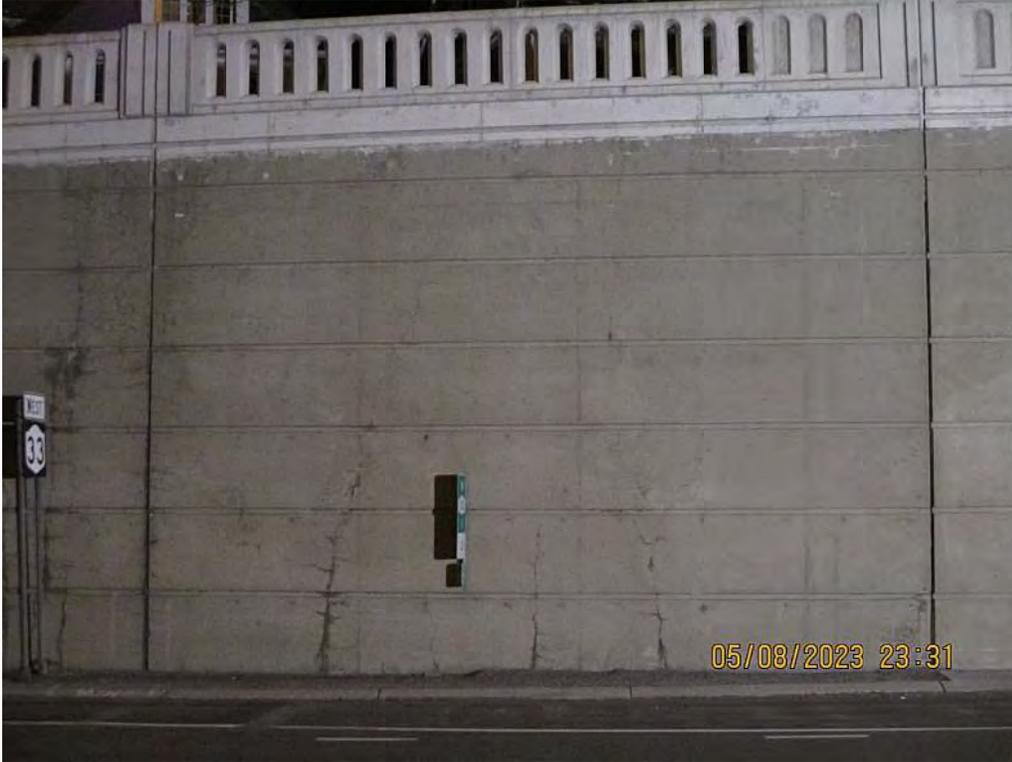
PHOTO 7  
PANEL 3.3

There is scattered map cracking in the bottom 3 panels. Map cracking extends the full height for 2' near the left joint.

Panel 4.3 is similar.

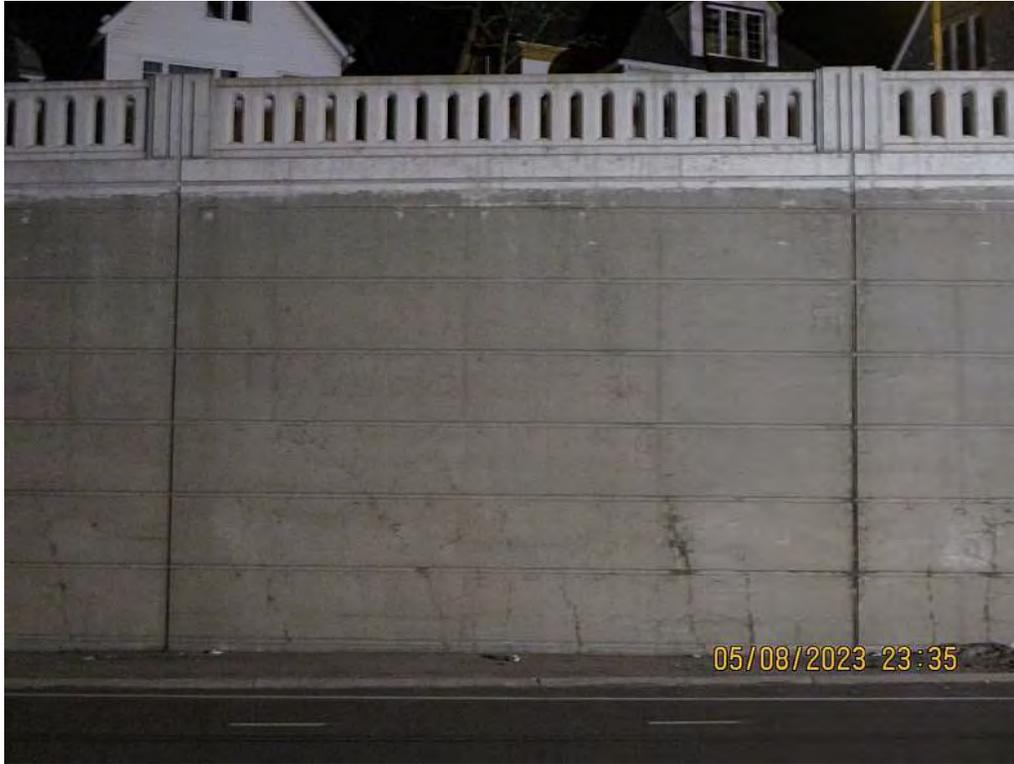
PHOTO 9

The bottom 3 to 5 panels are map cracked. There is full-height map cracking for 1' to 2' from the right joint.

Panel 4.1 is similar.

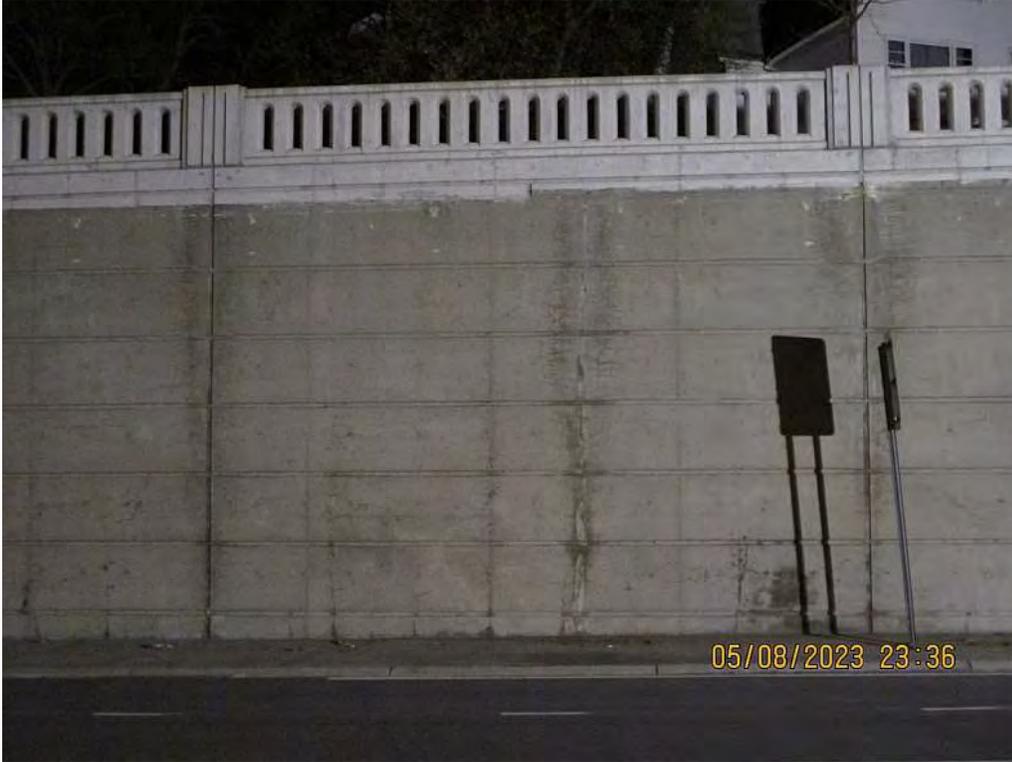
PHOTO 11

There is a full-height vertical crack with efflorescence near midspan of the panel. There are a few other long vertical cracks.

Map cracking bottom 4 panels. Map cracking extends full-height near joints and center of panel.

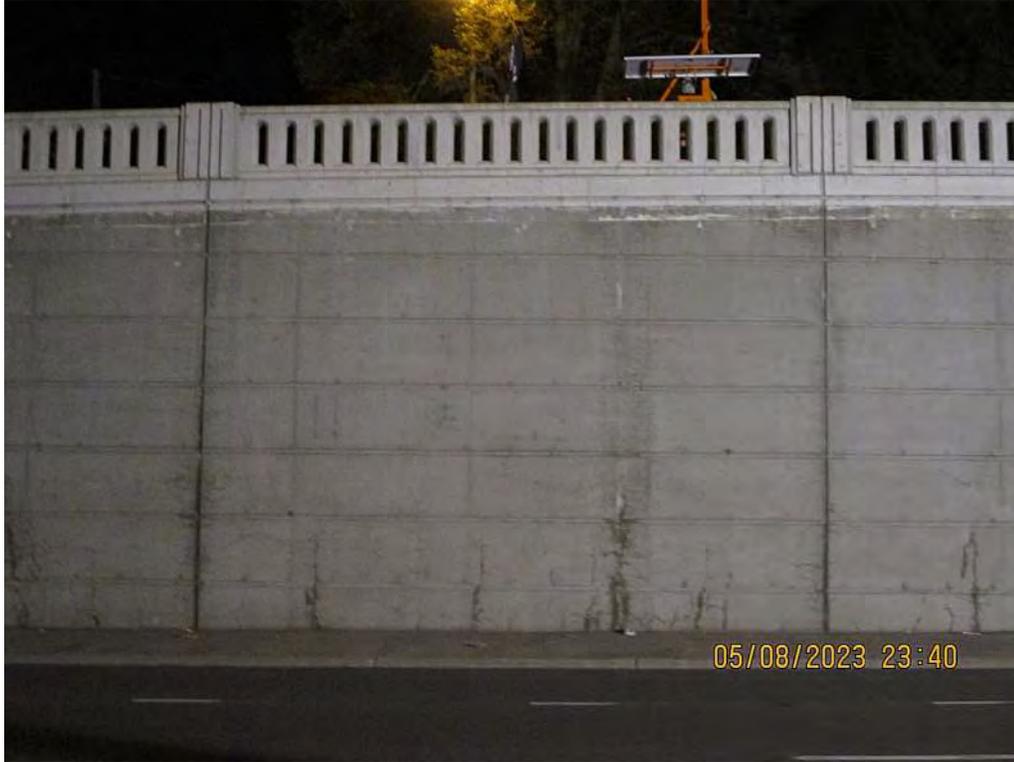
PHOTO 13  
PANEL 1.2  
Description:  
Full-height crack and 5' crack with efflorescence near midspan of panel.  
Map cracking bottom 4 panels. Map cracking extends to full-height near left joint and full-height crack.  
Small spall 6' off the ground closer to left joint.

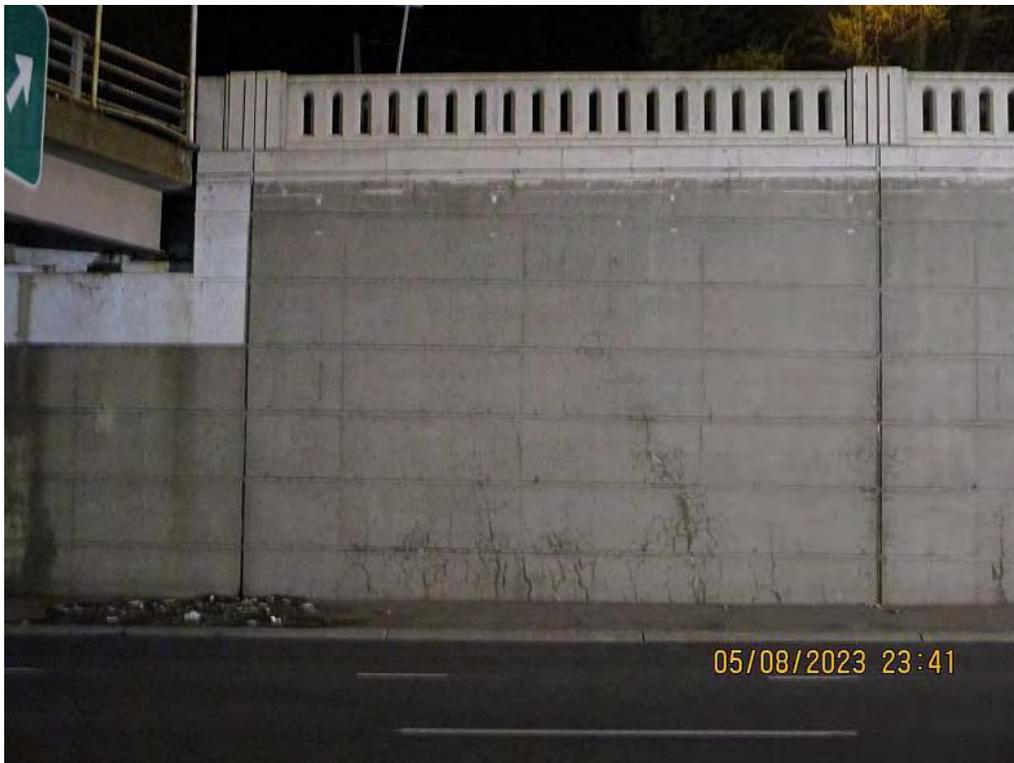
PHOTO 14  
PANEL 1.1  
Description:  
Begin RW9. Left of Dodge St bridge west abutment.  
There is a 13' long vertical / left leaning crack with 2' wide delamination in the bottom panel.  
There is a 5' high isolated area of delamination near the right joint.  
Map cracking bottom 4 panels.  
Small spall 6' off the ground closer to left joint.

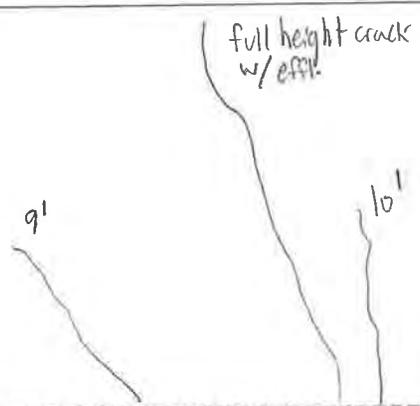
- Map Cr. Bot 5 pnts, worst for bot 3
- Map Cr. near right jnt 1' to 2'

(8 panels) 3.1  
(Bot pnt 6")

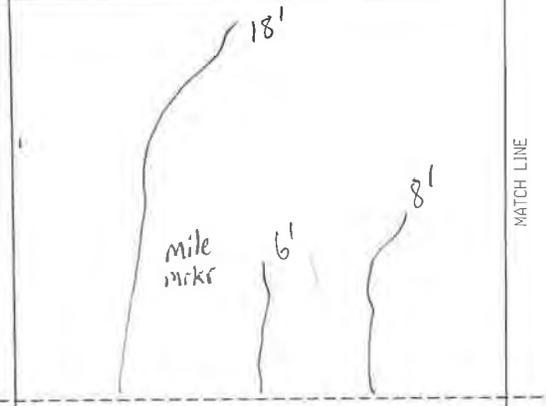
- Scattered Map Cr. bot 3 pnts
- Map Cr. full height for 2' from left jnt

(7 panels) 3.3

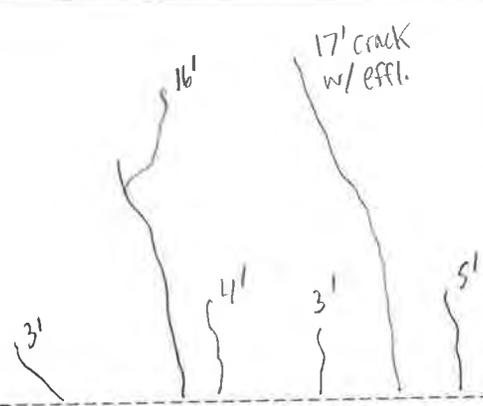
4.1  
Minimal Map cr. bot pnt

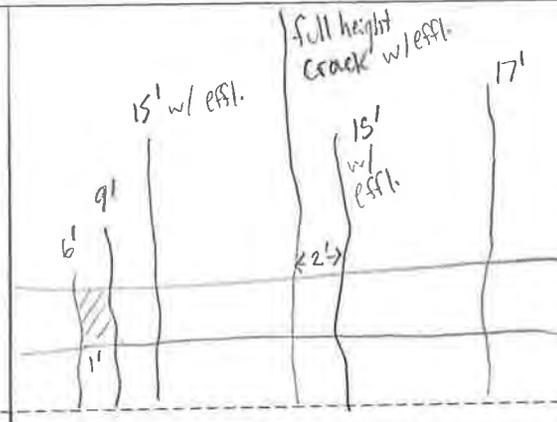
4.2  
PANEL 4 (3 SECTIONS)  
Map Cr. bot 3 pnts, higher near cracks

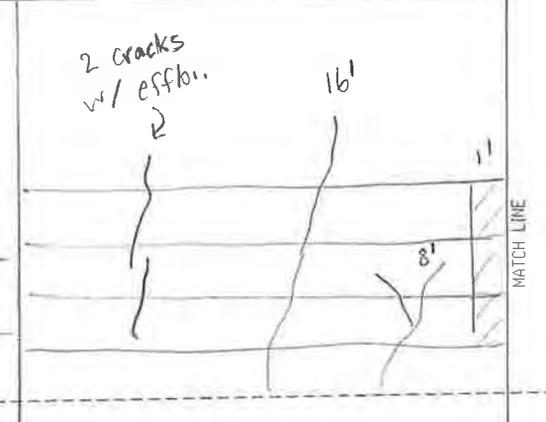
(7 panels) 4.3  
Map cracking bot 4 pnts, worse for bot 2

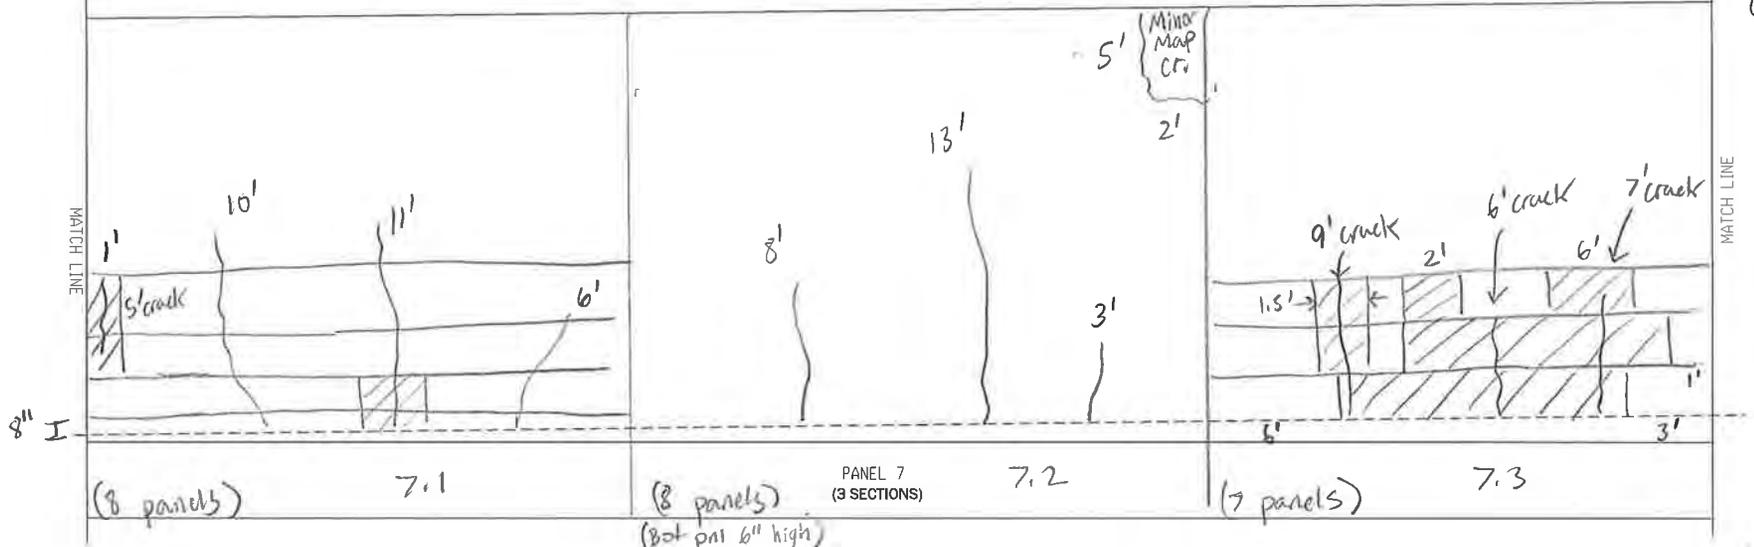
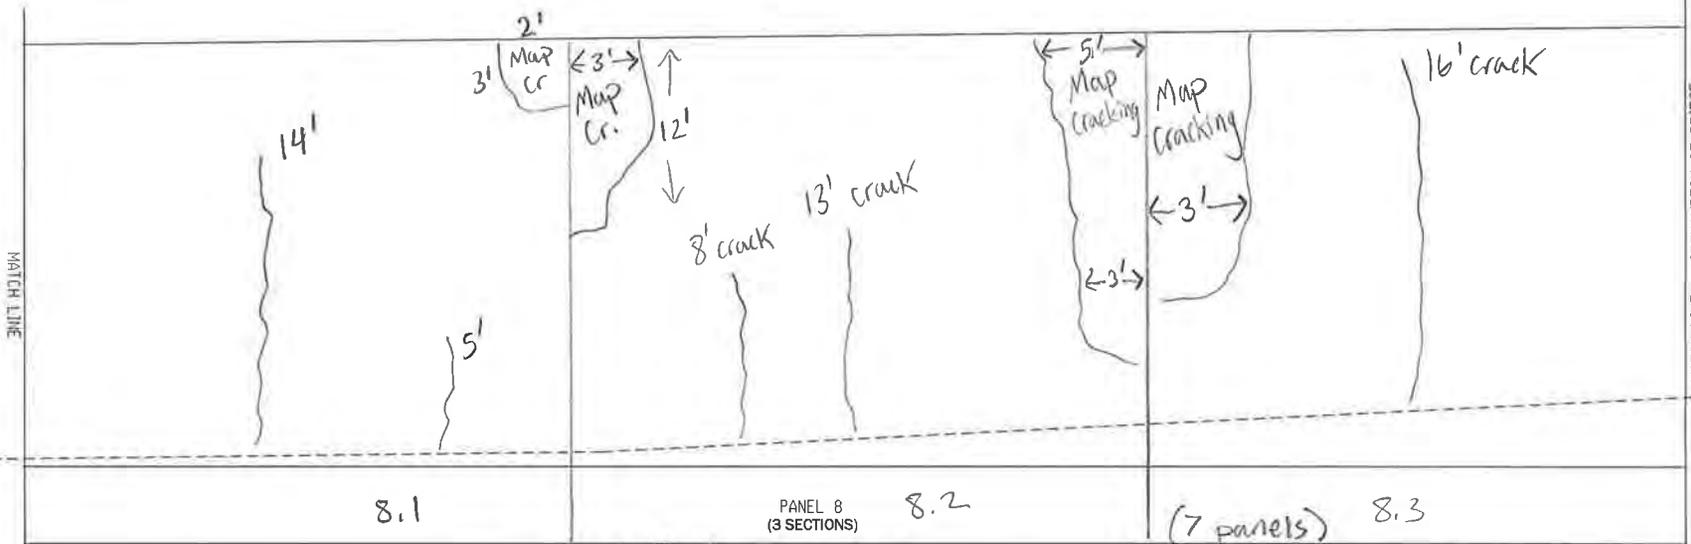
RW 9 PANELS 7-8

• Sparse vert. cracks bot 2 pnls

• Map cracking bot 3 pnls, 5 pnls near right joint, full height near left joint (3 to 4' from joint)

• Scattered vert. cracks bot pnt

• Scattered map cracking bot 3 pnls

• Scattered vert. cracks bot 3 pnls

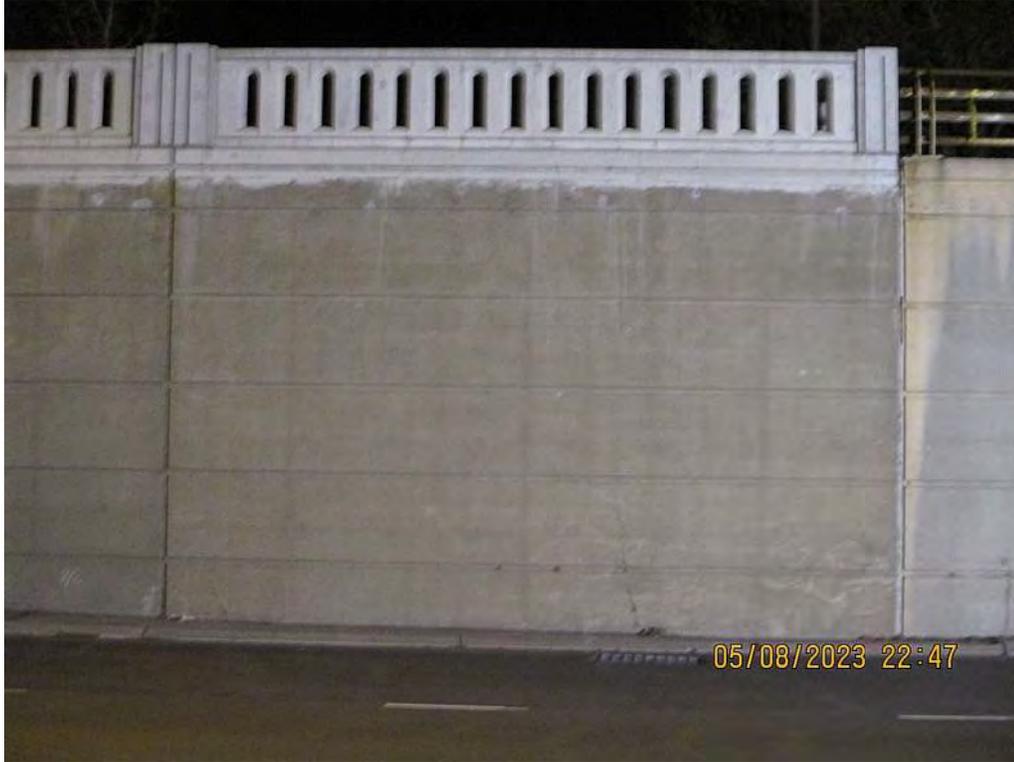
#### E Ferry to Wall end:

PIN 5512.52 Kensington Expressway  
Retaining Wall #1 (RT) along 33EB between Off Ramp to NB Humboldt Parkway and Pedestrian Bridge

## Calculations

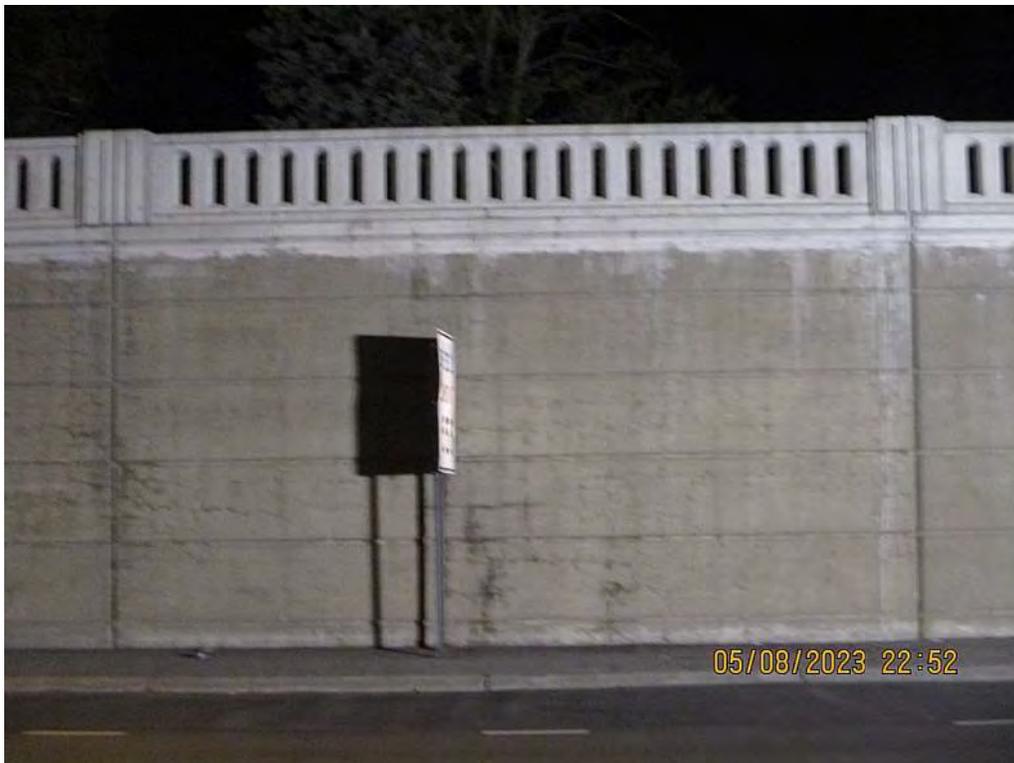
| Panel | Minor/Map Crack (sf) | Major Cracks (ft) | Spalls (sf) | Widespread Delam (sf) | Isolated Delam (sf) | Other (staining, efflor., etc.) |

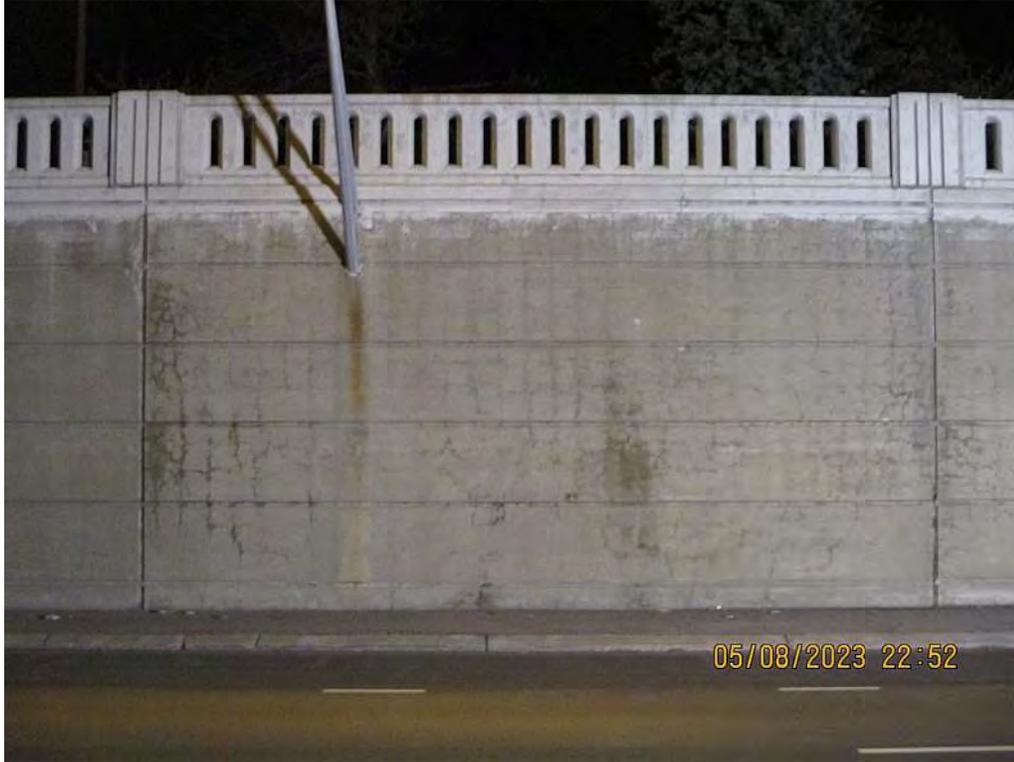
| Panel | Minor/Map Crack (sf) | Major Cracks (ft) | Spalls (sf) | Widespread Delam (sf) | Isolated Delam (sf) | Other (staining, efflor., etc.) |
|---|---|---|---|---|---|---|
| 104 | | | 8.5 | | 28.5 | |

| Panel | Minor/Map Crack (sf) | Major Cracks (ft) | Spalls (sf) | Widespread Delam (sf) | Isolated Delam (sf) | Other (staining, efflor., etc.) |
|---|---|---|---|---|---|---|
| 107 | 48.6 | | 1.0 | | 15.0 | |
| 108 | 60.8 | 10.9 | 3.0 | | | |

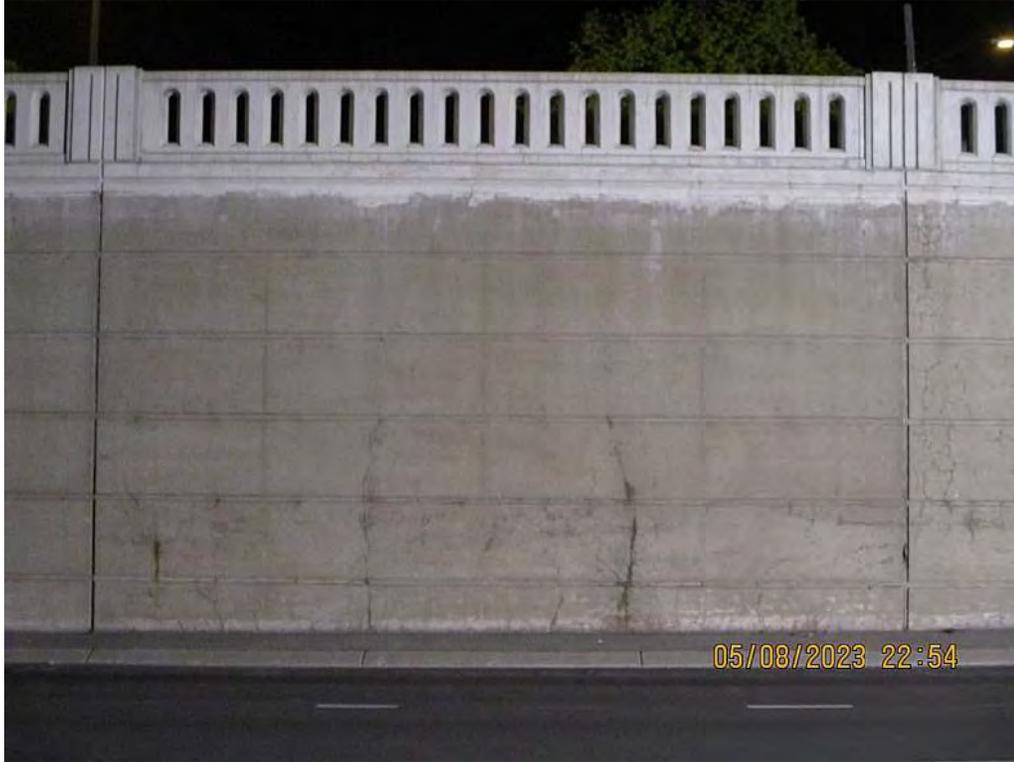
| Panel | Minor/Map Crack (sf) | Major Cracks (ft) | Spalls (sf) | Widespread Delam (sf) | Isolated Delam (sf) | Other (staining, efflor., etc.) |
|---|---|---|---|---|---|---|
| 117 | 22.5 | 19.0 | | | 12.0 | |

| Panel | Minor/Map Crack (sf) | Major Cracks (ft) | Spalls (sf) | Widespread Delam (sf) | Isolated Delam (sf) | Other (staining, efflor., etc.) |
|---|---|---|---|---|---|---|
| 120 | | | 30.0 | 30.0 | | |
| 121 | | | 9.0 | 9.0 | | |

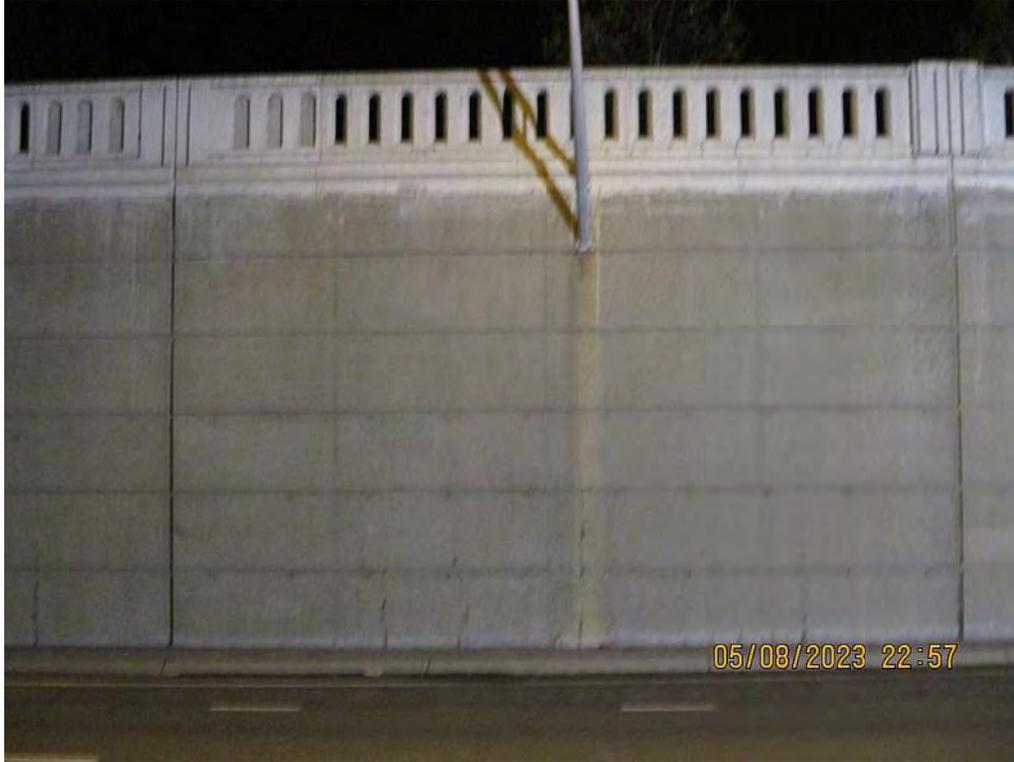
| Panel | Minor/Map Crack (sf) | Major Cracks (ft) | Spalls (sf) | Widespread Delam (sf) | Isolated Delam (sf) | Other (staining, efflor., etc.) |
|---|---|---|---|---|---|---|
| 129 | 112.5 | | | | 15.0 | |

| Panel | Minor/Map Crack (sf) | Major Cracks (ft) | Spalls (sf) | Widespread Delam (sf) | Isolated Delam (sf) | Other (staining, efflor., etc.) |
|---|---|---|---|---|---|---|
| 133 | 63.0 | | | 175.0 | | |
| 134 | | 17.0 | | | | |
