# **Appendix A5**

## Retaining Wall Inspection Reports

**NY33 RETAINING WALL CONDITION EVALUATION 2023**  
**KENSINGTON EXPRESSWAY PROJECT**  
**PIN 5512.52**  
**CITY OF BUFFALO, ERIE COUNTY**  
**RETAINING WALL 1**

# PIN 5512.52 – NY33 RETAINING WALL CONDITION EVALUATION 2023 FIELD INSPECTION SUMMARY

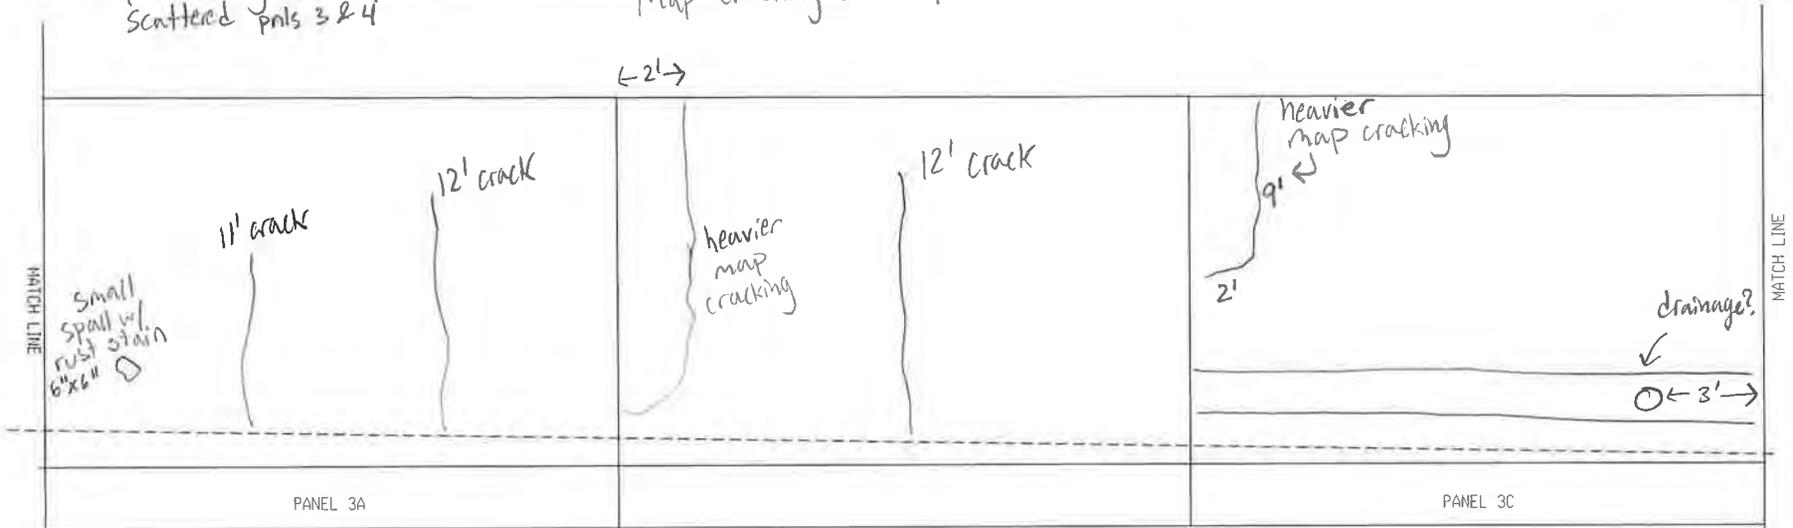
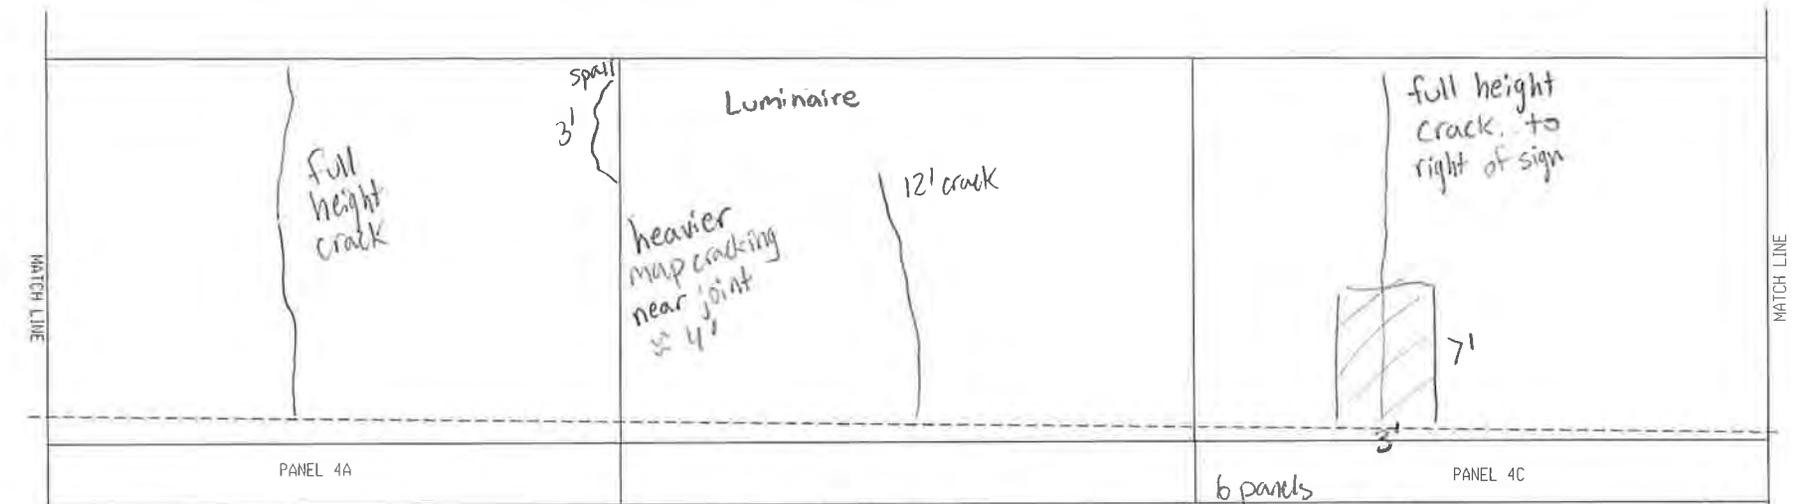
Map cracked throughout  
RW 10 PANELS 3A-4C

Map cracking bot 2 pnls,  
Scattered pnls 3 & 4

Map cracking bot 4 pnls

Scattered vert. cracks on bot 3 pnls

Map cracking throughout

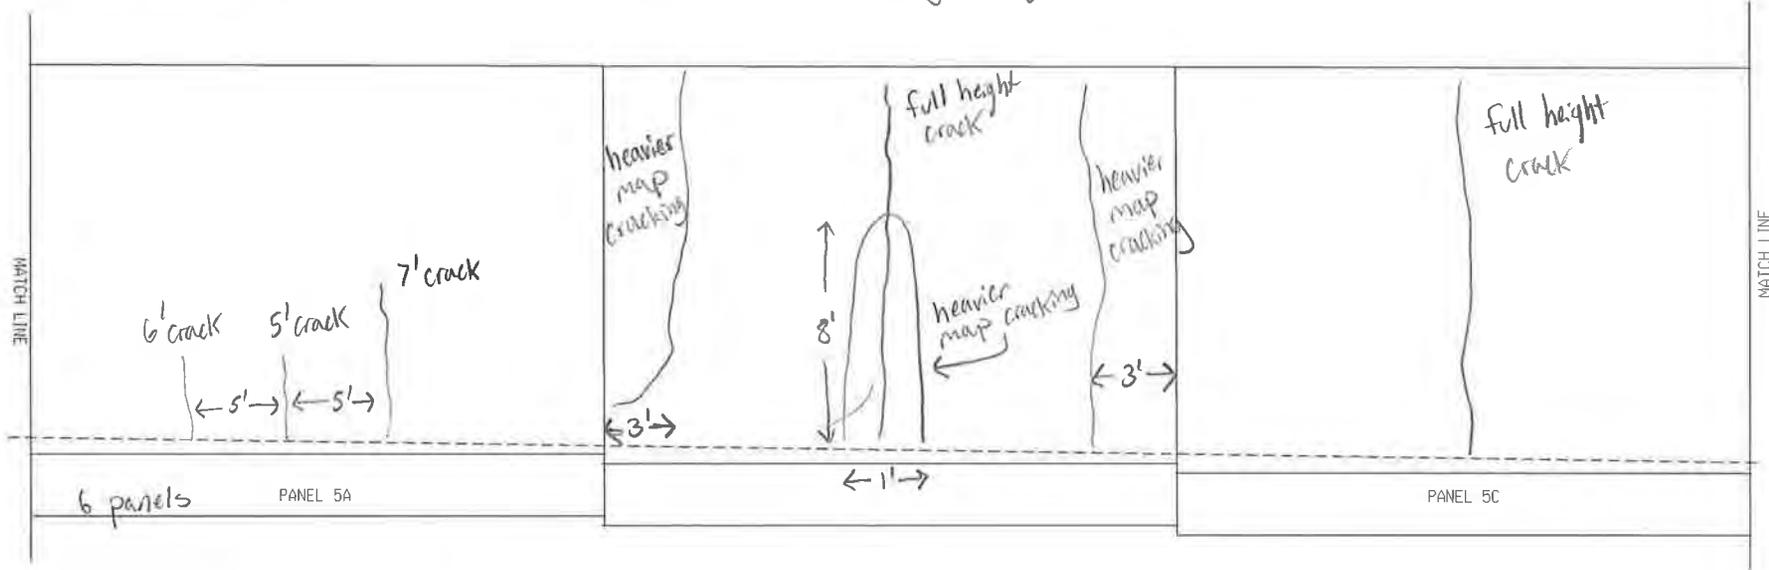
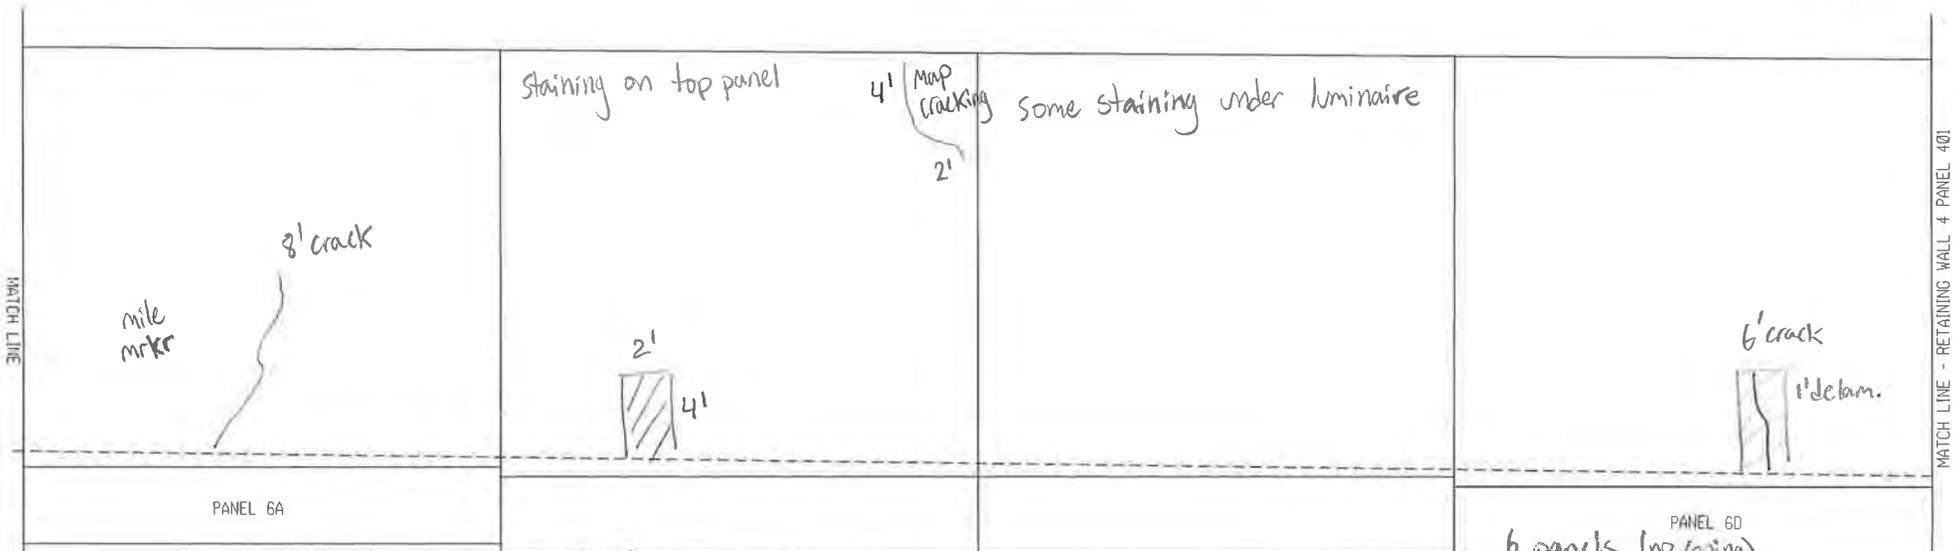
RW 10 PANELS 5A-6D

Scattered map cracking throughout

Map cracking top 2 pnts

Scattered map cracking, worst on panel 5 from bottom

6 panels (no coping)  
Scattered rust staining b/w pils 1-3

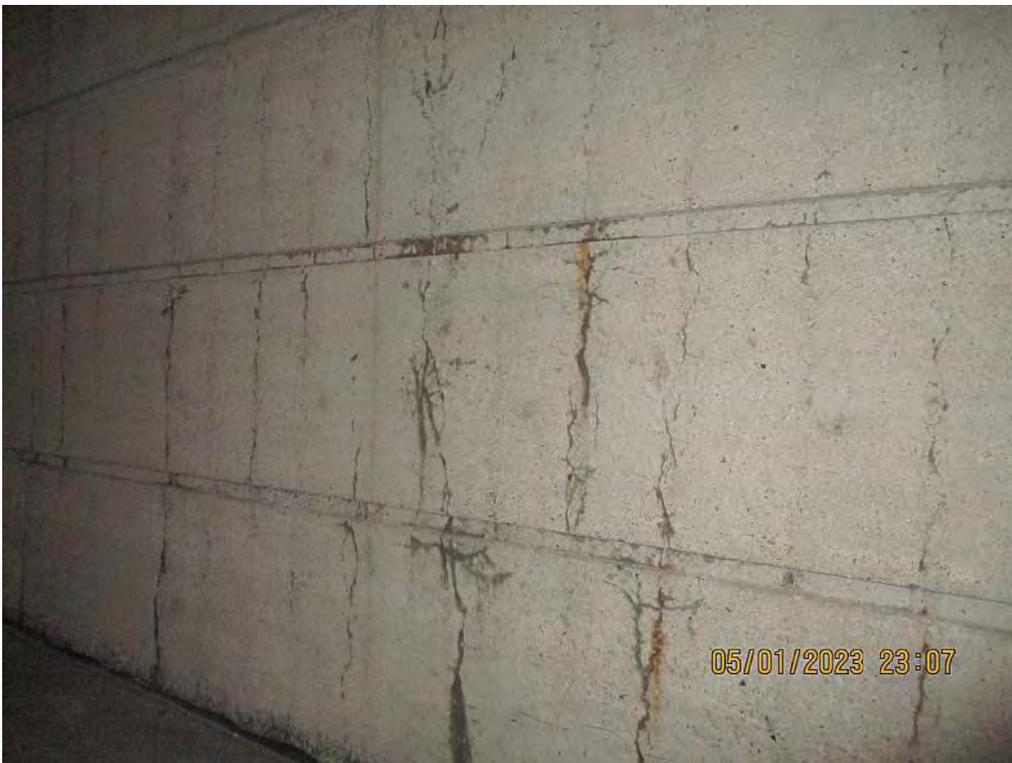
There are 2 full-height vertical cracks. Panel is 50% delaminated with widespread map cracking.

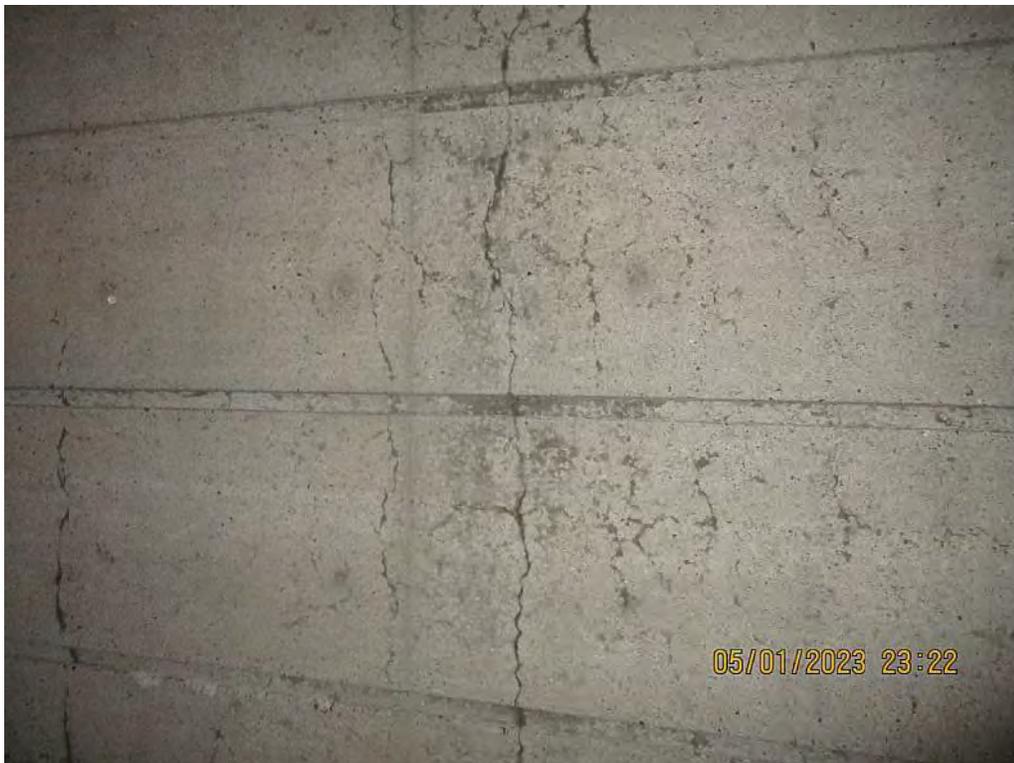
Rust staining under rail posts is typical for entire wall.

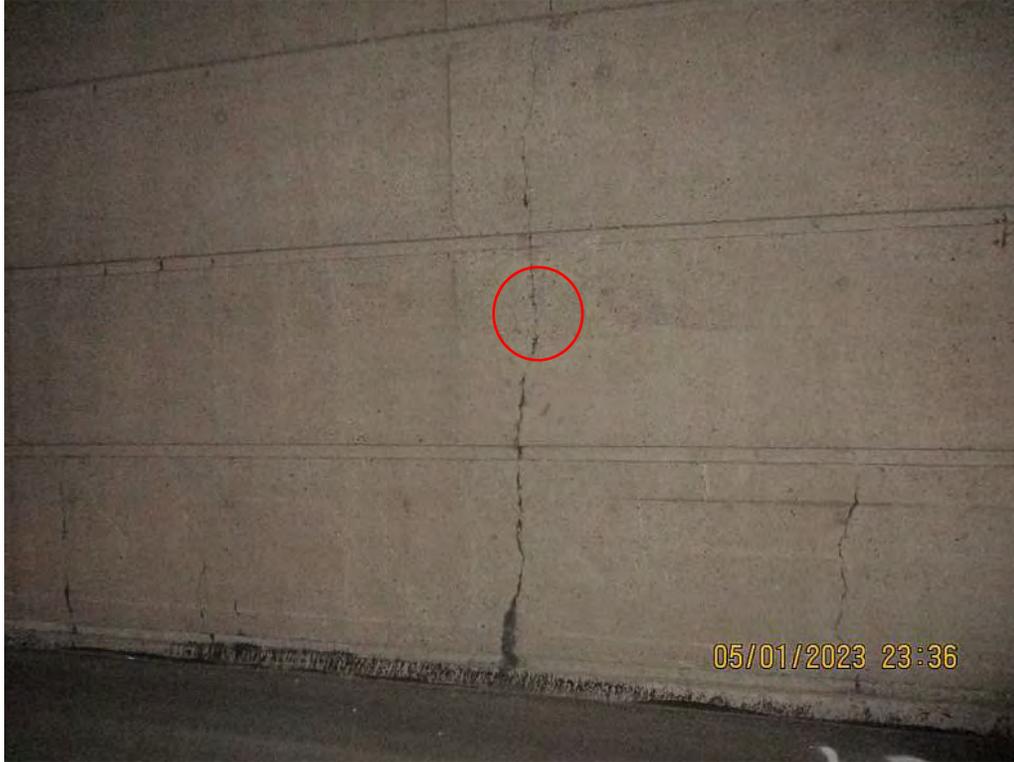
Right of Ferry St bridge west abutment.
