# Asbestos-Containing Materials Inspection

**BIN 1022609**  
**Best Street over**  
**Kensington Expressway (Rt. 33)**  
**City of Buffalo,**  
**Erie County, New York**

**New York State Department of Transportation Region 5**  
**100 Seneca Street**  
**Buffalo, NY 14203**

**August 2023, Revised September 2023**

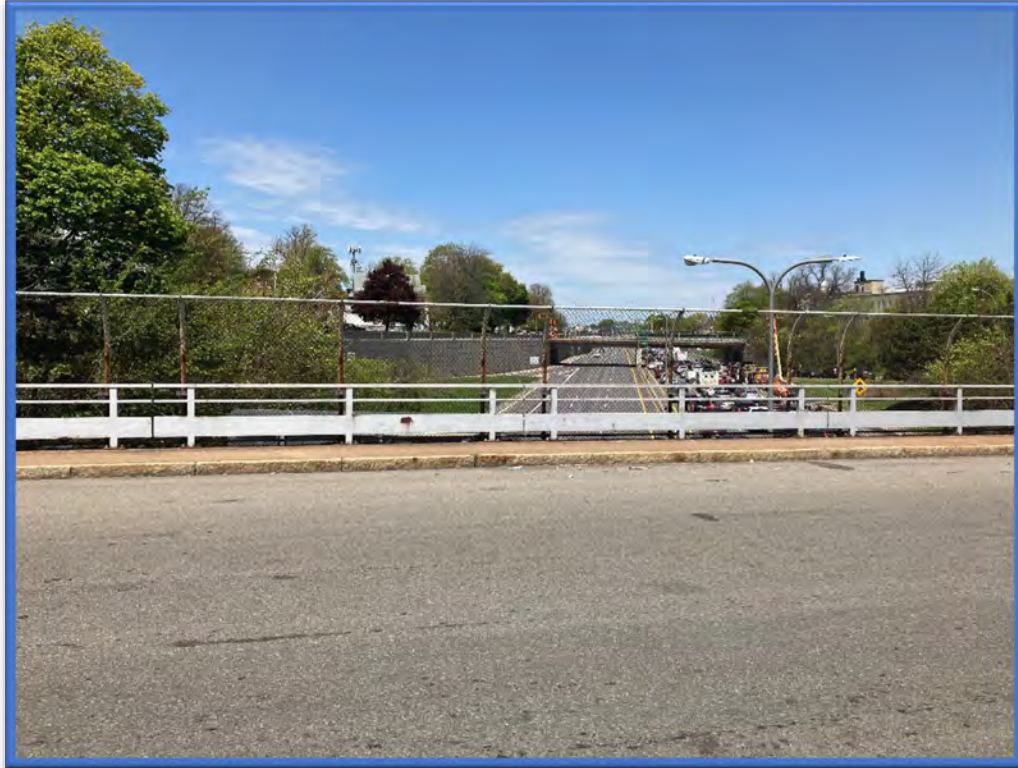
Photo 1 - View to the north from the middle of the Best Street Bridge over Kensington Expressway (Route 33) (BIN 1022609).

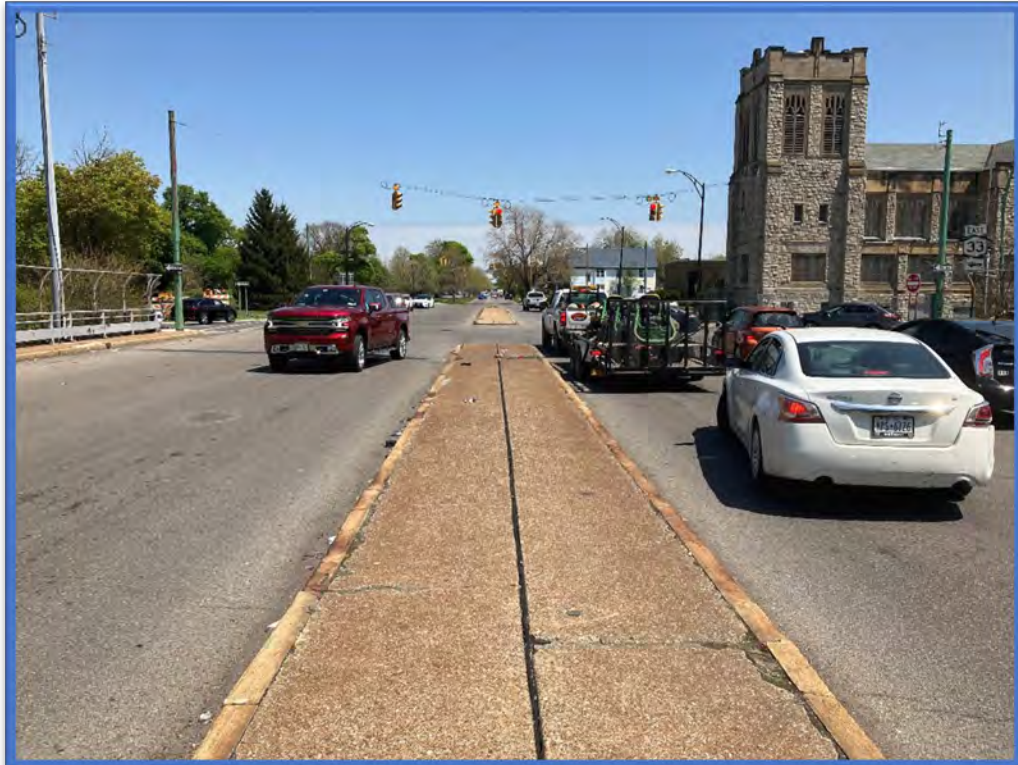
Photo 2 - View to the east from the middle of the Best Street Bridge over Kensington Expressway (Route 33) (BIN 1022609).

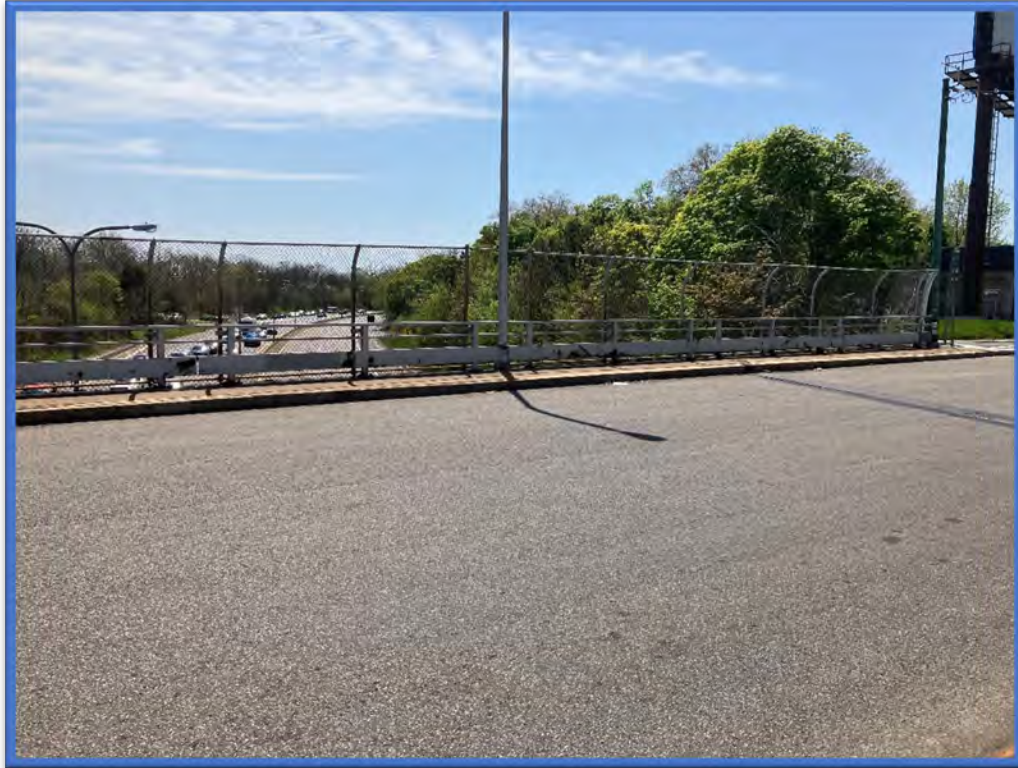
Photo 3 - View to the south from the middle of the Best Street Bridge over Kensington Expressway (Route 33) (BIN 1022609).

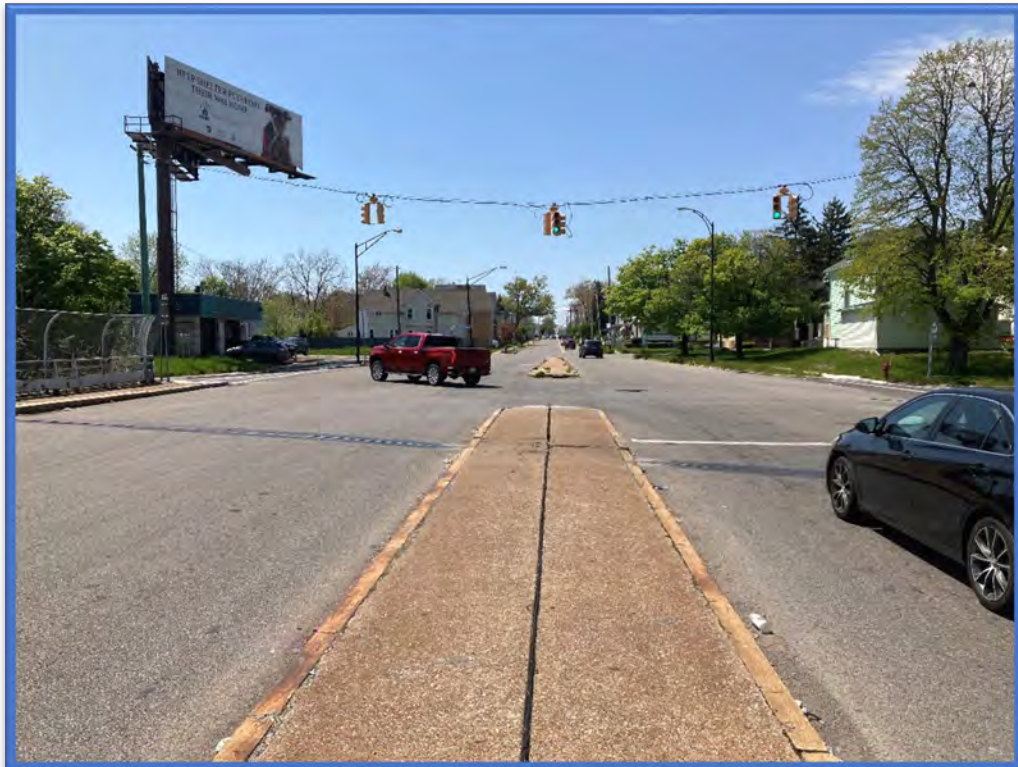
Photo 4 - View to the west from the middle of the Best Street Bridge over Kensington Expressway (Route 33) (BIN 1022609).

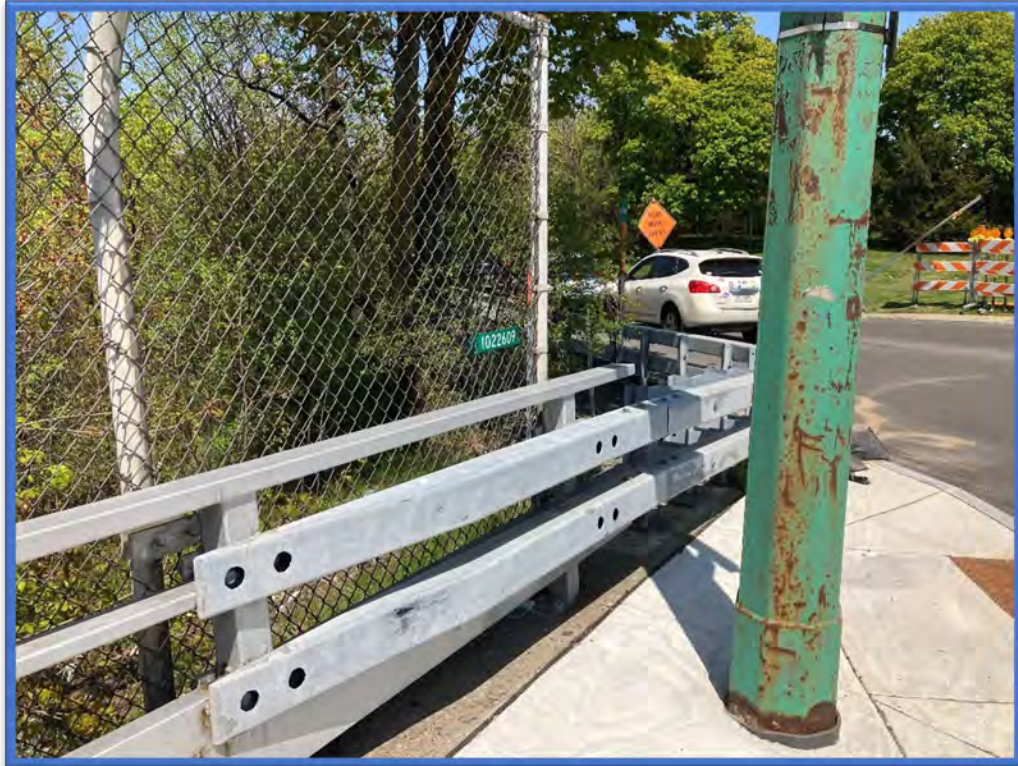
Photo 5 – BIN plate located on the adjacent fence at the northeast quadrant of BIN 1022609.

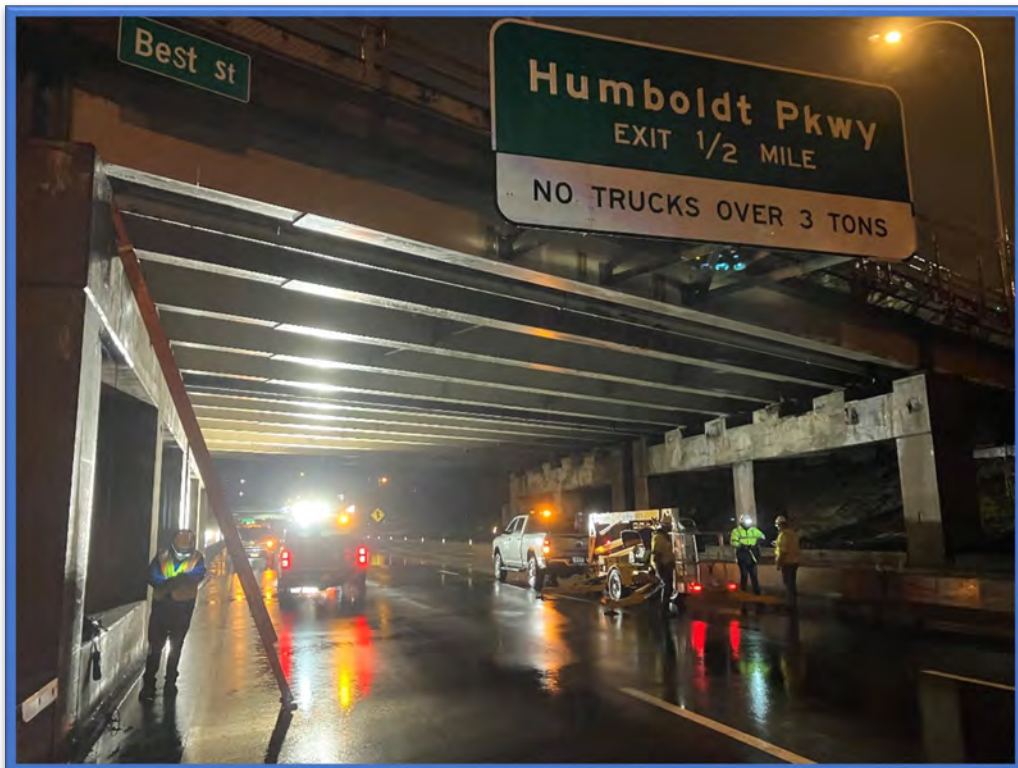
Photo 6 – View looking south towards the northeast side of BIN 1022609 during the night-time inspection that occurred after closing the EB Kensington Expressway (EB Route 33).

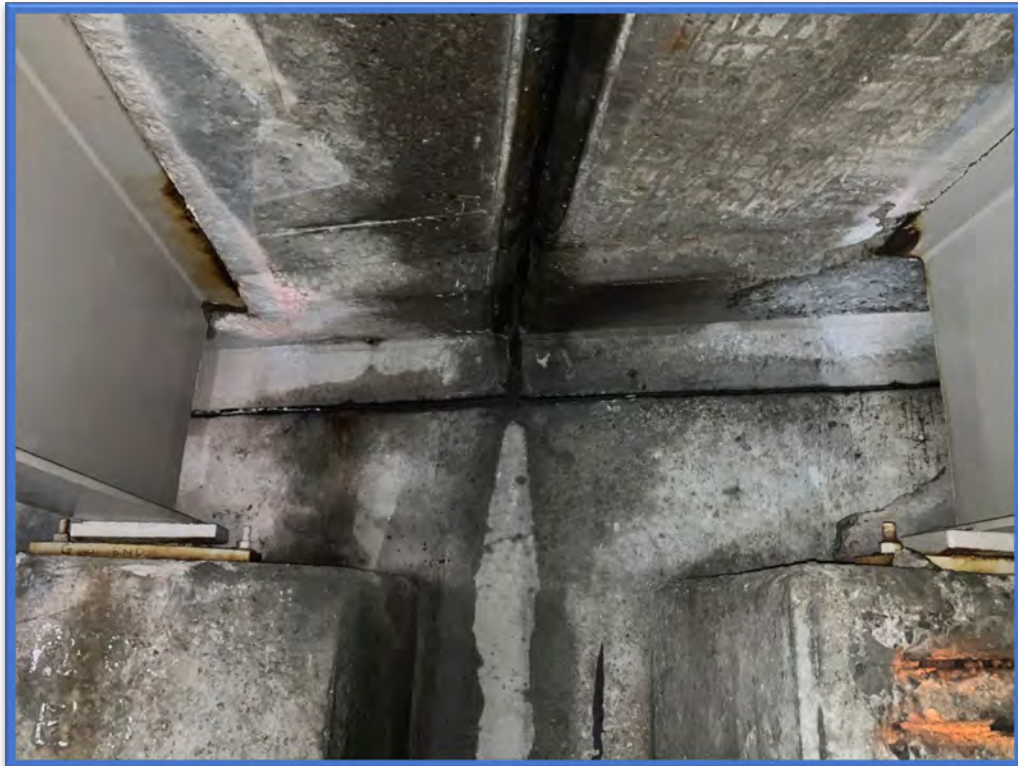
Photo 8 - Compressed asbestos sheet packing located on the abutment shelves at BIN 1022609 was confirmed as an ACM. Picture taken at the center of the east abutment.

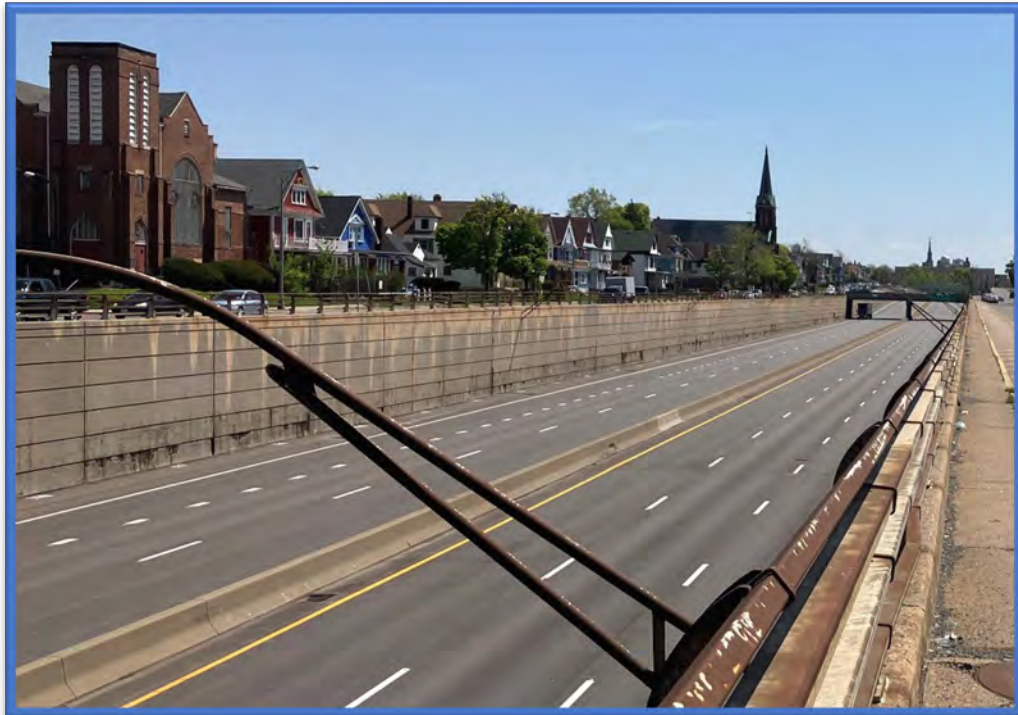
Photo 9 - Retaining wall system within the Kensington Expressway project corridor that has an associated asbestos-containing caulking located within each expansion joint and an inaccessible/assumed asbestos-containing waterproofing located on the back sides of the abutments, retaining walls, counterforts, and tops of footer piles.

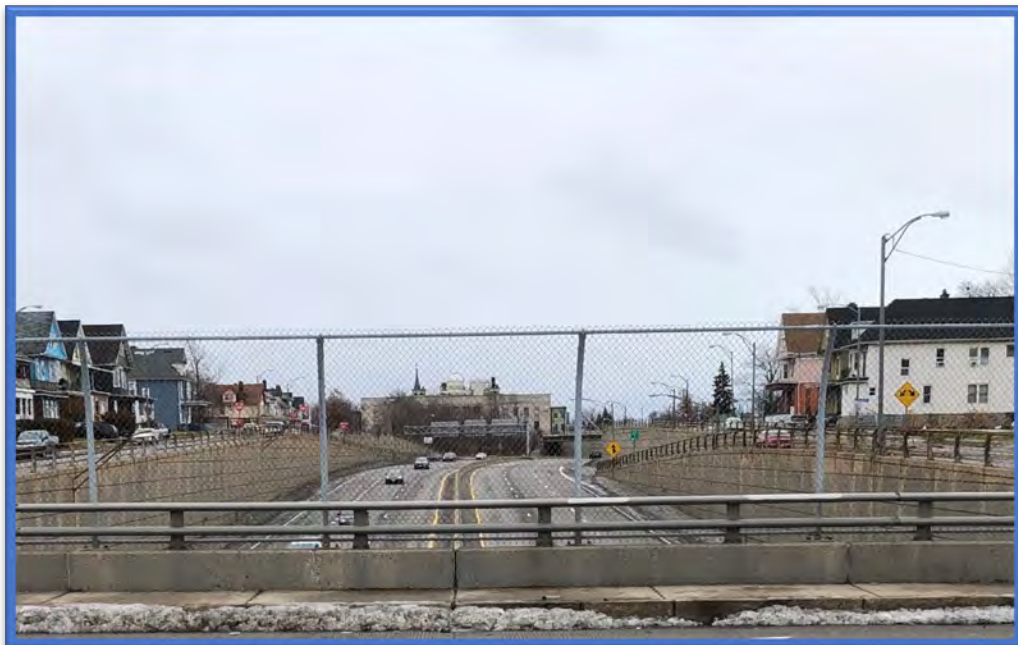
Photo 10 - Retaining wall system within the Kensington Expressway project corridor that has an associated asbestos-containing caulking located within each expansion joint and an inaccessible/assumed asbestos-containing waterproofing located on the back sides of the abutments, retaining walls, counterforts, and tops of footer piles.

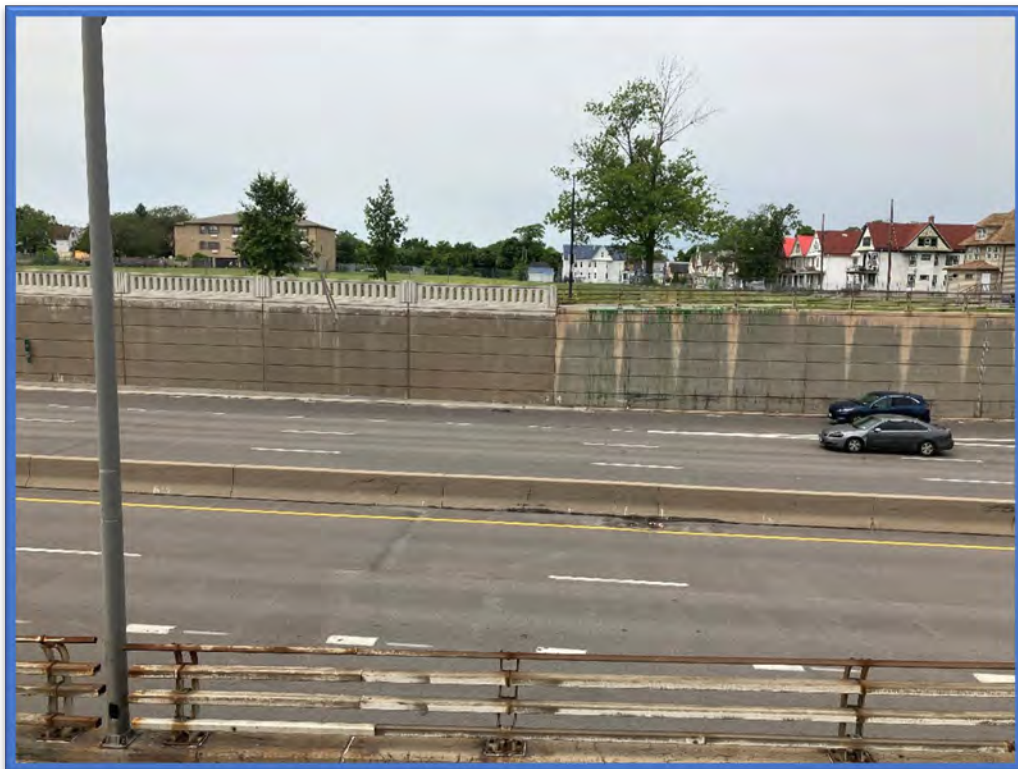
Photo 12 - Asbestos-containing railing post base caulk is associated with all of the metal guiderails located on top of the northern retaining walls. No asbestos-containing caulk is associated with the new decorative concrete guide rails located on top of the southern retaining walls.

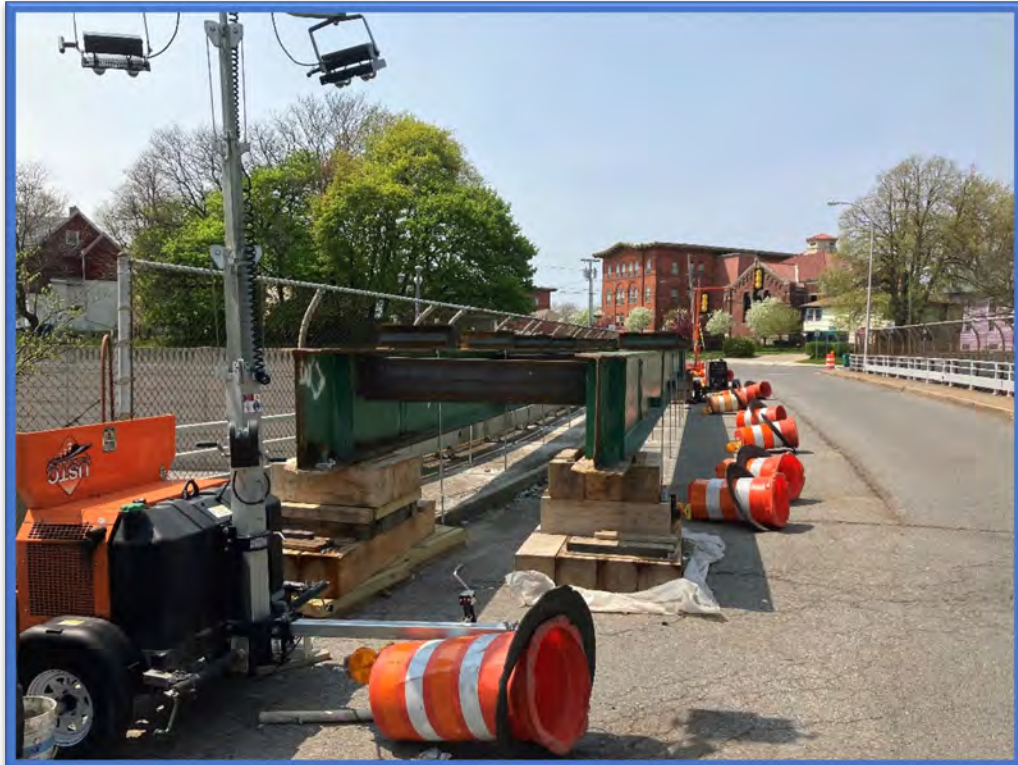
Photo 2 - View to the northwest of the southern side Dodge Street Bridge over Kensington Expressway (Route 33) (BIN 1022610). Repairs to the structure were being conducted at the time.

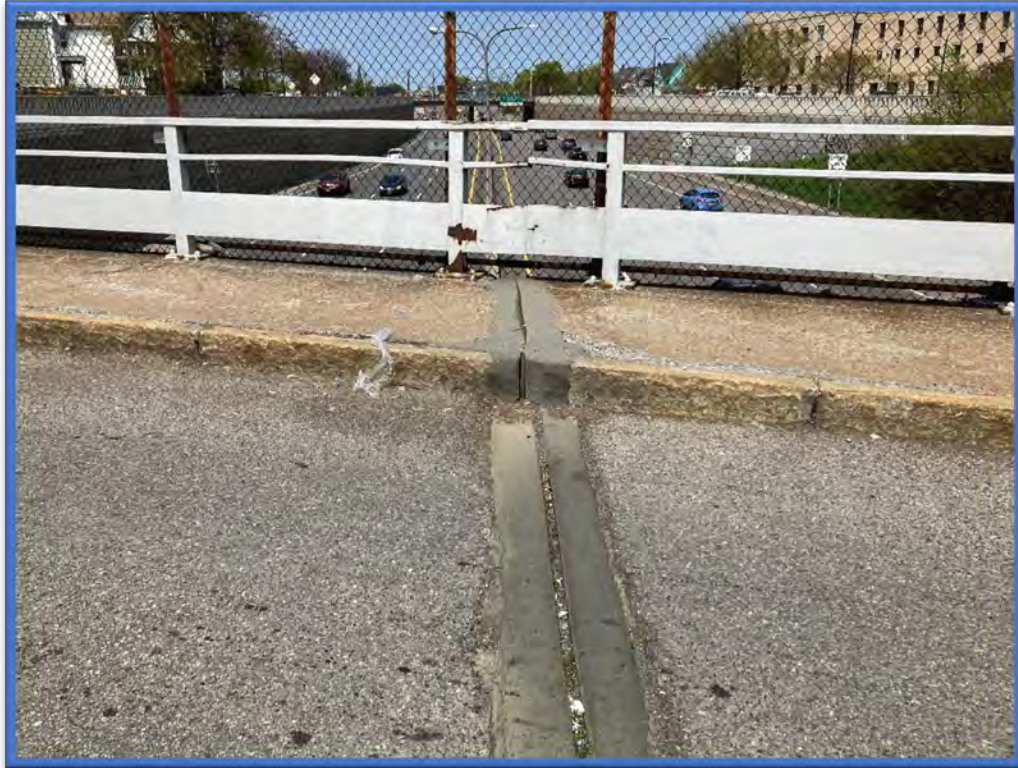
Photo 3 - View to the north from the middle of the Dodge Street Bridge over Kensington Expressway (Route 33) (BIN 1022610).

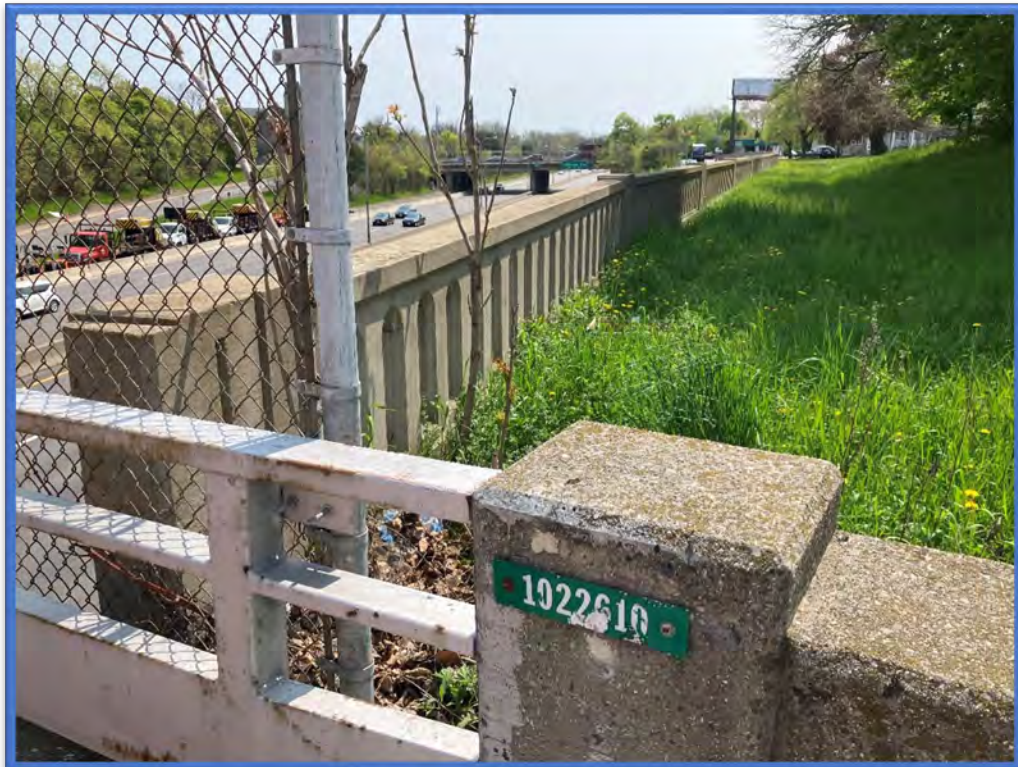
Photo 4 - View of the BIN plate located on the southwestern corner of the Dodge Street Bridge over Kensington Expressway (Route 33) (BIN 1022610).

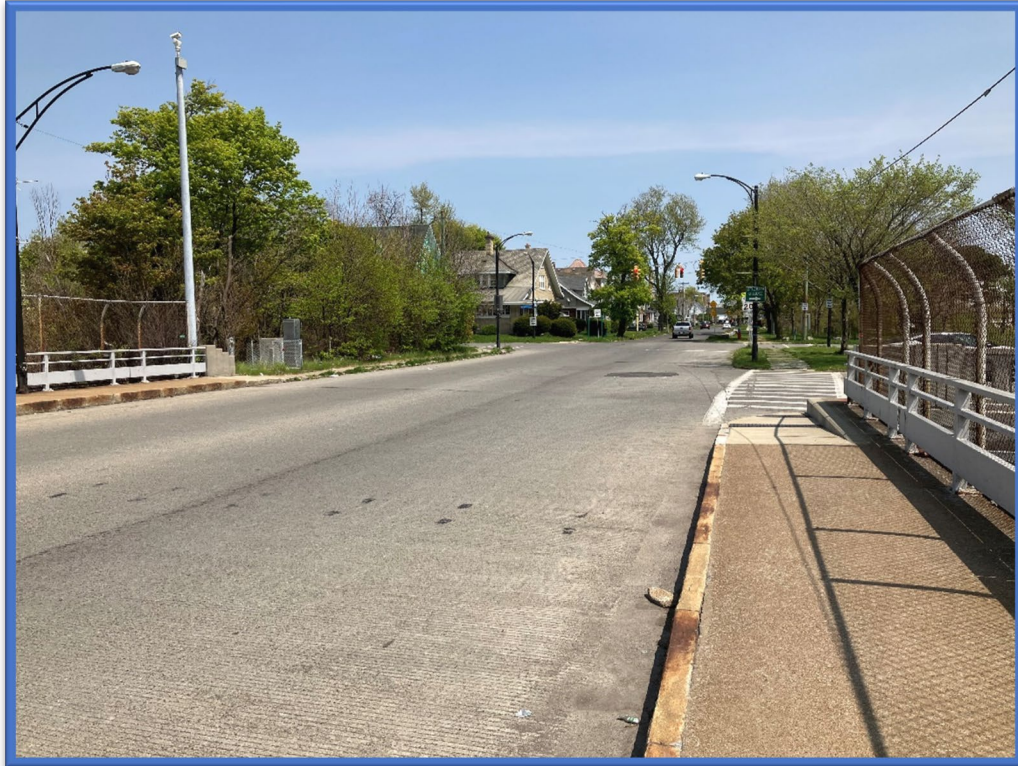
Photo 3 - View to the east from the middle of the deck of the Northampton Street Bridge over Kensington Expressway (Route 33) (BIN 1022620).

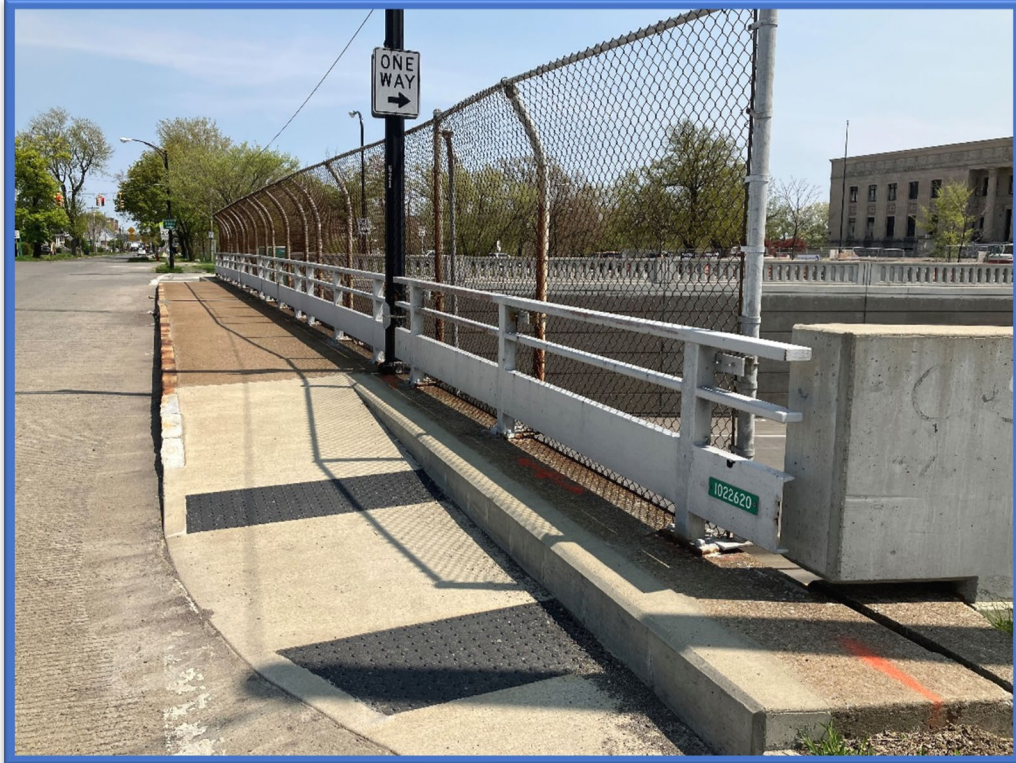
Photo 5 – BIN plate located on the adjacent fence at the southwest quadrant of BIN 1022620. ACM caulking is only associated with the older lower portion of the walls.

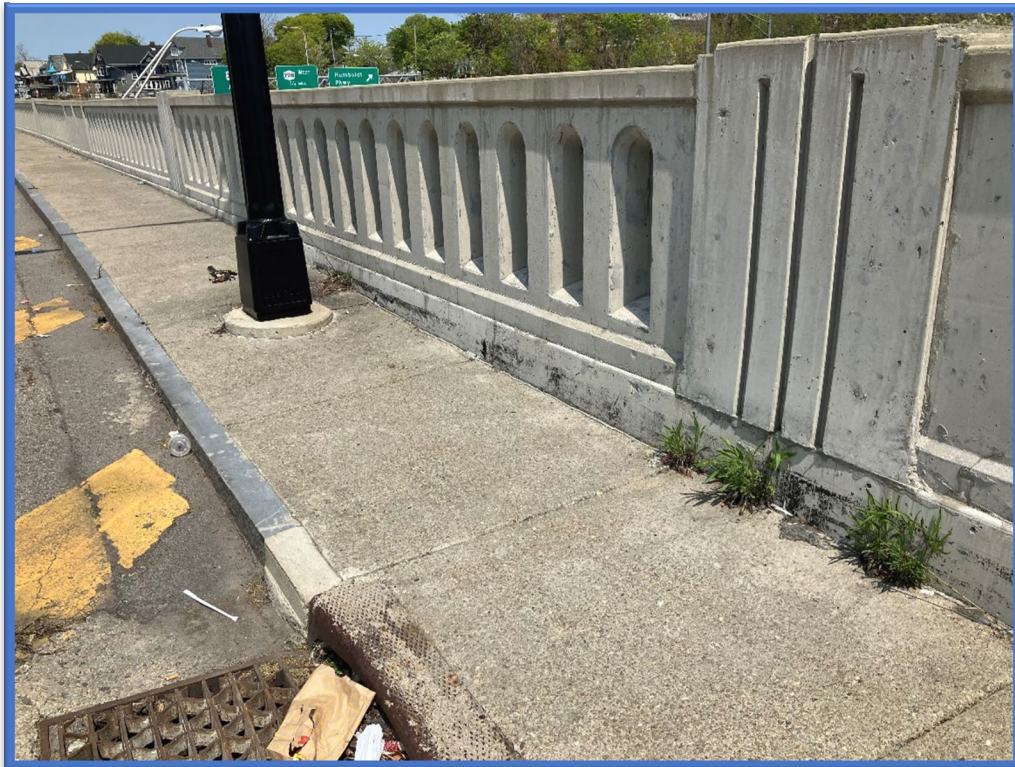
Photo 6 – View of the recently installed decorative upper portion retaining wall adjacent to BIN 1022620. Additional suspect ACM was identified and sampled, however all samples associated with the upper portion were negative for asbestos. The ACM caulking is only associated with the older lower portions of the retaining walls system in this area. (See Photos 4 & 5)

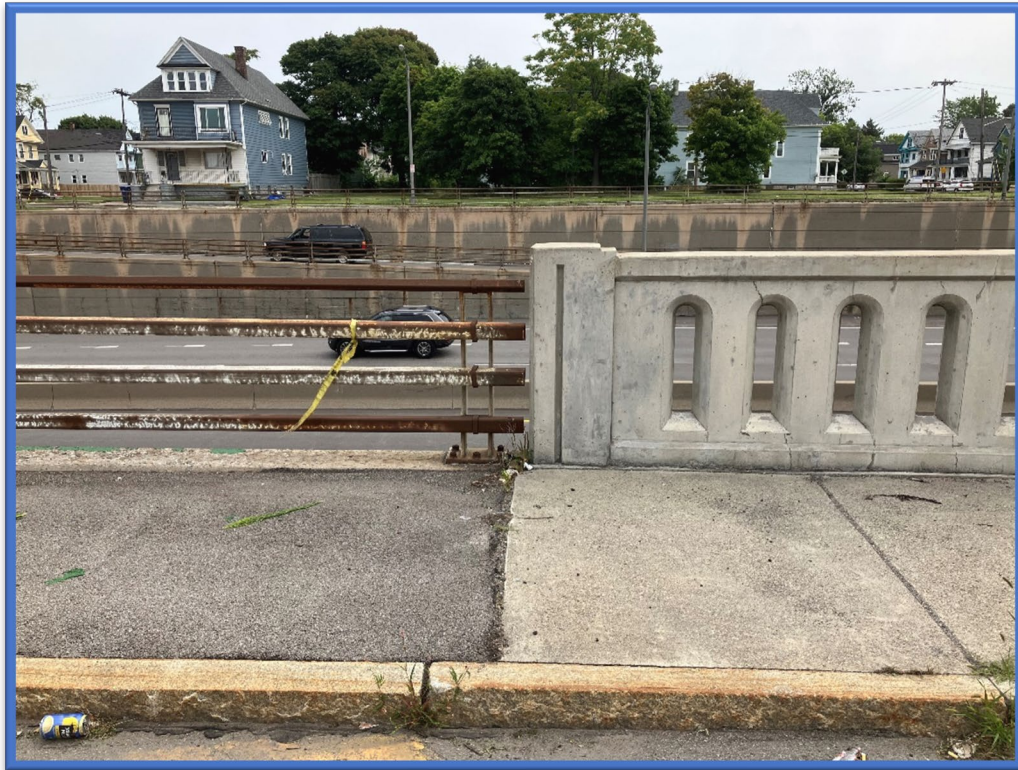
Photo 7 - Asbestos-containing railing post base caulk is associated with all of the metal guidrails located on top of the northern retaining walls. No asbestos-containing caulk is associated with the new decorative concrete guide rails located on top of the southern retaining walls.

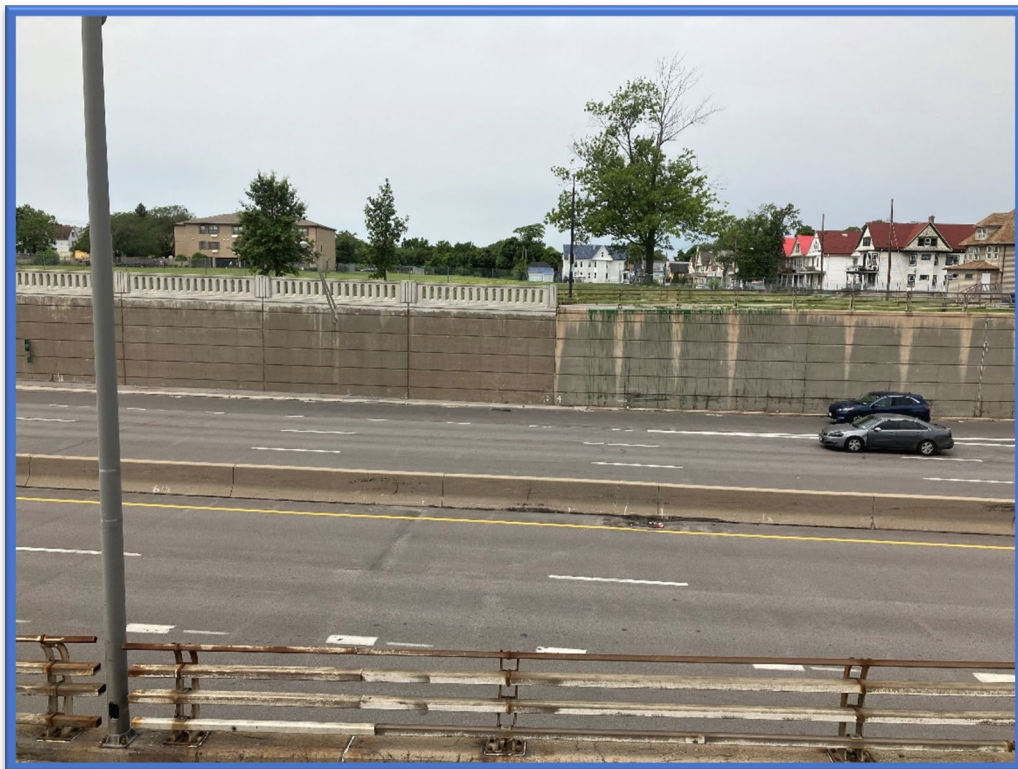
Photo 8 - Asbestos-containing railing post base caulk is associated with all of the metal guidrails located on top of the northern retaining walls. No asbestos-containing caulk is associated with the new decorative concrete guide rails located on top of the southern retaining walls.

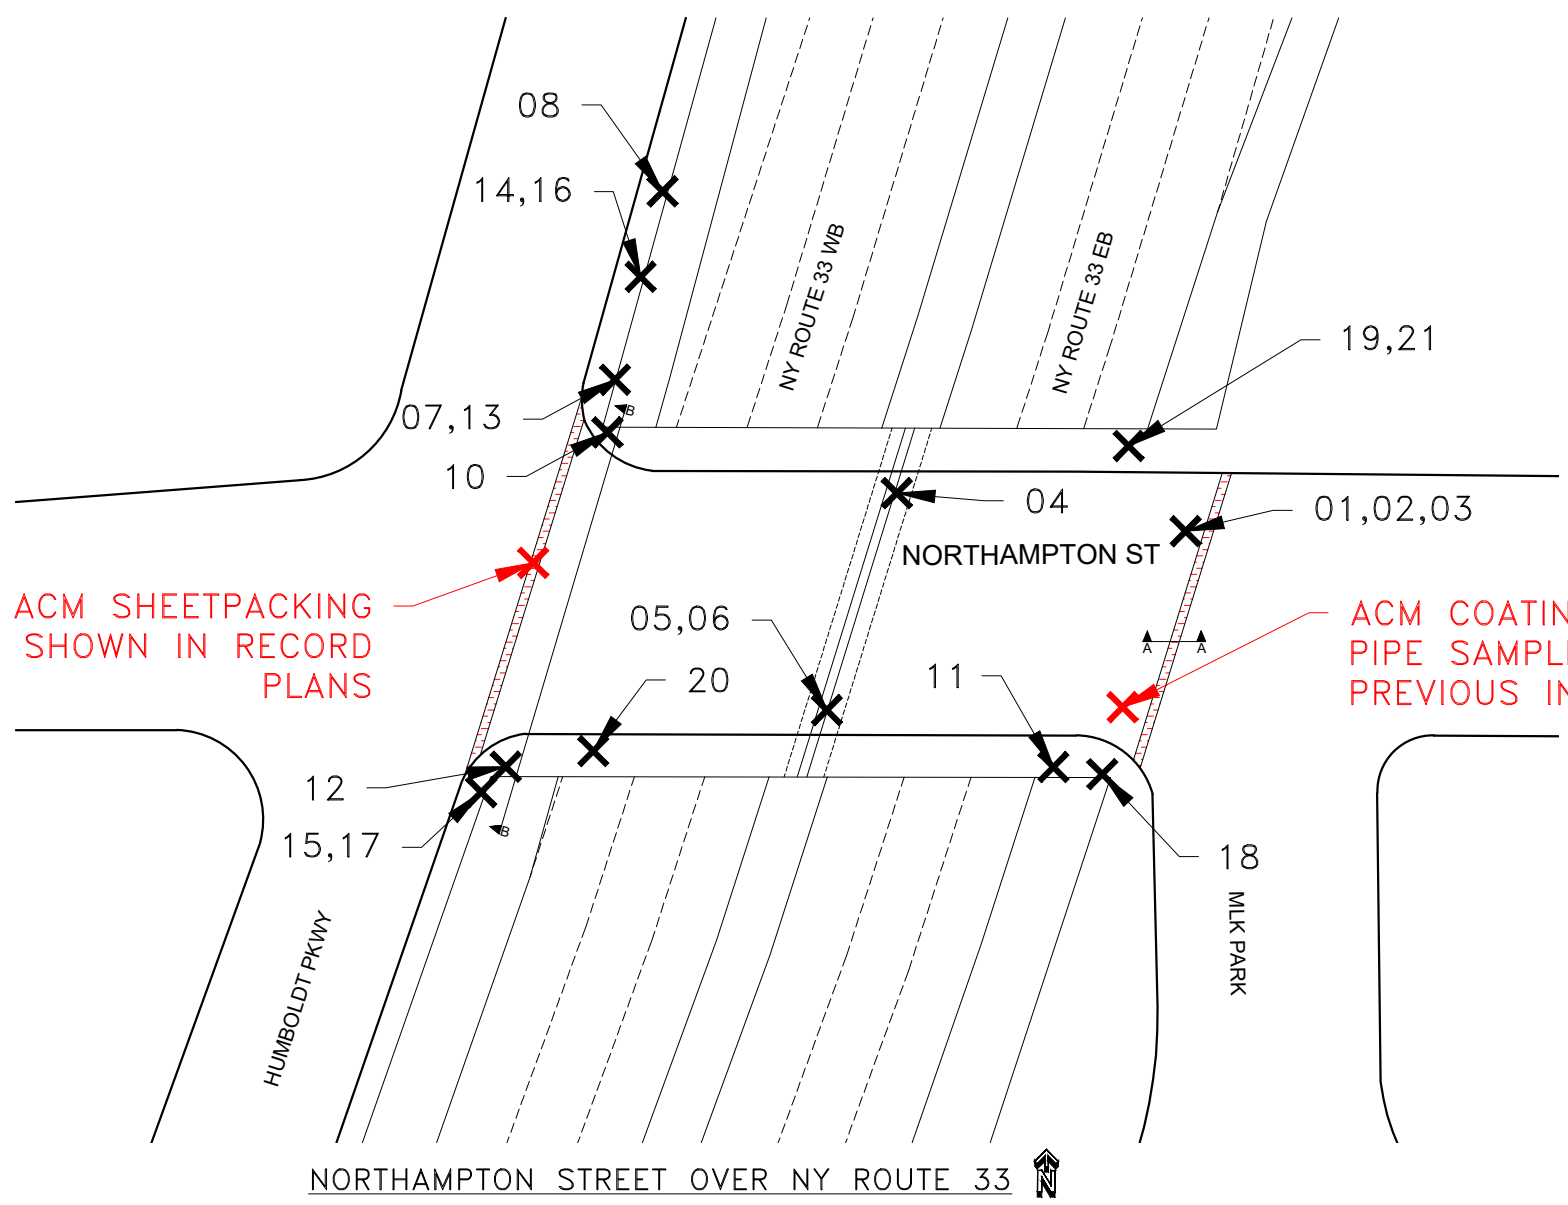
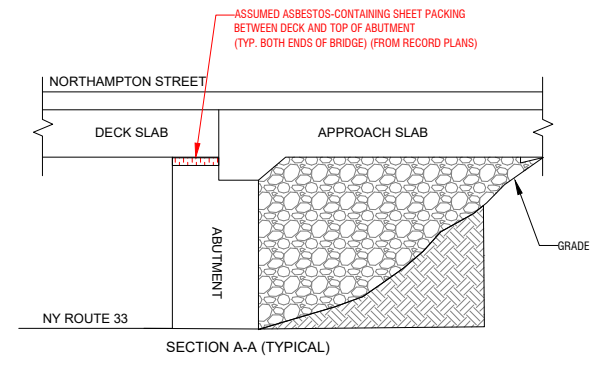
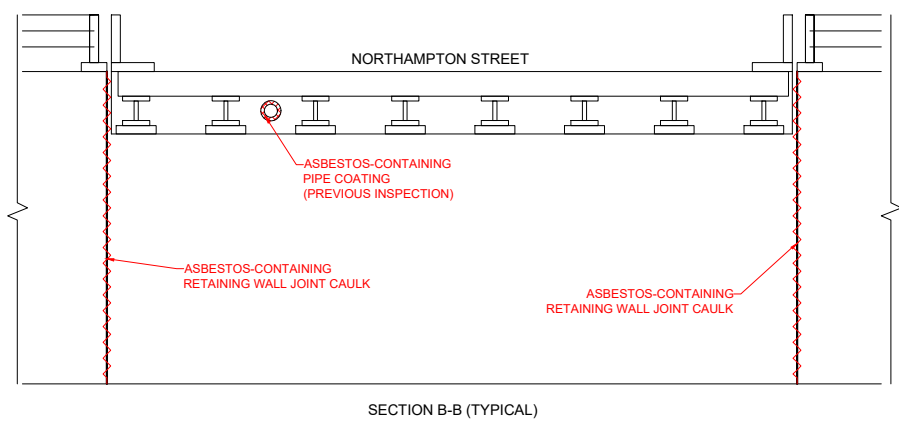
FIGURE 2  
ASBESTOS BULK SAMPLE LOCATIONS  
BIN 1022620

ACM SHEETPACKING SHOWN IN RECORD PLANS

ACM COATING ON PIPE SAMPLED IN PREVIOUS INSPECTION

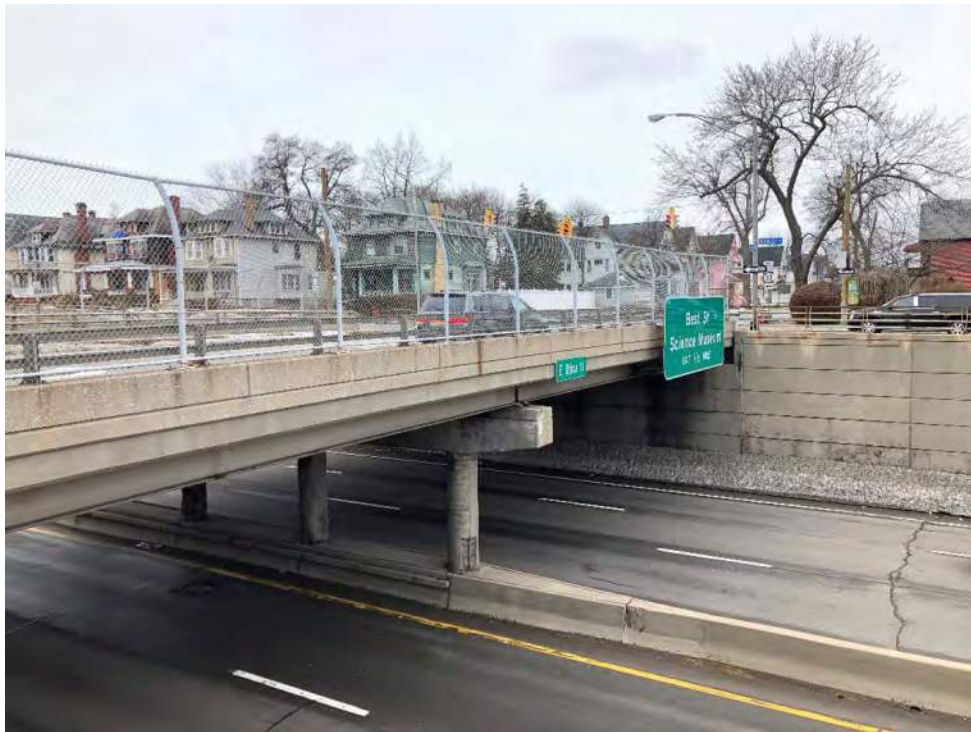
**Photo 1** – View looking east at BIN 1022630 (E. Utica Street over Kensington Expressway (NY Route 33)).

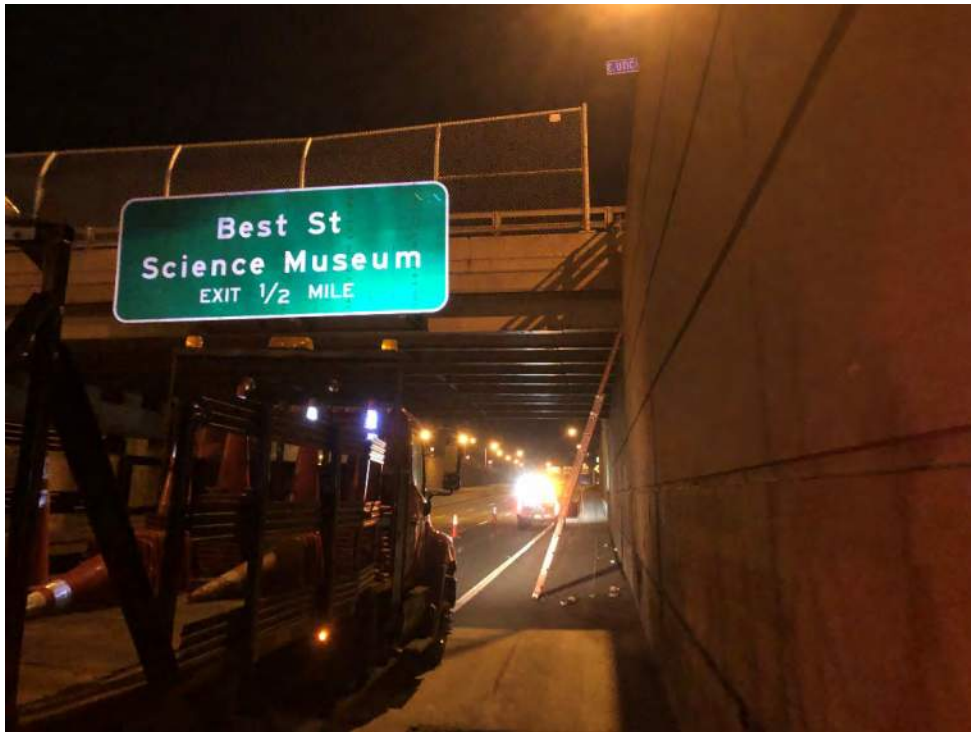
**Photo 3** – View looking south at BIN 1022630 (E. Utica Street over Kensington Expressway (NY Route 33)). MPT was necessary in order to inspect the underside of the bridge.

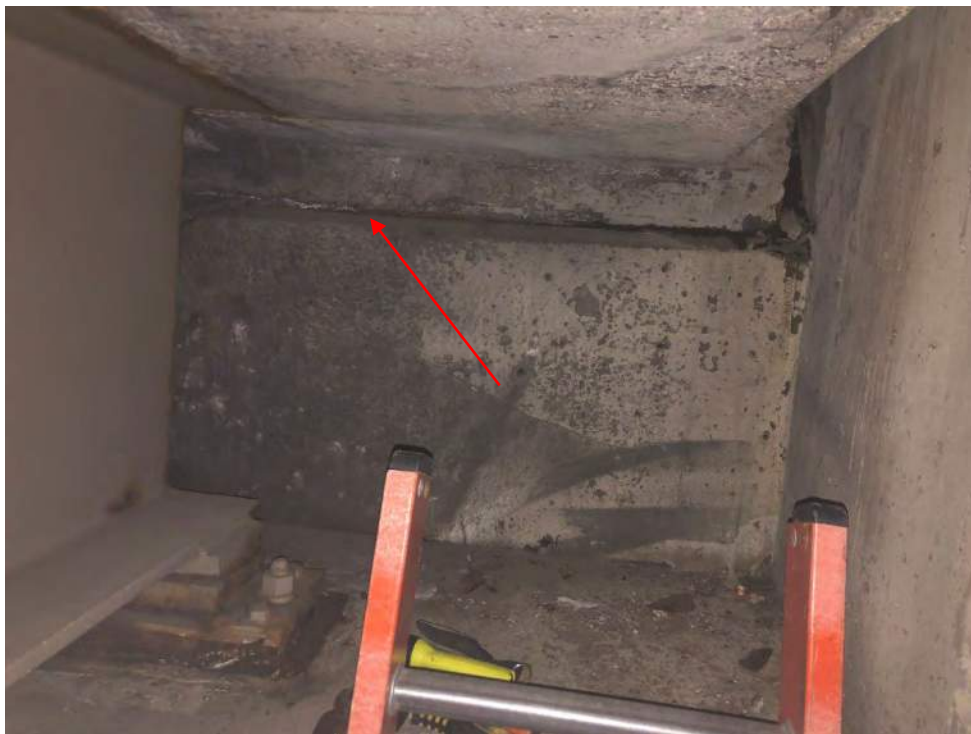
**Photo 4** – View of the grey sheet packing that has been identified as an ACM at BIN 1022630.

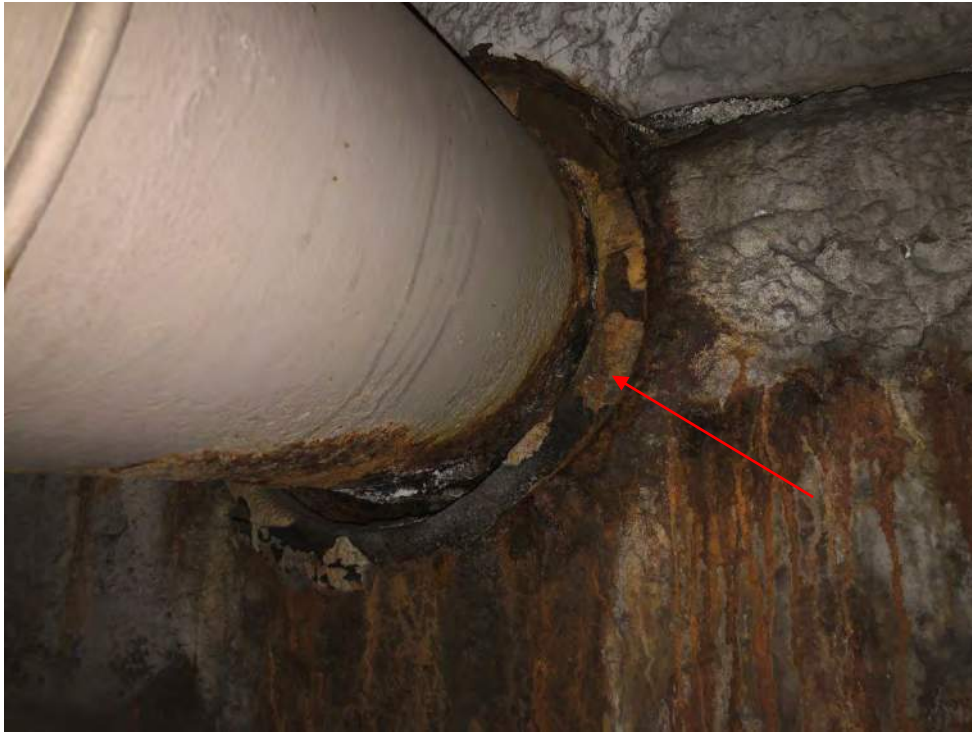
**Photo 5** – View of the 12” metal conduit associated with the 8” gas utility line where it penetrates the east abutment of BIN 1022630. The packing/sealant around the perimeter of the 12” conduit where it penetrates each abutment has been identified as an ACM.

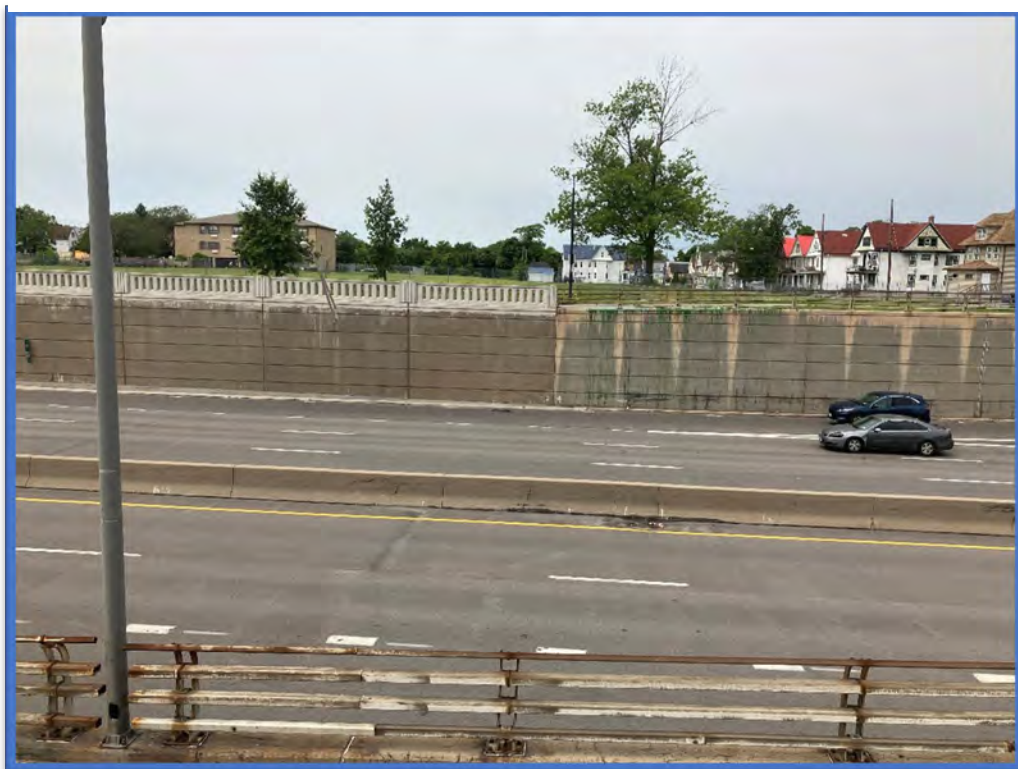
Photo 8 - Asbestos-containing railing post base caulk is associated with all of the metal guiderails located on top of the northern retaining walls. No asbestos-containing caulk is associated with the new decorative concrete guide rails located on top of the southern retaining walls.
