Asbestos-Containing Materials Inspection

BIN 1022609
Best Street over
Kensington Expressway (Rt. 33)
City of Buffalo,
Erie County, New York

PIN – 5512.52.123

Watts Project No. 20220255

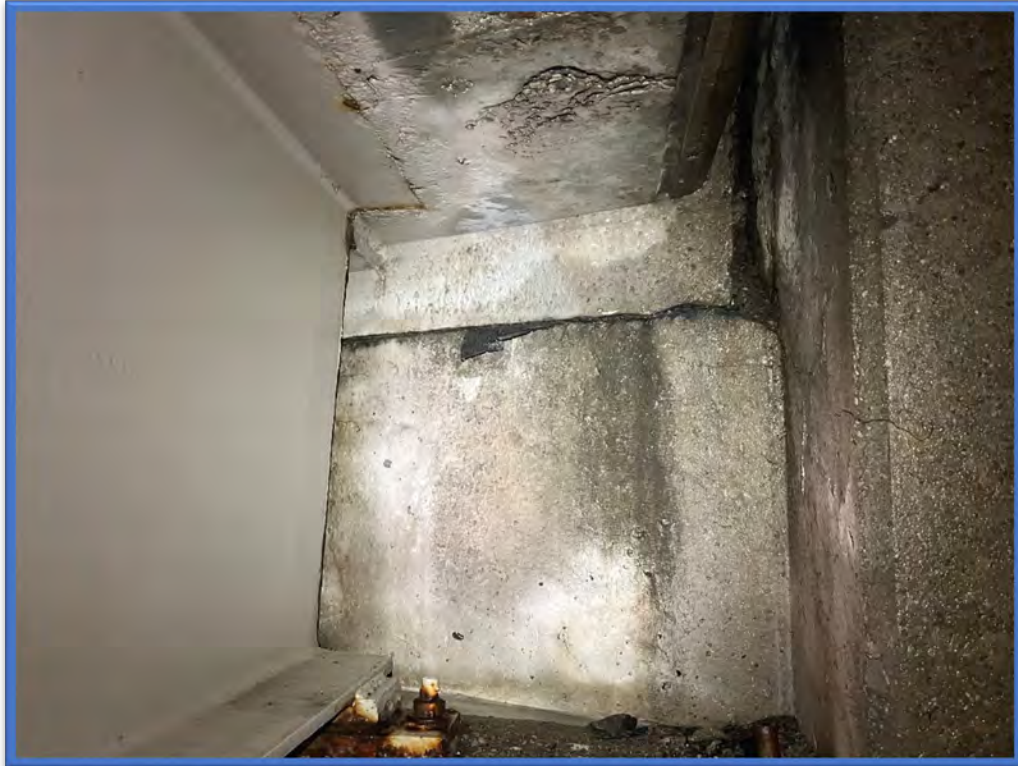
Photo 7 - Compressed asbestos sheet packing located on the abutment shelves at BIN 1022609 was confirmed as an ACM. Picture taken at the southeast quadrant of the bridge.

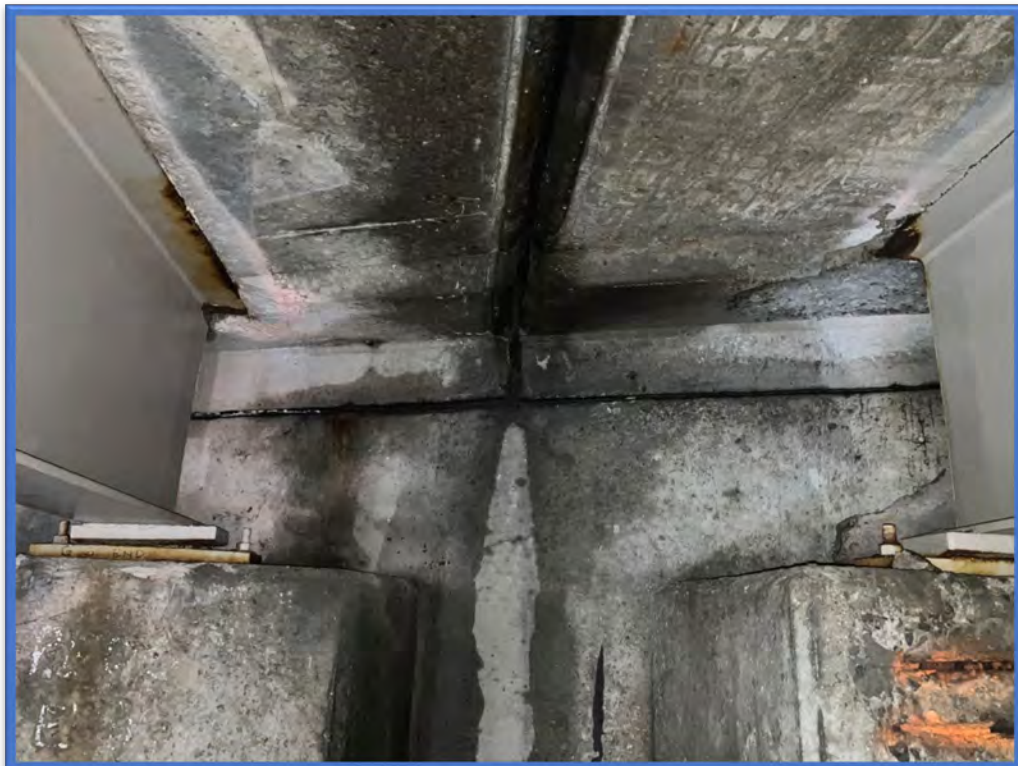
Photo 8 - Compressed asbestos sheet packing located on the abutment shelves at BIN 1022609 was confirmed as an ACM. Picture taken at the center of the east abutment.

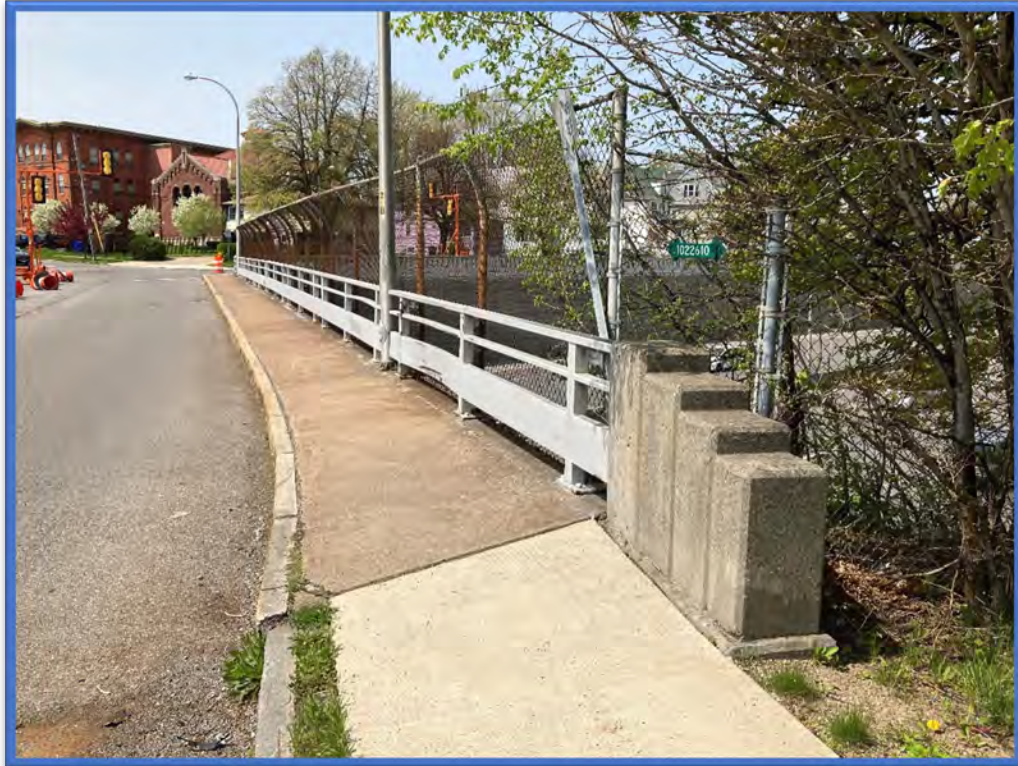
Photo 1 - View to the northwest of the northern side Dodge Street Bridge over Kensington Expressway (Route 33) (BIN 1022610).

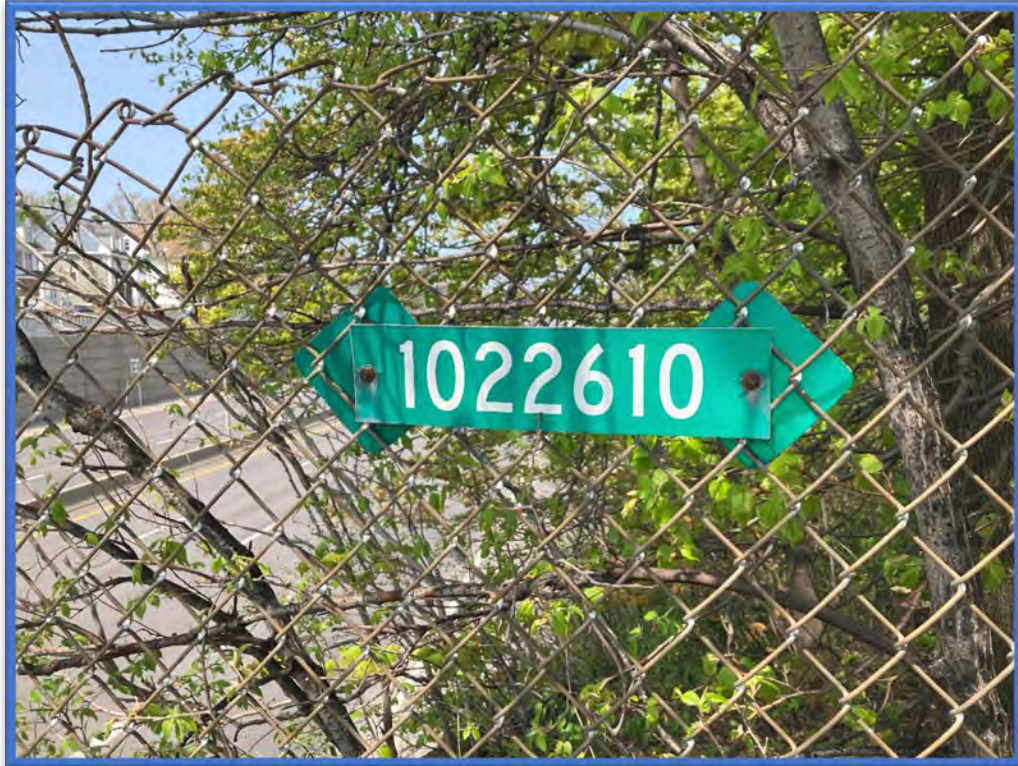
Photo 5 – View of the BIN plate located on the adjacent fence at the northeast quadrant of the Dodge Street Bridge over Kensington Expressway (Route 33) (BIN 1022610).

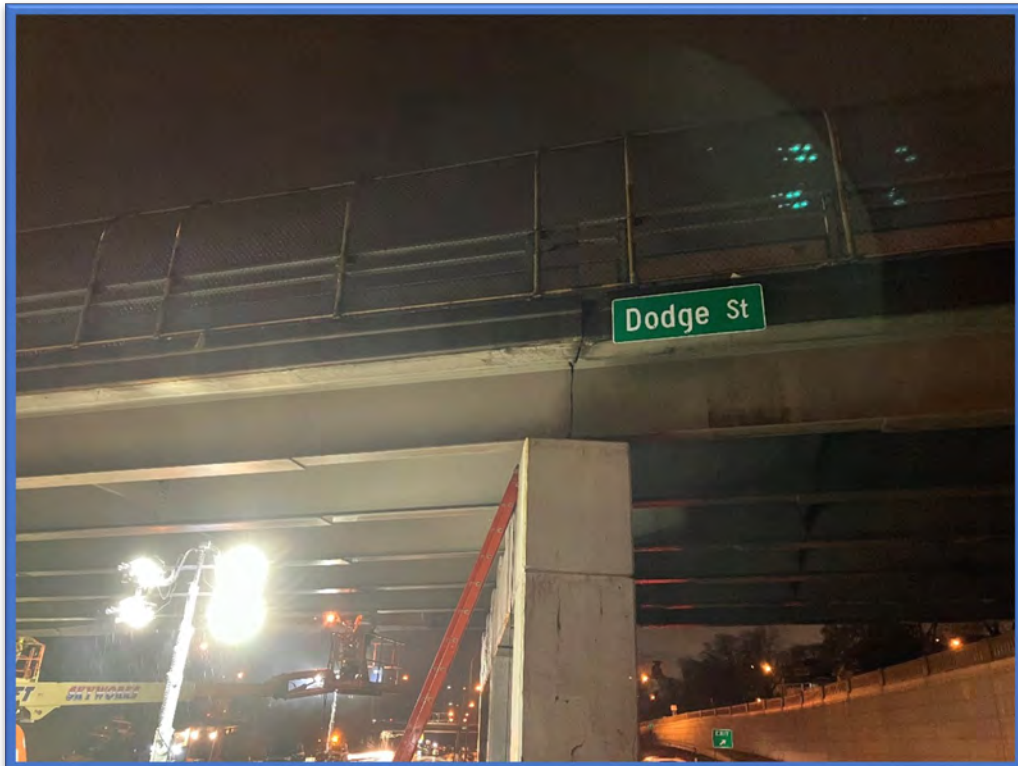
Photo 6 – View of the underside of the Dodge Street Bridge over Kensington Expressway (Route 33) (BIN 1022610) taken during the night-time inspection of the bridge.

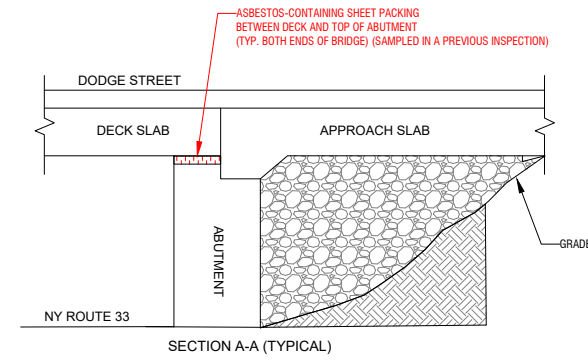
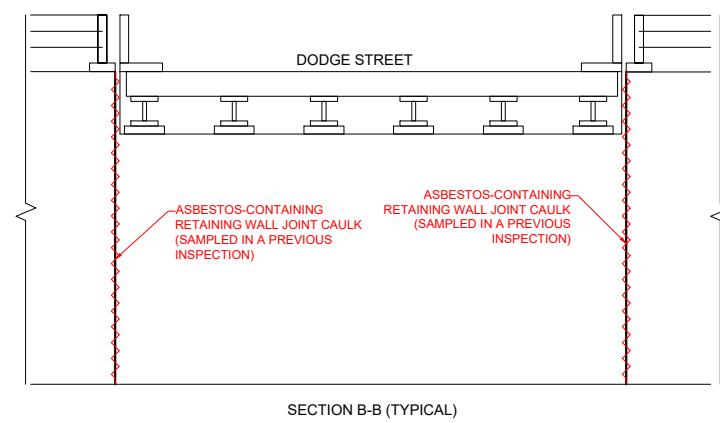
FIGURE 2
ASBESTOS BULK SAMPLE LOCATIONS
BIN 1022610

LEGEND
 ASBESTOS-CONTAINING SHEETPACKING
 ASBESTOS-CONTAINING CAULK

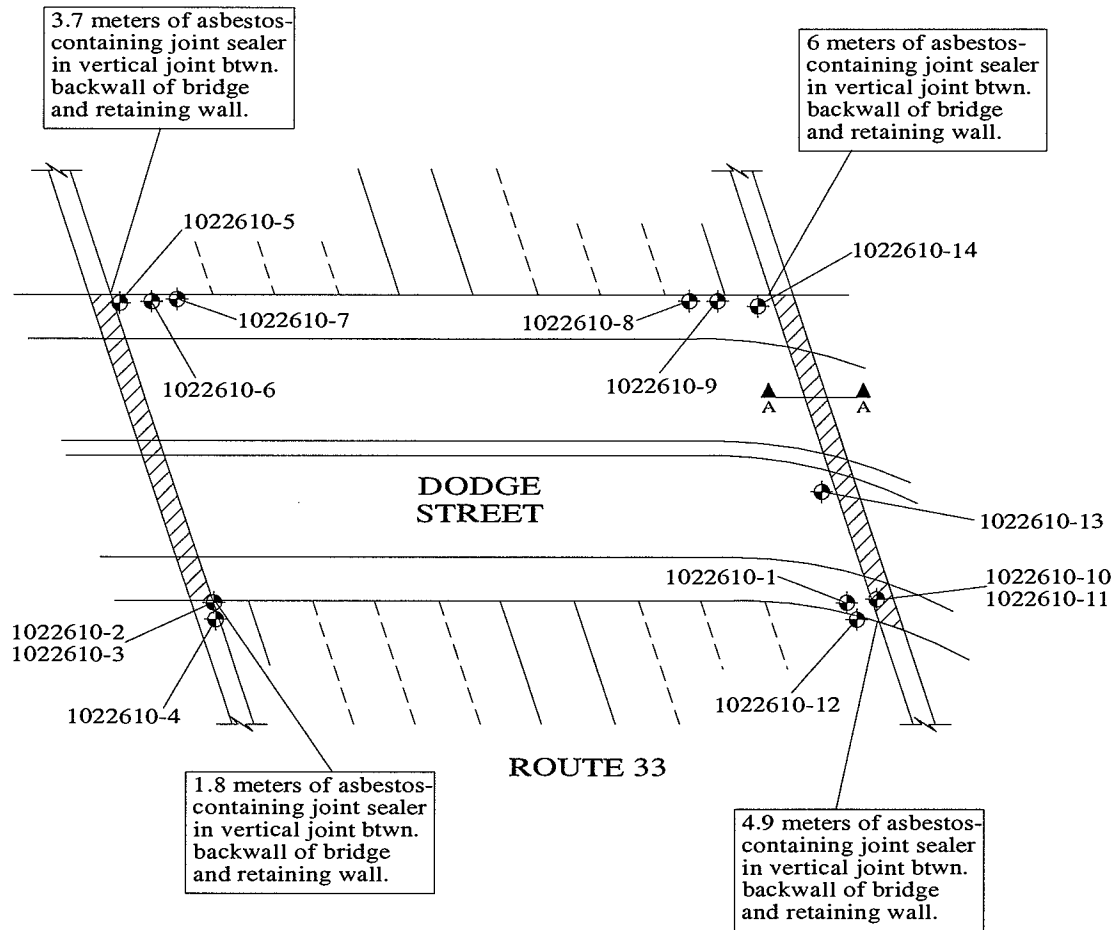
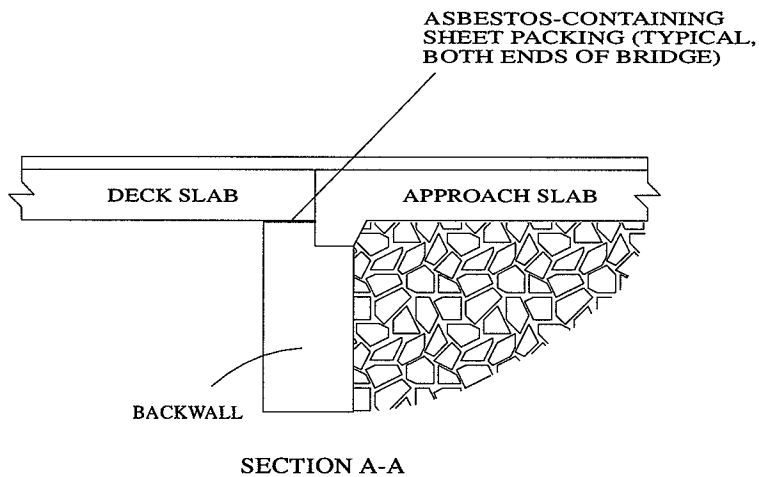
The approximate locations of this asbestos-containing joint sealer are noted in FIGURE 2.

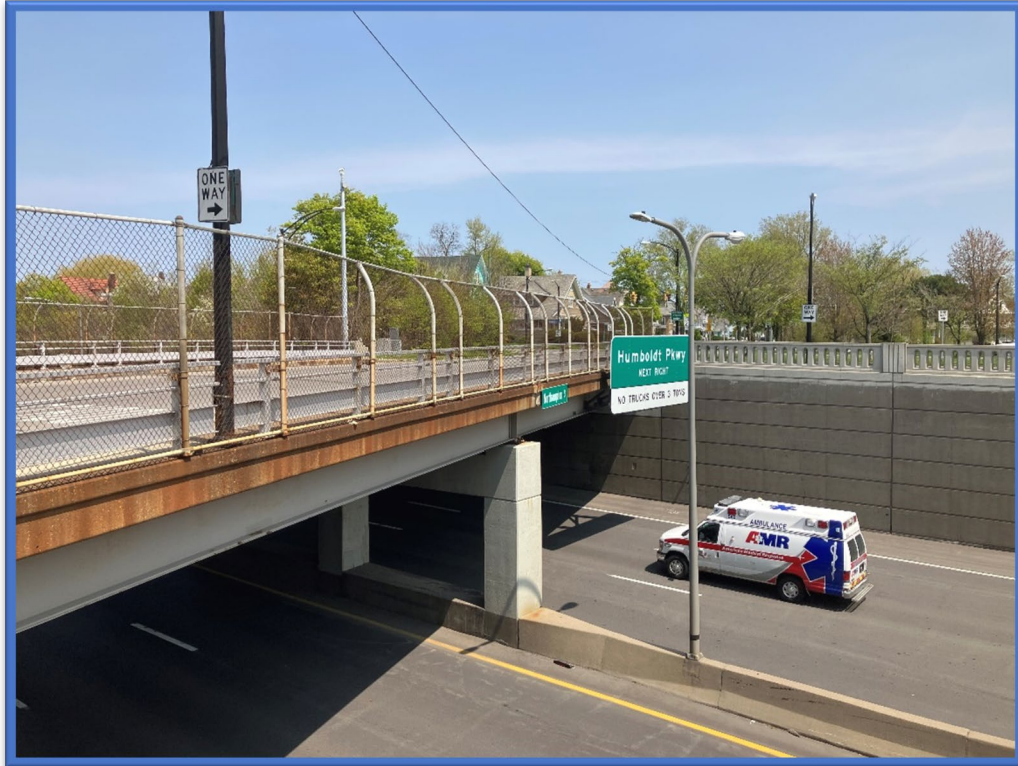
Photo 1 - View to the southern side of the Northampton Street Bridge over Kensington Expressway (Route 33) (BIN 1022620).

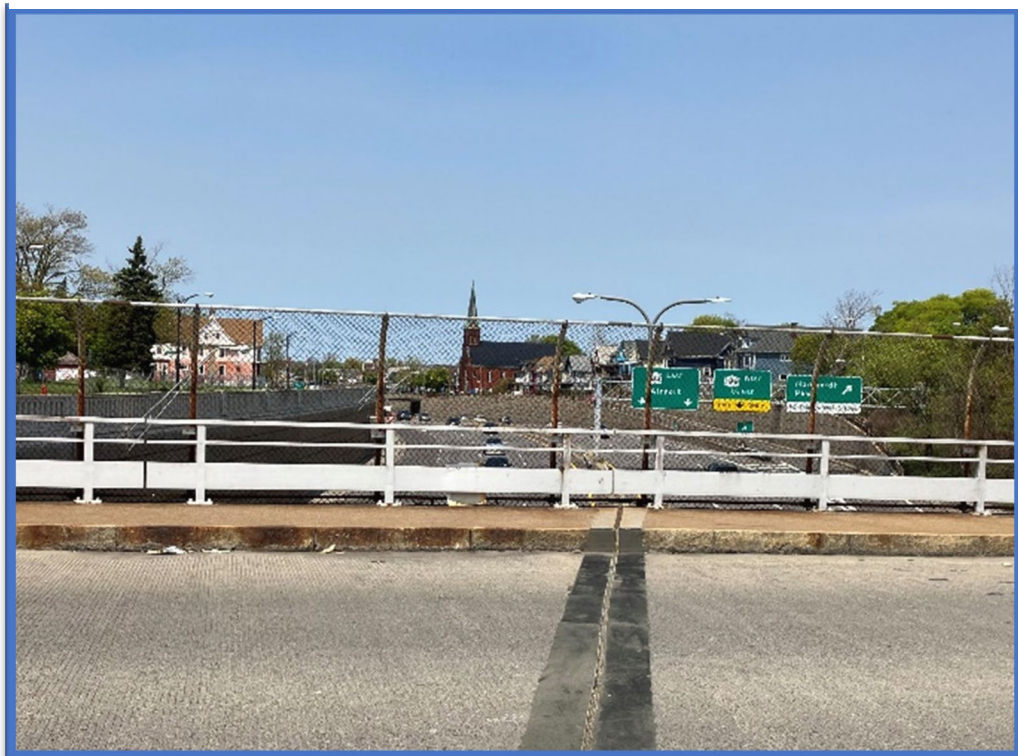
Photo 2 - View to the north from the middle of the deck of the Northampton Street Bridge over Kensington Expressway (Route 33) (BIN 1022620). Project corridor retaining walls are visible in the background of the photo.

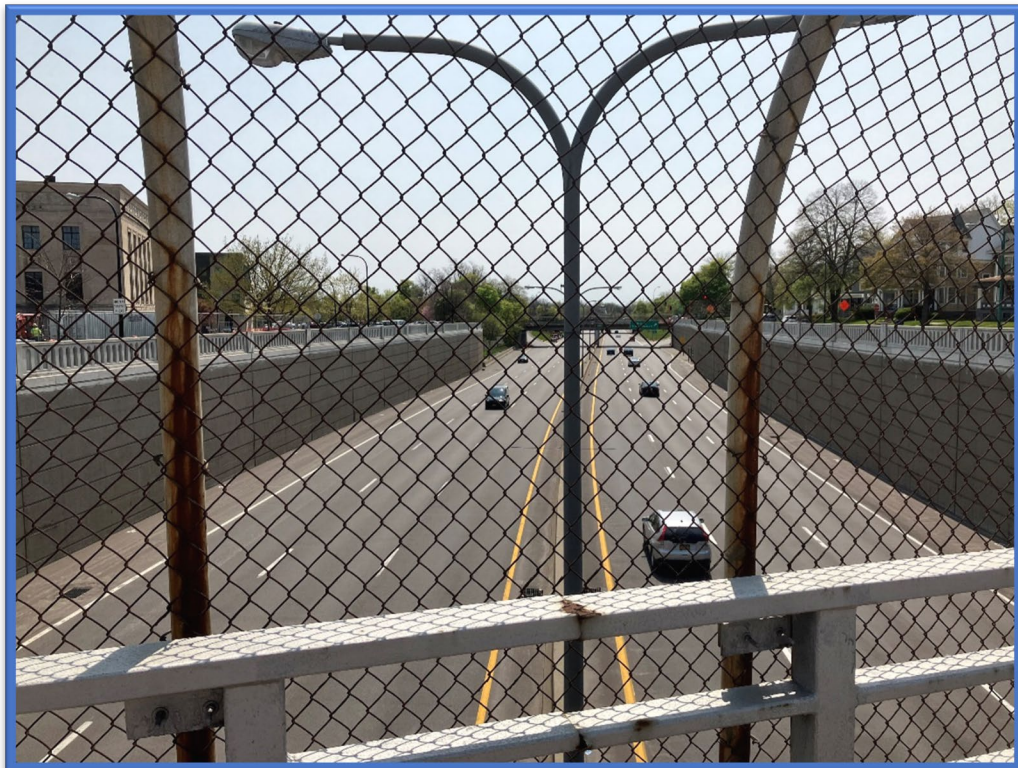
Photo 4 - View to the south from the middle of the deck of the Northampton Street Bridge over Kensington Expressway (Route 33) (BIN 1022620). Project corridor retaining walls are visible in the background of the photo. ACM caulking is only associated with the older lower portion of the walls.

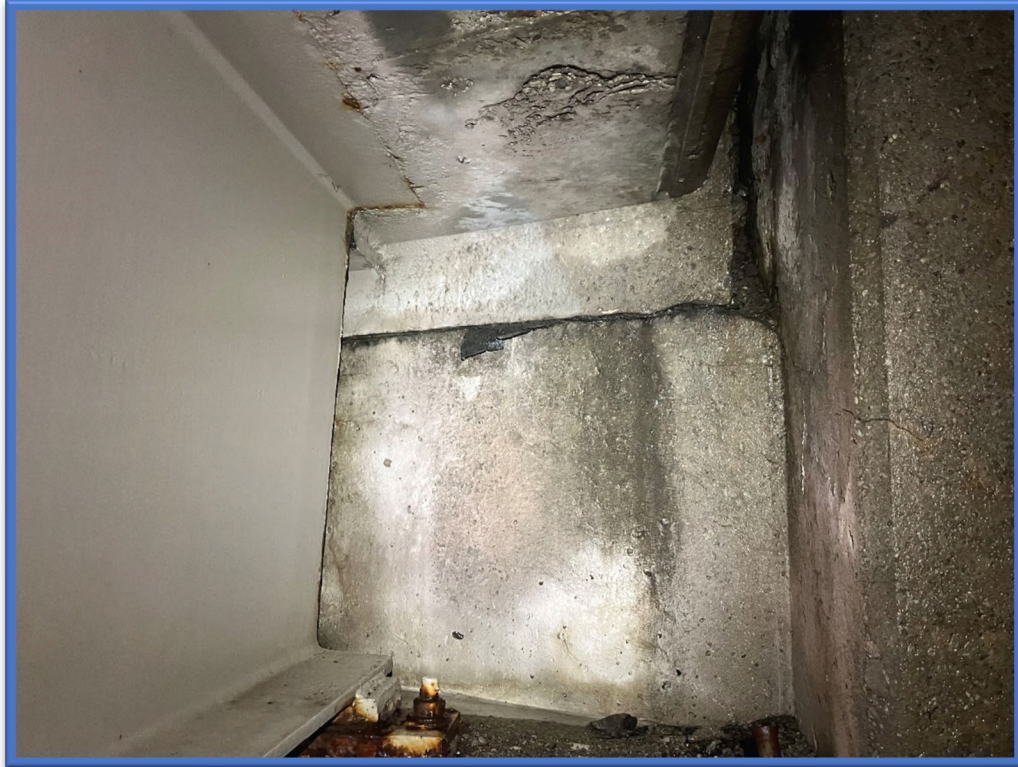
Photo 7 - Compressed asbestos sheet packing located on the abutment shelves at BIN 1022630 was confirmed as an ACM. Picture taken at the southeast quadrant of the bridge.

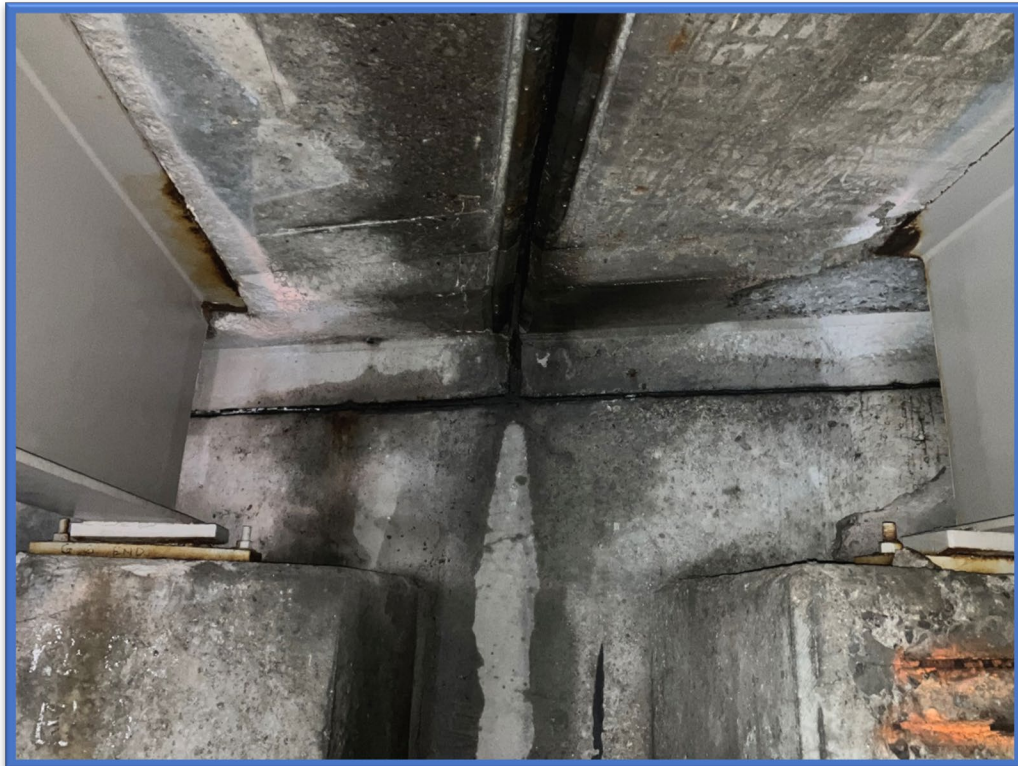
Photo 8 - Compressed asbestos sheet packing located on the abutment shelves at BIN 1022630 was confirmed as an ACM. Picture taken at the center of the east abutment.

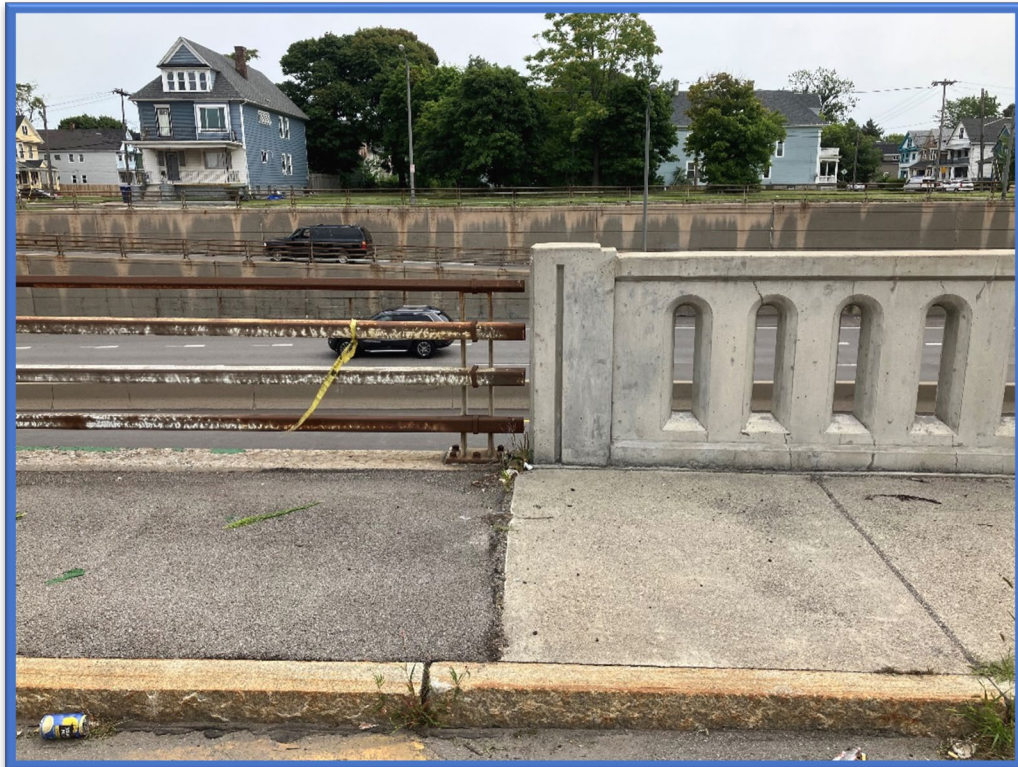
Photo 9 – Asbestos-containing railing post base caulk is associated with all of the metal guiderails located on top of the northern retaining walls. No asbestos-containing caulk is associated with the new decorative concrete guide rails located on top of the southern retaining walls.

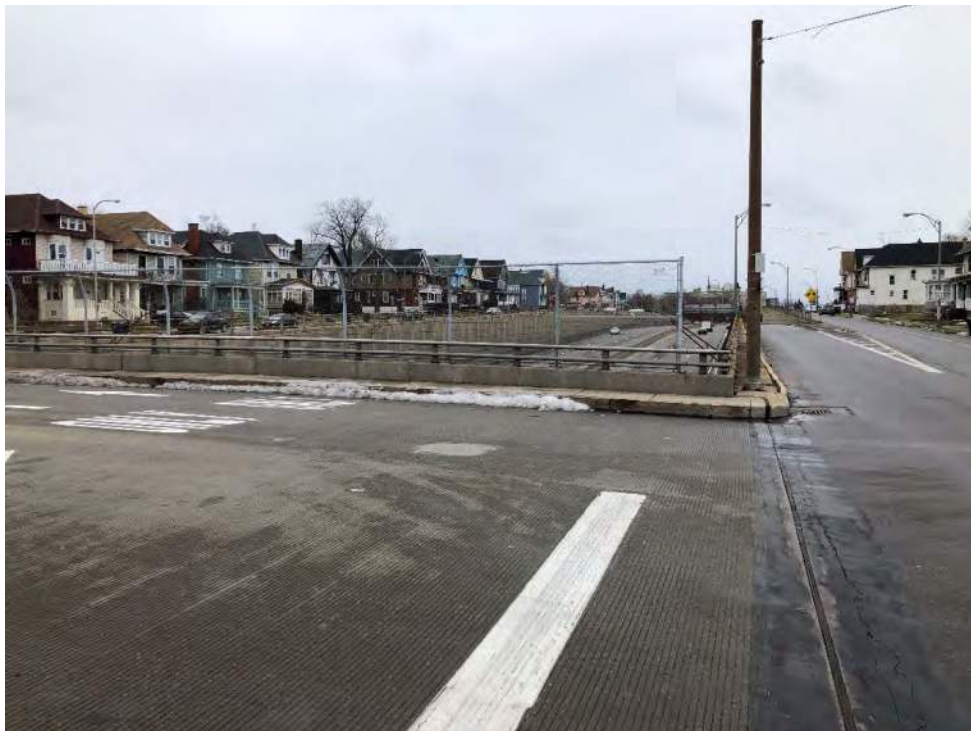
Photo 2 – View looking north at BIN 1022630 (E. Utica Street over Kensington Expressway (NY Route 33)).

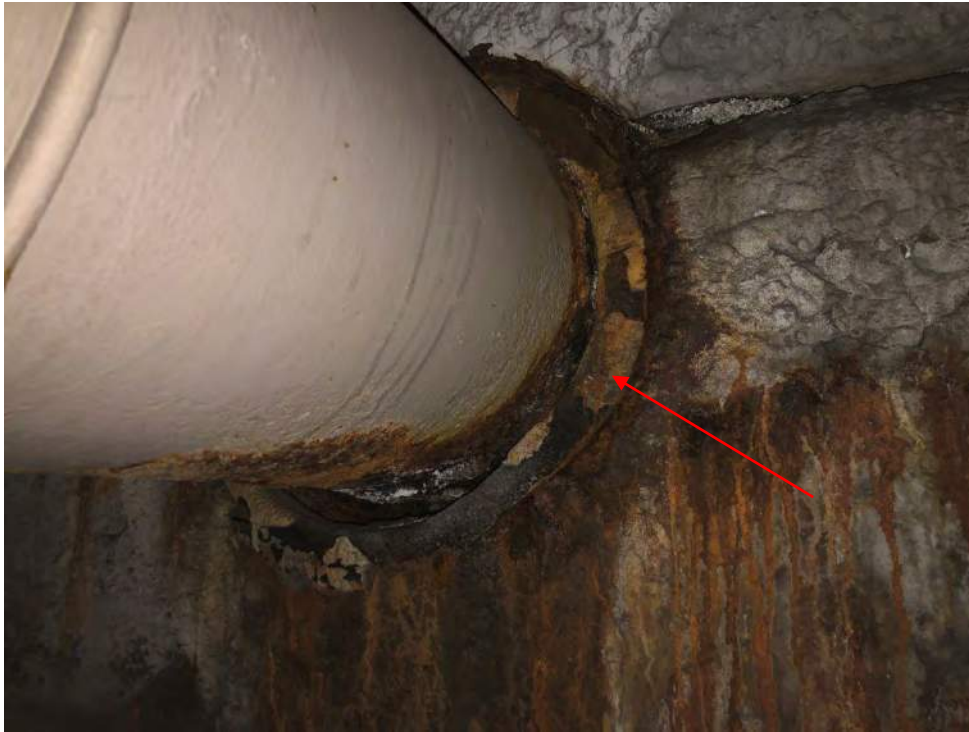
An asbestos-containing packing/sealant was identified at each abutment penetration of the 12” utility conduit that contains an 8” gas line. The approximately 2.5” thick bead of packing/sealant is located around the perimeter of the conduit. The ACM was observed to be generally intact at the eastern abutment, however, at the western abutment, approximately half of the ACM was observed to be dislodged and laying on top of the abutment shelf. It is estimated that the total amount of asbestos-containing packing/sealant associated with the two abutment penetrations is approximately 6 linear feet (1.25 square feet for NYSDOL reporting purposes). The approximate locations of this material are shown in FIGURE 2.

Photo 5 – View of the 12” metal conduit associated with the 8” gas utility line where it penetrates the east abutment of BIN 1022630. The packing/sealant around the perimeter of the 12” conduit where it penetrates each abutment has been identified as an ACM.

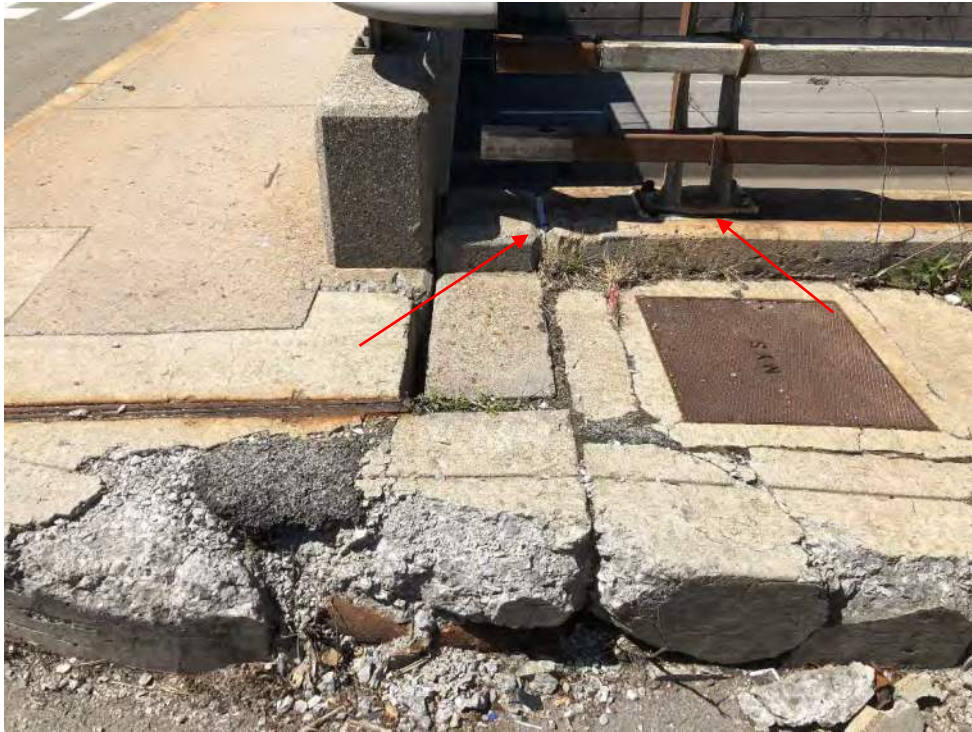
During our inspection, a bead of asbestos-containing caulk was observed within close proximity (within a few feet) at each corner of the bridge. Each bead is approximately 2" thick and approximately 20 linear feet long. At each location, the ACM is located within the vertical joint that extends from the Kensington Expressway (Route 33) roadway surface up the entire retaining wall (approximately 18' high), and also extends along the horizontal surface (approximately 1.5') on top of the retaining wall. The top of the retaining wall is located at the E. Utica Street surface level and extends along the entire length of Humboldt Parkway.

Photo 9 – View facing west at the northeast corner of BIN 1022630 and the retaining wall. The retaining wall grey caulk and the retaining wall guide rail post grey caulk have both been identified as an ACM. The retaining wall caulk is located along the vertical and horizontal face of the retaining wall.

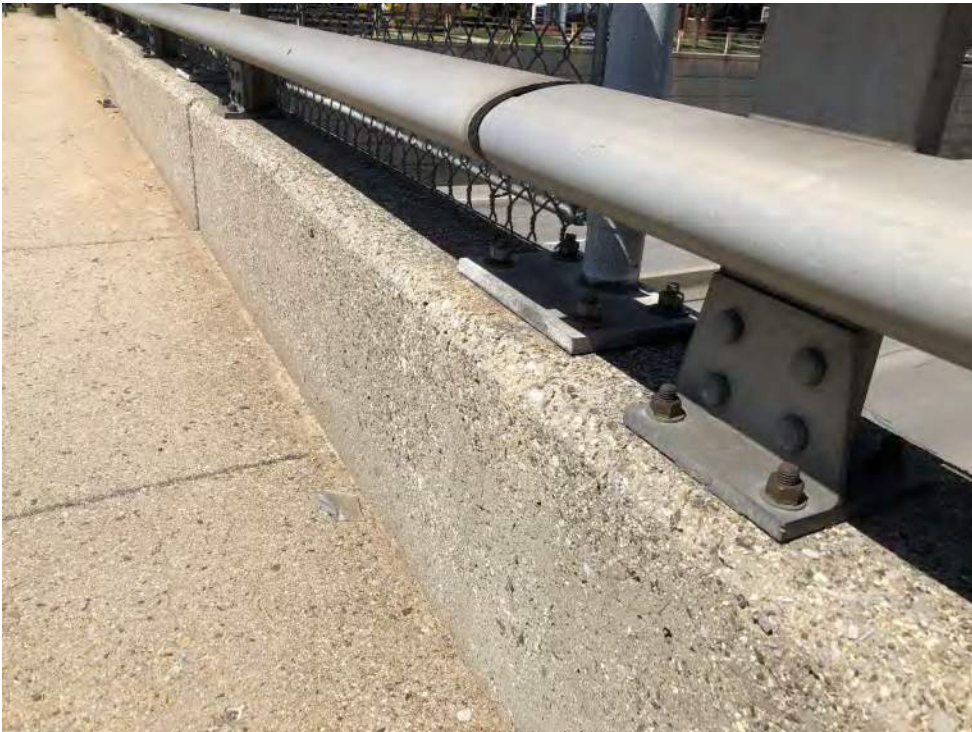
Photo 10 – View of the curb/knee wall along the north side of BIN 1022630. No ACM was identified in association with the associated concrete expansion joint caulk, guide rail, or fence posts.

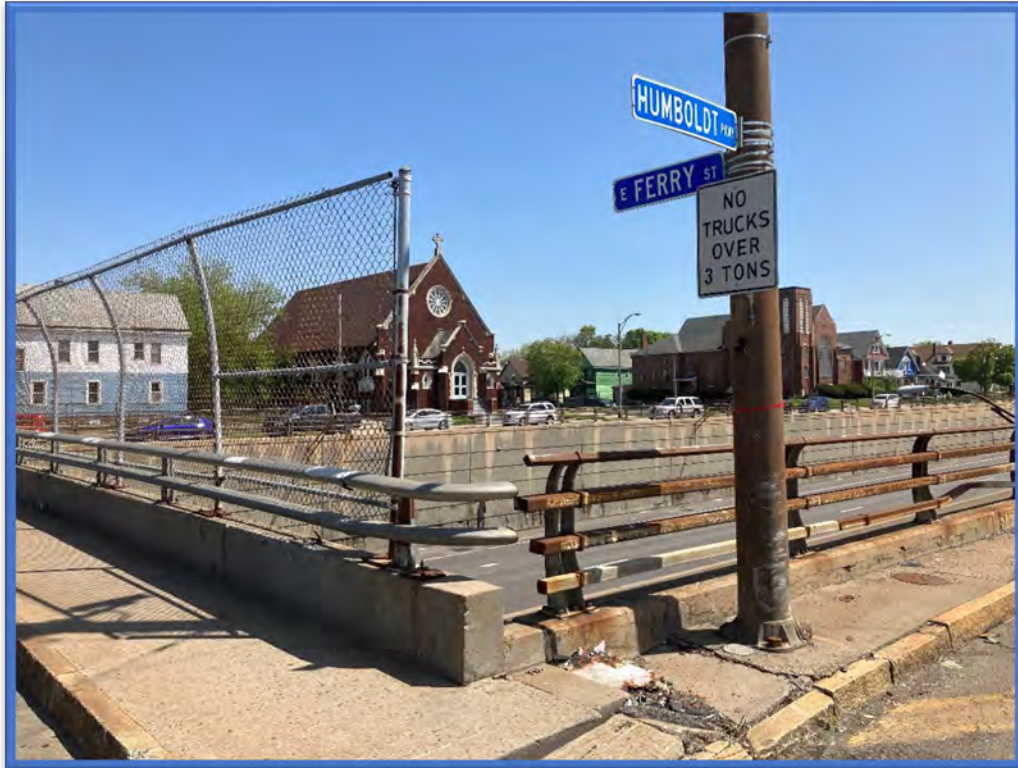
Photo 1 - View towards the southeast of the E Ferry Street Bridge over Kensington Expressway (Route 33) (BIN 1022640). The retaining wall ACMs (expansion joint caulking and railing post caulking) are visible within the photo.

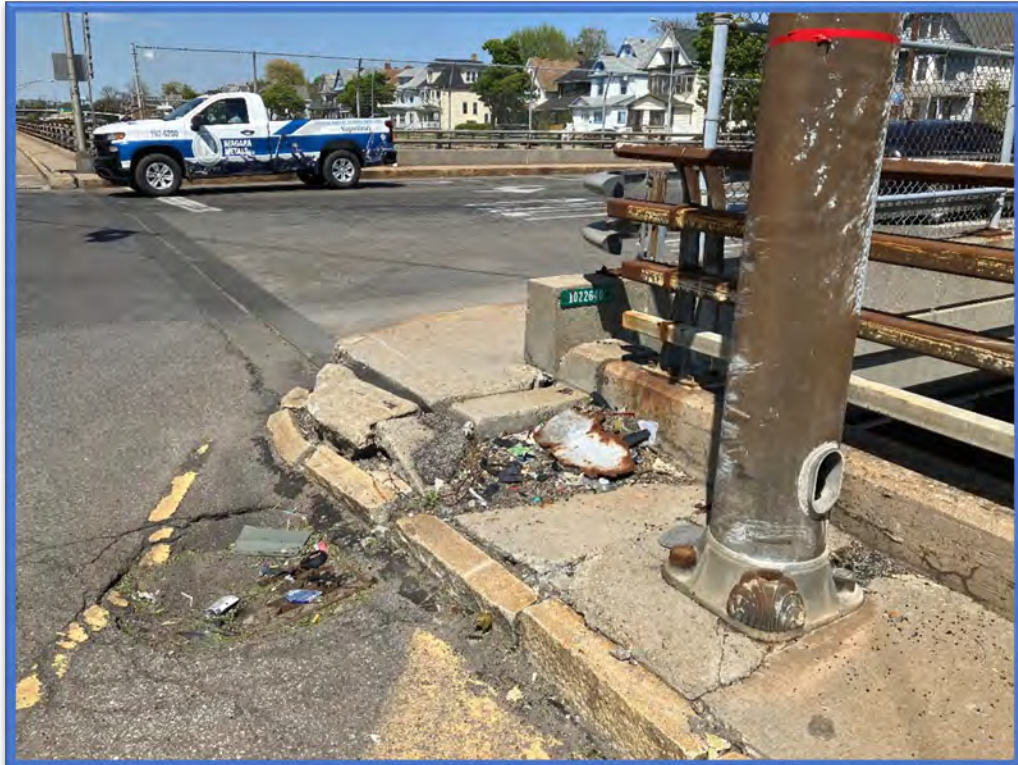
Photo 2 - View of the BIN plate located at the southwest corner of the E Ferry Street Bridge over Kensington Expressway (Route 33) (BIN 1022640).

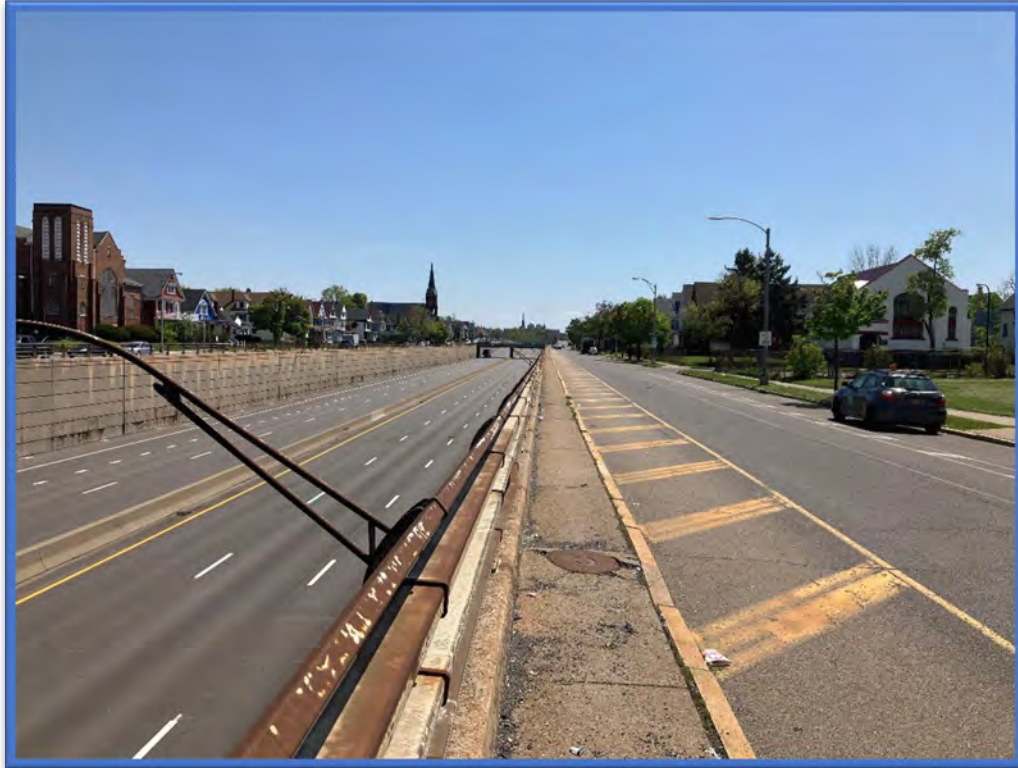
Photo 3 - View to the south from the southwest corner of the E Ferry Street Bridge over Kensington Expressway (Route 33) (BIN 1022640), with the highway retaining walls and East Utica Street over Kensington Expressway Bridge (BIN 1022630) visible in the background.

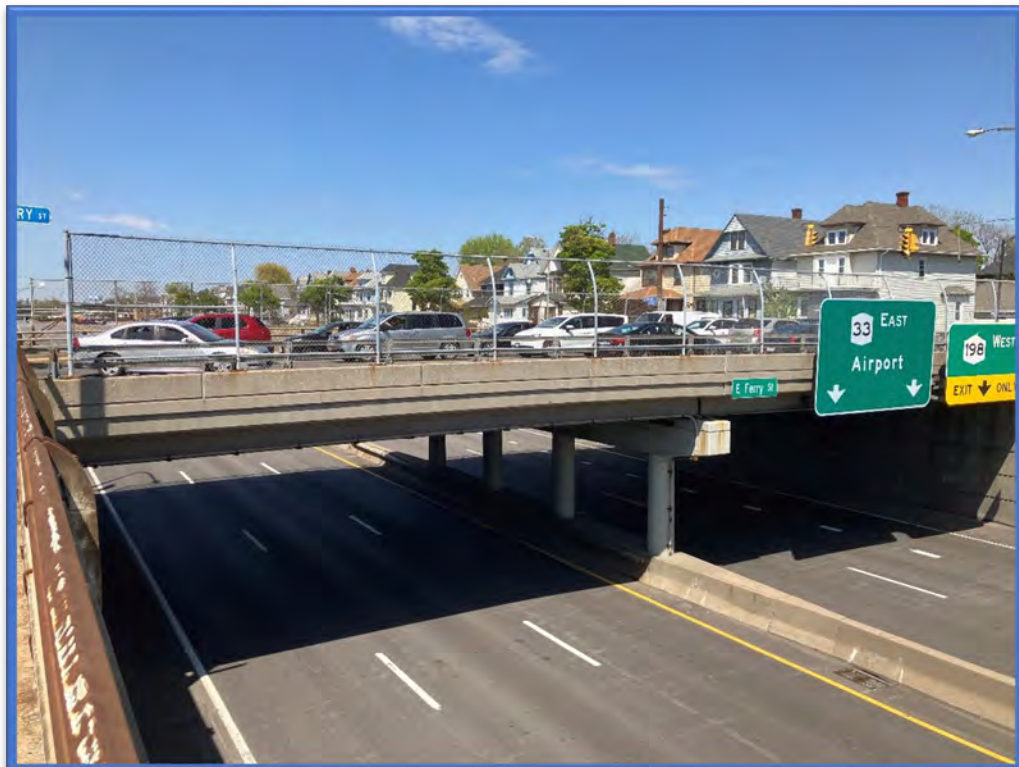
Photo 4 - View to the southern side of the E Ferry Street Bridge over Kensington Expressway (Route 33) (BIN 1022640).

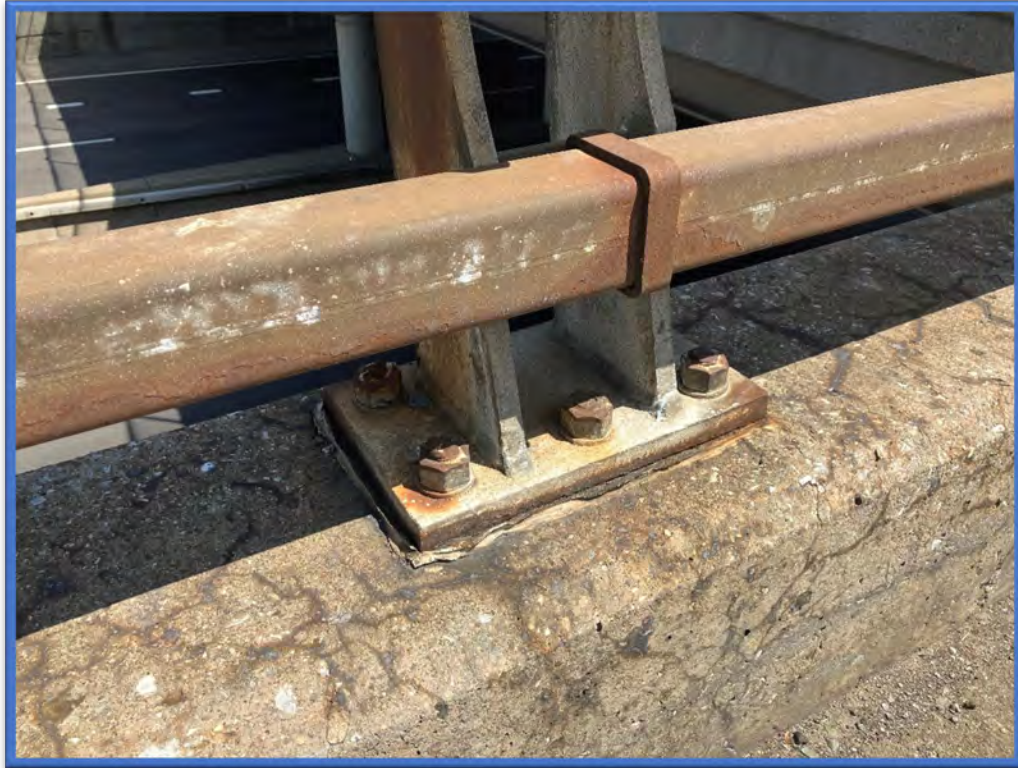
Photo 5 – Asbestos-containing railing post base caulk located at the top of the retaining walls near BIN 1022640. This ACM is present throughout the northern portion of the project corridor.

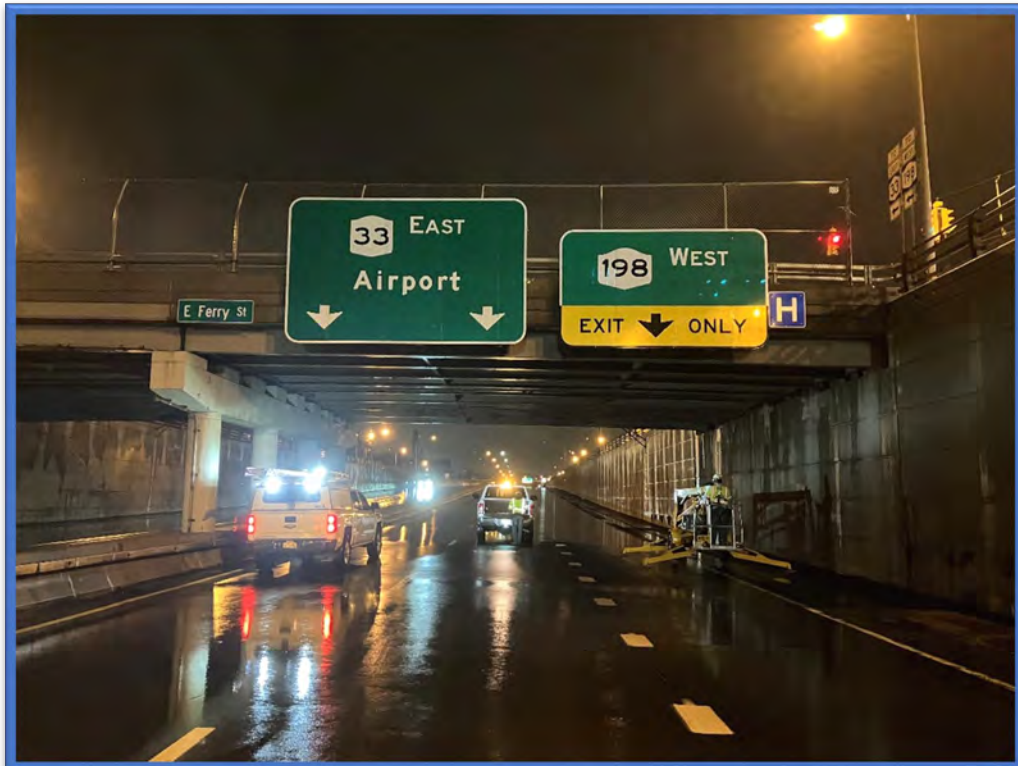
Photo 6 – View of the southern side of the E Ferry Street Bridge over Kensington Expressway (Route 33) (BIN 1022640). Photo taken during the night-time inspection that occurred after closing the EB Kensington Expressway.

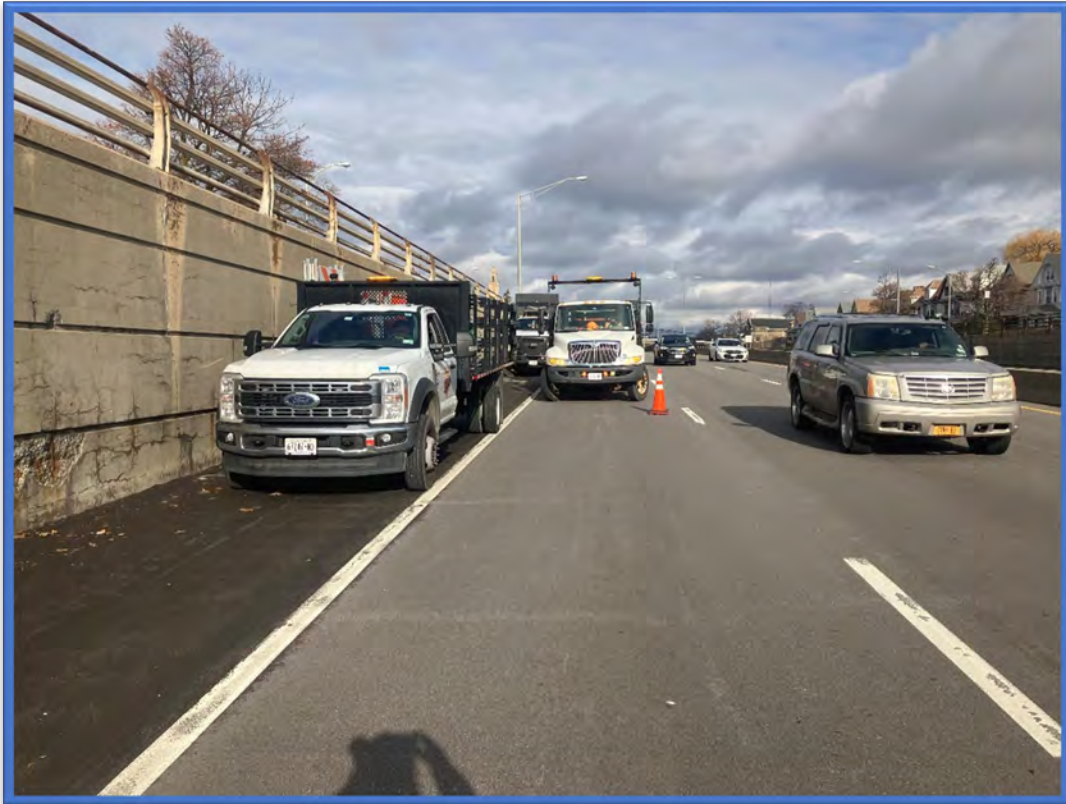
Photo 1 – Work Zone Traffic Control (WZTC) was conducted by U.S. Traffic Control.

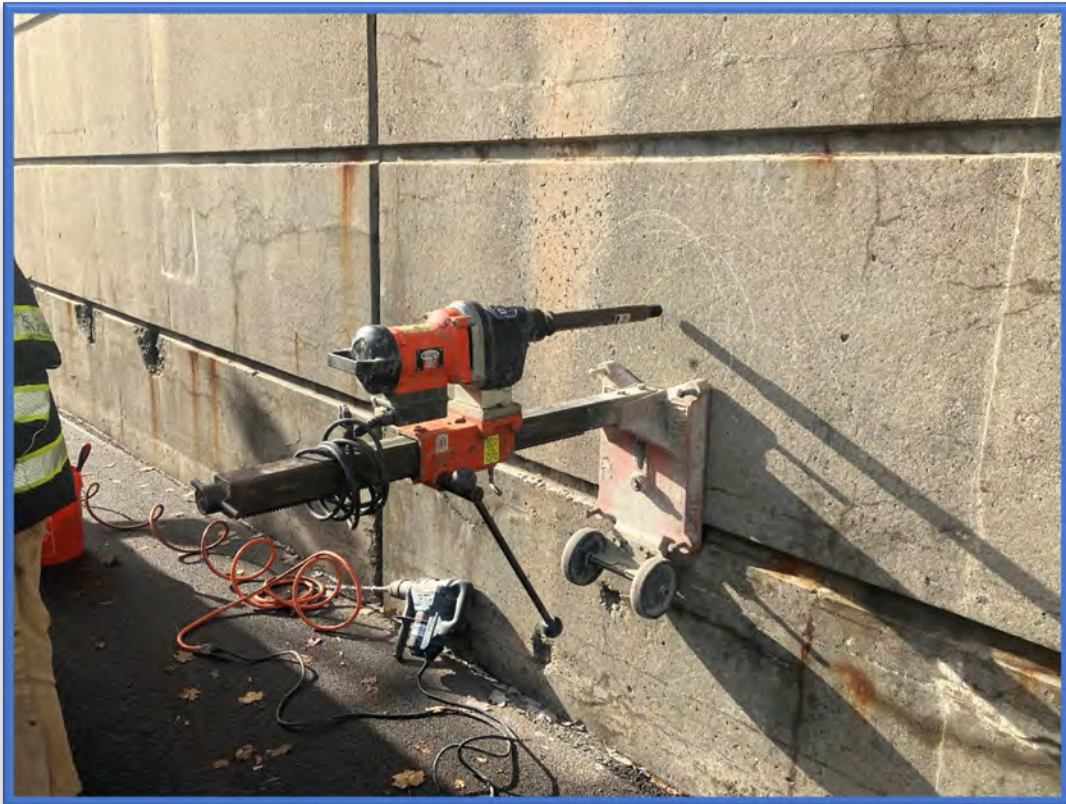
Photo 2 – Coring tool attached to the retaining wall prior to coring.

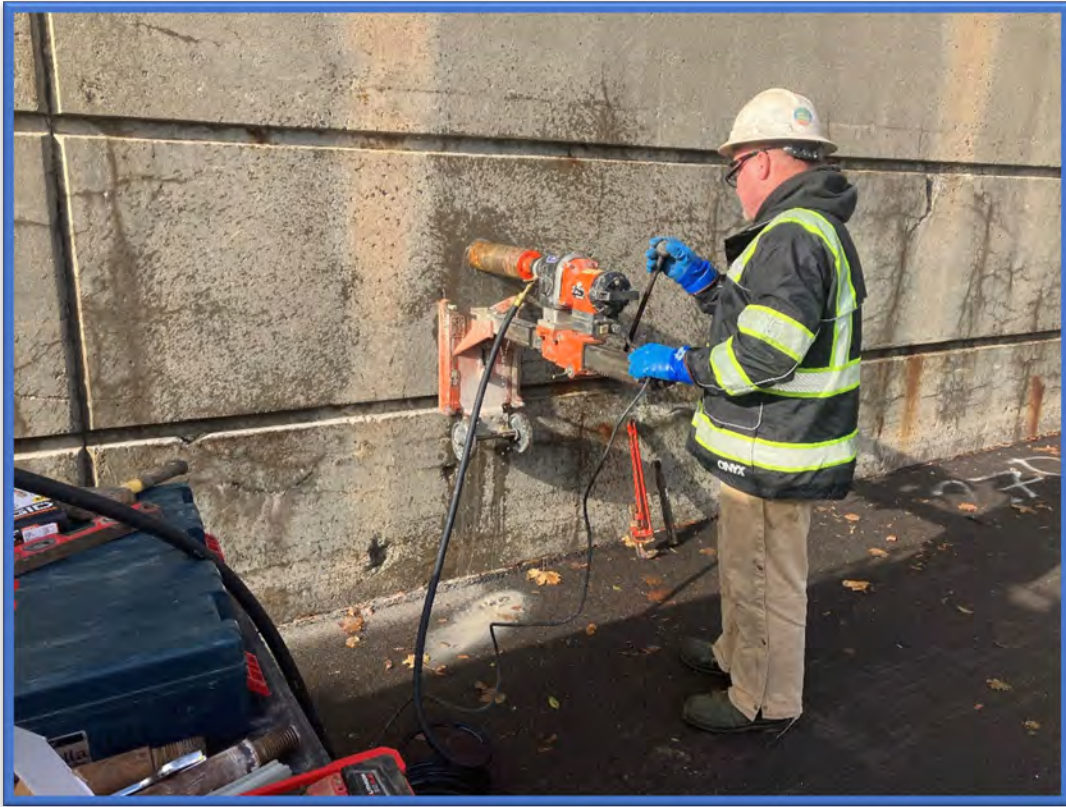
Photo 3 – Coring through the retaining wall.

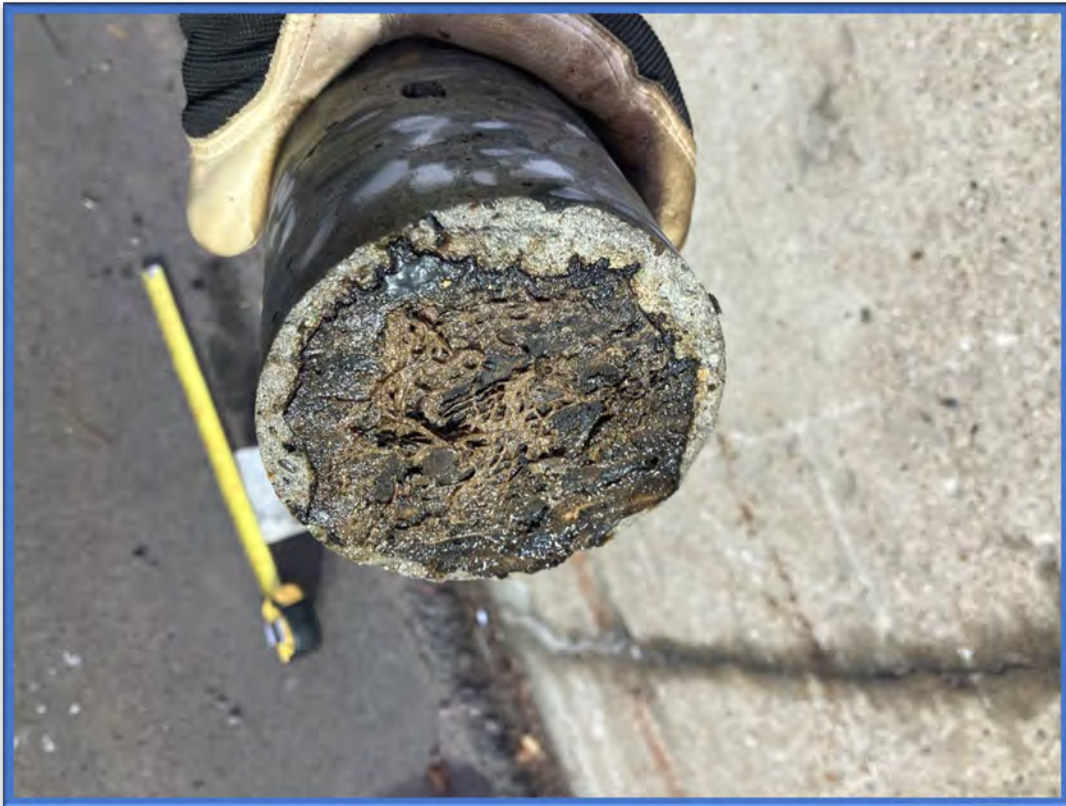
Photo 4 – Waterproofing tar located on the back of the retaining walls.
