Asbestos-Containing Materials Inspection

BIN 1022609
Best Street over
Kensington Expressway (Rt. 33)
City of Buffalo,
Erie County, New York

PIN – 5512.52.123

Watts Project No. 20220255

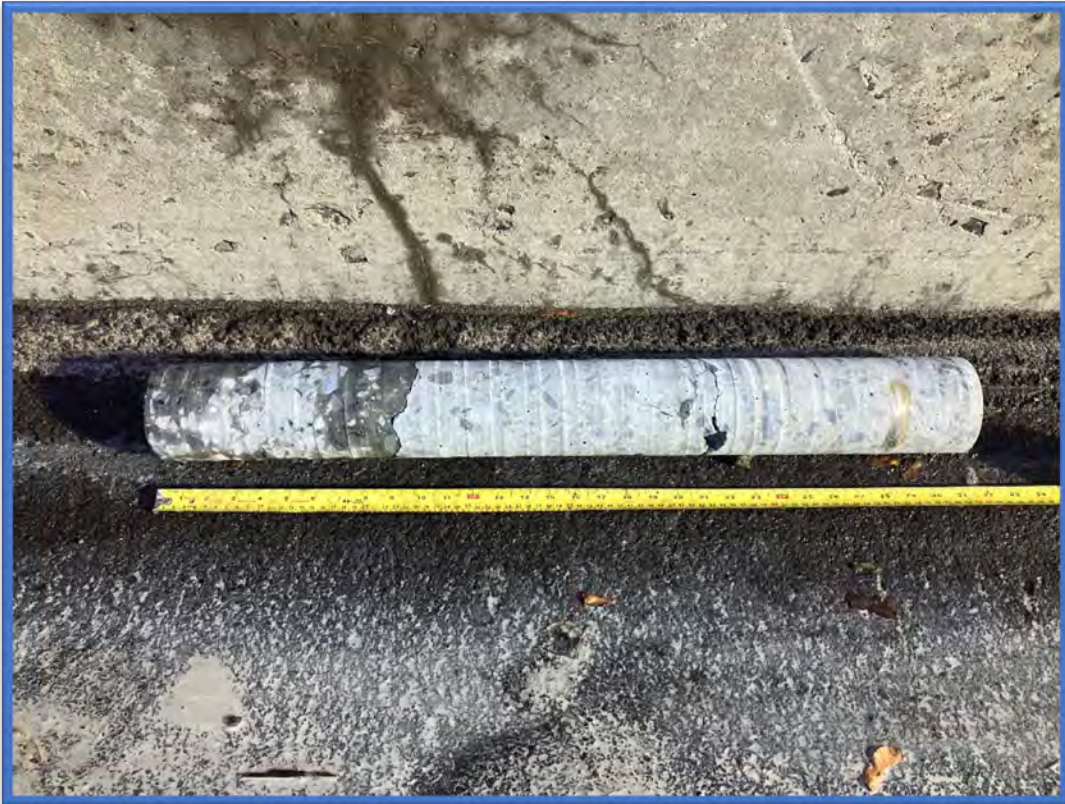
Photo 5 – Complete retaining wall core.

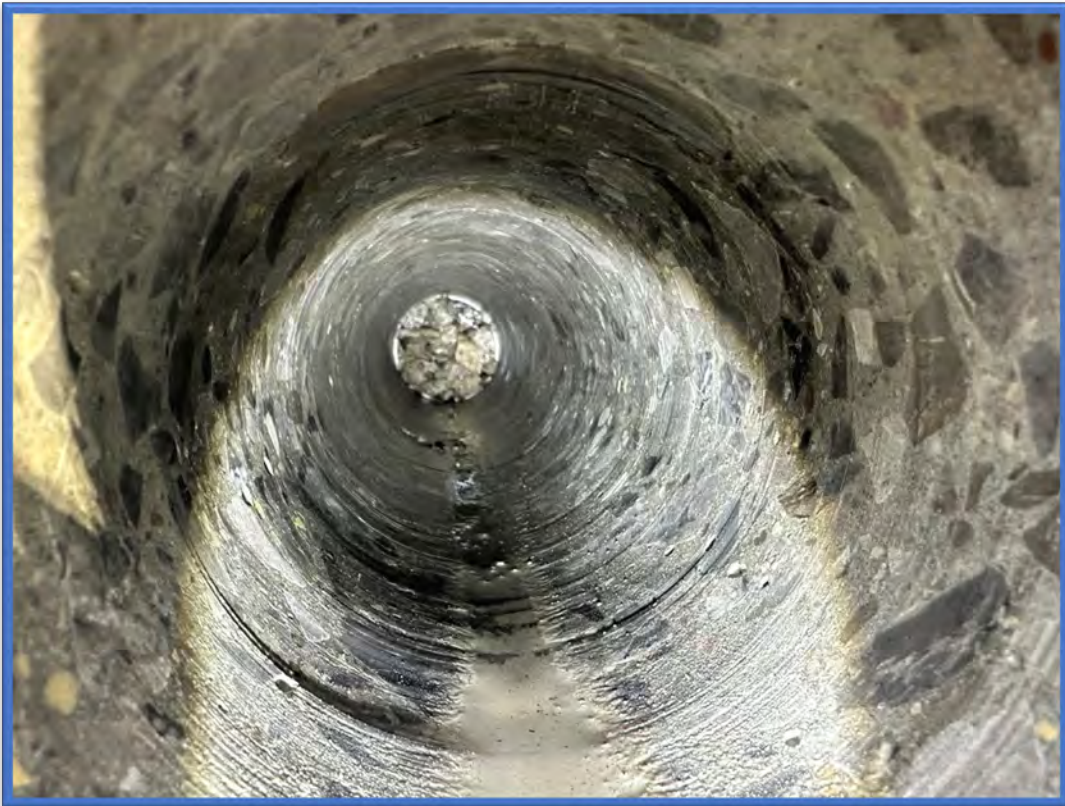
Photo 6 – Inside of the retaining wall core hole with stone visible on the back side.
