Appendix A5

Retaining Wall Inspection Reports

NY33 RETAINING WALL CONDITION EVALUATION 2023
KENSINGTON EXPRESSWAY PROJECT
PIN 5512.52
CITY OF BUFFALO, ERIE COUNTY
RETAINING WALL 1

PIN 5512.52 – NY33 RETAINING WALL CONDITION EVALUATION 2023 FIELD INSPECTION SUMMARY

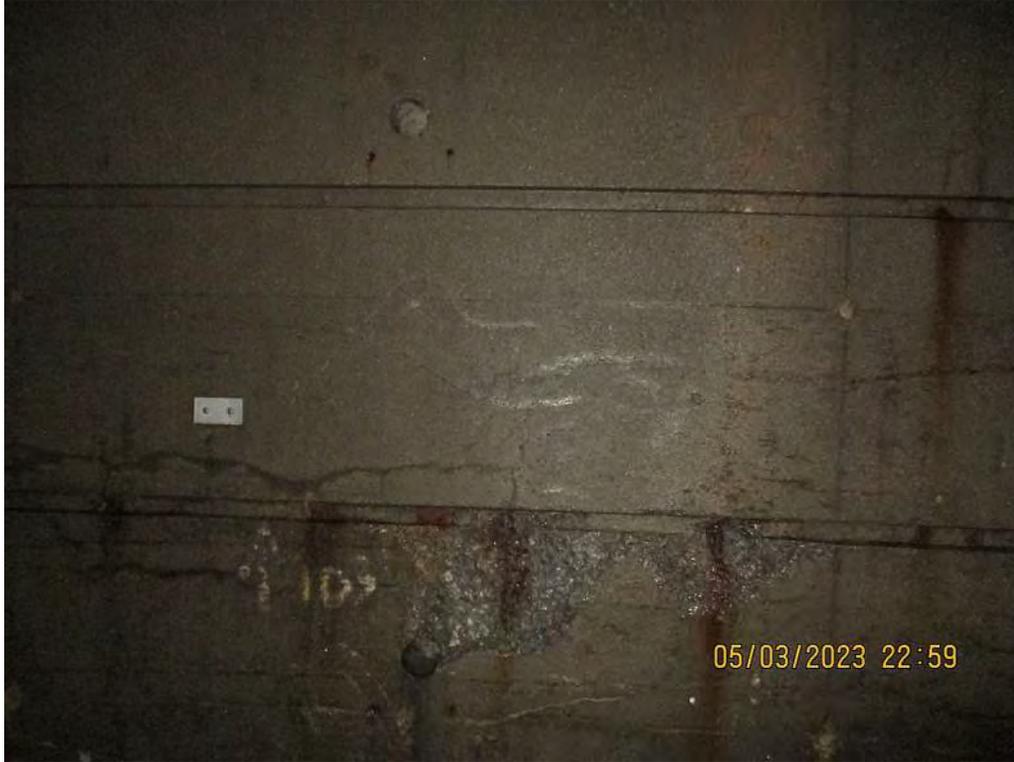
PHOTO 5
PANEL 120
Description:
The lower 4 ft of the wall surface is spalled and delaminated over 50% of the area.
The multiple spalls have exposed rebar.
There is a half height vertical crack in the wall face at 13 ft from the panel begin.

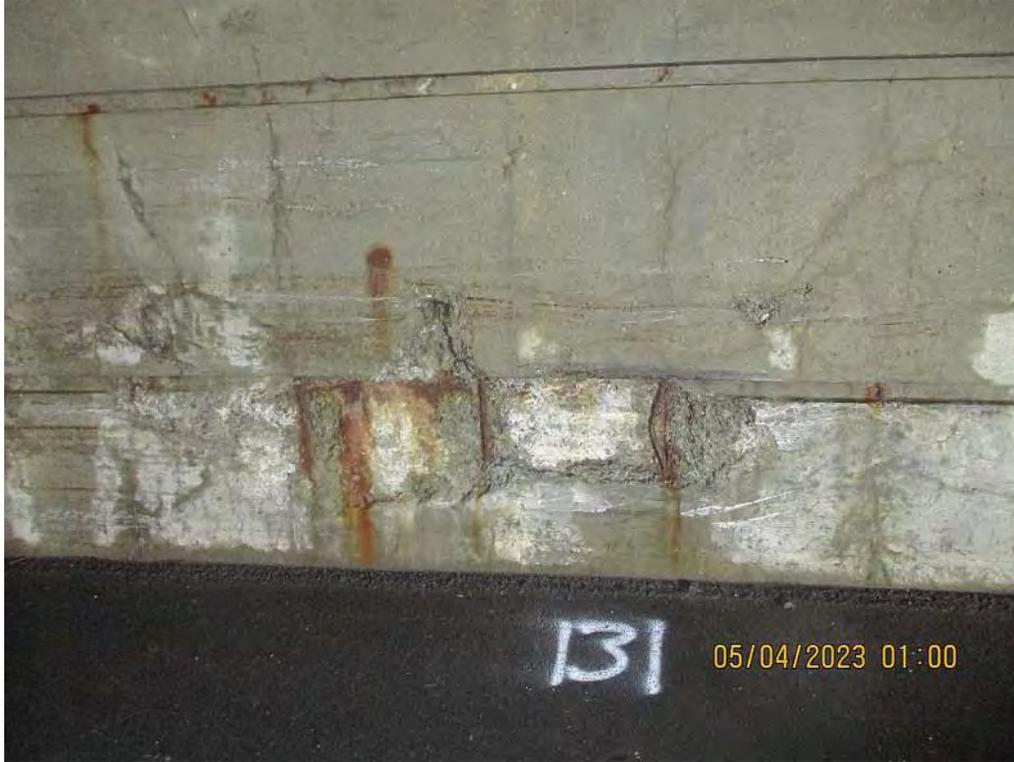
PHOTO 7
PANEL 131
Description:
The bottom three wall panels are delaminated over most of their area. The begin wall joint is delaminated approximately two-thirds the wall height by one foot wide. The lowest panel has a large spall with exposed rebar (rebar has 60% section loss).

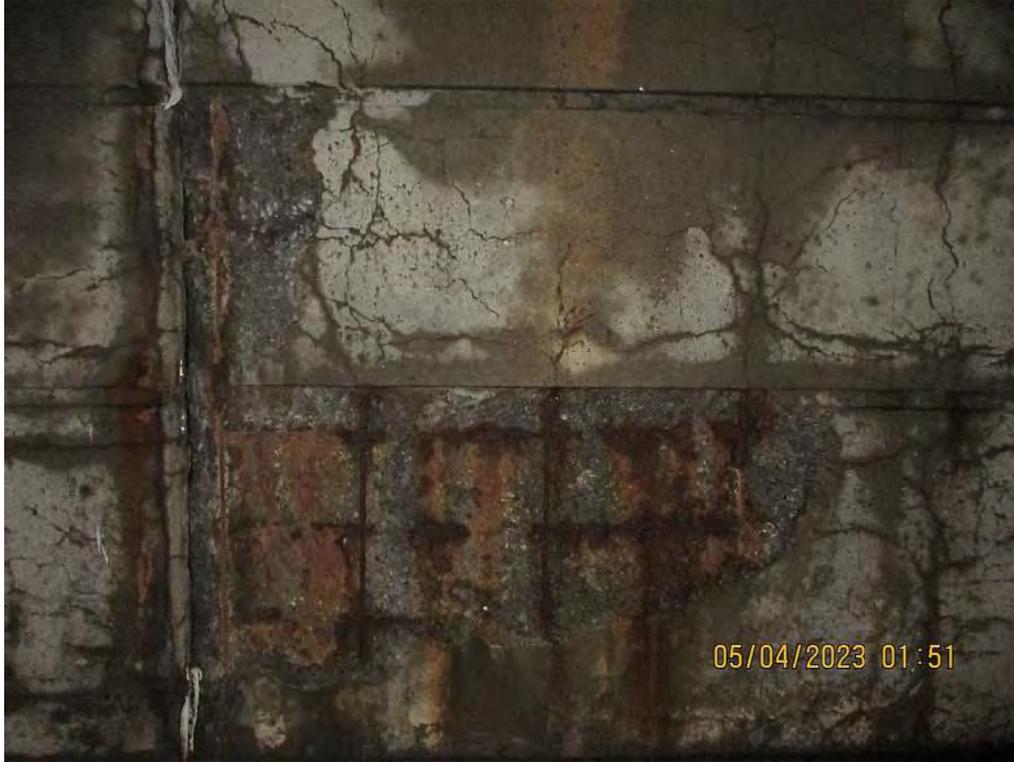
PHOTO 9
PANEL 134
Description:
The lower three sections of the wall are heavily map-cracked with rust staining and some efflorescence. There is a full height crack at 18 ft from the panel begin. The concrete adjacent to the wall end joint is spalled with exposed rebar (rebar is exhibiting 50% section loss)

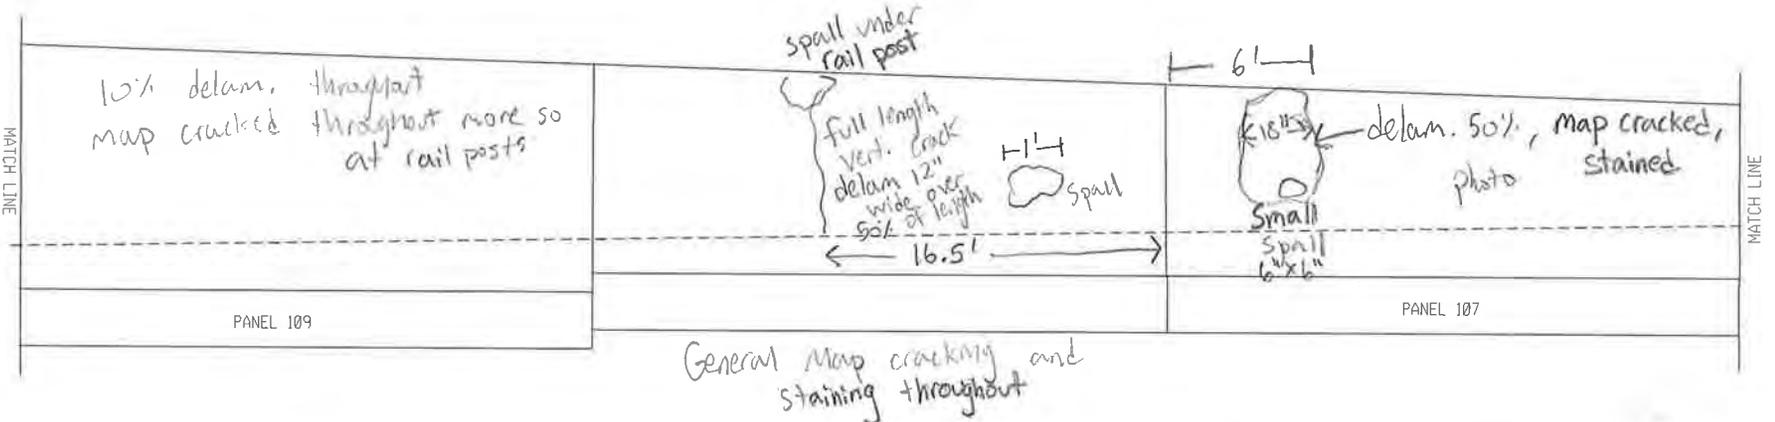
RW 1 PANELS 112-107

Map cracking under rail posts

General: Distress on coping under rail posts

General: Map cracking on coping

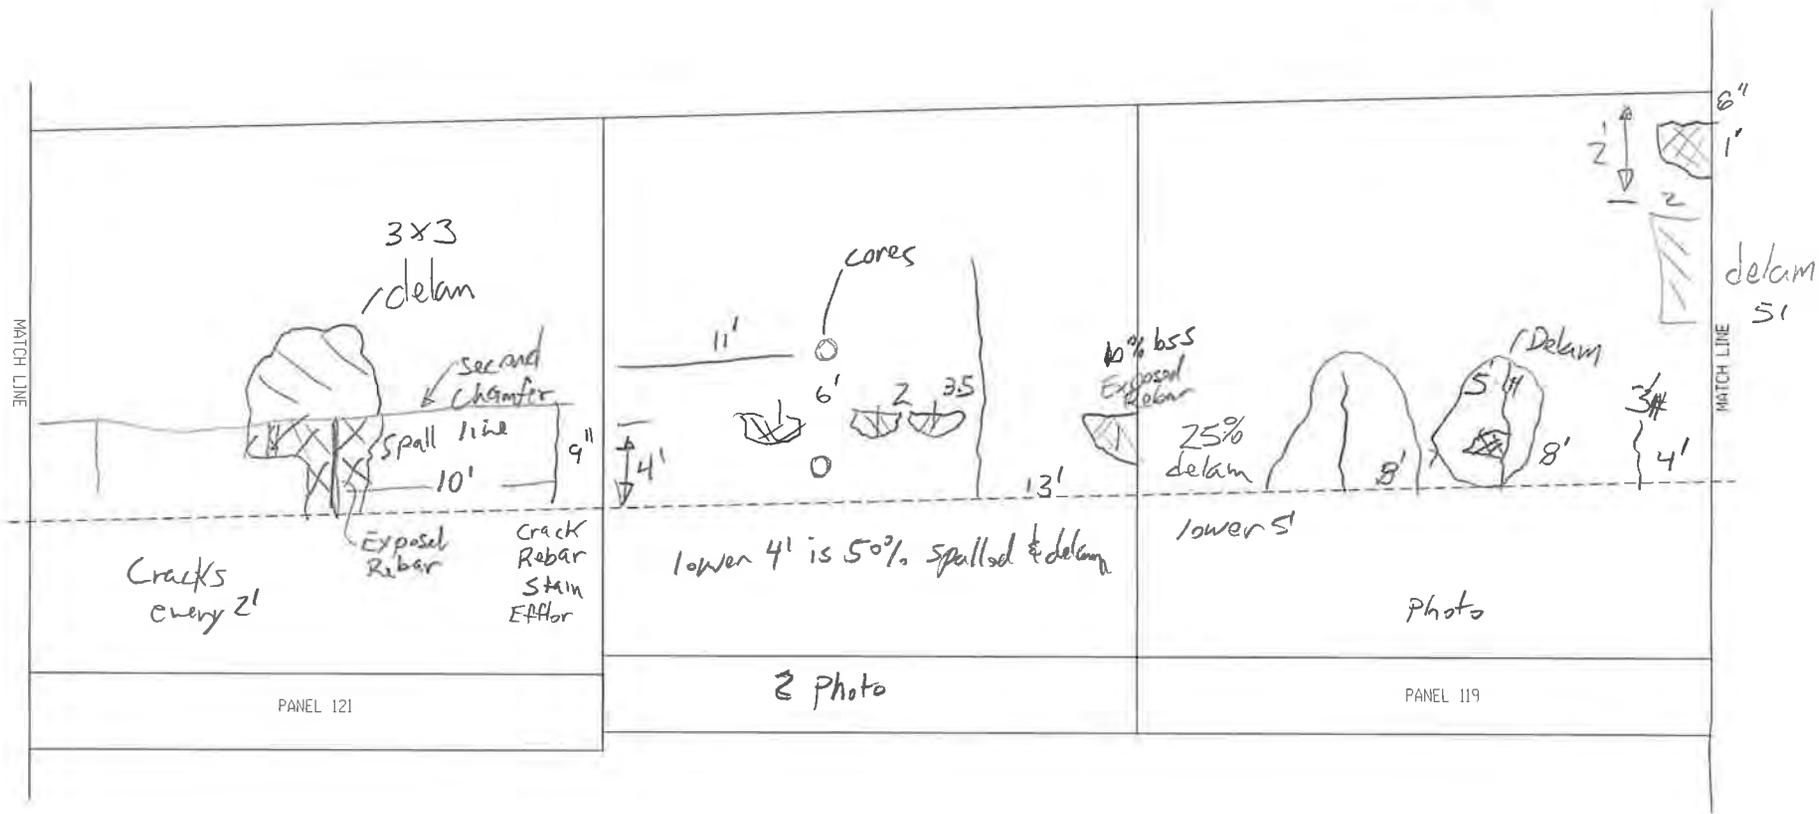
RW 1 PANELS 121-119

119 has light
can be viewed
from face

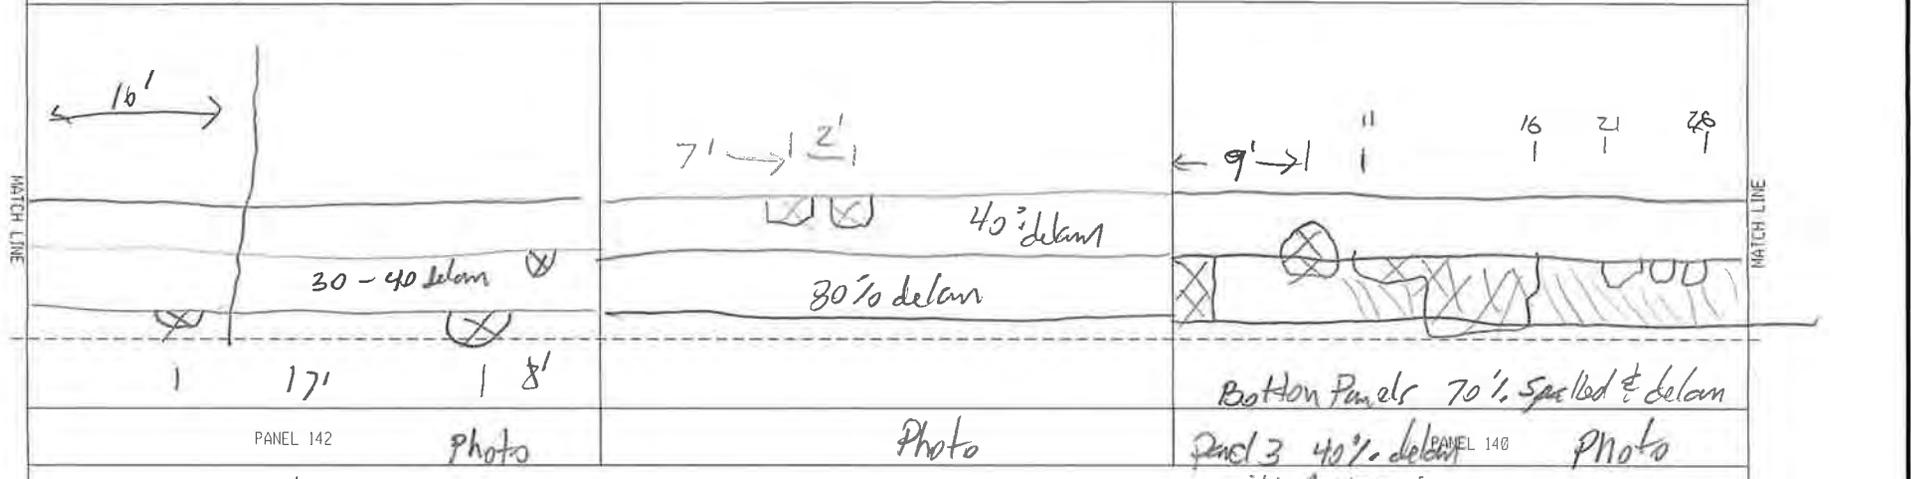
RW 1 PANELS 145-140

Rail coping cracked at mid height with efflorescence and rust staining Photo

Bottom 2 panels heavily mapcracked cracking every 2 ft at rebar lines Rust staining throughout

Heavily mapcracked with cracking at rebar lines 60-70% delam Photo

Bottom 2 panels heavily mapcracked 70% delam Panel 3 - 25% delam

Panel 1 & 2 Heavy mapcracking

Bottom Panels 70% spalled & delam Panel 3 40% delam with mapcracking Photo

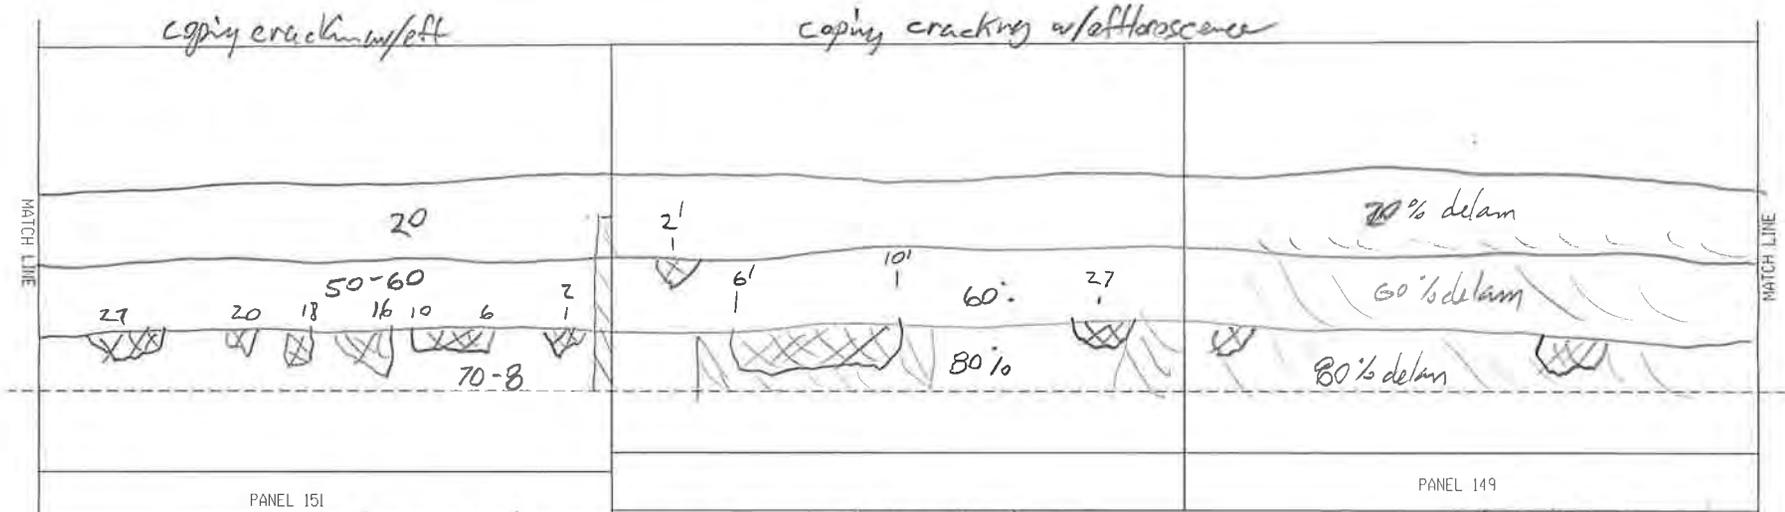
RW 1 PANELS 151-146

①② Heavily mapcracked and spalled with extensive delam

③ Mapcracking

② Mapcracked through out Photo

Heavily mapcracked bottom 2 panels 3 minor mapcracking

Heavy mapcracking Bottom 2 panels

Bottom 2 panels are cracked at 2' sp with spally delam, rust staining 75% delam

Panel 3 light mapcracking 20% delam

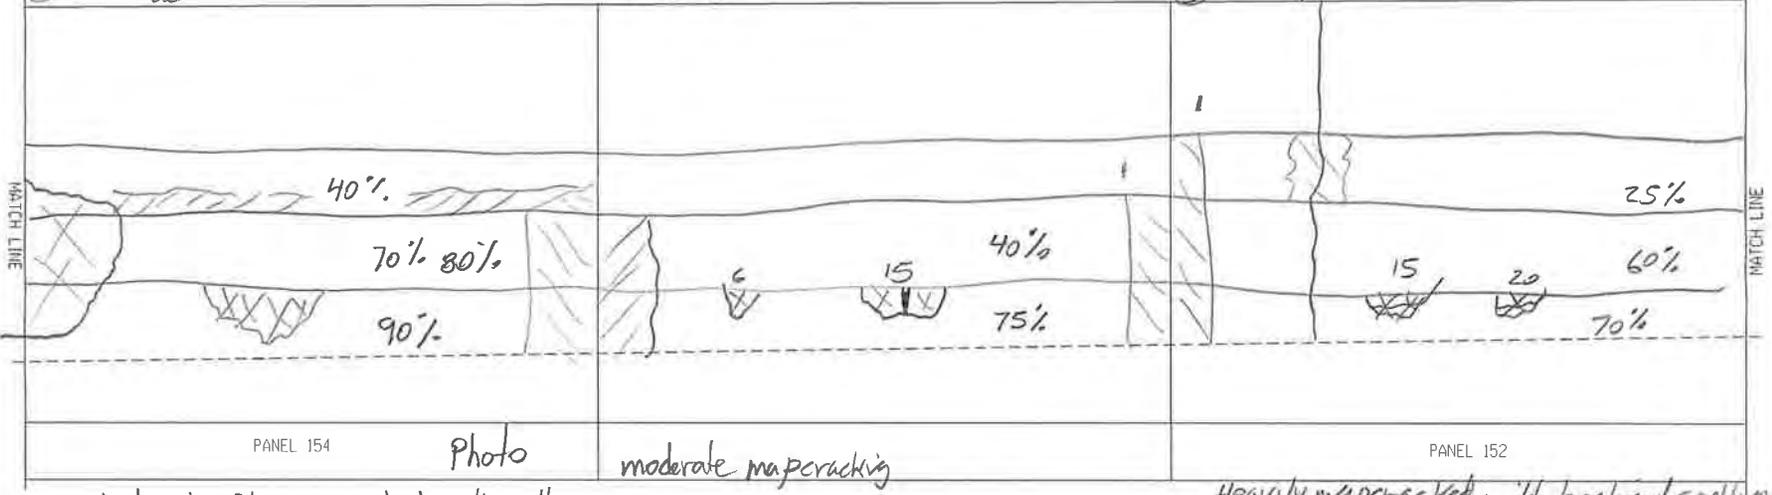
PANEL 157
 Panel 1 & 2 heavily mapcracked
 ① 60% delam
 ② 70% delam
 ③ 20% delam

Mapcracking at all rebar location Panel 1 & 2
 ① is 50% delam
 ② 40%
 ③ 20%

PANEL 154
 Panel 1 & 2 heavily mapcracked with spalling
 & del delam

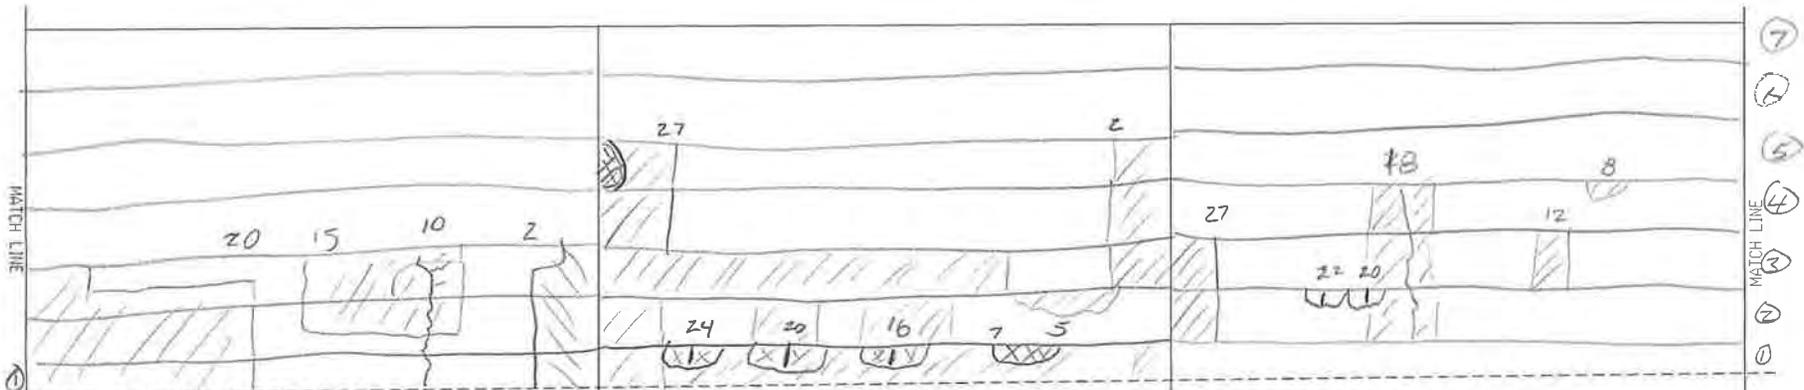
delam ① 40% ② 50% ③ 50%

Bottom 3 panels are Heavily mapcracked with spalling and exposed rebar and rust staining
Cracking follow rebar pattern
rebar section loss 30%

Bottom 3 panels are heavily mapcracked with rust staining

3 lower panels are heavily mapcracked with rust staining
panels ①②③ 80% delam
Photo

Bottom ③ panels are mapcracked with rust staining
④-⑦ 20% delam

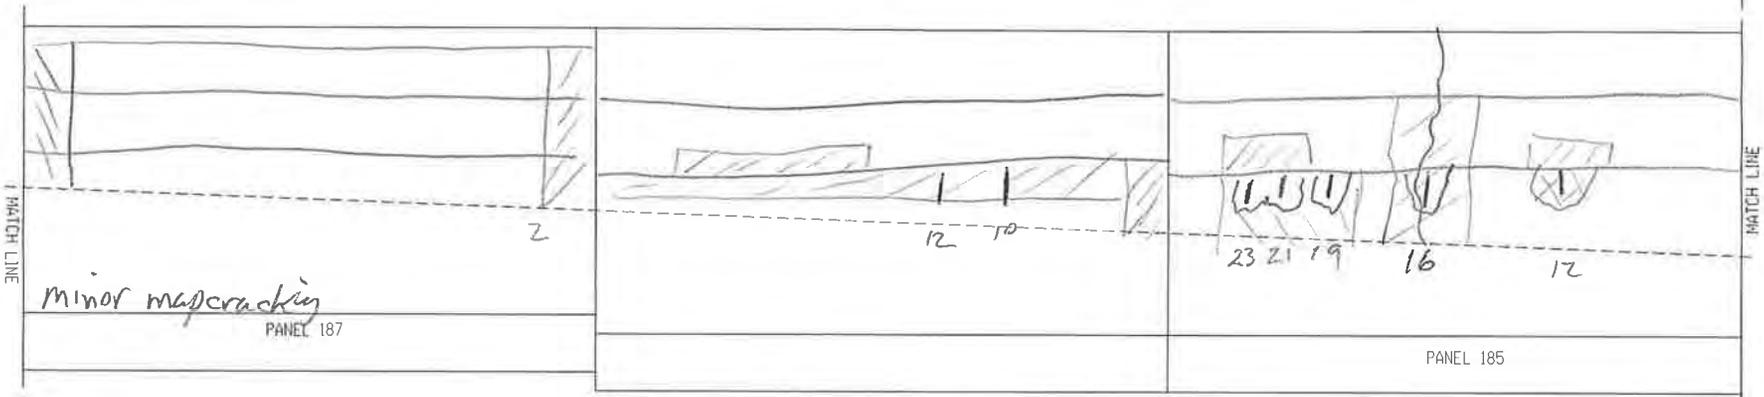
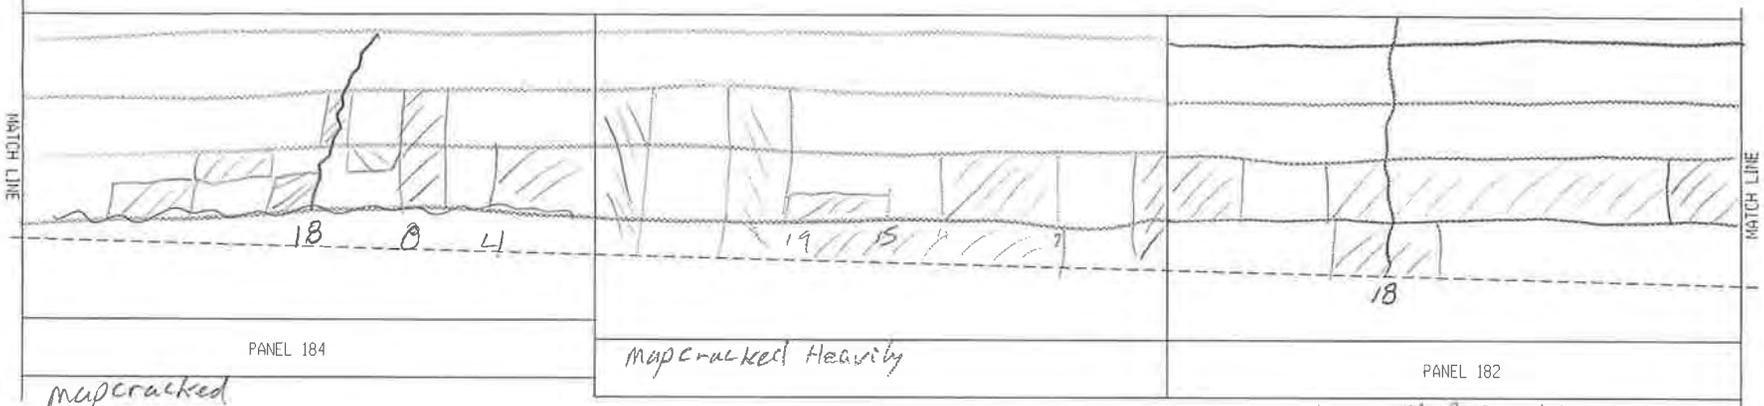
RW 1 PANELS 190-182

mapcracked
 Ⓧ 60% delam
 ○ 20% delam

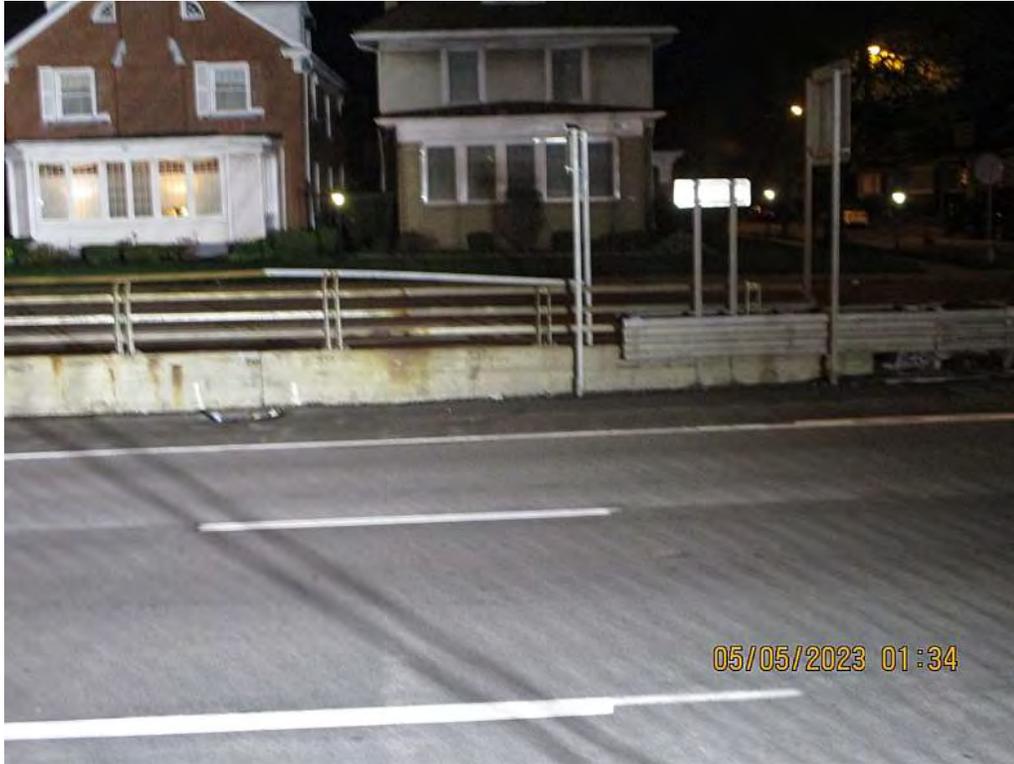
PHOTO 1
PANEL 286
Description:
End of RW2.
Map cracking and rust staining on rail coping.

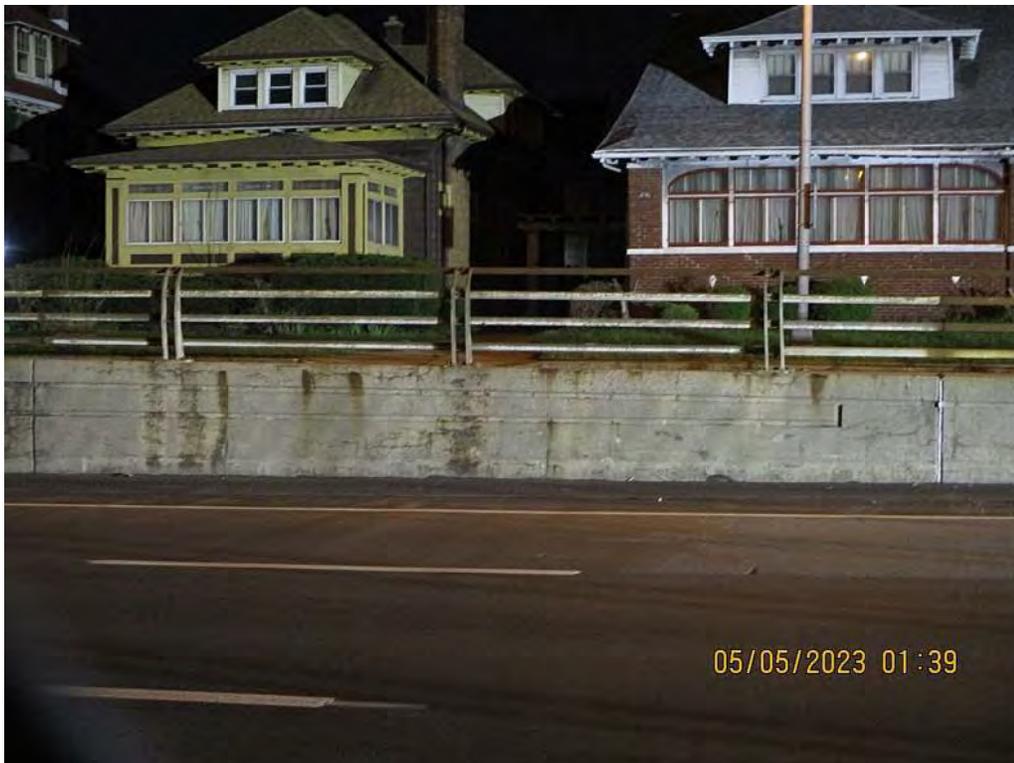
PHOTO 2
PANEL 283
Description:
Map cracking and rust staining on rail coping.
Map cracking with efflorescence throughout. More concentrated map cracking under rail posts, typical.
Delamination in top half of panel for 1' from right joint.
Similar for panels 285-279. Panels 285 and 282-280 have spalls as well.

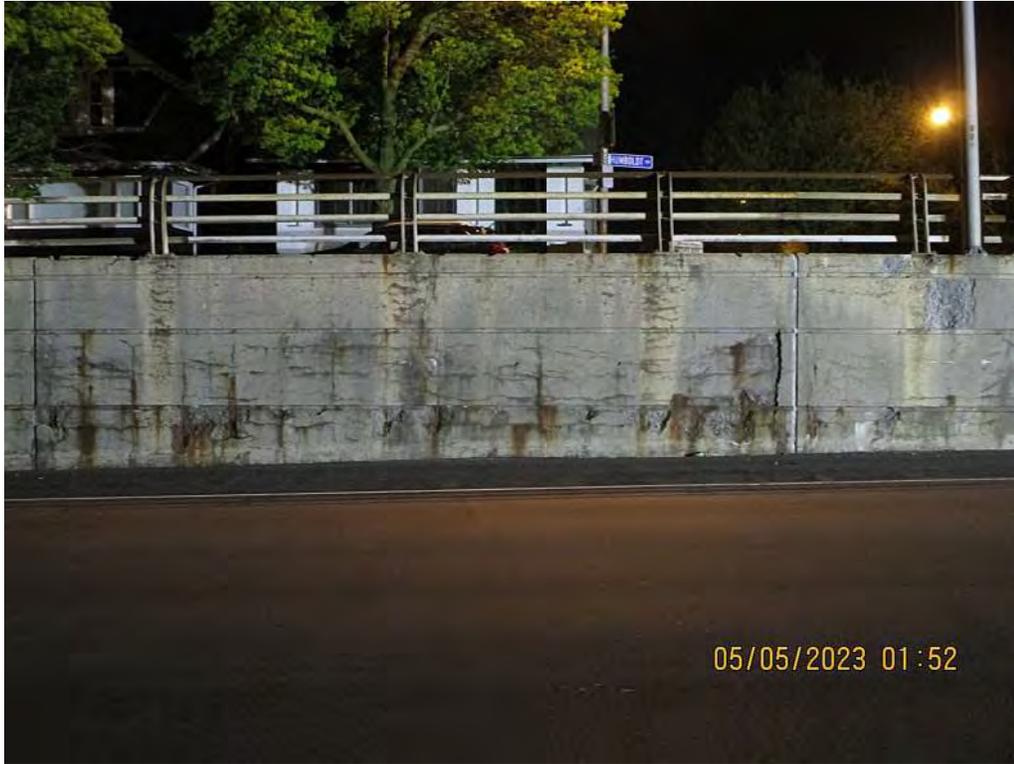
PHOTO 3
PANEL 277

The bottom panel has many large spalls with exposed rebar, rust staining, and efflorescence.

Panels 278 and 272 are similar.

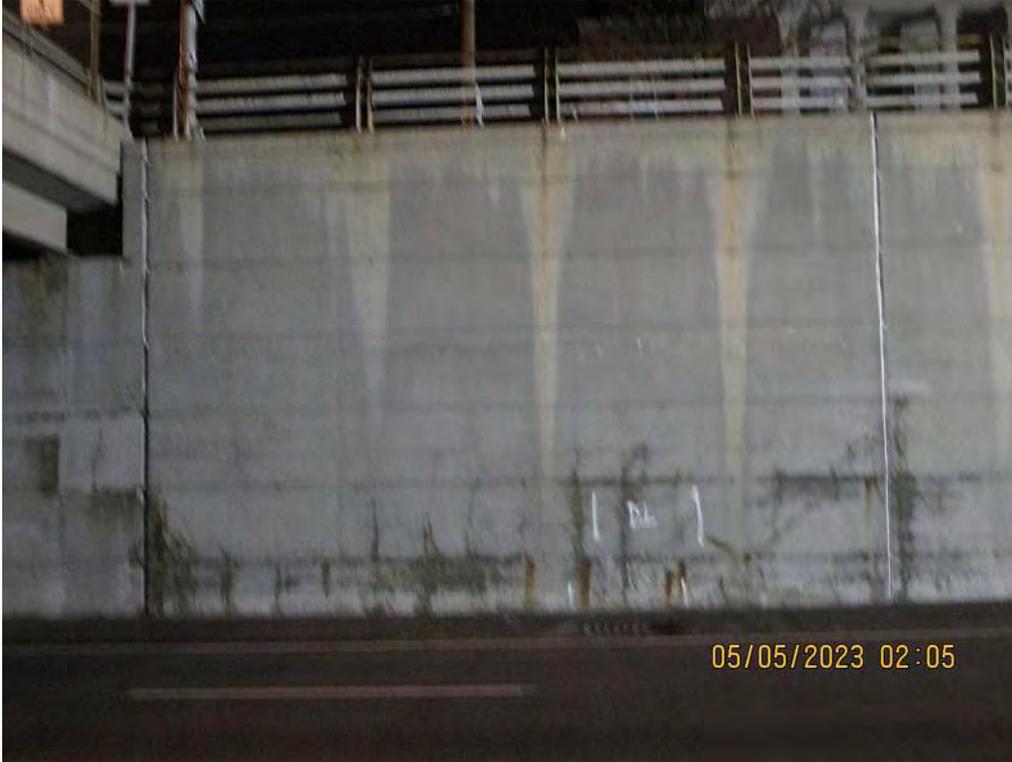
PHOTO 5
PANEL 262

Map cracking under rail posts, typical.

Bottom 2 panels are map cracked with rust staining and 50%-60% delamination. Some cracks extend into the third panel which is 20% delaminated.

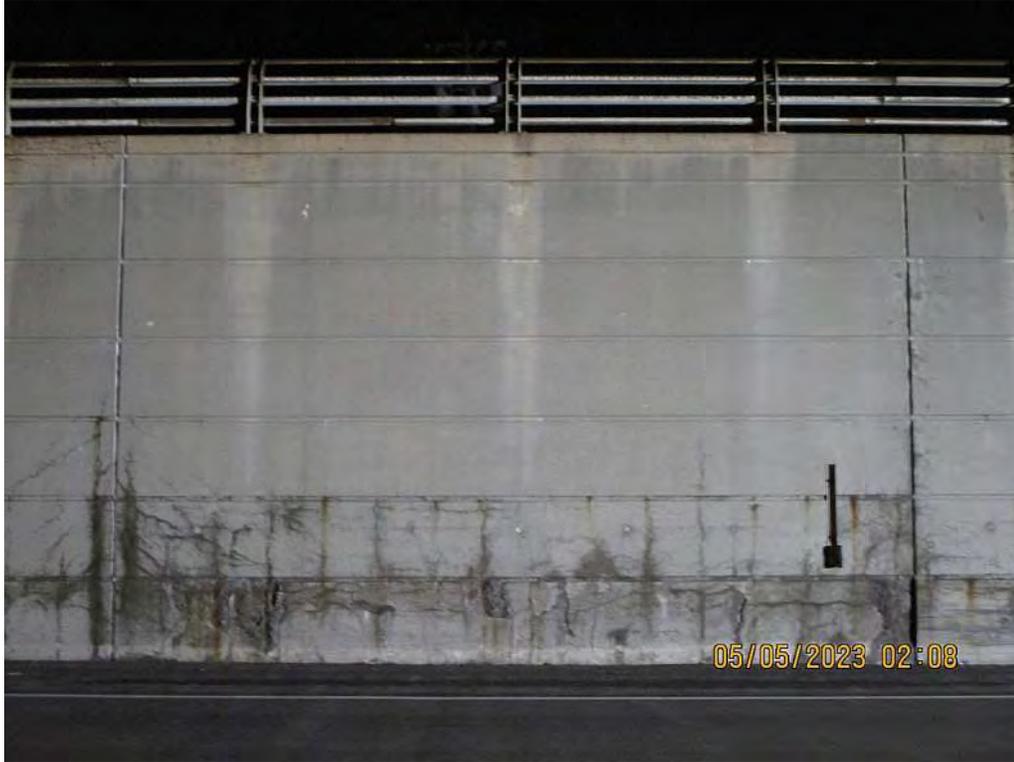
PHOTO 7
PANEL 258
Description:
Map cracking bottom 2 panels with 40% delamination. Map cracks extend into third panel near left joint.
Several large spalls on bottom panel with exposed rebar.

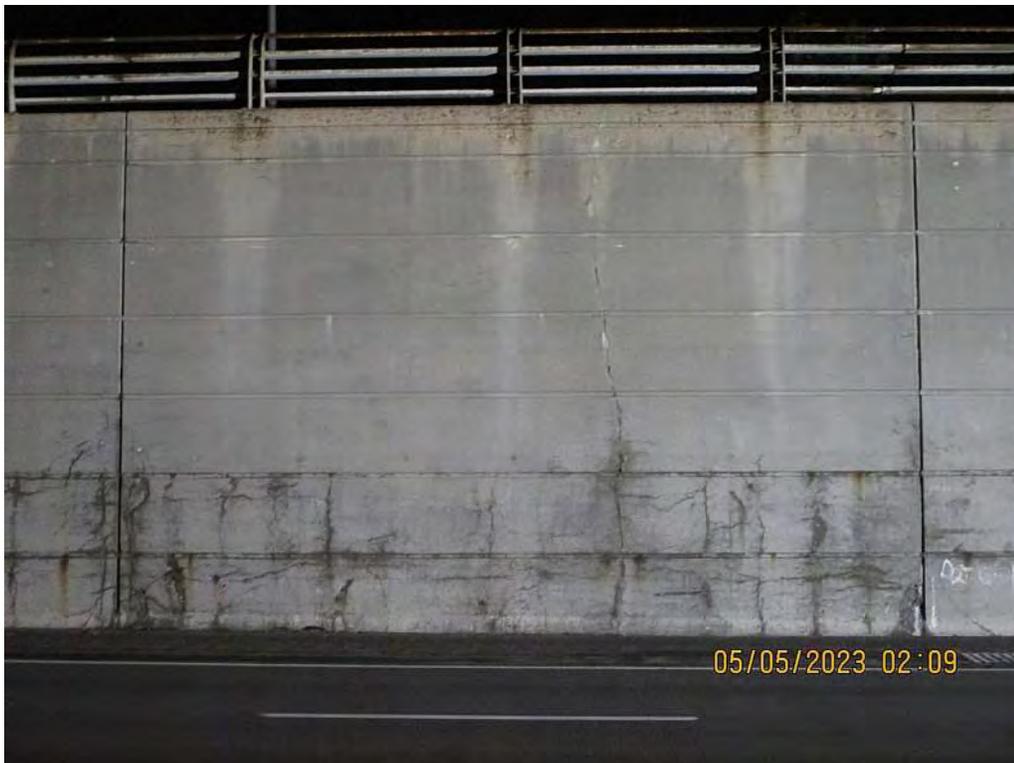
PHOTO 8
PANEL 256
Description:
Map cracking under rail posts, typical.
Full-height vertical crack with efflorescence near midspan of the panel.
Map cracking bottom 2 panels with a few rust stains. Bottom panel 100% delaminated, second panel 75% delaminated.
A few small spalls, most significant is in lower right corner of panel.

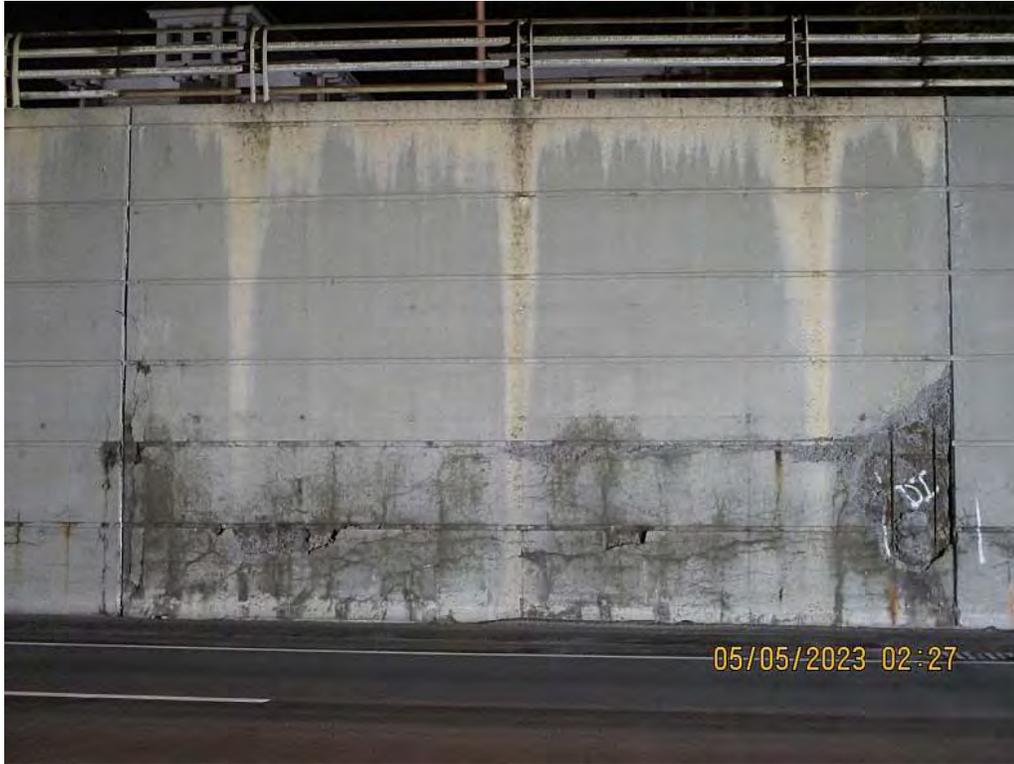
PHOTO 13
PANEL 222

There are several spalls. The large spall near the right joint has exposed rebar with 30% loss.

There is a 13' crack near the left joint that is about to spall.

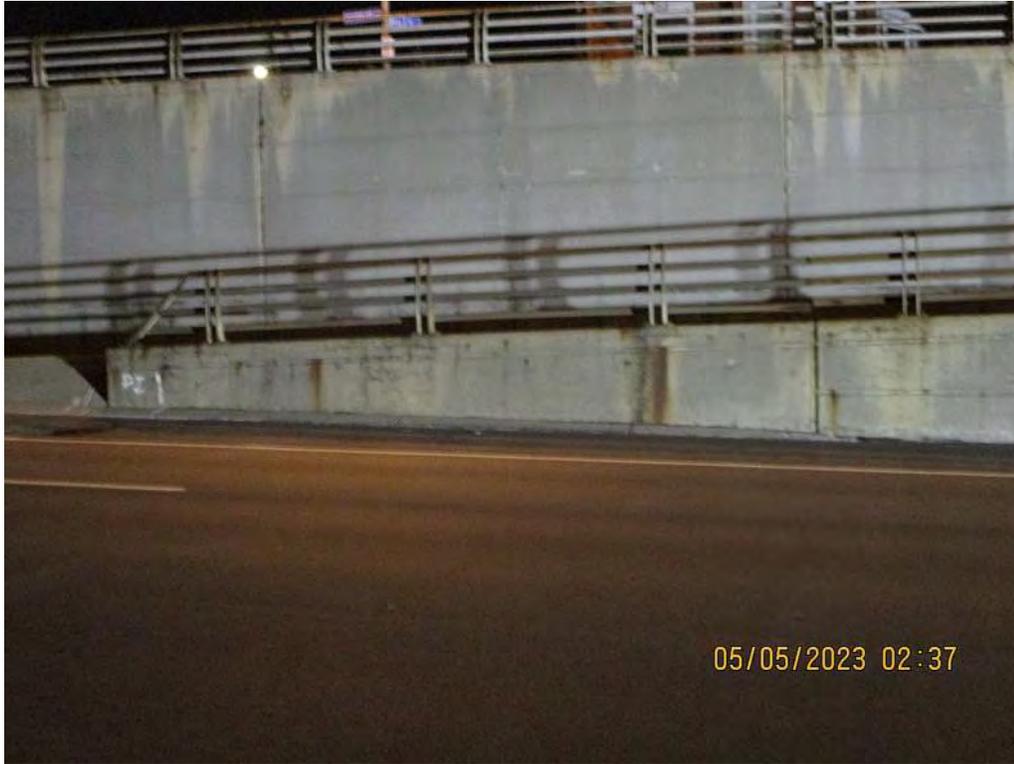
PHOTO 19
PANEL 201
Description:
Start of RW2.
Map cracking and rust staining under rail posts.
Sparsers map cracking throughout.

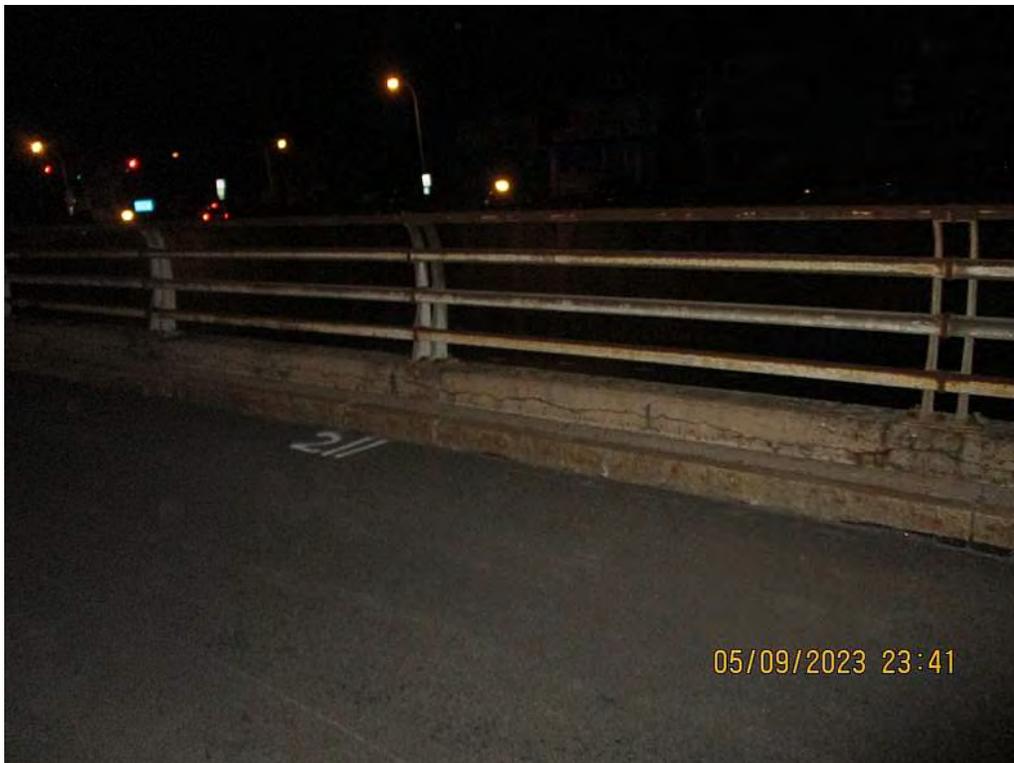
PHOTO 20
PANEL 211 (Back Side of Coping)
Description:
There is a large longitudinal crack on the coping along with general map cracking.

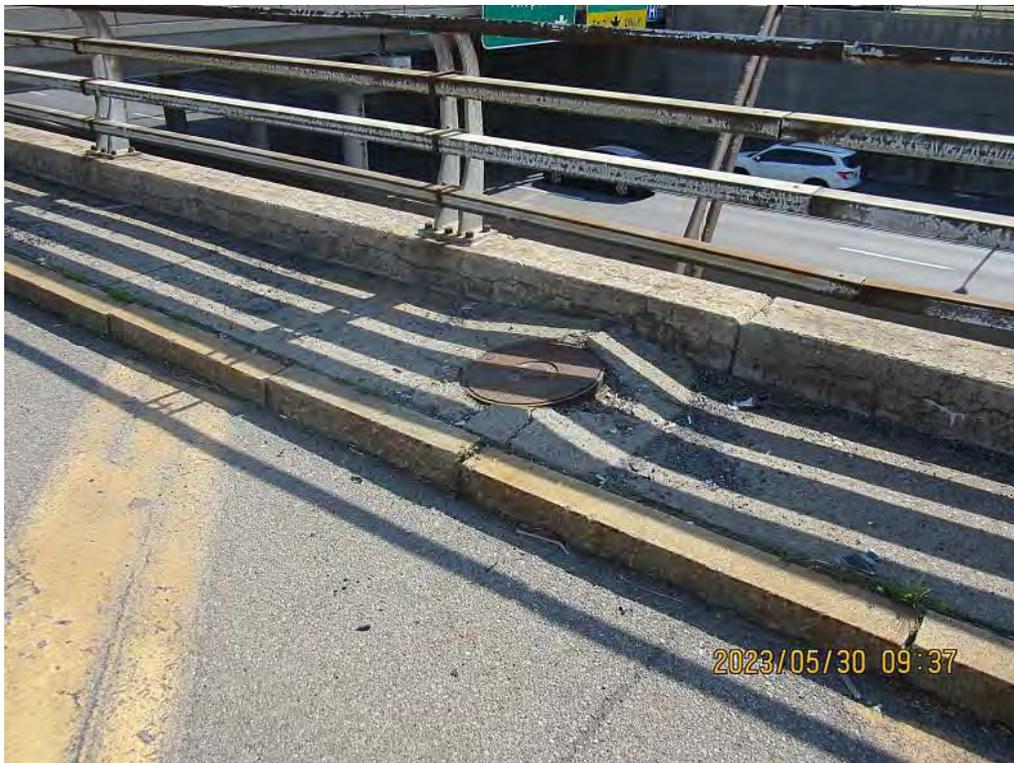
PHOTO 22
PANEL 260 (Back Side of Coping)

There is a large longitudinal crack on the coping.

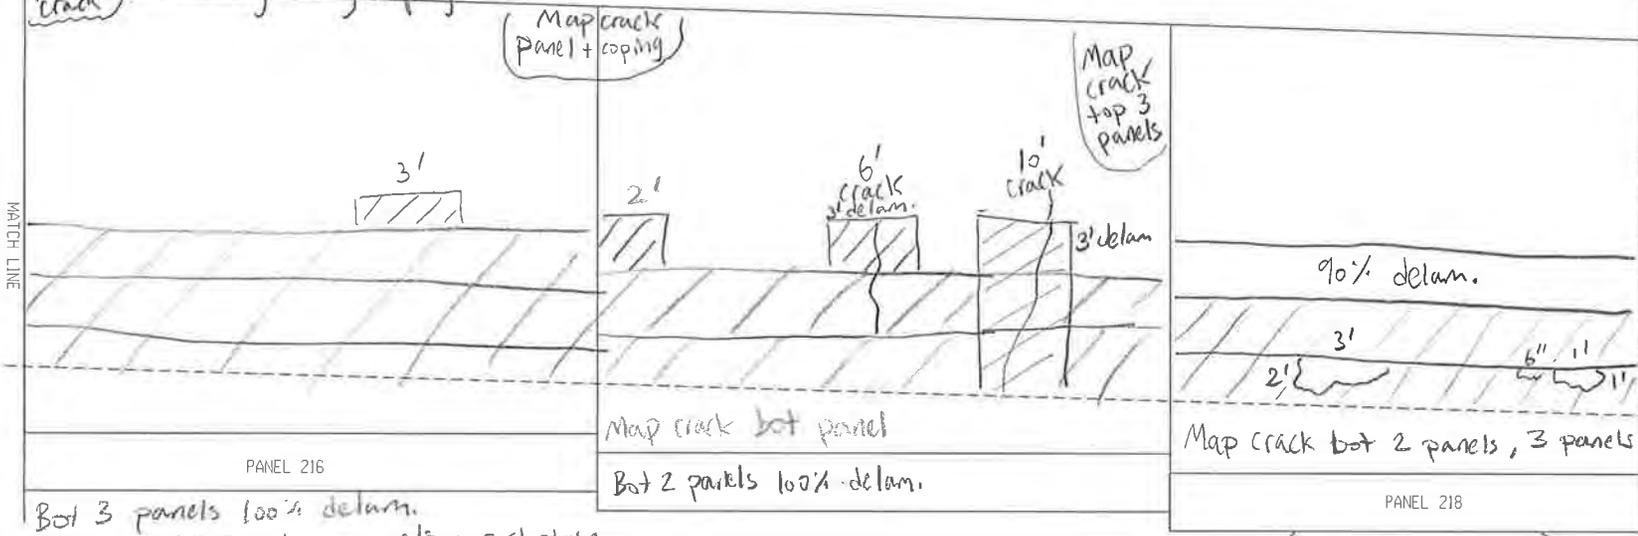
Cracking along coping

Bot 3 panels 100% delam.
Bot 2 panels map cracking

Map cracking bot panel, bot 3 near joint

Map cracking bot 2 panels

Map crack Cracking along coping

Bot 3 panels 100% delam.
Map cracking Bot 2 panels + rust stain

Map crack bot panel
Bot 2 panels 100% delam.

Map crack bot 2 panels, 3 panels at joints

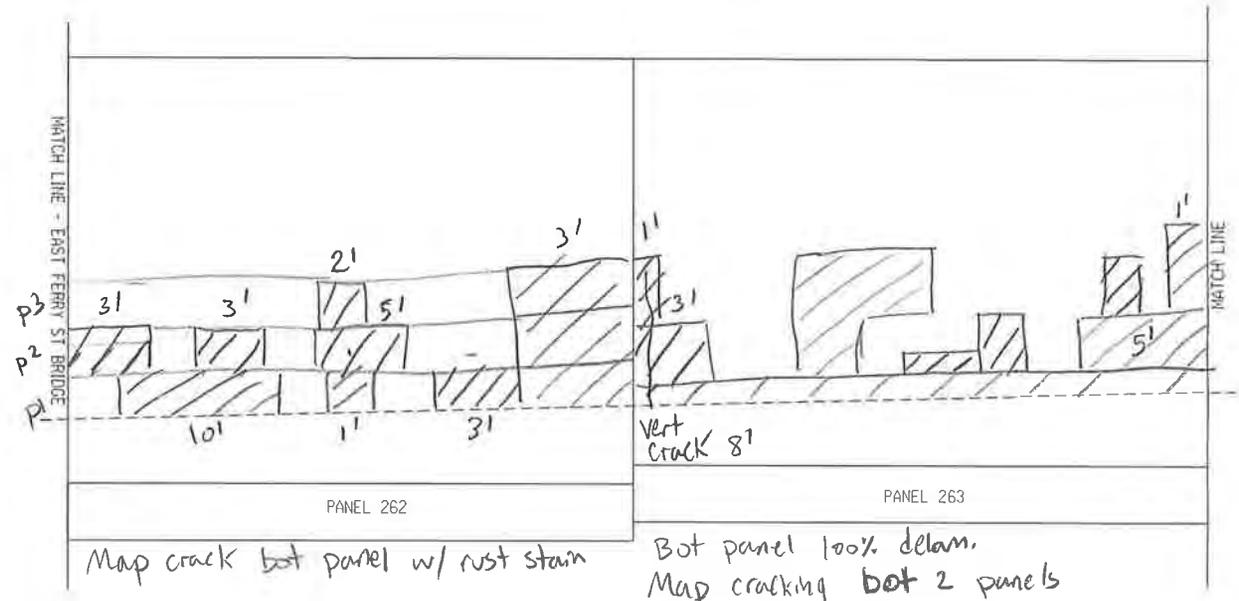
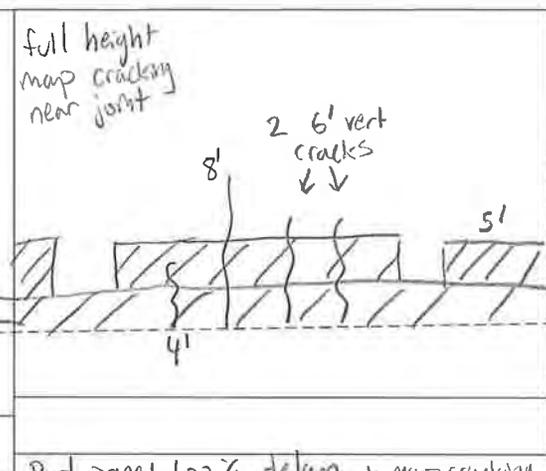
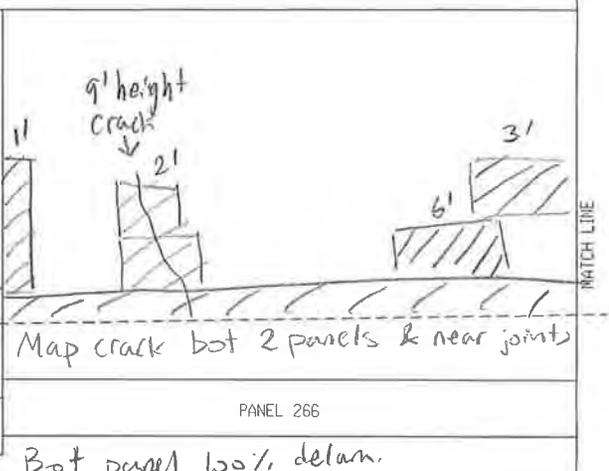
RW 2 PANELS 261-266

P1 & P2 panels 100% delam.

Map crack bot panel w/ rust stain

Bot panel 100% delam. Map cracking bot 2 panels

7 panels + coping Bot 2 panels 100% delam. + map cracking + rust stain

Bot panel 100% delam. + map cracking

Bot panel 100% delam.

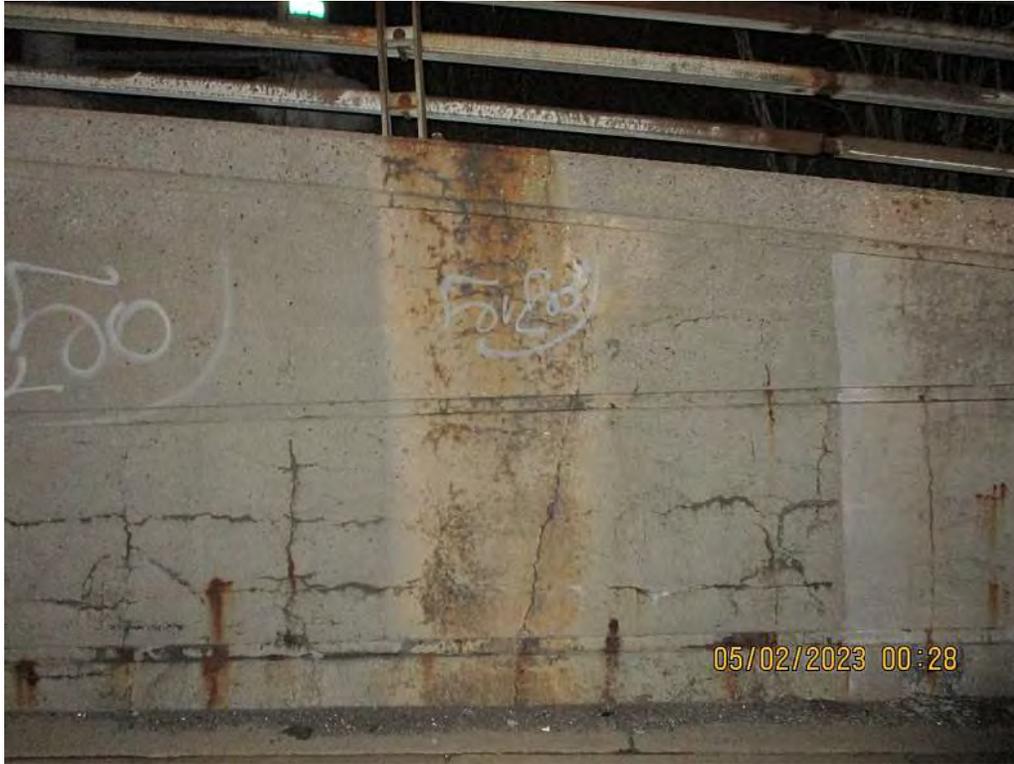
PHOTO 1

Full-height crack to right of rail post. Rust staining and map cracking under rail post typical throughout the wall. Map cracking and rust staining on bottom 2 panels.

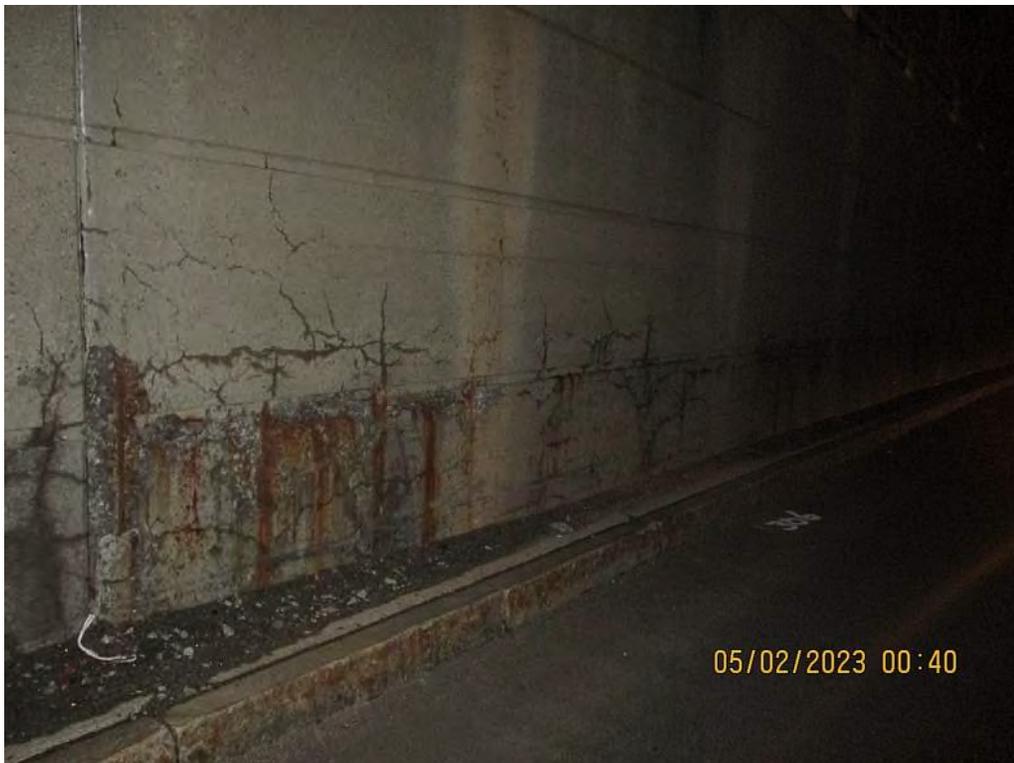
PHOTO 4

Bottom 4' of wall is 50% delaminated and map cracked. Vertical cracks are present at rebar locations.

Panel has the largest spall on RW3, with exposed rebar with 20% loss.

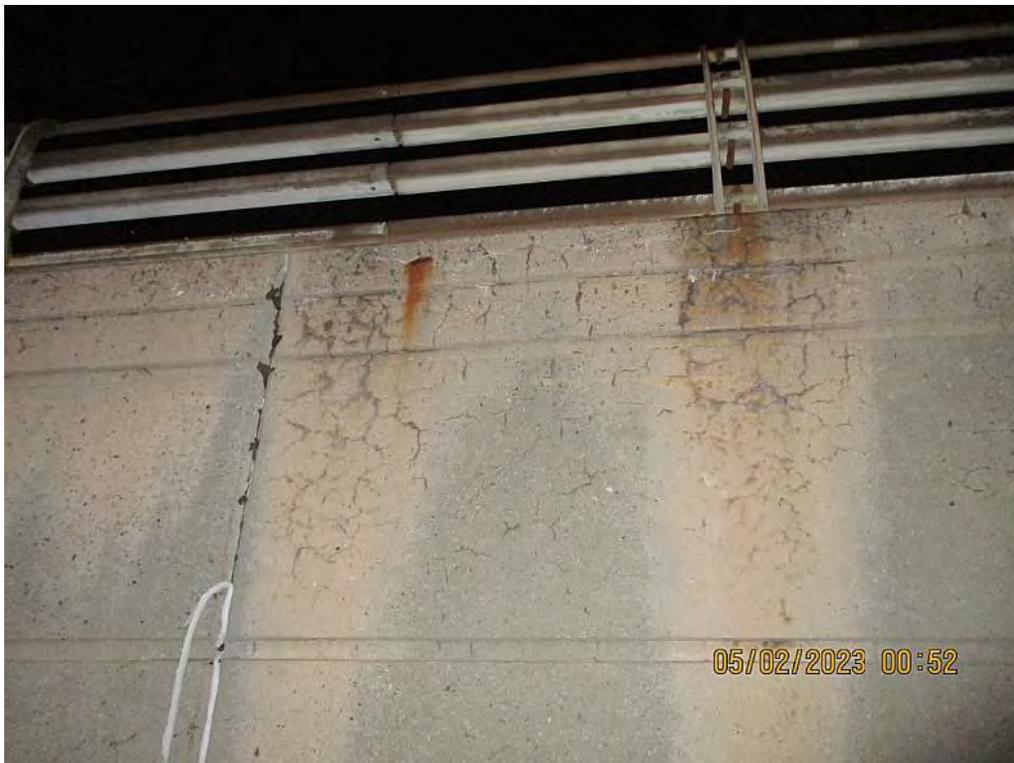
PHOTO 6

Map cracking and rust staining underneath rail post and near top of joints. Material loss from joint.

Rail coping is map cracked 50% with minimal delamination for most of RW3.
