Appendix A5

Retaining Wall Inspection Reports

NY33 RETAINING WALL CONDITION EVALUATION 2023
KENSINGTON EXPRESSWAY PROJECT
PIN 5512.52
CITY OF BUFFALO, ERIE COUNTY
RETAINING WALL 1

PIN 5512.52 – NY33 RETAINING WALL CONDITION EVALUATION 2023 FIELD INSPECTION SUMMARY

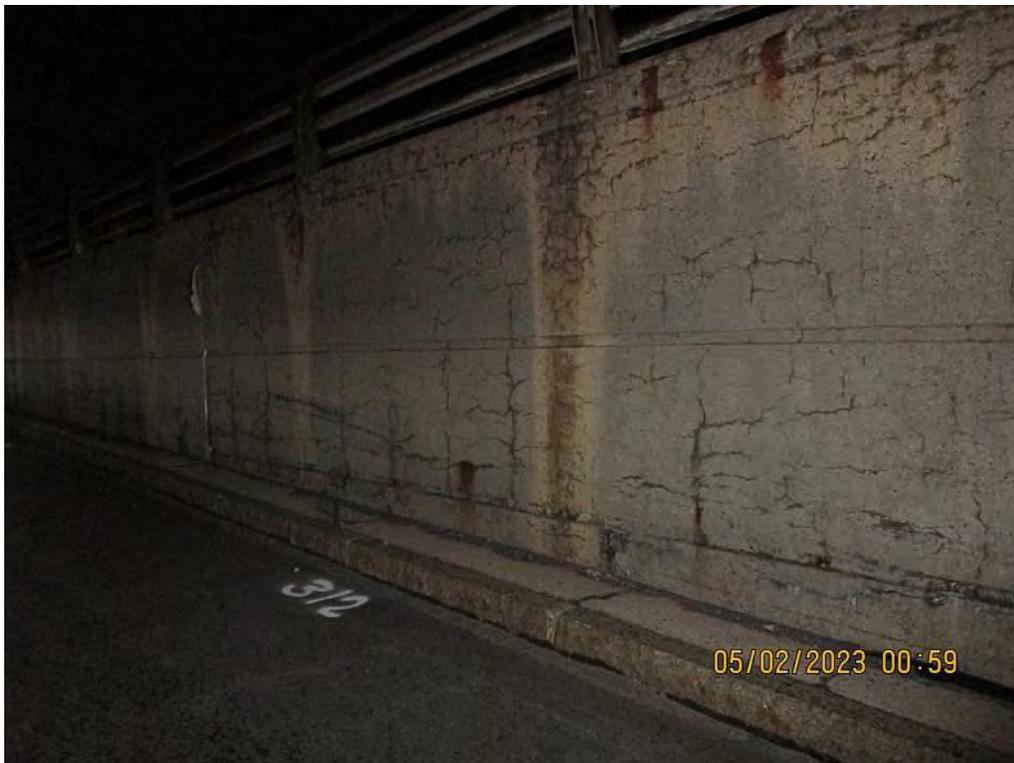
PHOTO 8

Heavier map cracking throughout especially under rail posts. No measurable delamination.

Scattered areas of rust staining.

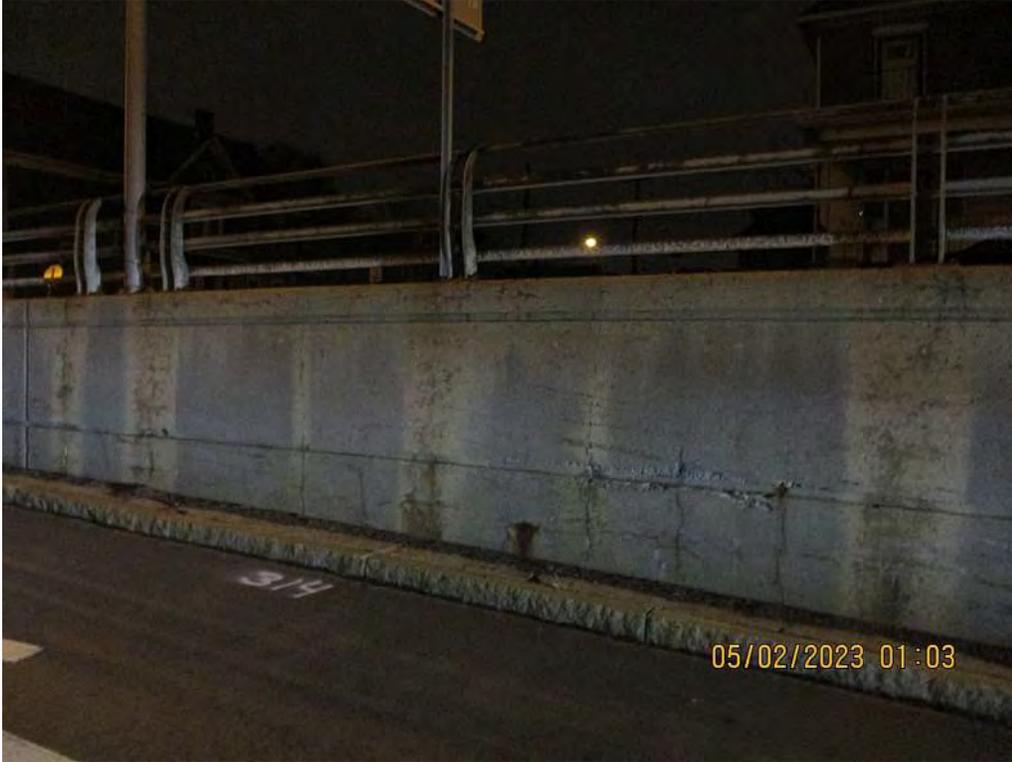
PHOTO 9
PANEL 314
Description:
Two full-height cracks and map cracking on bottom panel. Minor map cracking and staining under rail posts.
Minor spalling in the chamfer between panels.
Conditions similar for panels 313 to 317.

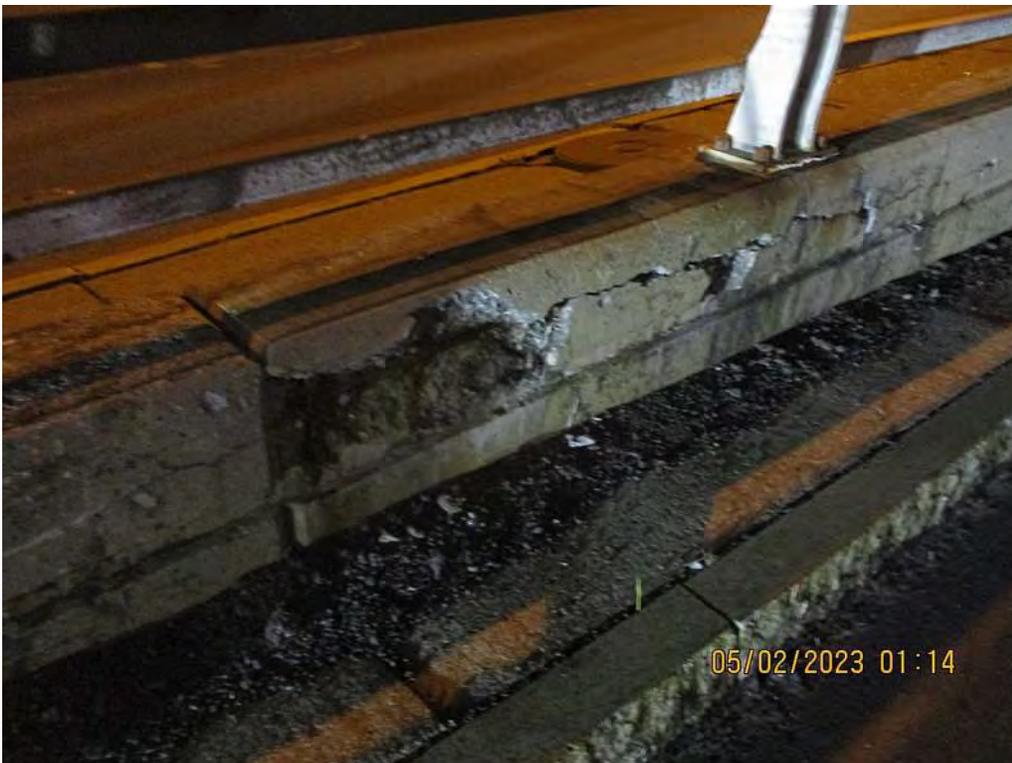
PHOTO 10
PANEL 318
Description:
Longitudinal crack on rail coping extends full length of panels 318 and 319. Coping is 40% delaminated.
Panel is heavily spalled for 4' from the left joint with exposed rebar with 20% loss.

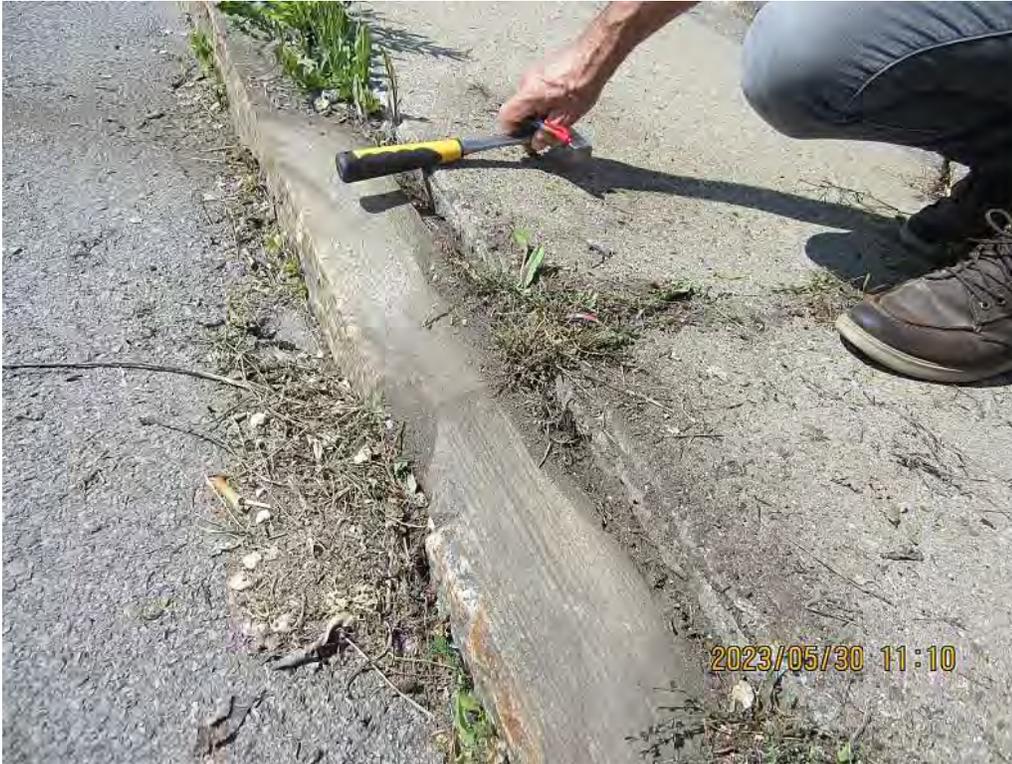
PHOTO 11

The safety walk and curb are misaligned. The safety walk has settled at the retaining wall back face, rotating the safety walk to be higher than the curb.

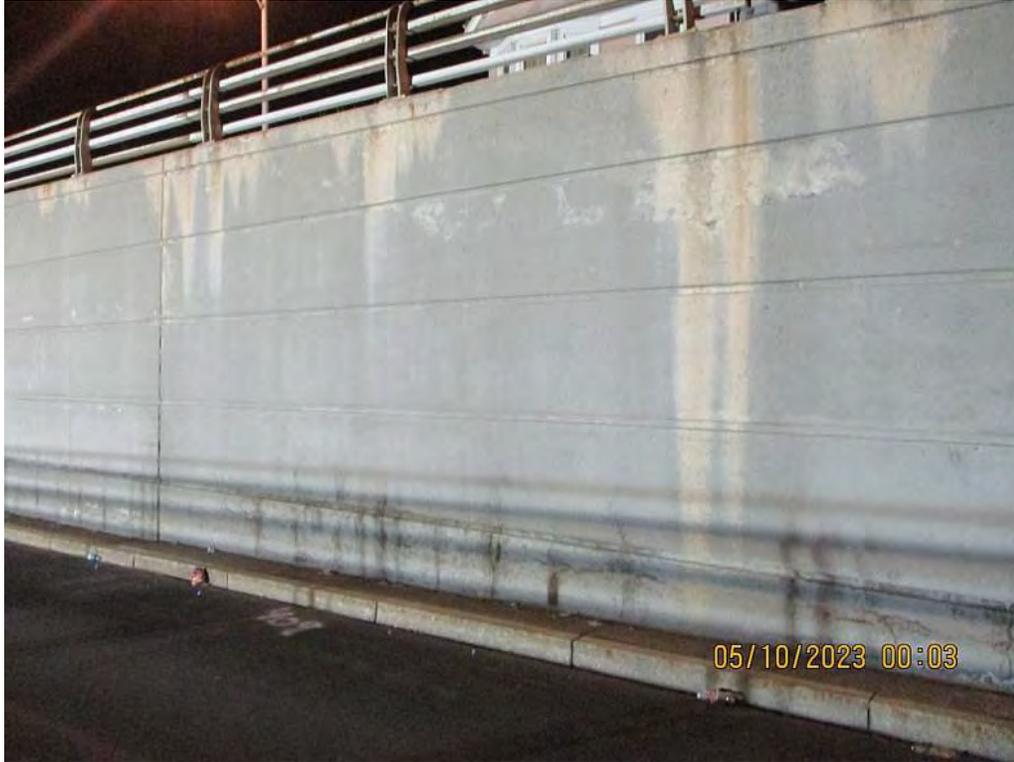
PHOTO 5
PANEL 409
Map cracking on bottom panel and coping with scattered rust stains. Map cracking extends full height near the left joint. There is a 4' wide area of map cracking in the second panel from the top.
To the left of the map cracking, there is a 12' high vertical crack with 1' wide delamination on the bottom 3 panels.
Bottom panel is 100% delaminated with a small spall.

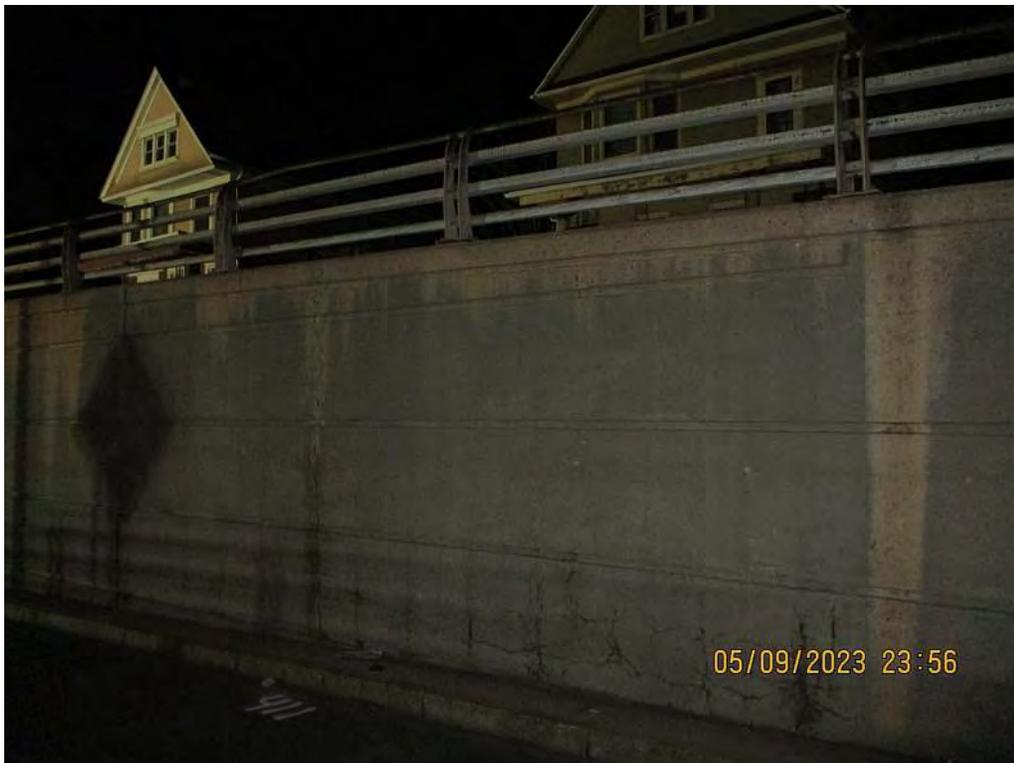
PHOTO 6
PANEL 411
Description:
Map cracking and 75% delamination on bottom panel.
Full-height crack with 1' wide delamination at 10' from left joint.

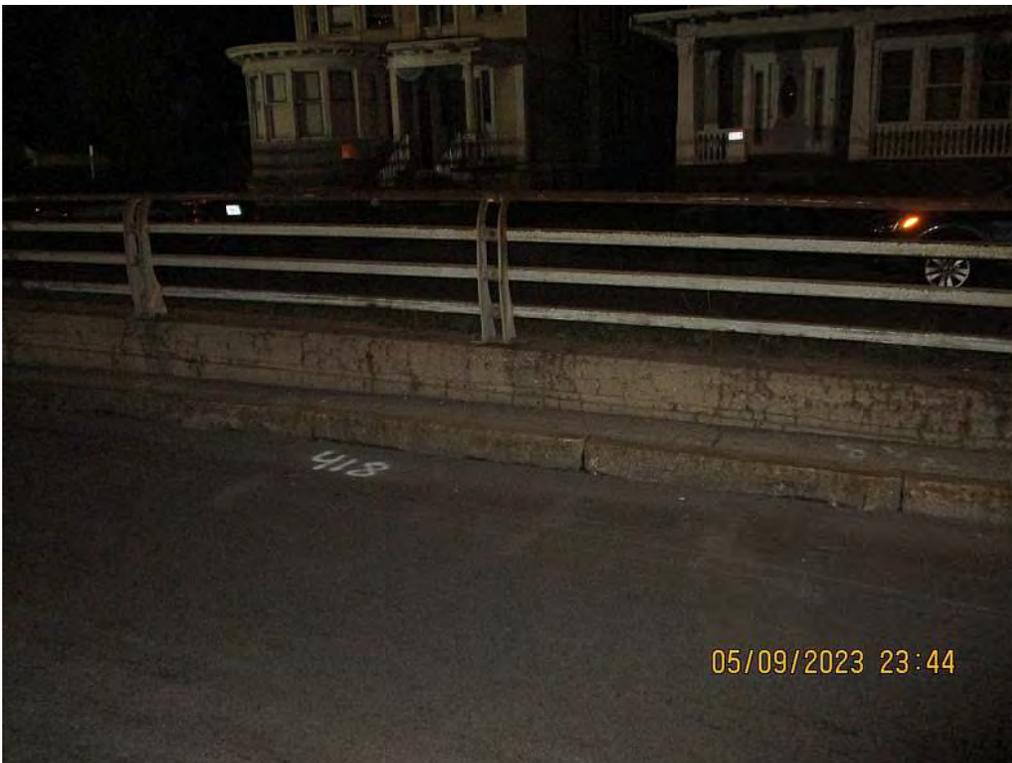
PHOTO 10
PANEL 418
Description:
End of RW4.
Heavy map cracking throughout.

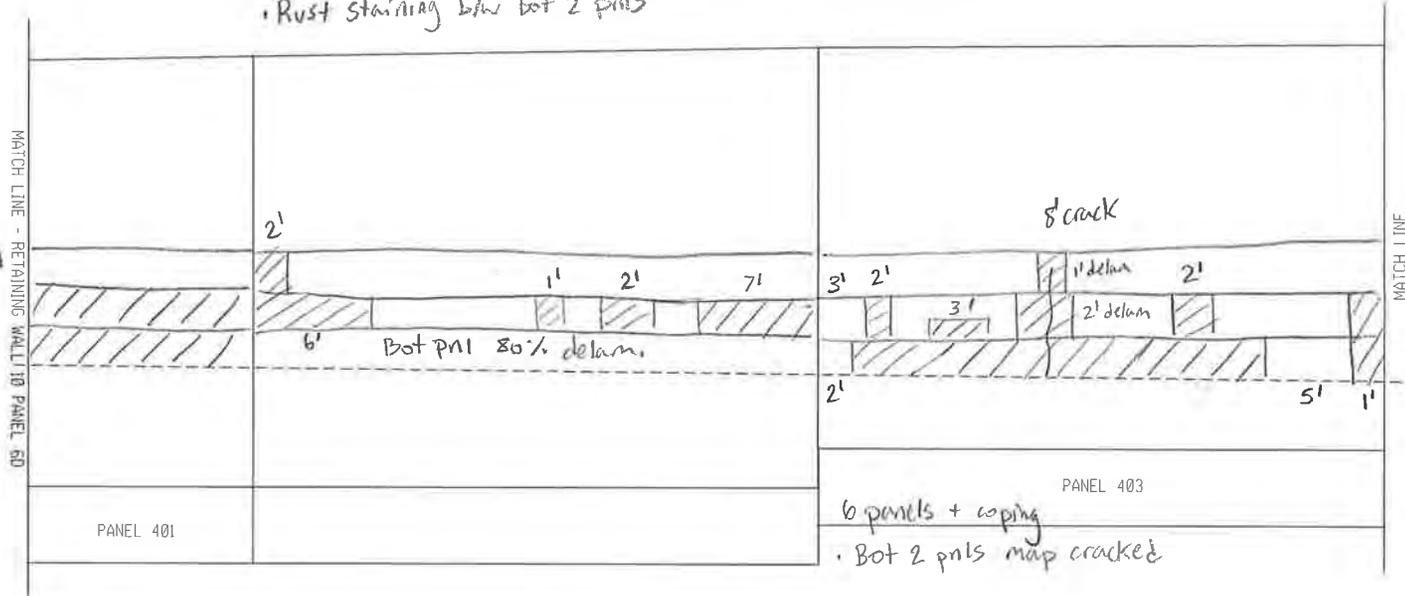
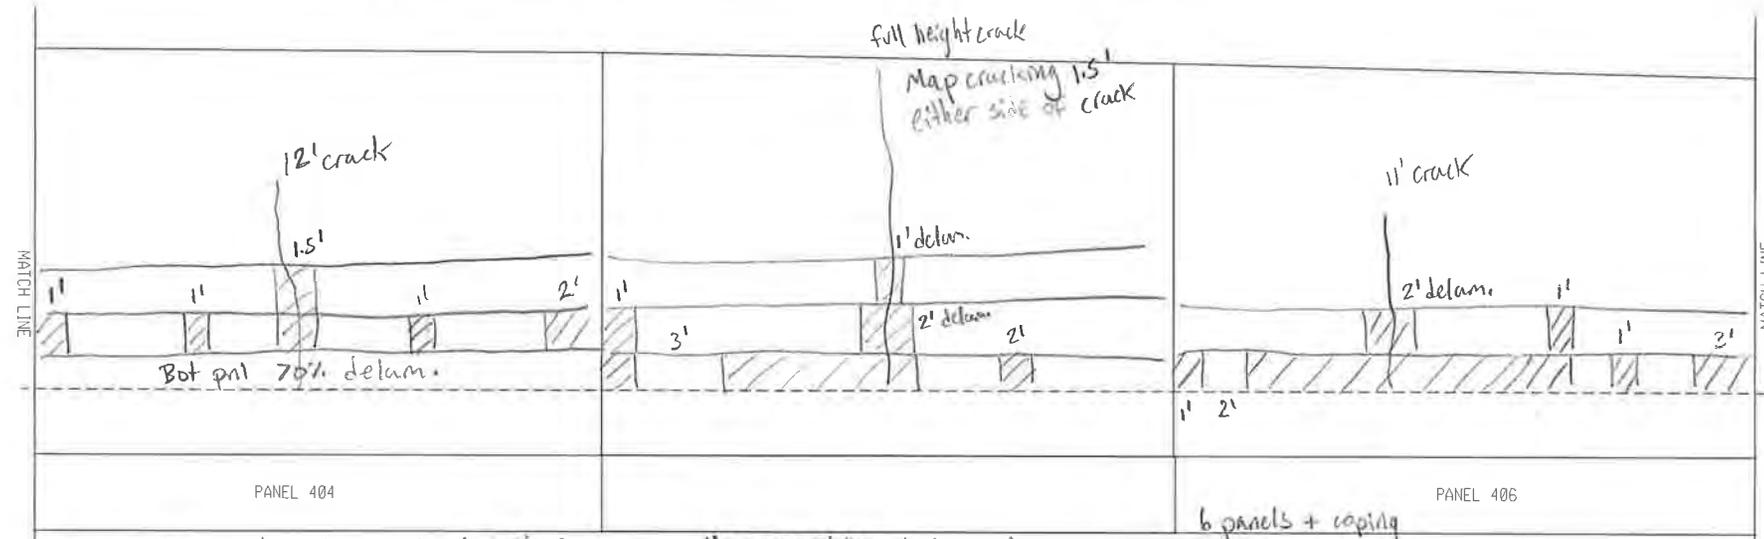
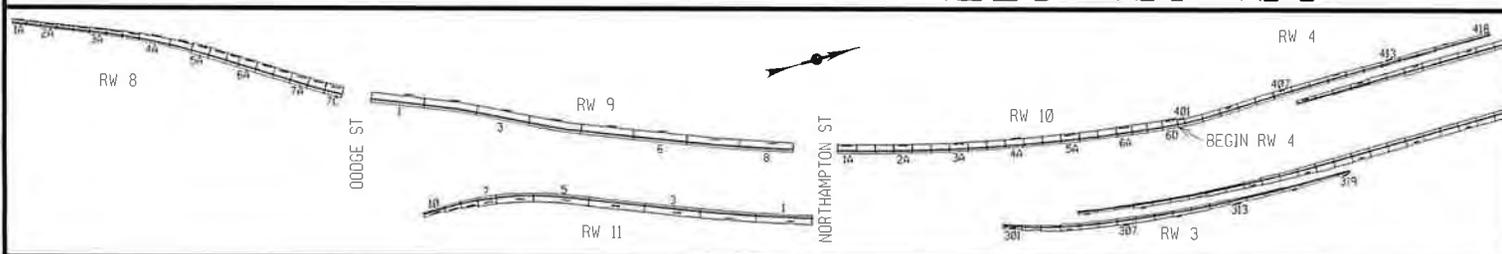
RW 4 PANELS 401-406

- Map crack bot 2 pnls, bot 4 near joints
- Rust staining b/w bot 2 pnls

Scattered map cracking bot pnl

Map cracking bot pnl, scattered rust stain

Map cracking bot pnl

Map cracking bot pnl + coping

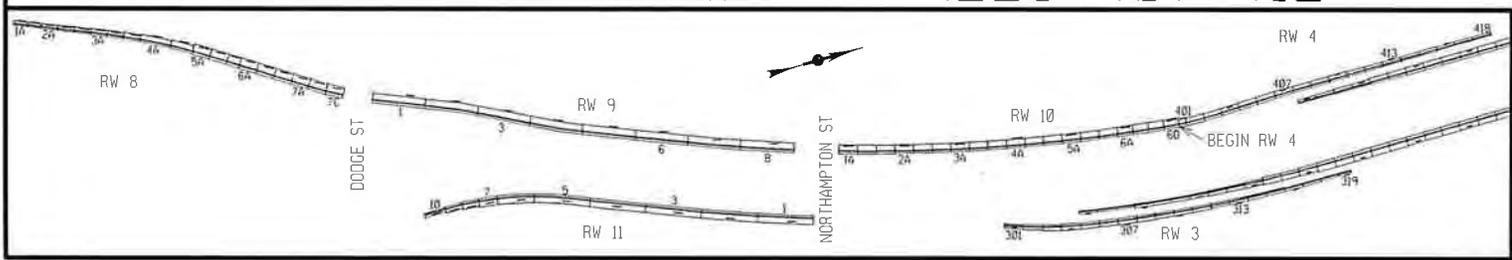
RW 4 PANELS 407-412

• Bot pnl 100% delam. scattered rust stains

Map cracking top panel near joints

Map cracking bot panel + coping
Bot pnl 100% delam.

Scattered map cracking bot 2 panels + coping

Map cracking bot panel

Map cracking bot 1.5 pnls, full height at joints

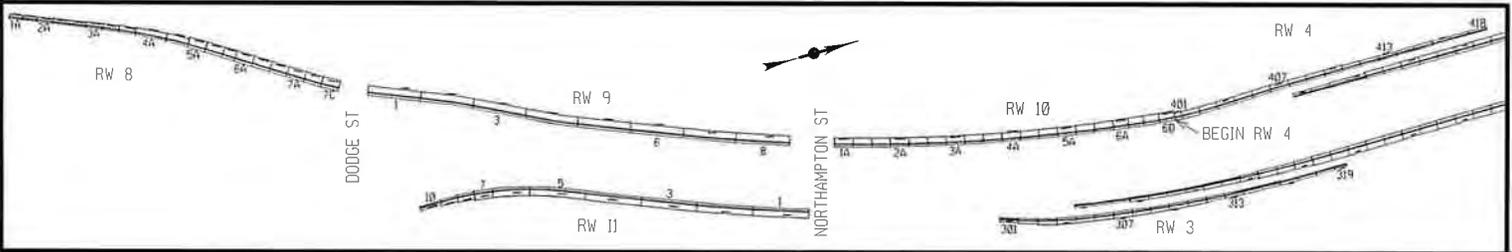
RW 4 PANELS 413-418

- Map cracking bot 2 panels + coping
- Rust staining bot panel
- Bot panel 100% delam.

- Scattered map cracking on bot 2 panels, worst near joints

- Map cracking on coping
- Scattered map cracking on bot panel

- Longit. crack on coping + map cracking
- Map cracking under rail posts to ground

Map cracking

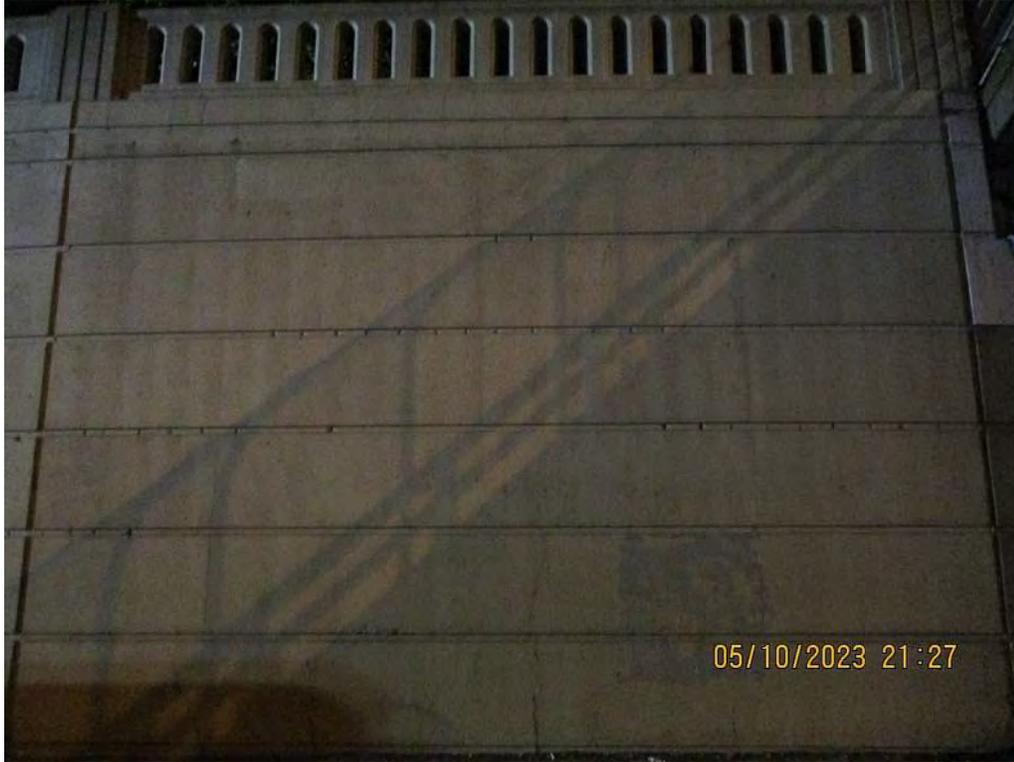
PHOTO 1
PANEL 7C

Minor map cracking on bottom two panels and coping. Cracking on coping is similar for most of RW8.

Rust staining present at vertical rebar location in between most panel chamfers.

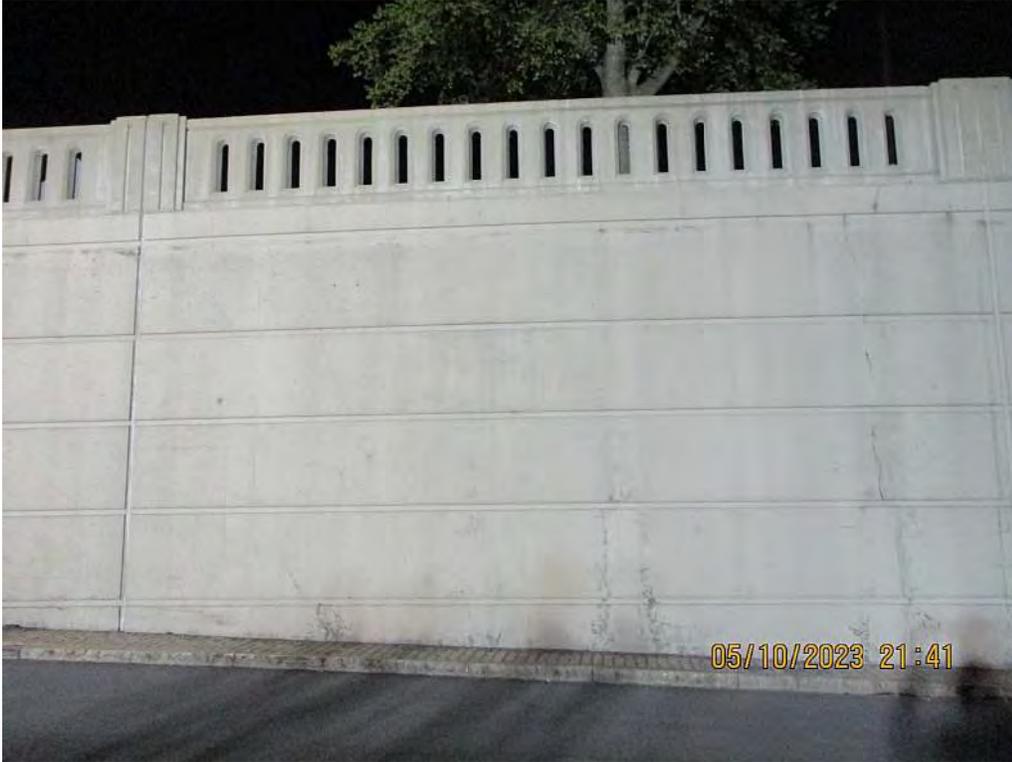
PHOTO 7
PANEL 4A.1

Above the repaired area near the right joint, there is a 9' vertical crack that extends to the coping.

The top panel has areas of spalling on the edge below the coping.

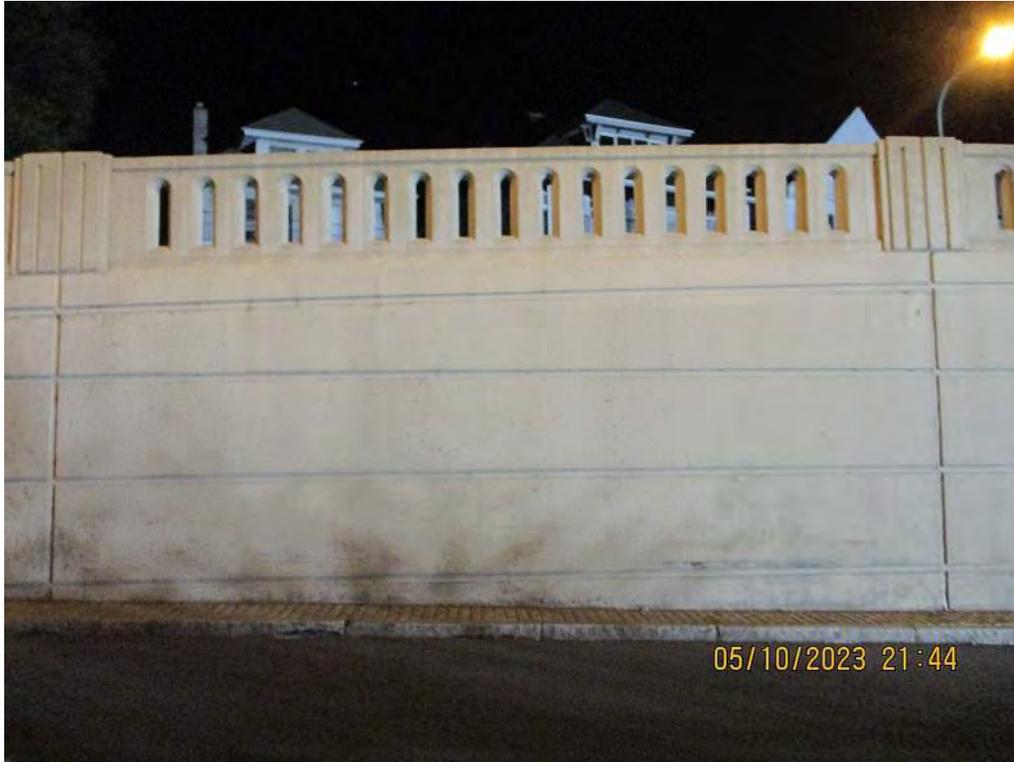
PHOTO 9
PANEL 2C
Description:
Minor cracking on coping, typical.
Isolated map cracking near bottom of left joint. Continues onto Panel 2B.

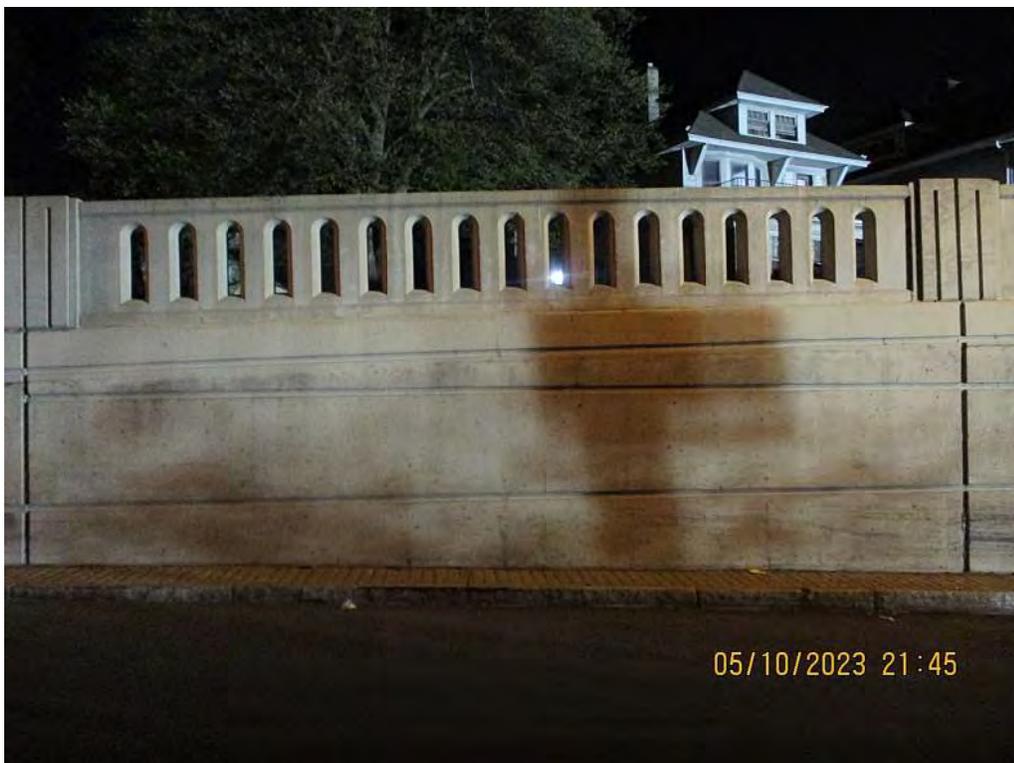
PHOTO 10
PANEL 2A
Description:
Minor cracking on coping, typical.
Scattered vertical crack throughout.

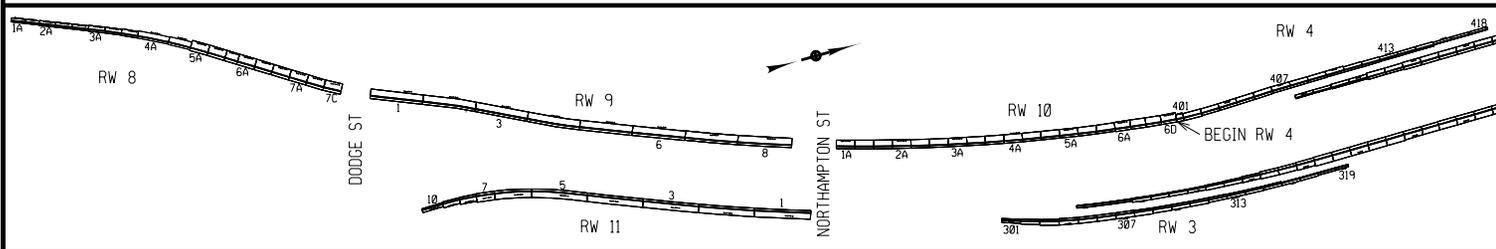
RW 8 PANELS 1A-3C

Minor cracking on bottom panel and coping.	Small spalls on edge of top panel (below chamfer). Minor cracking on coping. Map cracking on top 2 panels for 1.5' from each joint (9SF each side)	Small spalls on edge of top panel (below chamfer). Minor cracking on bottom panel and coping.
PANEL 3A		PANEL 3C

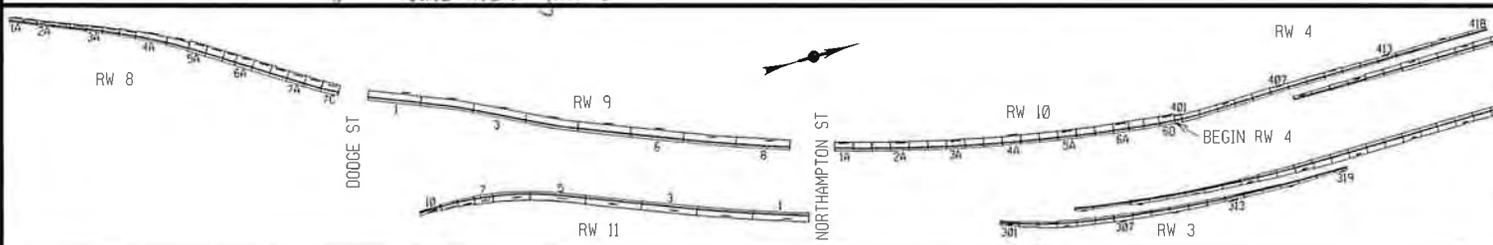
(bot pnl 1') (top pnl ends hwy)
RW 9 PANELS 1-2

Map Cr. bot 4 pnls, full height near crack and left joint

Map Cr. bot 4 panels

full height crack w/ effh.

- Map Cr. bot 3 pnls, scattered map cr. throughout
- Effh. in bot. pnl cracks

Map Cr. bot 4 pnls, full height near center and joints

full height crack w/ effh

Map cracking throughout, especially near left joint

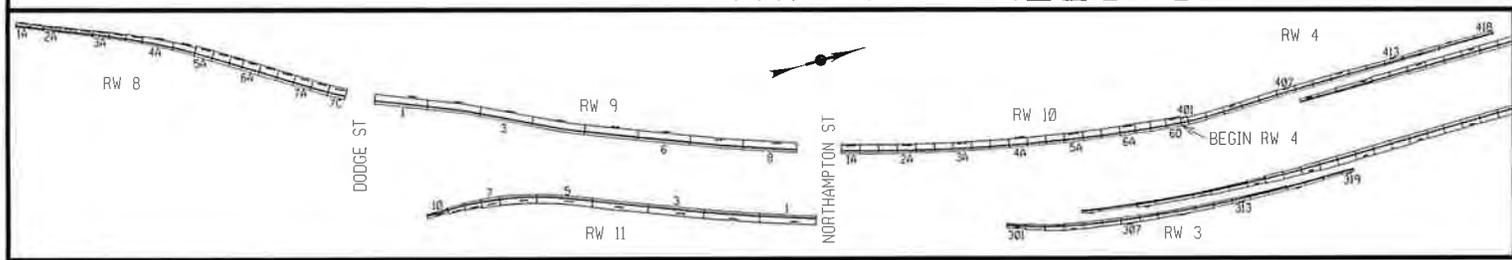
Map Cr. bot 3 pnts, higher near cracks
RW 9 PANELS 3-4

- Map Cr. Bot 5 pnts, worst for bot 3
- Map Cr. near right jnt 1' to 2'

full height cracks behind sign w/ effl.

- Scattered Map Cr. bot 3 pnts
- Map Cr. full height for 2' from left jnt

Minimal Map cr. bot pnt

Map cracking bot 4 pnts, worse for bot 2

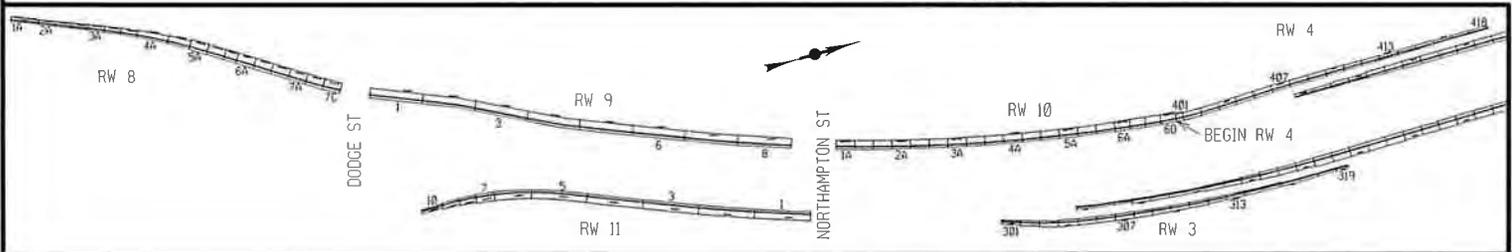
RW 9 PANELS 7-8

• Sparse vert. cracks bot 2 pnls

• Map cracking bot 3 pnls, 5 pnls near right joint, full height near left joint (3 to 4' from joint)

• Scattered vert. cracks bot pnt

• Scattered map cracking bot 3 pnls

• Scattered vert. cracks bot 3 pnls

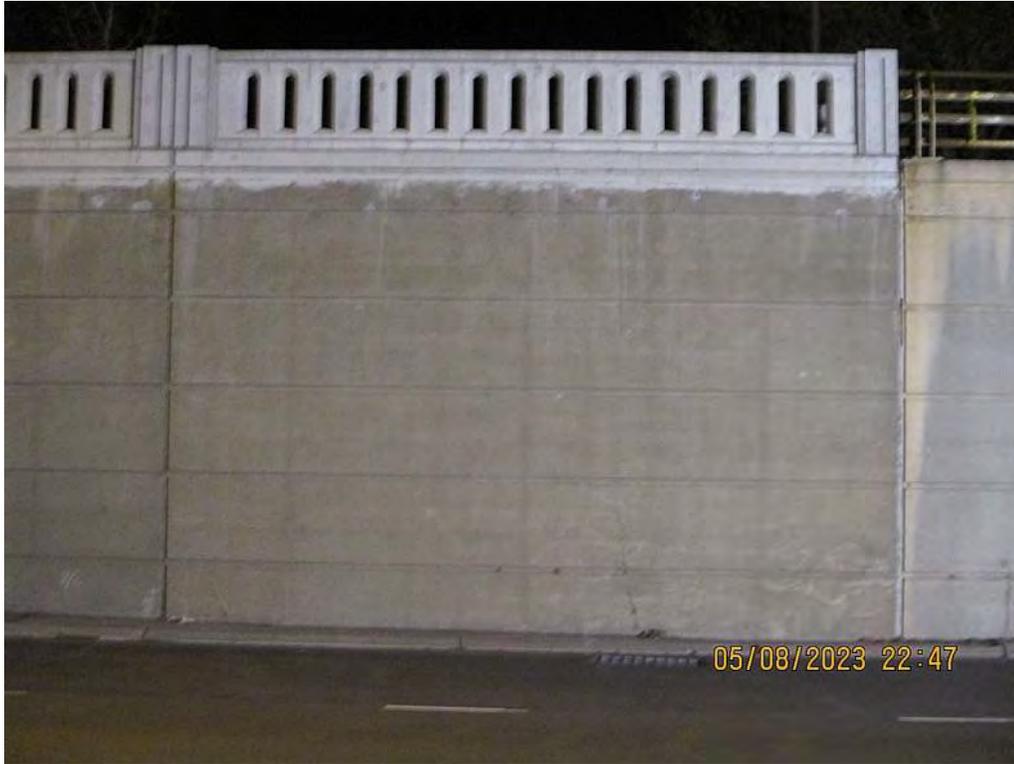
PHOTO 1
PANEL 6D

There is a 6' vertical crack with 1' wide delamination.

There is scattered rust staining on chamfers between panels 1 and 2, and 2 and 3.

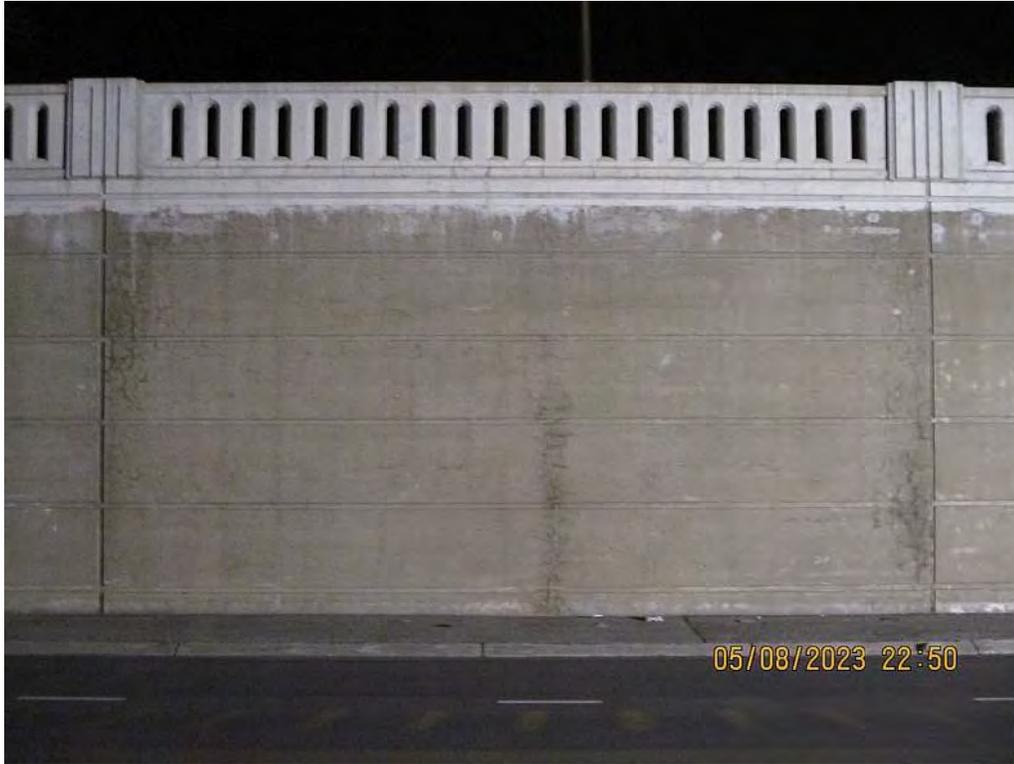
PHOTO 3
PANEL 5B
Description:
Full-height crack at midspan of panel.
Scattered map cracking throughout. Heavier map cracking around center crack and for 3' from either joint.

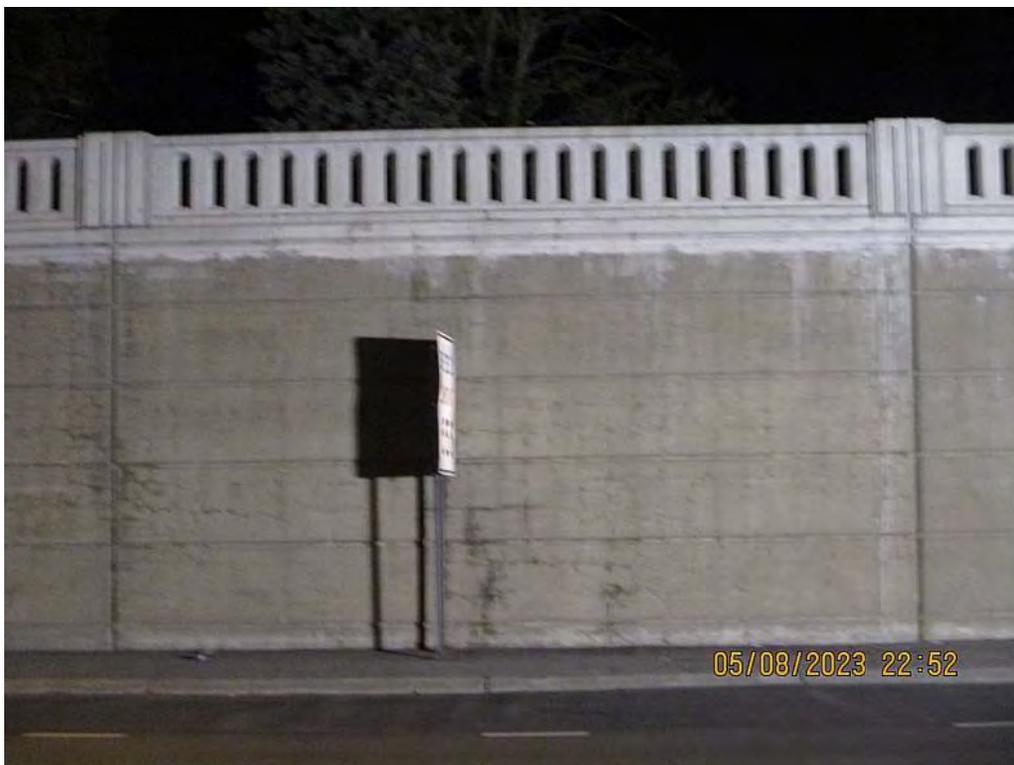
PHOTO 4
PANEL 4C
Description:
Full-height crack to right of sign. Delaminated 3' wide for bottom 7'.
Map cracking throughout.

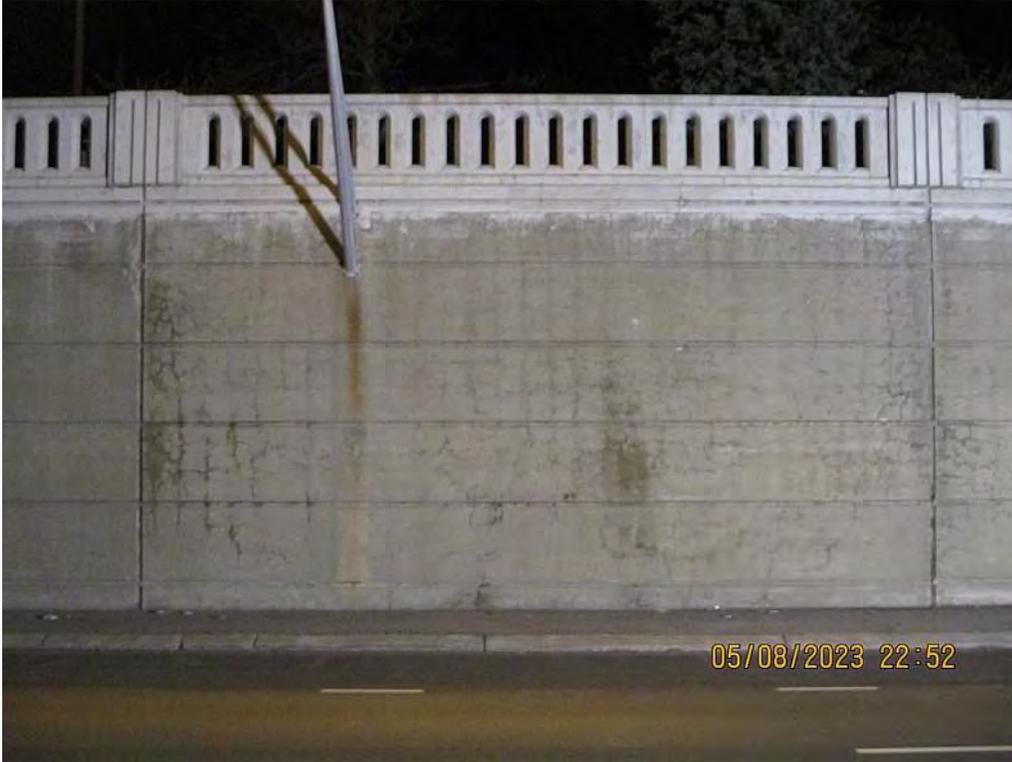
PHOTO 5
PANEL 4B

Map cracking throughout, heaviest near joints.

Rust staining under the luminaire.

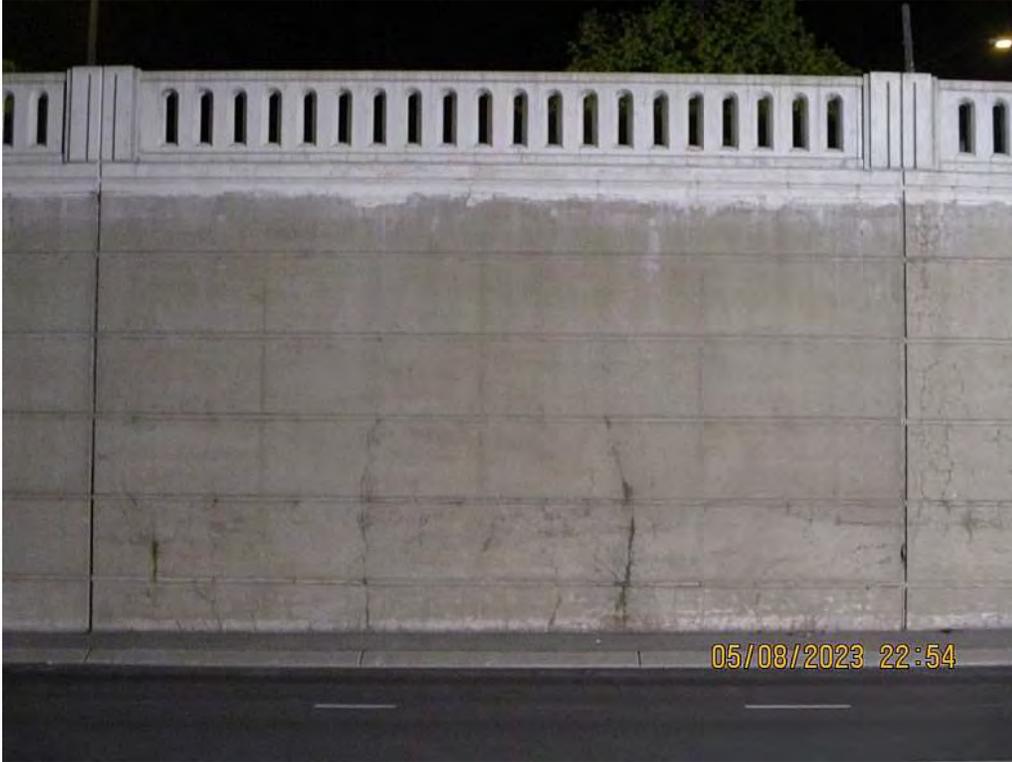
PHOTO 7
PANEL 3A

Map cracking bottom on bottom 2 panels. Scattered map cracking on panels 3 and 4.

There is a small spall with rust staining near the left joint.

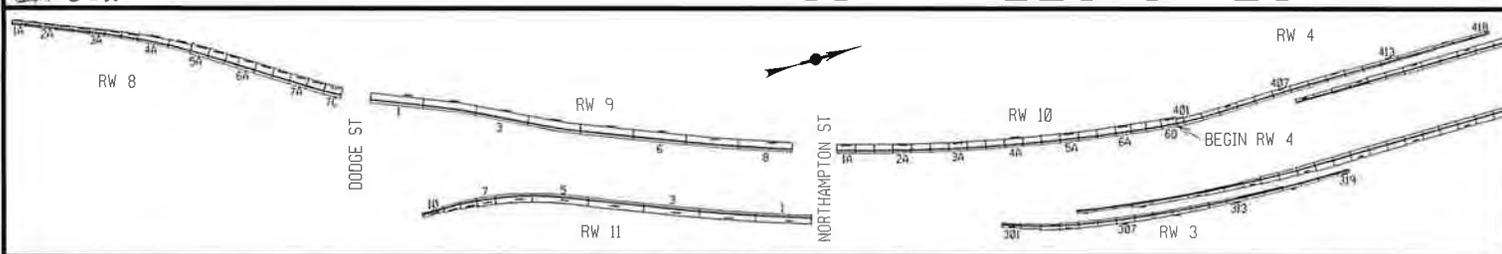
RW 10 PANELS 1A-2C

delaminated

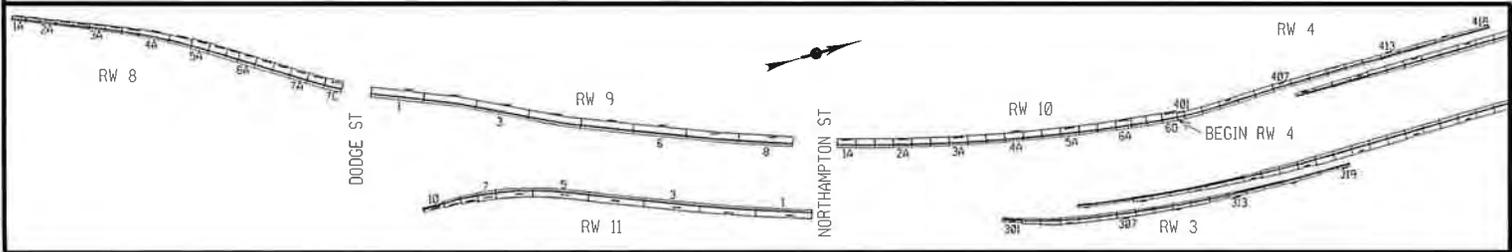
RW 10 PANELS 5A-6D

Scattered map cracking throughout

Map cracking top 2 pnts

Scattered map cracking, worst on panel 5 from bottom

6 panels (no coping)
Scattered rust staining b/w pils 1-3

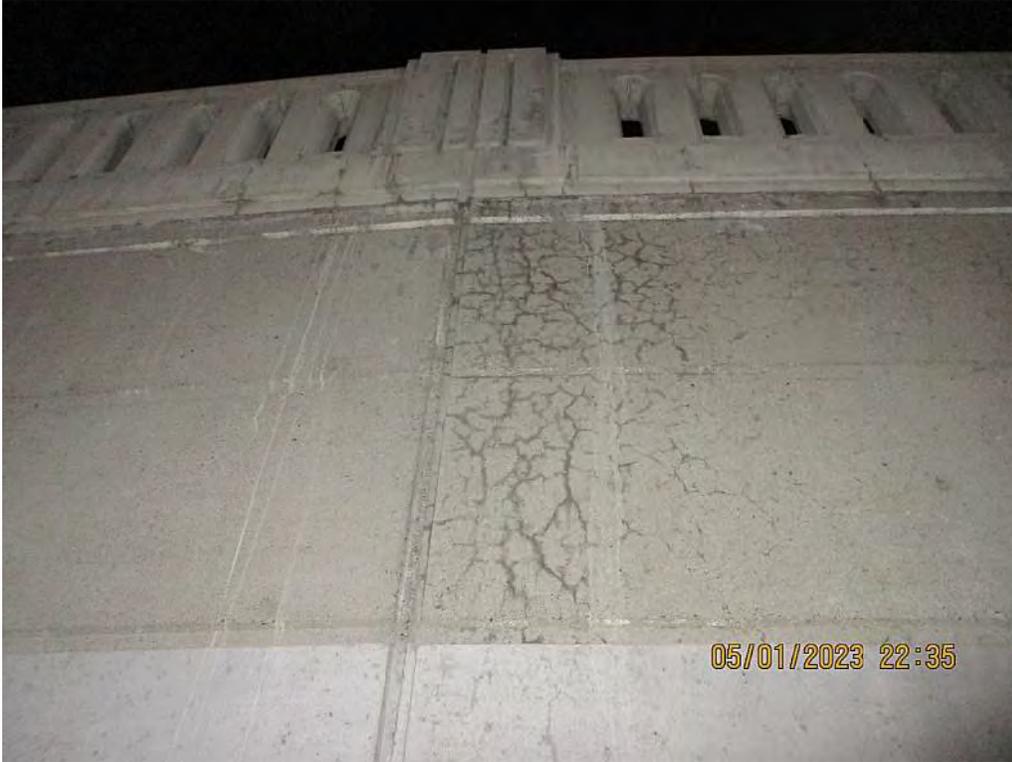
PHOTO 1
PANEL 7
Description:
There is map cracking on the top 7' of panel 7 near the left joint.
Panels 4.1 and 3.1 have similar cracking near the right joint.

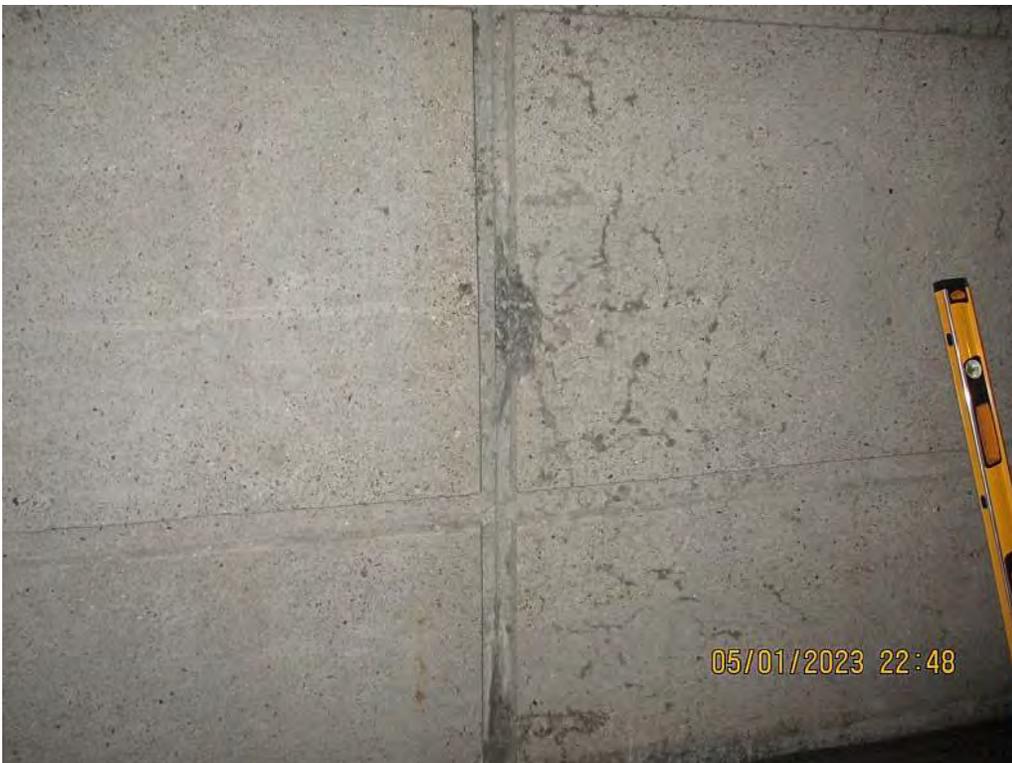
PHOTO 2
PANEL 5.3
Description:
There is a 3"x8" spall on the edge of panel 5.3 at the left joint.

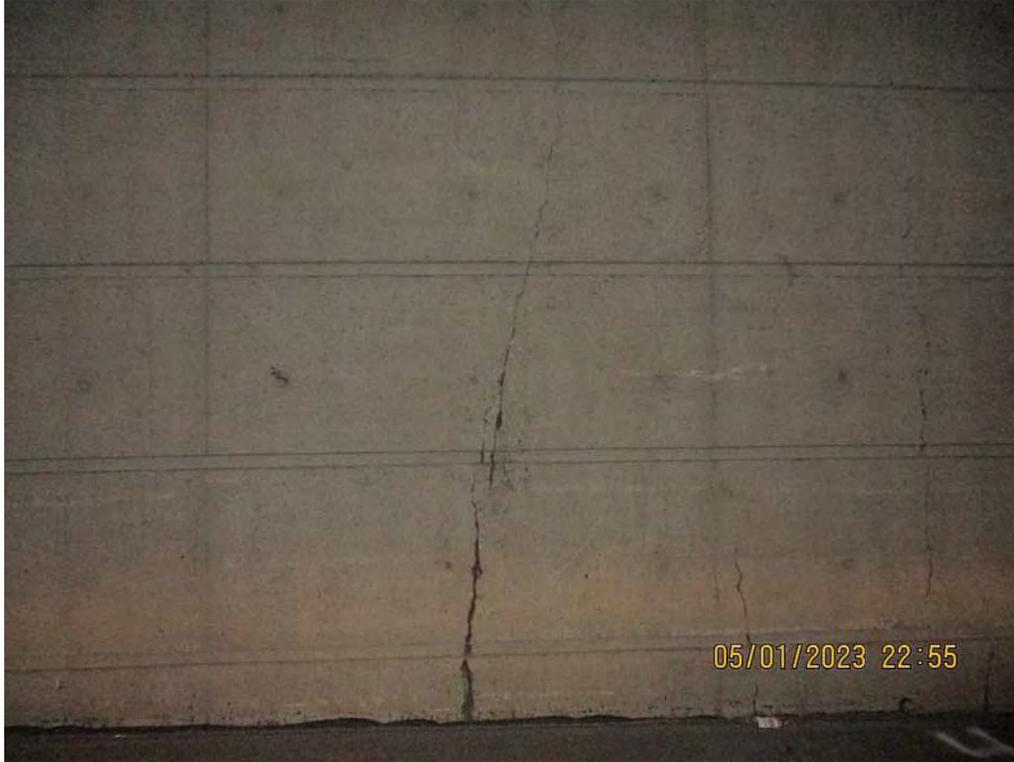
PHOTO 3
PANEL 4.3
Description:
There is a 15' vertical crack at 11' from the left joint.
Most panels have a 6' to full-height crack at 10' to 15' from the edge of the panel.

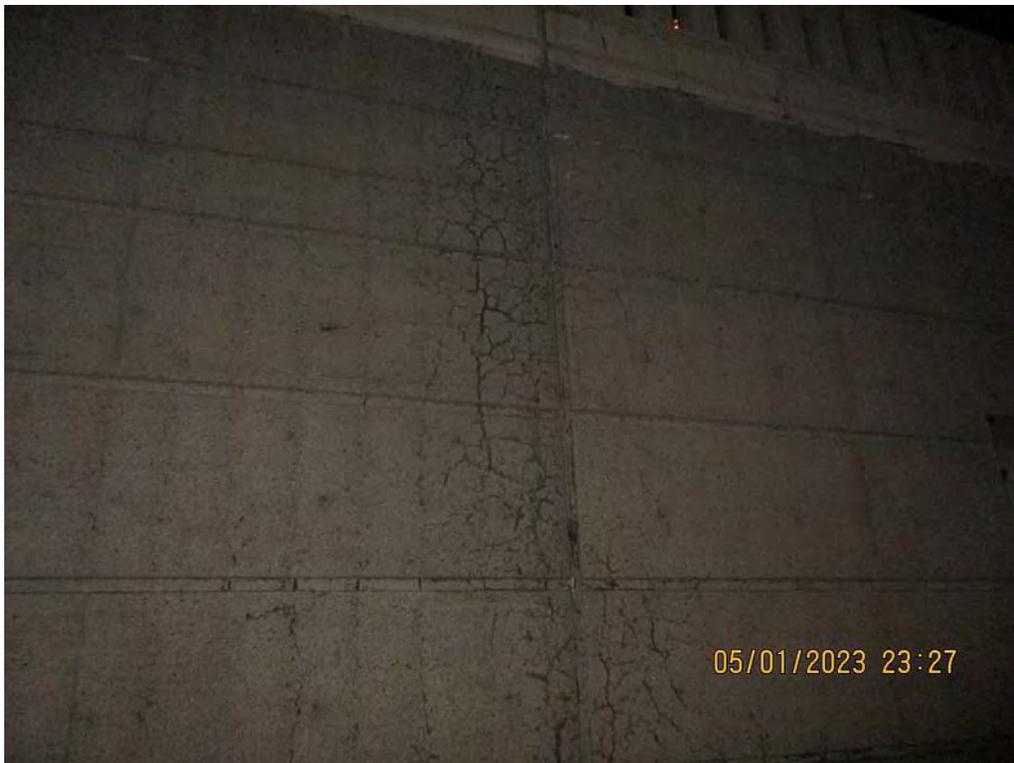
PHOTO 10
PANEL 2.1 & 2.2
Description:
Map cracking is present on either side of the joint.
