Appendix A5

Retaining Wall Inspection Reports

NY33 RETAINING WALL CONDITION EVALUATION 2023
KENSINGTON EXPRESSWAY PROJECT
PIN 5512.52
CITY OF BUFFALO, ERIE COUNTY
RETAINING WALL 1

PIN 5512.52 – NY33 RETAINING WALL CONDITION EVALUATION 2023 FIELD INSPECTION SUMMARY

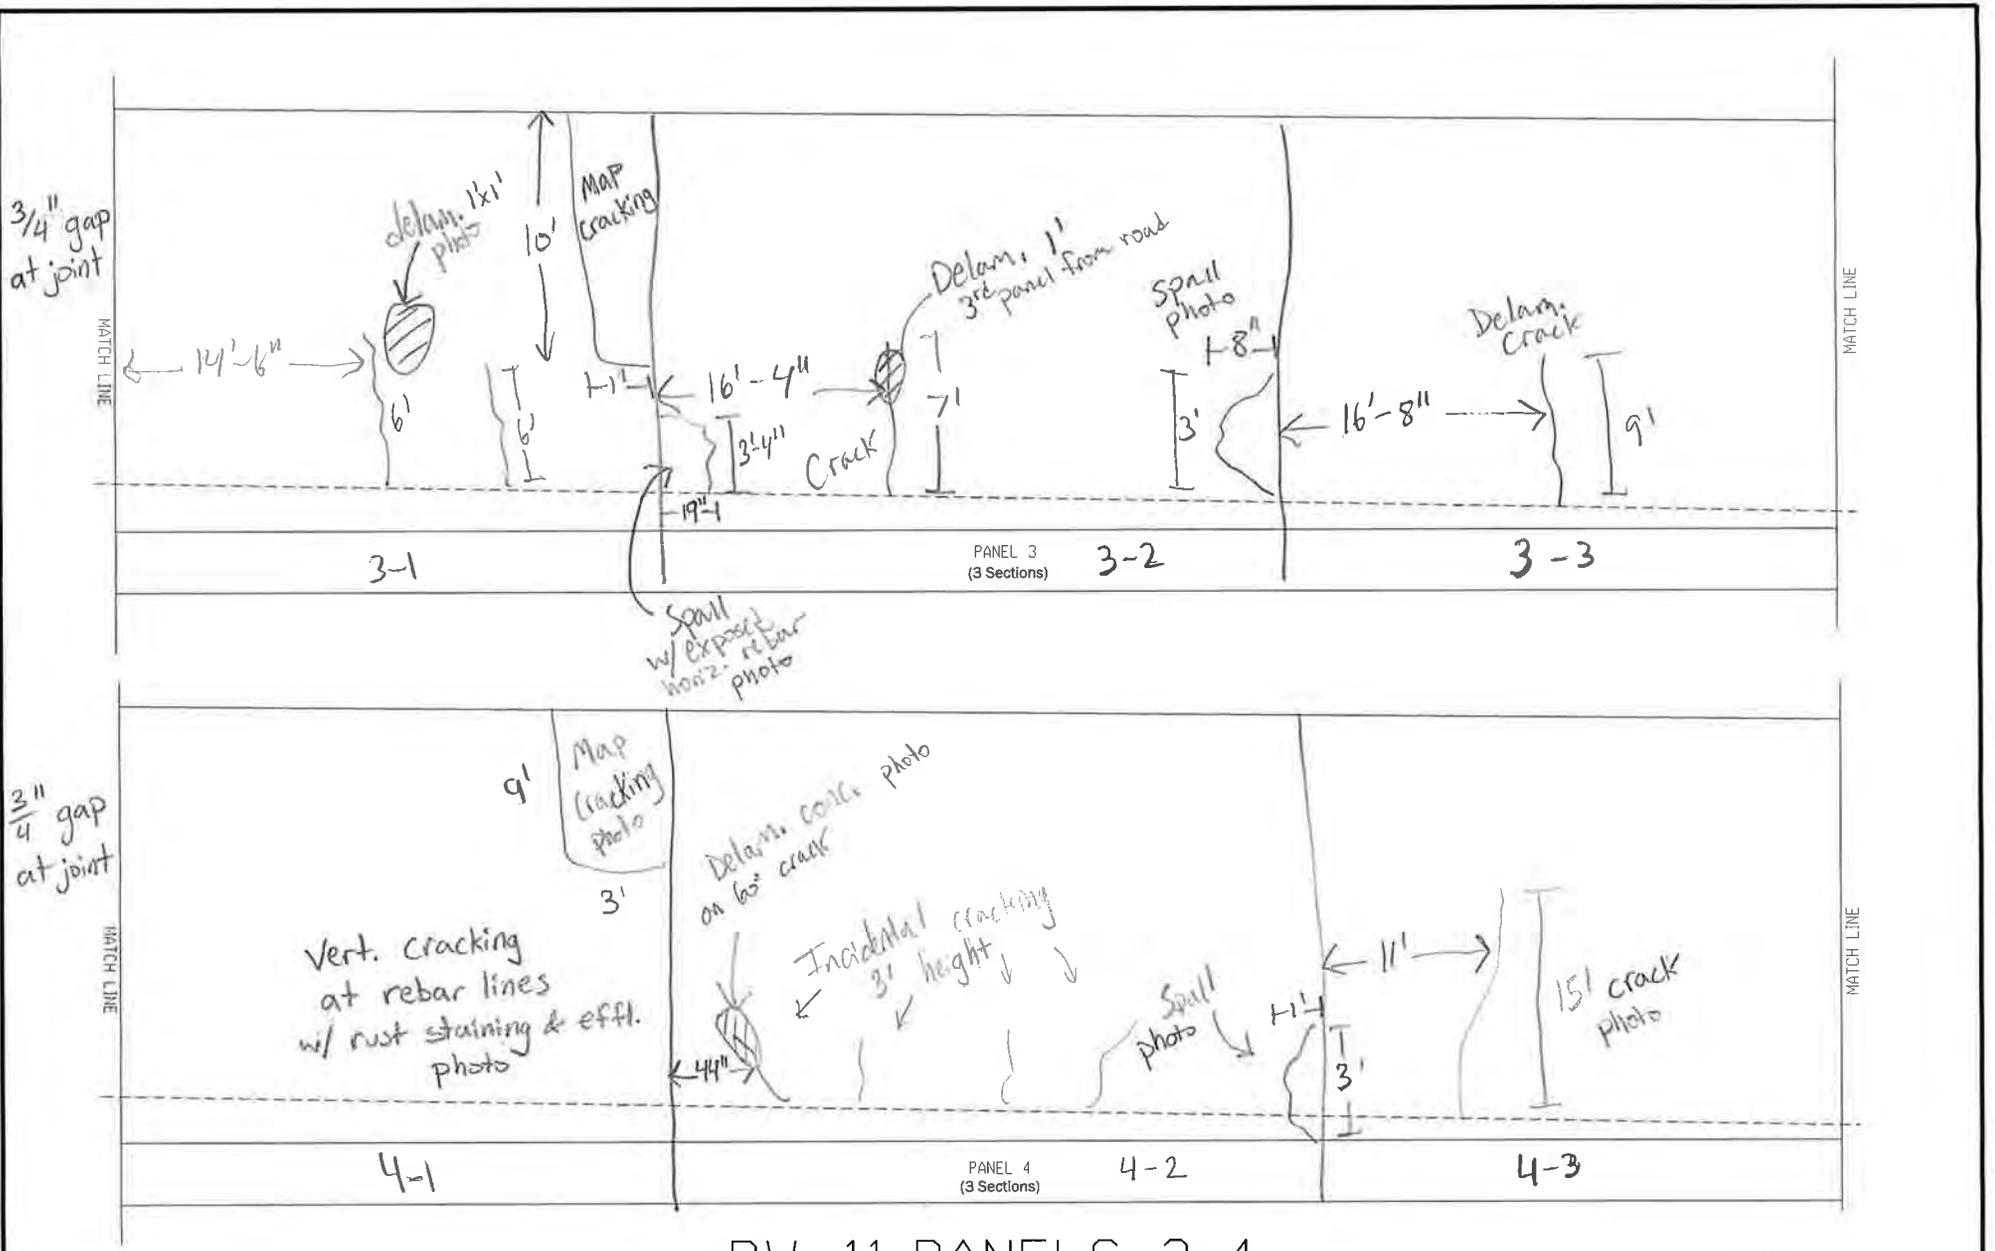
RW 11 PANELS 3-4

3/4" gap at joint w/ joint material missing
