Ground Penetrating Radar Report

Subsurface Mapping PIN 5512.52 – Kensington Expressway in Buffalo, NY

FINAL REPORT

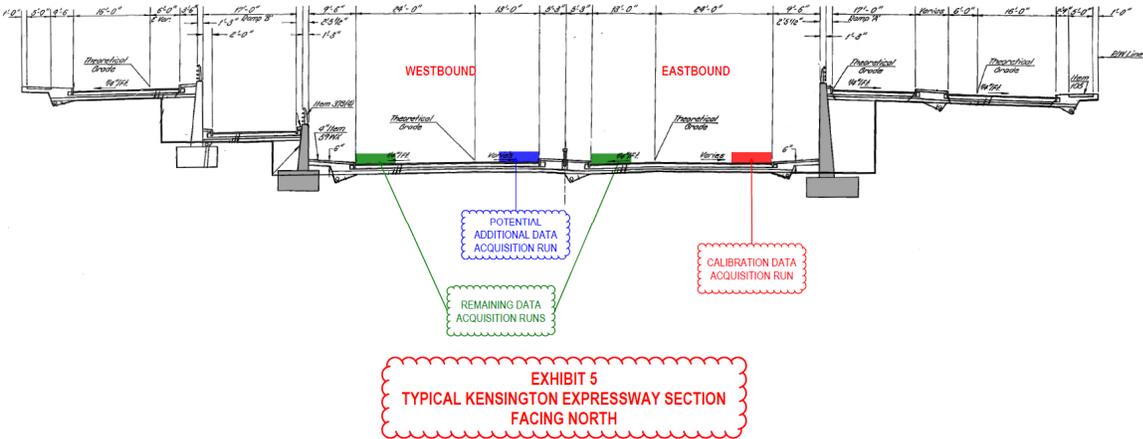
Figure 1. Exhibit 5 from the solicitation showing the prescribed lateral positions of GPR profiles.

The overall objective of the ground penetrating radar (GPR) survey was to map the top of bedrock along an approximately 1-mile section of Kensington Expressway, along 4-offsets from approximately Northland Street to Best Street as shown on the title page. Infrasense used a low frequency GPR antenna to map the changing bedrock elevation that boring logs indicate varies between 6-feet and 35-feet below the roadway surface. The night surveys were conducted between May 5th and 7th, 2023. During both nights, the Eastbound (EB) lane was closed to traffic due to repair work on the W. Parade Avenue bridge. The Westbound (WB) data were collected with the help of a mobile traffic closure.

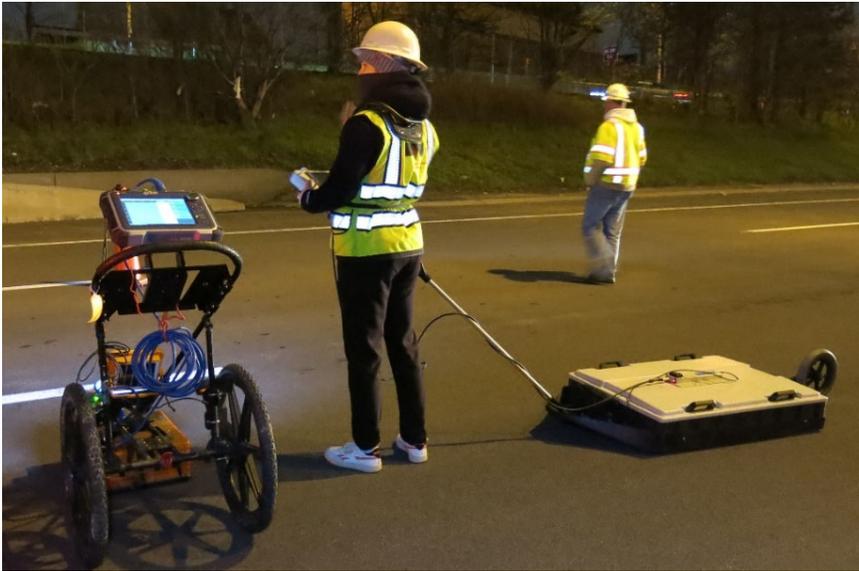
Figure 2. Picture of the GPR systems used during the field work. (Left) the 270 MHz GSSI GPR pushcart system and (right) the pulled 80 MHz Mala system.

A Mala GX80 80-MHz GPR Collection system (Mala, 2023) was used for the bedrock exploration. In addition, a 270 MHz GSSI antenna (GSSI, 2023a) with a GSSI SIR-4000 control unit (GSSI, 2023b) was used for the purpose of delineating the shallower bedrock.

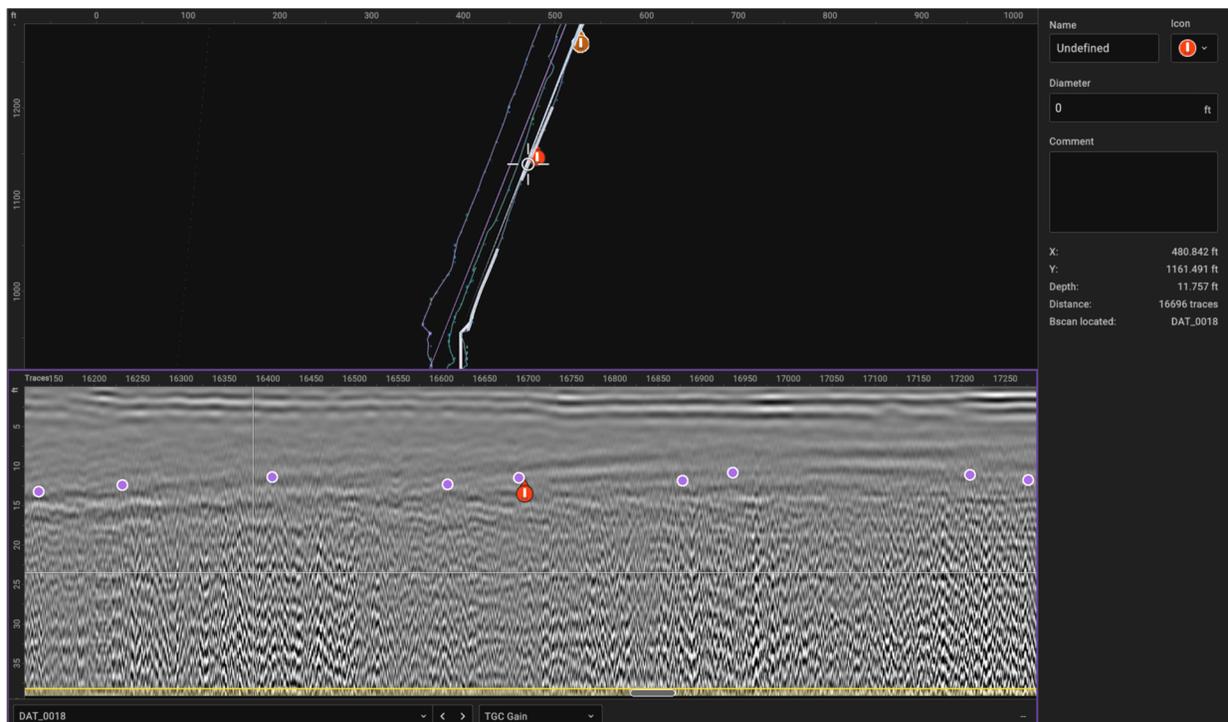
Figure 3. Night 1 data sample showing top of bedrock tracked in purple. The known core location shown as red tag.

Data collected on May 6th were reviewed and it was determined that there was sufficient depth of penetration and resolution to map the depth to bedrock. Figure 3 below shows sample data collected along the EB right shoulder on the first night. A brief data review document was provided to LaBella to summarize the data quality and get permission to complete the remaining data collection. The night 1 data review document is included as Attachment C.

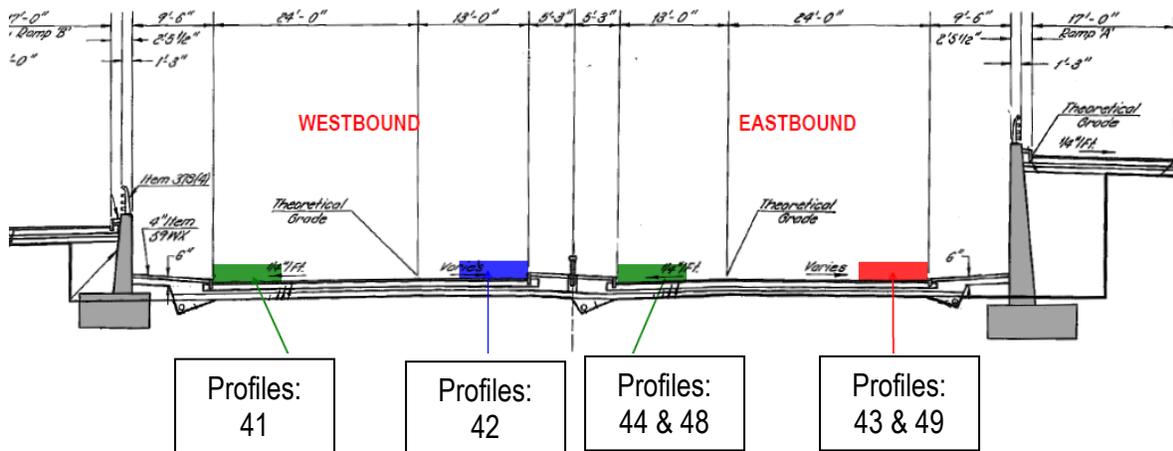
Figure 4. A cross section of the four offsets collected for bedrock profile mapping.

Mapping of the top of bedrock was completed using 6 of the 80 MHz GPR profiles collected during the second night of collection based on the quality of the GPR data. The position of each of the profiles is represented in Figure 4 and described in Table 1.

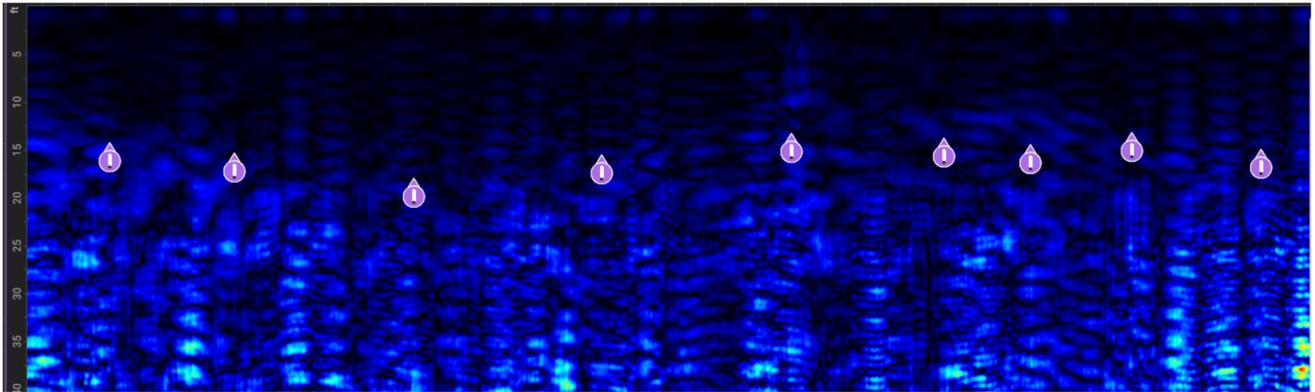
Figure 5. Sample GPR profile showing top of rock tracked with discrete “picks.”
From Profile 48 near Station 12000.

The top of bedrock was tracked manually by an experienced analyst across the four offset positions based on continuous subsurface interface reflections, interpreted subsurface diffractions of the GPR signal, and abrupt changes amplitudes. The various types of reflections are common in bedrock mapping due to inconsistencies in the rock surface. The bedrock surface was “picked” at regular intervals as shown in Figure 5. The core information was then used to calibrate the calculated depths and make adjustments to best fit the known depth elevations. When the rock dropped below 25 feet the GPR datasets were unable to resolve the top of rock with sufficient accuracy, and therefore were not mapped. The vertical resolution of the GPR data is approximately +/- 2 feet in the top 10 feet, and +/- 4 at depths greater than 15 feet.

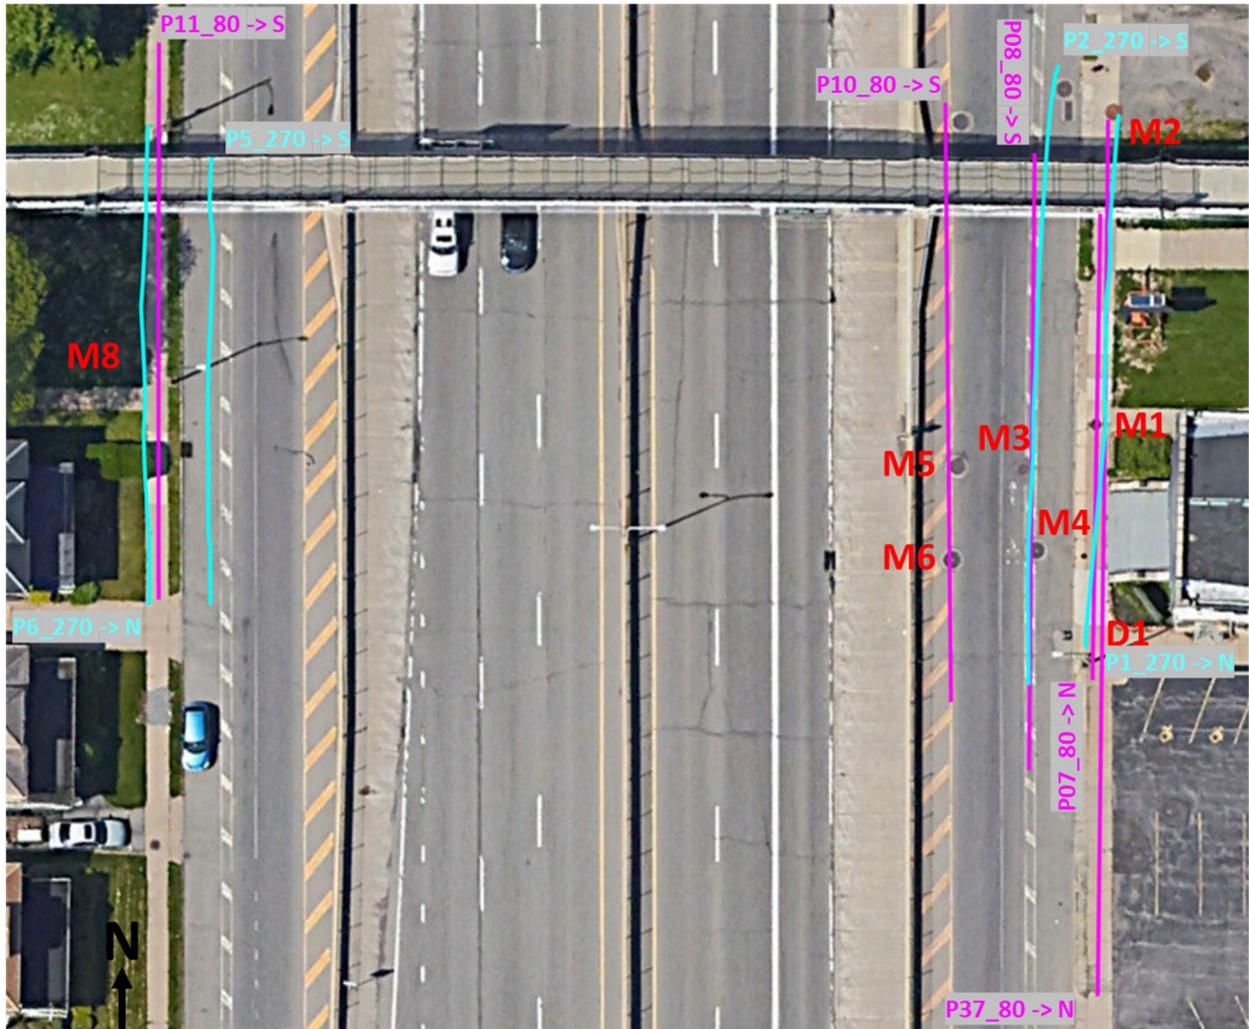
Figure 6. Google Earth map with various 80 MHz profile paths overlaid in pink and 270 MHz profiles paths in blue. Also indicated are eight manholes (red M#) and one drainage as red D1.

Several radar profiles were collected specifically targeting the suspected location limits of the SCI. These files were collected and analyzed independently of the bedrock mapping files, and their positions are shown in Figure 6. A total of 9 GPR profiles (five 80-MHz and four 270-MHz) were used to map the limits of the SCI with the clearest signal being along the edges of the Kensington Expressway, over the sidewalks and grassy areas.

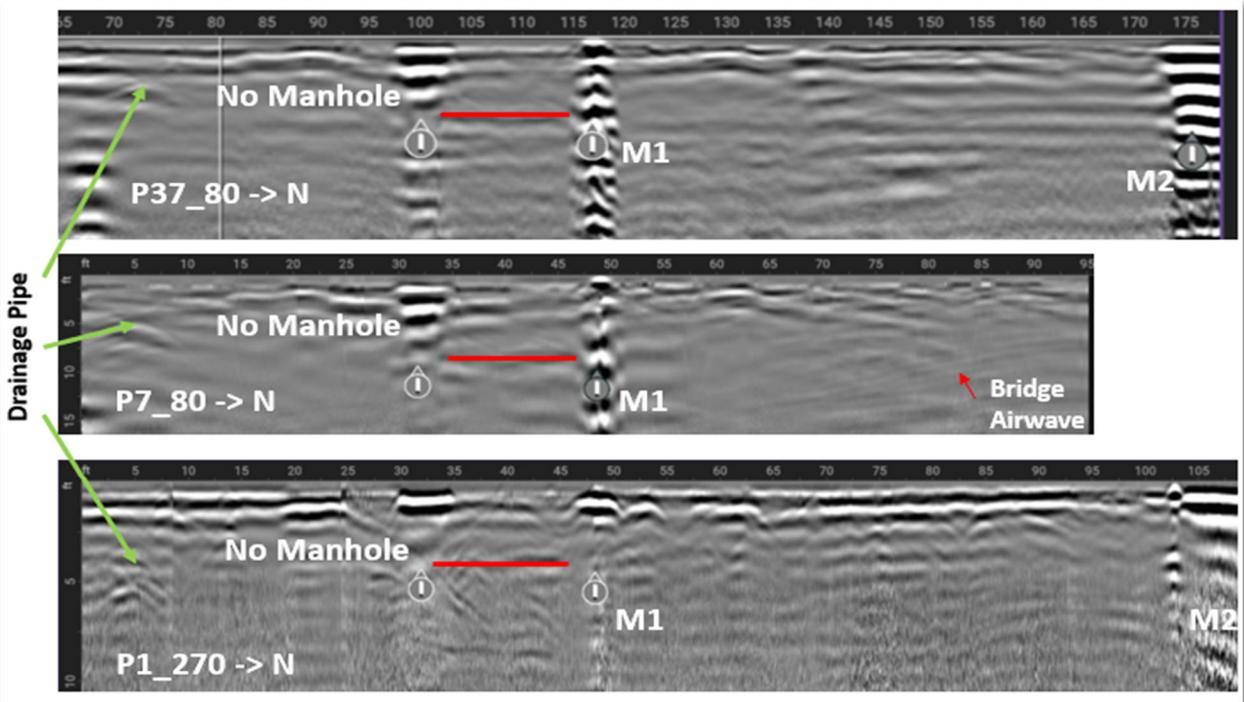
Figure 7. Three parallel GPR profiles on the EB side of the Kensington Expressway showing a horizontal target with similar appearance that is in close proximity to a known sewer manhole, but may represent the top of the SCI.

The profiles P1, P7, and P37 (Figure 7) show a horizontal target (red line) that may be related to the SCI. The red line anomaly could potentially be related to drainage or sewer lines that cross below M1 and should be compared against known utility information in the area. The same feature can be observed in P5, P6, and P11 in (Figure 8) on the Westbound side of the expressway. The horizontal feature (shown in red) is also in close proximity to manhole M8. However, its size and similar profile shape suggests that this is the result of a continuous structure across the Kensington Expressway.

It is our recommendation to compare these findings as-builts, especially the sewer network, to verify the presence of pipes in the areas marked with a red line. If there are no pipes expected, then this feature is unknown. It is possible that these horizontal features are directly related to the SCI. However, the alignment is not within the grass area as expected. The alignment of these targets shows it crossing beneath the northern corner of the Faith Baptist Church, and crossing the Kensington Expressway at an angle that places it close to the northern property line of 617 Humbolt parkway.

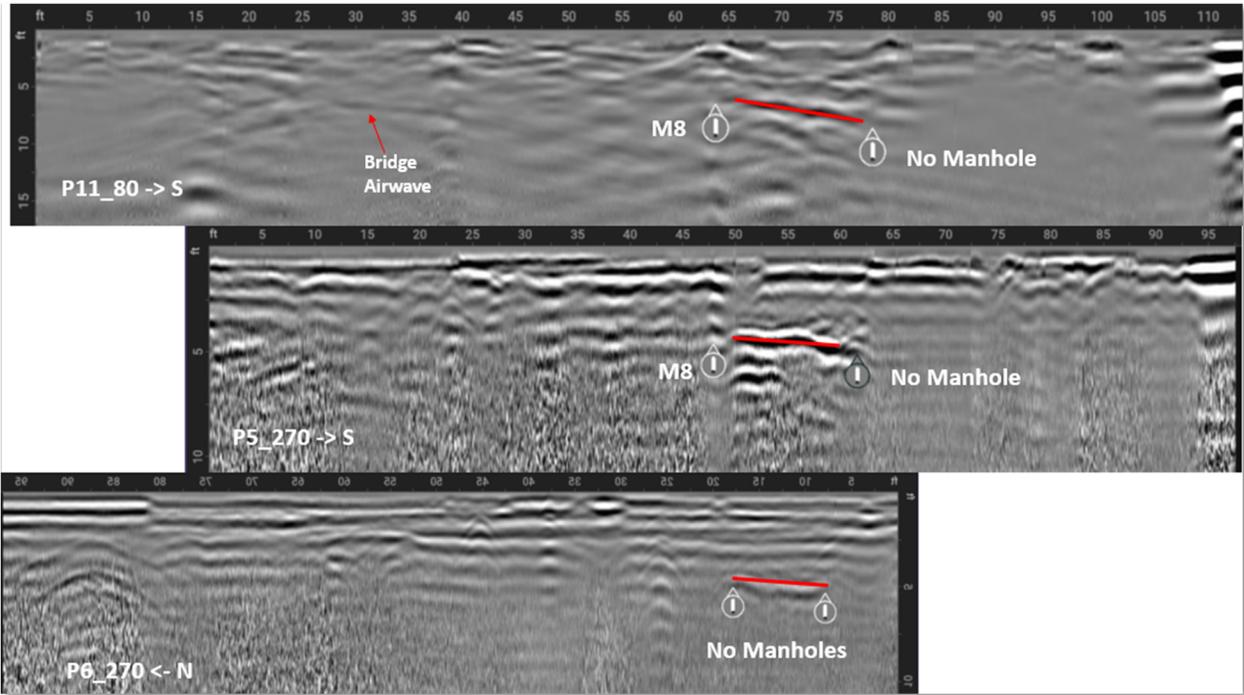
Figure 8. Three parallel GPR profiles on the WB side of the Kensington Expressway showing a horizontal target with similar appearance that is in close proximity to a known drainage manhole, but may represent the top of the SCI.

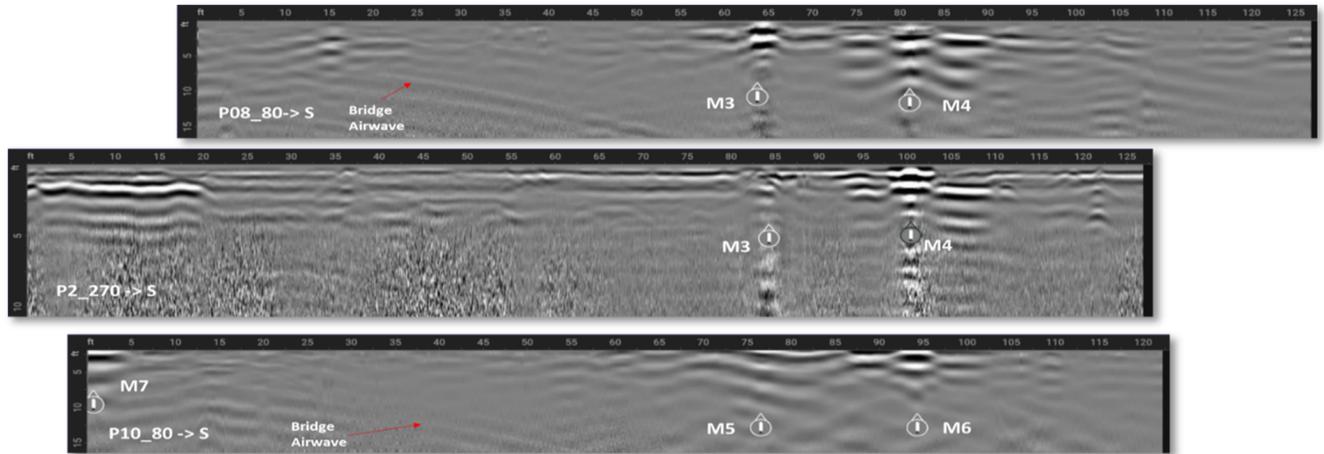
Figure 9. Three parallel GPR profiles on the EB side of the Kensington Expressway showing little evidence of the SCI, potentially due to attenuation from the roadway above.

Additional profiles in the vicinity of the SCI on the Kensington Expressway are not shown as they show little evidence of the channel in the top 10 feet. It is believed that the increased road structure is limiting the shallow resolution of the GPR antennas, and thus the relatively shallow channel is blending in with the roadbase. The SCI was expected to be between the pedestrian bridge and the first houses to the South.

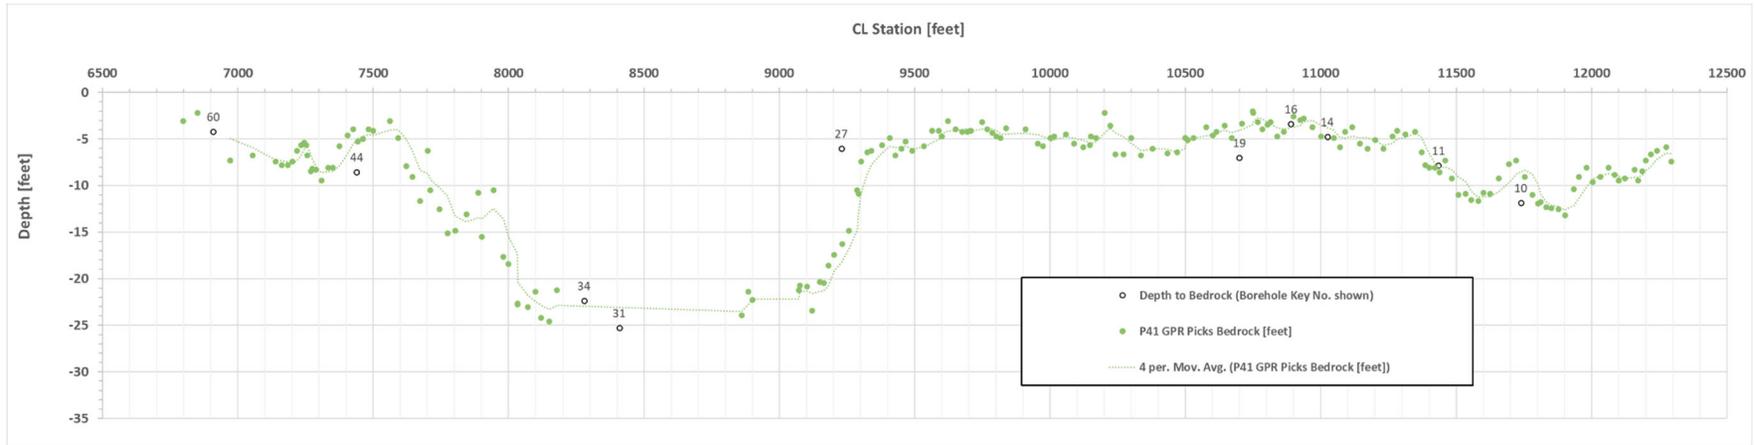
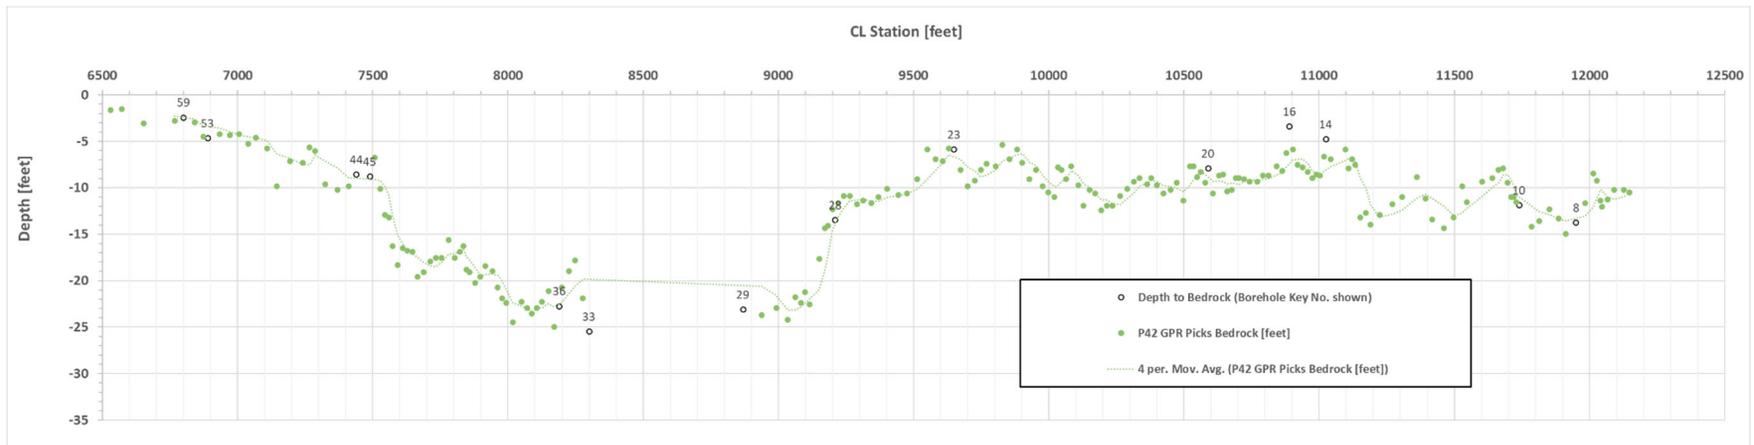
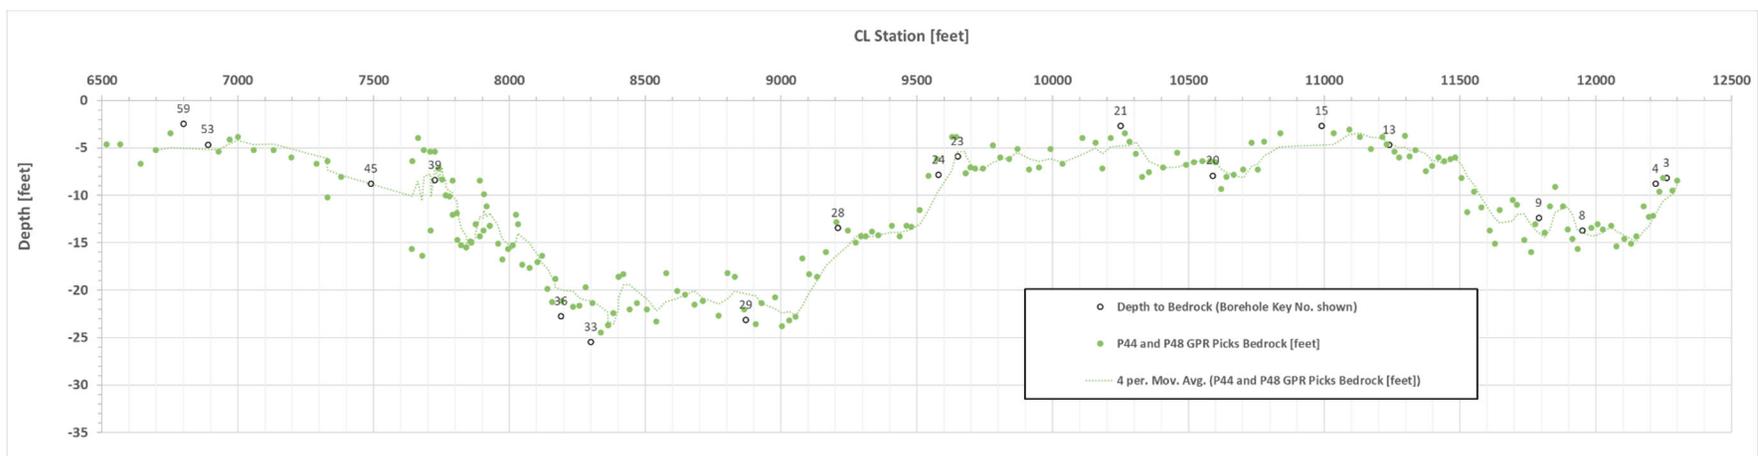
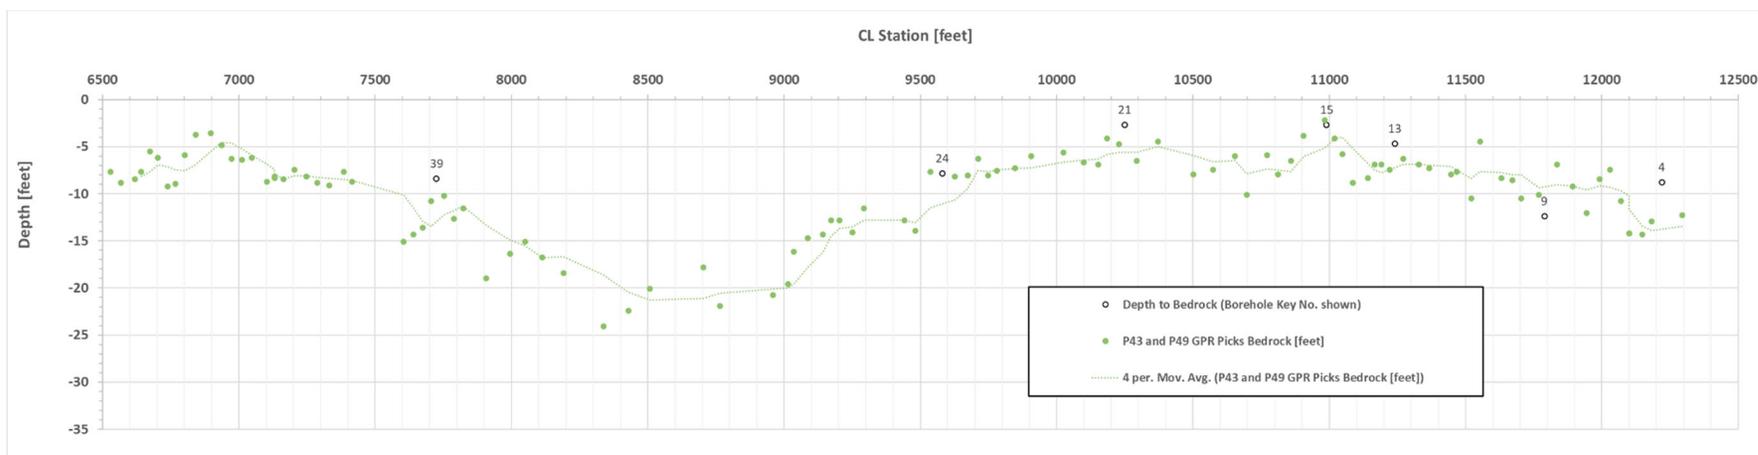
**ATTACHMENT A
BEDROCK DEPTH PROFILES
(DISTANCE IN CENTERLINE STATIONING)**

The mapped bedrock layers were exported in tabular format and are provided in Attachment A as a set of 4 depth profiles.

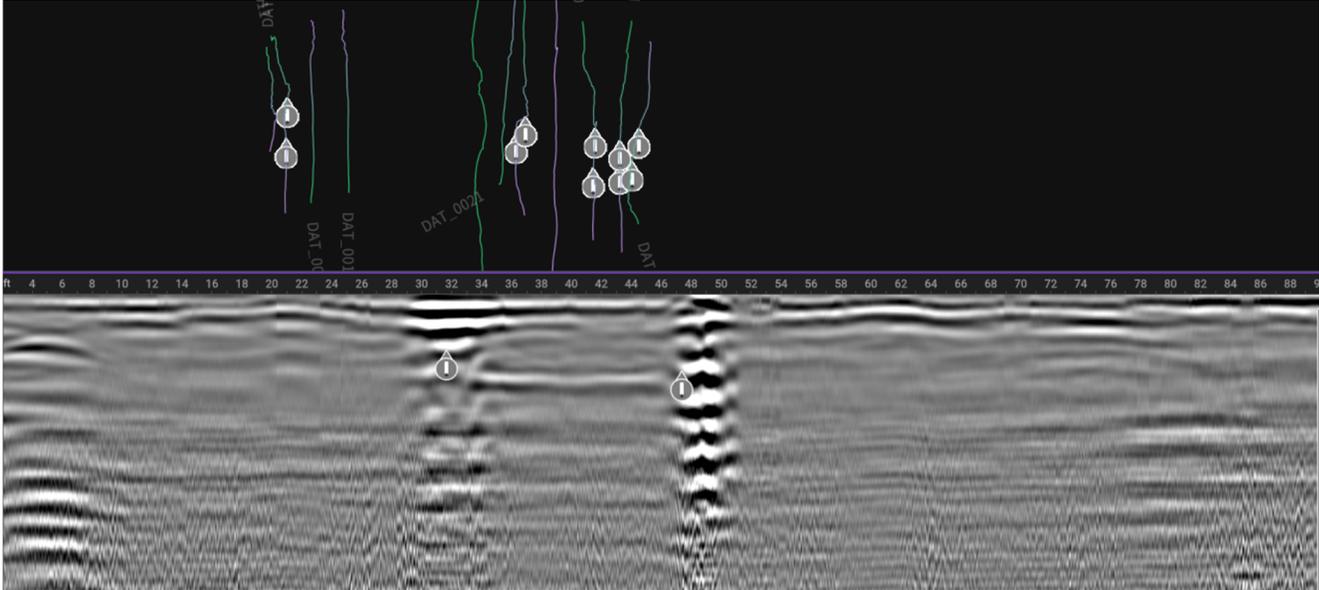
Grey tags show location of Sajaquada Creek Interceptor

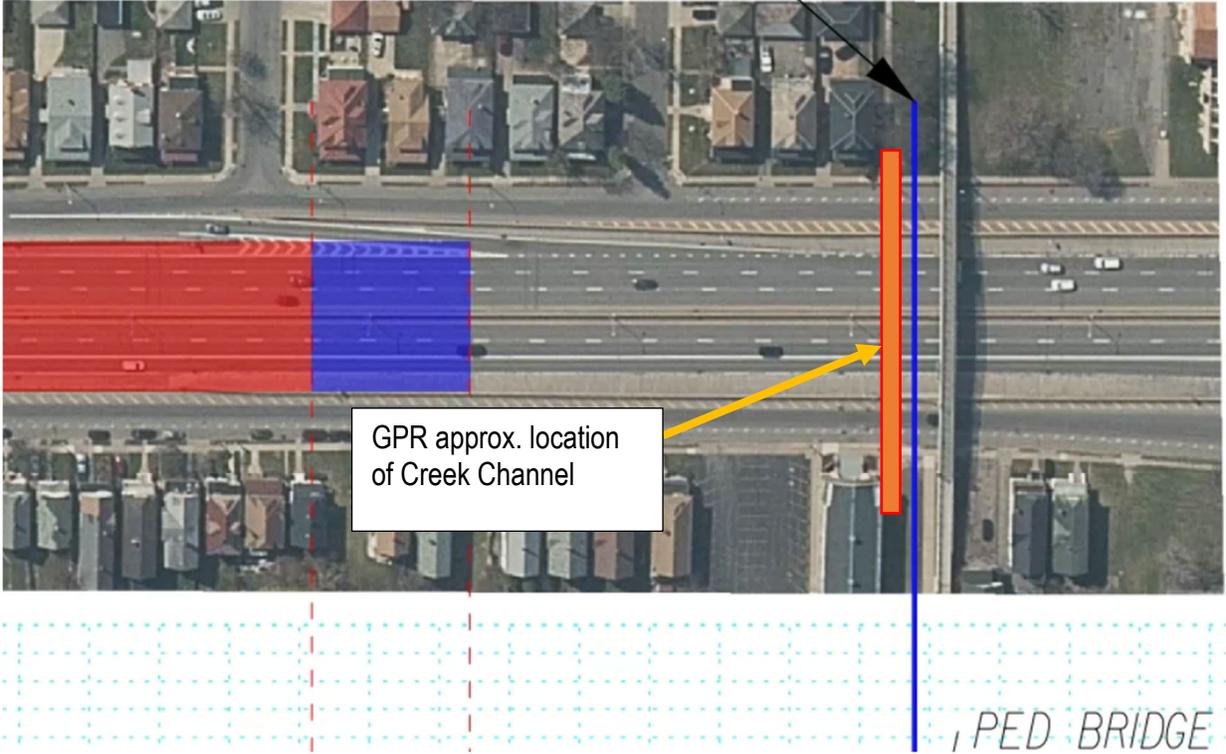
GPR approx. location of Creek Channel

GPR location is approximately where the orange box appears...closer to the church property on the east side and the house property on the west.

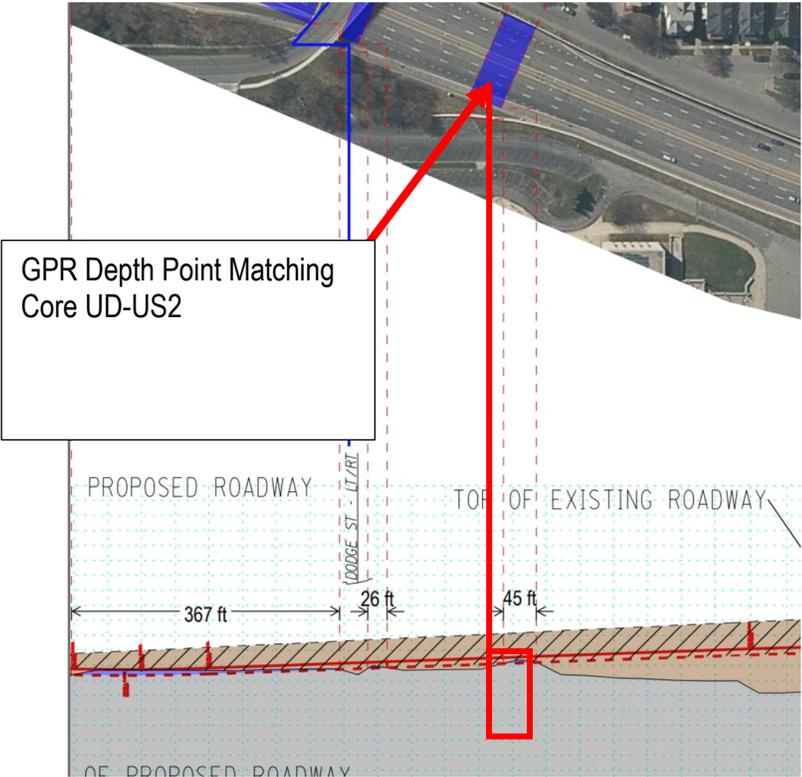
Red box – shows core related depth of 10-12 feet

GPR data shows top of rock profile at UD-US2 – 11.757 foot depth

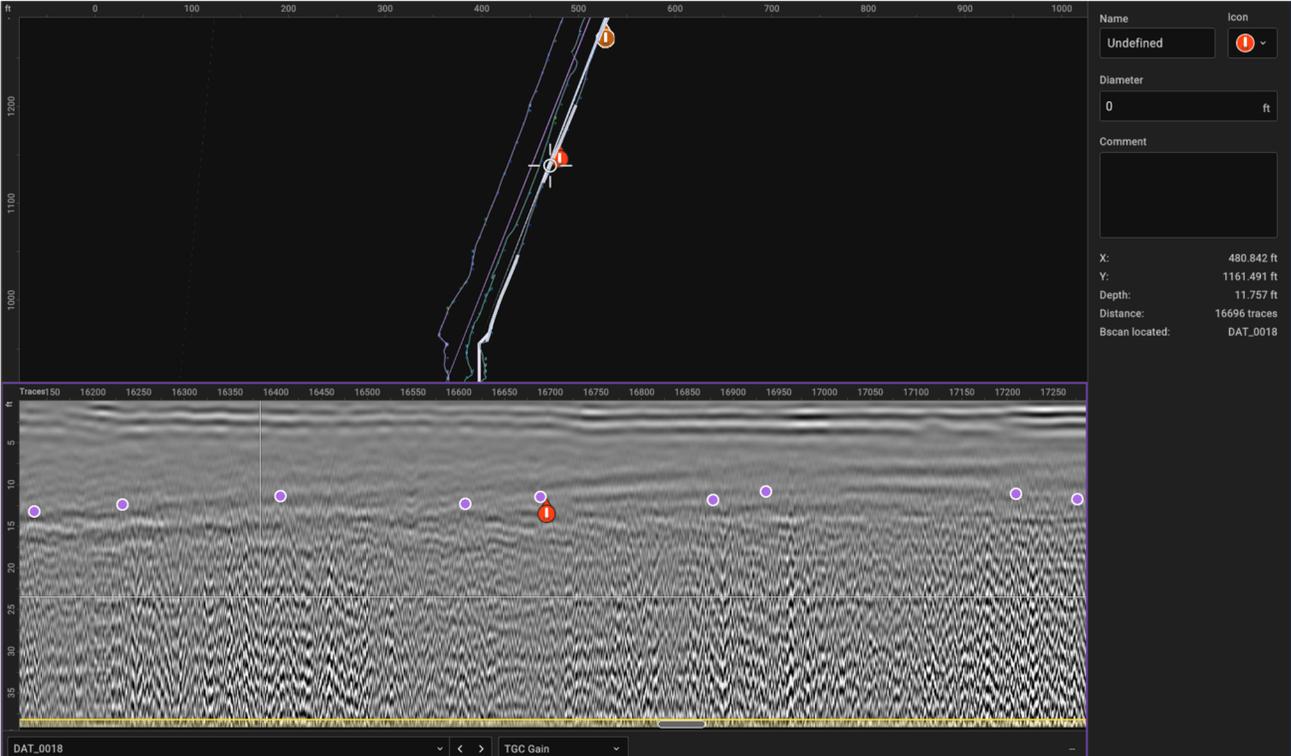
Layer tracked in purple, Core location shown in Red

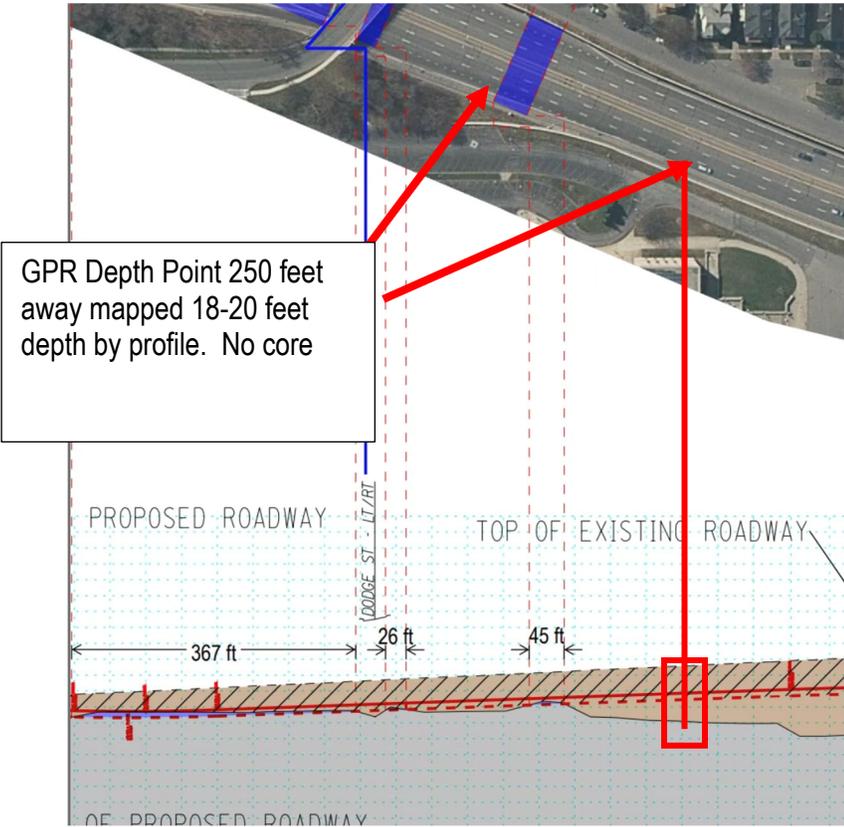
GPR data shows top of rock profile hovering around 21-22 foot depth which is a bit deeper than the expected profile.

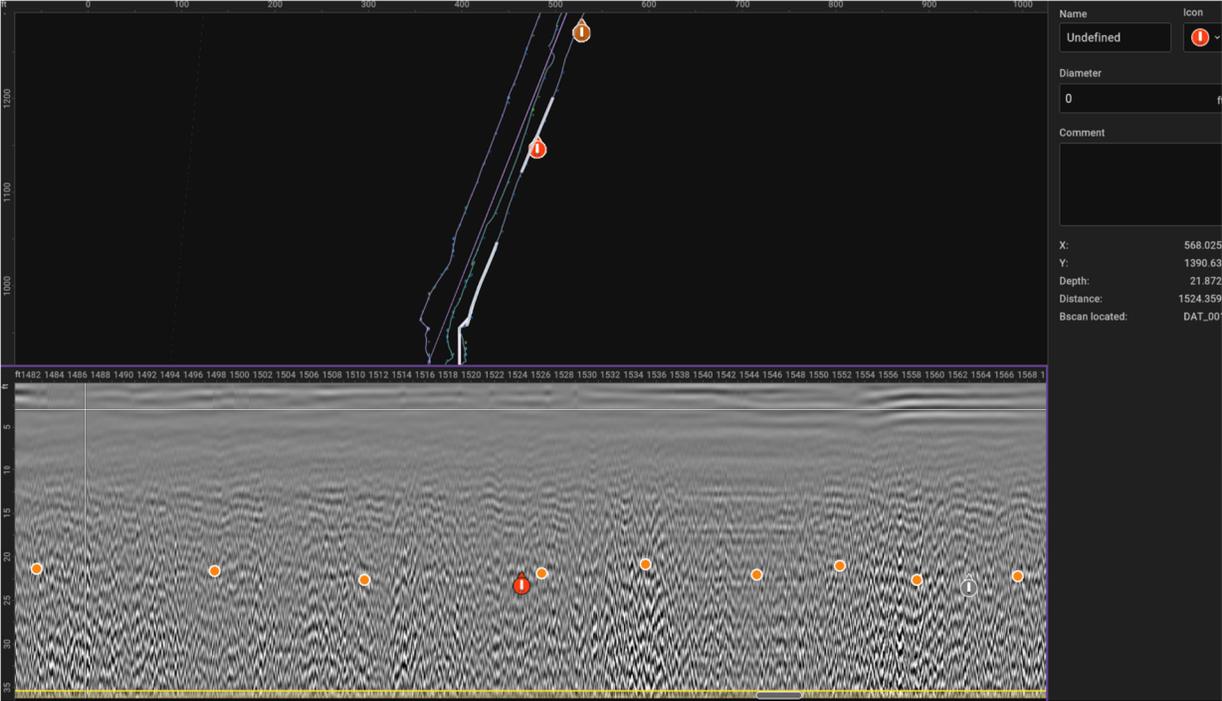
Layer tracked in orange, Core location shown in Red

Further calibration with additional data offsets near cores will help to refine the dielectric material and more closely represent the true depth.

Current depths are based on the proximity to a single core location and thus the second deeper location may change in the final analysis.
