Bridge Inspection Reports and Work History Summaries

**NY33 BRIDGE CONDITION VERIFICATION 2023
KENSINGTON EXPRESSWAY PROJECT
PIN 5512.52
CITY OF BUFFALO, ERIE COUNTY
BIN 1022609**

STRUCTURE: BIN 1022609 - Best Street on NY33 Kensington Expressway

STRUCTURE TYPE: Four (4) span Steel, Multi-Stringer (12 beams) structure with concrete abutments founded on piles and 3-six column piers with spread footings. Year Built: 1959

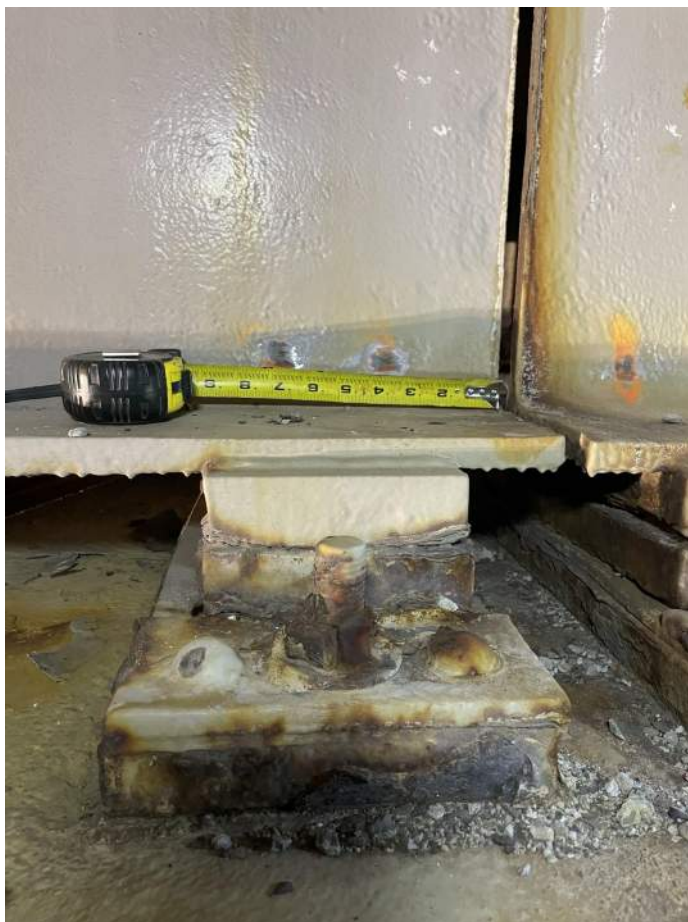
PHOTO 2

LOCATION:
G1 IN SPAN 2 AT
PIER

DESCRIPTION:
BEARING AREA
SECTION LOSS
MEASUREMENT
LOCATIONS

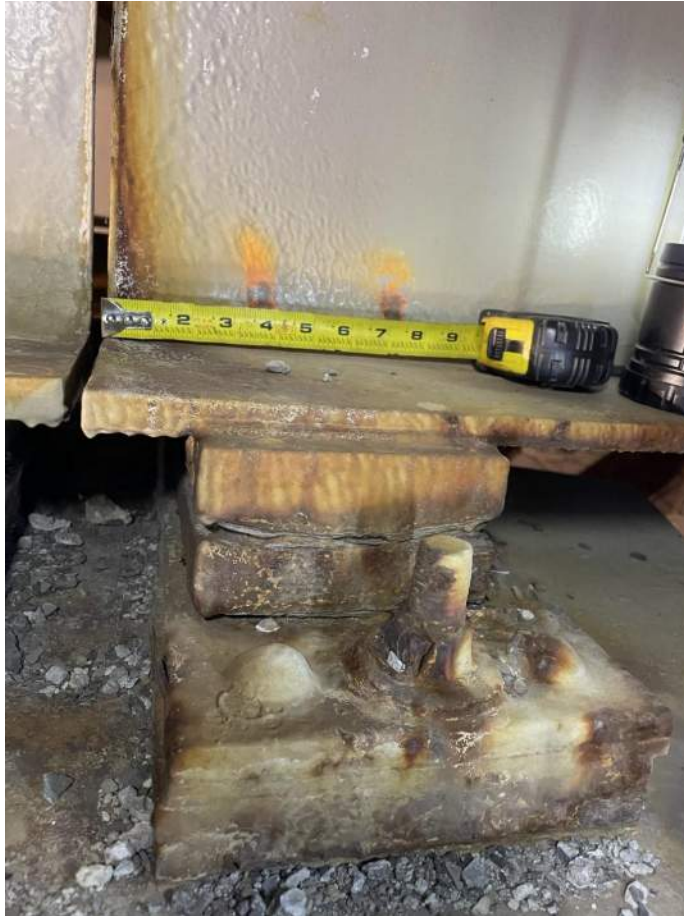
PHOTO 3

LOCATION:
G1 IN SPAN 1 AT
PIER

DESCRIPTION:
BEARING AREA
SECTION LOSS
MEASUREMENT
LOCATIONS

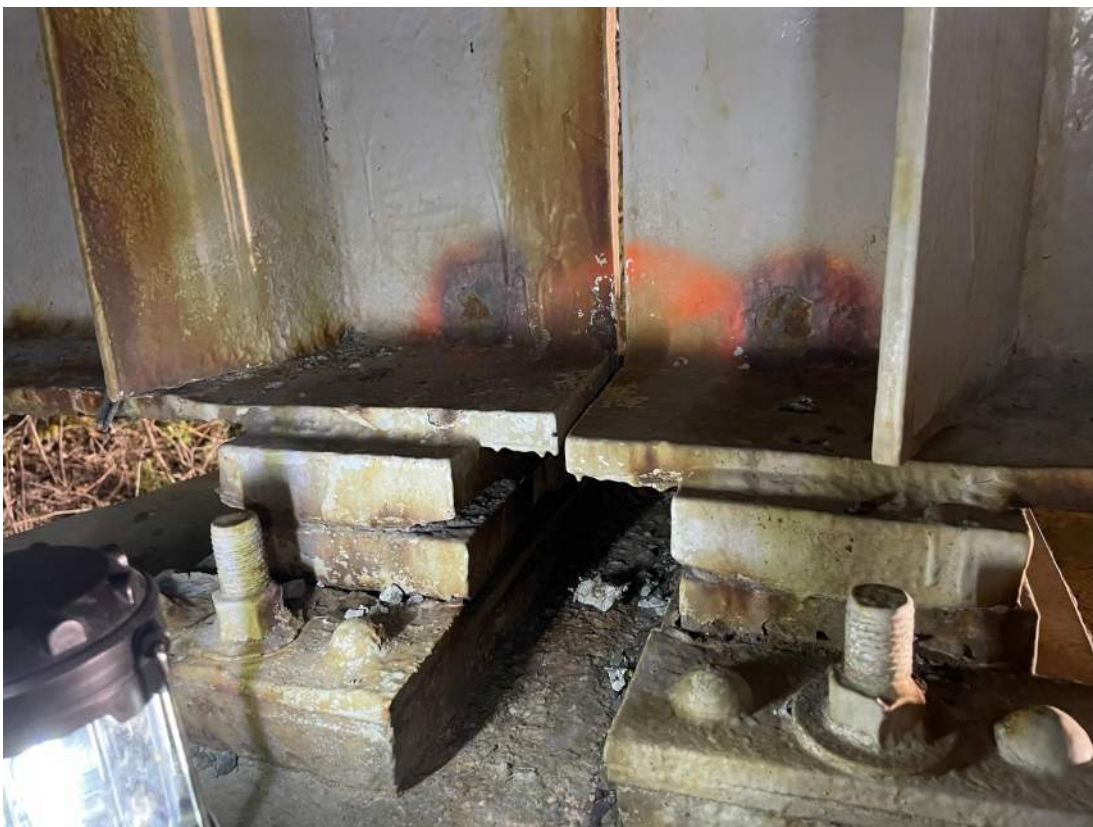
PHOTO 4

LOCATION:
G1 IN SPANS 1 & 2 AT
PIER

DESCRIPTION:
BEARING AREA
SECTION LOSS
MEASUREMENT
LOCATIONS

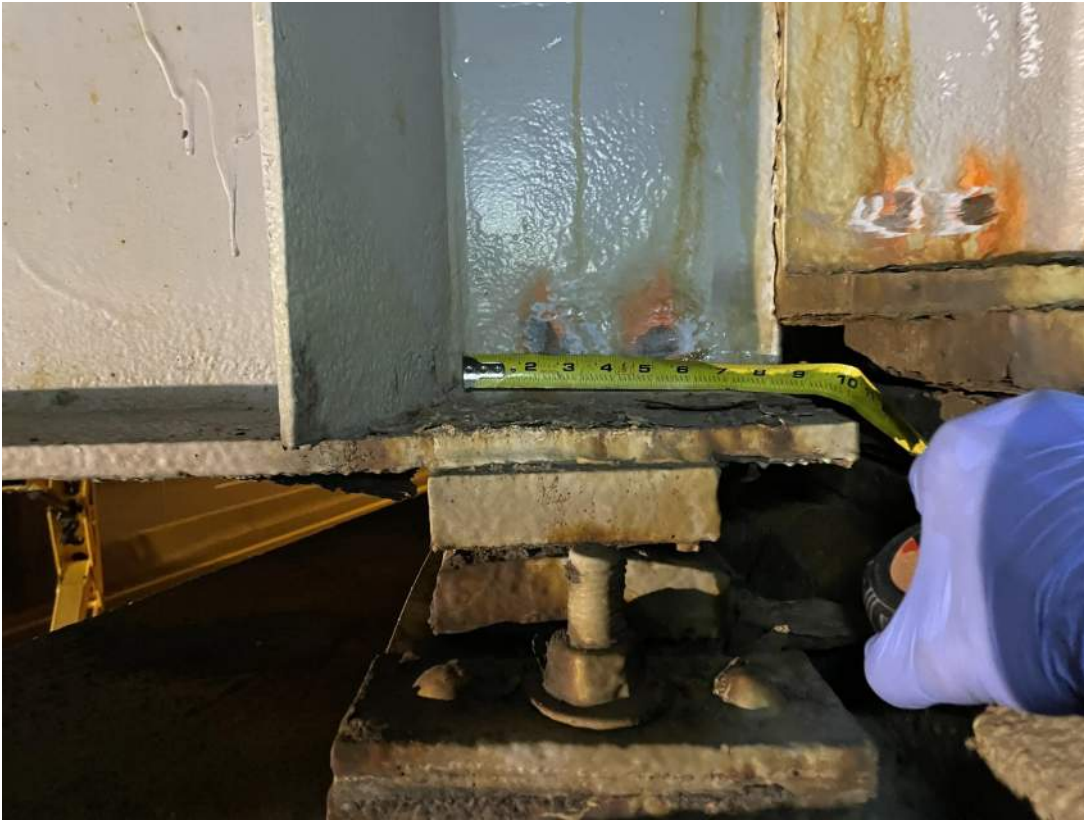
PHOTO 5

LOCATION:
G5 IN SPANS 1 & 2 AT
PIER

DESCRIPTION:
BEARING AREA
SECTION LOSS
MEASUREMENT
LOCATIONS

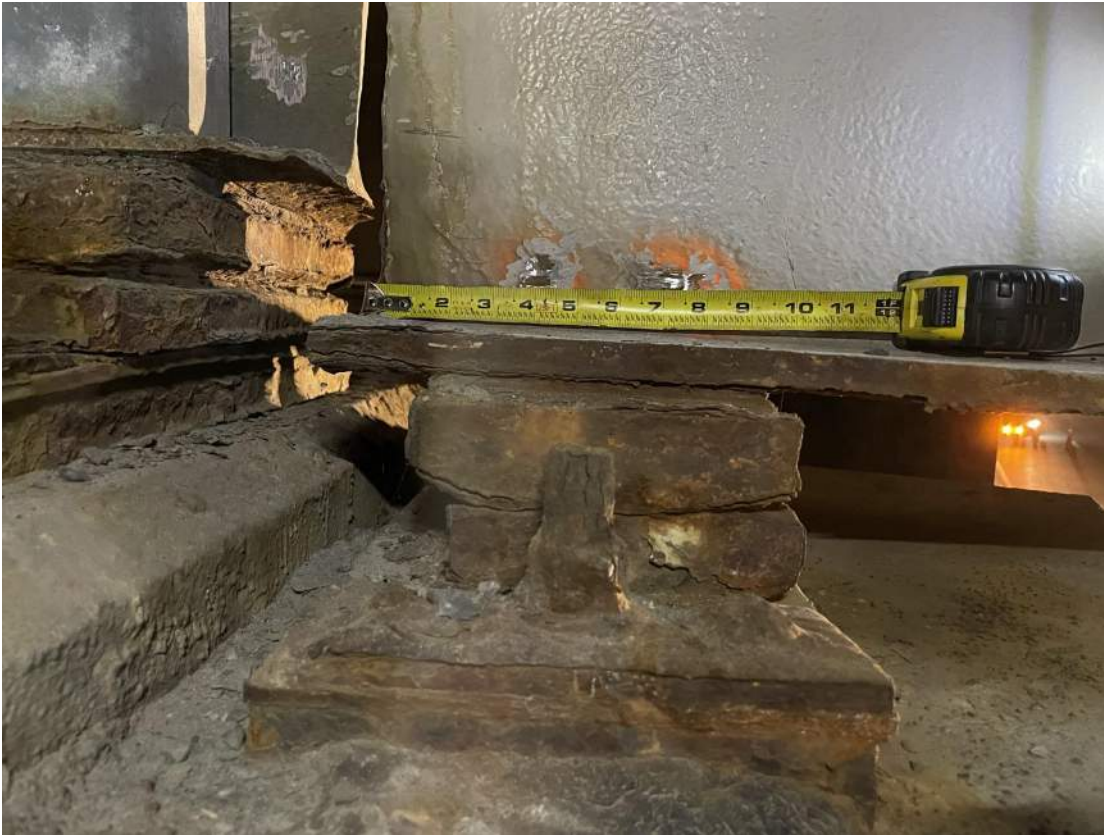
PHOTO 7

LOCATION:
G6 IN SPAN 2 AT
PIER

DESCRIPTION:
BEARING AREA
SECTION LOSS
MEASUREMENT
LOCATIONS

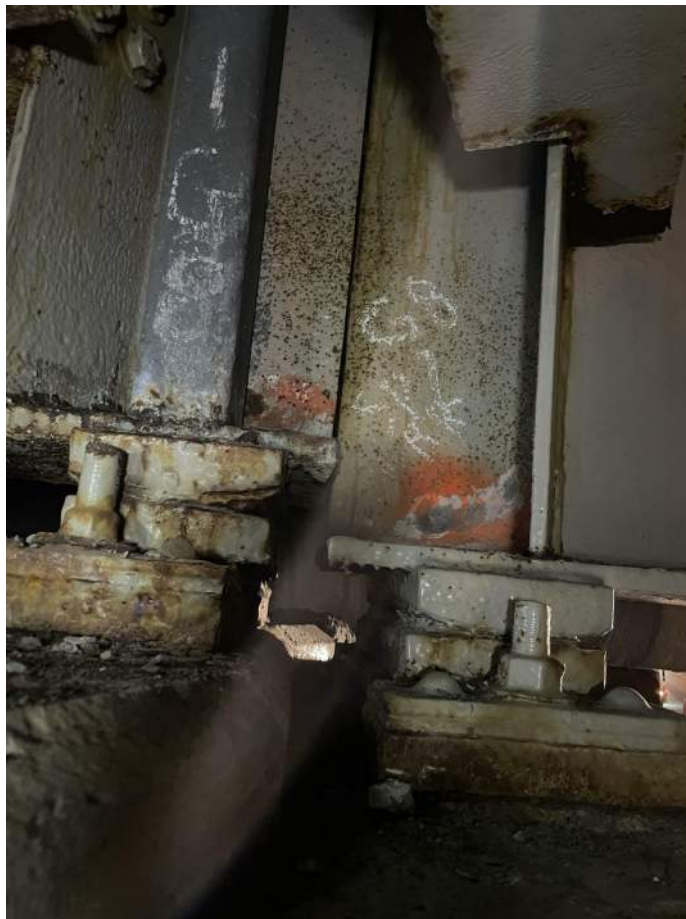
PHOTO 8

- The bearing area loss ranged from 23% to 61%. The maximum loss was observed in Span 1 at G6 (end) at 44%, in Span 2 at G8 (begin) and G11 (begin) at 48% and 47% respectively, in Span 3 at G1 (begin) , G12 (begin) and G7 (end) at 61%, 45% and 41%, respectively, and in Span 4 at G8 (begin) and G9 (begin) at 38% each.

LOCATION:
G8 IN SPANS 1 & 2 AT
PIER

DESCRIPTION:
BEARING AREA
SECTION LOSS
MEASUREMENT
LOCATIONS

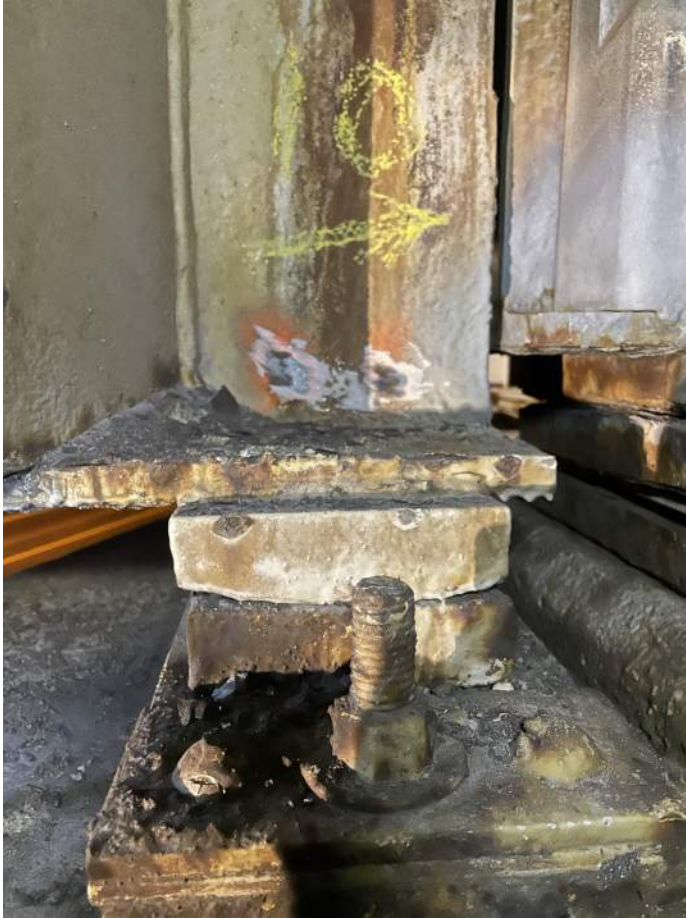
PHOTO 9

LOCATION:
G10 IN SPANS 1 & 2
AT PIER

DESCRIPTION:
BEARING AREA
SECTION LOSS
MEASUREMENT
LOCATIONS

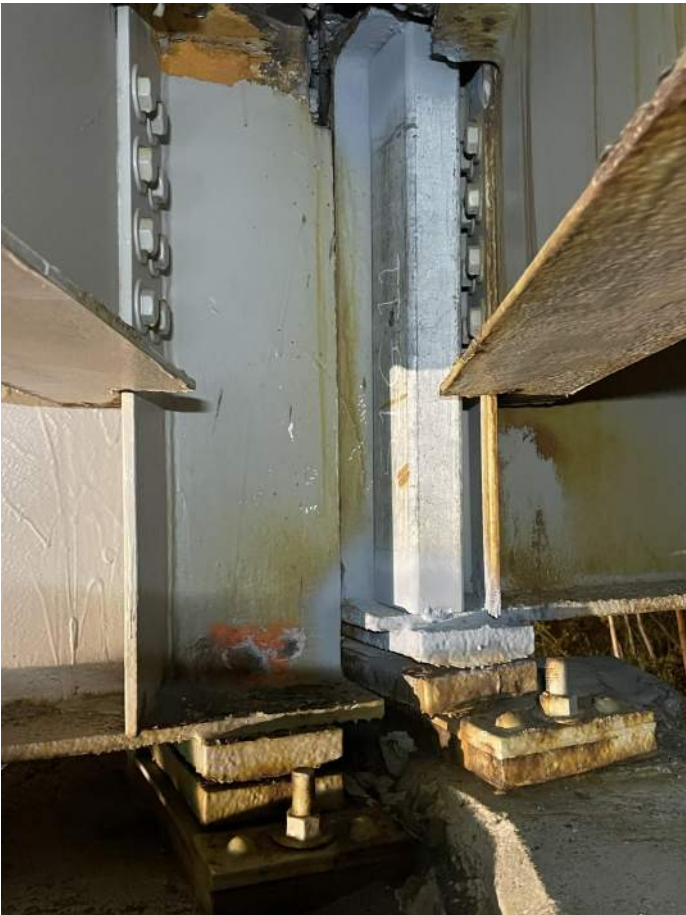
PHOTO 10

LOCATION:
G11 IN SPANS 1 & 2
AT PIER

DESCRIPTION:
BEARING AREA
SECTION LOSS
MEASUREMENT
LOCATIONS

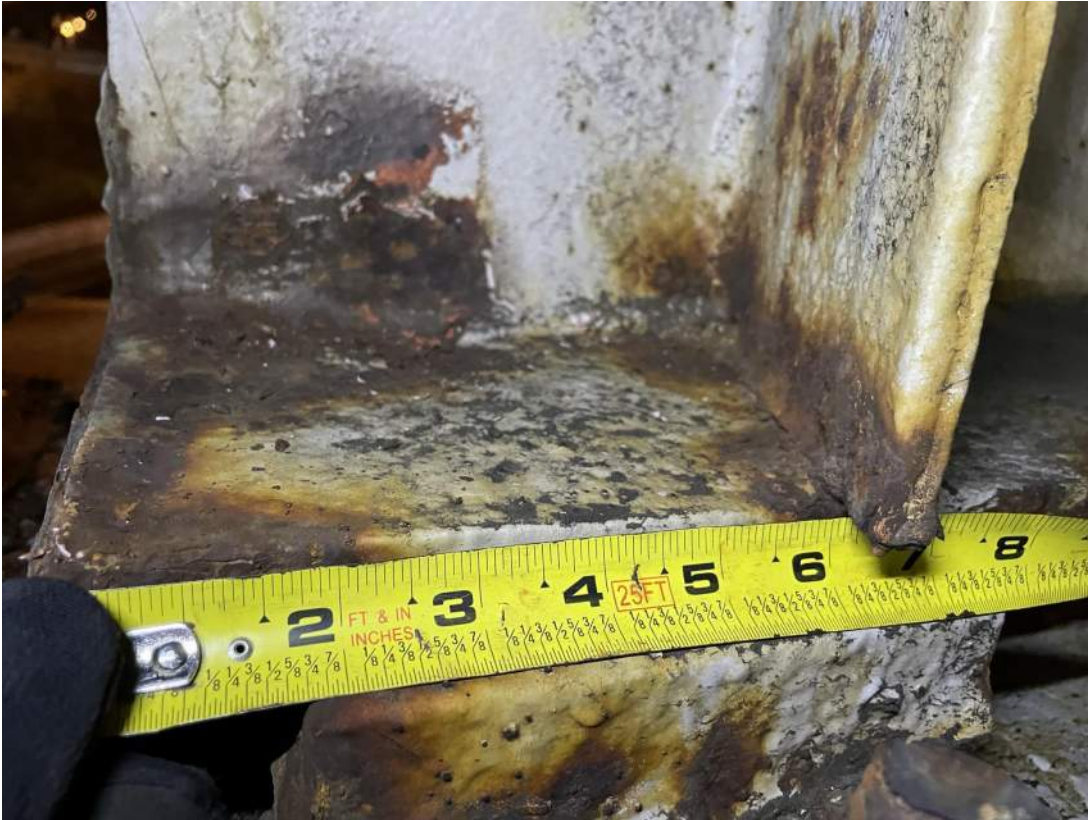
PHOTO 11

LOCATION:
G1 IN SPAN 3 AT
PIER

DESCRIPTION:
BEARING AREA
SECTION LOSS
MEASUREMENT
LOCATIONS

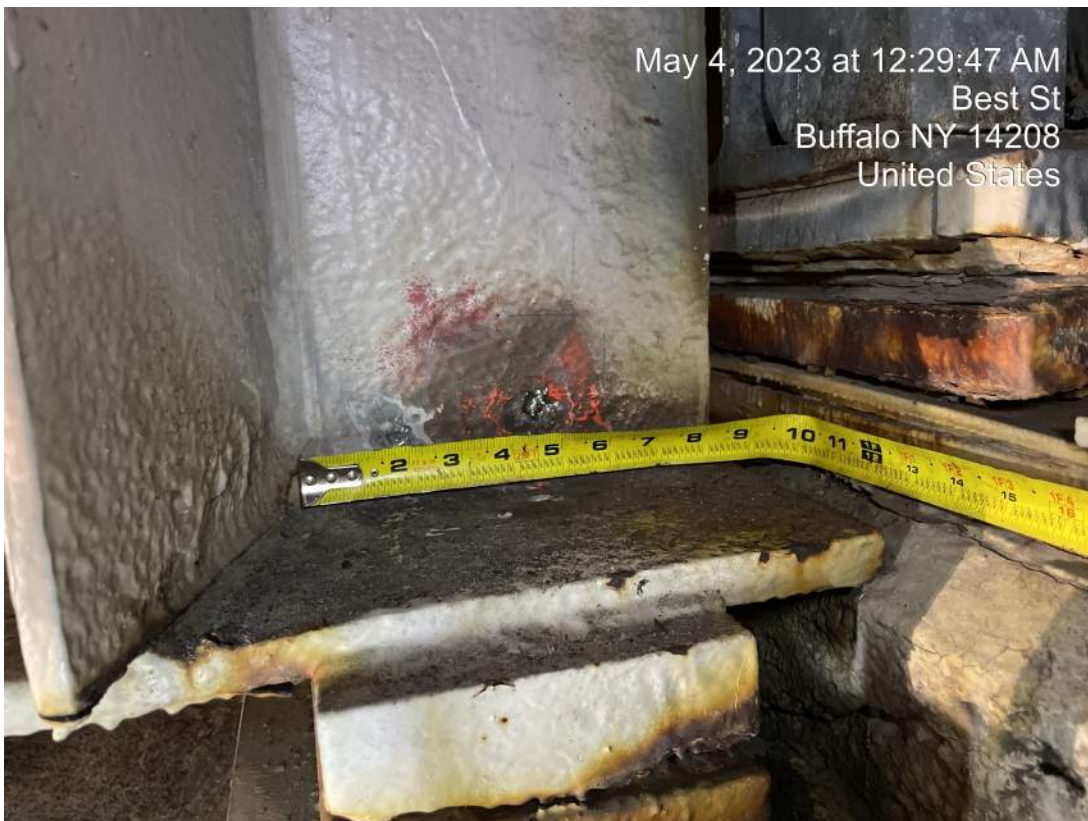
PHOTO 12

LOCATION:
G2 IN SPANS 3 & 4 AT
PIER

DESCRIPTION:
BEARING AREA
SECTION LOSS
MEASUREMENT
LOCATIONS

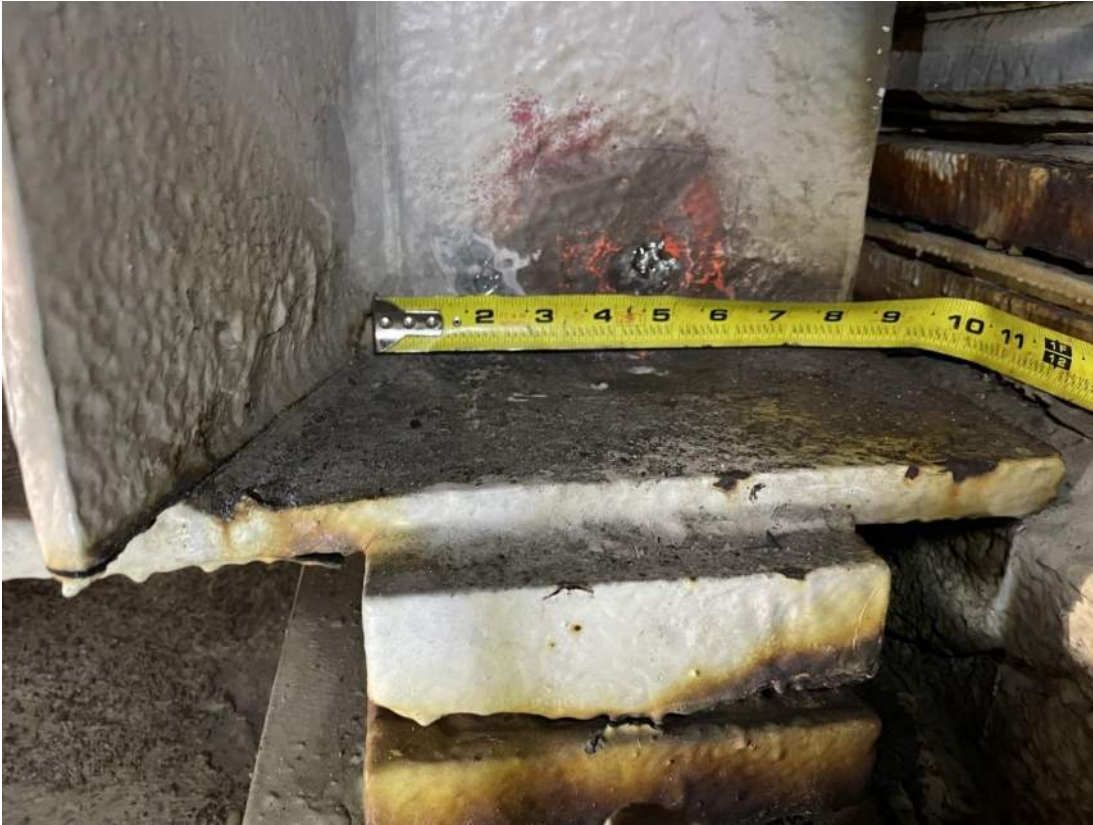
PHOTO 13

LOCATION:
G2 IN SPANS 3 & 4 AT
PIER

DESCRIPTION:
BEARING AREA
SECTION LOSS
MEASUREMENT
LOCATIONS

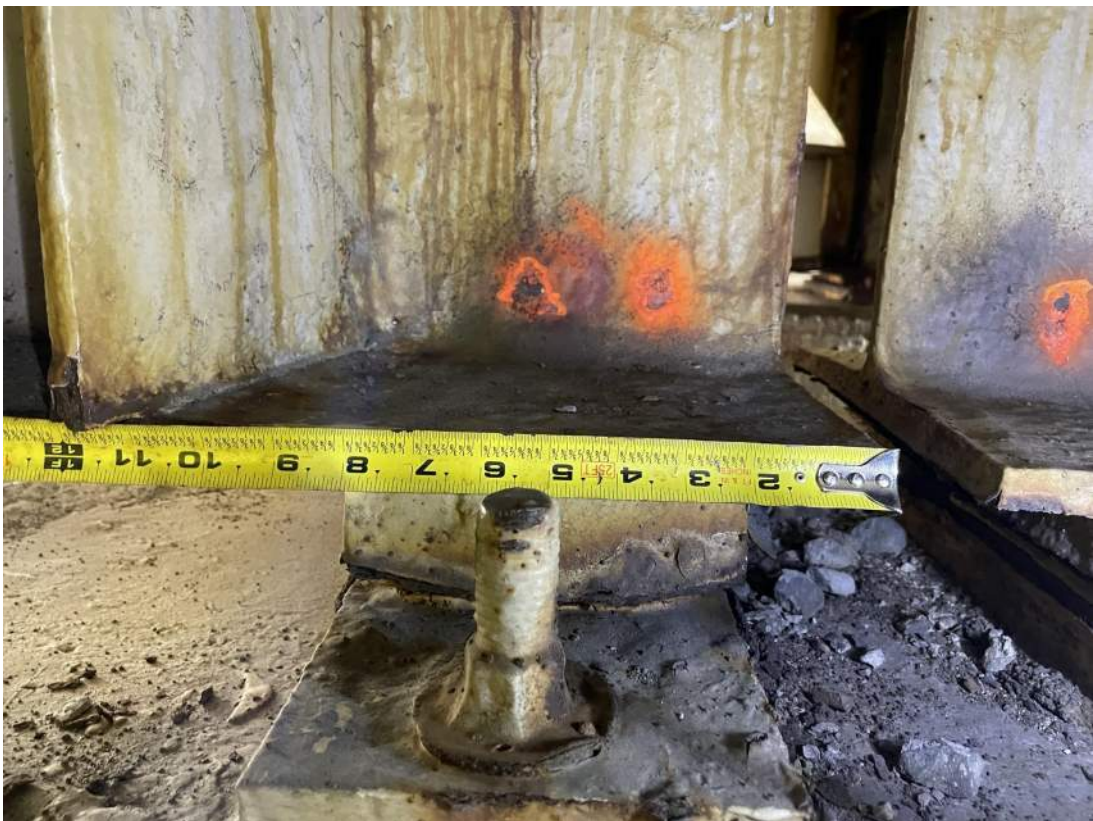
PHOTO 14

LOCATION:
G5 IN SPANS 2 & 3 AT
PIER

DESCRIPTION:
BEARING AREA
SECTION LOSS
MEASUREMENT
LOCATIONS

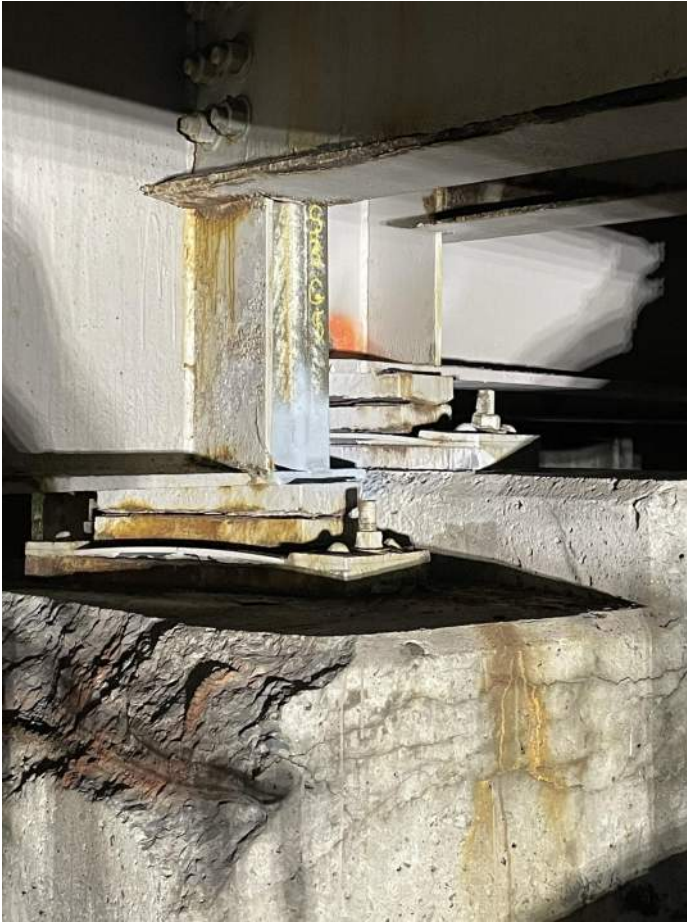
PHOTO 15

LOCATION:
G5 IN SPANS 3 & 4 AT
PIER

DESCRIPTION:
BEARING
CONDITIONS WITH
PREVIOUSLY
INSTALLED TUBE
STIFFENER

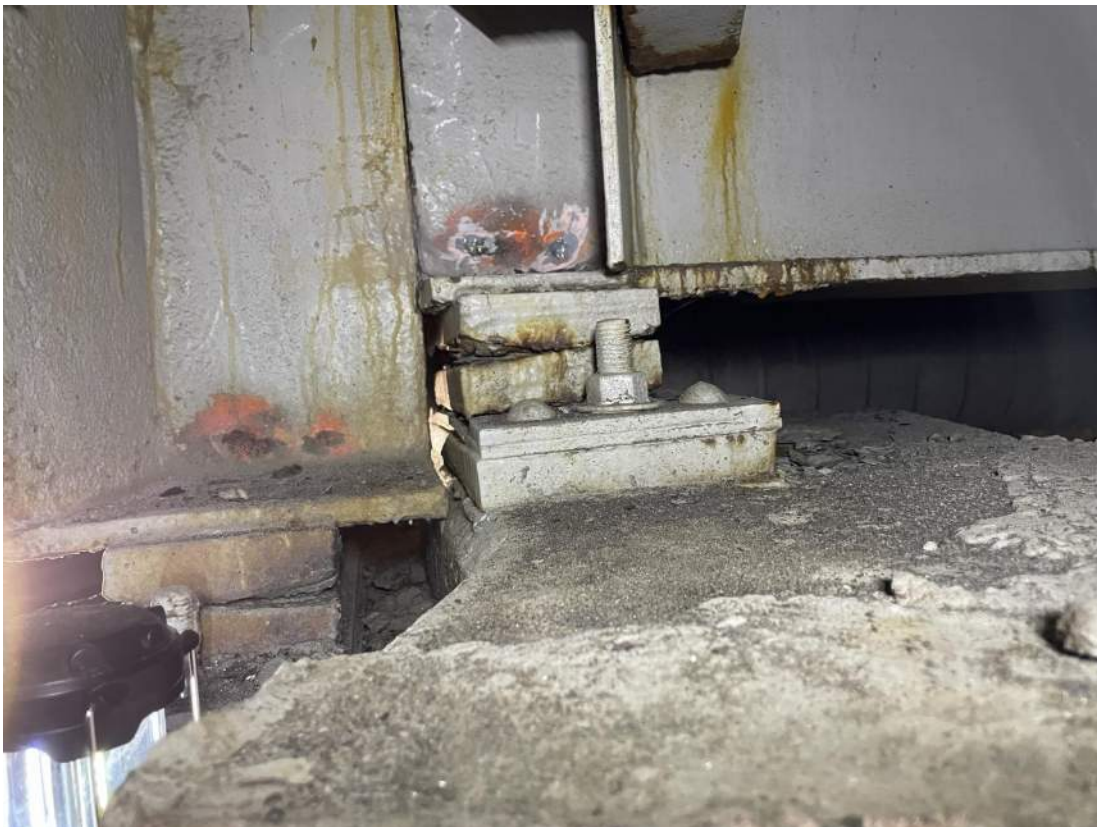
PHOTO 28

LOCATION:
G8 IN SPAN 4 AT
PIER

DESCRIPTION:
BEARING AREA
SECTION LOSS
MEASUREMENT
LOCATIONS

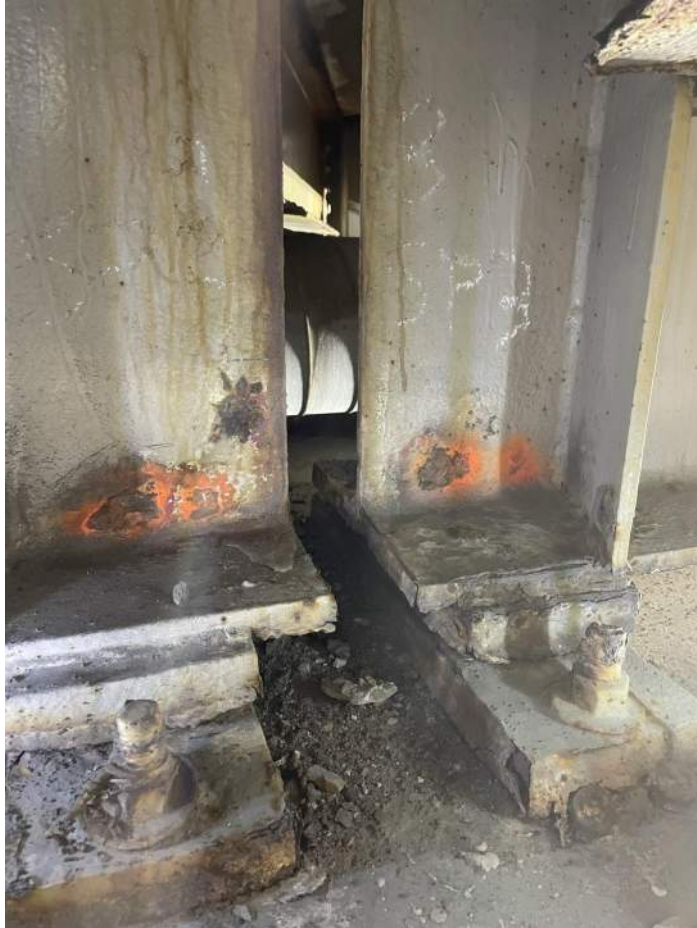
PHOTO 29

LOCATION:
G6 IN SPAN 3 AT
PIER

DESCRIPTION:
BEARING AREA
SECTION LOSS
MEASUREMENT
LOCATIONS

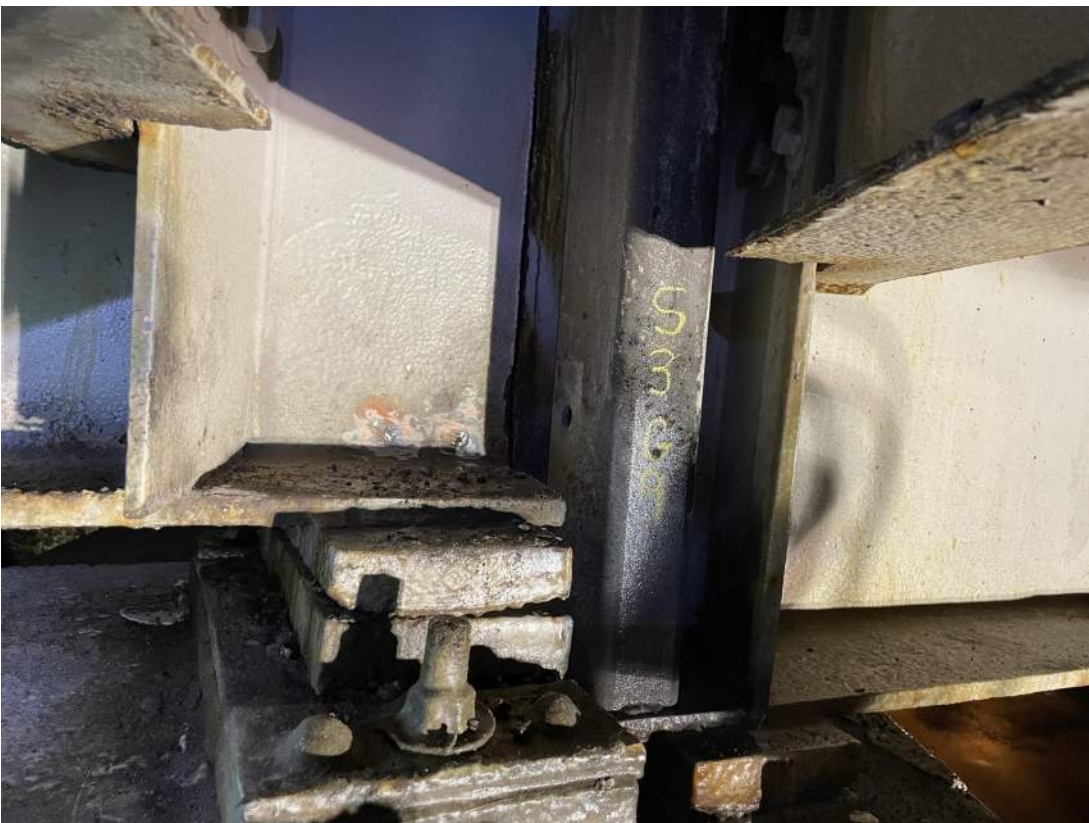
PHOTO 30

LOCATION:
G9 IN SPAN 3 AT
PIER

DESCRIPTION:
BEARING AREA
SECTION LOSS
MEASUREMENT
LOCATIONS

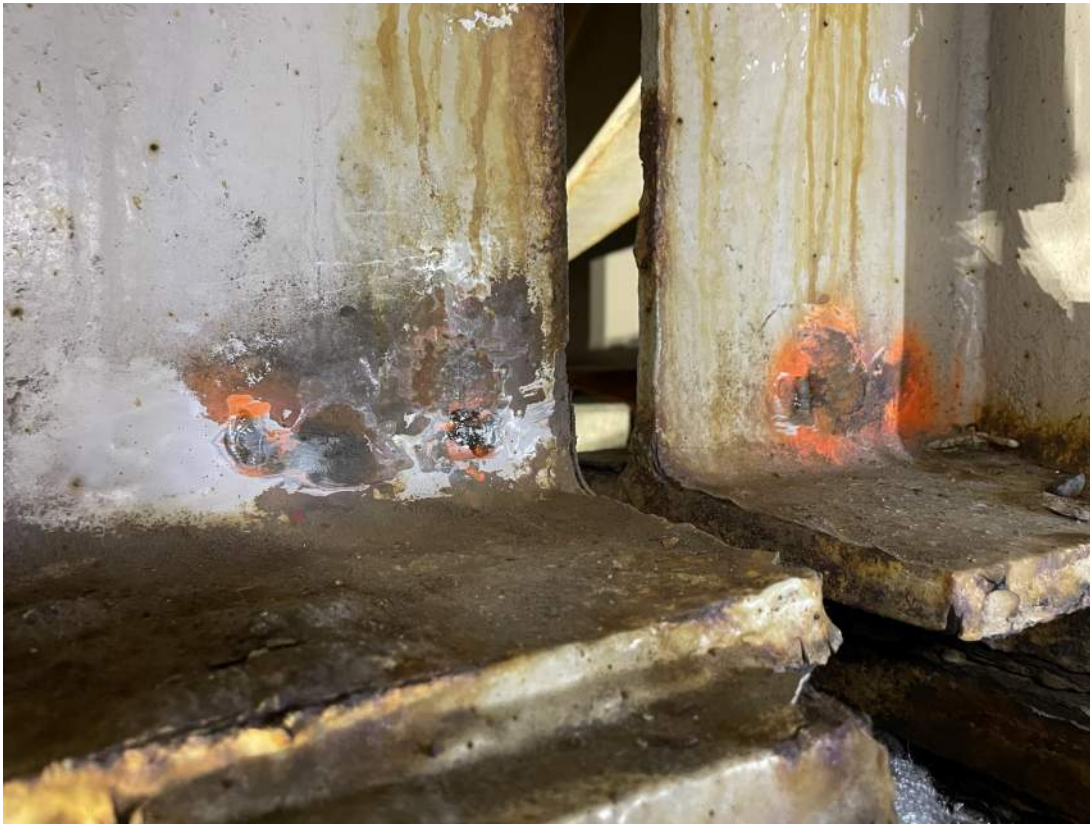
PHOTO 31

LOCATION:
G9 IN SPAN 3 AT
PIER

DESCRIPTION:
BEARING AREA
SECTION LOSS
MEASUREMENT
LOCATIONS

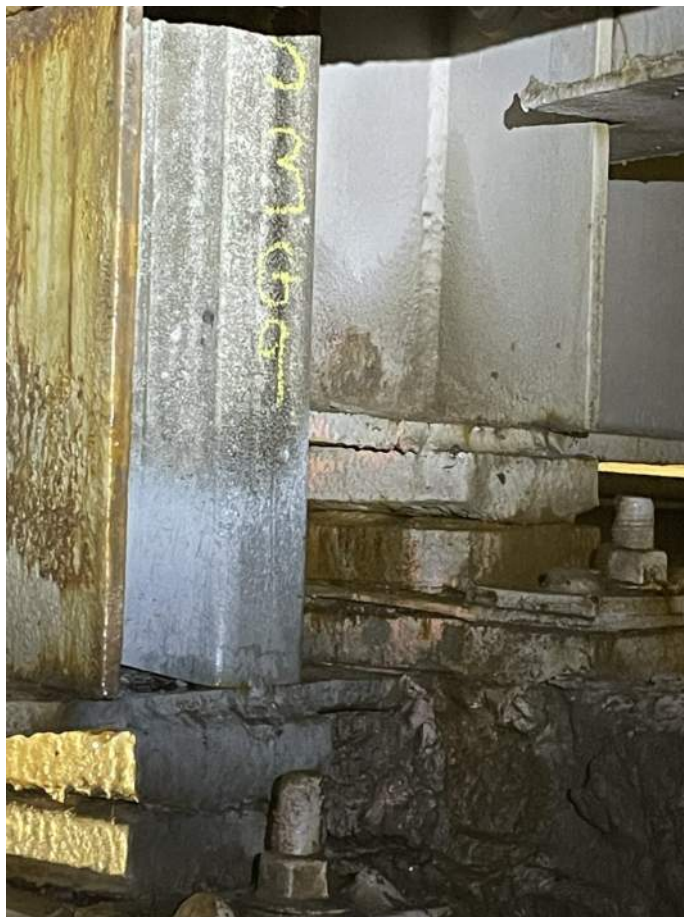
PHOTO 32

LOCATION:
G9 IN SPAN 4 AT
PIER

DESCRIPTION:
BEARING
CONDITIONS WITH
PREVIOUSLY
INSTALLED TUBE
STIFFENER

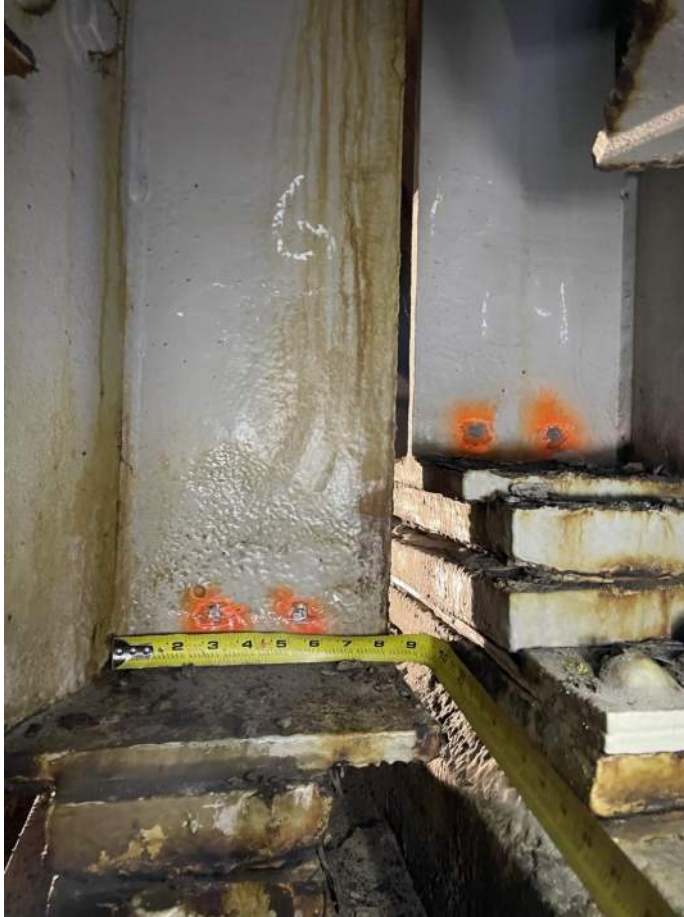
PHOTO 33

LOCATION:
G10 IN SPANS 3 & 4
AT PIER

DESCRIPTION:
BEARING AREA
SECTION LOSS
MEASUREMENT
LOCATIONS

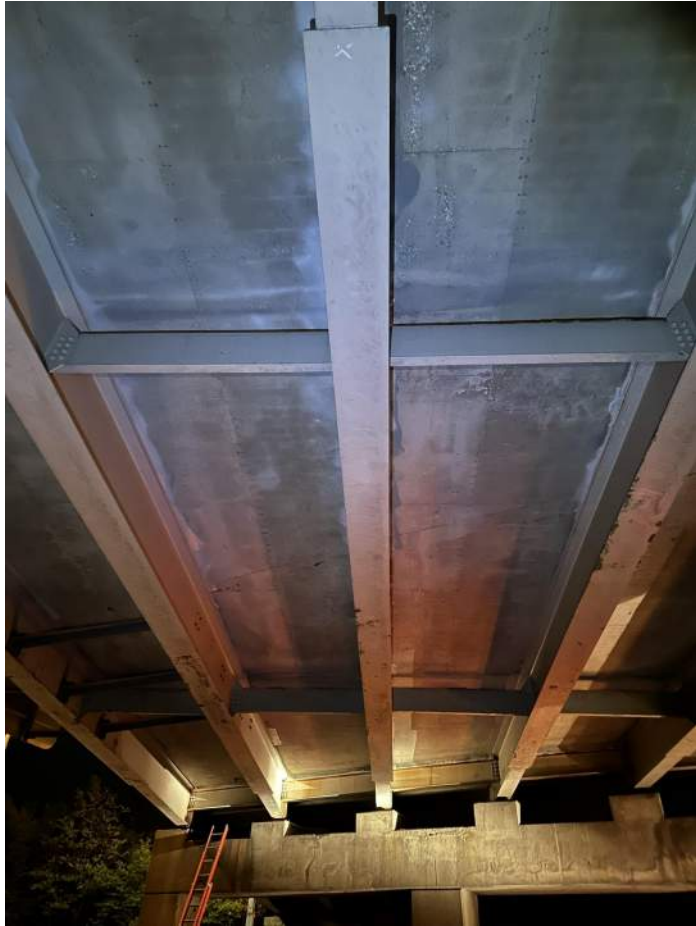
PHOTO 41

LOCATION:
UNDERSIDE OF
DECK IN SPAN 3
LOOKING EAST

DESCRIPTION:
TYPICAL DECK
CONDITION PHOTO
NEAR NORTH END
OF BRIDGE

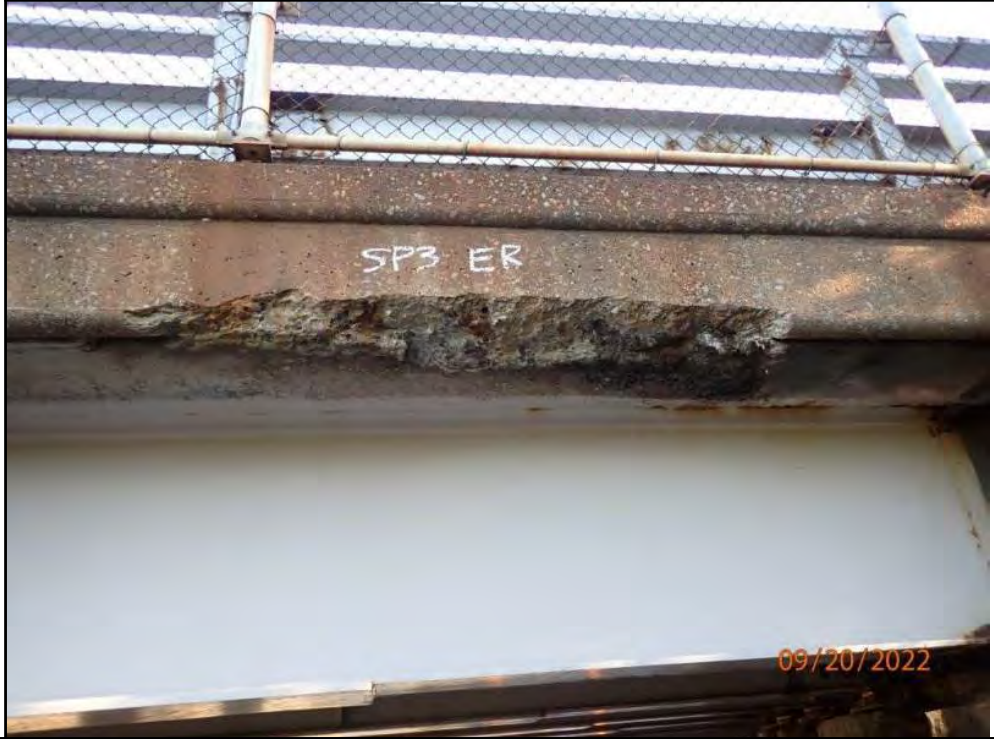
Photo Number: 5 Photo Filename: 5-Bottom corner spall in Right fascia of Span

Attachment Description:
Bottom corner spall in Right fascia of Span 3 Deck near End (Looking Left)

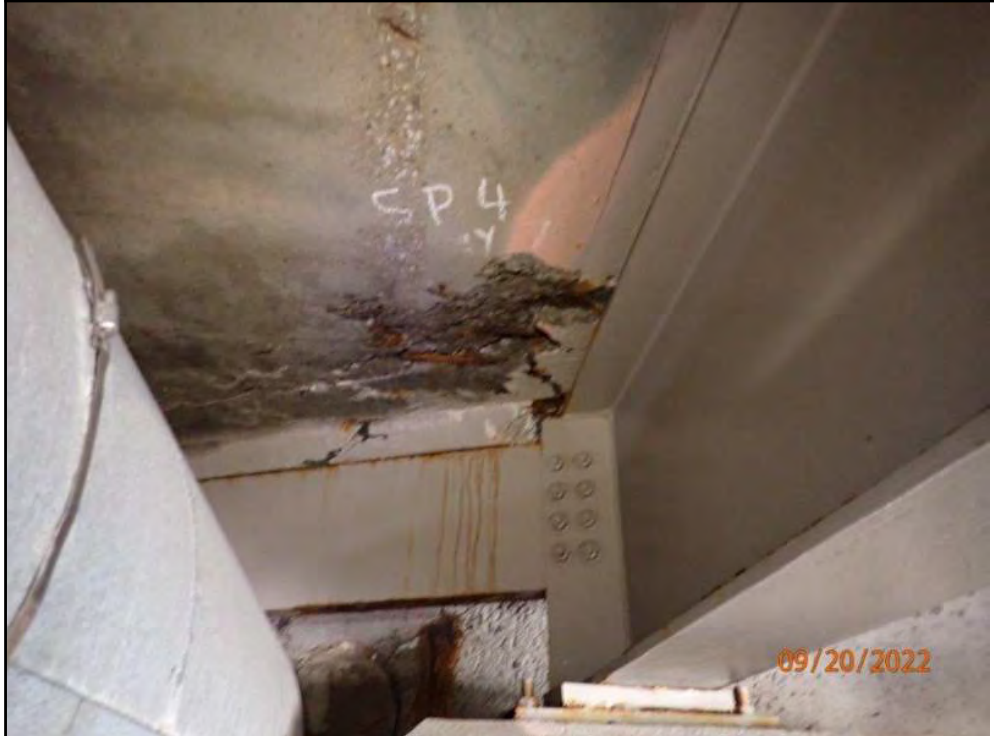
Photo Number: 6 Photo Filename: 6-Spall in underside of Deck in Bay 7 at End

Attachment Description:
Spall in underside of Deck in Bay 7 at End Span 4 (Looking toward End)

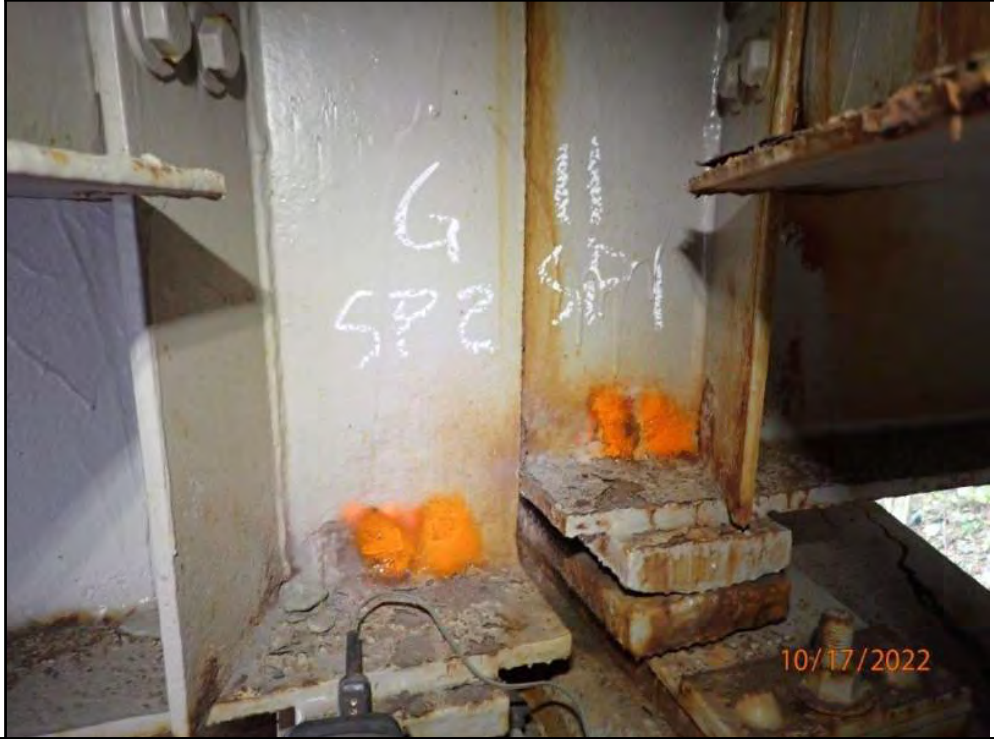
Photo Number: 9 Photo Filename: 9-Painted over pitting in lower webs of G-11

Attachment Description:
Painted over pitting in lower webs of G-11 over PR-1 (Looking Right)

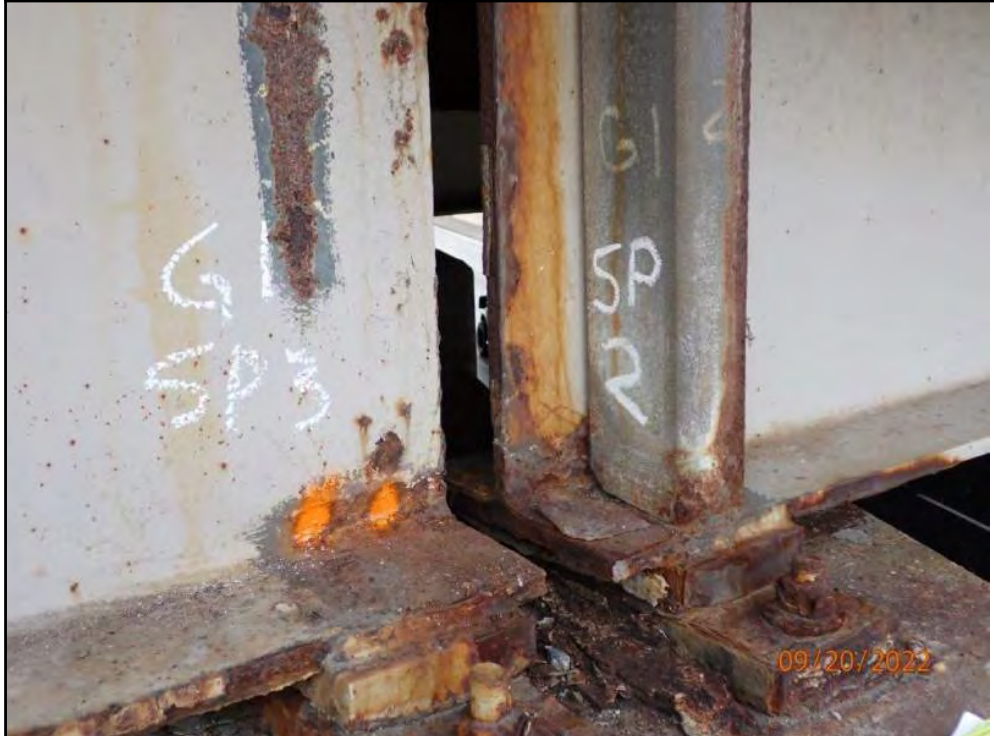
Photo Number: 10 Photo Filename: 10-Tube repair and active corrosion in lower

Attachment Description:
Tube repair and active corrosion in lower web of G-1 over PR-2 (Looking Right)

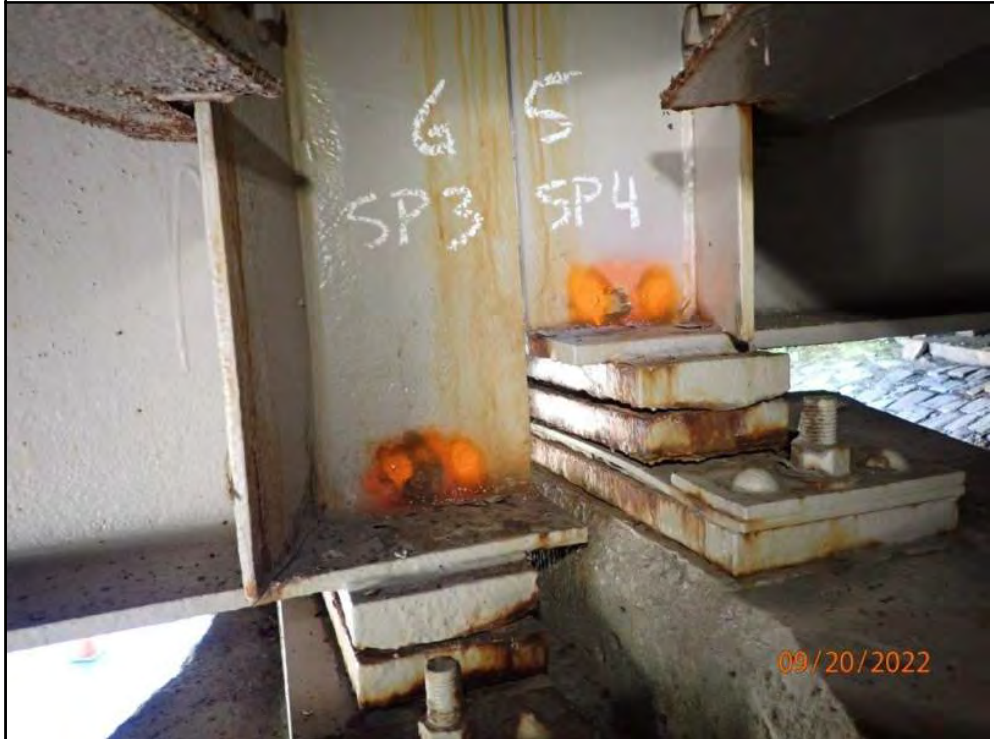
Photo Number: 11

Attachment Description:
Active corrosion and painted over pitting in lower web of G-5 over PR-3 (Looking Left)

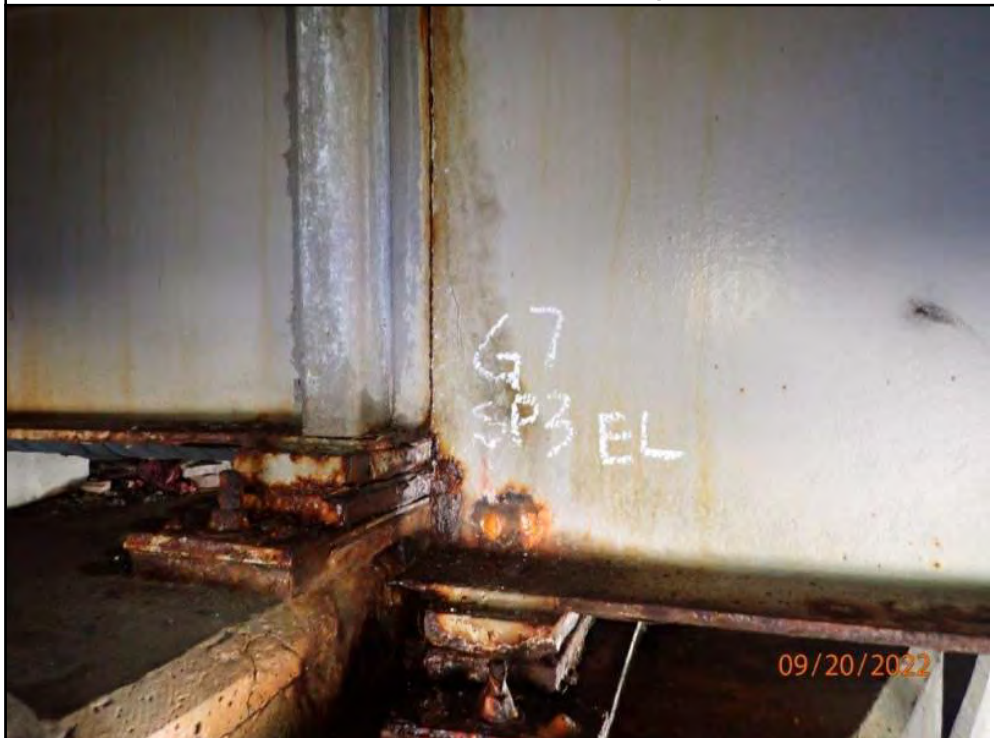
Photo Number: 12

Attachment Description:
Tube repair and active corrosion in lower web of G-7 over PR-3 (Looking Right)

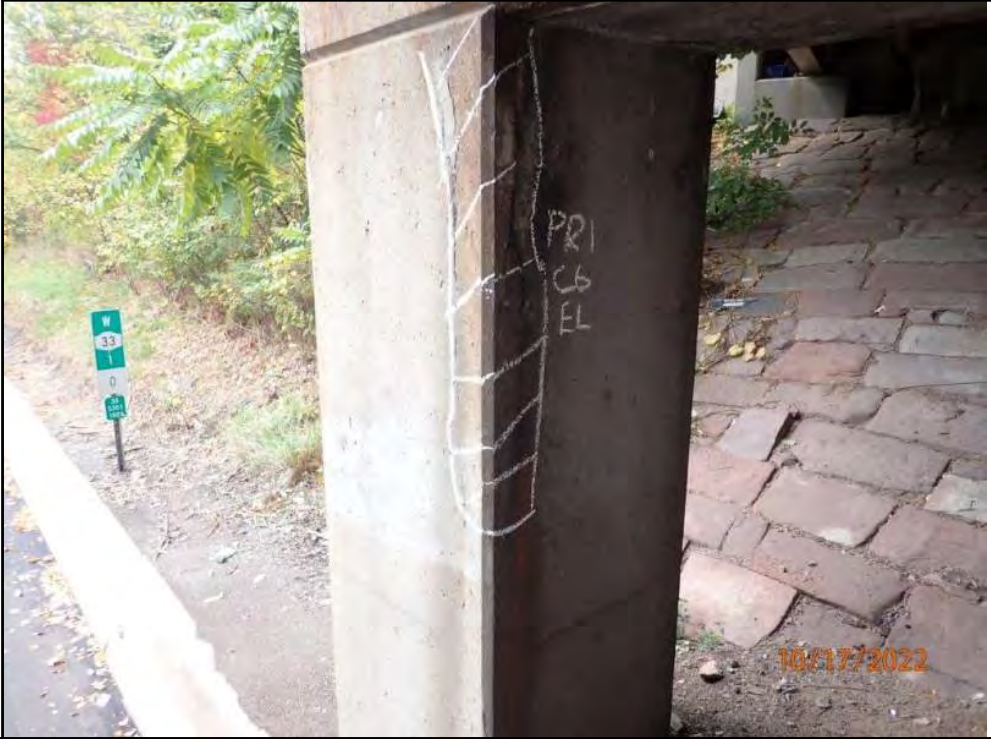
Photo Number: 13

Attachment Description:
Vertical cracking in End Left corner of Column C-6 at PR-1 (Looking toward Begin Right)

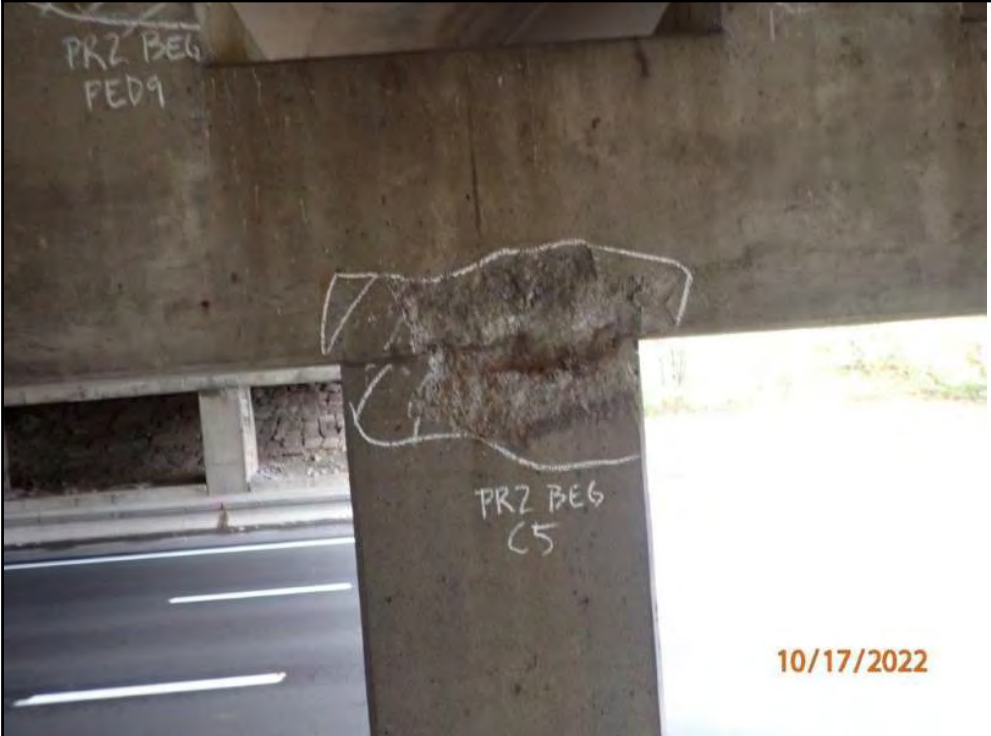
Photo Number: 14

Attachment Description:
Spalling near top of Begin face of Column C-5 at PR-2 (Looking toward End)

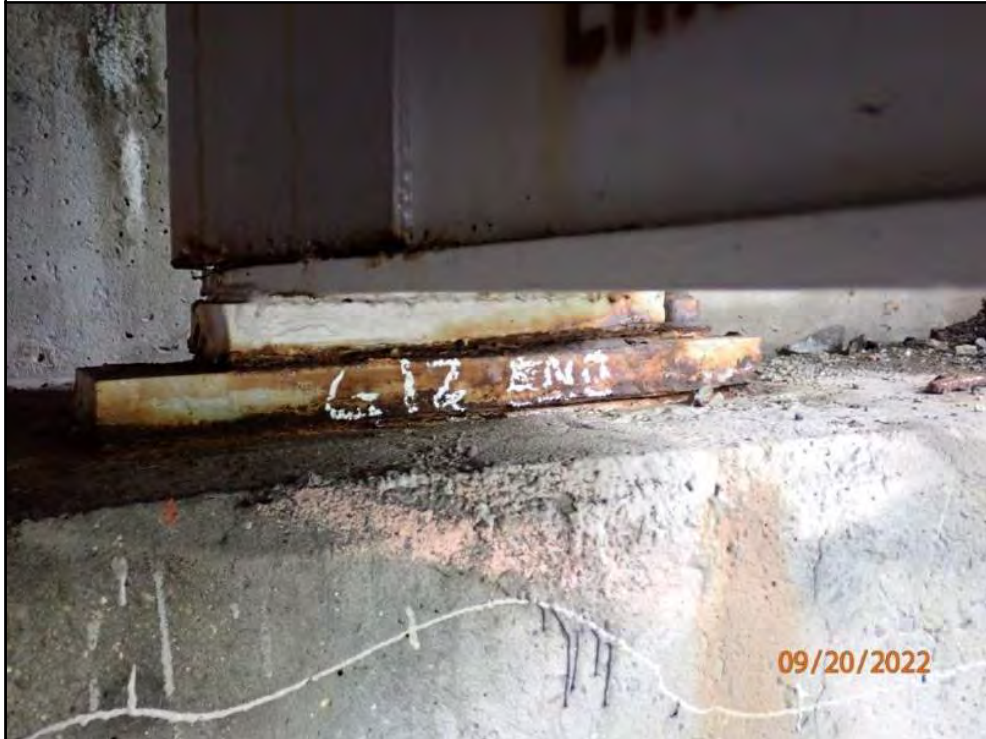
Photo Number: 29

2022 – At the End Abutment, there is a gap between the masonry and sole plates varying from contact on the Left side to 3/16" on the Right side, for the Fixed Bearing below the end of G-4, but the gap did not change under vehicular live load. Additionally, the Left anchor bolt for the G-12 Bearing is missing (Photo 29). There is no apparent displacement of the Bearing.

Attachment Description:
Typical paint condition on Fixed Bearings and missing anchor at G-12 Brg at End Abutment (Looking toward End)
