Bridge Inspection Reports and Work History Summaries

**NY33 BRIDGE CONDITION VERIFICATION 2023
KENSINGTON EXPRESSWAY PROJECT
PIN 5512.52
CITY OF BUFFALO, ERIE COUNTY
BIN 1022609**

STRUCTURE: BIN 1022609 - Best Street on NY33 Kensington Expressway

STRUCTURE TYPE: Four (4) span Steel, Multi-Stringer (12 beams) structure with concrete abutments founded on piles and 3-six column piers with spread footings. Year Built: 1959

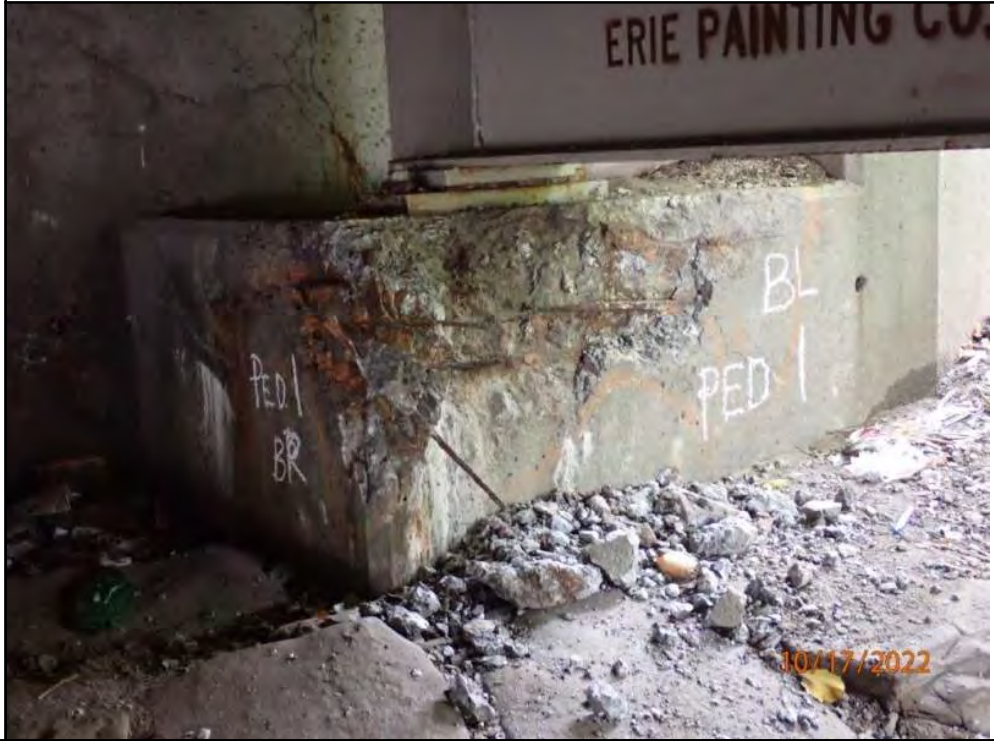
Photo Number: 33

Pedestal 1 – the top of the front Right corner is spalled up to 2'W x up to 1'H on each face with exposed and corroded reinforcing (Photo 33).

Attachment Description:
G-1 Pedestal at Begin
Abutment spalled (Looking
toward Begin)

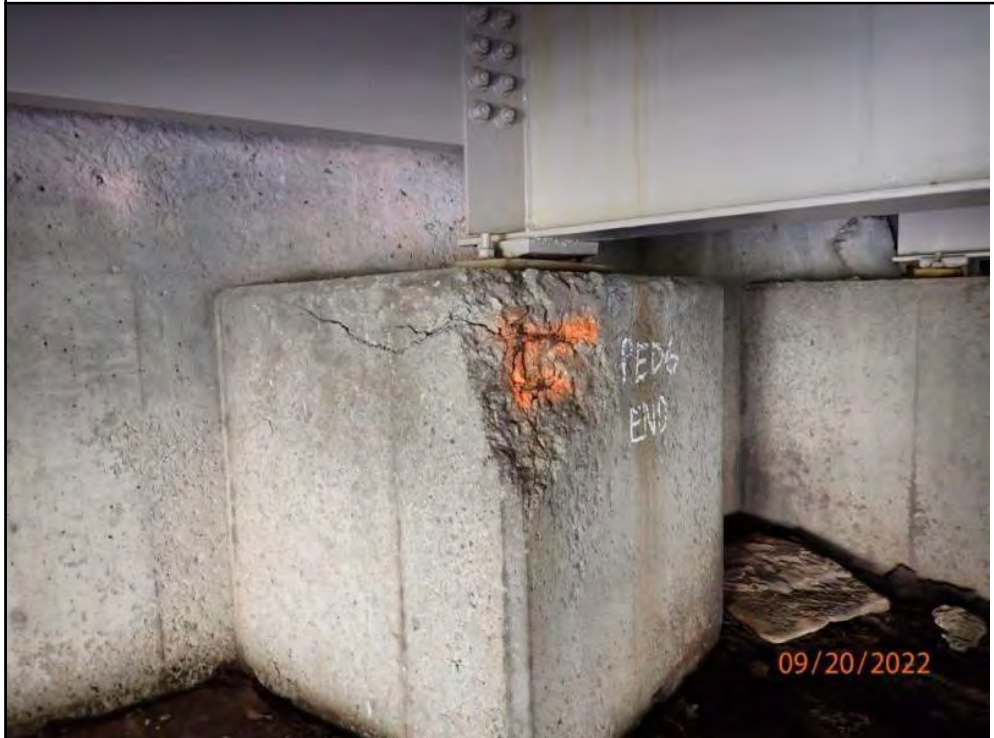
Photo Number: 34

Pedestal 6 – the top of the front Left corner is spalled up to 1.5'W x up to 1.5'H on the front face with exposed and corroded reinforcing and the Left face is cracked full length x up to 1/4" (Photo 34).

Attachment Description:
G-6 Pedestal at End
Abutment spalled and
cracked (Looking toward
End Right)

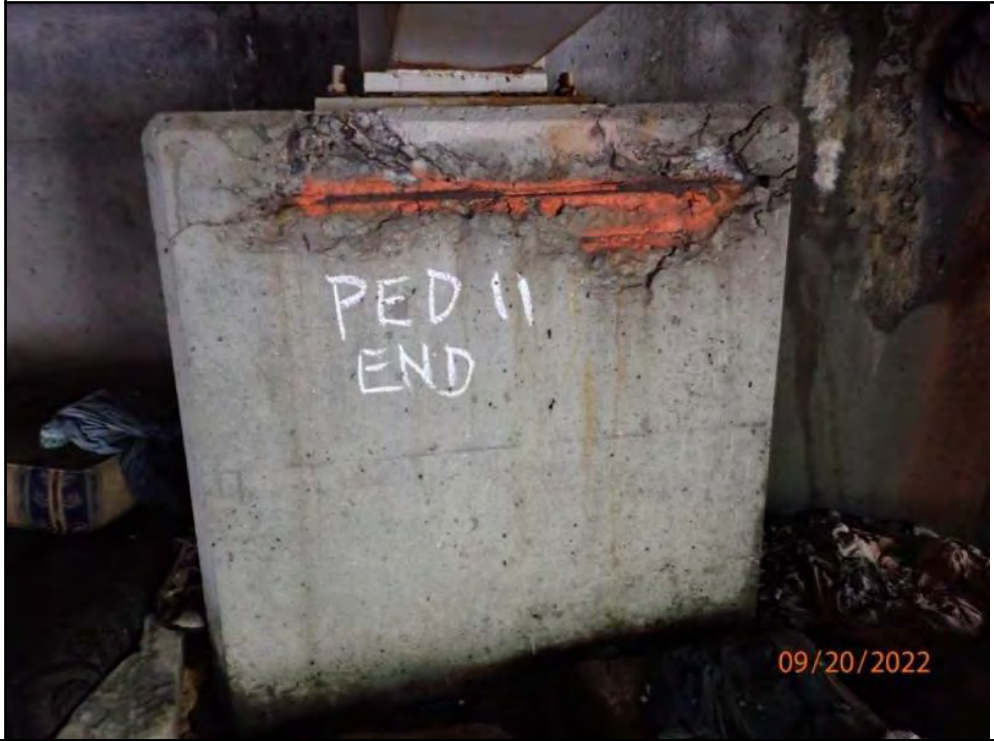
Photo Number: 35

Pedestal 11 - the top of the front face is spalled full width x up to 1.5"H x up to 2"D with exposed and corroded reinforcing (Photo 35)

Attachment Description:
G-11 Pedestal at End
Abutment spalled (Looking
toward End)

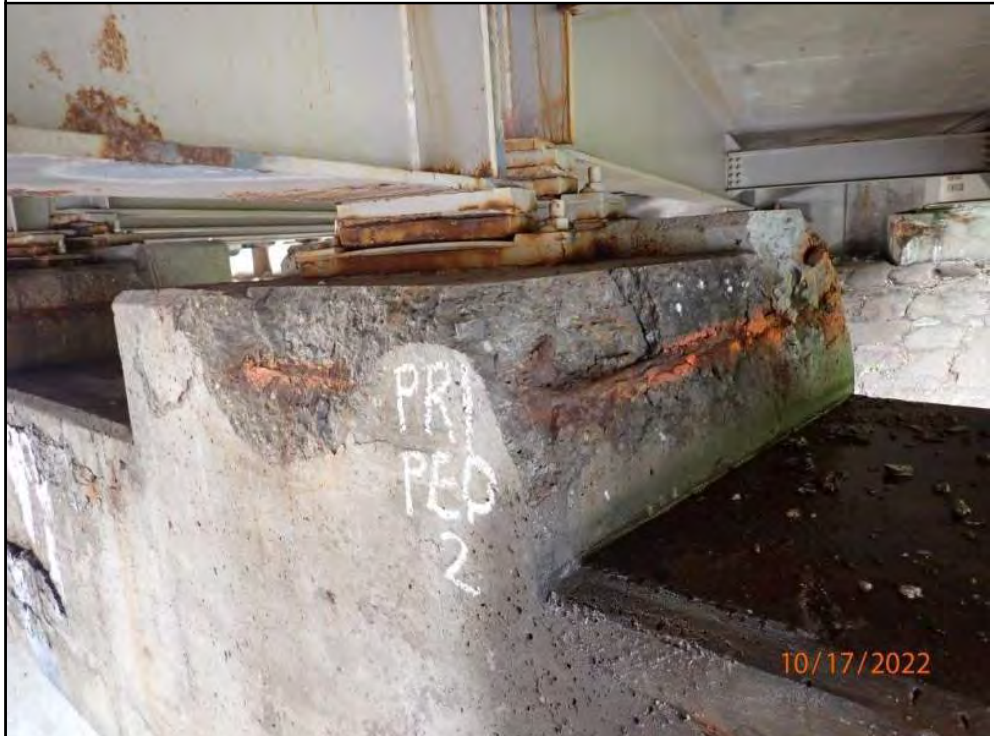
Photo Number: 36

Pedestal 2 – the Left face is spalled full length x up to 2"D with exposed and corroded reinforcing; End face is spalled 1.7'W x up to 2"D with exposed and corroded reinforcing (Photo 36)

Attachment Description:
G-2 Pedestal at PR-1
spalled (Looking toward
Begin Right)

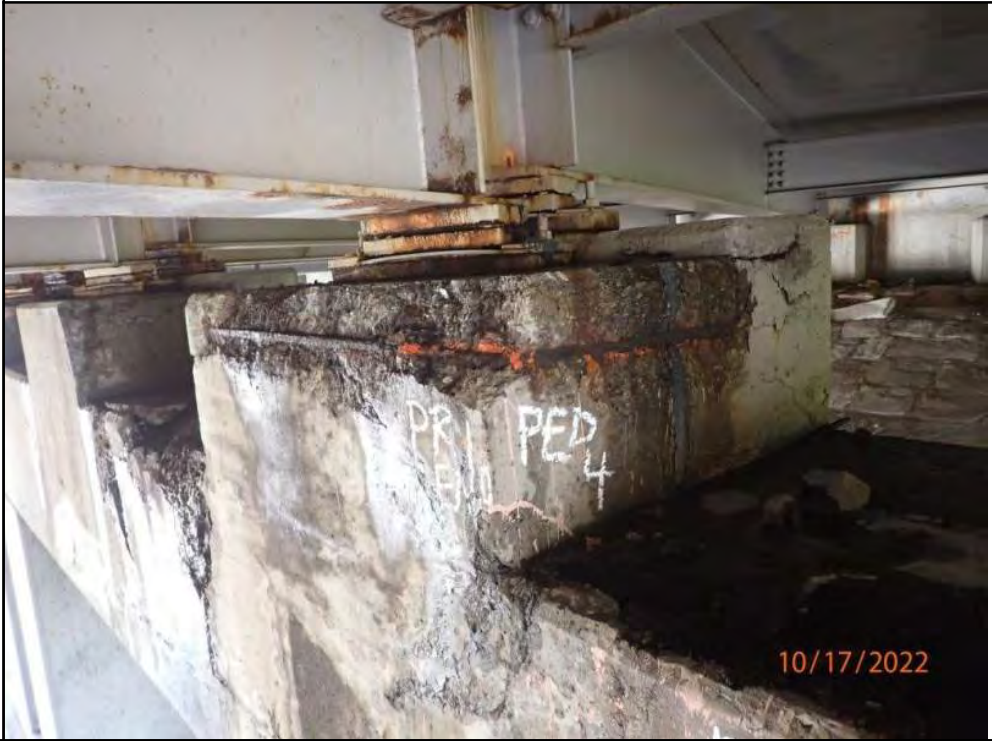
Photo Number: 37

Pedestal 4 – the End face is spalled 2.5'W x full height x up to 2.5"D with exposed and corroded reinforcing (Photo 37)

Attachment Description:
G-4 Pedestal at PR-1
spalled (Looking toward
Begin Right)

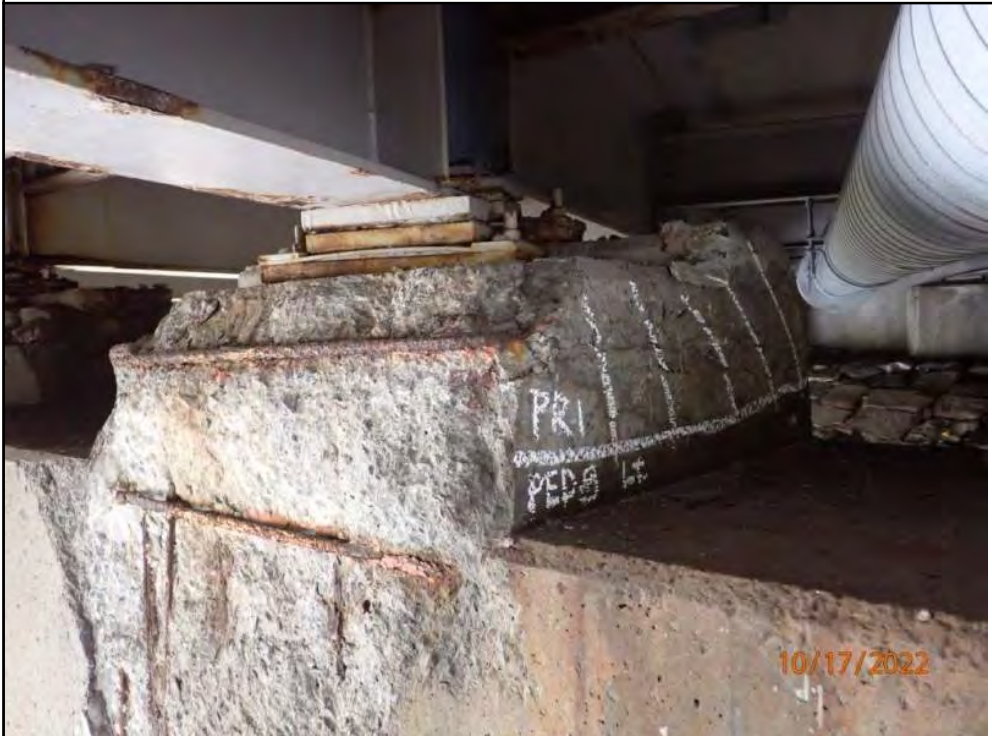
Photo Number: 38

Pedestal 8 – the End face is spalled full height x full width x up to 8"D with exposed and corroded reinforcing, and the Left face is spalled and delaminated full length x full height x up to 1.5"D with exposed and corroded reinforcing (Photo 38)

Attachment Description:
G-8 Pedestal at PR-1
spalled (Looking toward
Begin Right)

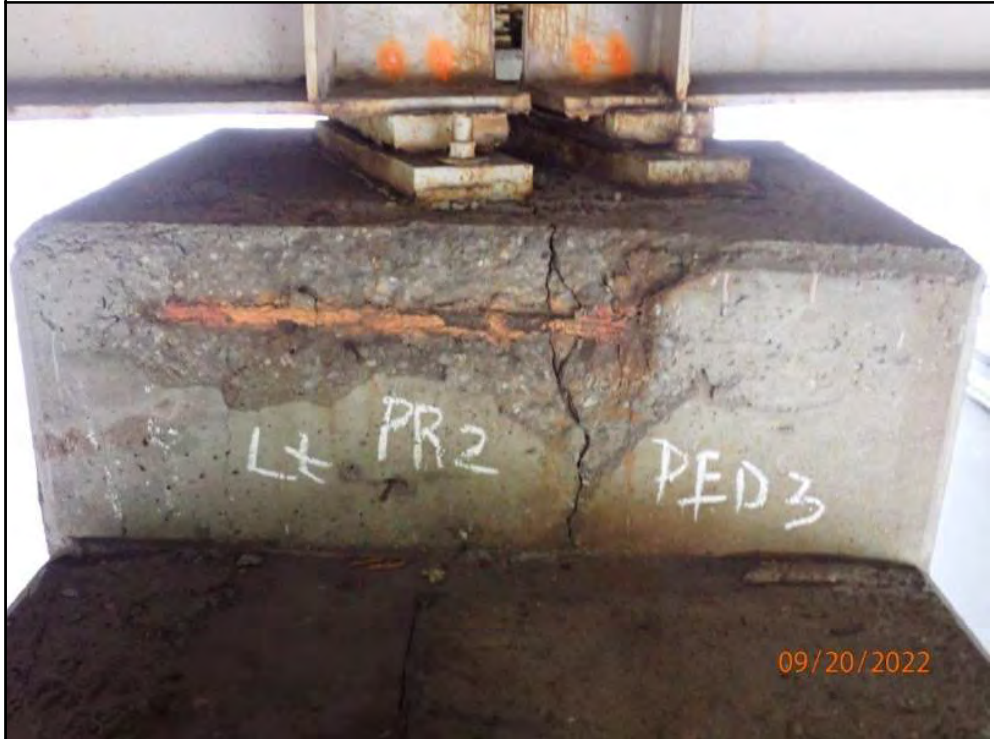
Photo Number: 39 Photo Filename: 39-Left face of G-3 Pedestal at PR-2 spalled

Pedestal 3 – the Left face is spalled 2'W x up to 1'H x up to 2.5"D with exposed and corroded reinforcing and the Right face is cracked and delaminated (Photo 39)

Attachment Description:
Left face of G-3 Pedestal at
PR-2 spalled (Looking
Right)

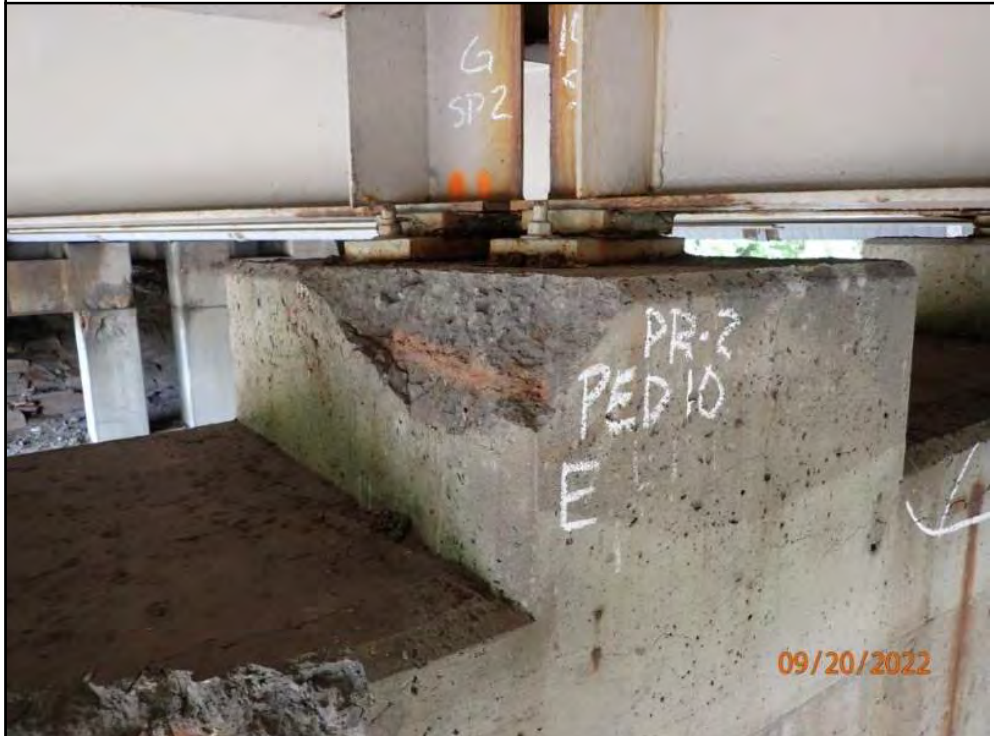
Photo Number: 40 Photo Filename: 40-Right face of G-10 Pedestal at PR-2 spalled

Pedestal 10 – the Right face is spalled 3.5'L x up to 8"H x up to 5"D with exposed and corroded reinforcing (Photo 40)
 Pedestal 12 – the Right face is cracked and delaminated with heavy rust staining

Attachment Description:
Right face of G-10 Pedestal
at PR-2 spalled (Looking
toward Begin Left)

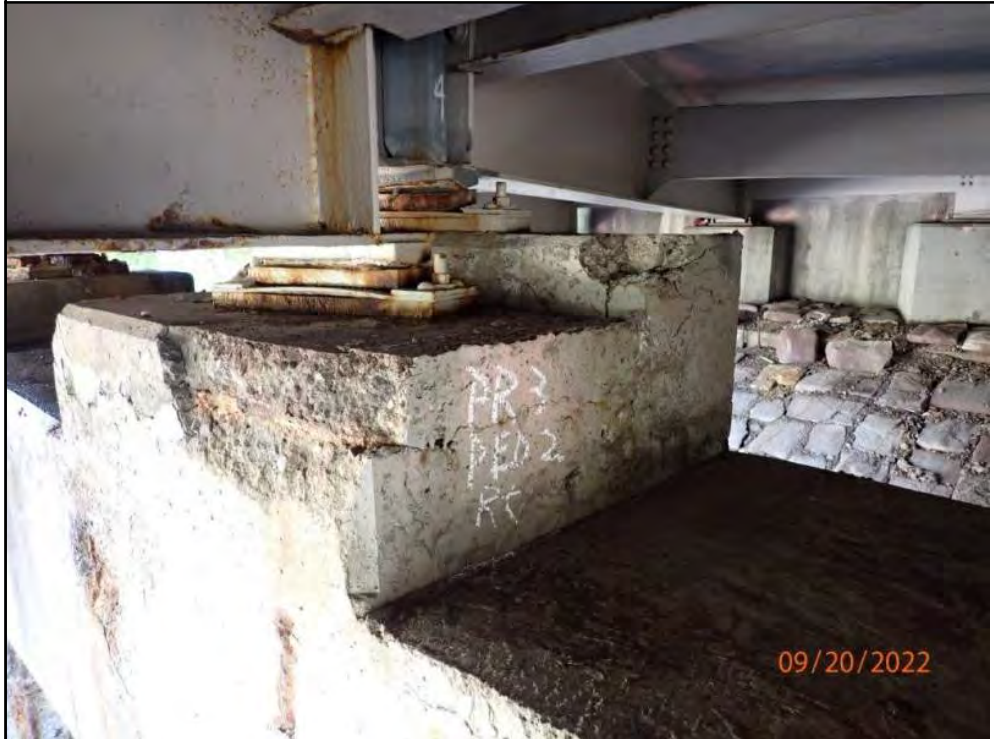
Photo Number: 41

Attachment Description:
Begin faces of G-2 Pedestal
at PR-3 spalled (Looking
toward End Left)

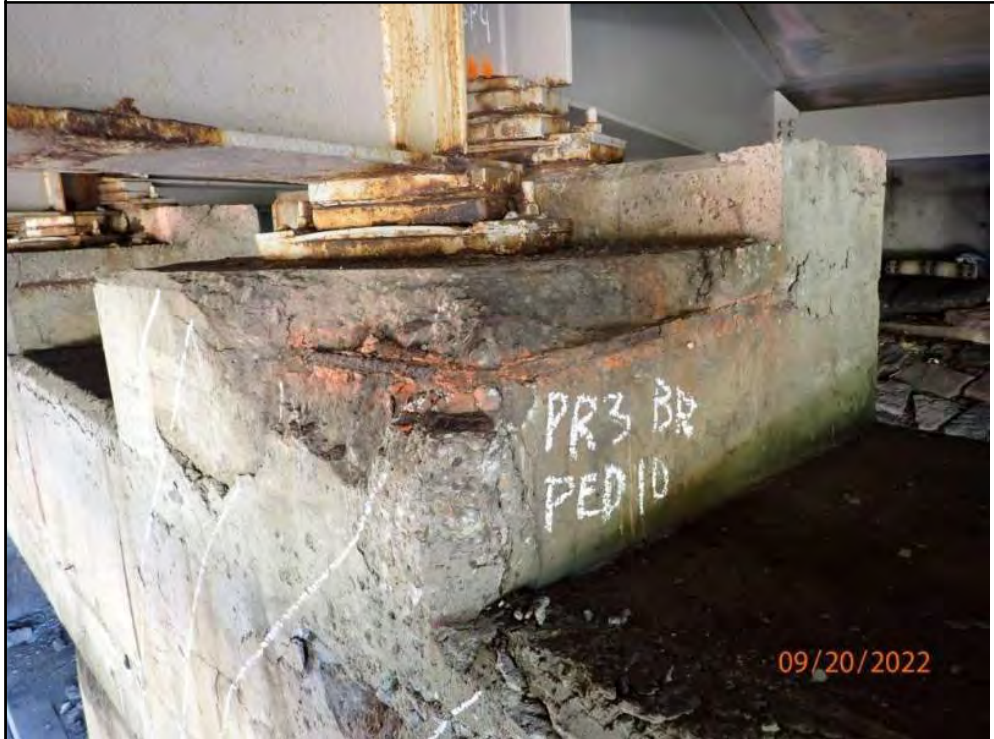
Attachment Description:
Begin Right corner of G-10
Pedestal at PR-3 spalled
(Looking toward End Left)

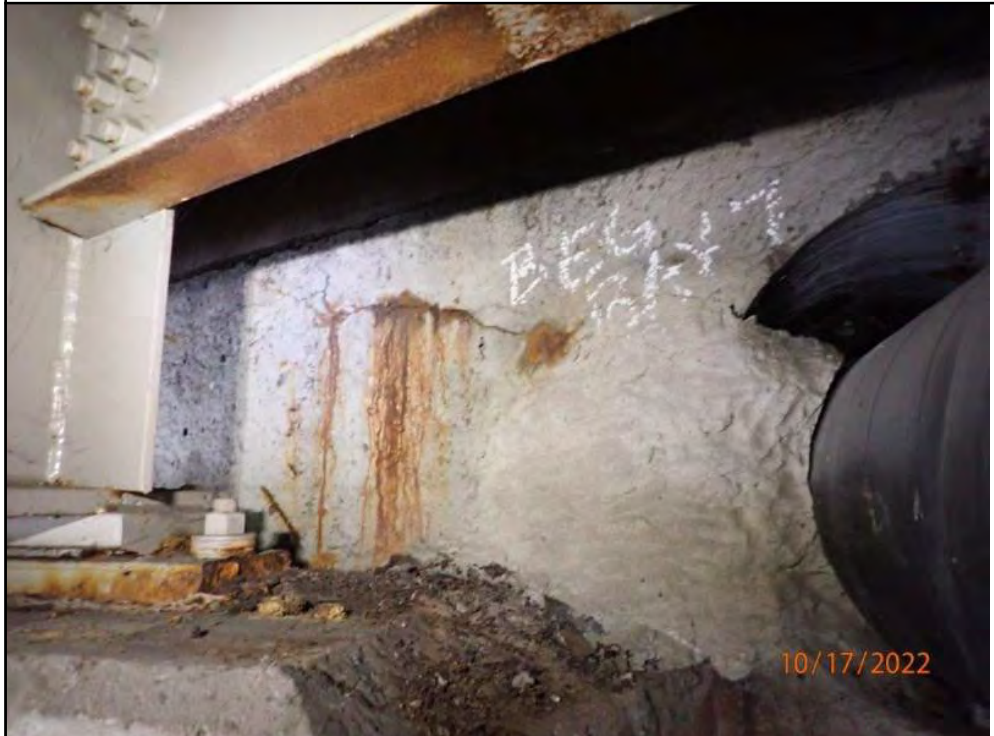
Photo Number: 44

Attachment Description:
Horizontal crack in Bay 7 of
Begin Backwall (Looking
toward Begin Right)

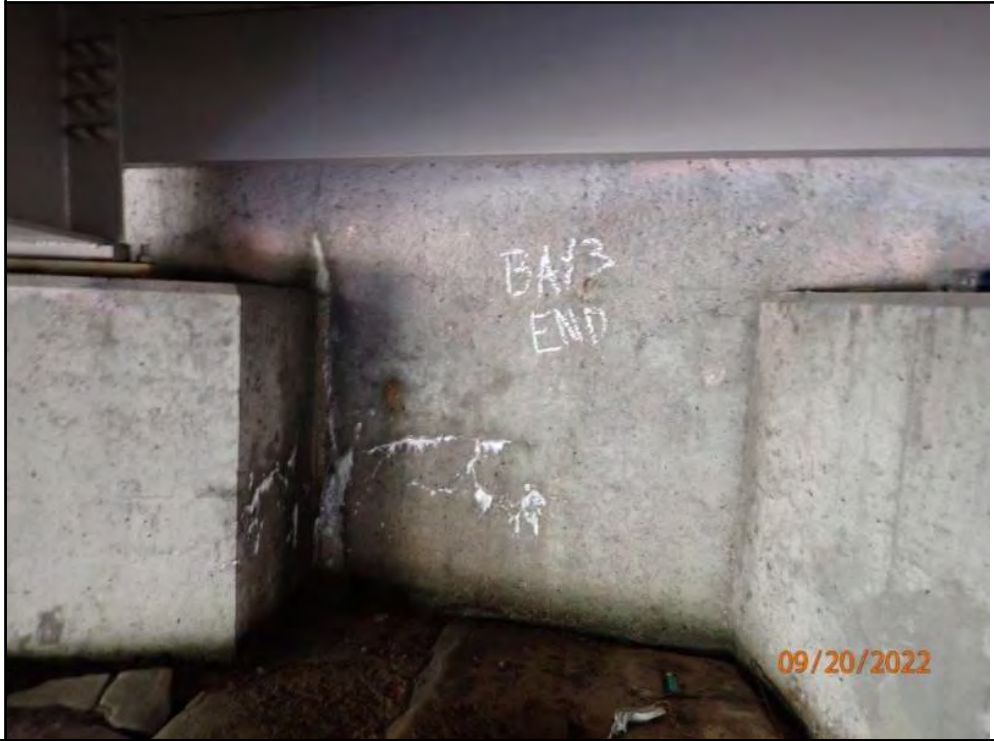
Photo Number: 45

Attachment Description:
Cracking with efflorescence
in Bay 3 of End Backwall
(Looking toward End)

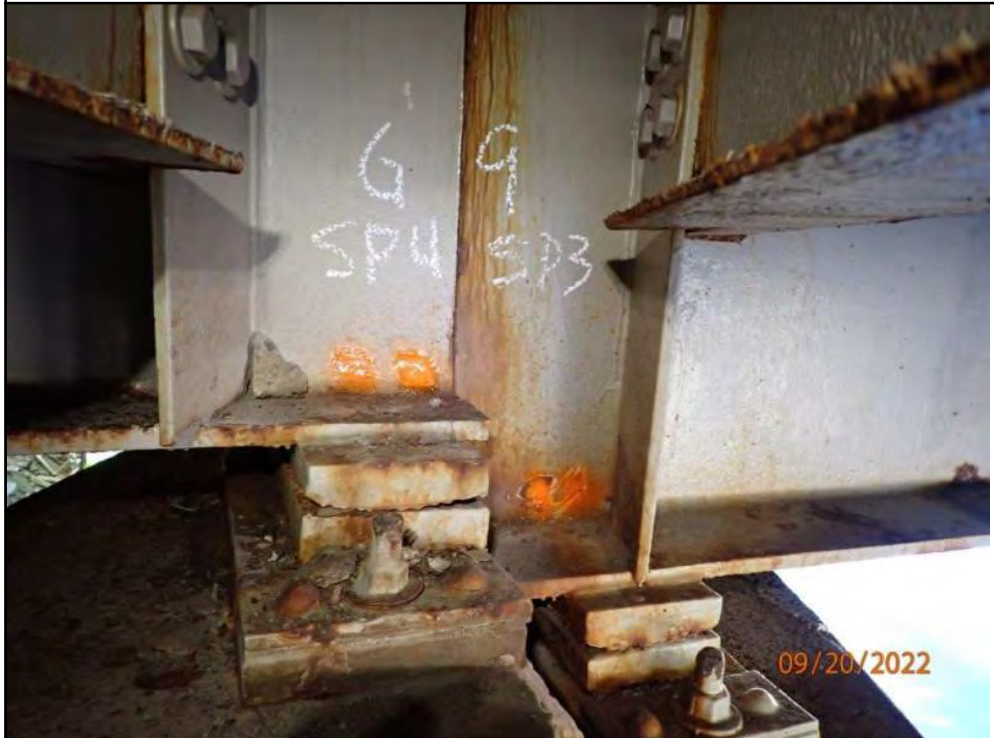
Photo Number: 46

Attachment Description:
Painted over pitting in lower
webs of G-9 over PR-3
(Looking Right)

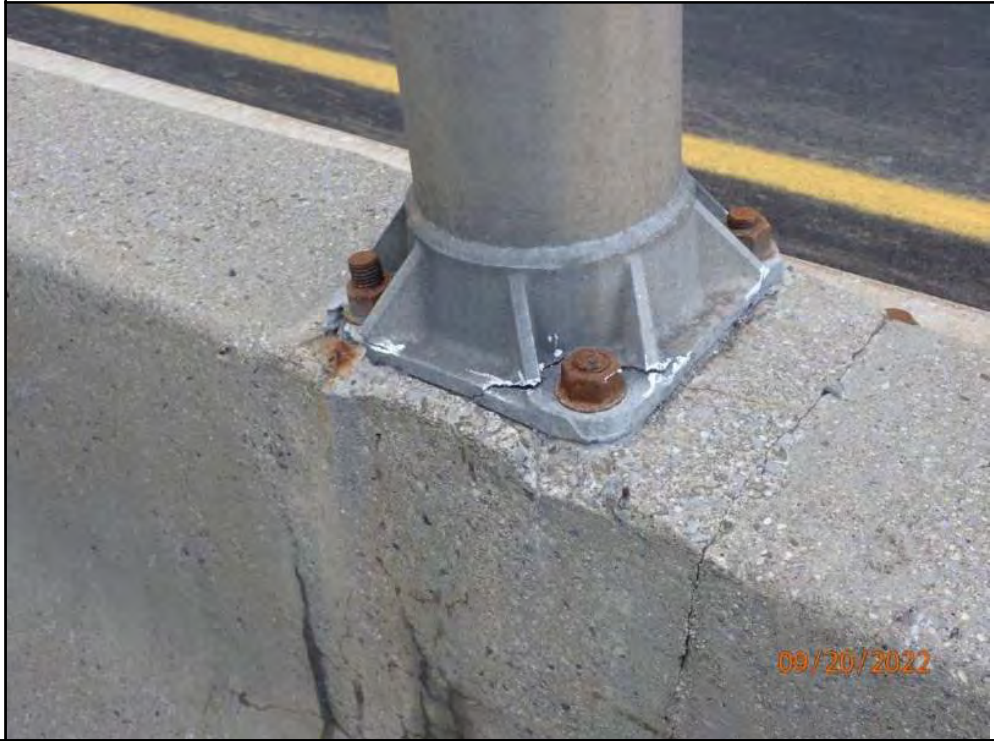
Photo Number: 47

Attachment Description:
Cracked base on NY-33
median light standard Left
of Bridge (Looking toward
Begin Right)

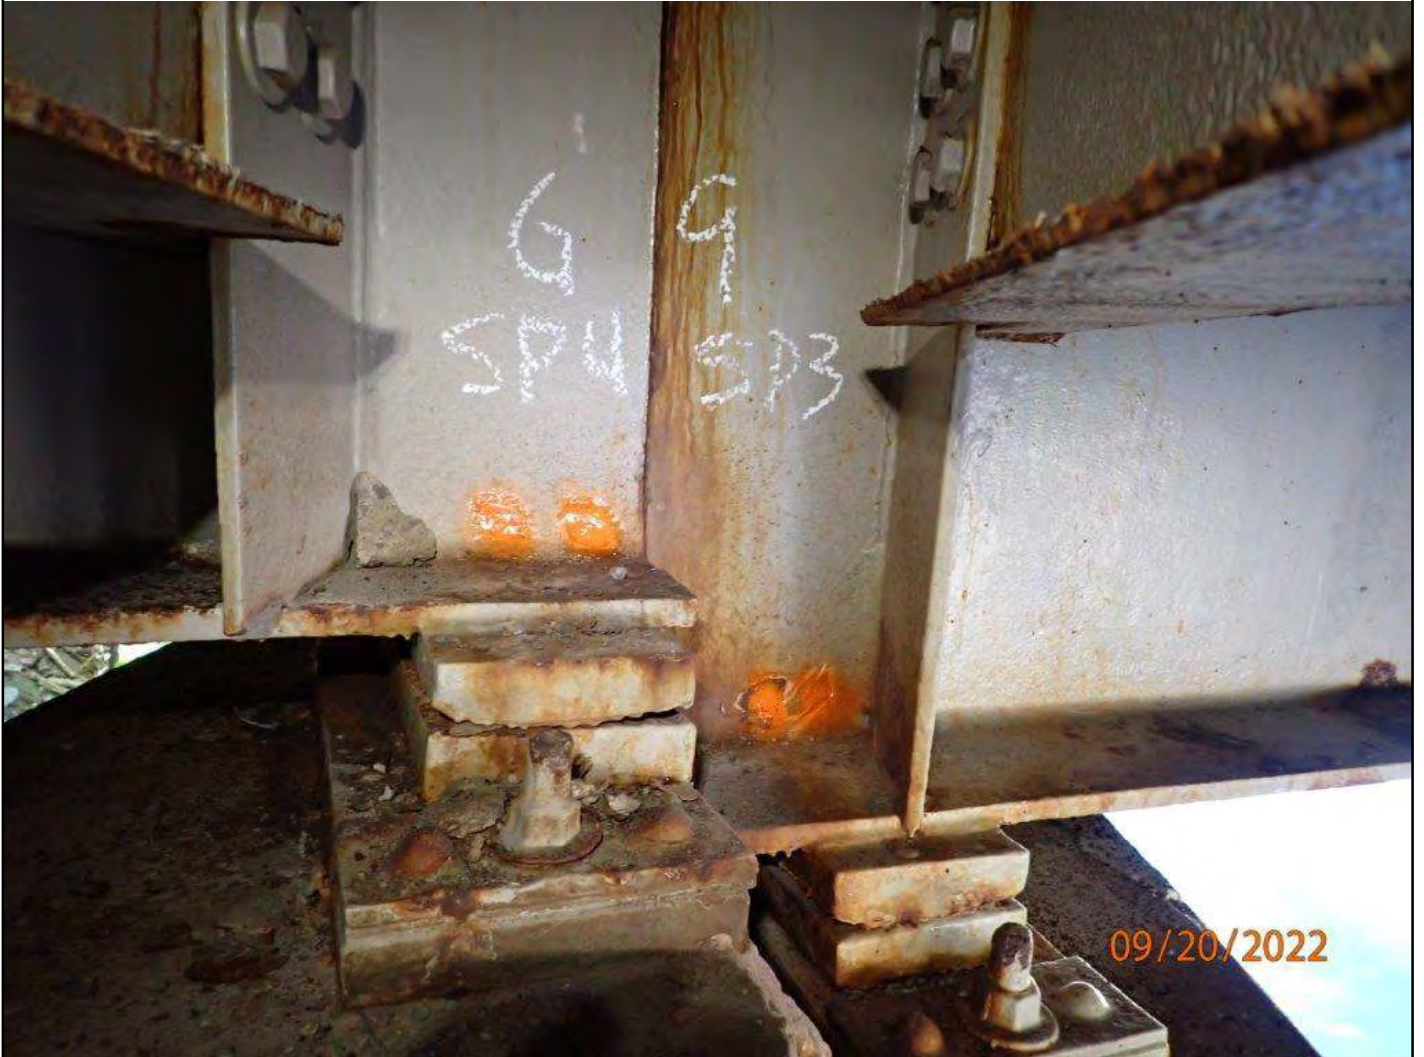
Photo Number: 3

Remaining thickness was measured during the 2020 Inspection by caliper or D-meter at a single location on each girder, above the bearing. There is no new or active corrosion occurring on Girder G-9. Changes in Section Loss are most likely due to small differences in location of measurements as well as precision of D-meter vs Caliper.

Attachment Description: Painted over pitting in lower webs of G-9 over PR-3 (Looking Right)

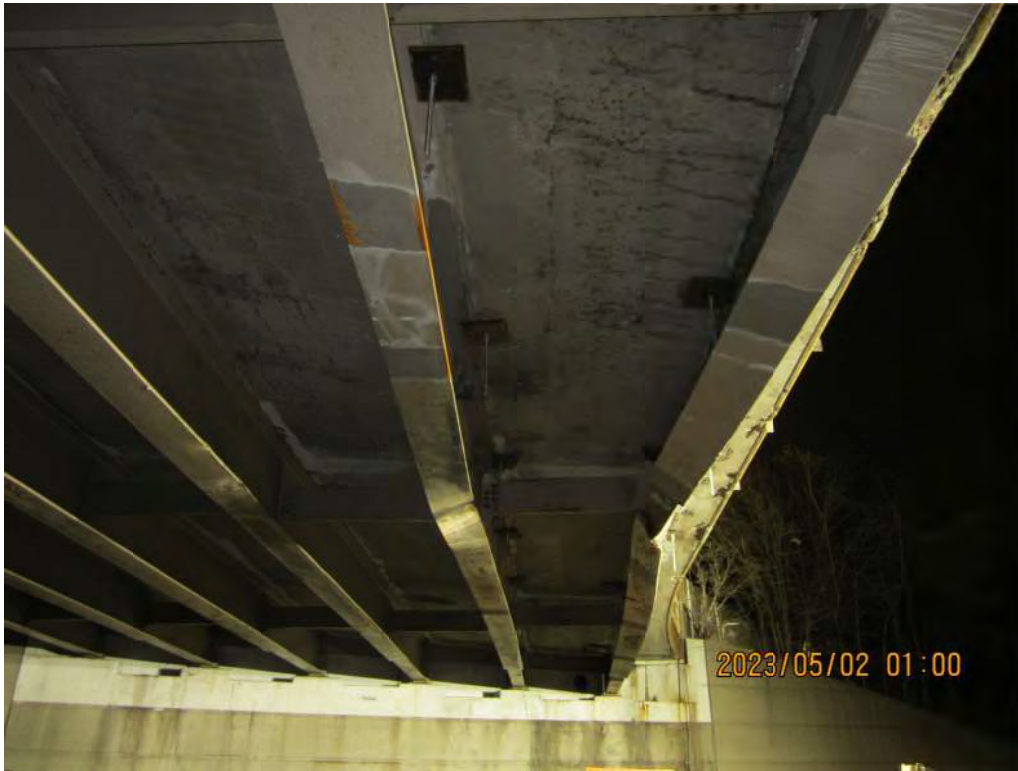
PHOTO 1

LOCATION:
SPAN 1 LOOKING EAST

DESCRIPTION:
IMPACT DAMAGE TO G1
AND G2, GENERAL DECK
CONDITION

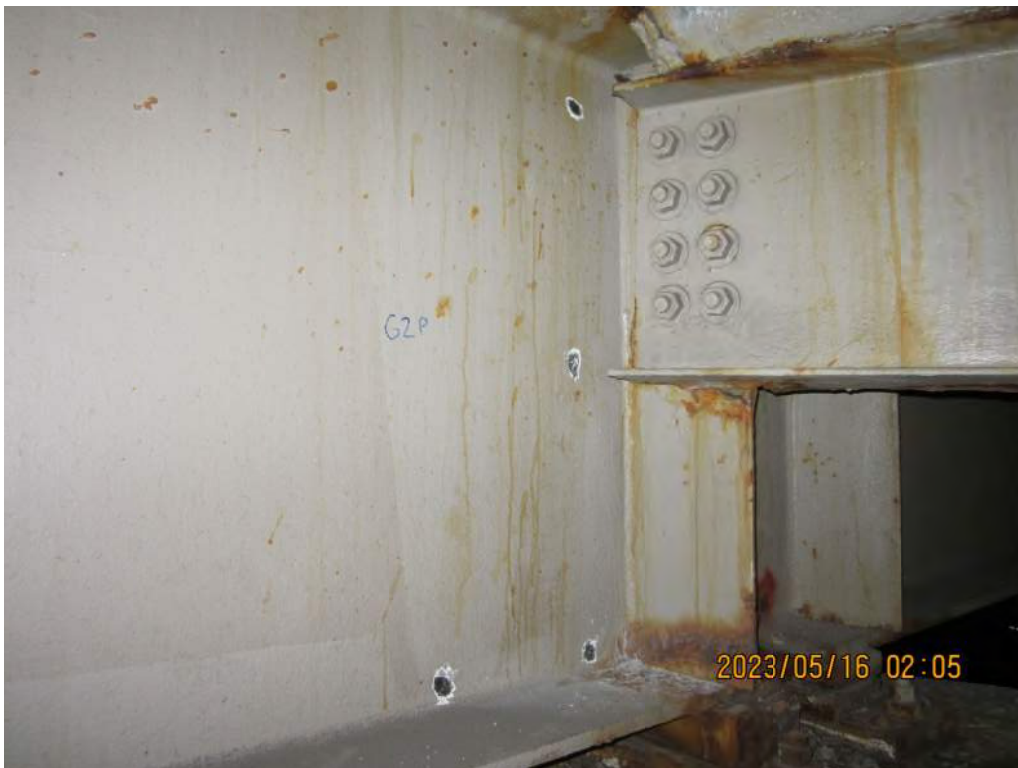
PHOTO 2

LOCATION:
G2 IN SPAN 2 AT PIER

DESCRIPTION:
TYPICAL GIRDER END
CONDITION

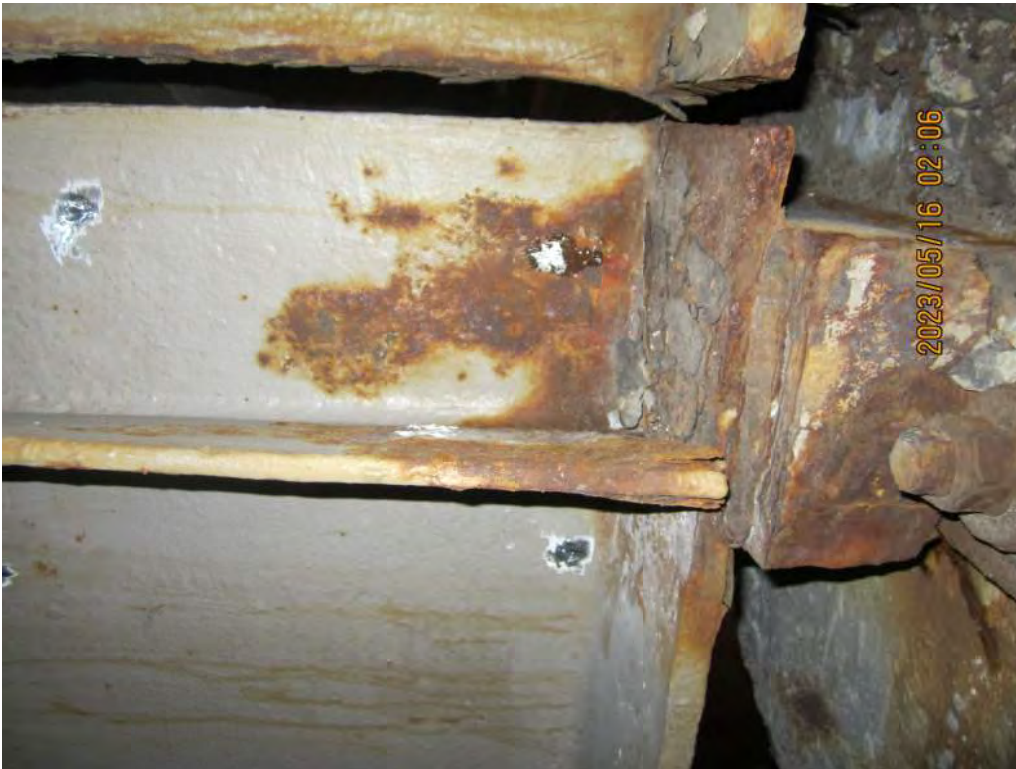
PHOTO 3

LOCATION:
G2 IN SPAN 2 AT PIER

DESCRIPTION:
TYPICAL BEARING AND
GIRDER END CONDITION

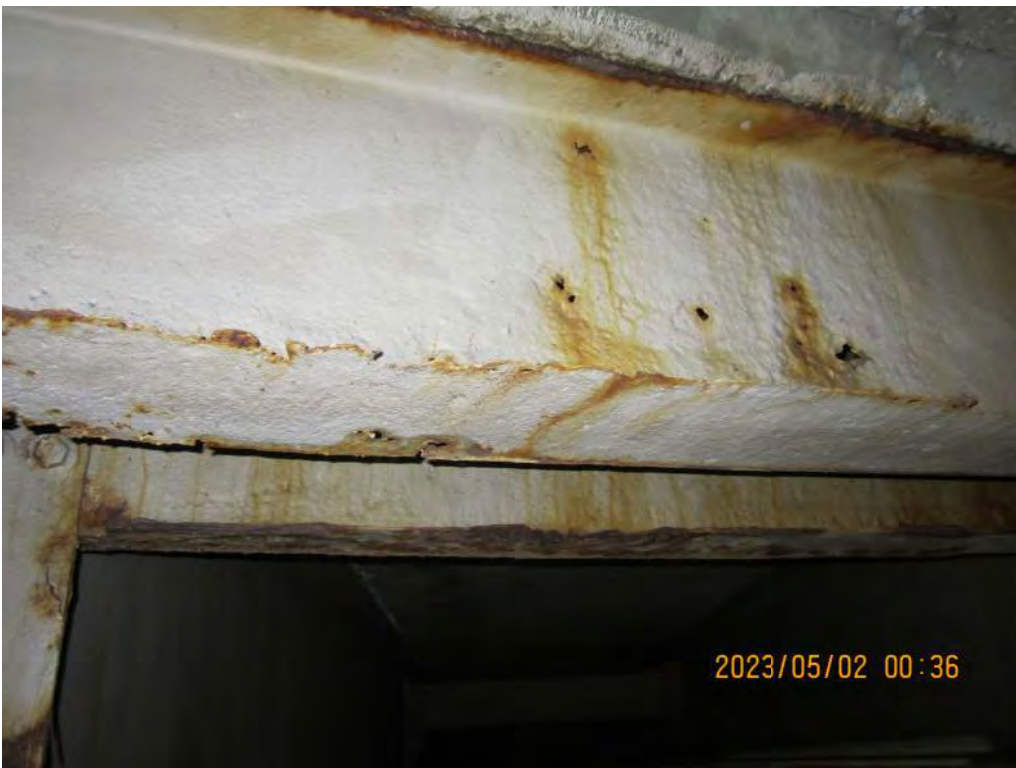
PHOTO 4

LOCATION:
END DIAPHRAGM SPAN
1 AT PIER BETWEEN G1
AND G2

DESCRIPTION:
SEVERAL HOLES IN WEB
AND BOTTOM FLANGE

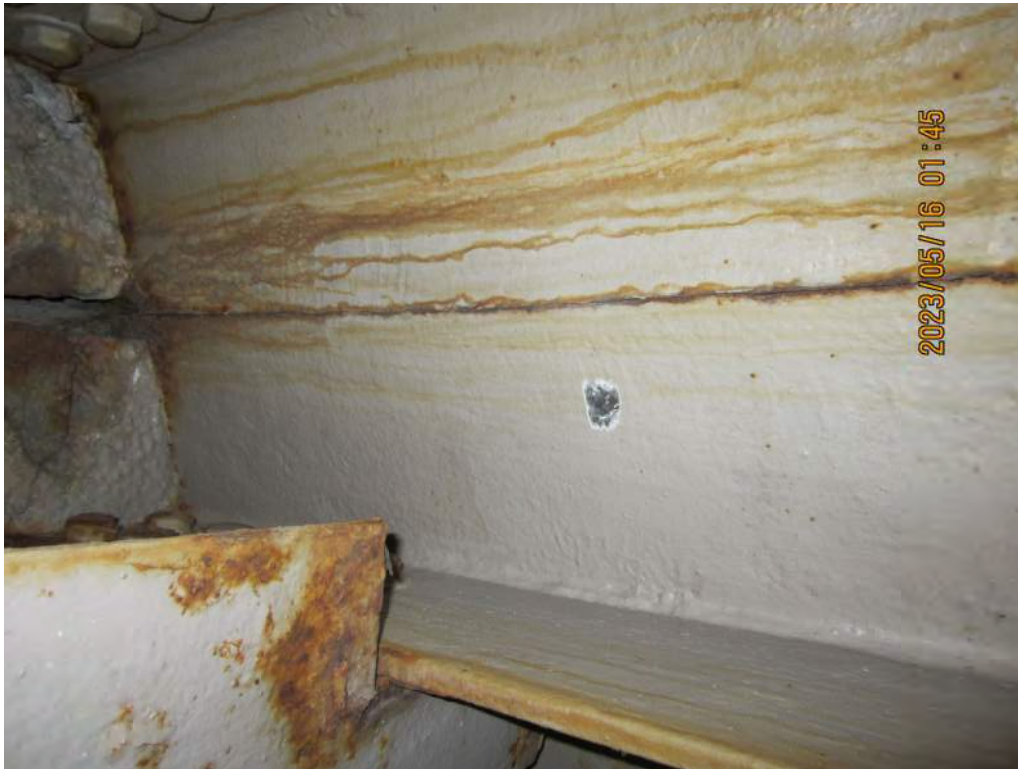
PHOTO 5

LOCATION:
G4 IN SPAN 2 AT PIER

DESCRIPTION:
OVEREXTENDED
BEARINGS CAUSING
GIRDERS IN SPAN 1 AND
SPAN 2 TO TOUCH

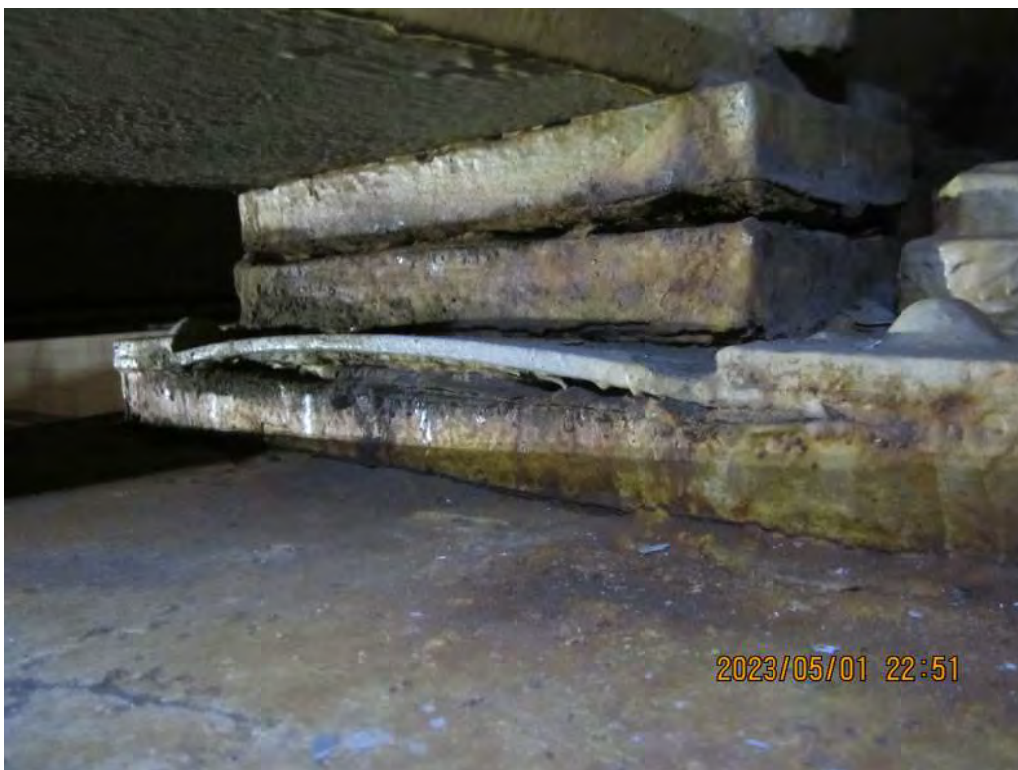
PHOTO 6

LOCATION:
G4 IN SPAN 1 AT PIER

DESCRIPTION:
TYPICAL BEARING
CONDITION, PACK RUST
CAUSING PLATES TO
BOW UPWARDS

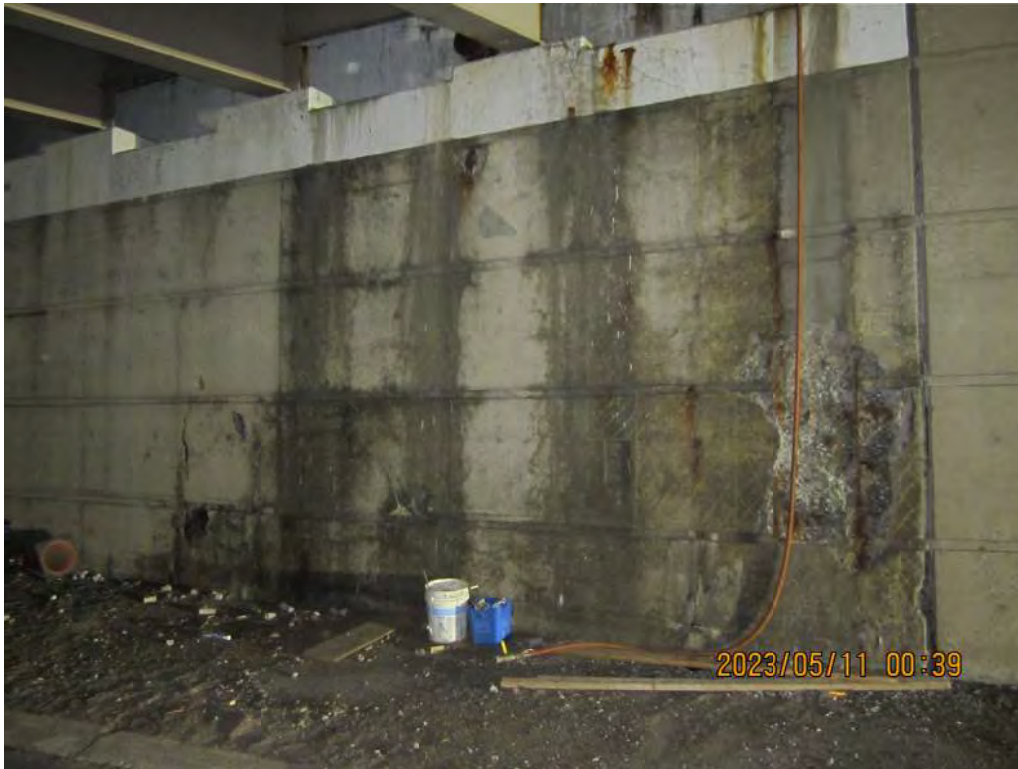
PHOTO 7

LOCATION:
BEGIN ABUTMENT

DESCRIPTION:
LARGE SPALL WITH
EXPOSED REBAR,
WATER LEAKAGE FROM
ABOVE

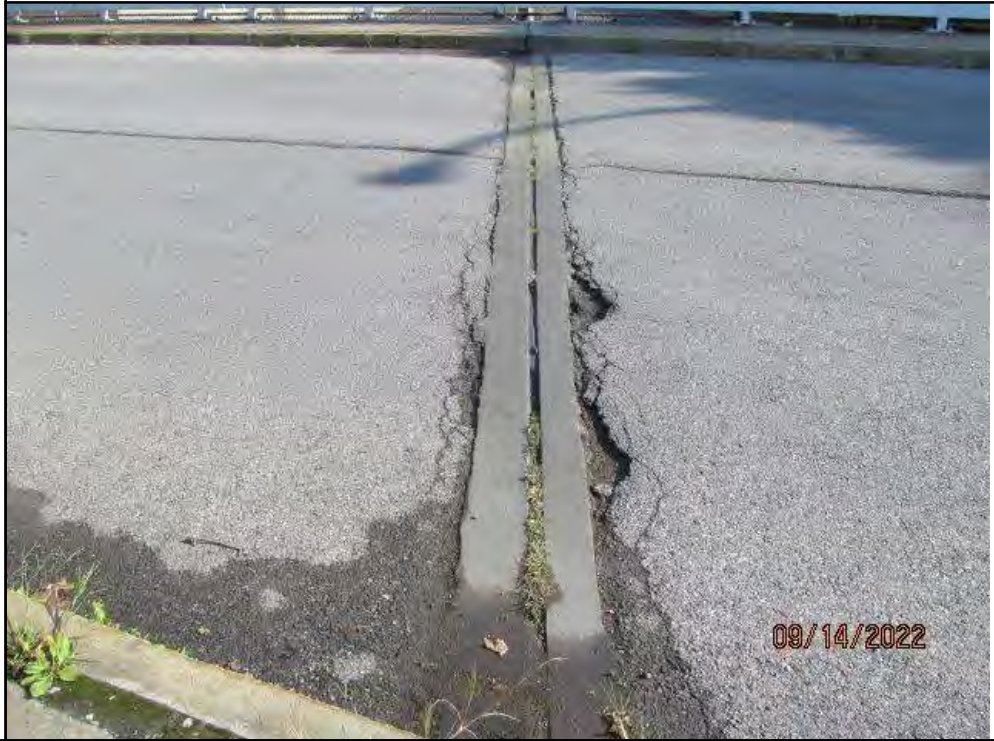
Photo Number: 4 Photo Filename: 22 4 WSSp2LeftaneNearEnd.JPG

Attachment Description:
Wearing surface in the Left travel lane of Span 2 looking toward the End Right.

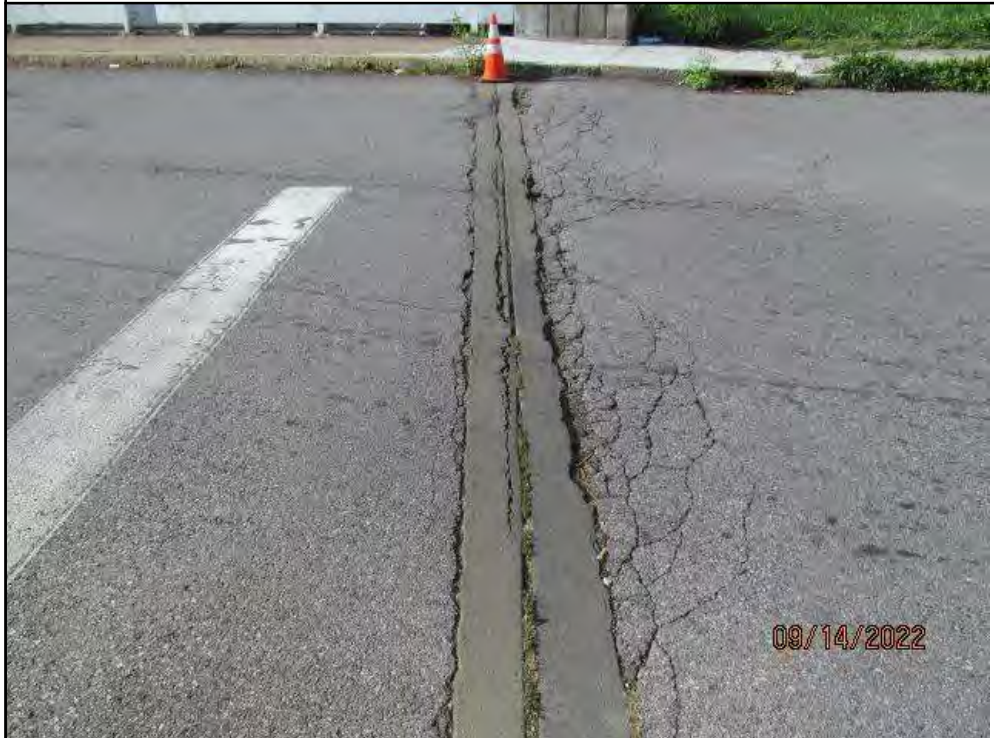
Photo Number: 14

2022 – Above deck, the End joint exhibits widespread areas of depressed and debonded seal. The joint header is transversely cracked across the full length of the joint. (Photo No. 14)

Below deck, there is evidence of active leakage affecting nearly the full length of the joint.

Attachment Description:
End joint, from the Right.

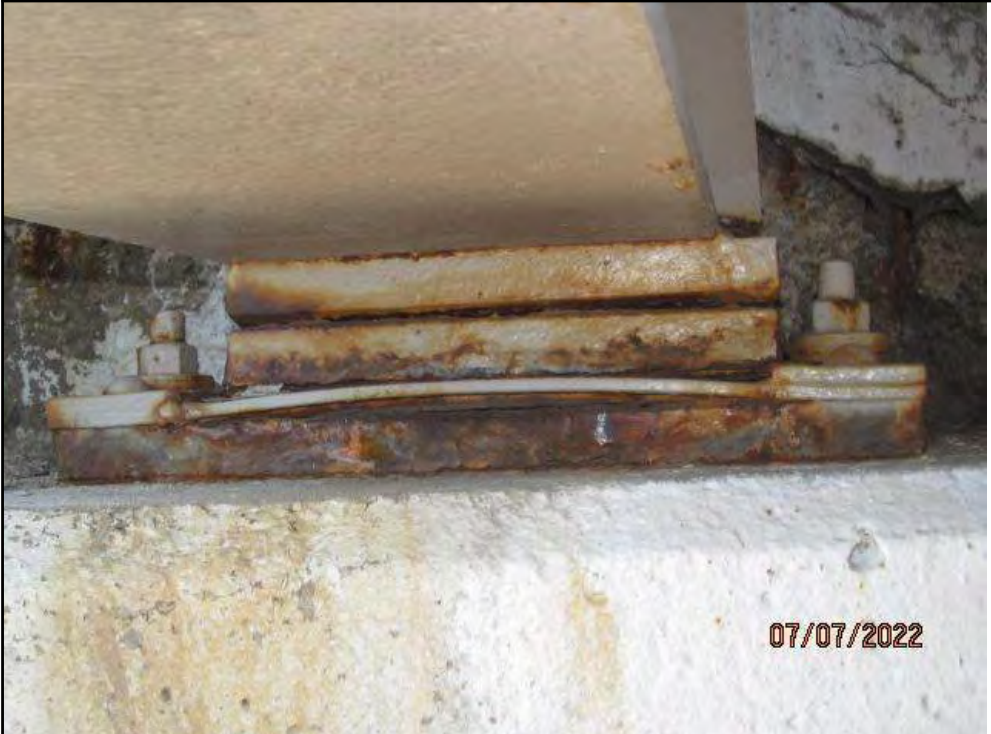
Photo Number: 18

2022 – The End abutment expansion bearings are all typically shifted toward the Right. All six bearings exhibit pack rust between the bronze slide plate and the masonry plate. The bronze plates are bowed upward between 1/4" and 5/8" inhibiting proper thermal movement. Additionally, the bearings below girders G-4 thru G-6 are in contracted positions at 80 degrees F. (Photo No. 18)

Attachment Description:
End bearing below girder G-
1.

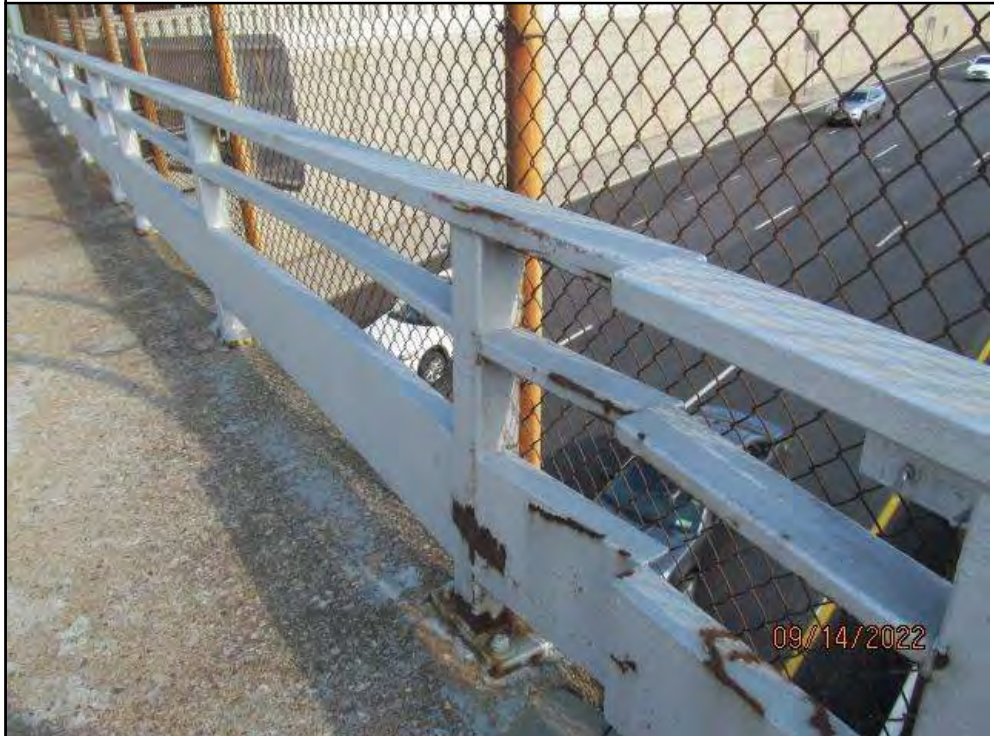
Photo Number: 20

2022 – The Right side bridge rail exhibits impact damage affecting the Begin-most 2 LF of the rail. Additionally, the bottom rail on the Left side is bent adjacent to the 9th post. (Photo No. 20)

Attachment Description:
Bridge rail in Span 2 at the
Begin Right.

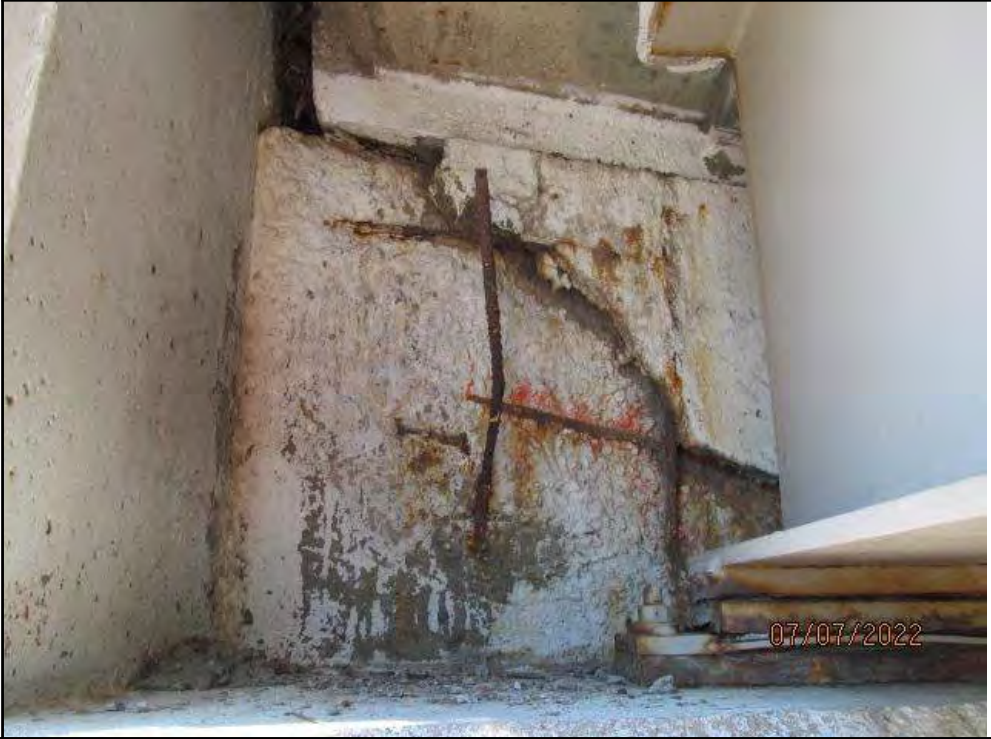
Photo Number: 23

Bay 1 – There are two areas of spalling affecting a total of 5.5 feet wide by 2" to 6" deep with exposed corroded debonded reinforcement affecting the backwall from the Left end and Bay 1. (Photo No's. 23 and 24)

Attachment Description:
End backwall to the Left of
girder G-1.
