Bridge Inspection Reports and Work History Summaries

**NY33 BRIDGE CONDITION VERIFICATION 2023
KENSINGTON EXPRESSWAY PROJECT
PIN 5512.52
CITY OF BUFFALO, ERIE COUNTY
BIN 1022609**

STRUCTURE: BIN 1022609 - Best Street on NY33 Kensington Expressway

STRUCTURE TYPE: Four (4) span Steel, Multi-Stringer (12 beams) structure with concrete abutments founded on piles and 3-six column piers with spread footings. Year Built: 1959

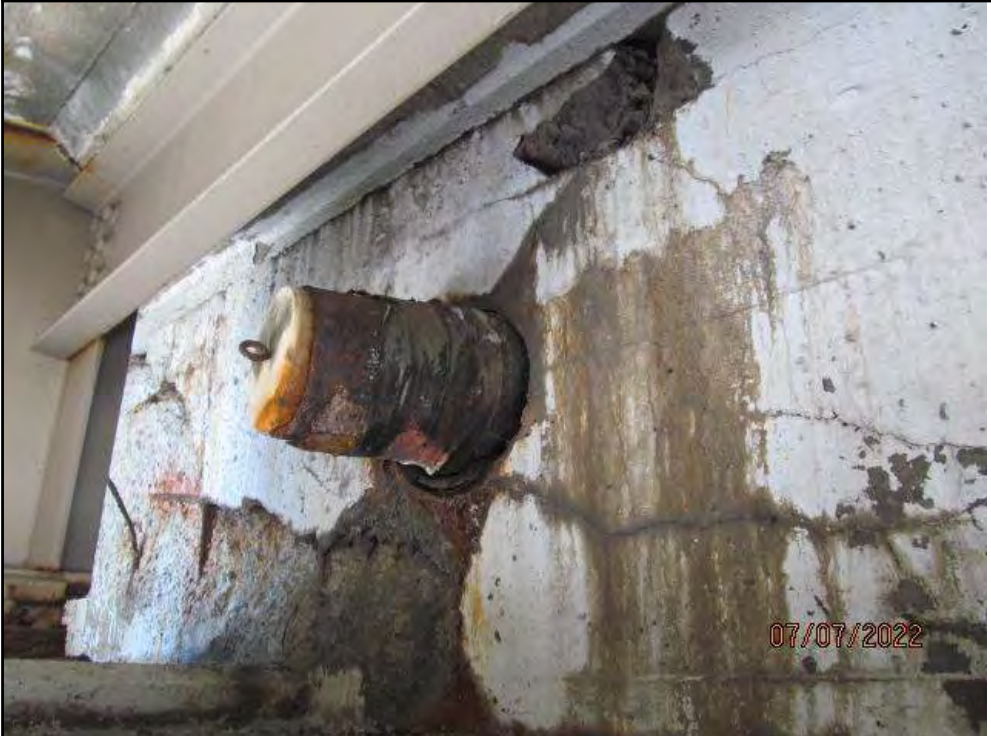
Photo Number: 24

Bay 1 – There are two areas of spalling affecting a total of 5.5 feet wide by 2" to 6" deep with exposed corroded debonded reinforcement affecting the backwall from the Left end and Bay 1. (Photo No's. 23 and 24)

Attachment Description:
End backwall in Bay 1.

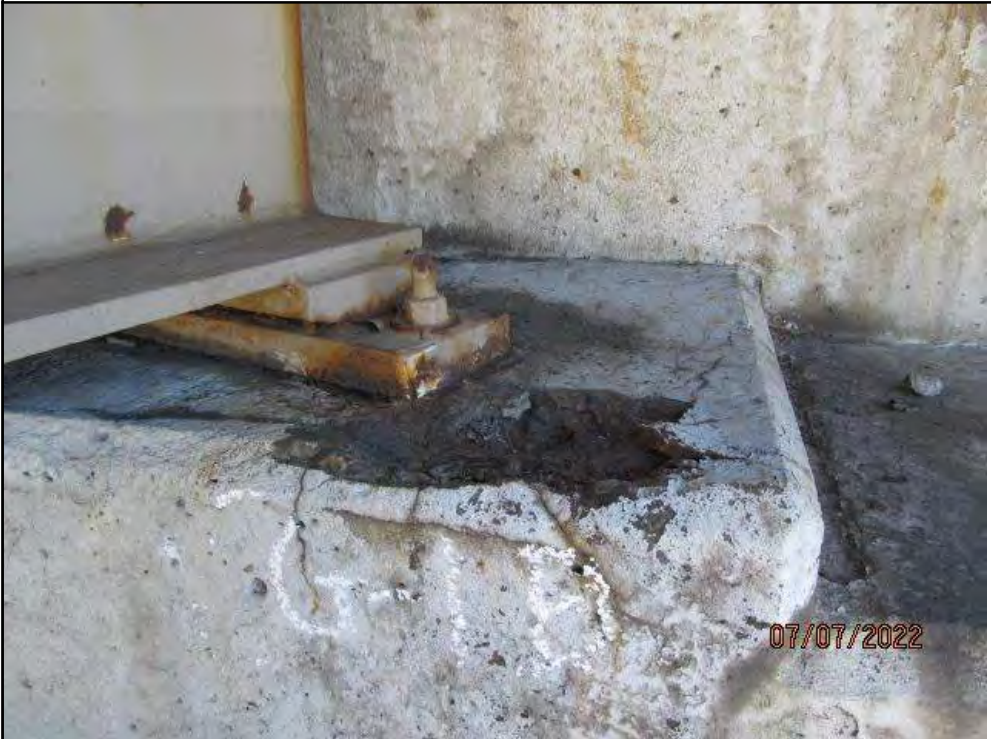
Photo Number: 25

2022 – The Begin pedestal below girder G-1 exhibits spalling that measures 1 foot by 6" by 1-1/4" deep with exposed bonded reinforcement (CS-3) (Photo No. 25). The spalling reaches the edge of the masonry plate with loss of bearing observed. The pedestals below girders G-2 and G-5 exhibit cracked and hollow sounding concrete on their Begin faces (CS-2).

Attachment Description:
Begin pedestal below girder
G-1.

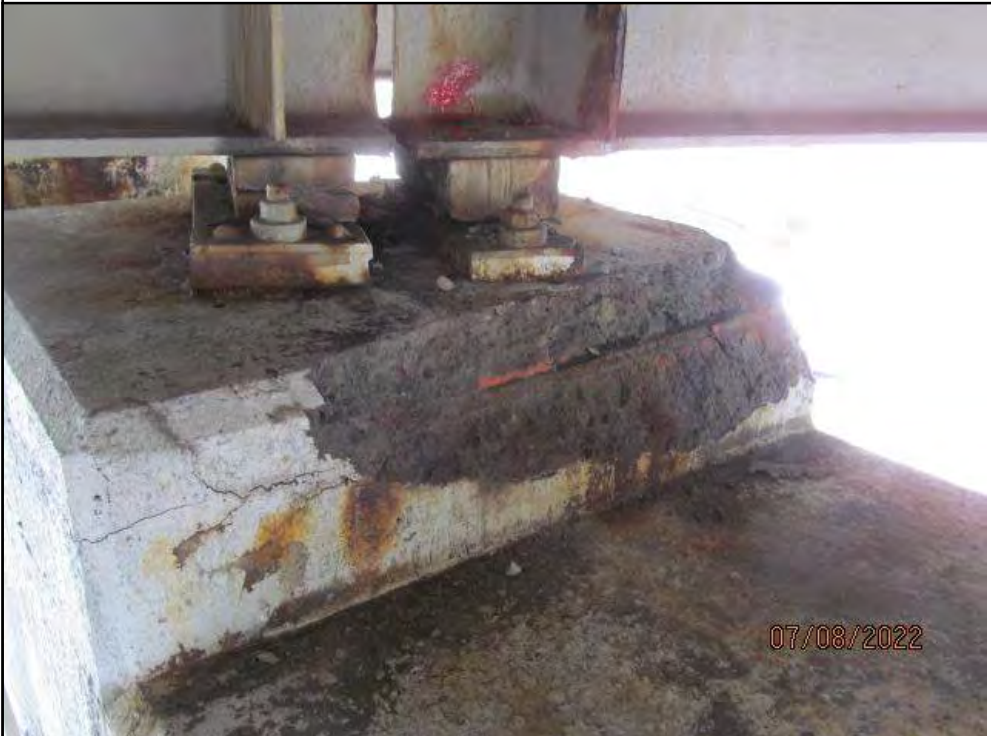
Photo Number: 26

G-4 – The Right side of both G-2 pedestals exhibits spalling that measures 2.4 feet wide by 0.8 feet high by 2" to 2-1/2" deep with exposed corroded bonded reinforcement. (Photo No. 26)

The concrete adjacent to both spalls is cracked and hollow sounding.

Attachment Description:
Pier pedestal below girder
G-4, Right side.

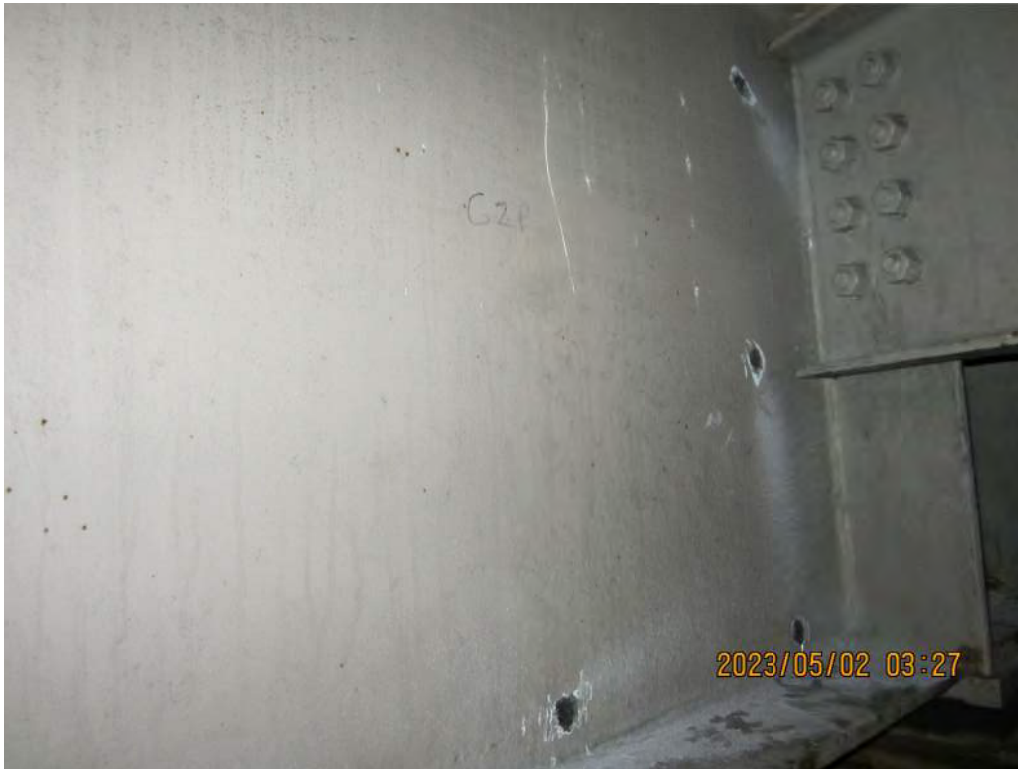
PHOTO 1:

LOCATION:
G2 IN SPAN 2 AT PIER

DESCRIPTION:
GIRDER END CONDITION
PHOTO (WORST CASE
FULL HEIGHT LOSS)

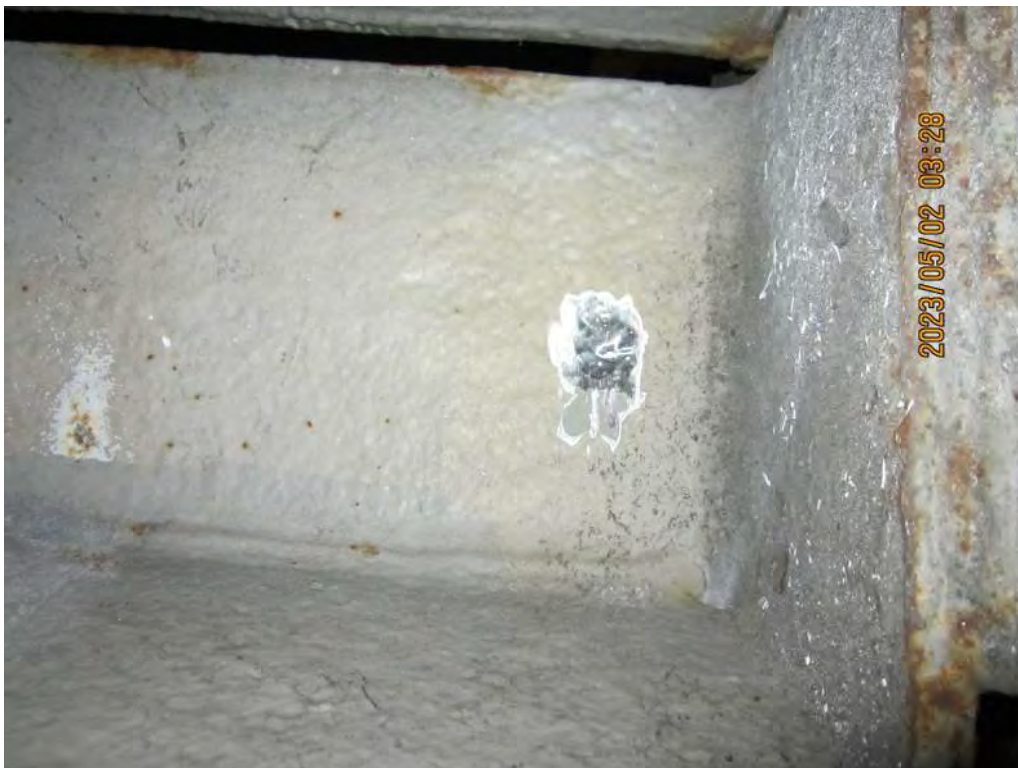
PHOTO 2:

LOCATION:
G2 IN SPAN 2 AT PIER

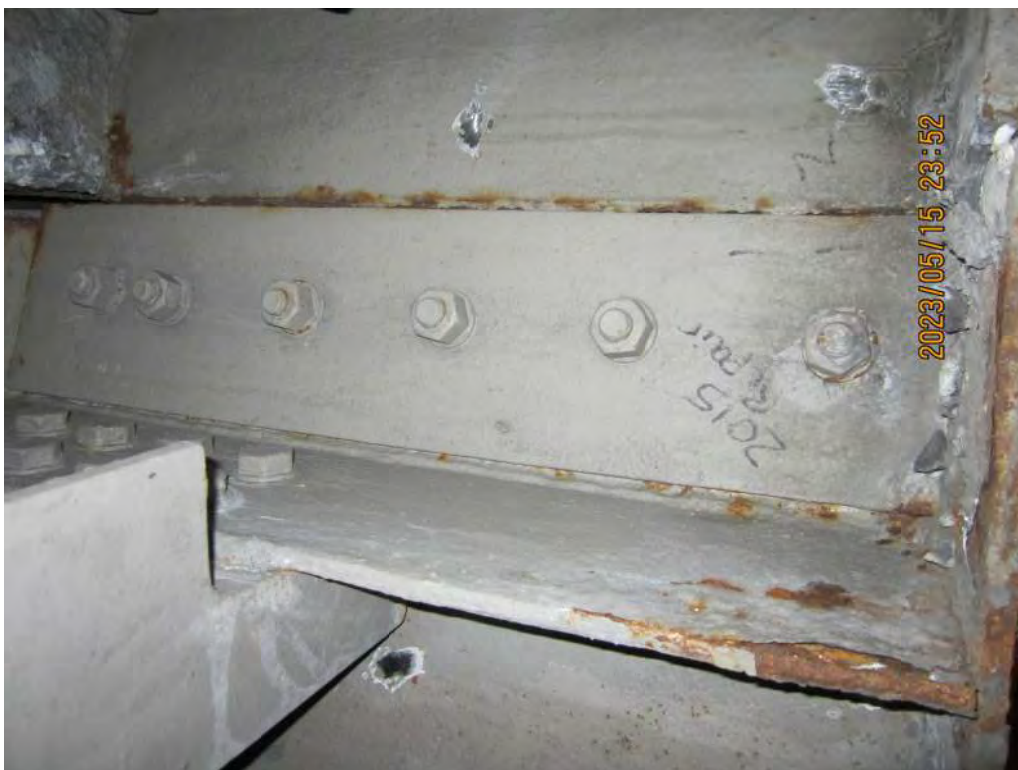
PHOTO 4:

LOCATION:
G1 IN SPAN 1 AT PIER

DESCRIPTION:
REPAIR PLATE LOCATED
BEHIND BEARING LINE,
ALL OTHER REPAIR
PLATES SIMILAR

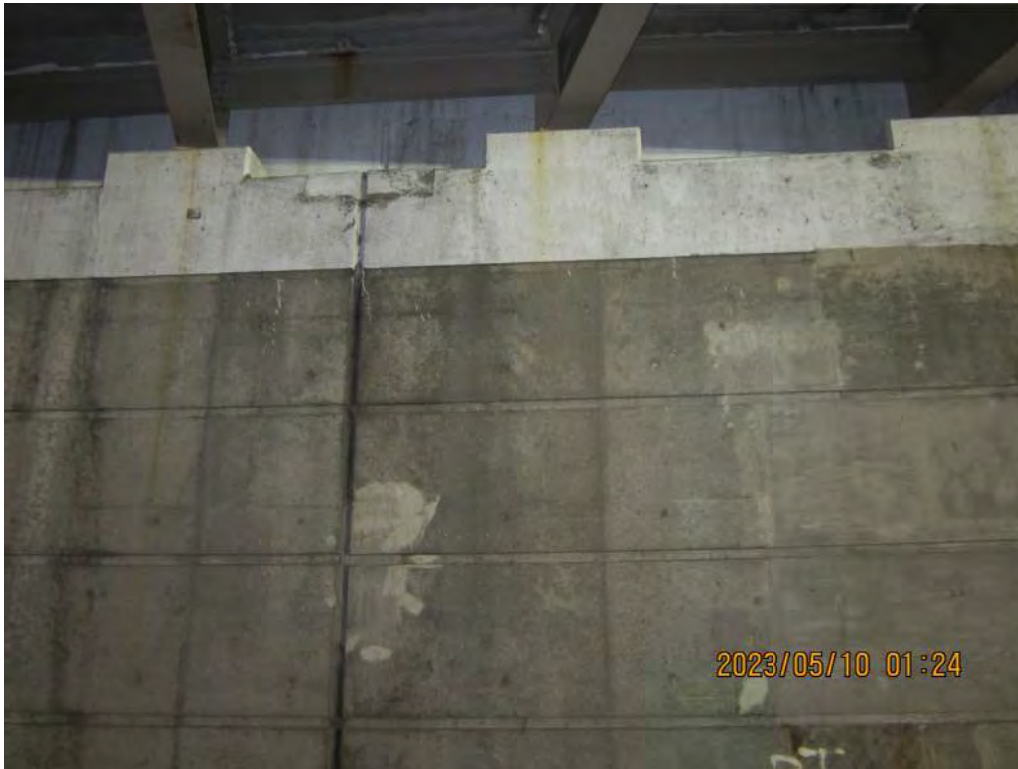
PHOTO 5:

LOCATION:
BEGIN ABUTMENT

DESCRIPTION:
GENERAL CONDITION
PHOTO

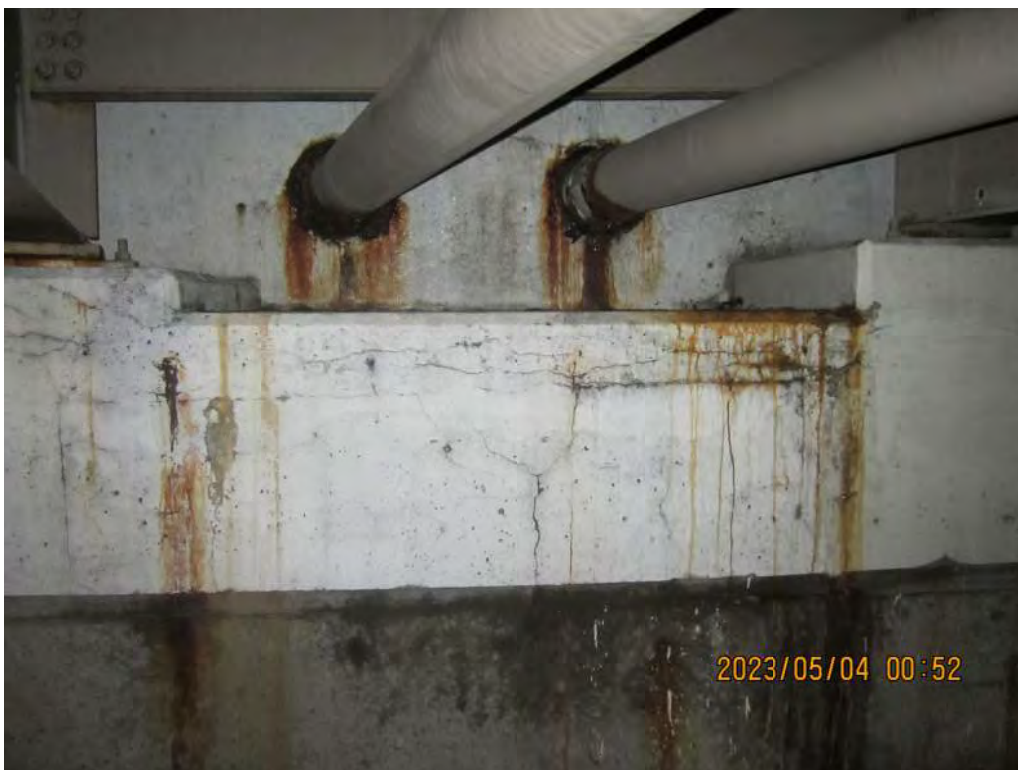
PHOTO 6:

LOCATION:
END ABUTMENT

DESCRIPTION:
MAP CRACKING TO
CONCRETE, LEAKAGE
WITH RUST STAINING AT
UTILITY LOCATIONS

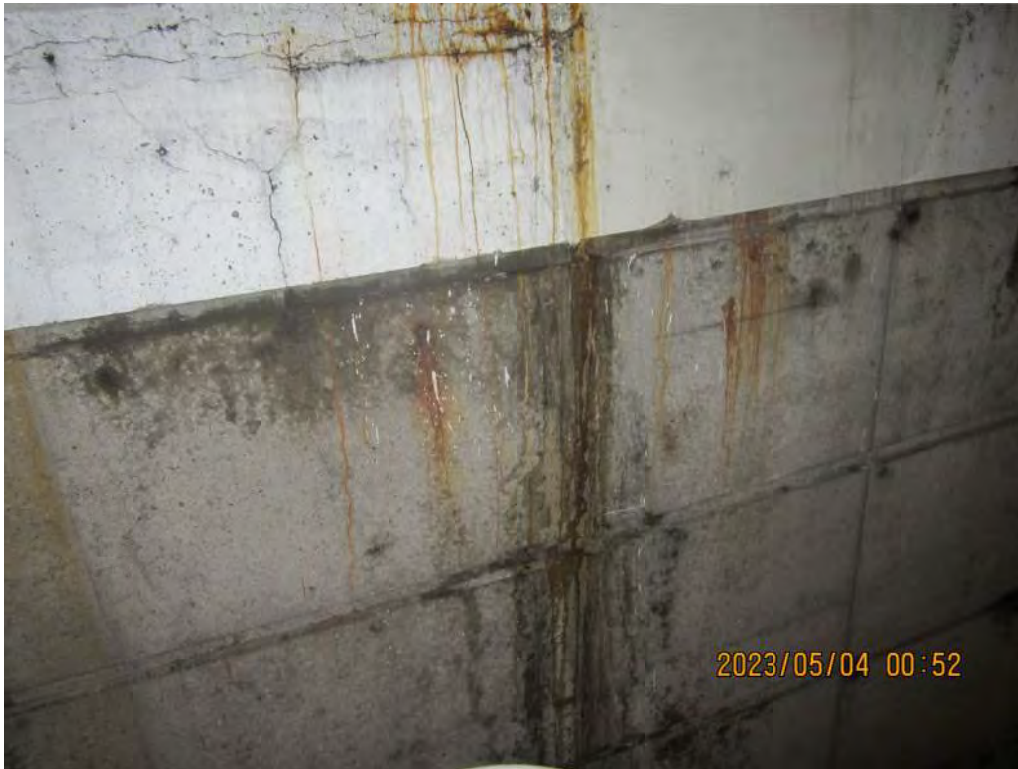
PHOTO 7:

LOCATION:
END ABUTMENT

DESCRIPTION:
VERTICAL CRACKS
COMING DOWN FROM
BRIDGE
SEAT/PEDESTALS

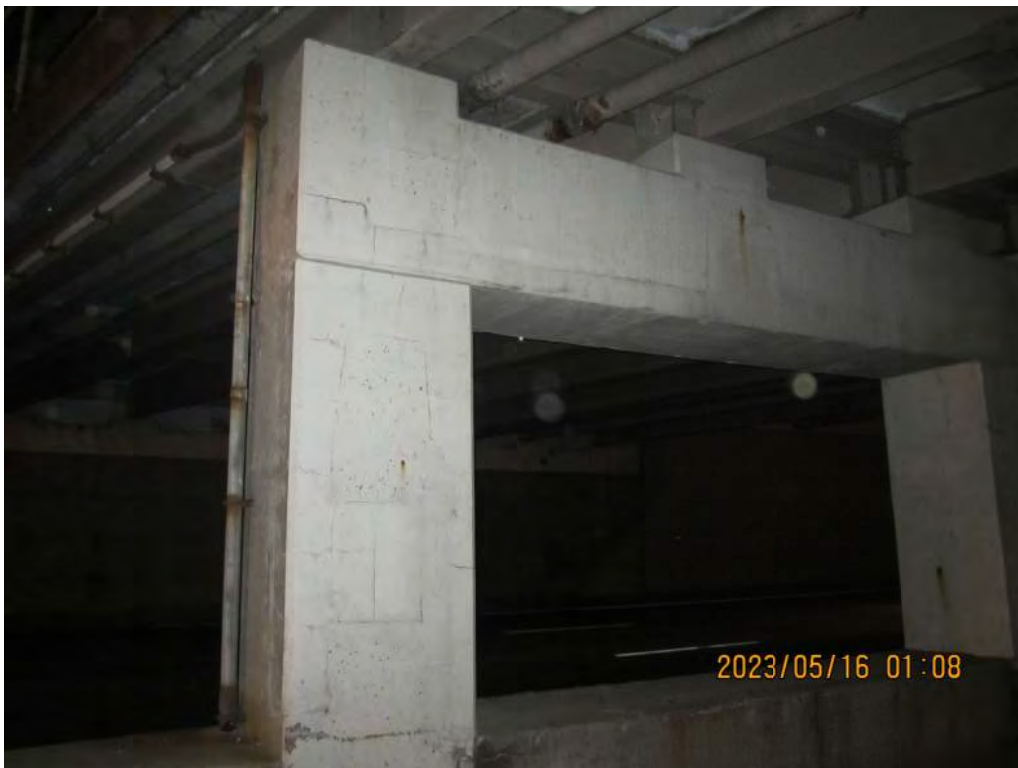
PHOTO 8:

LOCATION:
PIER FROM SPAN 1

DESCRIPTION:
GENERAL CONDITION
PHOTO, MINOR MAP
CRACKING

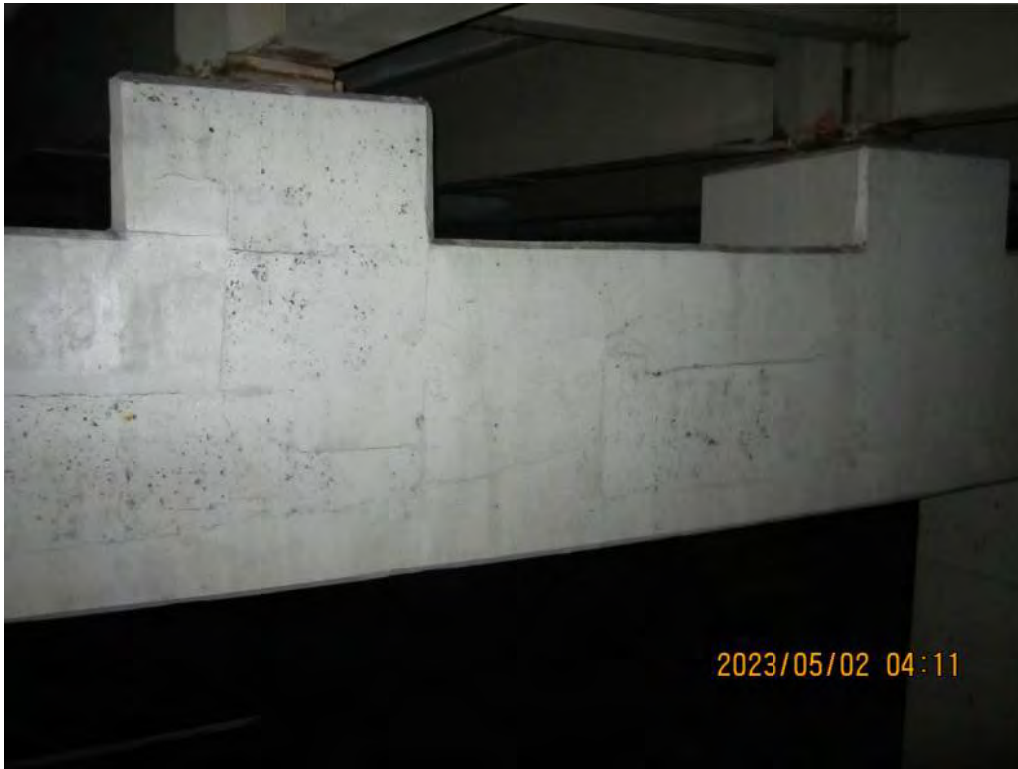
PHOTO 9:

LOCATION:
PIER FROM SPAN 2

DESCRIPTION:
GENERAL CONDITION
PHOTO, MINOR MAP
CRACKING TO CONCRETE
CAP BEAM AND
PEDESTALS

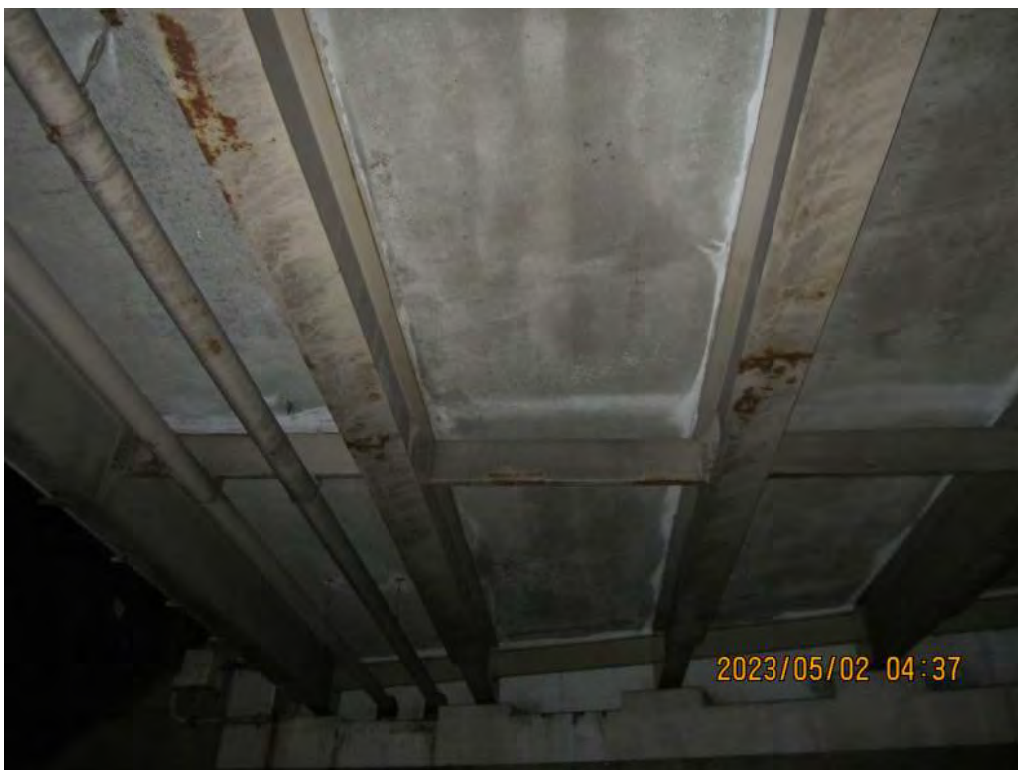
PHOTO 10:

LOCATION:
UNDERSIDE OF DECK
FROM SPAN 2

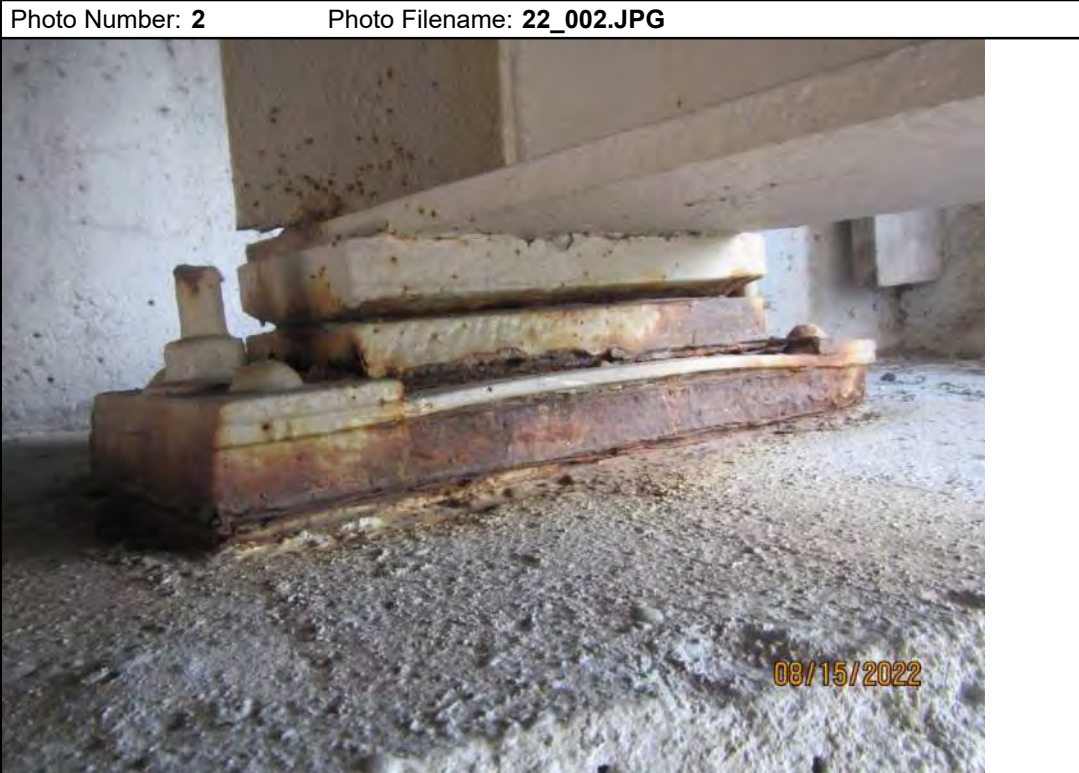
Attachment Description:
Begin Bearing 1, Pack Rust Under Sliding Plate and Paint Failure

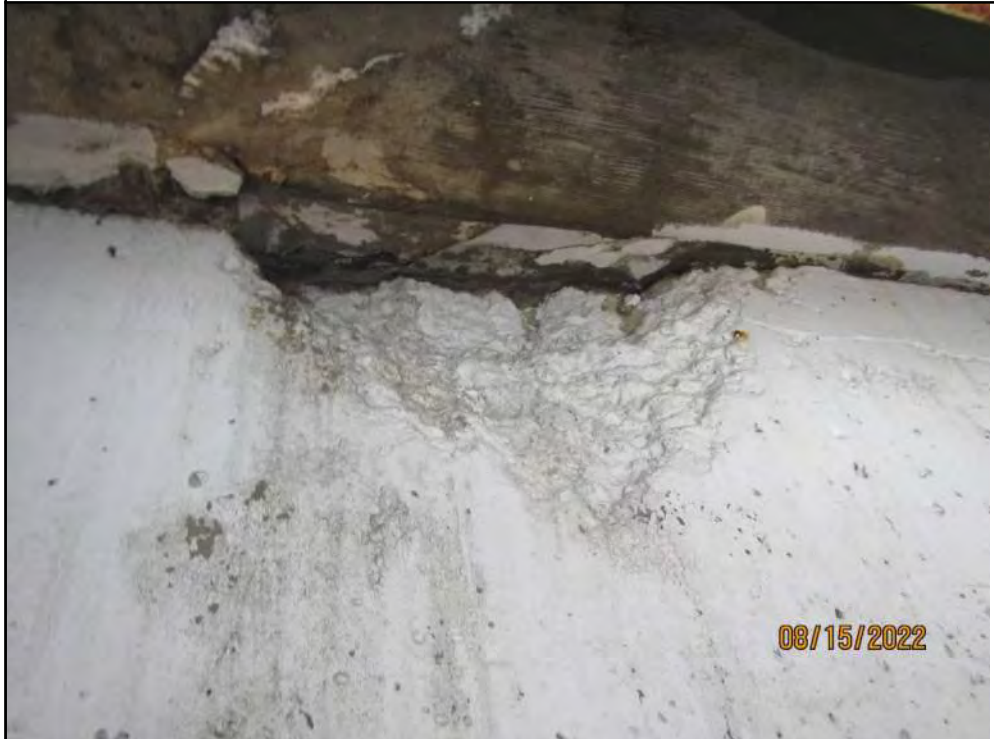
Photo Number: 3 Photo Filename: 22_003.JPG

Attachment Description:
Begin Backwall, Bay 7,
Spall

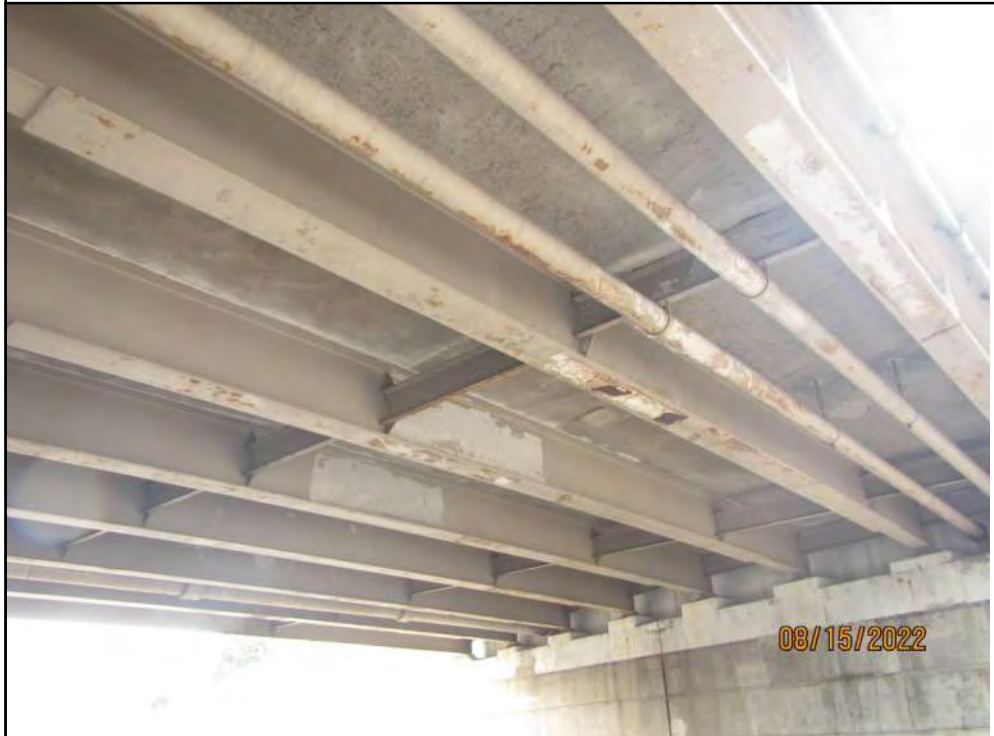
Photo Number: 4 Photo Filename: 22_004.JPG

Attachment Description:
Span 1 Framing, Paint
Failure

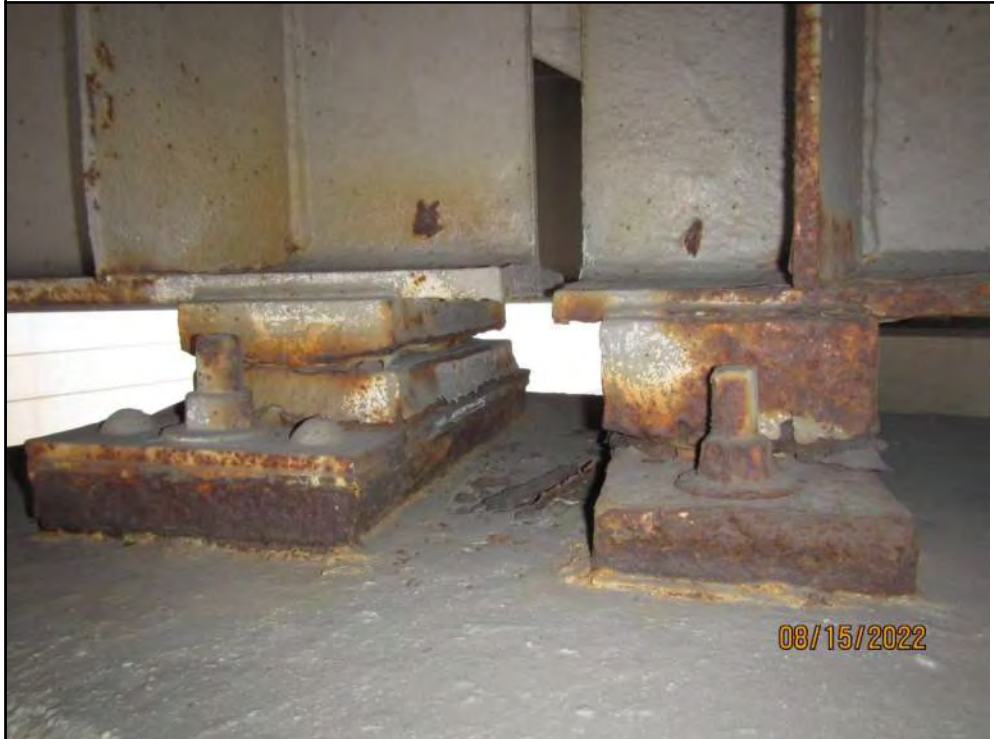
Photo Number: 5 Photo Filename: 22_005.JPG

Attachment Description:
Pier, G4 Beam Ends,
Section Loss; Bearing 4,
Paint Failure

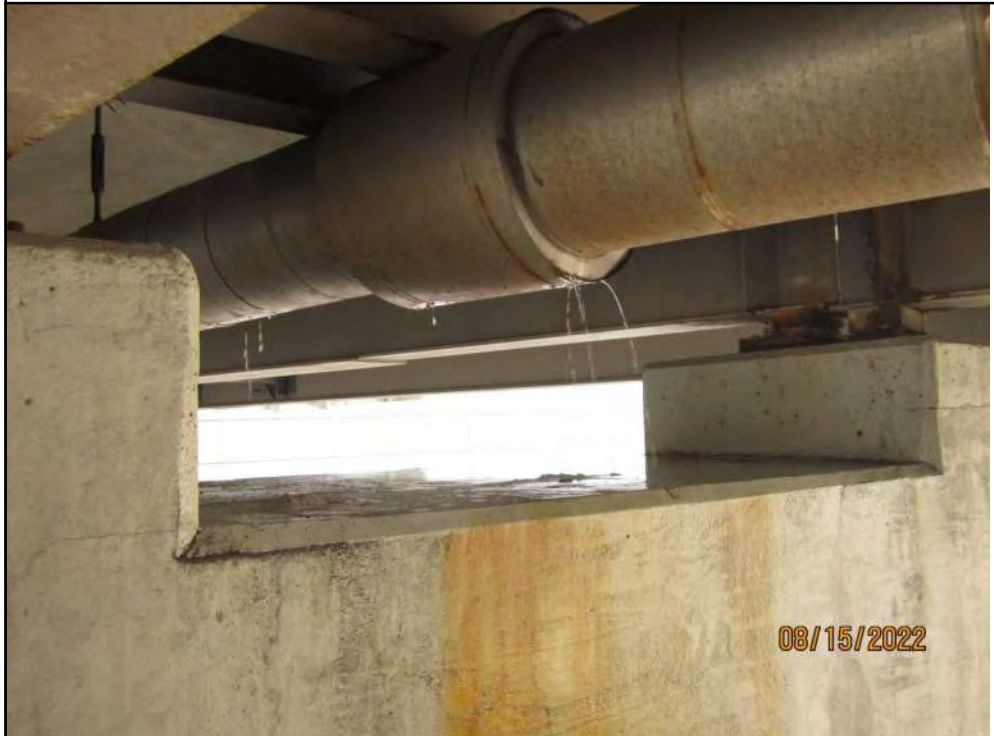
Photo Number: 6 Photo Filename: 22_006.JPG

Attachment Description:
(NSCO) Utility, Bay 6 at
Pier, Leaking

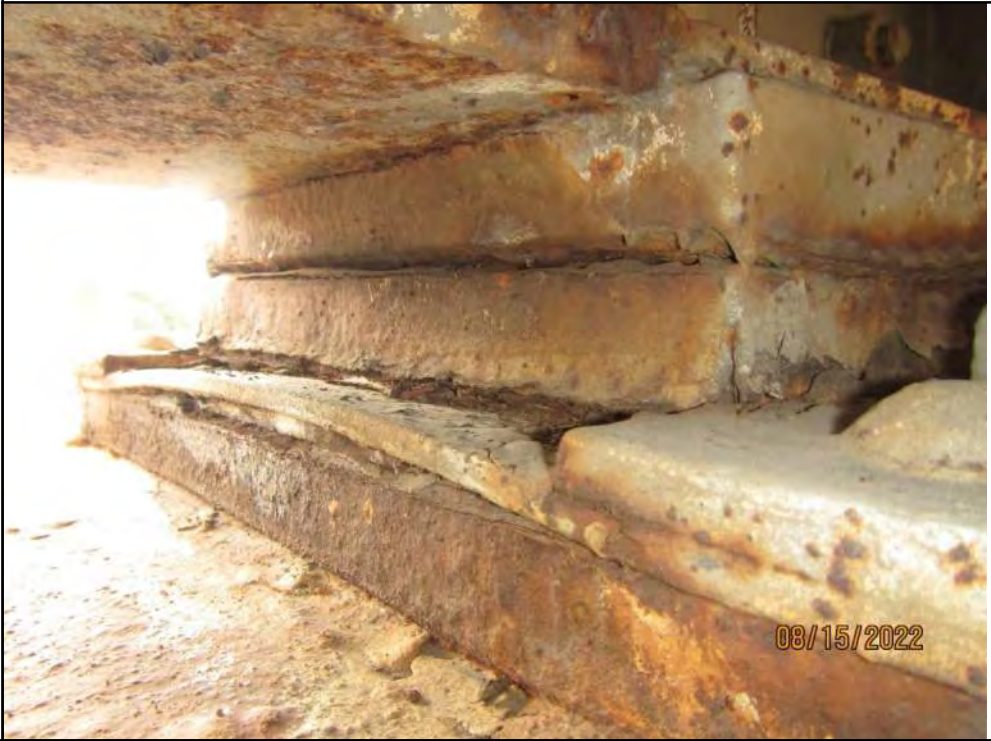
Photo Number: 7 Photo Filename: 22_007.JPG

Attachment Description:
Begin Span 2, Pier Bearing
8, Pack Rust Under Sliding
Plate and Paint Failure

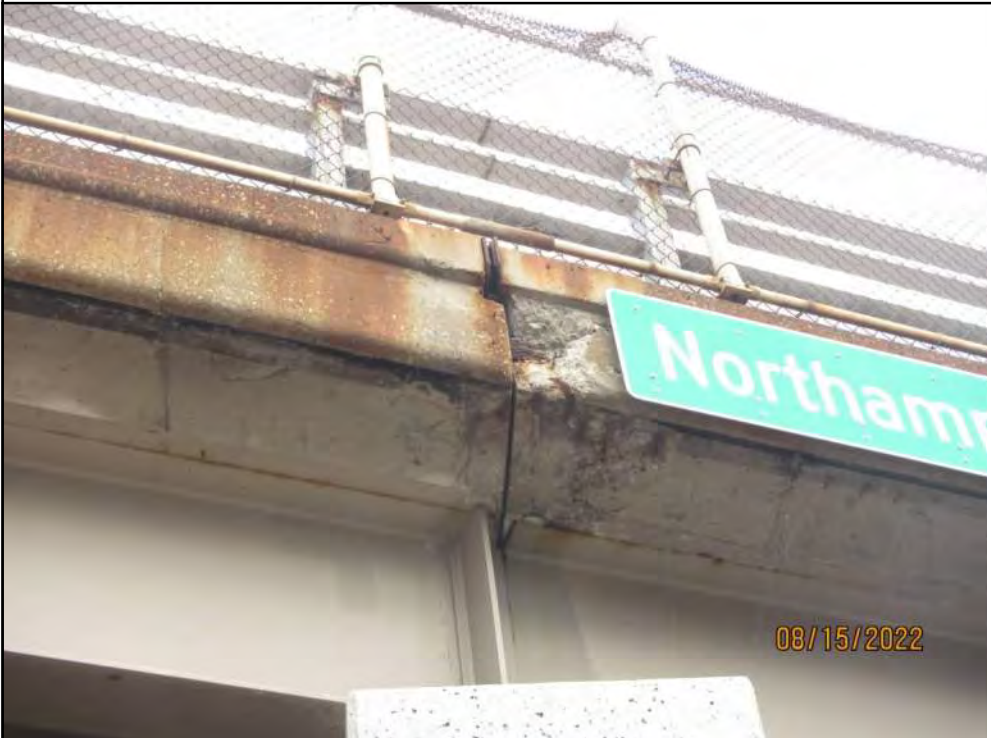
Photo Number: 8 Photo Filename: 22_008.JPG

Attachment Description:
Begin Span 2, Right Fascia,
Spall to Rebar

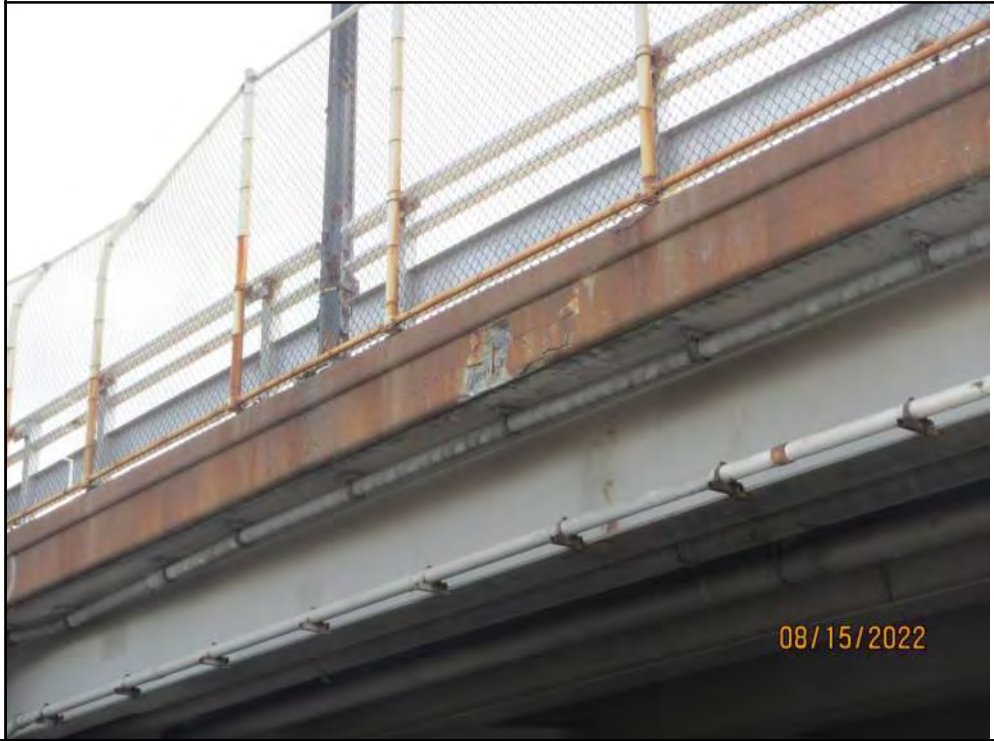
Photo Number: 9 Photo Filename: 22_009.JPG

Attachment Description:
Span 2, Midspan, Left
Fascia, Spall to Rebar

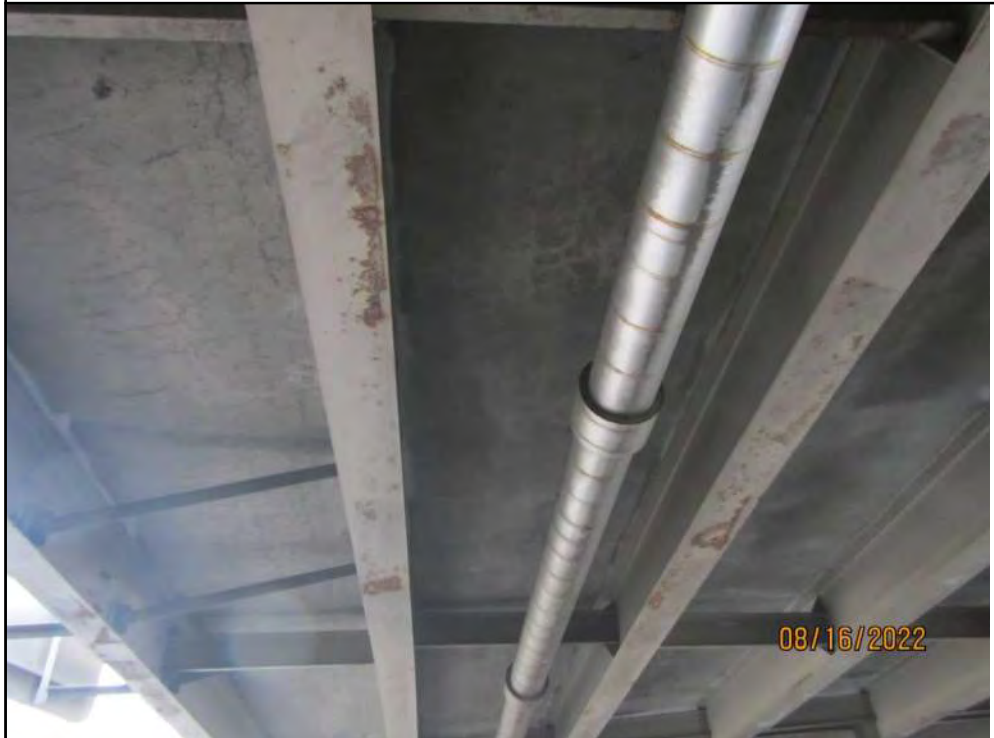
Photo Number: 10 Photo Filename: 22_010.JPG

Attachment Description:
Span 2, G6 - G8, Bottom
Flange, Paint Failure

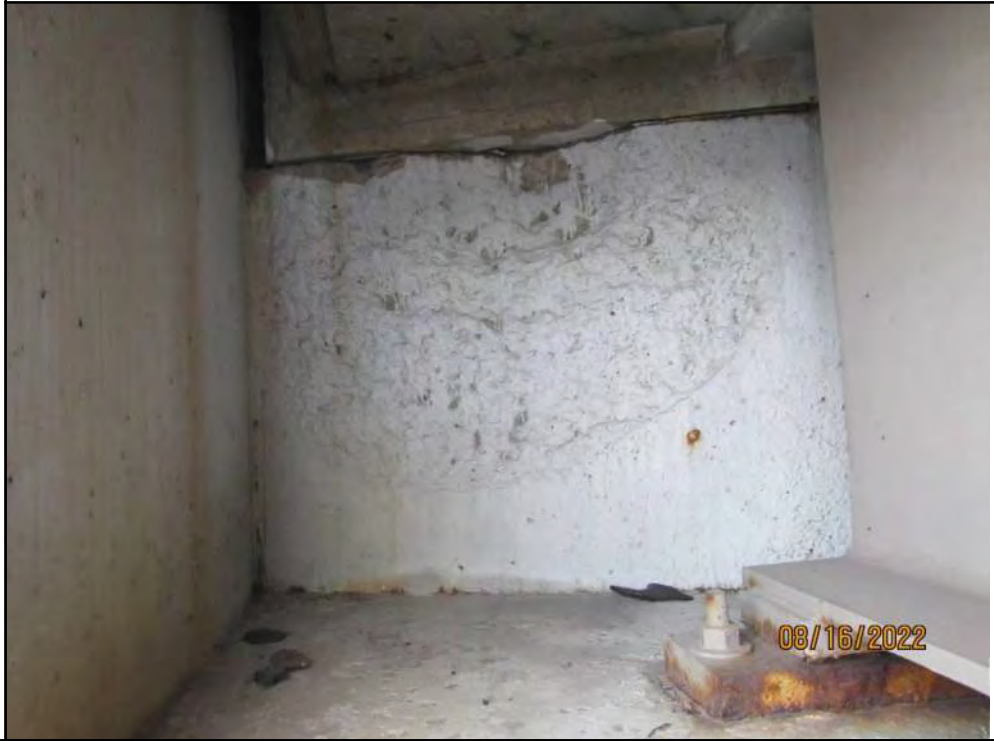
Photo Number: 11

Attachment Description:
End Abutment, Left of G1,
Spall; End Bearing 1, Paint
Failure

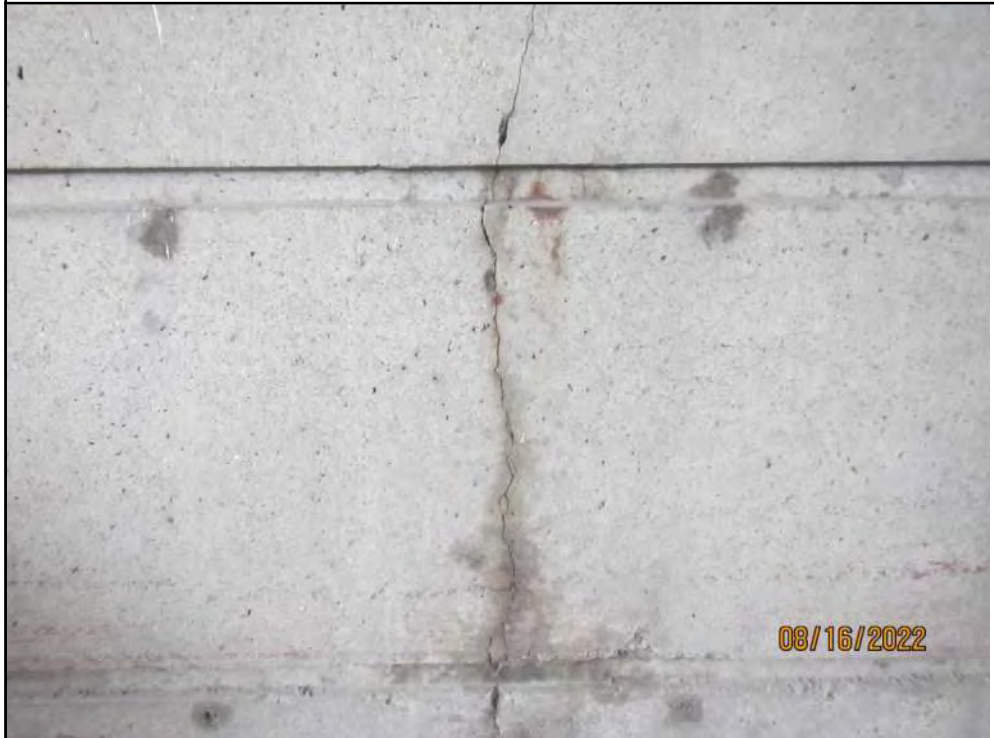
Photo Number: 12

Attachment Description:
End Abutment, Bay 2,
Crack

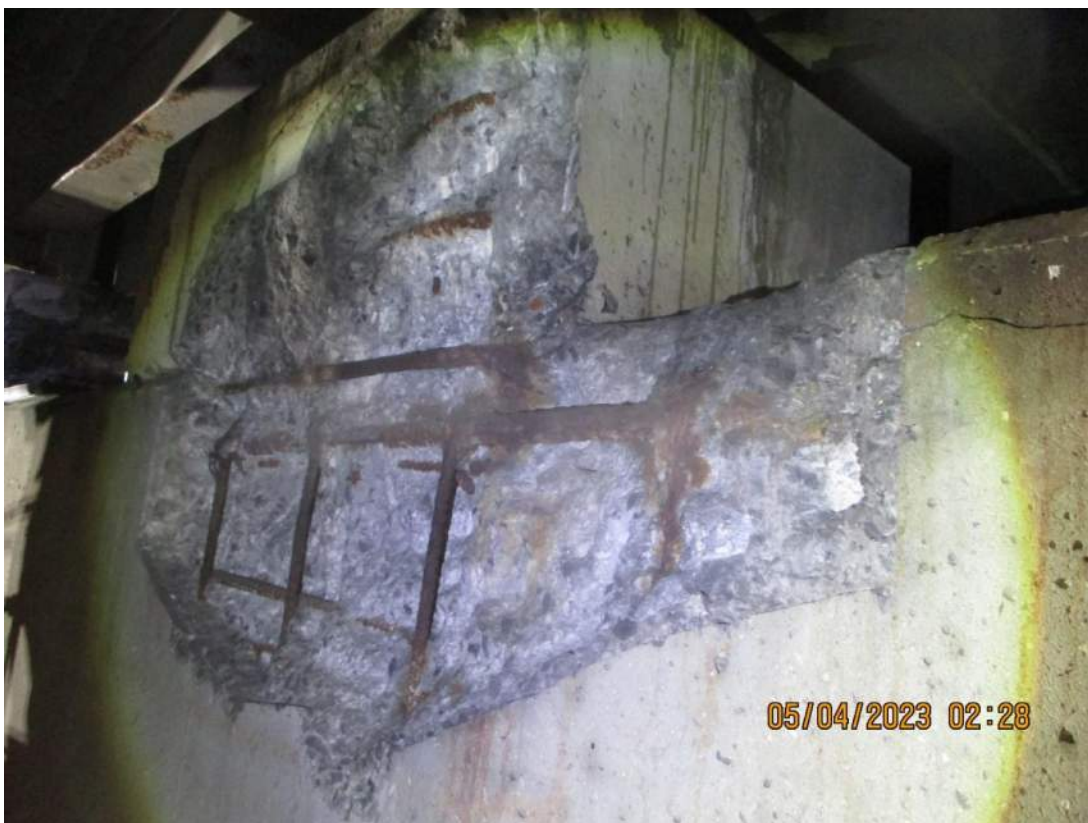
PHOTO 8

LOCATION:
END FACE OF PIER
CAP AND PEDESTAL
P5

DESCRIPTION:
SPALL TO
CORRODED REBAR

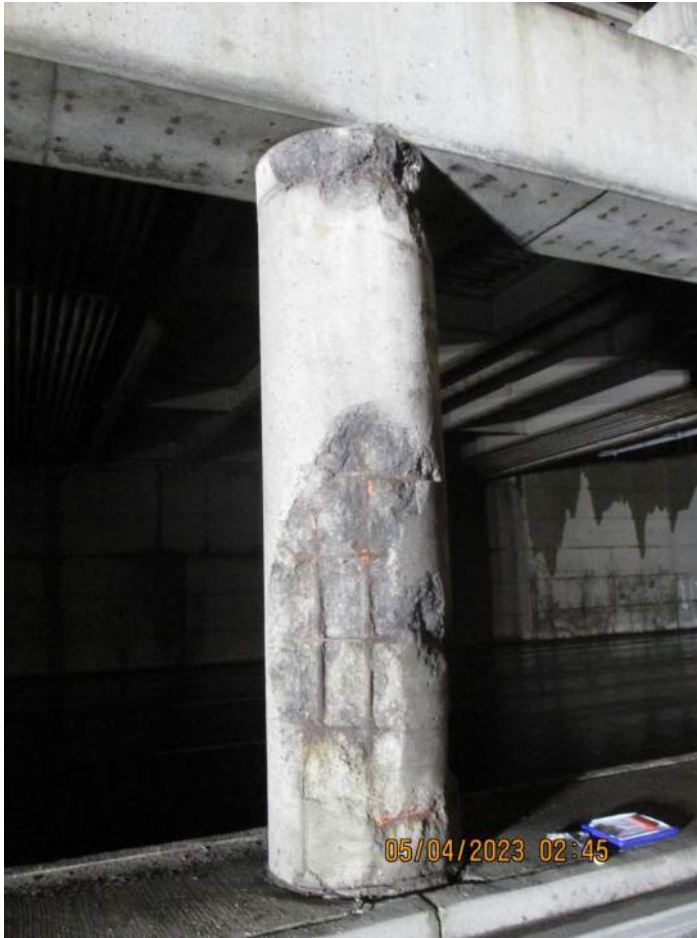
PHOTO 9
LOCATION: COLUMN 3 END FACE LOOKING WEST
DESCRIPTION: SPALL TO CORRODED REBAR THROUGHOUT THE COLUMN HEIGHT; TYPICAL FOR ALL COLUMNS

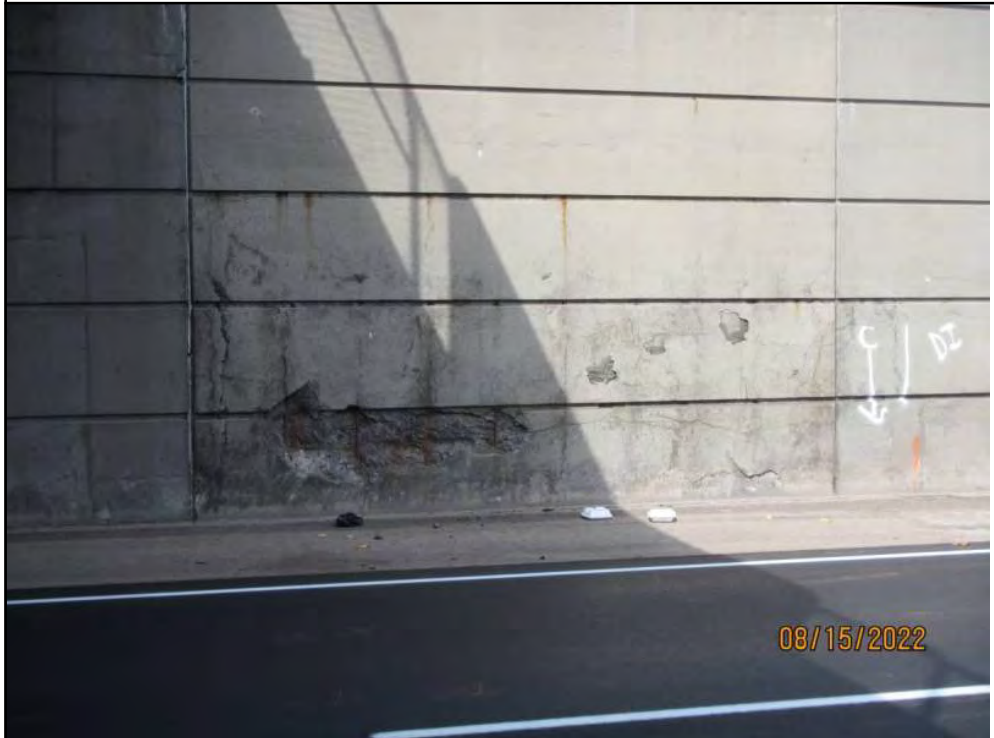
Photo Number: 5 Photo Filename: 22_005.JPG

Attachment Description:
Begin Left Cheekwall, Spall
to Rebar

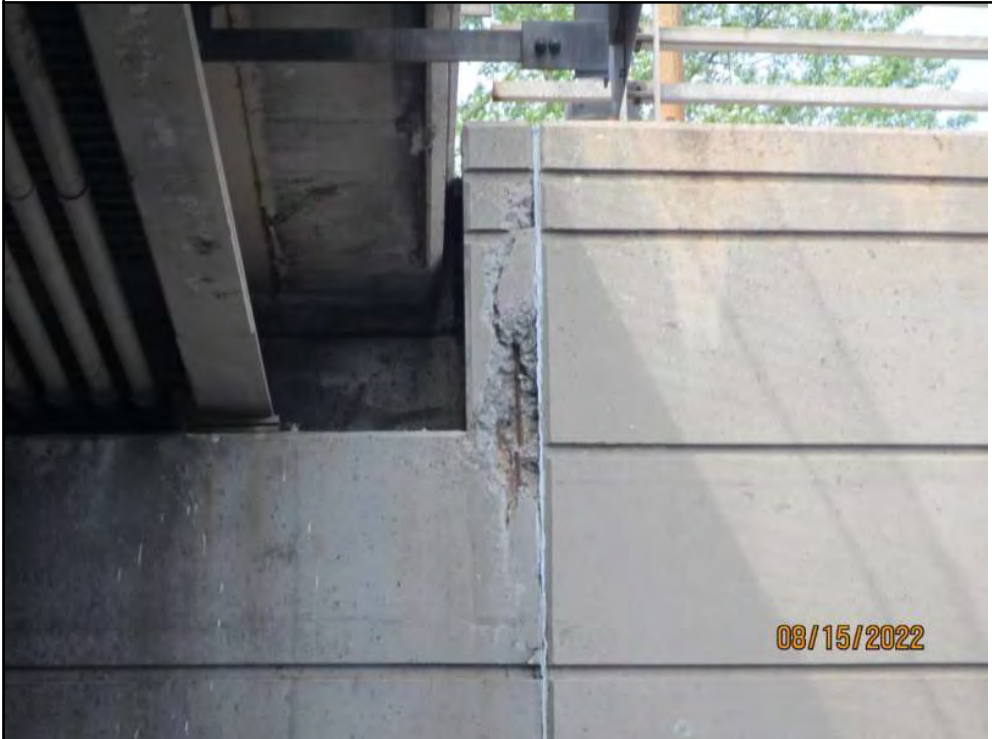
Photo Number: 6 Photo Filename: 22_006.JPG

Attachment Description:
Begin Backwall, Bay 1,
Spall

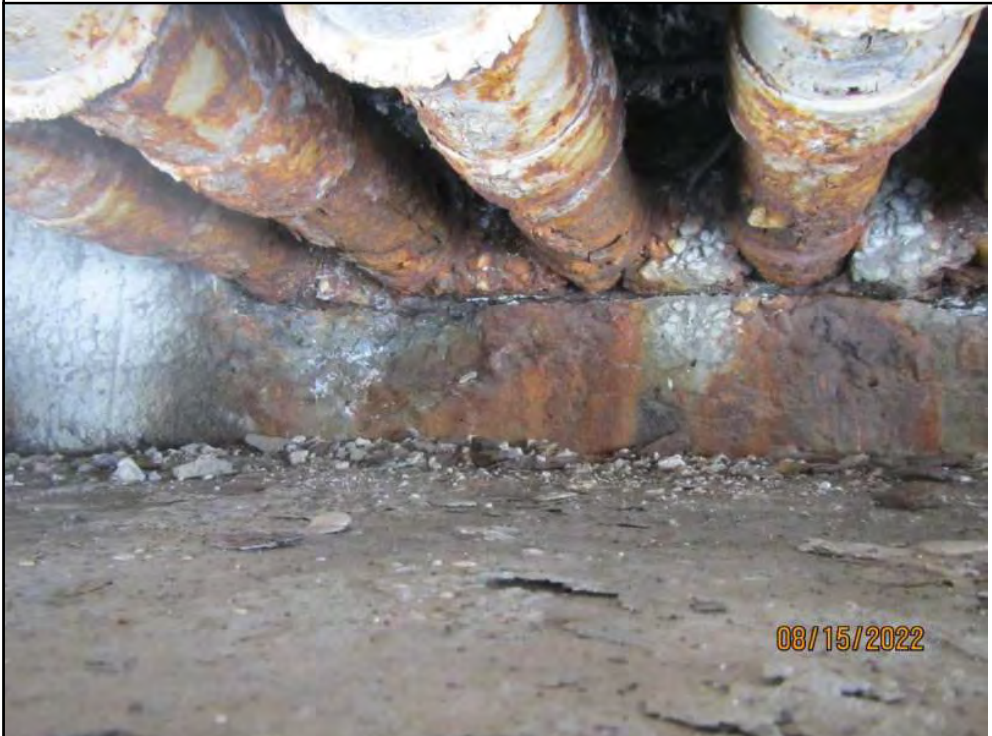
Photo Number: 7 Photo Filename: 22_007.JPG

Attachment Description:
Begin Abutment at G2,
Crack w/ Delamination;
Begin Bearing 2, Pack Rust
(Typical)

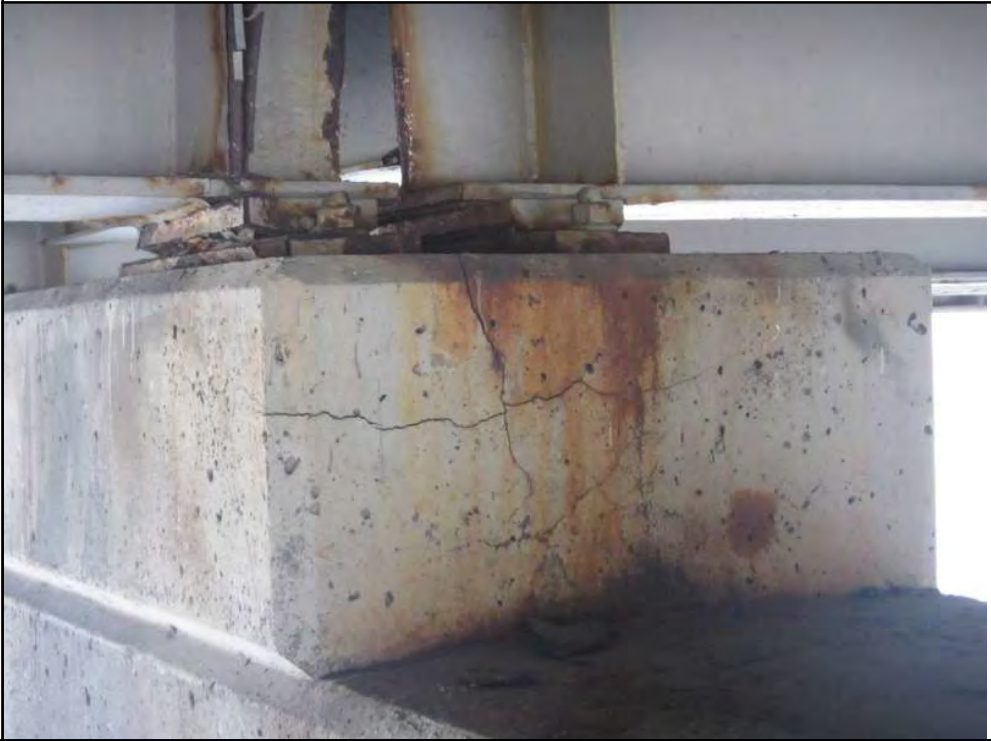
Photo Number: 12

Attachment Description:
Pier Pedestal 6, Left, Spall
to Rebar; G6, Pier Beam
Ends, Section Loss
