Bridge Inspection Reports and Work History Summaries

**NY33 BRIDGE CONDITION VERIFICATION 2023
KENSINGTON EXPRESSWAY PROJECT
PIN 5512.52
CITY OF BUFFALO, ERIE COUNTY
BIN 1022609**

STRUCTURE: BIN 1022609 - Best Street on NY33 Kensington Expressway

STRUCTURE TYPE: Four (4) span Steel, Multi-Stringer (12 beams) structure with concrete abutments founded on piles and 3-six column piers with spread footings. Year Built: 1959

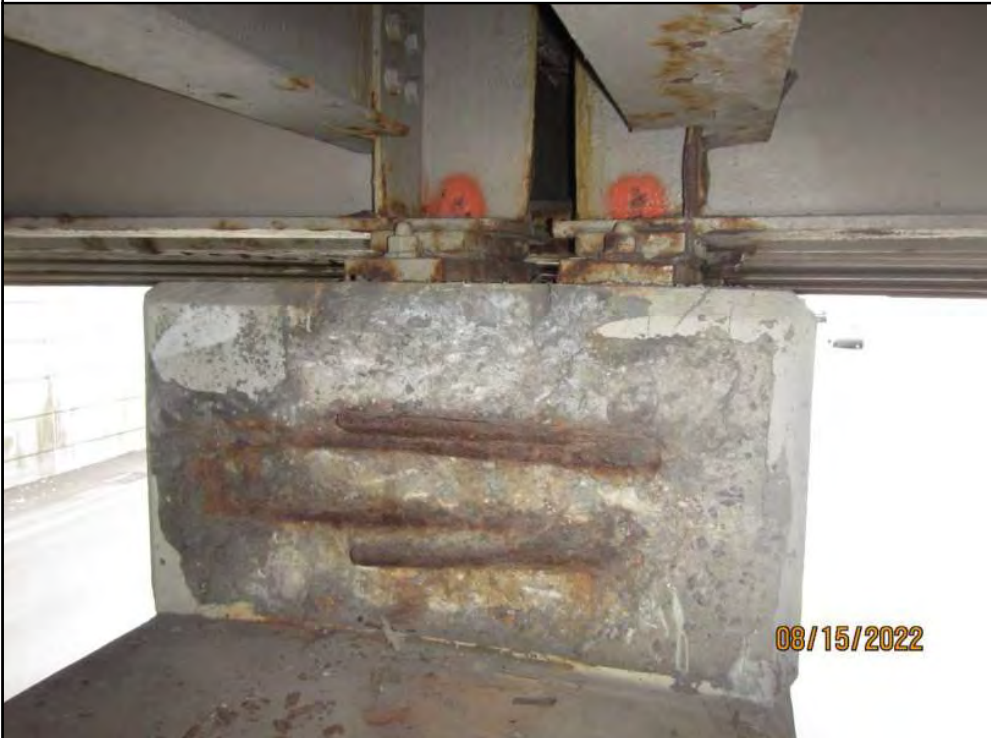
Photo Number: 13

Attachment Description:
Pier Pedestal 8, Left, Spall
to Rebar

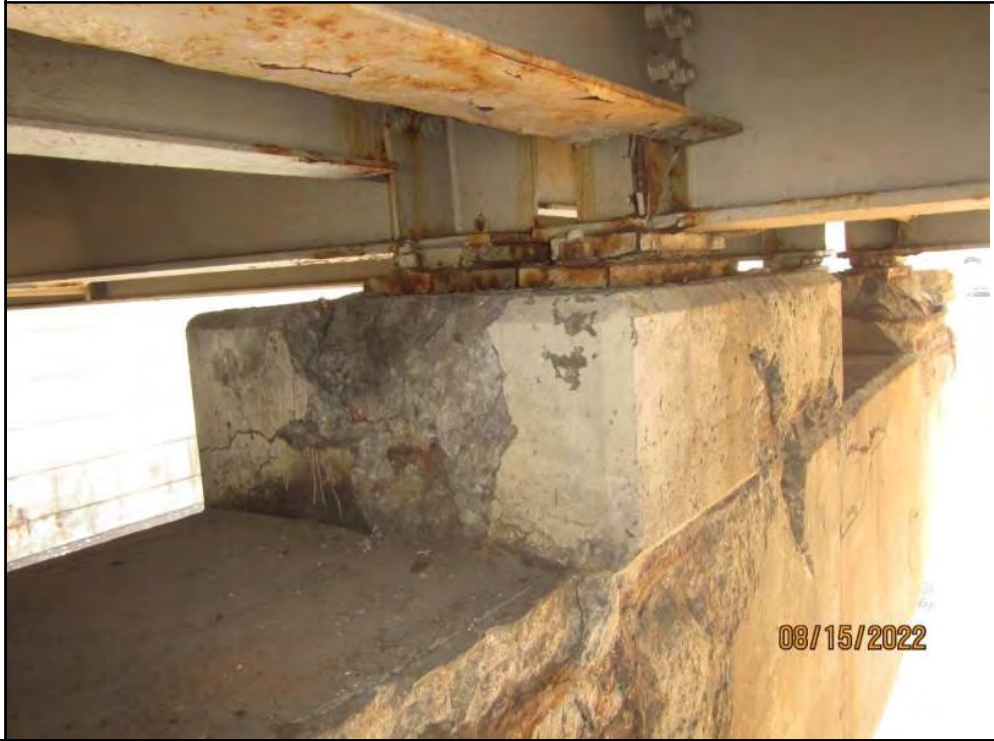
Photo Number: 14

Attachment Description:
Pier Pedestal 9, Begin
Face, Spall to Rebar

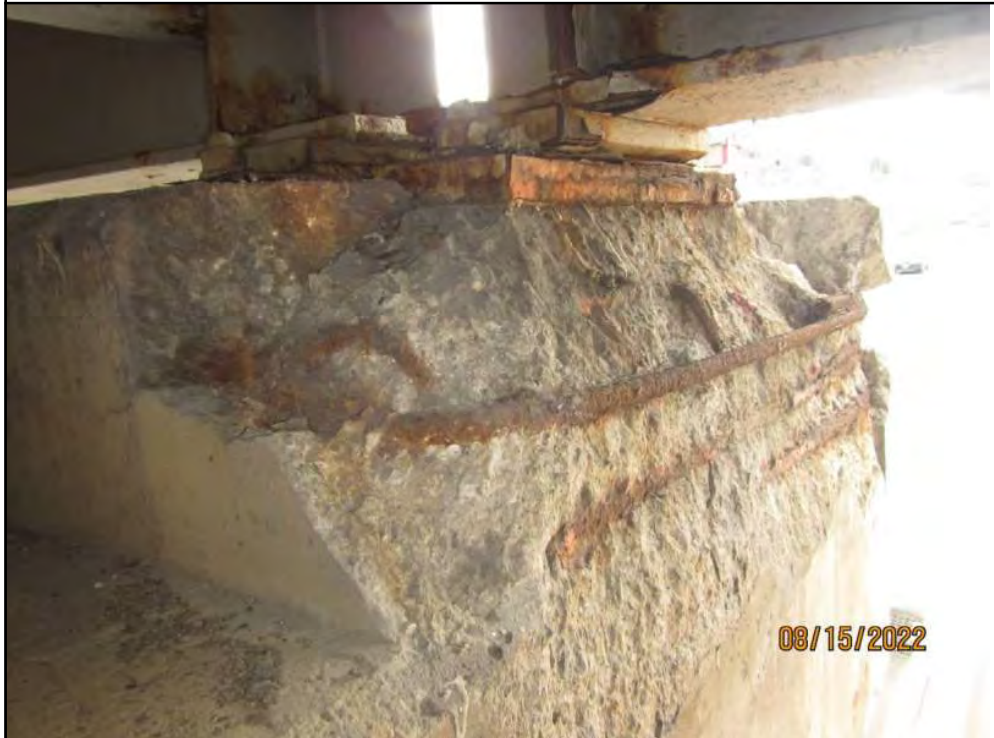
Photo Number: 15

Attachment Description:
Pier Cap, Begin Face,
Column Bay 3, Spall to
Rebar; Pier Pedestals 7 – 9,
Spall to Rebar; Pier Column
4, Spall to Rebar (Typical)

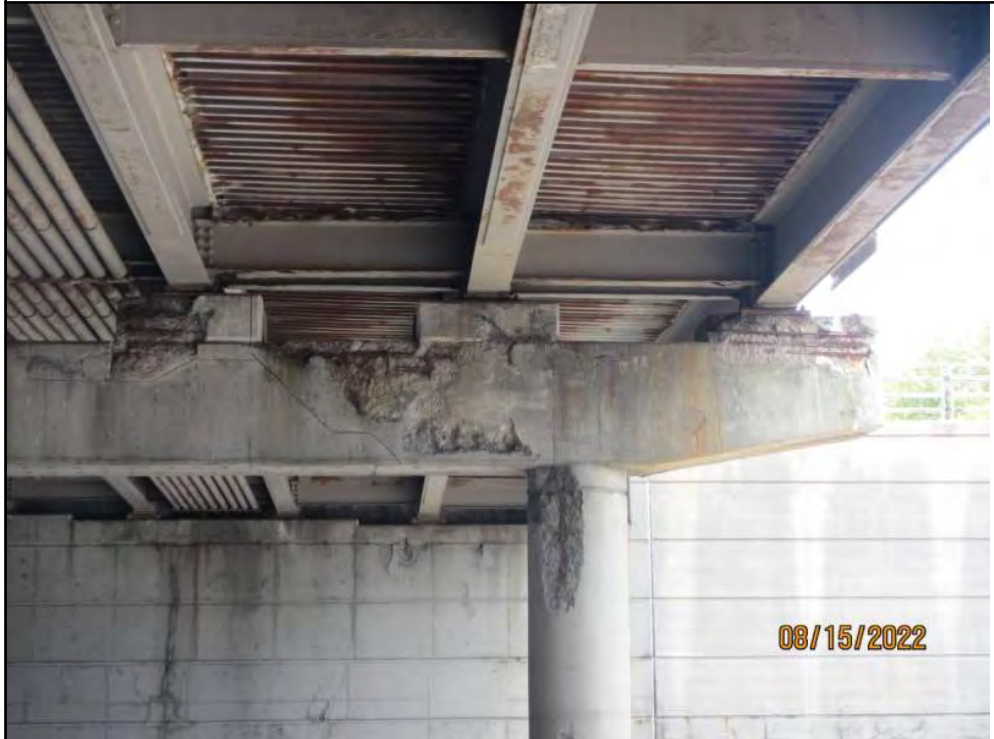
Photo Number: 16

Attachment Description:
Pier Cap, End Face,
Column Bay 2, Spall to
Rebar; Pier Pedestal 5,
Spall to Rebar; Pier
Columns 2 and 3, Spall to
Rebar (Typical)

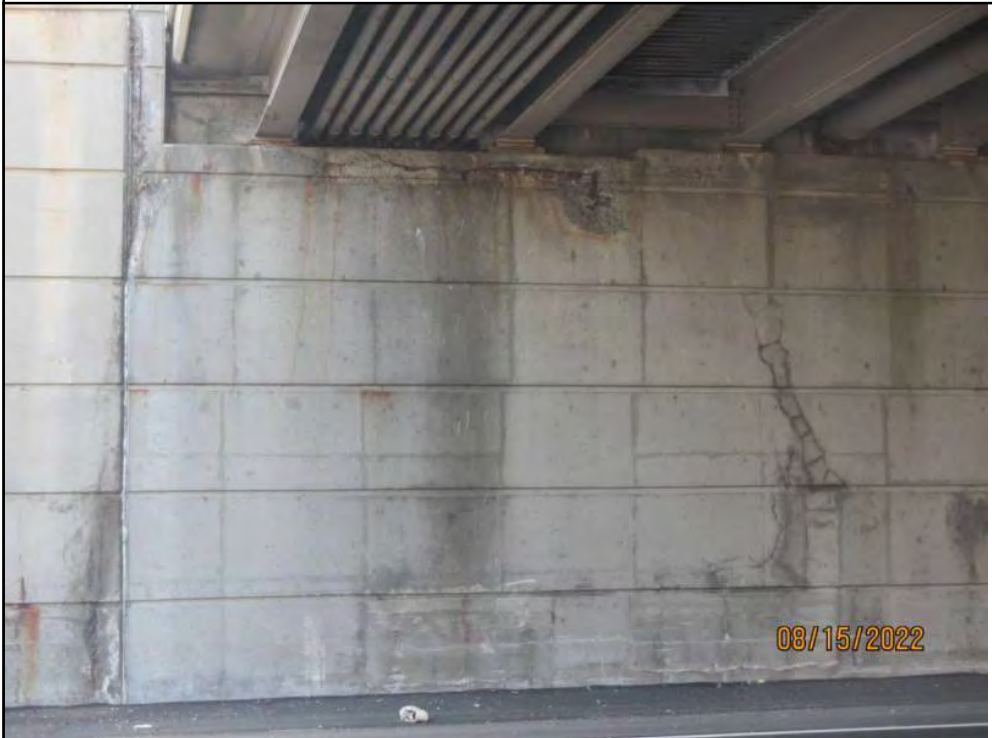
Attachment Description:
End Abutment, Left
Cheekwall and Bays 1 – 2,
Spall to Rebar

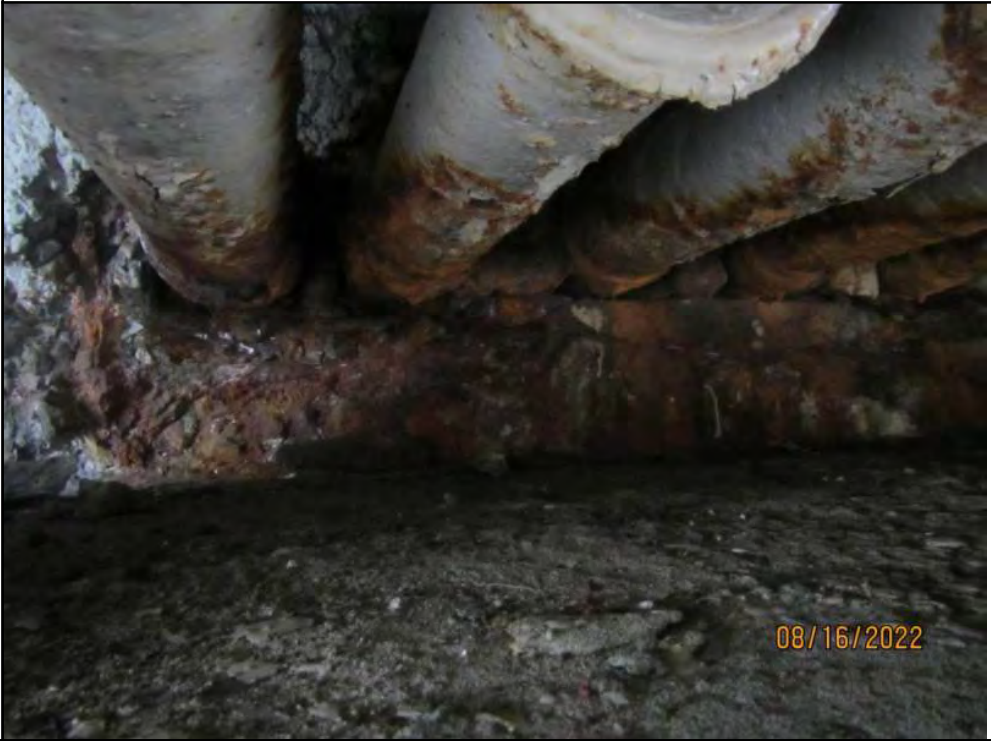
Photo Number: 19

Attachment Description:
End Backwall, Bay 1, Spall
to Rebar (Typical Bay 6)

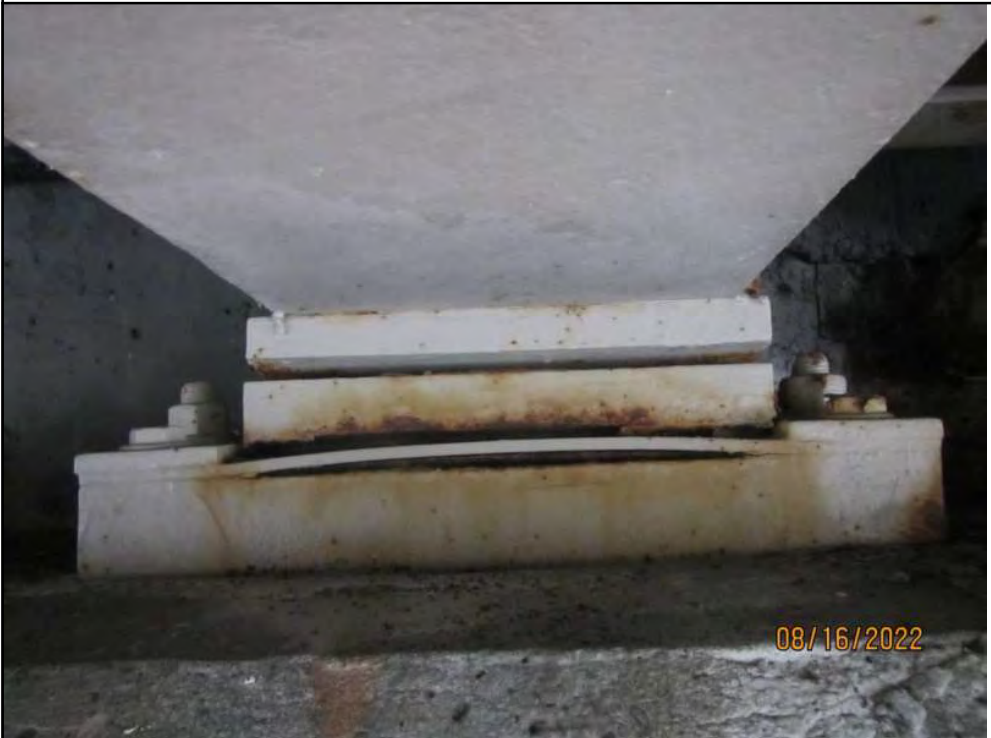
Photo Number: 20

Attachment Description:
End Abutment Bearing 6,
Pack Rust (Typical)

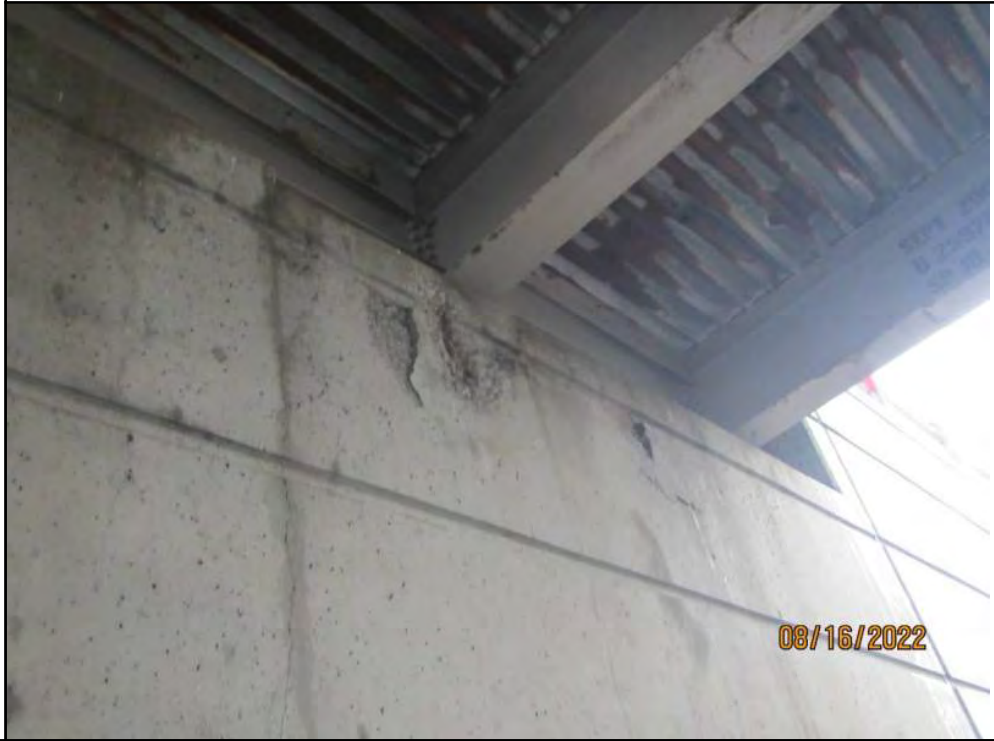
Photo Number: 21 Photo Filename: 22_021.JPG

Attachment Description:
End Abutment, Bays 7 – 8,
Spall to Rebar and
Delamination

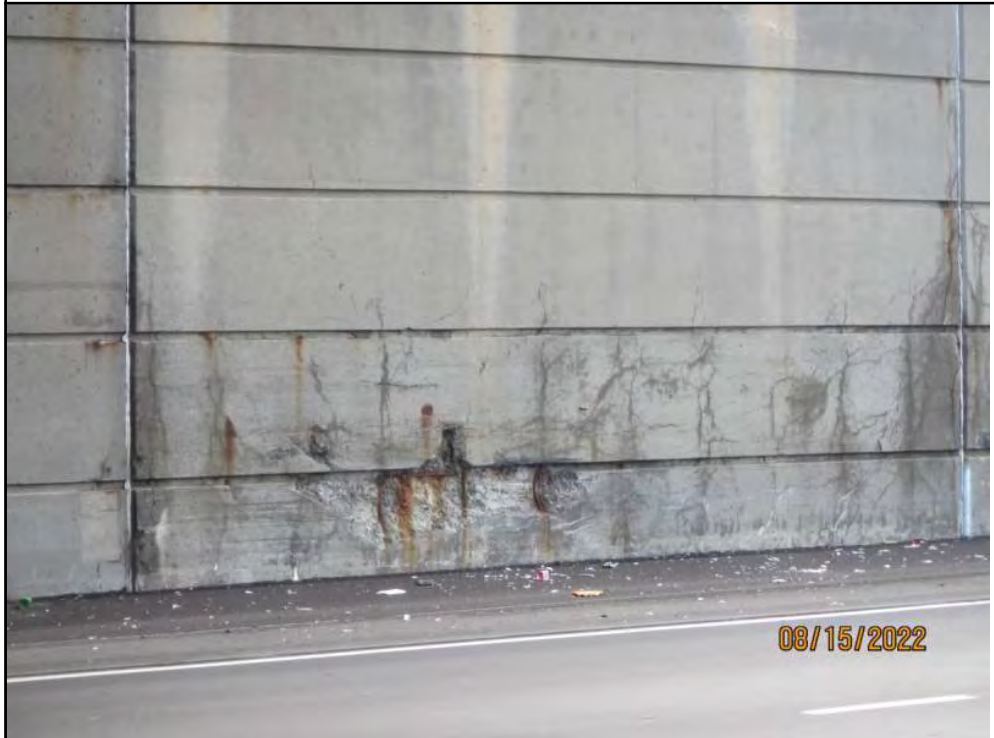
Photo Number: 22 Photo Filename: 22_022.JPG

Attachment Description:
End Right Wingwall, Cracks
and Spall to Rebar

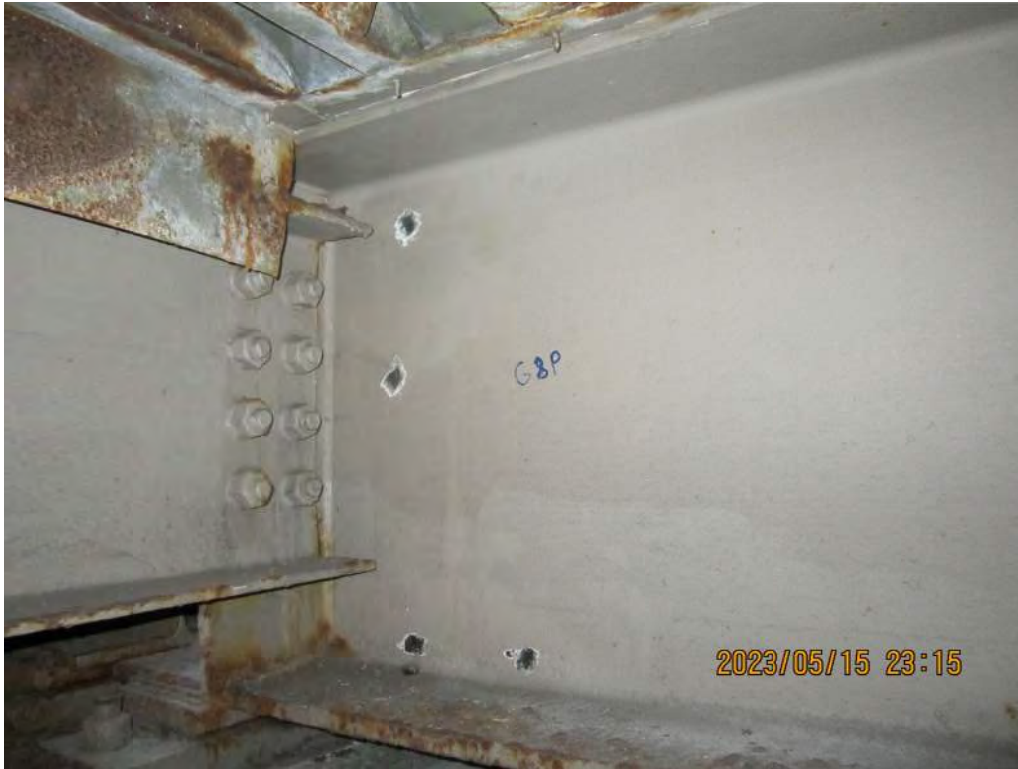
PHOTO 1:

LOCATION:
G8 IN SPAN 1 AT PIER

DESCRIPTION:
GIRDER END CONDITION
PHOTO (WORST CASE
FULL HEIGHT)

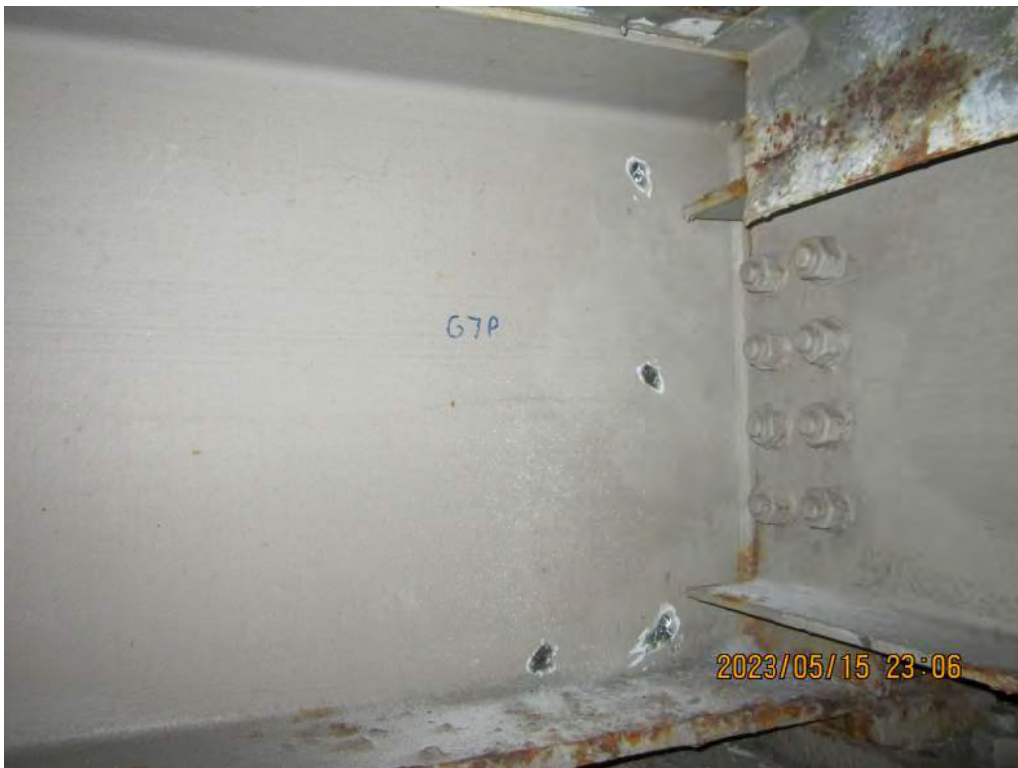
PHOTO 2:

LOCATION:
G7 IN SPAN 1 AT PIER

DESCRIPTION:
GIRDER END CONDITION
PHOTO (WORST CASE
BEARING AREA)

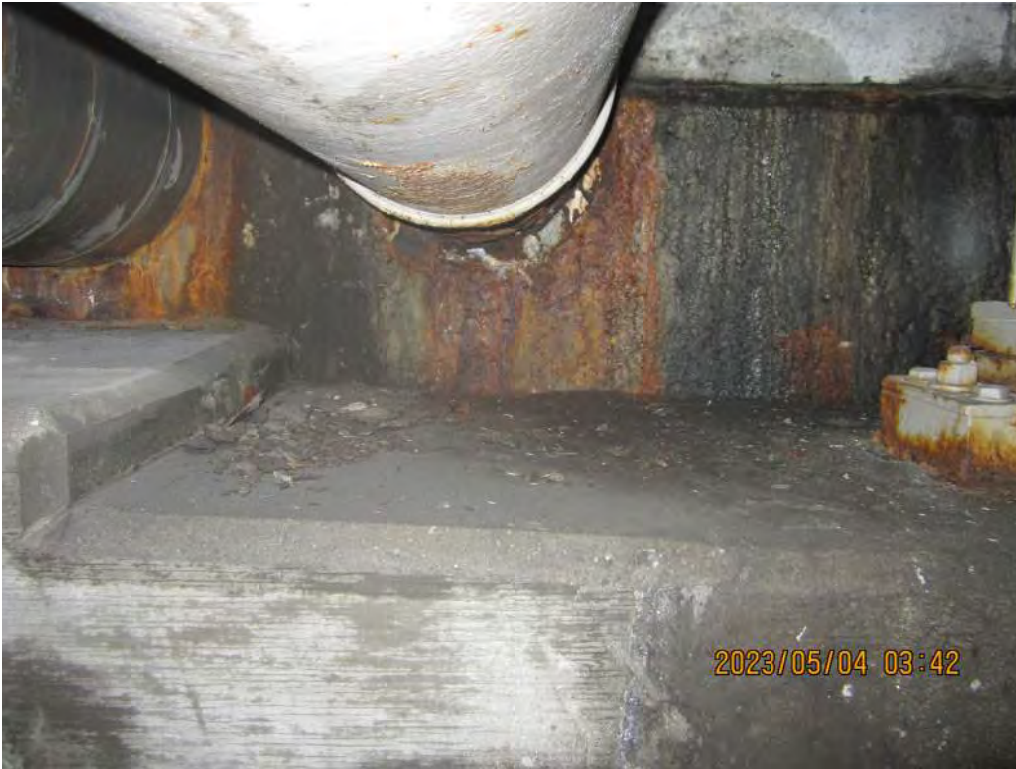
PHOTO 3:

LOCATION:
END ABUTMENT

DESCRIPTION:
LEAKAGE AND RUST
STAINING TO
CONCRETE
ABUTMENT/BACKWALL
AT UTILITY LOCATIONS

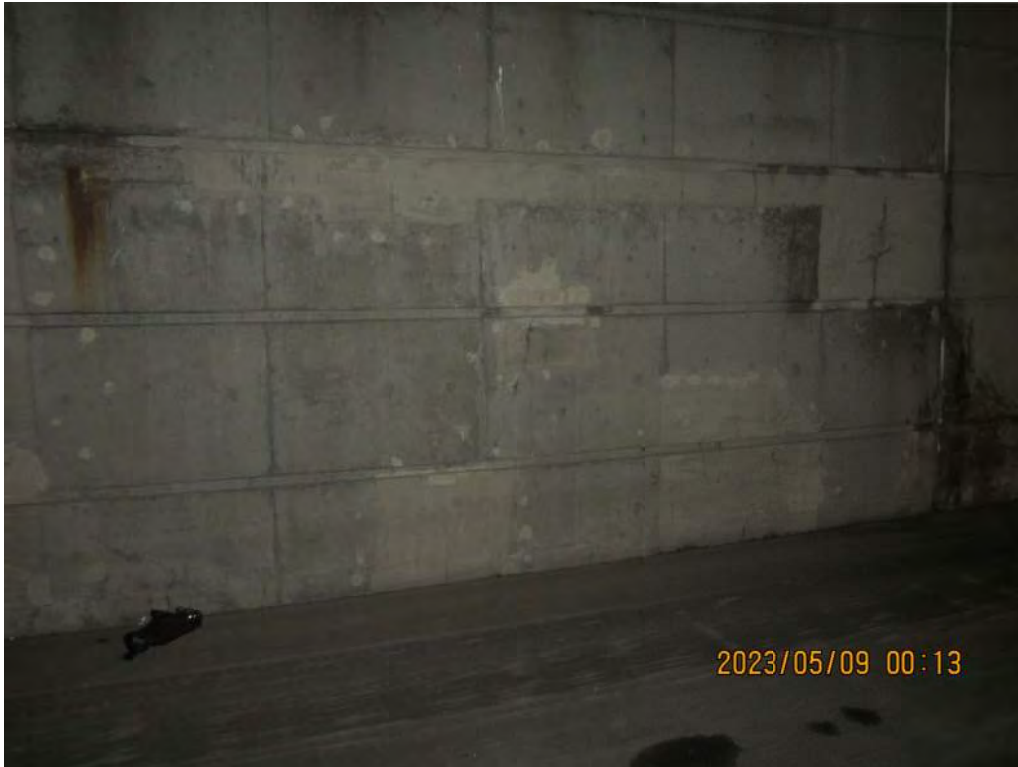
PHOTO 5:

LOCATION:
BEGIN ABUTMENT

DESCRIPTION:
GENERAL CONDITION
PHOTO

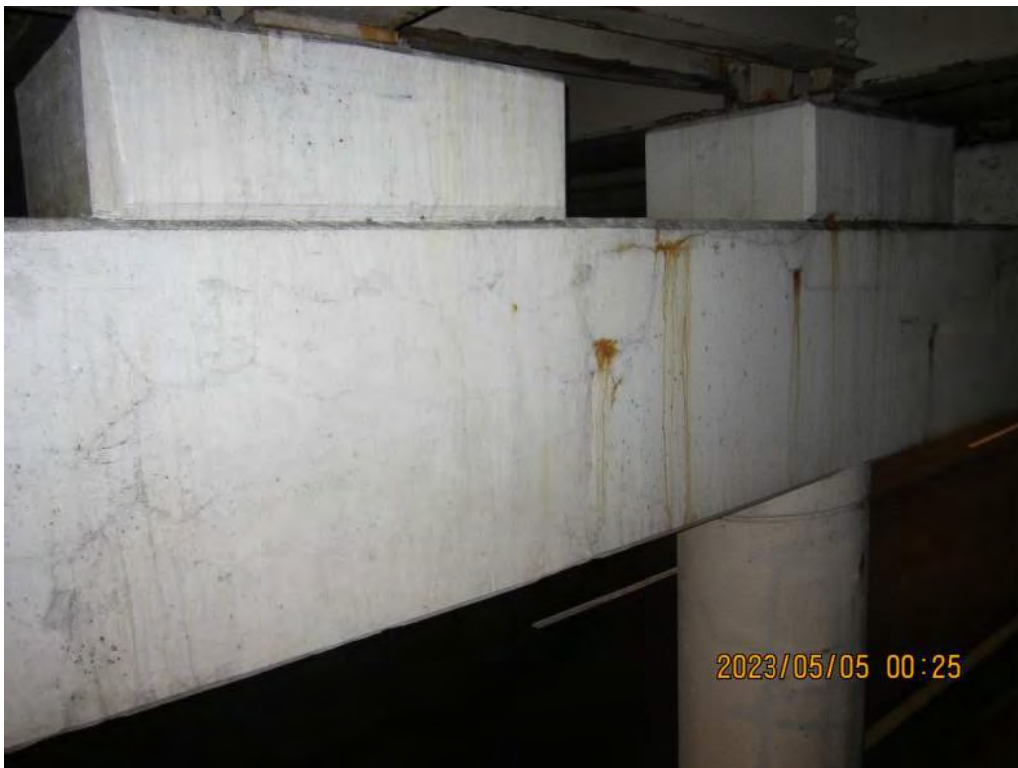
PHOTO 6:

LOCATION:
CONCRETE PIER CAP
AND PEDESTALS

DESCRIPTION:
MINOR MAP CRACKING
TO CONCRETE FACES

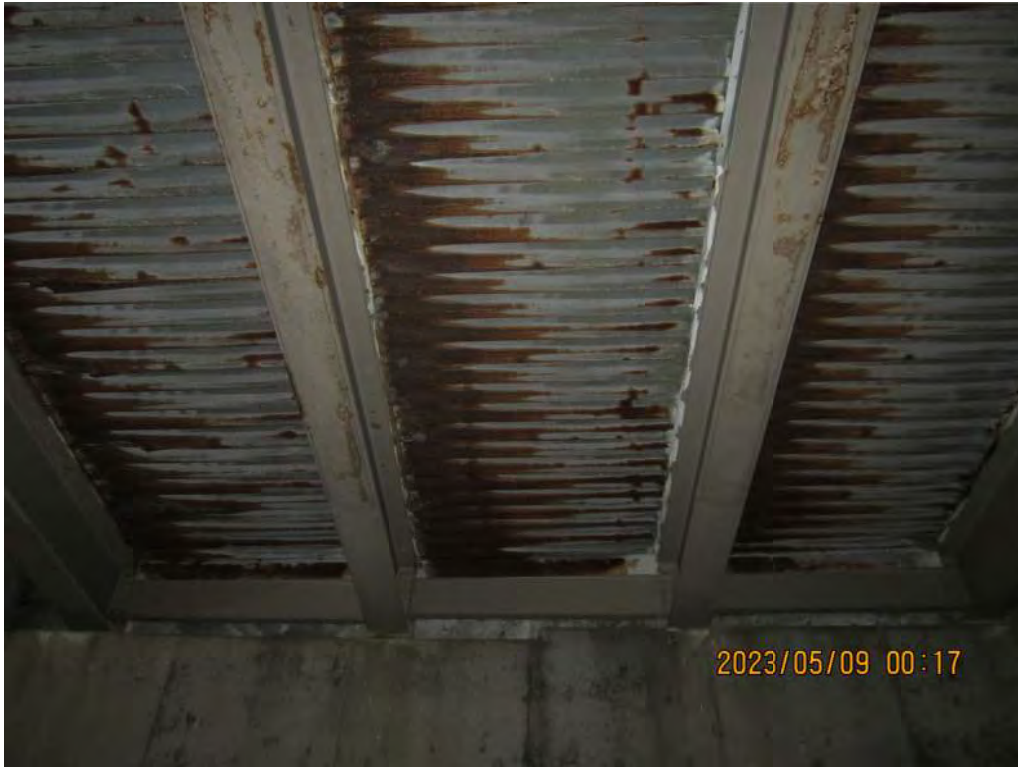
PHOTO 9:

LOCATION:
UNDERSIDE OF DECK IN
SPAN 1

DESCRIPTION:
TYPICAL DECK
CONDITION PHOTO,
SIGNIFICANT RUSTING
TO STAY-IN-PLACE
FORMS

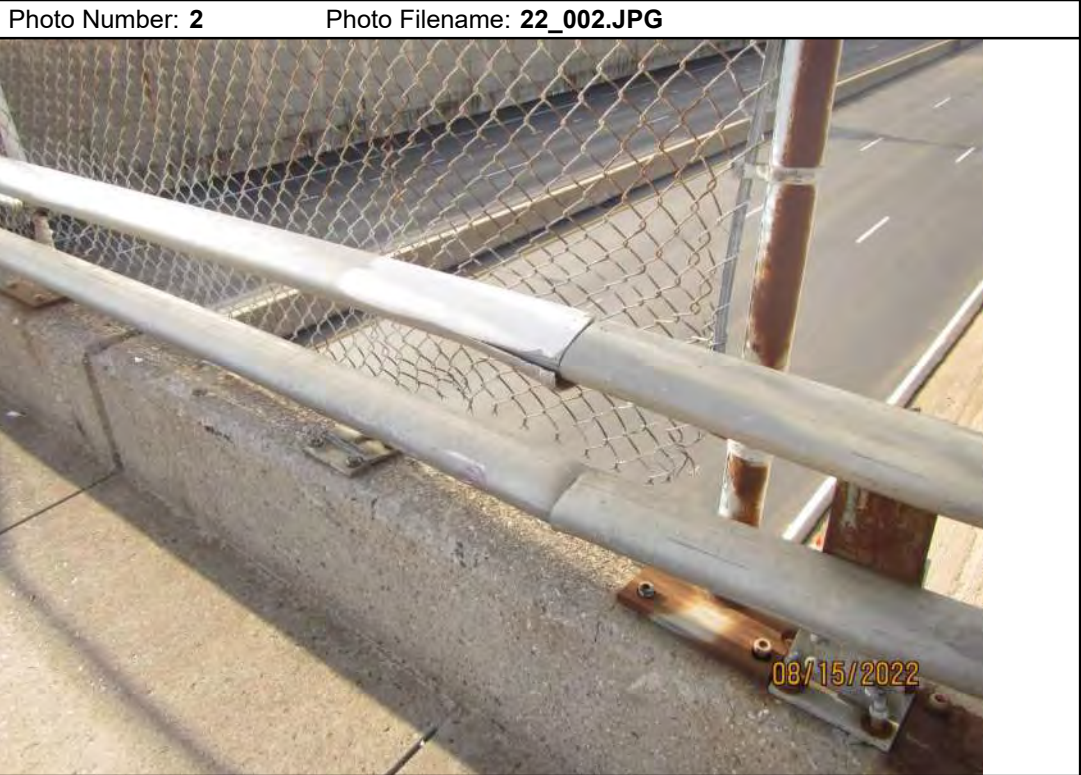
Photo Number: 3 Photo Filename: 22_003.JPG

The steel railing has impact damage at the begin right approach. One post is missing which leaves a 13 foot long section of the two rail system without support.

Attachment Description:
Begin Span 1, Right Railing,
Impact Damage

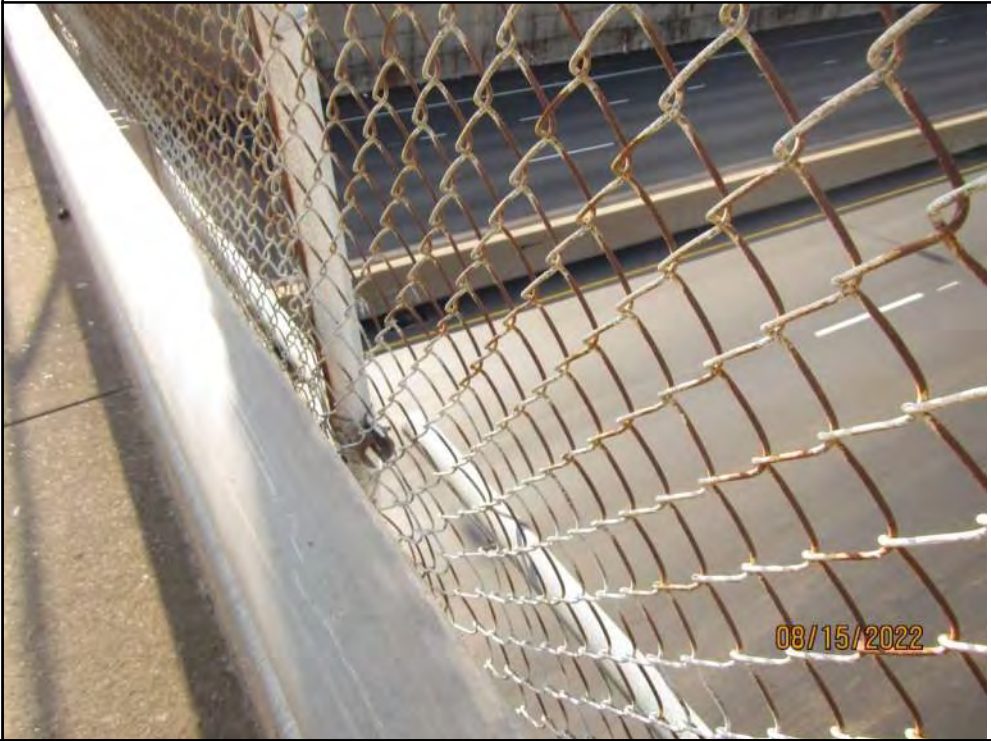
Photo Number: 4 Photo Filename: 22_004.JPG

The begin right bottom pedestrian rail is disconnected and loose.

Attachment Description:
(NSCO) Pedestrian Fence,
Begin Span 1, Right,
Bottom Rail Disconnected
from Post

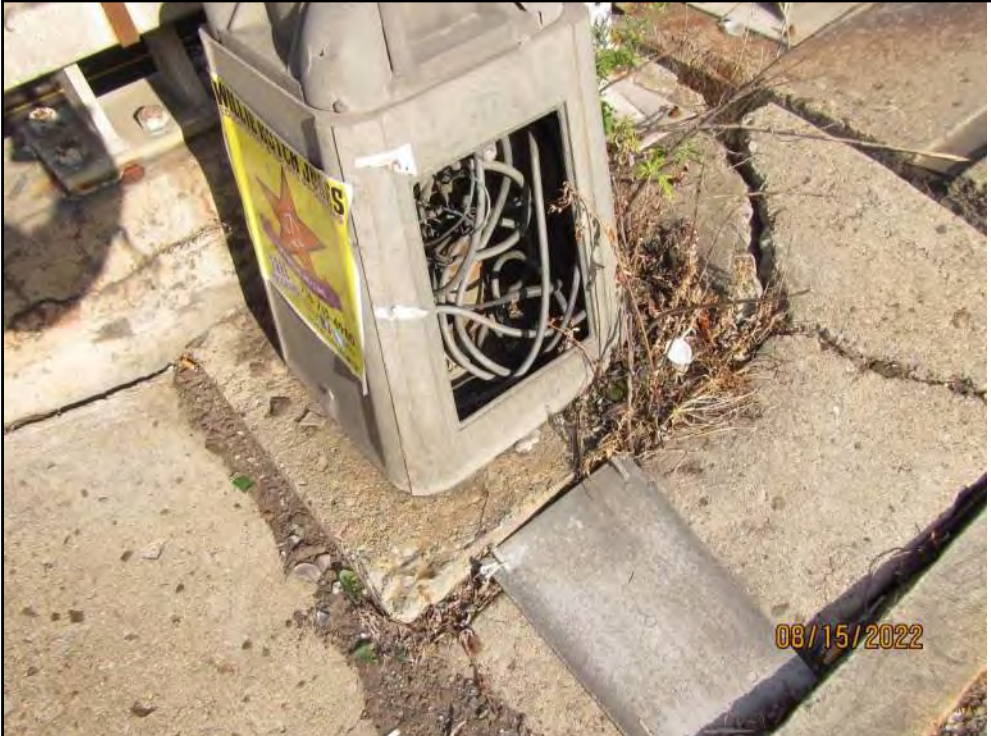
Photo Number: 5 Photo Filename: 22_005.JPG

Attachment Description:
(NSCO) Approach Light
Post, End Right, Wires
Exposed

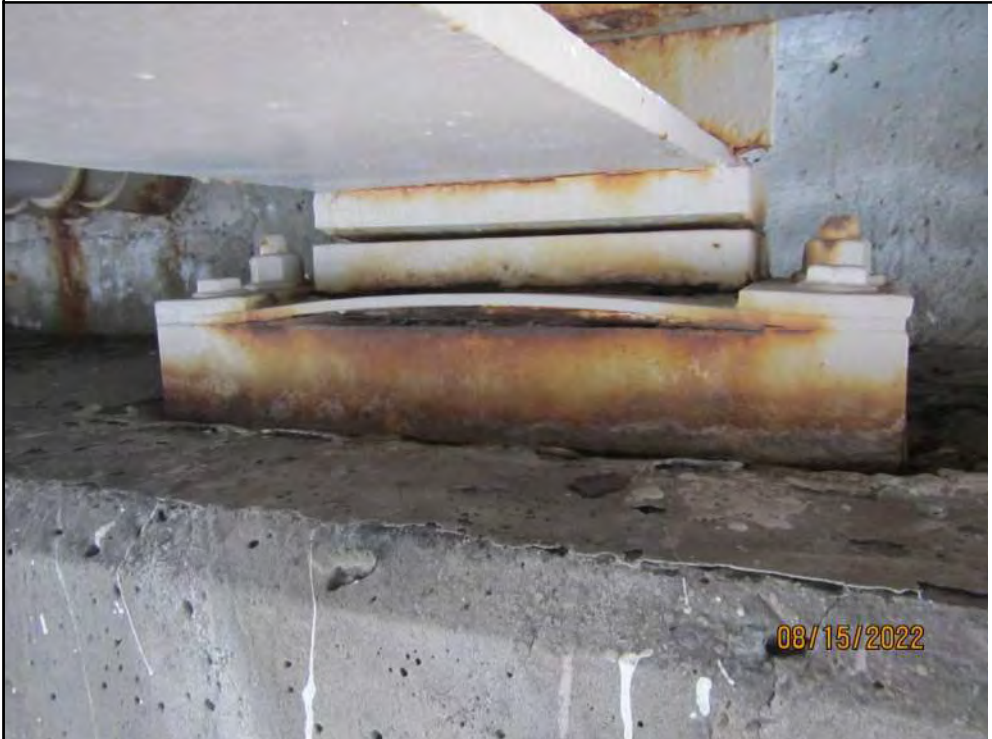
Photo Number: 6 Photo Filename: 22_006.JPG

| | TQ | CS-1 | CS-2 | CS-3 | CS-4 | CS-5 |
|--|---|---|---|---|---|---|
| Begin and end bearings have 1/4" to 1/2" of pack rust between bronze slider and masonry plates. All bearings are over expanded and slightly skewed, the worst condition is along the begin abutment where the bearings have at least 1" of displacement. | | | | | | |

Attachment Description:
Begin Abutment Bearing 2,
Pack Rust Under Sliding
Plate and Paint Failure

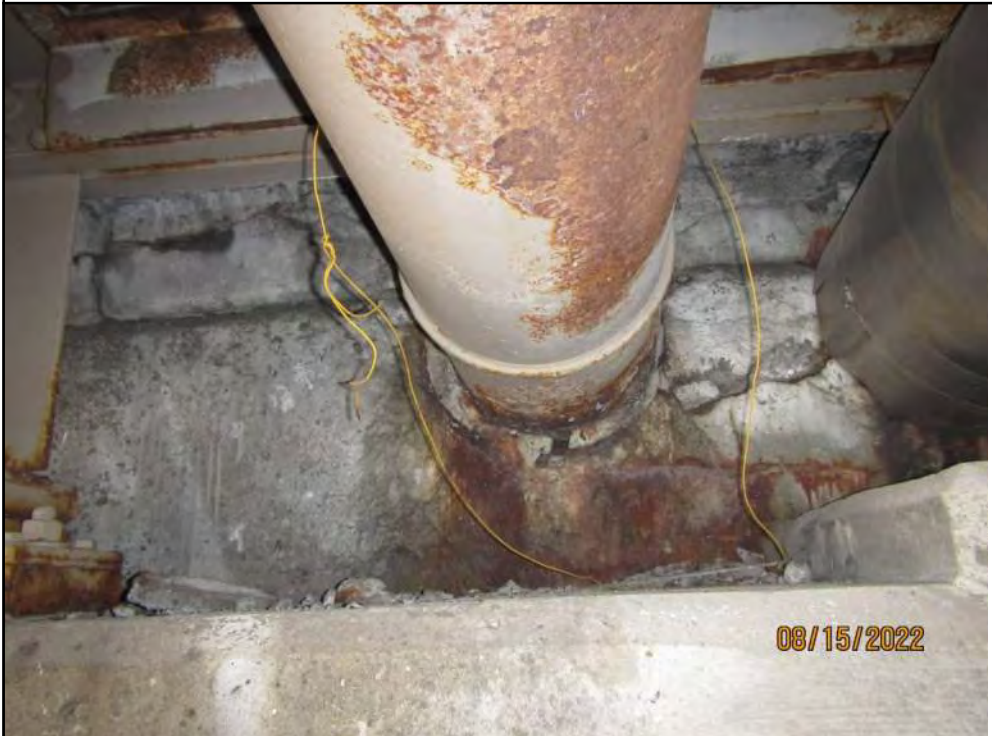
Photo Number: 7 Photo Filename: 22_007.JPG

The begin backwall under a utility pipe in bay 5 has a 2'x2' area of cracks and spalling, no exposed rebar.

Attachment Description:
Begin Backwall, Bay 5,
Cracks and Spall

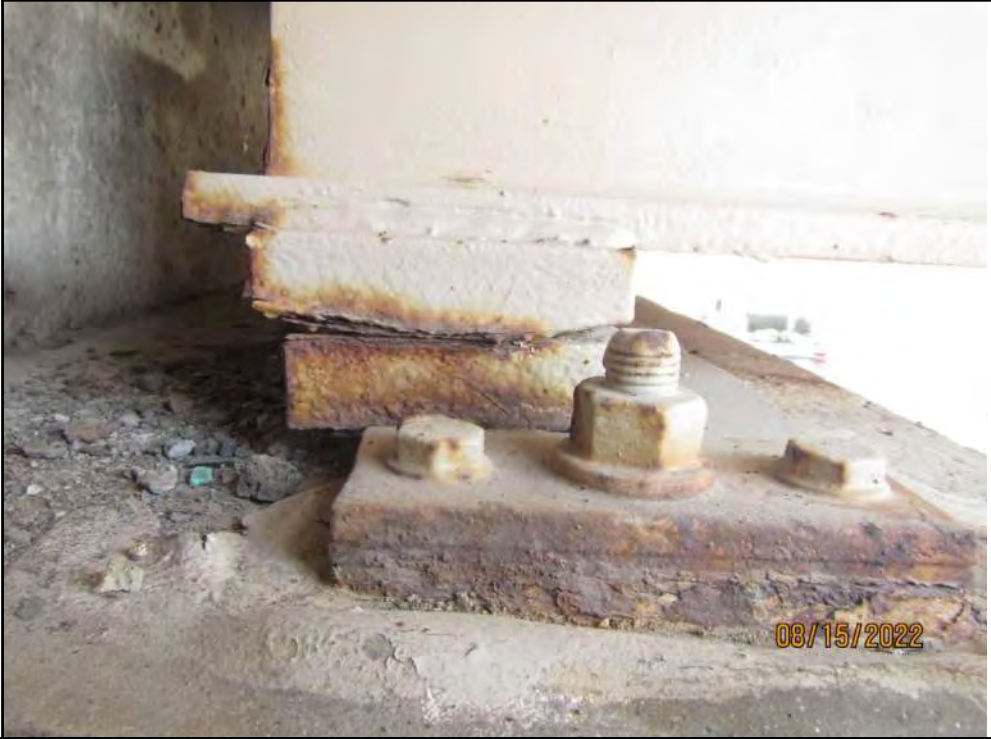
Photo Number: 8 Photo Filename: 22_008.JPG

Attachment Description:
Begin Abutment Bearing 9,
Overexpanded (Typical)

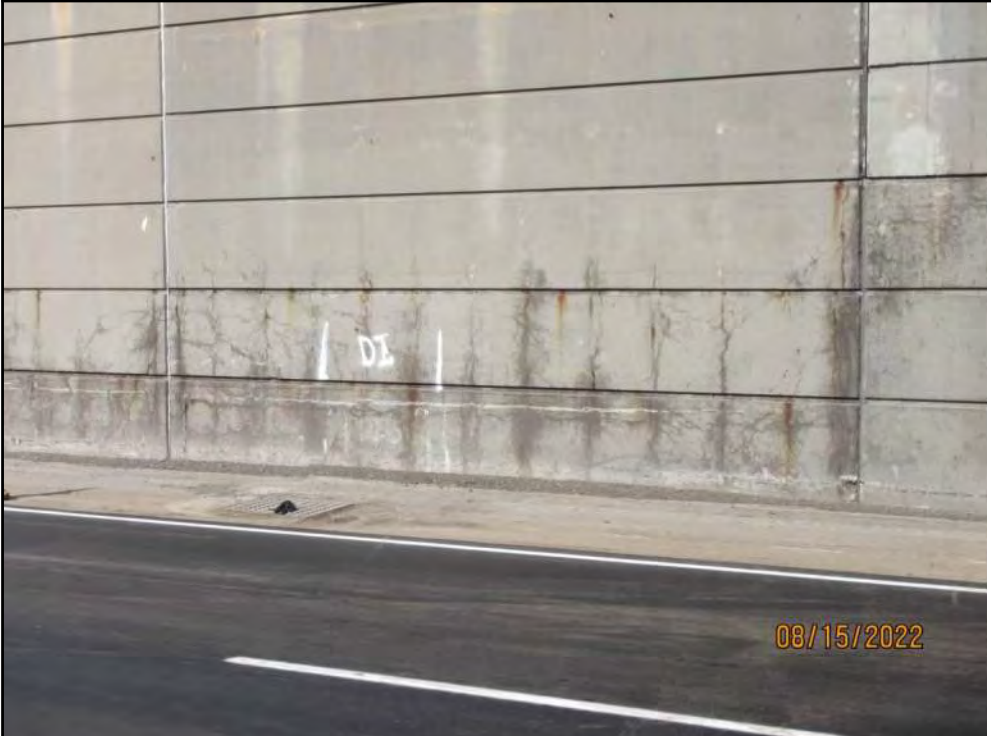
Photo Number: 9 Photo Filename: 22_009.JPG

The lower portion of the begin right wingwall has a 5'x2' area of cracking and delamination. The lower portion of the end left and end right wingwall has a 5'x2' area of small spalls to rebar, delaminations and rust stained concrete.

Attachment Description:
Begin Right Wingwall,
Cracks with Efflorescence
and Rust Staining

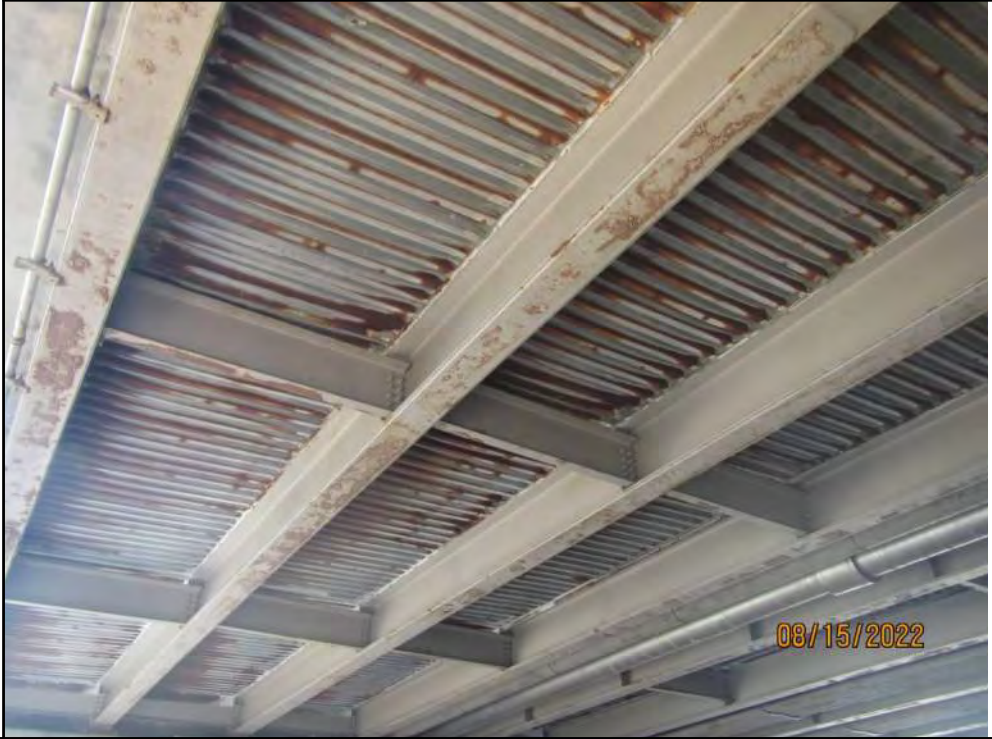
Photo Number: 10 Photo Filename: 22_010.JPG

| | TQ | CS-1 | CS-2 | CS-3 | CS-4 | CS-5 |
|--|---|---|---|---|---|---|
| The underside of the bottom flange of the girders and secondary members has paint failure, G1 and G2 are in the worst condition. The beam ends at the pier have paint failure and section loss. | | | | | | |

Attachment Description:
Span 1, G6 – G9, Bottom
Flange, Paint Failure; Bays
6 – 8, SIP Form, Corrosion
(Typical)

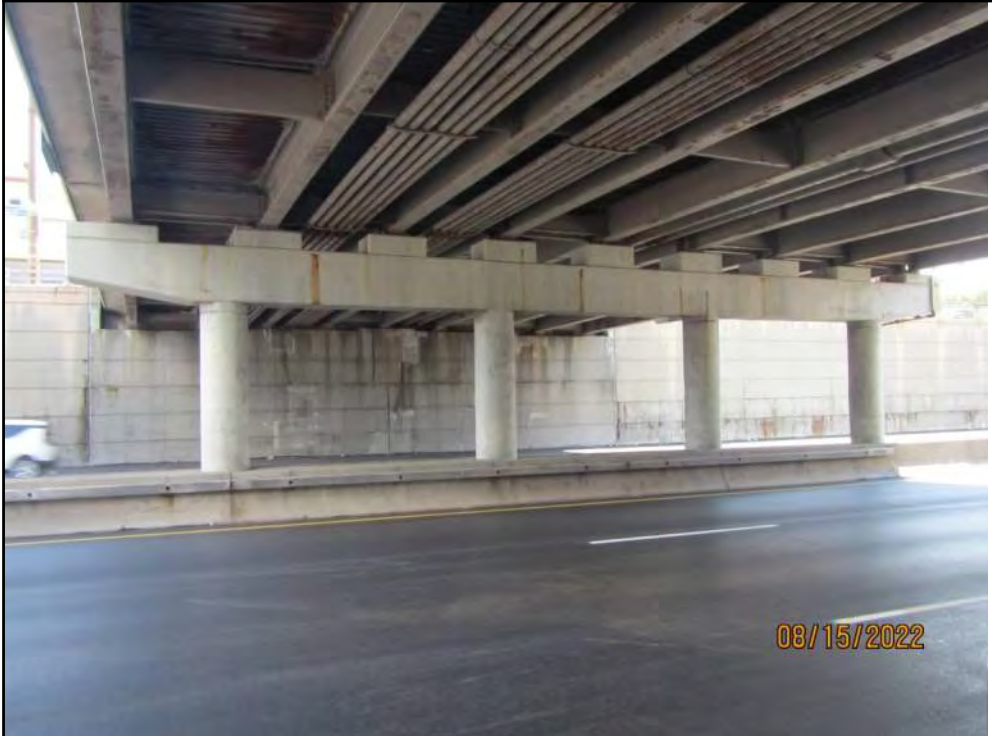
Photo Number: 11

Attachment Description:
Pier Cap, Begin Face, Rust
Staining

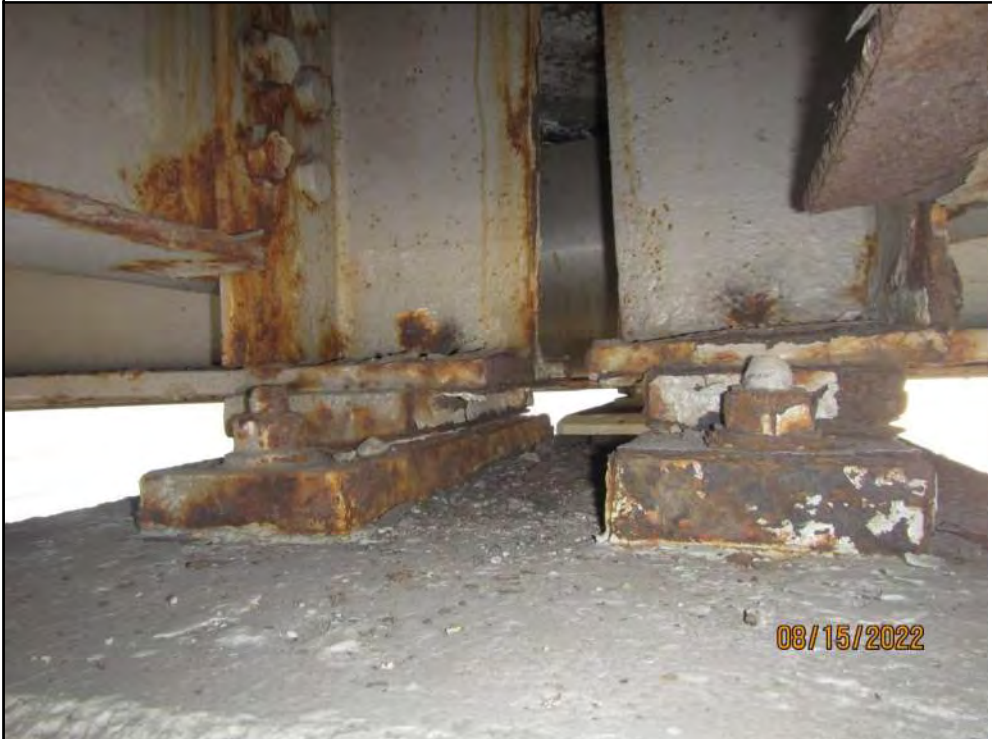
Photo Number: 12

The begin and end bearing have paint failure but no section loss. The pier bearing at the begin has paint failure and section loss at G3 to G9 and at the end G2 and G4.

Attachment Description:
Pier Bearing 5, Paint Failure
and Section Loss

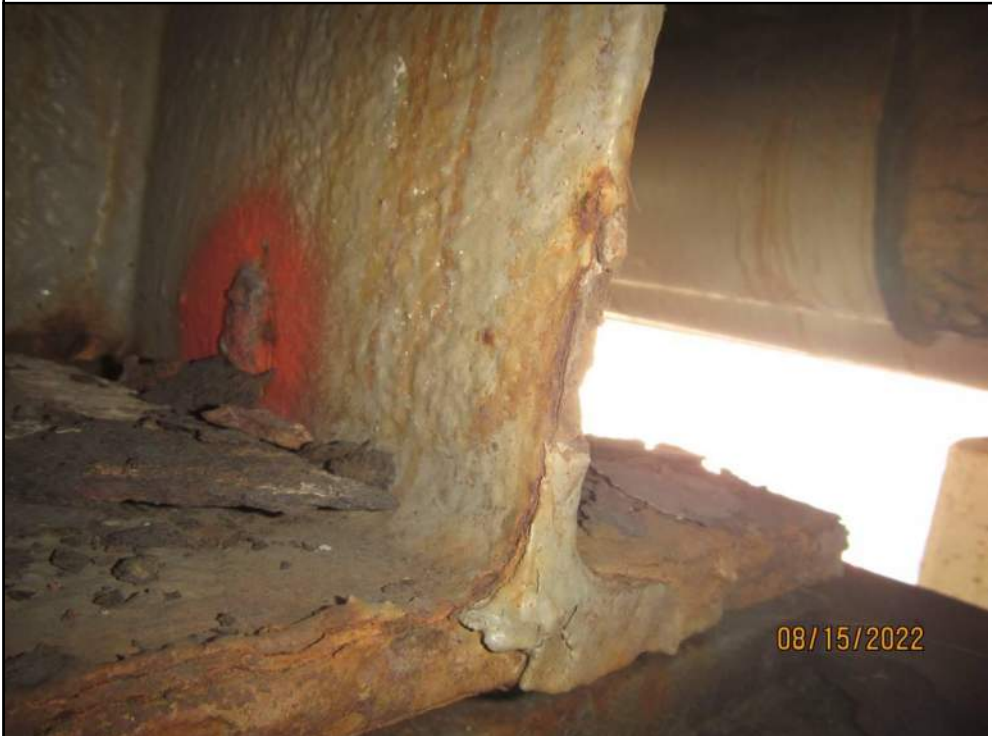
Photo Number: 13

Attachment Description:
End Span 1, G6 Beam End,
Section Loss

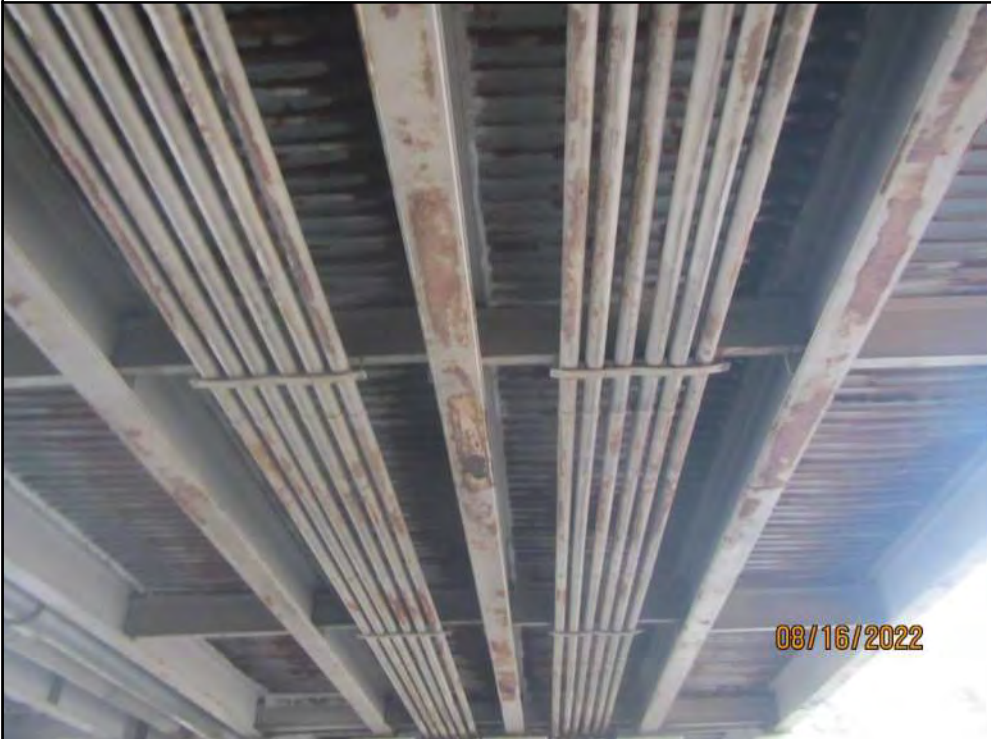
Photo Number: 14

Attachment Description:
Span 2, G2 – G4, Bottom
Flange, Paint Failure; Bays
1 – 4, SIP Form, Corrosion
(Typical)

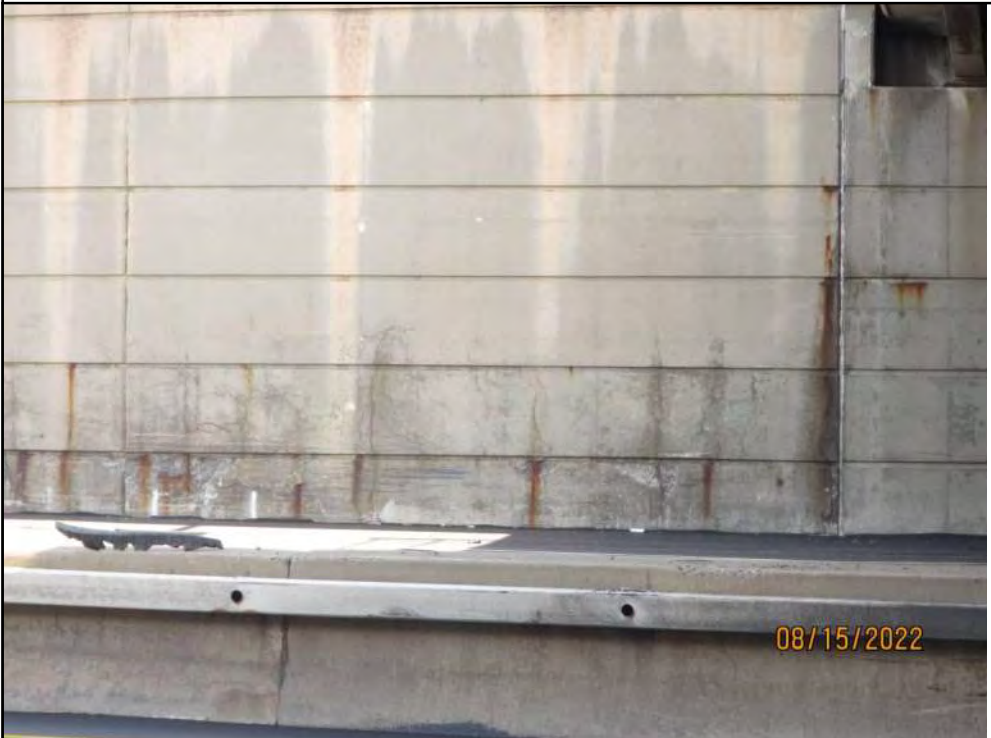
Photo Number: 15

Attachment Description:
End Left Wingwall, Spalls to
Rebar and Cracks with Rust
Staining

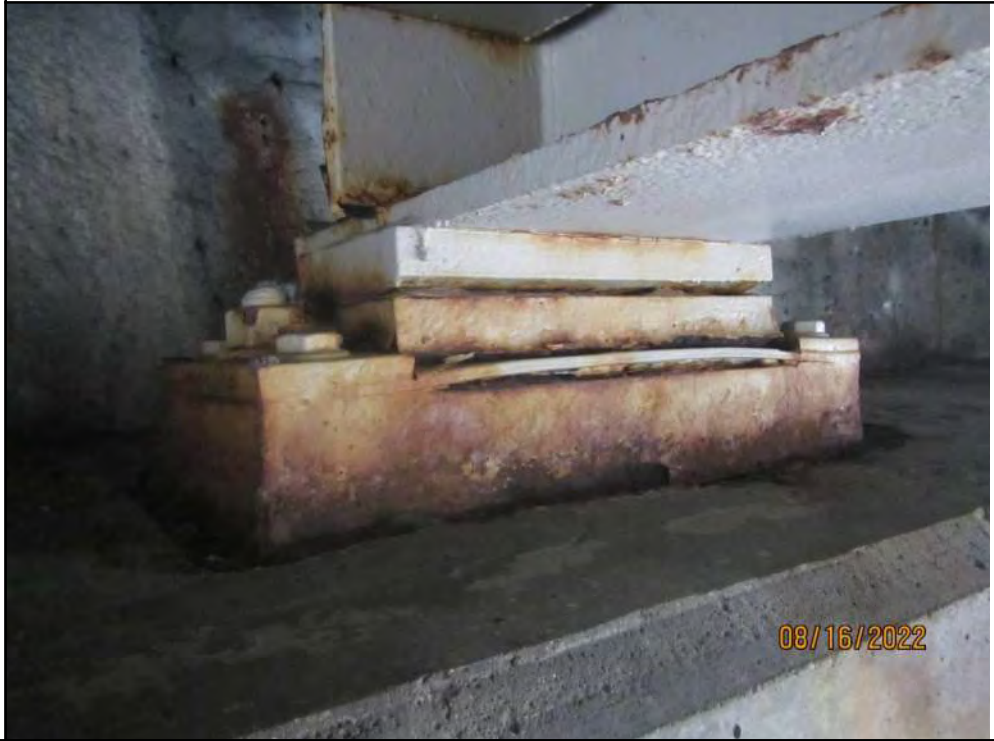
Photo Number: 16

Attachment Description:
End Abutment Bearing 8,
Pack Rust Under Sliding
Plate and Paint Failure
