Bridge Inspection Reports and Work History Summaries

**NY33 BRIDGE CONDITION VERIFICATION 2023
KENSINGTON EXPRESSWAY PROJECT
PIN 5512.52
CITY OF BUFFALO, ERIE COUNTY
BIN 1022609**

STRUCTURE: BIN 1022609 - Best Street on NY33 Kensington Expressway

STRUCTURE TYPE: Four (4) span Steel, Multi-Stringer (12 beams) structure with concrete abutments founded on piles and 3-six column piers with spread footings. Year Built: 1959

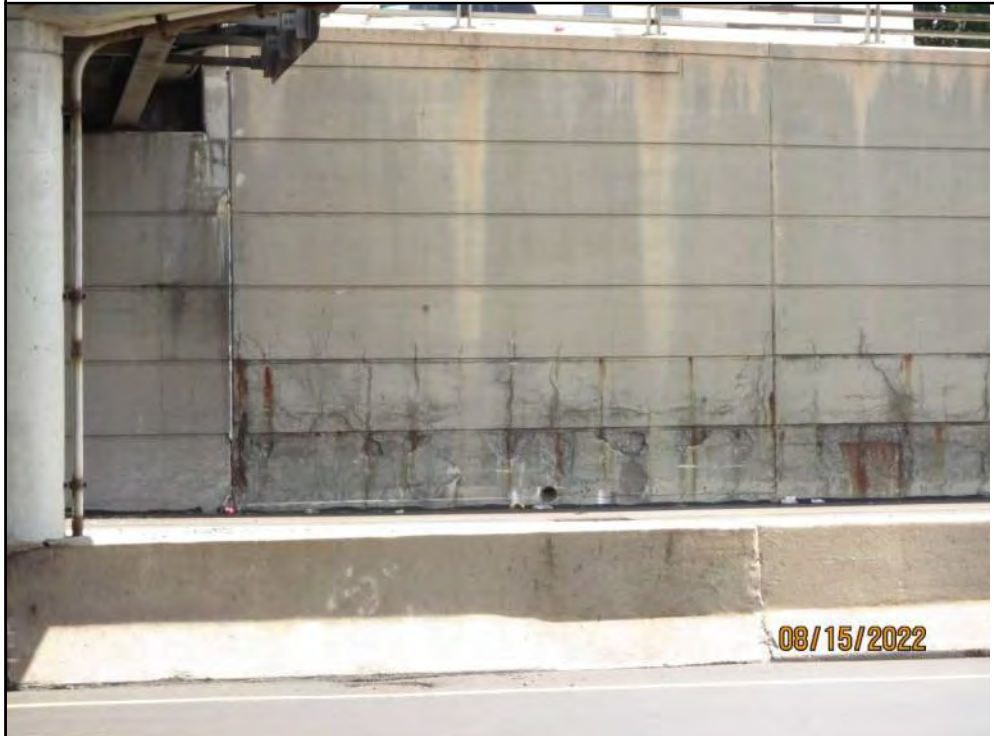
Attachment Description:
End Right Wingwall, Spalls
to Rebar and Cracks with
Rust Staining
