Appendix A4

Bridge Inspection Reports and Work History Summaries

**NY33 BRIDGE CONDITION VERIFICATION 2023
KENSINGTON EXPRESSWAY PROJECT
PIN 5512.52
CITY OF BUFFALO, ERIE COUNTY
BIN 1022609**

STRUCTURE: BIN 1022609 - Best Street on NY33 Kensington Expressway

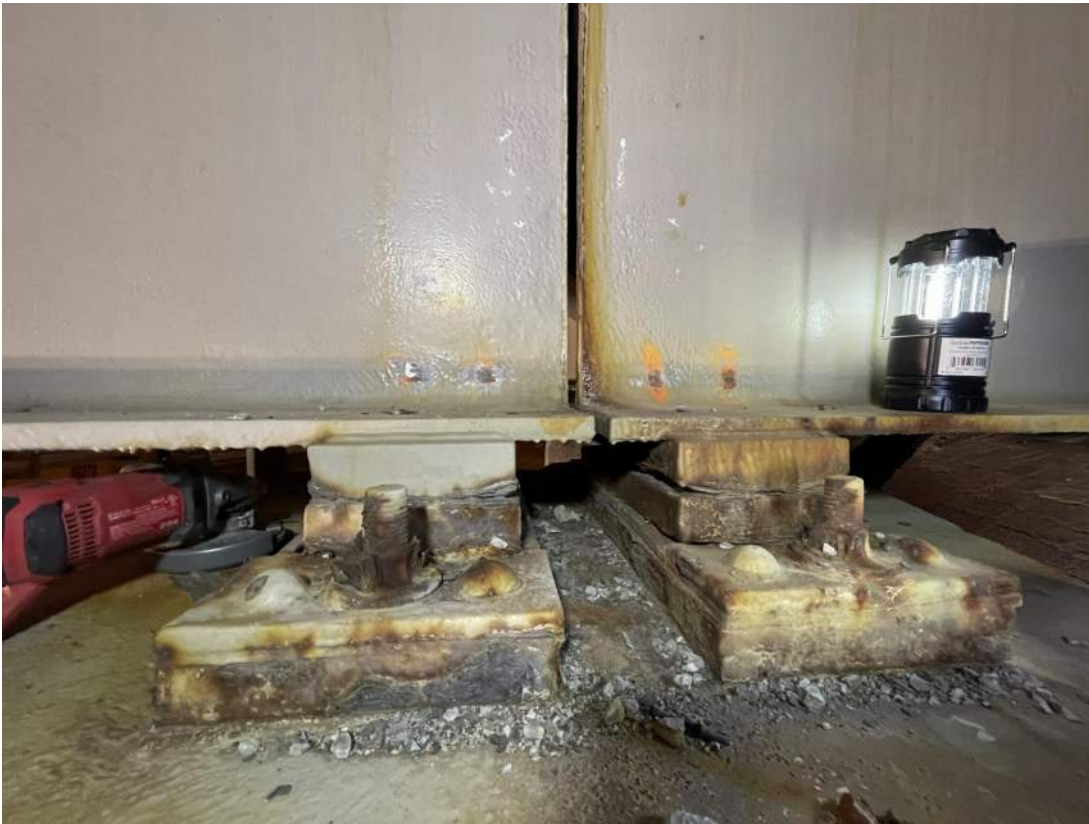
PHOTO 1

LOCATION:
G1 IN SPANS 1 & 2 AT
PIER

DESCRIPTION:
BEARING AREA
SECTION LOSS
MEASUREMENT
LOCATIONS

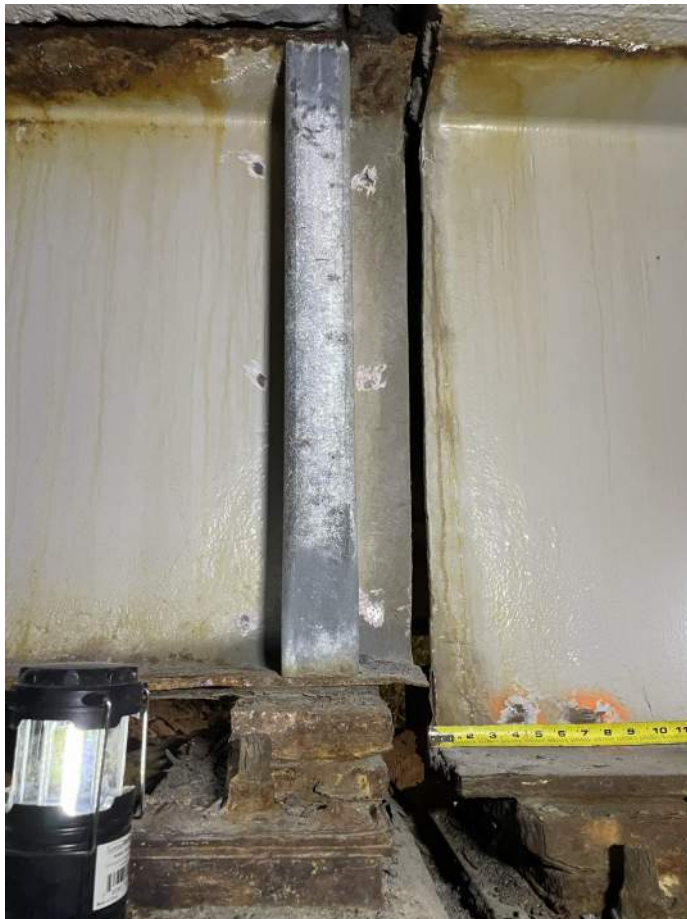
PHOTO 6

- The average full height web section loss, excluding the bearing area, was found to range from 13% - 53%. The maximum full height web section loss was determined to be in Span 1 at G6 and G10 locations with 44% and 53% losses, respectively.

LOCATION:
G6 IN SPANS 1 & 2 AT
PIER

DESCRIPTION:
FULL-HEIGHT
SECTION LOSS
MEASUREMENT
LOCATIONS

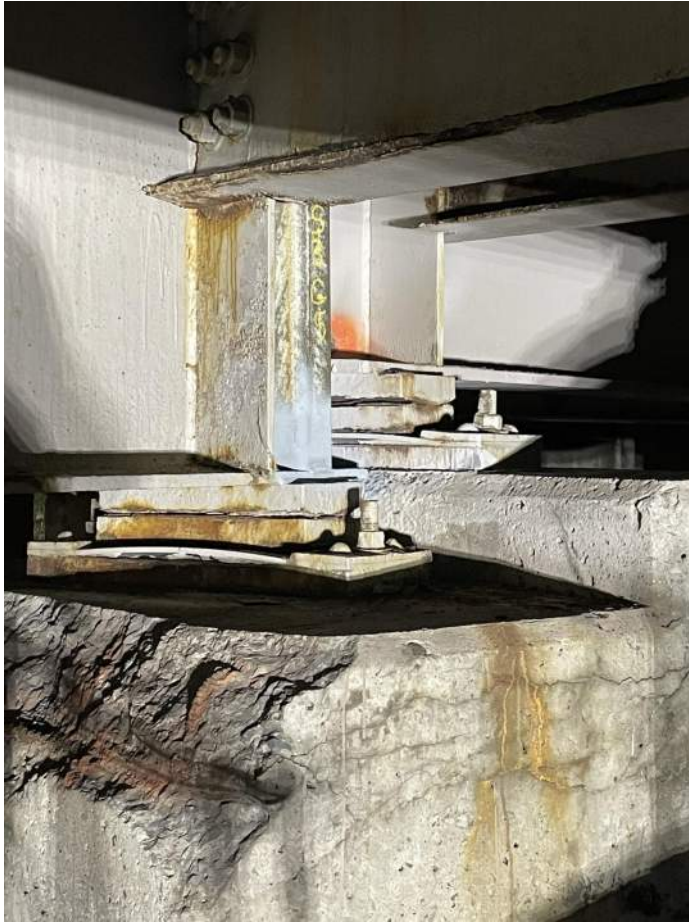
PHOTO 15

LOCATION:
G5 IN SPANS 3 & 4 AT
PIER

DESCRIPTION:
BEARING
CONDITIONS WITH
PREVIOUSLY
INSTALLED TUBE
STIFFENER

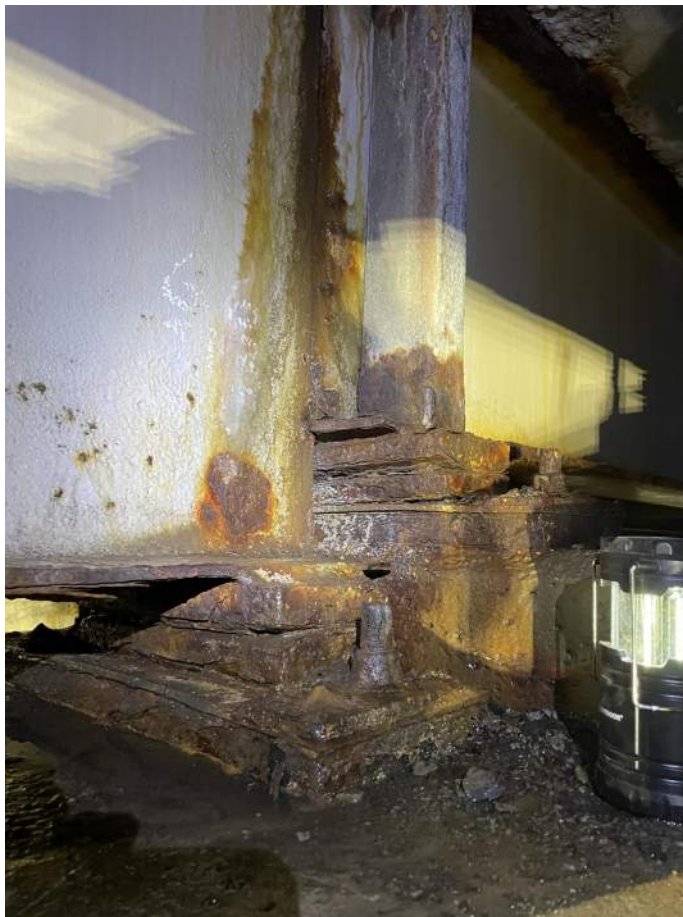
PHOTO 18

- Several expansion bearings had pack rust noted between plates causing the sliding bronze plates to bow upwards in the center and likely cause the bearing to not function as originally designed. In the 2022 inspection report, this condition was reported as Poor (CS3) for all 48 expansion bearings.

LOCATION:
G6 IN SPANS 3 & 4 AT
PIER

DESCRIPTION:
HEAVILY RUSTED
AND
OVEREXTENDED
EXPANSION
BEARINGS

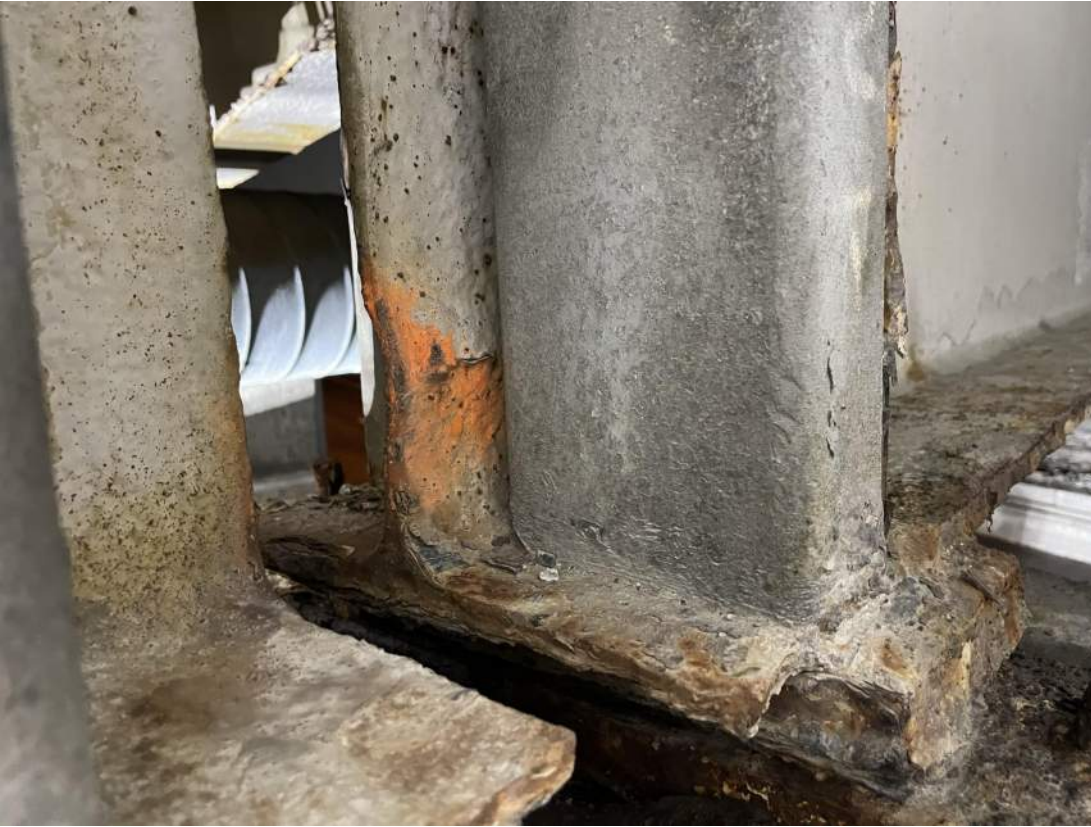
PHOTO 19

LOCATION:
G6 IN SPANS 2 & 3 AT
PIER

DESCRIPTION:
WEB CRIPPLE
ADJACENT TO
TEMPORARY WEB
SUPPORT

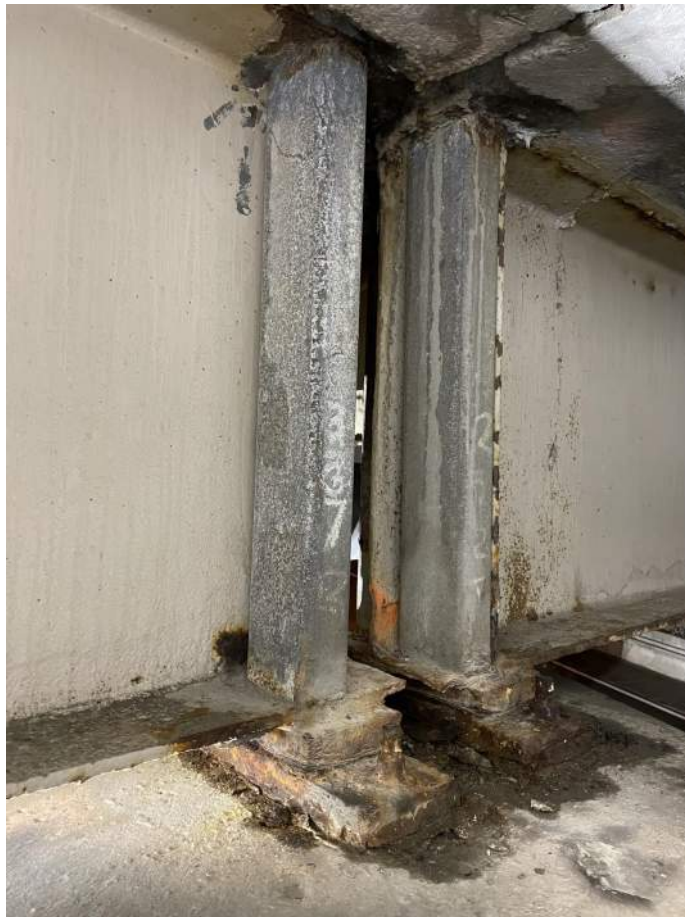
PHOTO 20

LOCATION:
G6 IN SPANS 2 & 3 AT
PIER

DESCRIPTION:
TYPICAL 3" x 5" TUBE
TEMPORARY WEB
SUPPORT

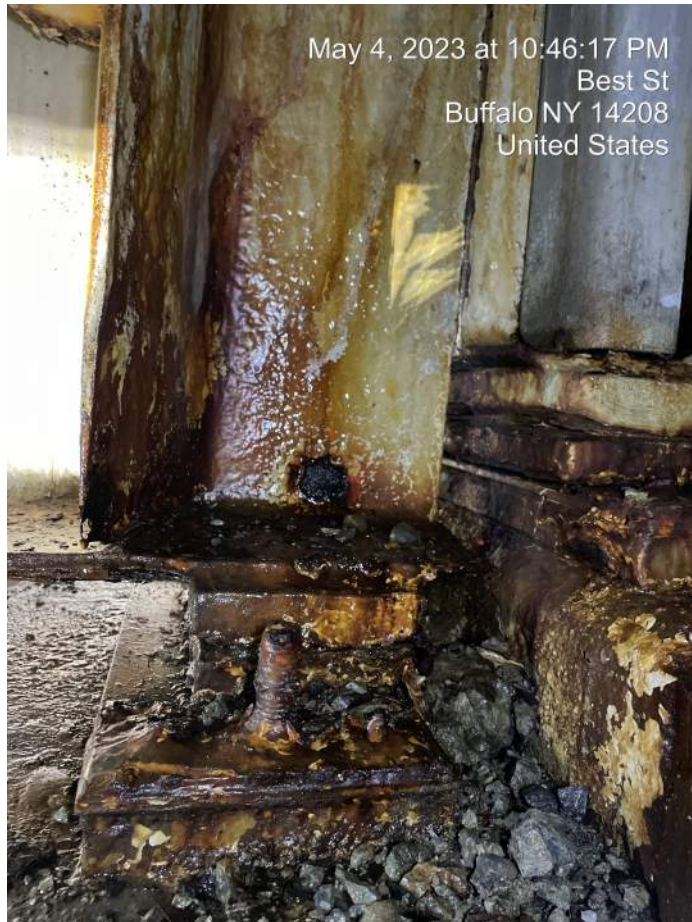
PHOTO 21

LOCATION:
G7 IN SPAN 3 AT
PIER

DESCRIPTION:
HEAVILY RUSTED
AND
OVEREXTENDED
EXPANSION
BEARINGS

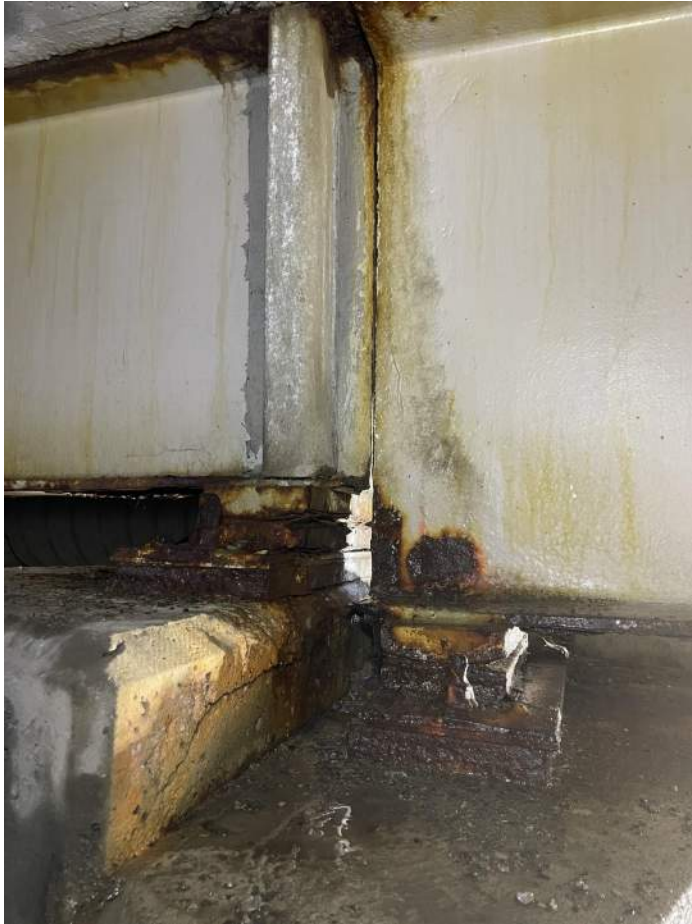
PHOTO 23

LOCATION:
G7 IN SPANS 3 & 4 AT
PIER

DESCRIPTION:
RUSTED AND
OVEREXTENDED
EXPANSION
BEARINGS; END OF
BEAM SPANS IN
CONTACT

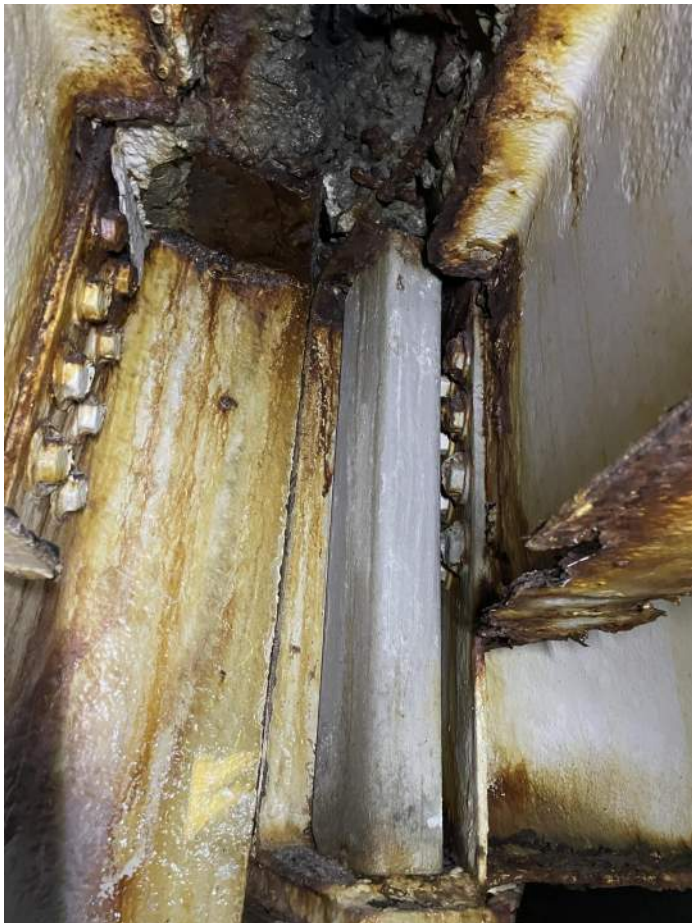
PHOTO 24

LOCATION:
G7 IN SPANS 3 & 4 AT
PIER

DESCRIPTION:
END OF BEAM
SPANS IN CONTACT;
HEAVILY CORRODED
END DIAPHRAGM

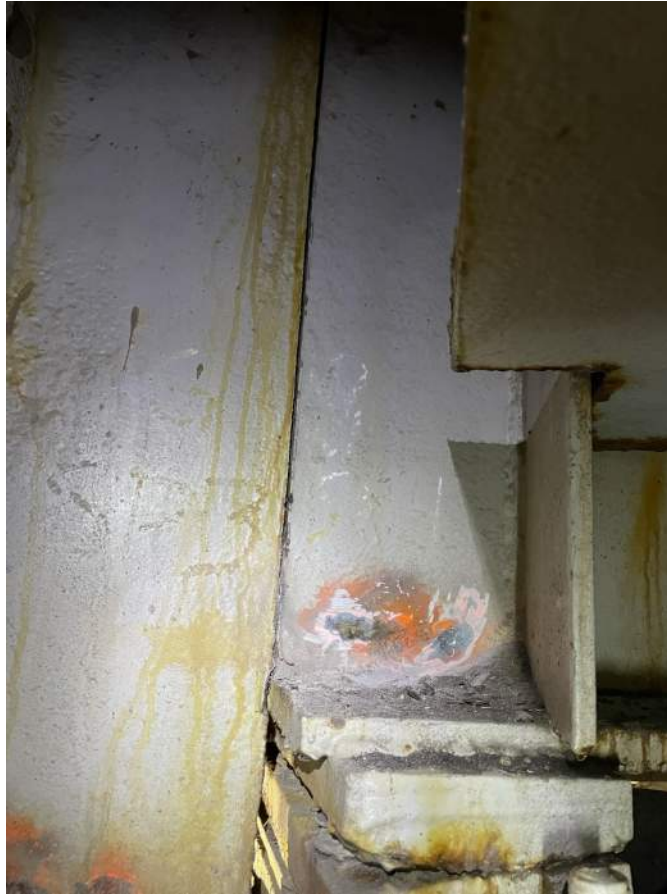
PHOTO 27

LOCATION:
G8 IN SPAN 4 AT
PIER

DESCRIPTION:
OVEREXTENDED
EXPANSION
BEARINGS; END OF
BEAM SPANS IN
CONTACT

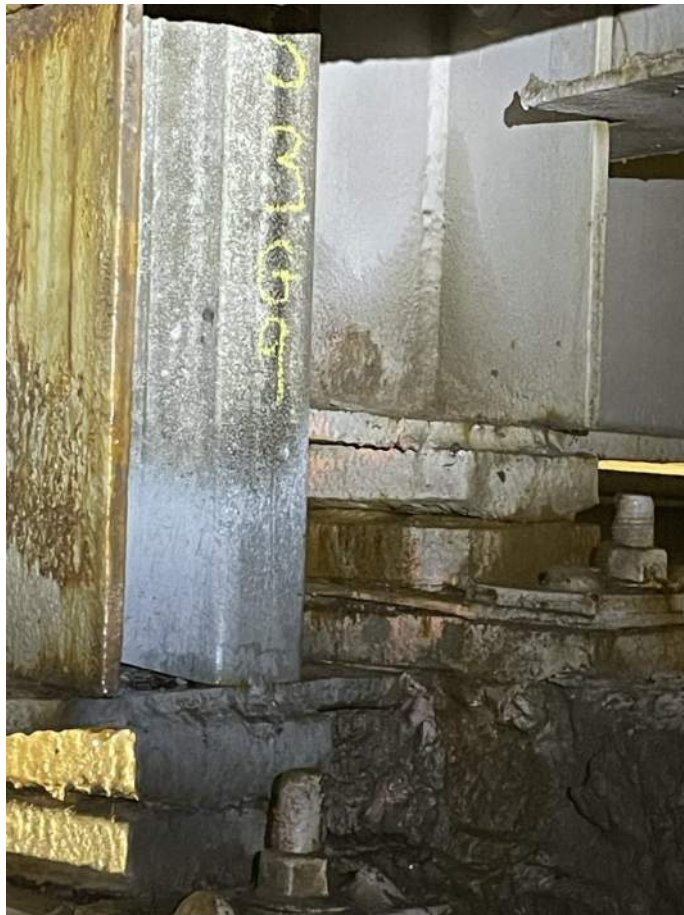
PHOTO 32

LOCATION:
G9 IN SPAN 4 AT
PIER

DESCRIPTION:
BEARING
CONDITIONS WITH
PREVIOUSLY
INSTALLED TUBE
STIFFENER

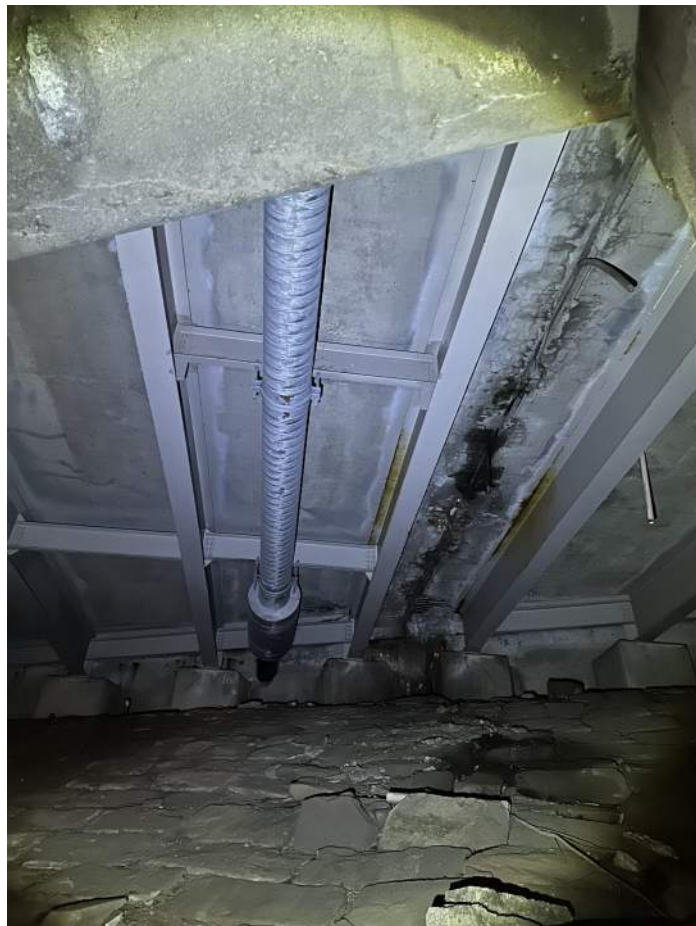
PHOTO 42

LOCATION:
UNDERSIDE OF
DECK IN SPAN 4 AND
END ABUTMENT
LOOKING WEST

DESCRIPTION:
TYPICAL DECK AND
ABUTMENT
CONDITIONS WITH 8"
GAS LINE NEAR
SOUTH END OF
BRIDGE

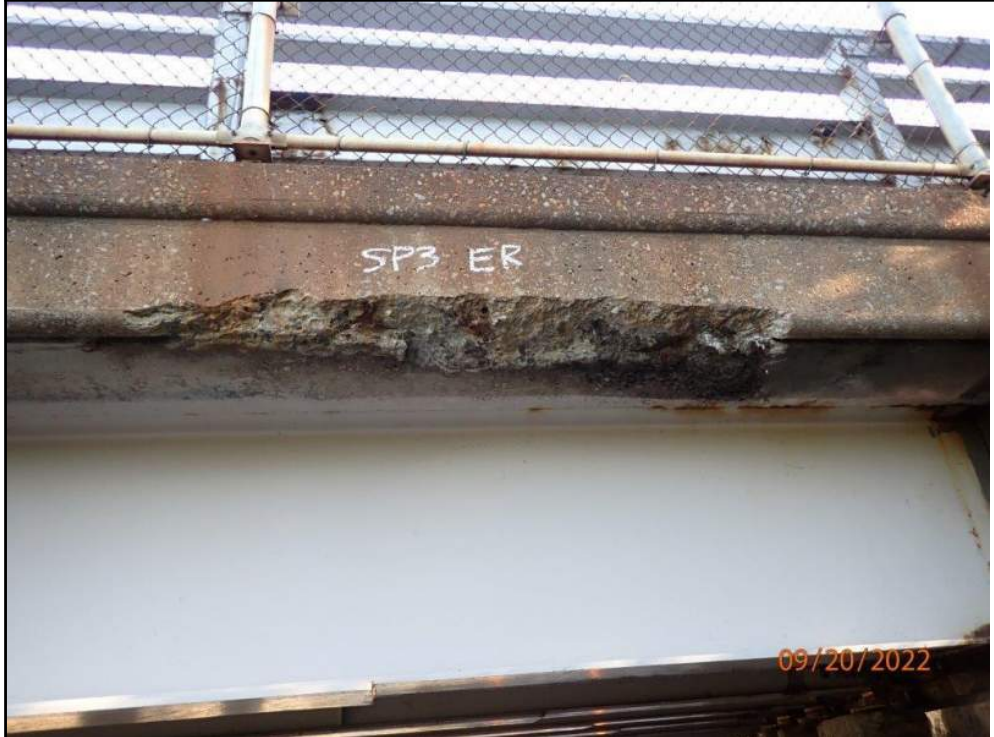
Photo Number: 5 Photo Filename: 5-Bottom corner spall in Right fascia of Span

Span 3 - Right fascia overhang has 6 SF of spalling to rebar near Begin, spalling to rebar near 1/3-Span for 18 SF (Photo 5) and spalling to rebar near End for 12 SF.

Attachment Description:
Bottom corner spall in Right fascia of Span 3 Deck near End (Looking Left)

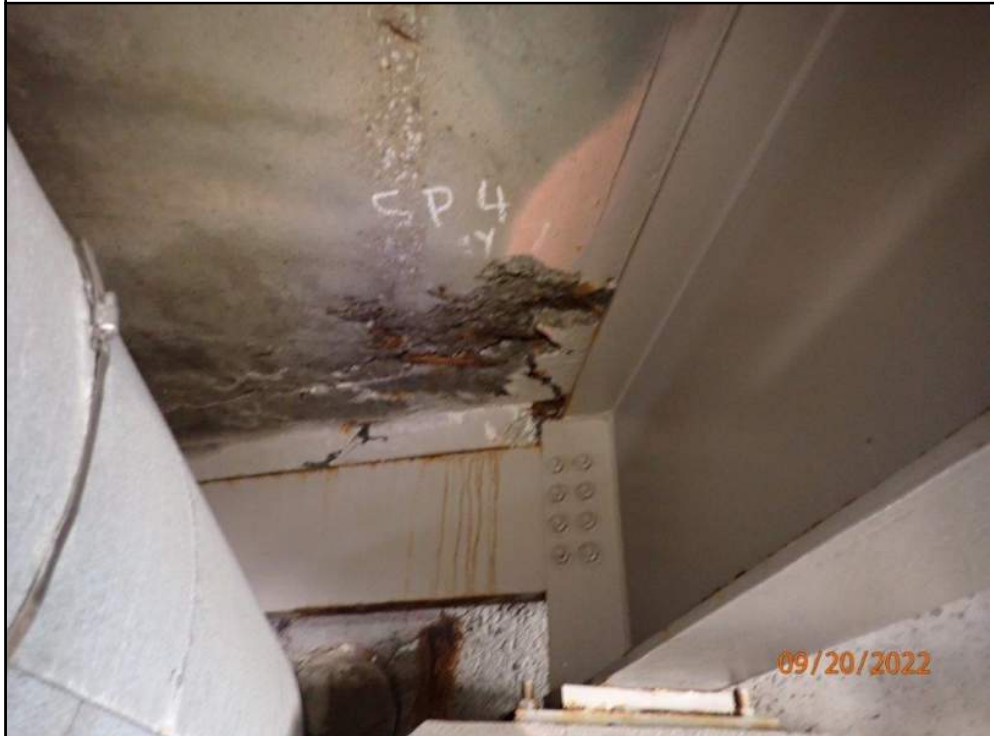
Photo Number: 6 Photo Filename: 6-Spall in underside of Deck in Bay 7 at End

Bay 7 has 4 SF and 1 SF spalls to rebar near End Abutment (Photo 6).

Attachment Description:
Spall in underside of Deck in Bay 7 at End Span 4 (Looking toward End)

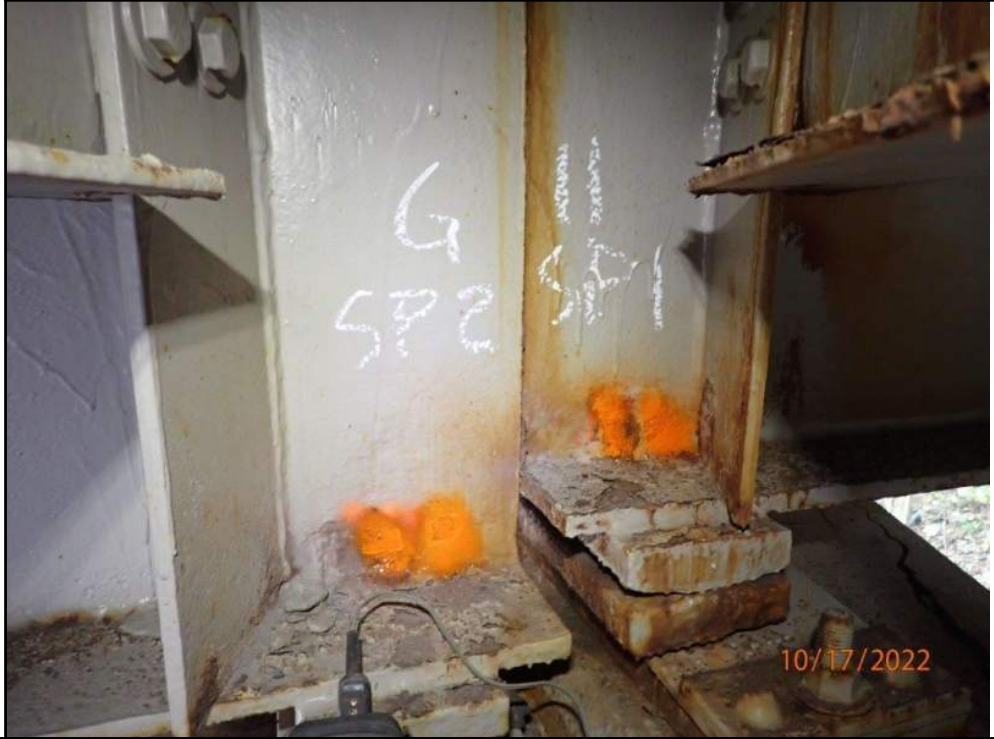
Photo Number: 9 Photo Filename: 9-Painted over pitting in lower webs of G-11

Attachment Description:
Painted over pitting in lower webs of G-11 over PR-1 (Looking Right)

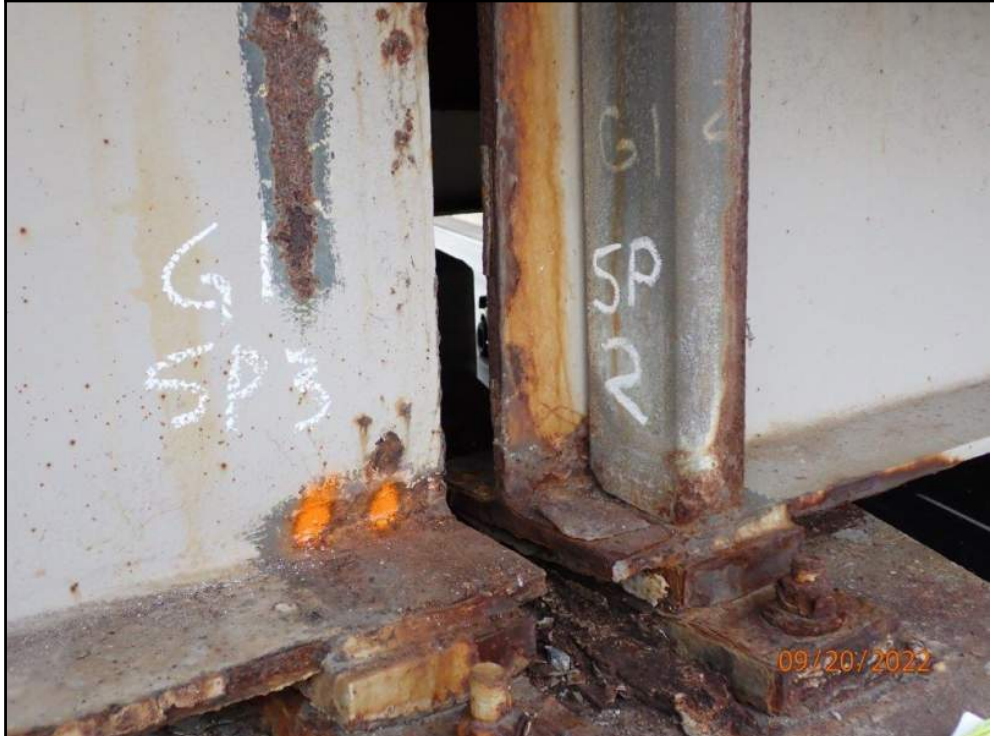
Photo Number: 10 Photo Filename: 10-Tube repair and active corrosion in lower

Girder end locations not noted above either exhibit no apparent section loss or have previously been repaired with a box section installed between the flanges on each side of the web, above the bearing (Photos 10, 12).

Attachment Description:
Tube repair and active corrosion in lower web of G-1 over PR-2 (Looking Right)

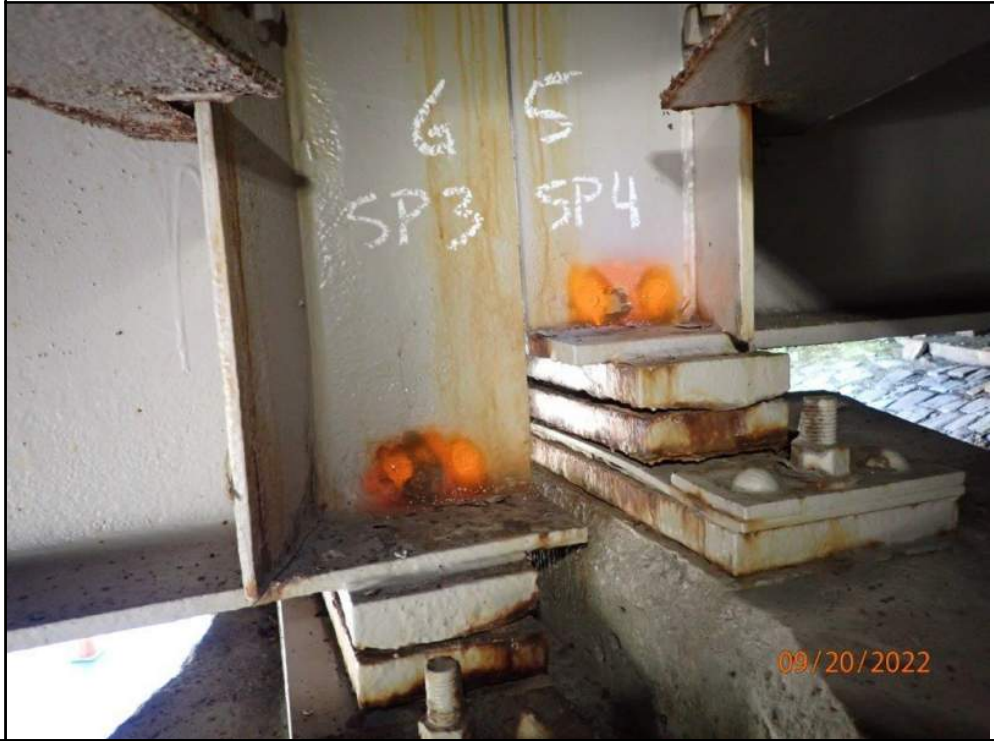
Photo Number: 11

Attachment Description:
Active corrosion and painted over pitting in lower web of G-5 over PR-3 (Looking Left)

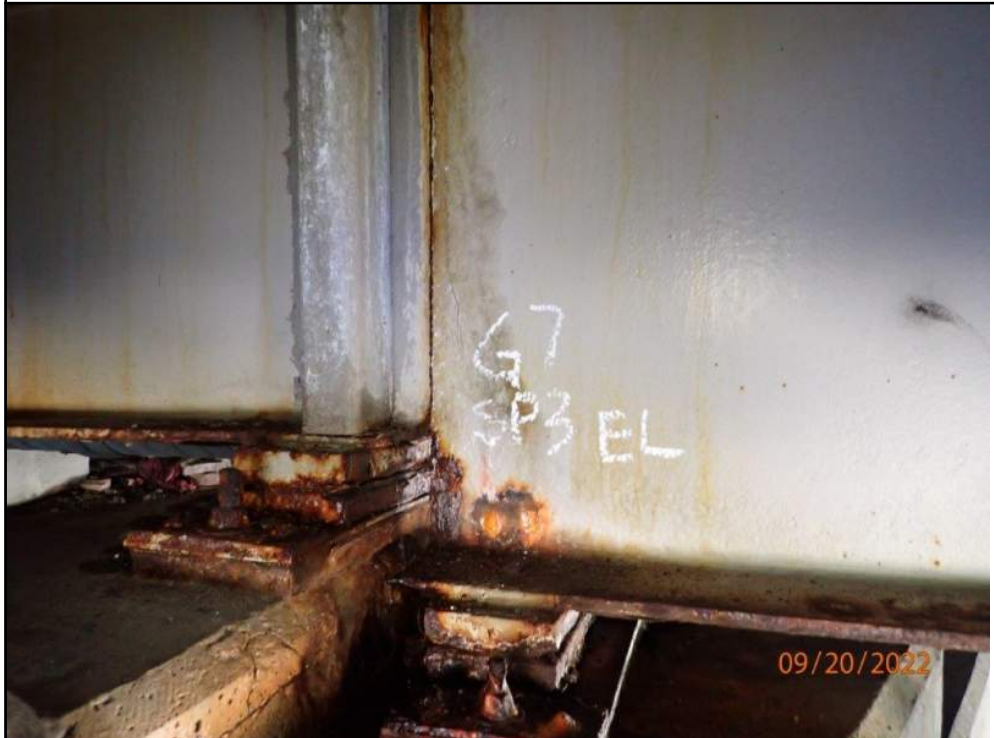
Photo Number: 12

Attachment Description:
Tube repair and active corrosion in lower web of G-7 over PR-3 (Looking Right)

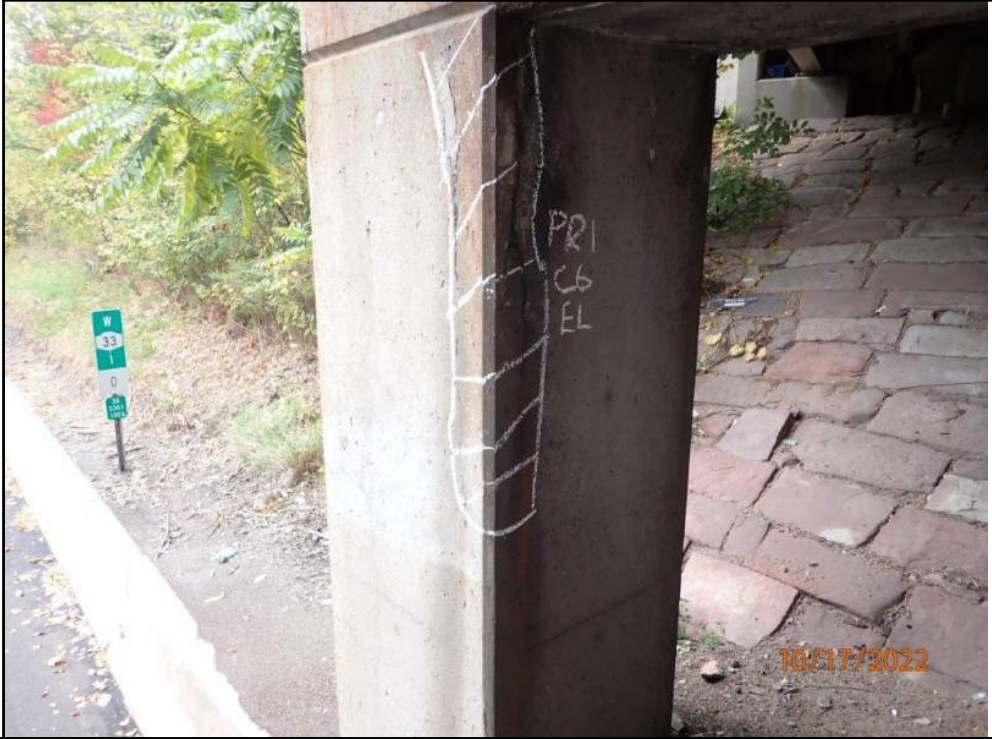
Photo Number: 13 Photo Filename: 13-Vertical cracking in End Left corner of C-6 at

Column C-6 – End Left corner is cracked up to 1/4"W with rust staining for the upper 1/2 (Photo 13)

Attachment Description:
Vertical cracking in End Left corner of Column C-6 at PR-1 (Looking toward Begin Right)

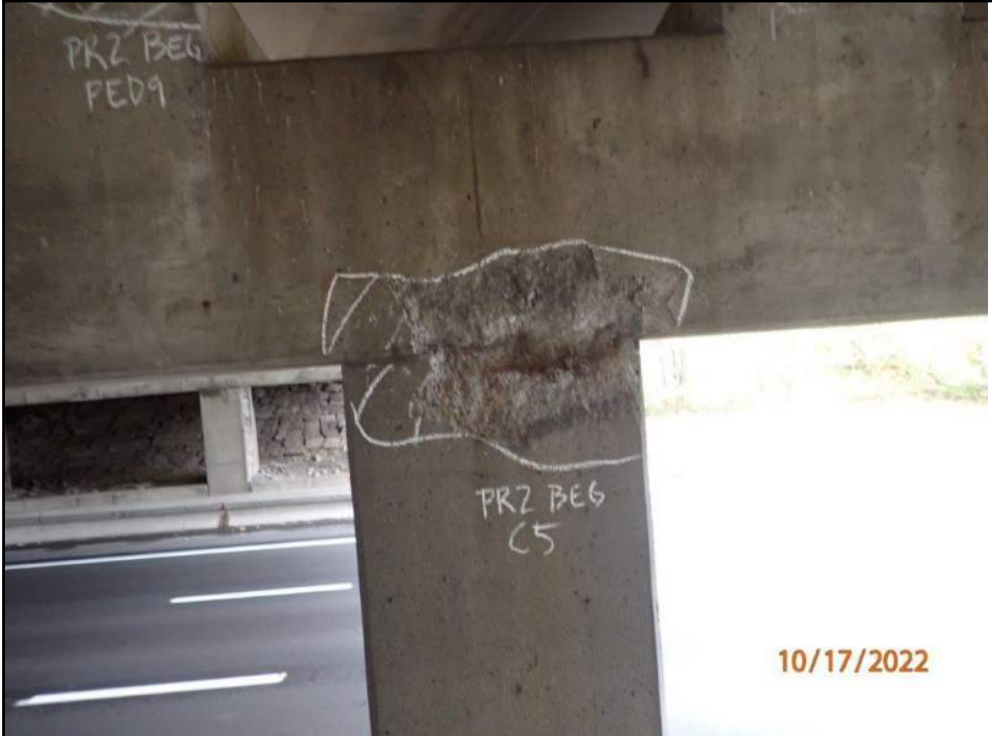
Photo Number: 14 Photo Filename: 14-Spalling near top of Begin face of C-5 at

Attachment Description:
Spalling near top of Begin face of Column C-5 at PR-2 (Looking toward End)

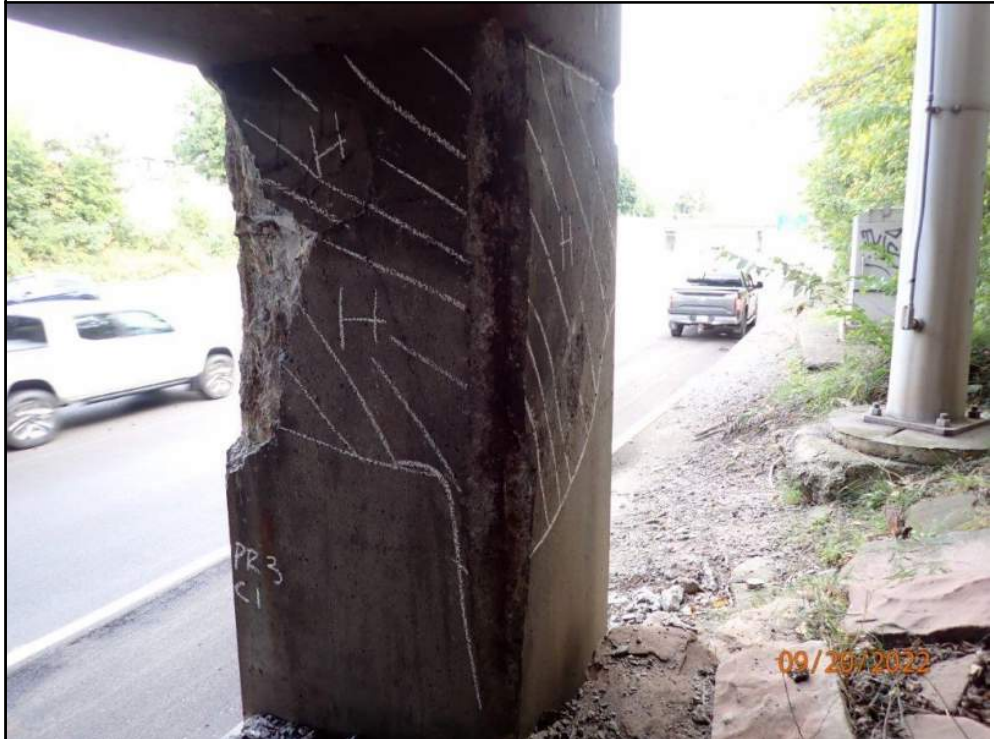
Photo Number: 15

Attachment Description:
End and Right faces of
Column C-1 at PR-3
(Looking Left)

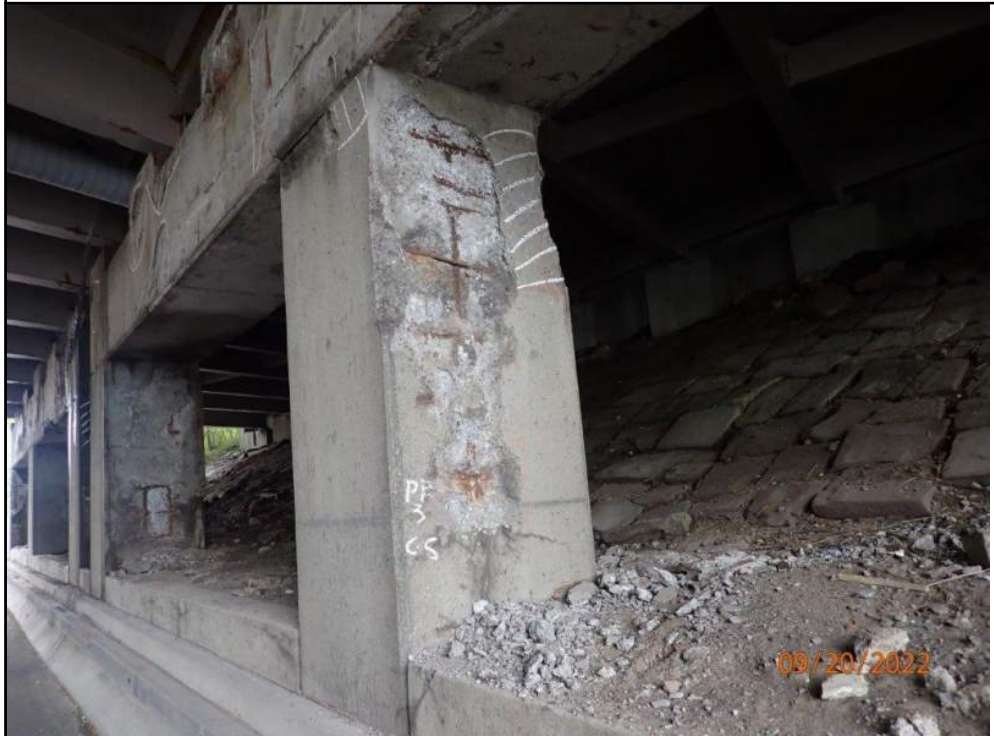
Photo Number: 16

Attachment Description:
Right faces of Columns C-4
and C-5 at PR-3 (Looking
toward End Left)

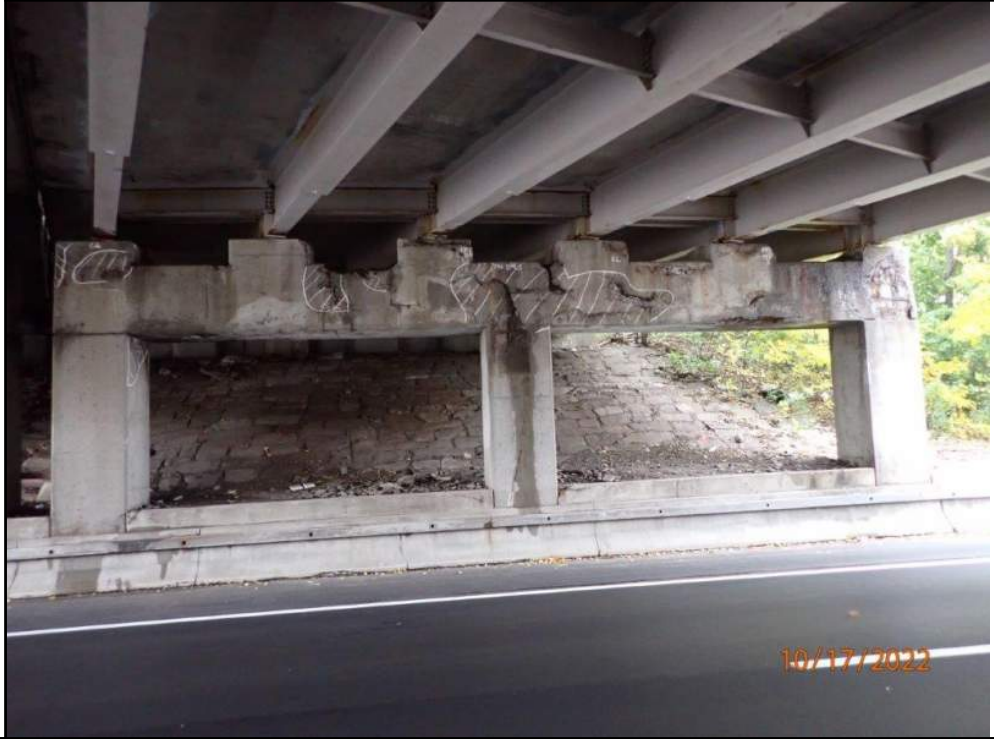
Photo Number: 17 Photo Filename: 17-End face of PR-1 below Bays 1-6 (Looking

Attachment Description:
End face of PR-1 below
Bays 1-6 (Looking toward
Begin)

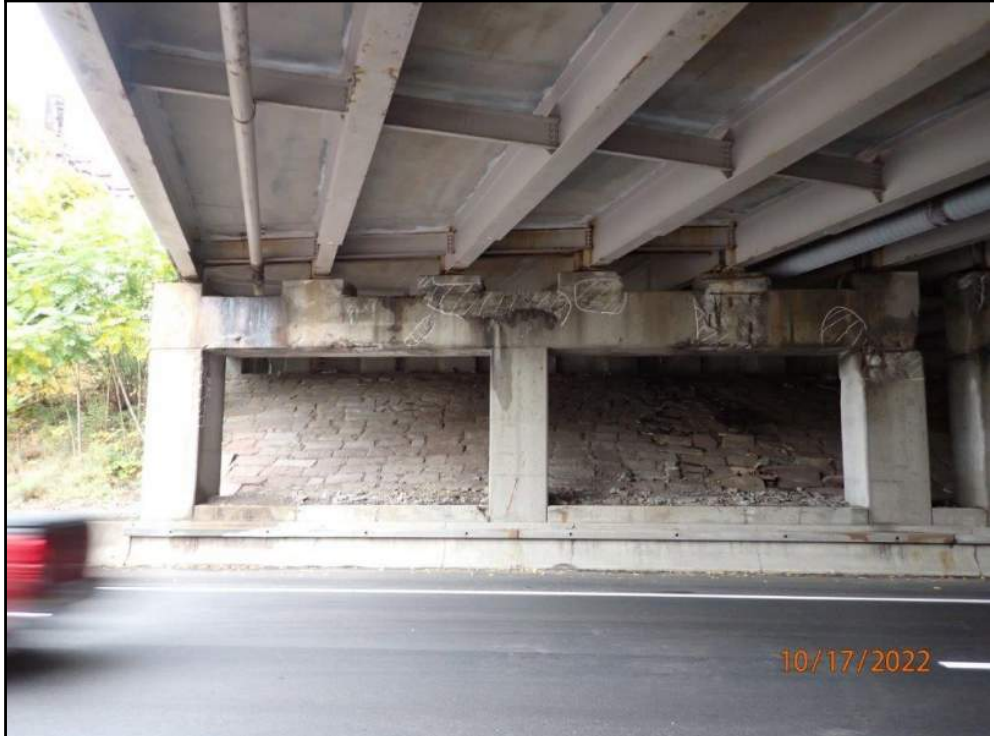
Photo Number: 18 Photo Filename: 18-End face of PR-1 below Bays 6-11 (Looking

Attachment Description:
End face of PR-1 below
Bays 6-11 (Looking toward
Begin)

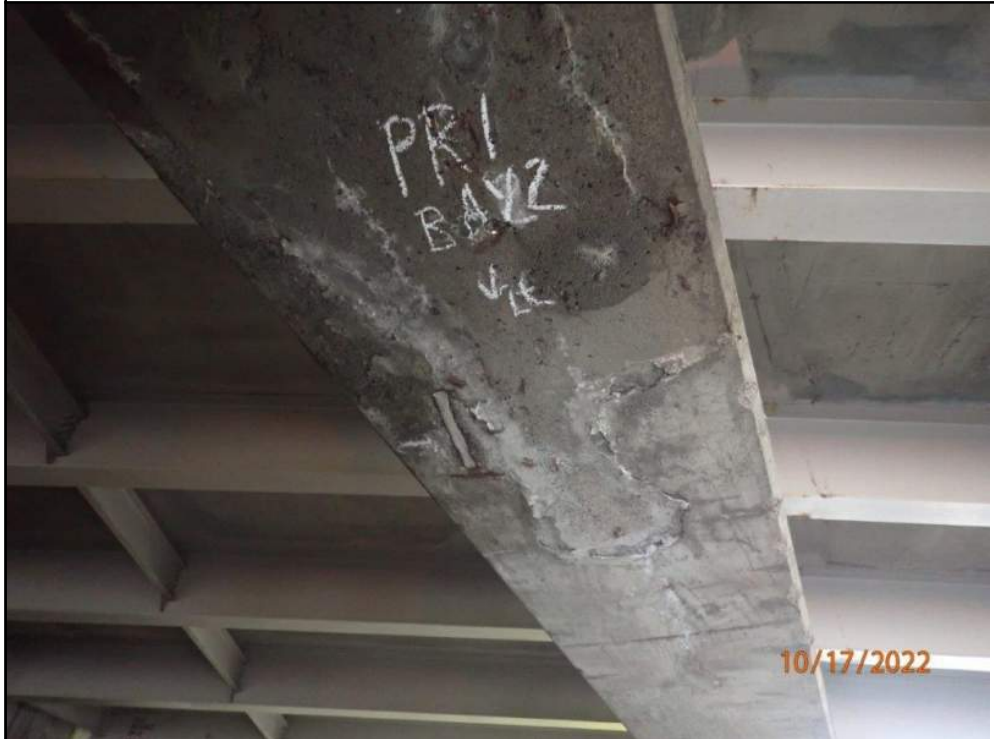
Photo Number: 19

Attachment Description:
Underside of PR-1 Cap
beam in column Bay 2
(Looking Left)

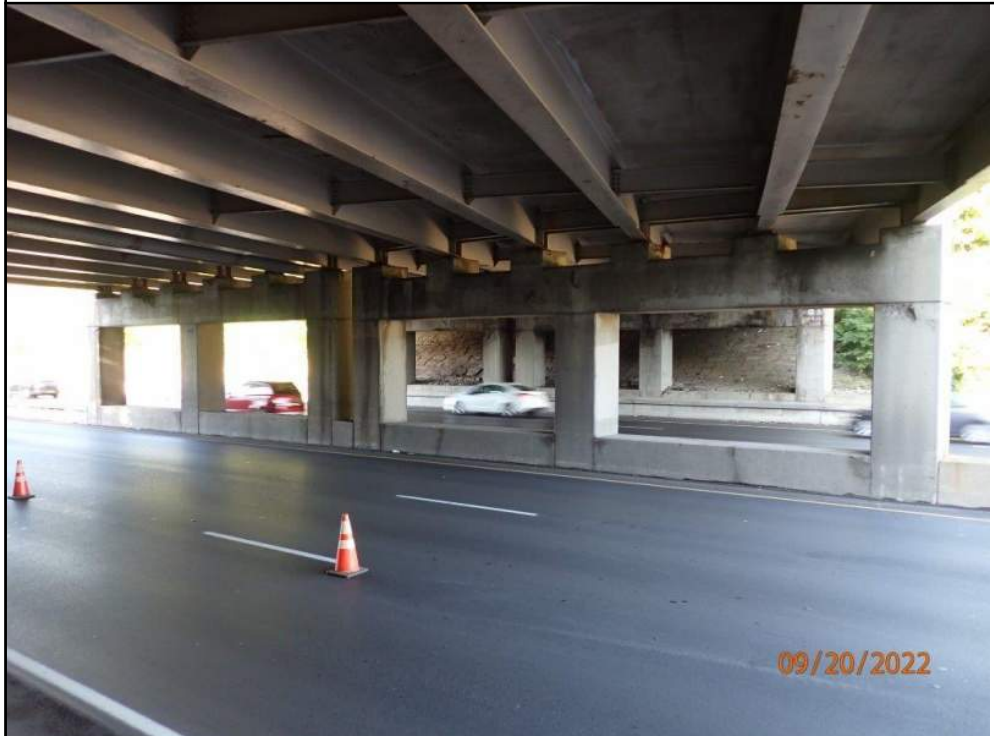
Photo Number: 20

Attachment Description:
End face of PR-2 (Looking
toward Begin Right)

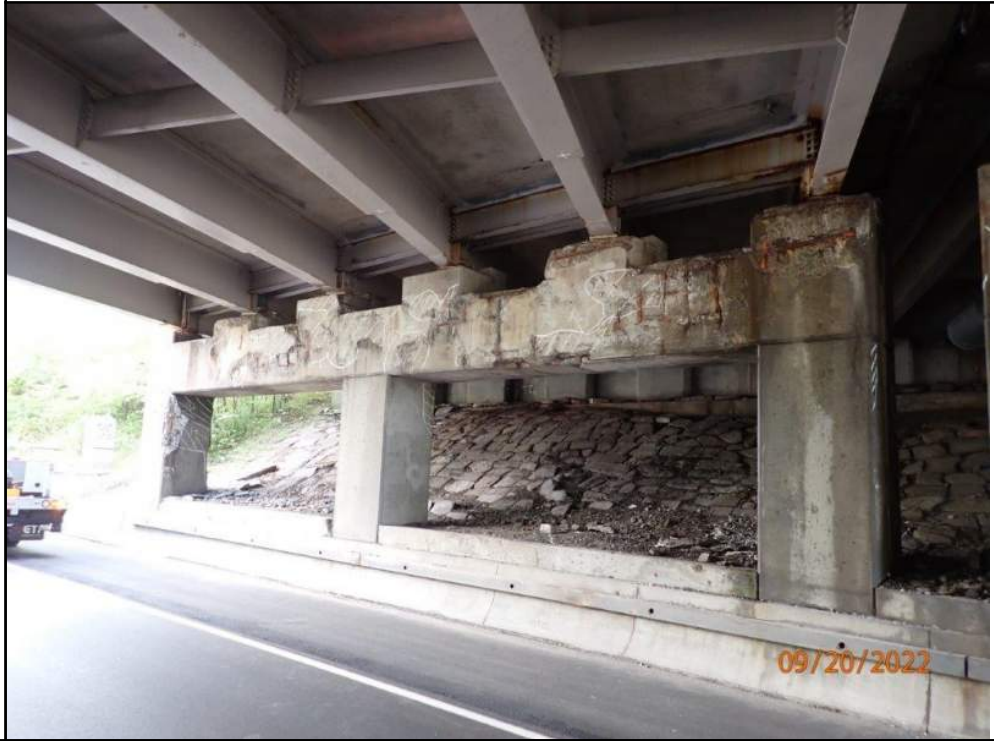
Photo Number: 21

Attachment Description:
Begin face of PR-3 below
Bays 1-6 (Looking toward
Begin Left)

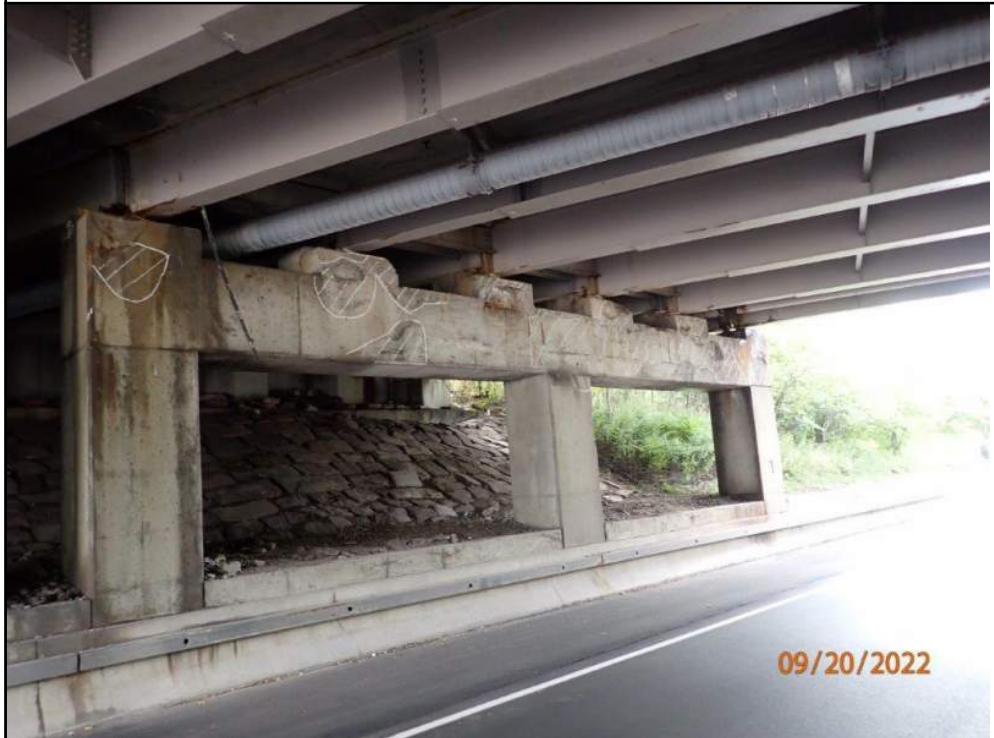
Photo Number: 22

Attachment Description:
Begin face of PR-3 below
Bays 6-11 (Looking toward
End Right)

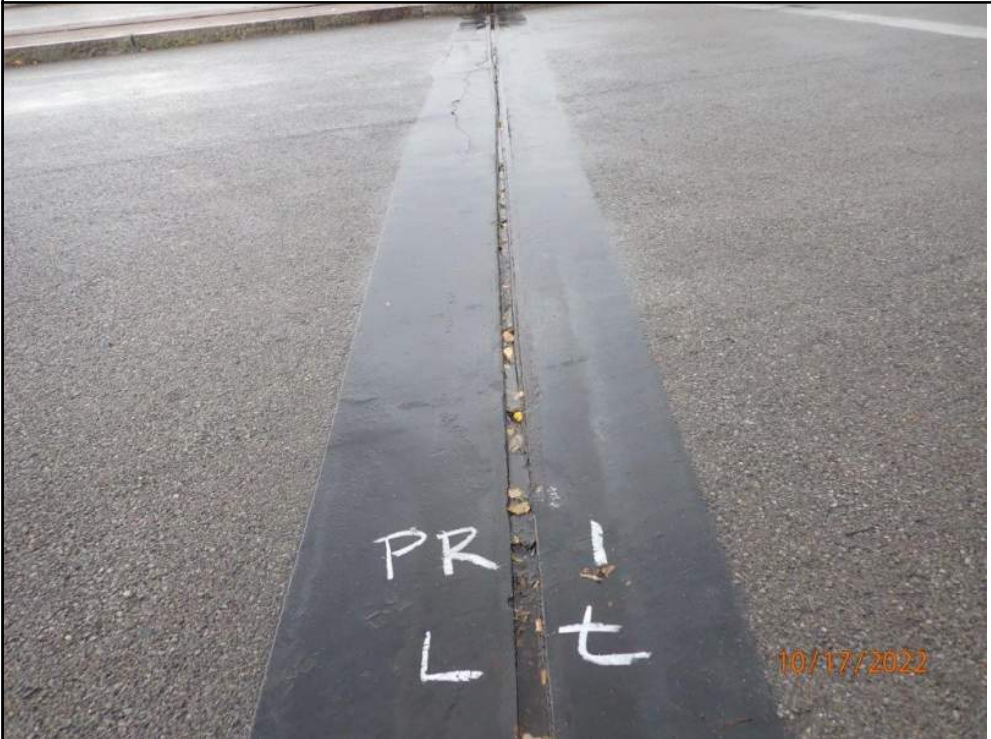
Photo Number: 23

Attachment Description:
Typical new Joints and Headers over PR-1 and PR-3 (PR-1 shown looking Right)

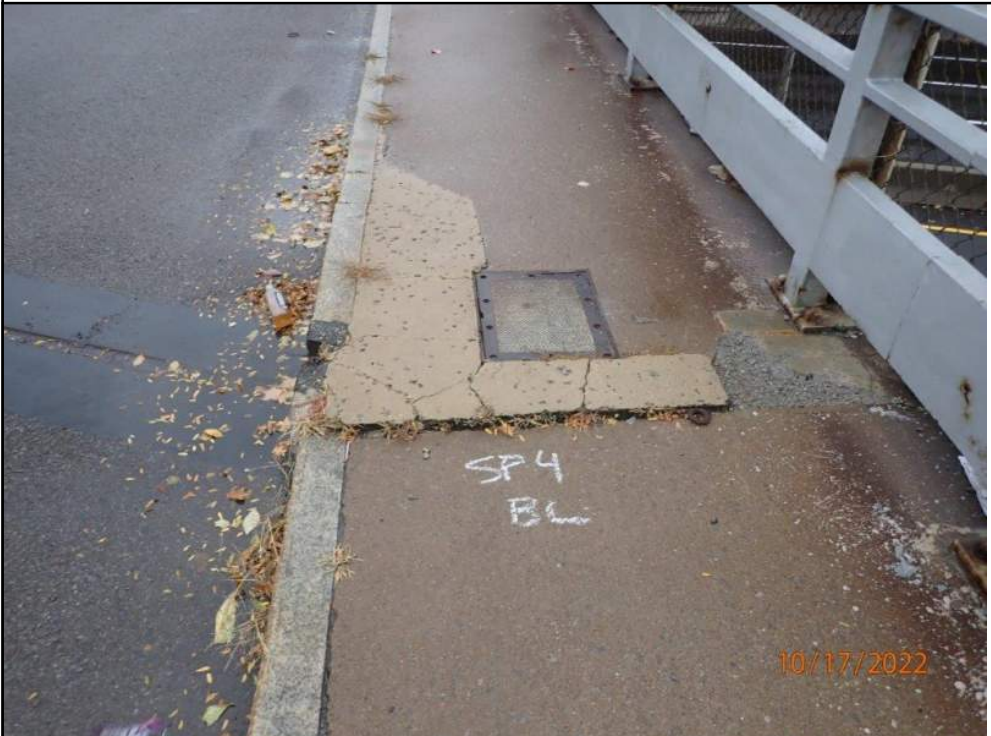
Photo Number: 24

Attachment Description:
Typical condition of Joints through sidewalks (Left side over PR-3 shown looking toward Begin)
