Appendix A4

Bridge Inspection Reports and Work History Summaries

**NY33 BRIDGE CONDITION VERIFICATION 2023
KENSINGTON EXPRESSWAY PROJECT
PIN 5512.52
CITY OF BUFFALO, ERIE COUNTY
BIN 1022609**

STRUCTURE: BIN 1022609 - Best Street on NY33 Kensington Expressway

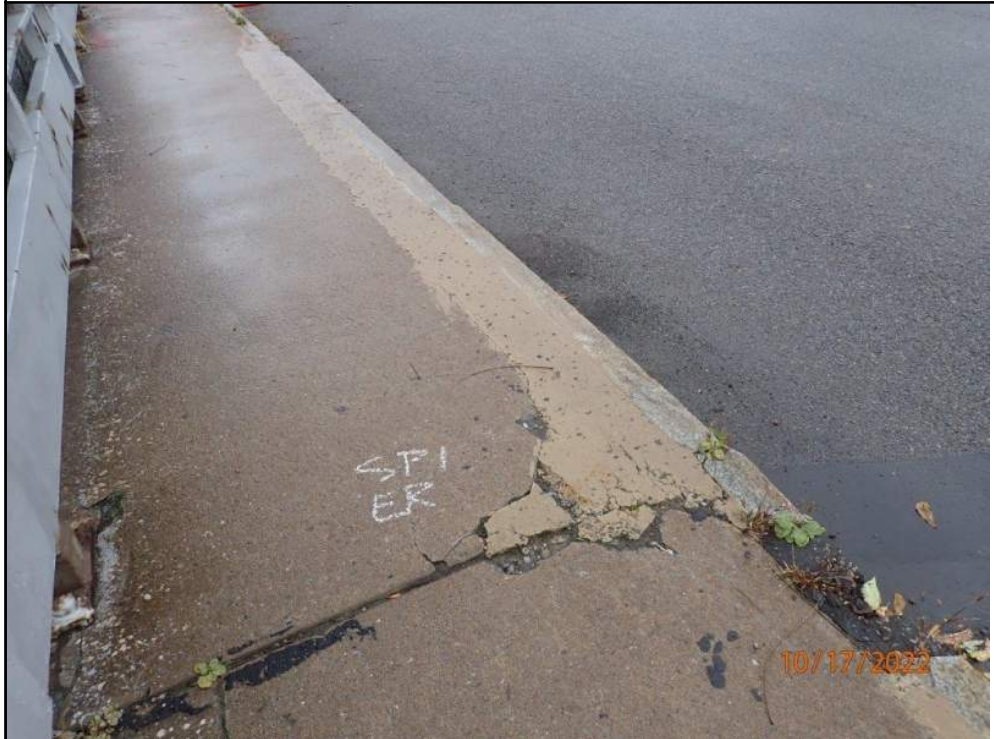
Photo Number: 25 Photo Filename: 25-Typical condition of Joints through

Attachment Description:
Typical condition of Joints through sidewalks (Right side over PR-1 shown looking toward Begin)

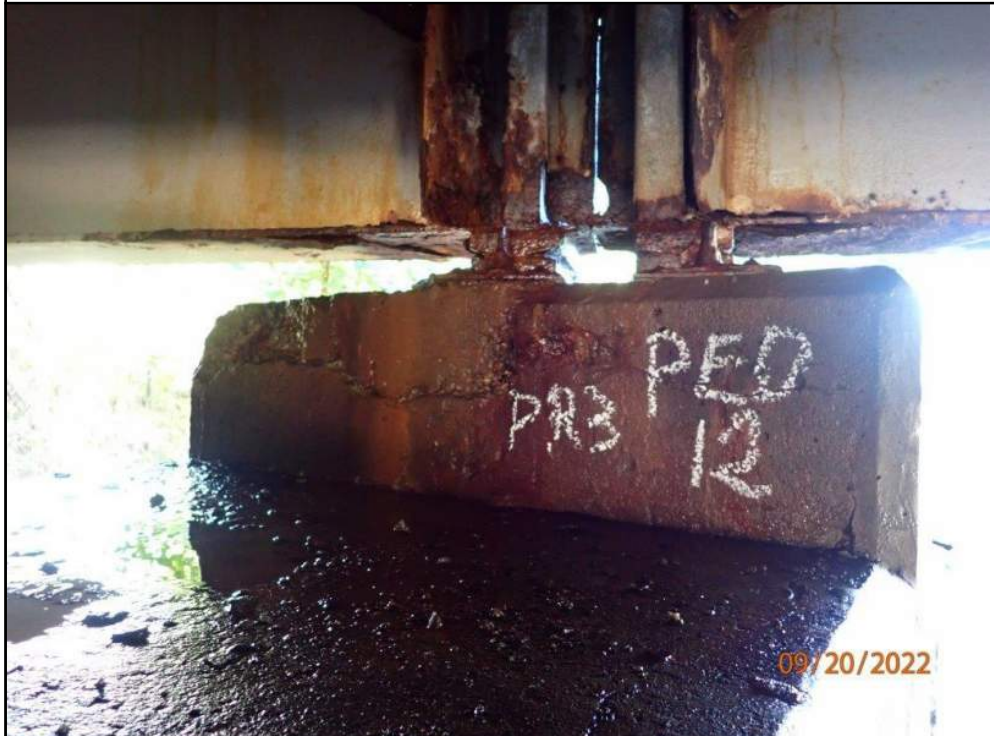
Photo Number: 26 Photo Filename: 26-Active leakage through joint above Bay 11

Attachment Description:
Active leakage through joint above Bay 11 at PR-3 (Looking Right)

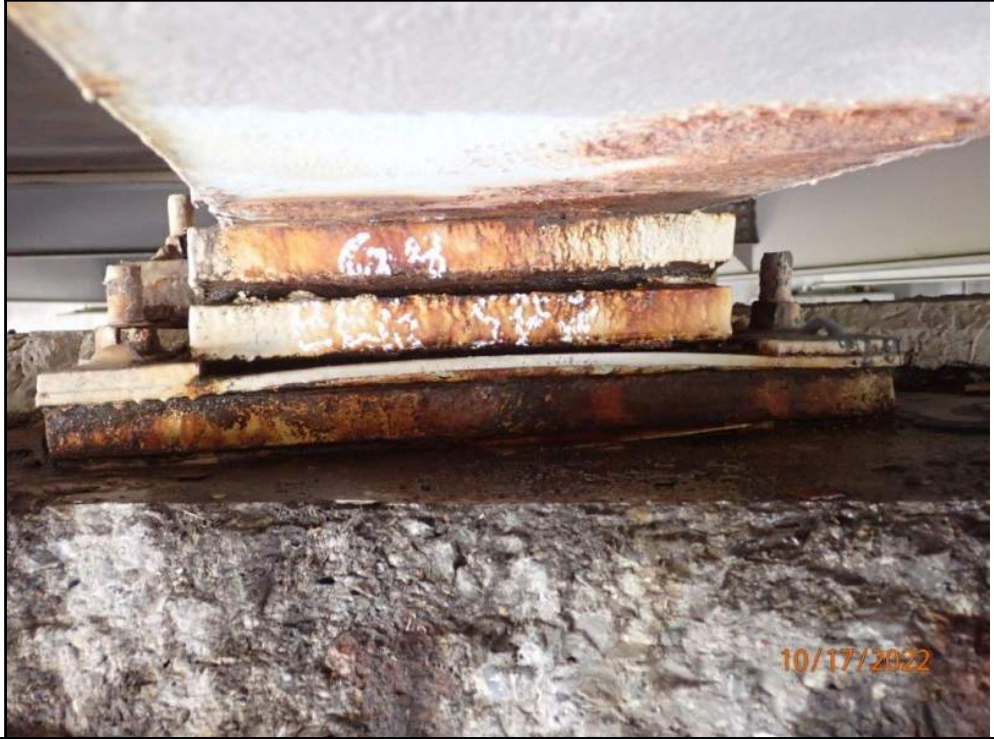
Photo Number: 27

Attachment Description:
Typical condition of sliding Bearings at PR-1 (G-4 Bearing at Beg Span 2 shown looking to Begin)

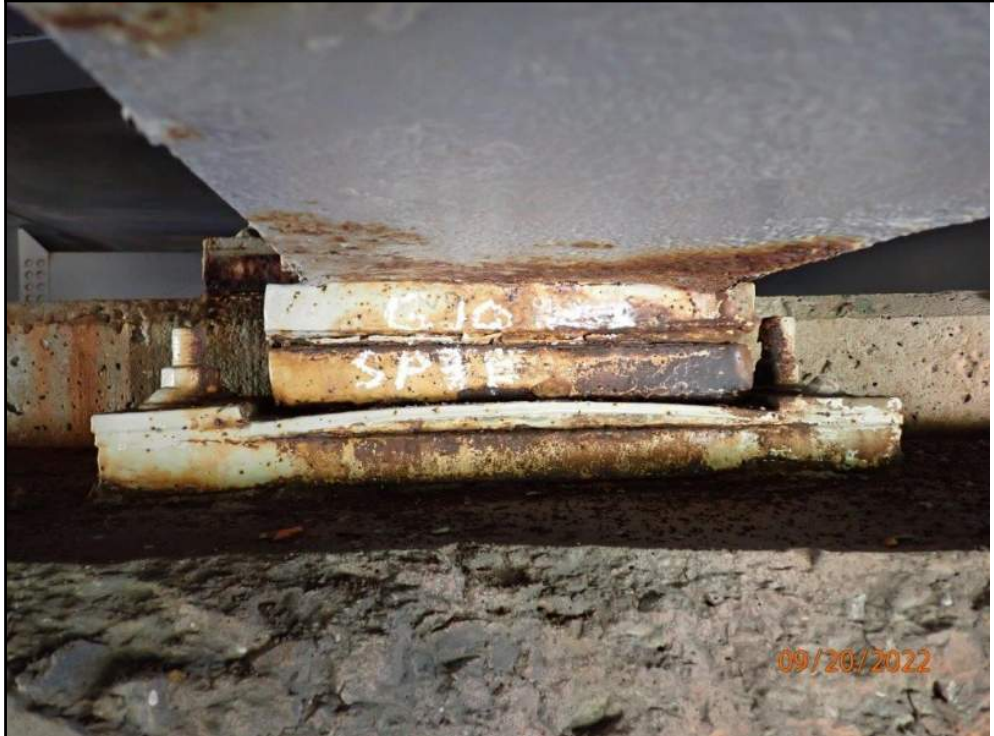
Photo Number: 28

Attachment Description:
Typical condition of sliding Bearings at PR-3 (G-10 Bearing at End Span 3 shown looking to End)

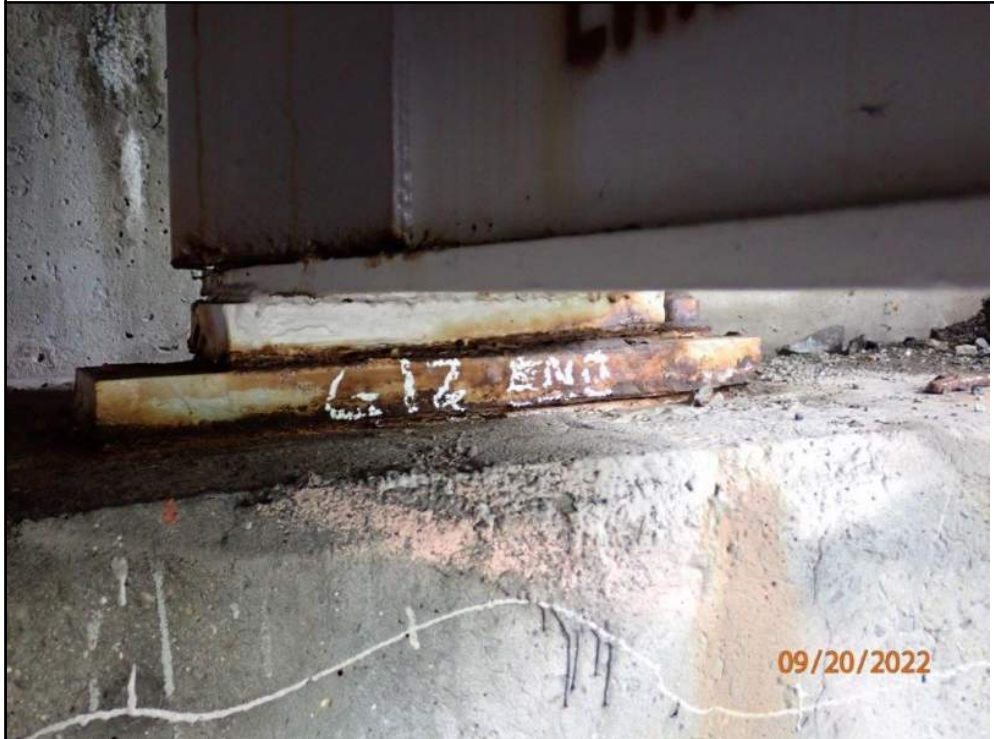
Photo Number: 29

Attachment Description:
Typical paint condition on Fixed Bearings and missing anchor at G-12 Brg at End Abutment (Looking toward End)

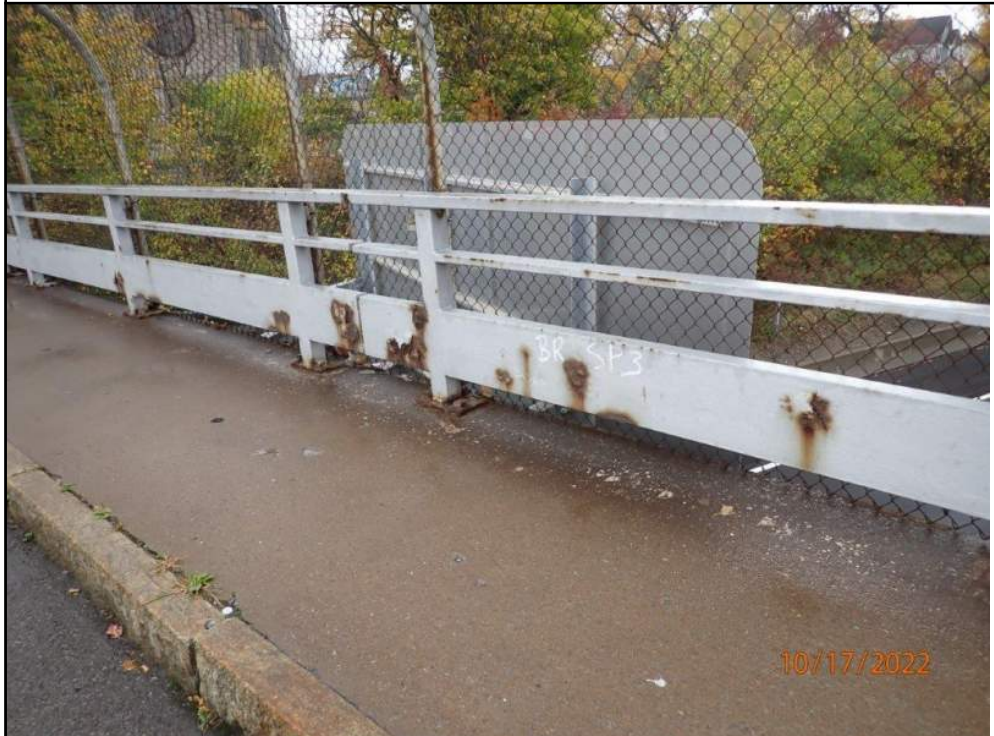
Photo Number: 30

Attachment Description:
Typical condition of paint coating on Railings (Right side in Span 3 shown looking toward End Right)

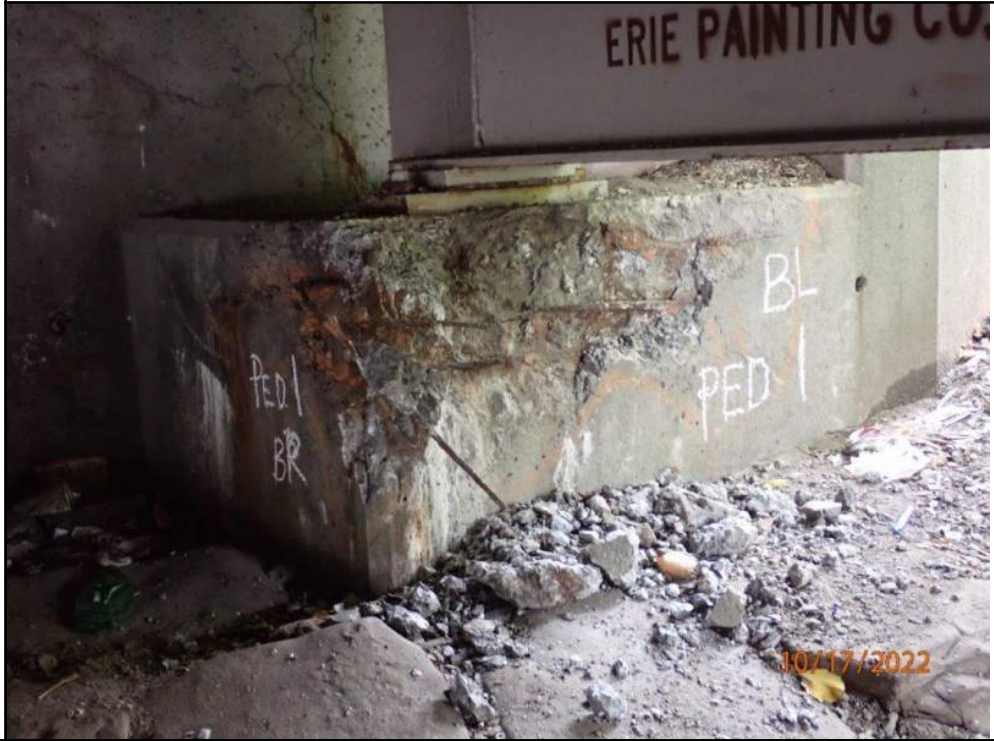
Photo Number: 33

Attachment Description:
G-1 Pedestal at Begin
Abutment spalled (Looking
toward Begin)

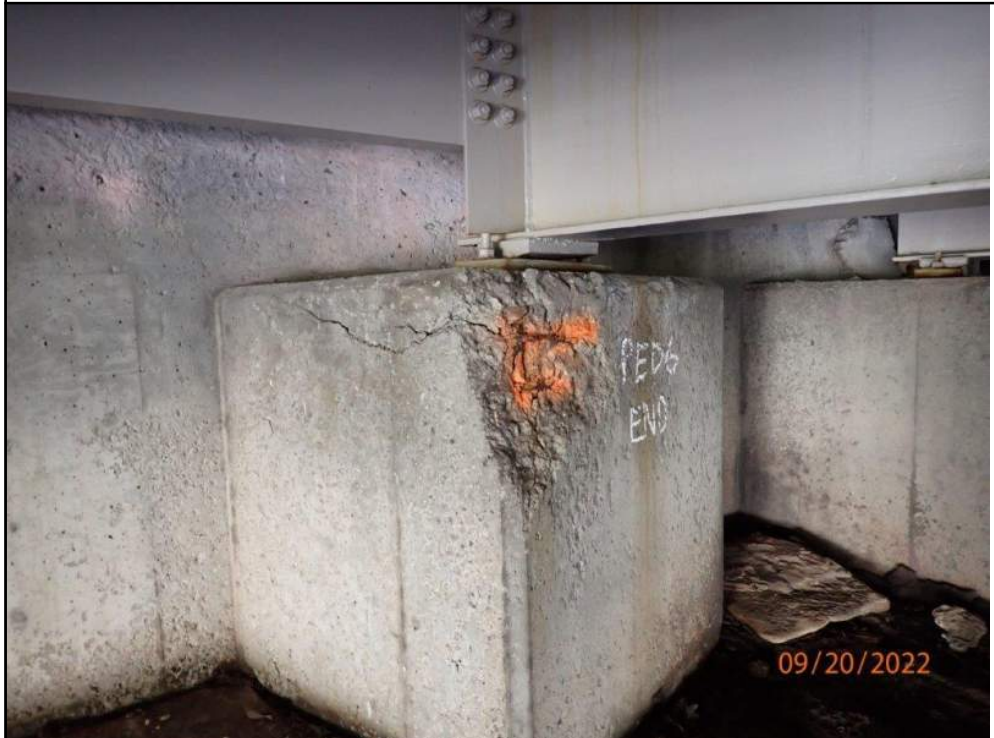
Photo Number: 34

Attachment Description:
G-6 Pedestal at End
Abutment spalled and
cracked (Looking toward
End Right)

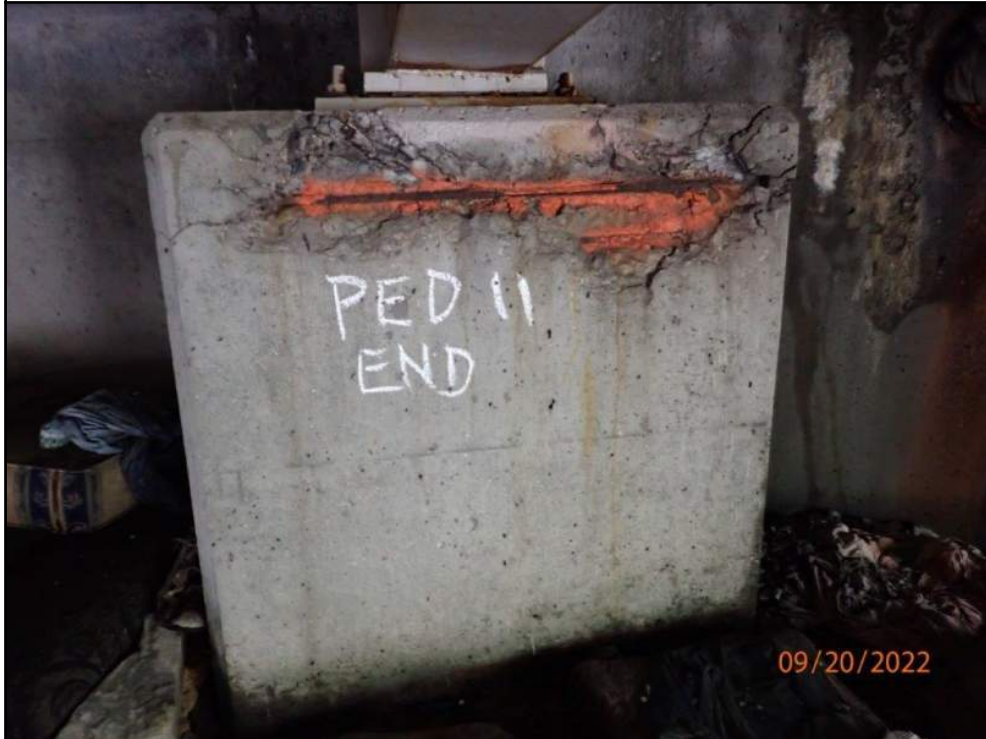
Photo Number: 35

Attachment Description:
G-11 Pedestal at End
Abutment spalled (Looking
toward End)

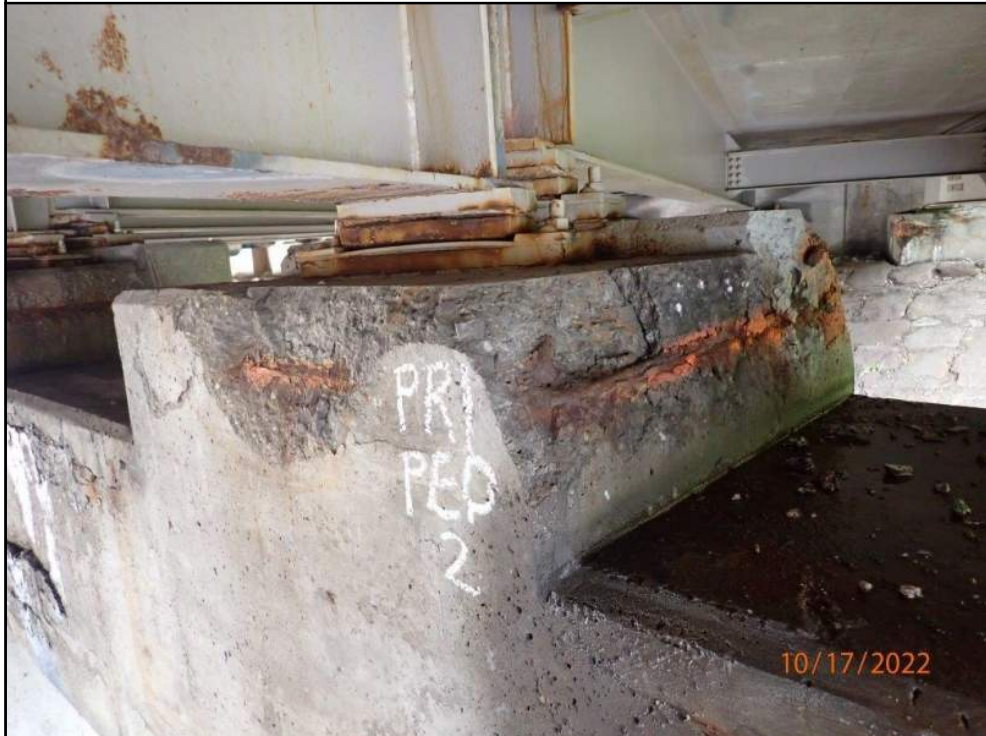
Photo Number: 36

Attachment Description:
G-2 Pedestal at PR-1
spalled (Looking toward
Begin Right)

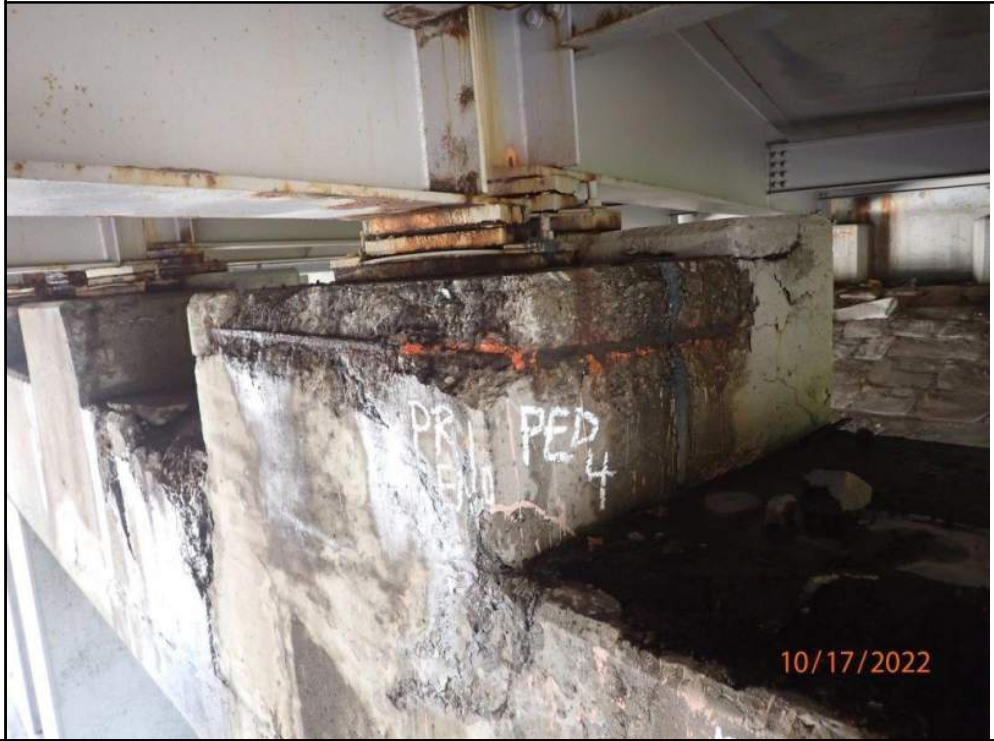
Photo Number: 37

Attachment Description:
G-4 Pedestal at PR-1
spalled (Looking toward
Begin Right)

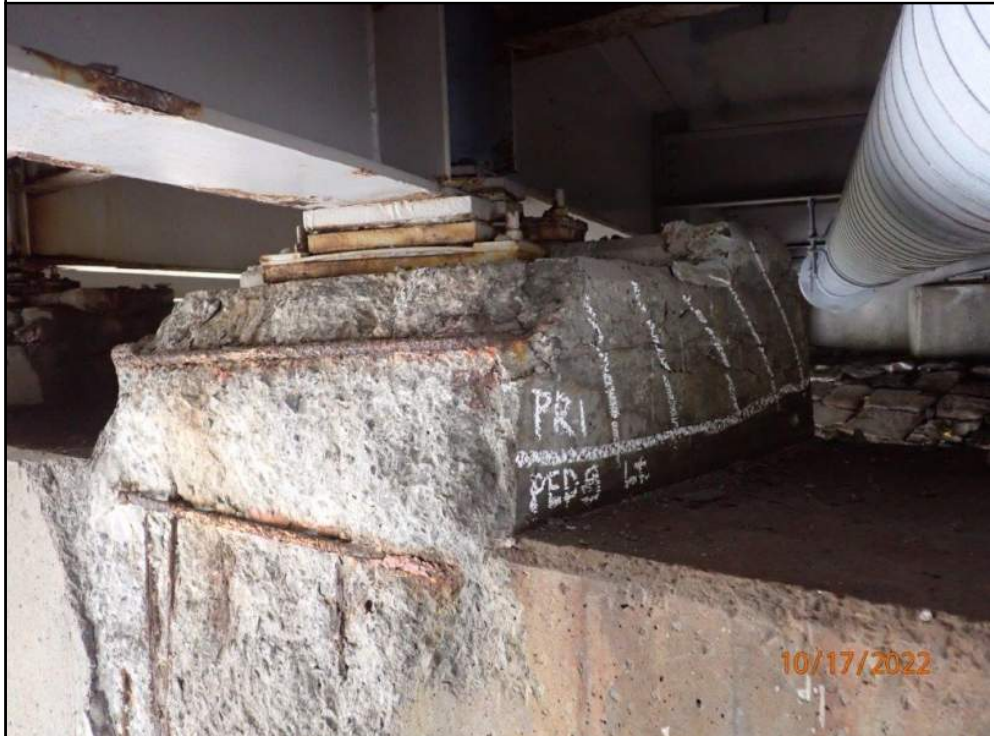
Photo Number: 38

Attachment Description:
G-8 Pedestal at PR-1
spalled (Looking toward
Begin Right)

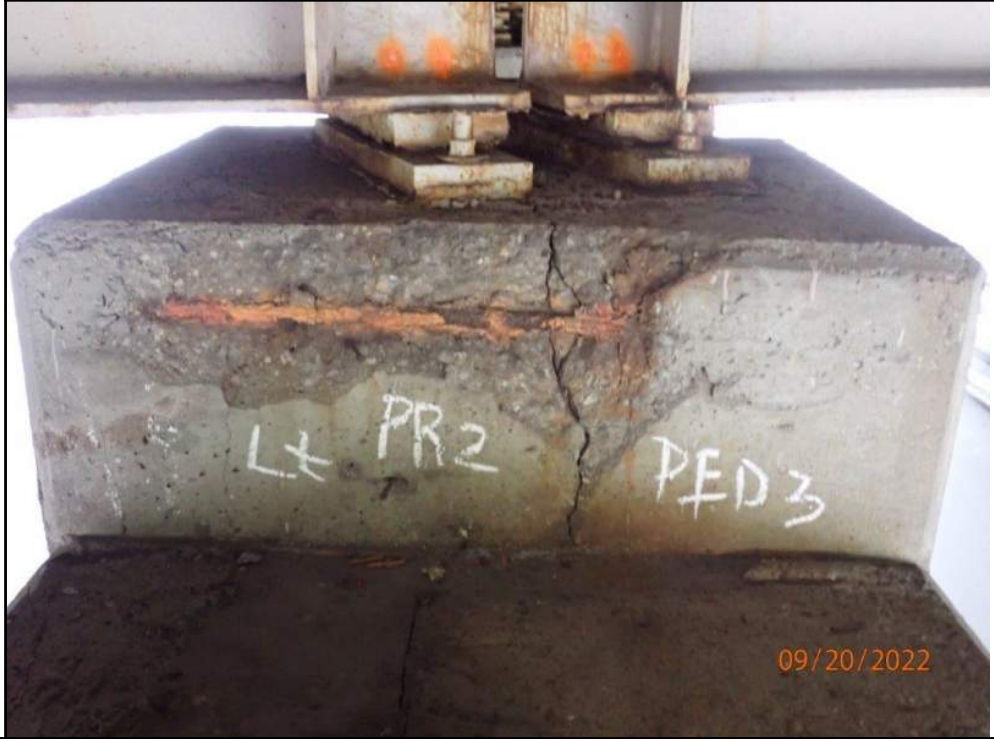
Photo Number: 39 Photo Filename: 39-Left face of G-3 Pedestal at PR-2 spalled

Attachment Description:
Left face of G-3 Pedestal at
PR-2 spalled (Looking
Right)

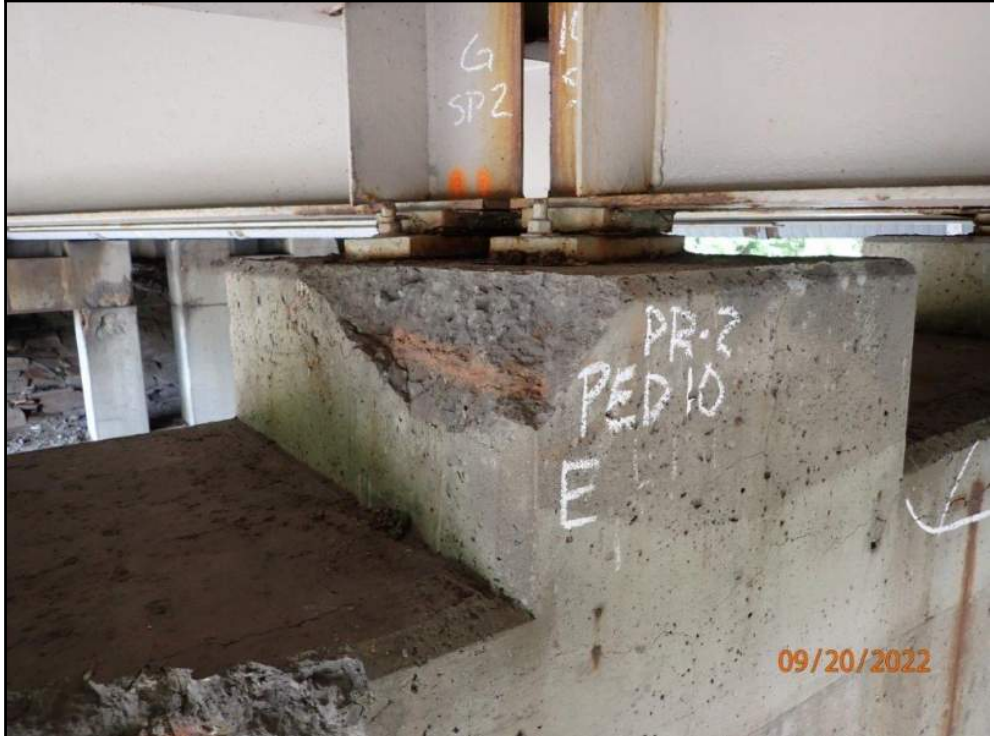
Photo Number: 40 Photo Filename: 40-Right face of G-10 Pedestal at PR-2 spalled

Attachment Description:
Right face of G-10 Pedestal
at PR-2 spalled (Looking
toward Begin Left)

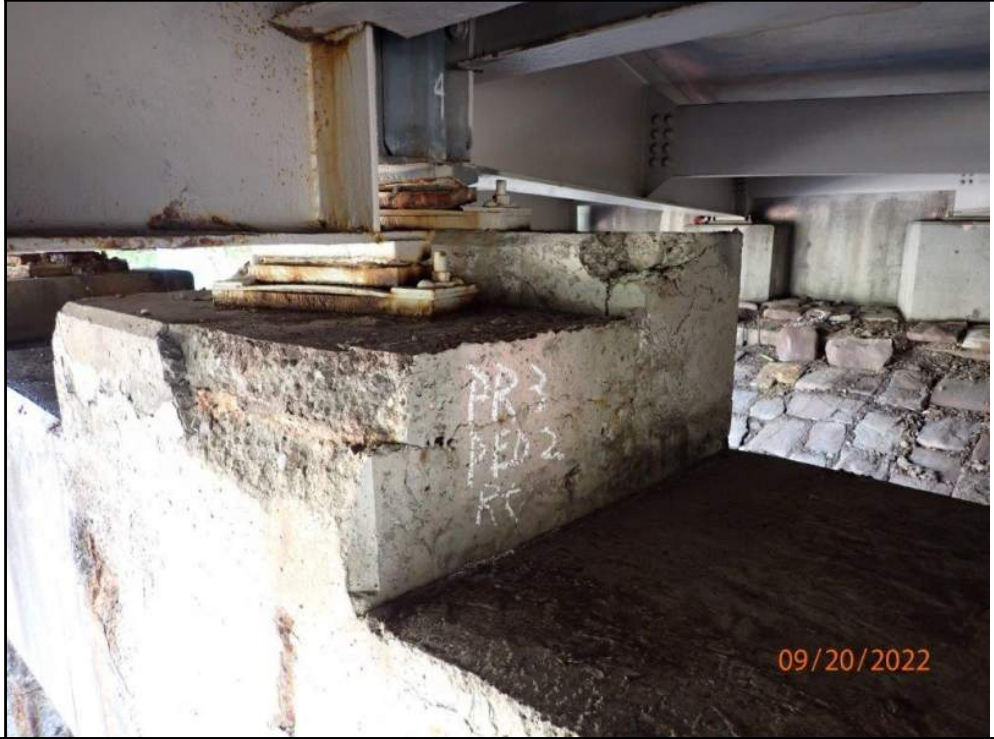
Photo Number: 41 Photo Filename: 41-Begin faces of G-2 Pedestal at PR-3

Attachment Description:
Begin faces of G-2 Pedestal
at PR-3 spalled (Looking
toward End Left)

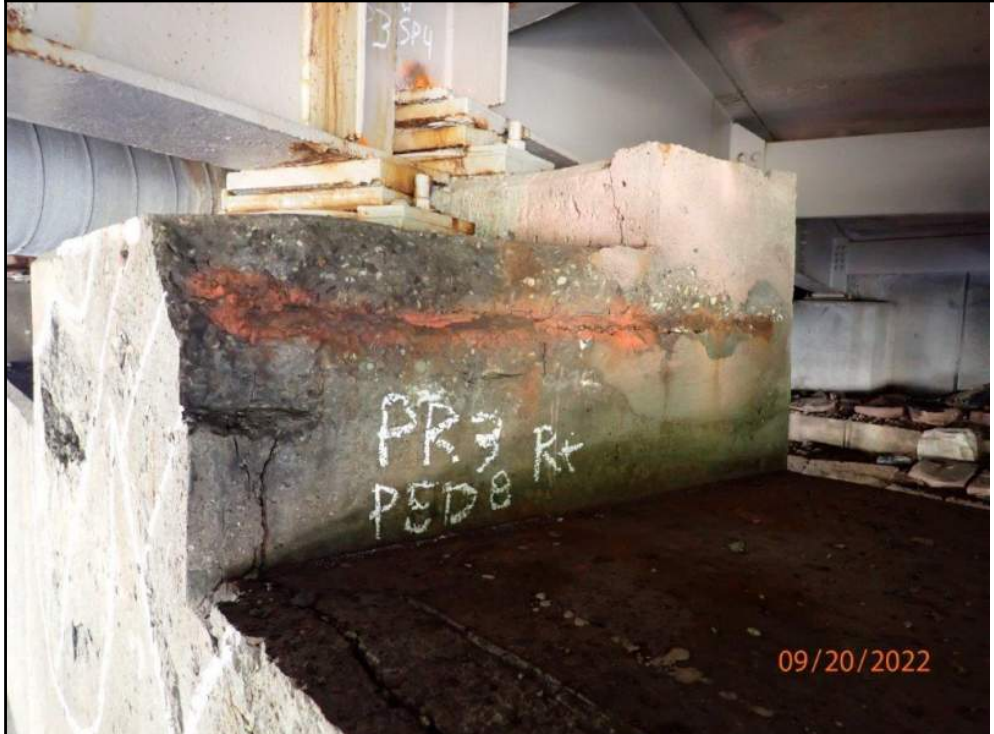
Photo Number: 42 Photo Filename: 42-Right face of G-8 Pedestal at PR-3 spalled

Attachment Description:
Right face of G-8 Pedestal
at PR-3 spalled (Looking
toward End Left)

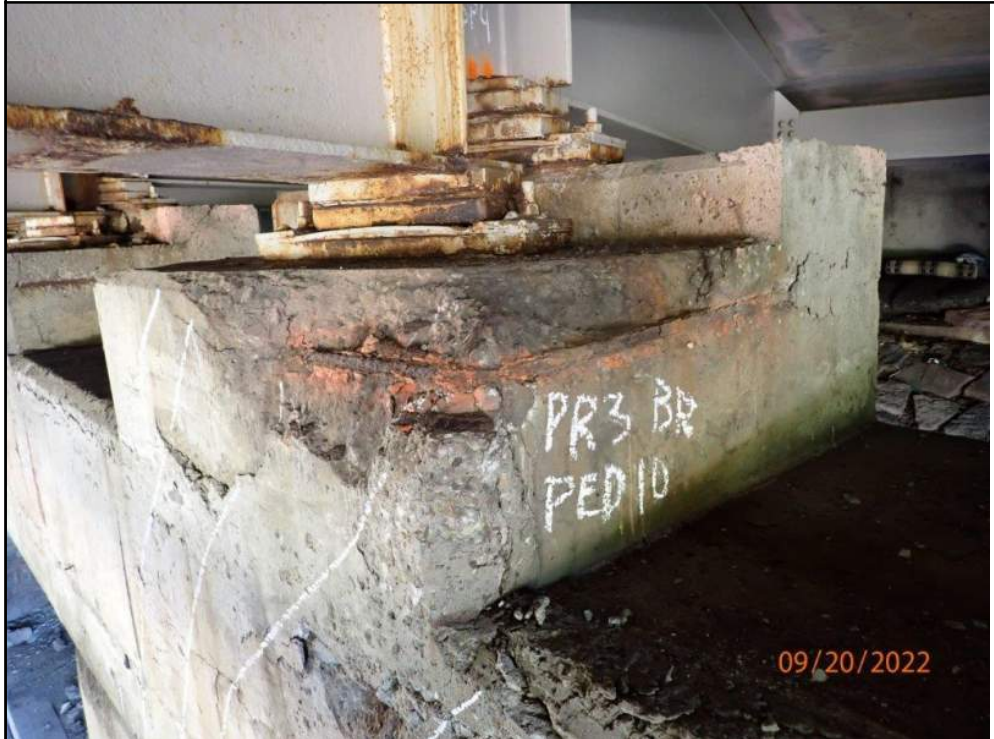
Photo Number: 43

Attachment Description:
Begin Right corner of G-10
Pedestal at PR-3 spalled
(Looking toward End Left)

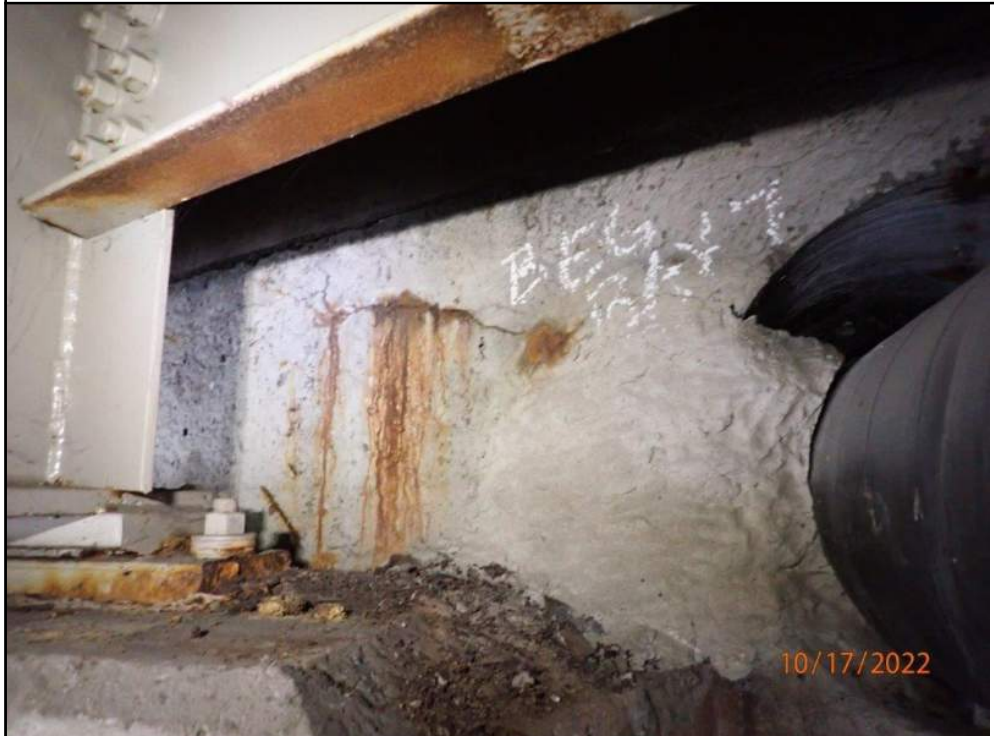
Photo Number: 44

Attachment Description:
Horizontal crack in Bay 7 of
Begin Backwall (Looking
toward Begin Right)

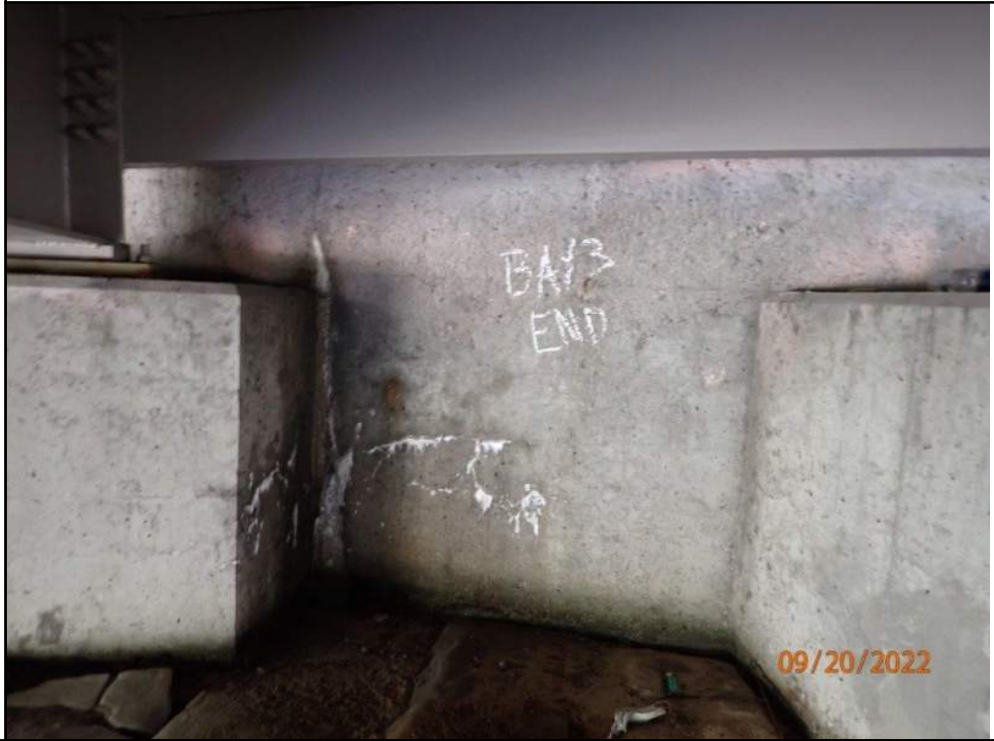
Photo Number: 45

Attachment Description:
Cracking with efflorescence
in Bay 3 of End Backwall
(Looking toward End)

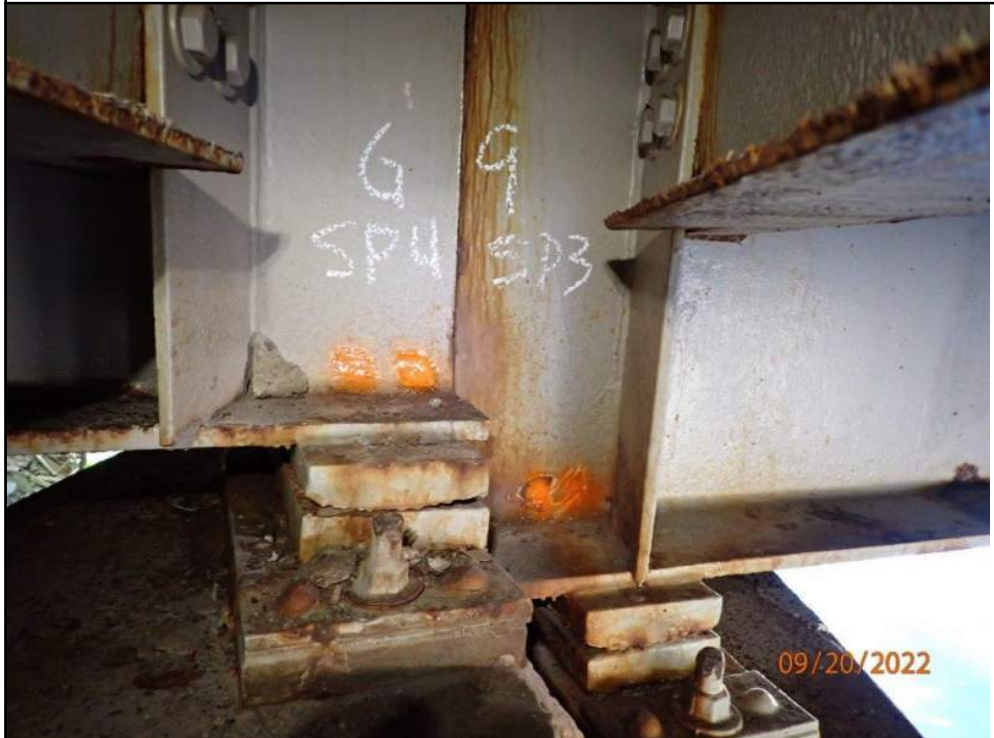
Photo Number: 46

Attachment Description:
Painted over pitting in lower
webs of G-9 over PR-3
(Looking Right)

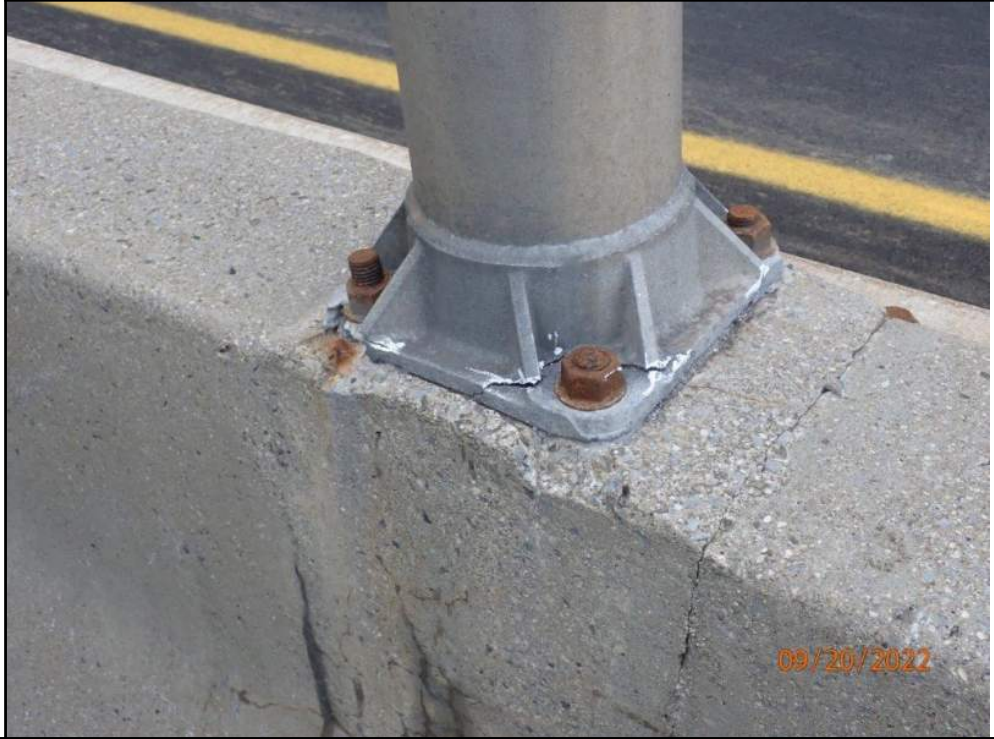
Photo Number: 47

Attachment Description:
Cracked base on NY-33
median light standard Left
of Bridge (Looking toward
Begin Right)

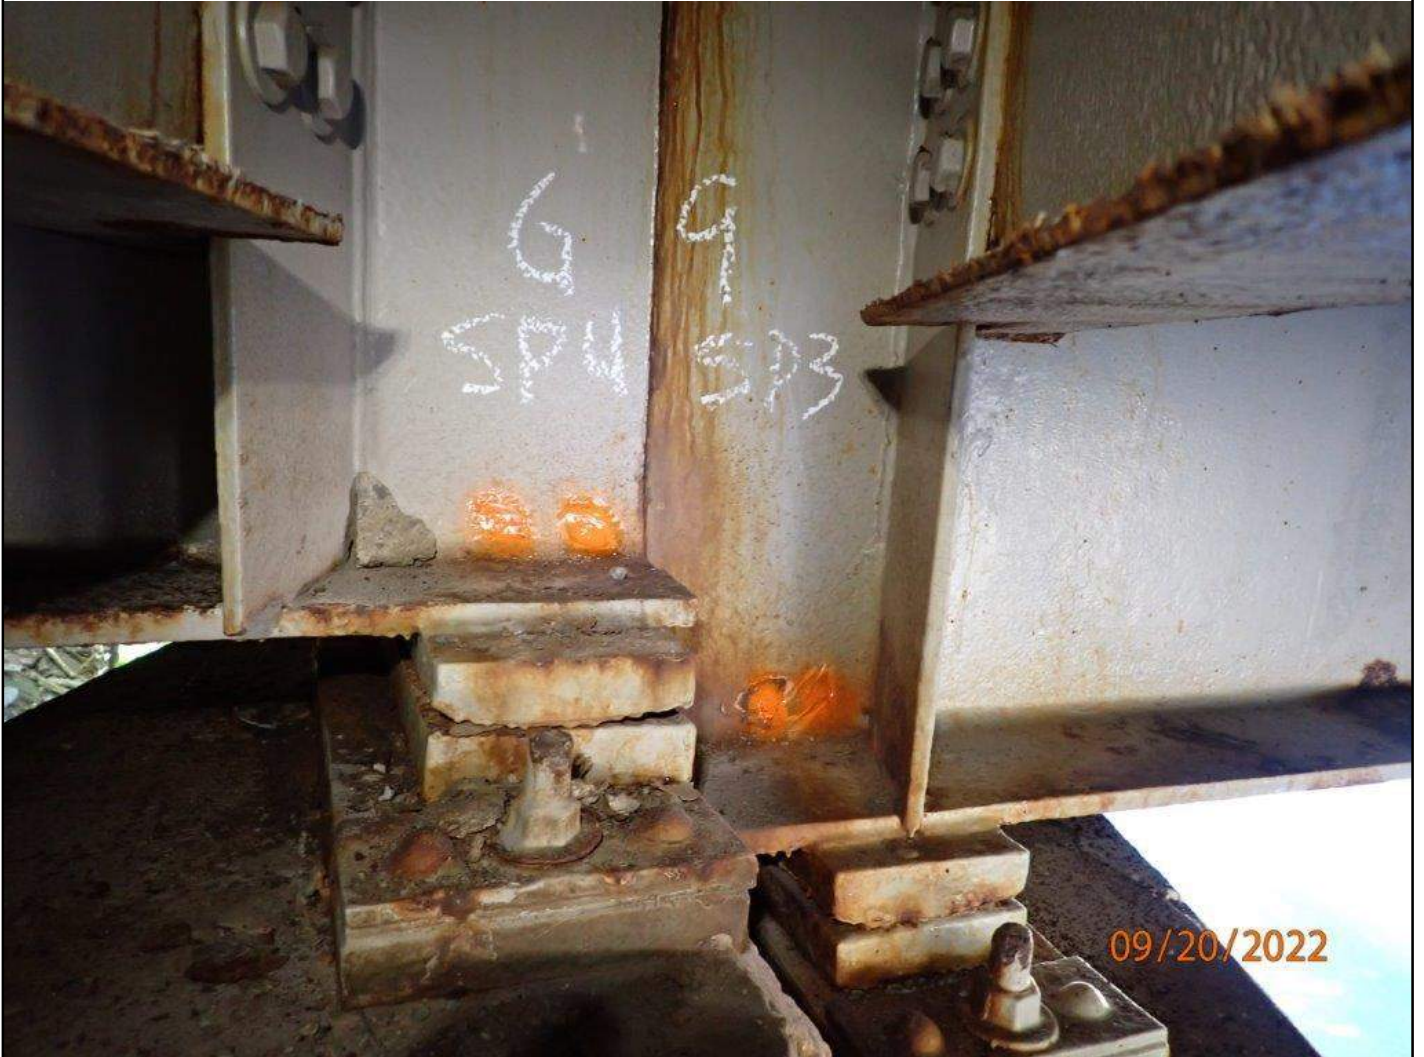
Photo Number: 3

Remaining thickness was measured during the 2020 Inspection by caliper or D-meter at a single location on each girder, above the bearing. There is no new or active corrosion occurring on Girder G-9. Changes in Section Loss are most likely due to small differences in location of measurements as well as precision of D-meter vs Caliper.

Attachment Description: Painted over pitting in lower webs of G-9 over PR-3 (Looking Right)

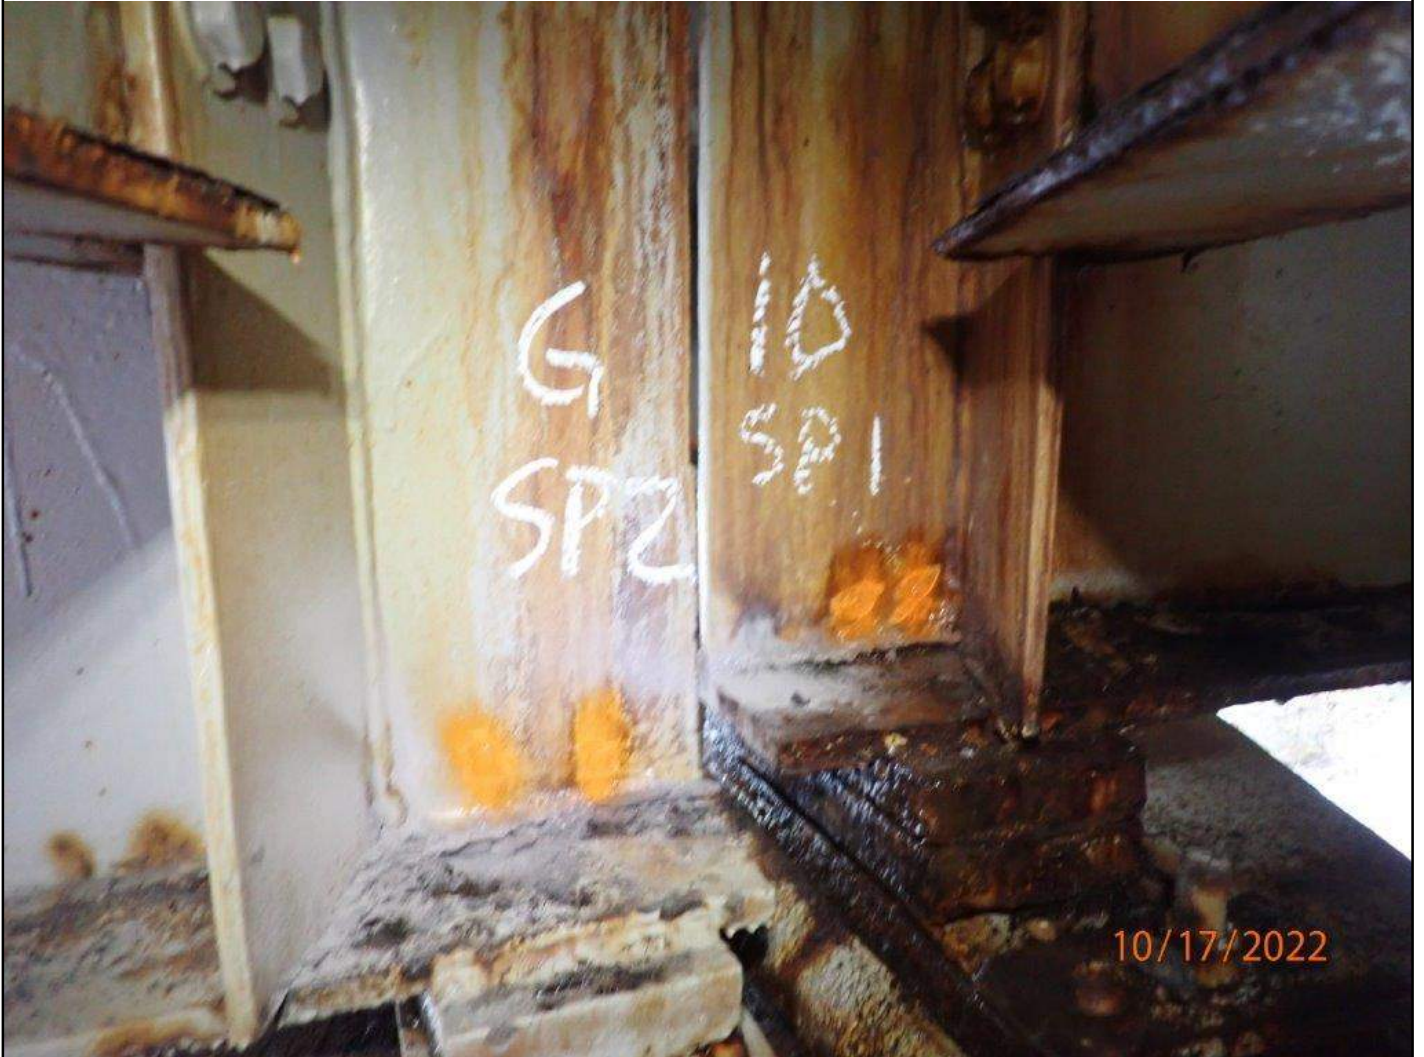
Photo Number: 3

Attachment Description: Painted over pitting in lower webs of G-10 over PR-1 (Looking Right)

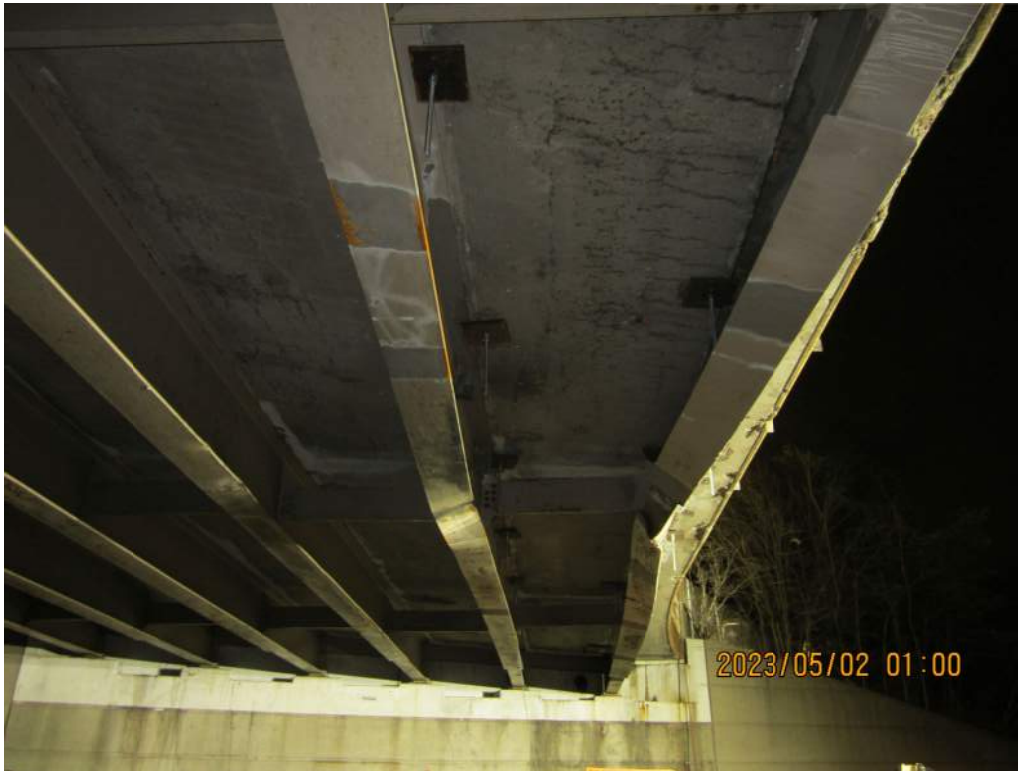
PHOTO 1

- The bearing area loss ranged from 5% to 43%. The maximum loss was observed at G5 in span 2 at the pier with 43% loss in bearing area.
 - The bridge was recently hit, causing significant damage to G1 and G2 in span 1 and some minor damage to G3. A strongback beam was installed and work to repair the girders was going on during the time of inspection. No measurements were taken for G1 and G2 at the abutment due to the ongoing repair work. Refer to the photos attached to this report to see the extent of damage.

LOCATION:
SPAN 1 LOOKING EAST

DESCRIPTION:
IMPACT DAMAGE TO G1
AND G2, GENERAL DECK
CONDITION

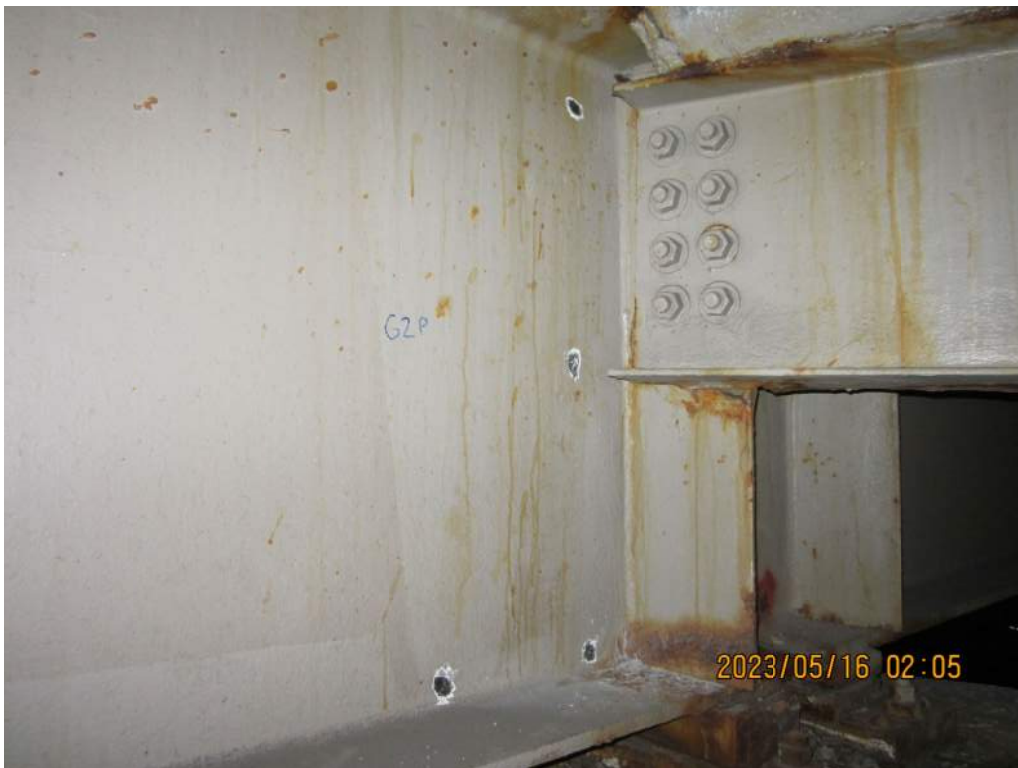
PHOTO 2

LOCATION:
G2 IN SPAN 2 AT PIER

DESCRIPTION:
TYPICAL GIRDER END
CONDITION

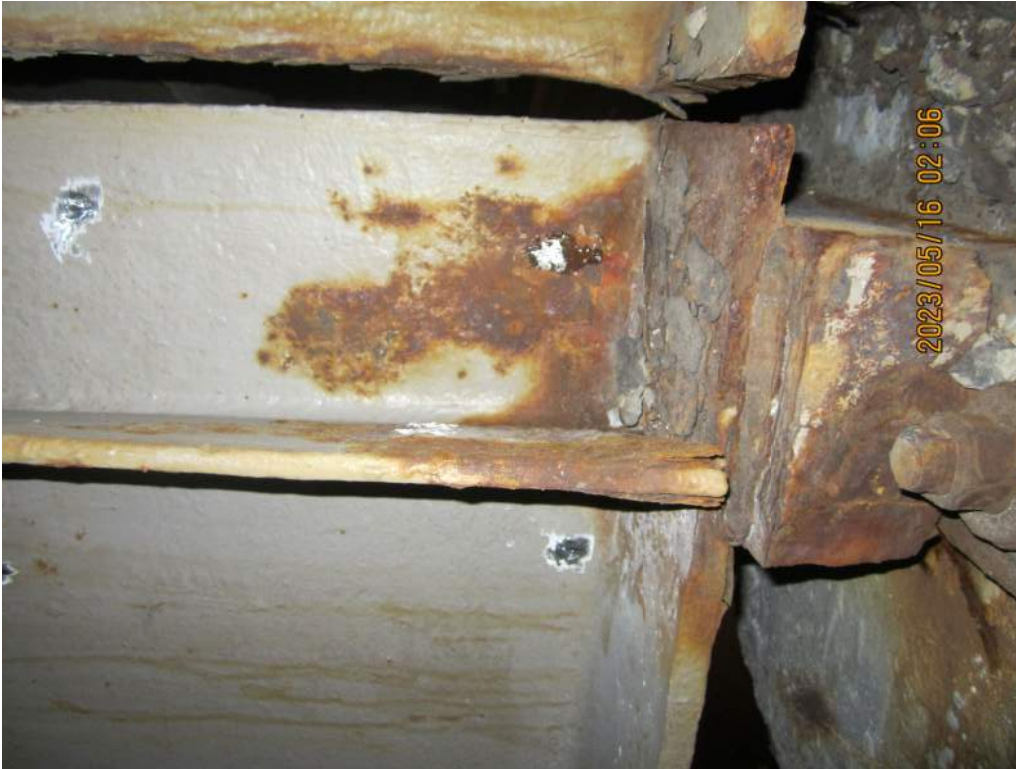
PHOTO 3

LOCATION:
G2 IN SPAN 2 AT PIER

DESCRIPTION:
TYPICAL BEARING AND
GIRDER END CONDITION

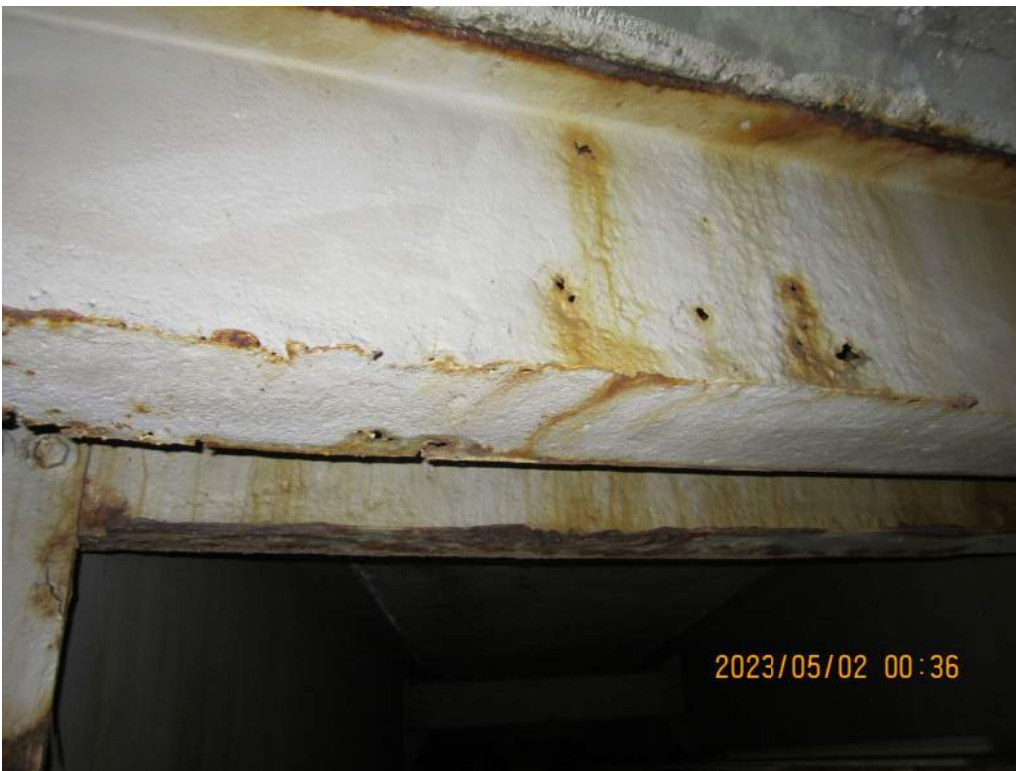
PHOTO 4

LOCATION:
END DIAPHRAGM SPAN
1 AT PIER BETWEEN G1
AND G2

DESCRIPTION:
SEVERAL HOLES IN WEB
AND BOTTOM FLANGE
