Appendix A4

Bridge Inspection Reports and Work History Summaries

**NY33 BRIDGE CONDITION VERIFICATION 2023
KENSINGTON EXPRESSWAY PROJECT
PIN 5512.52
CITY OF BUFFALO, ERIE COUNTY
BIN 1022609**

STRUCTURE: BIN 1022609 - Best Street on NY33 Kensington Expressway

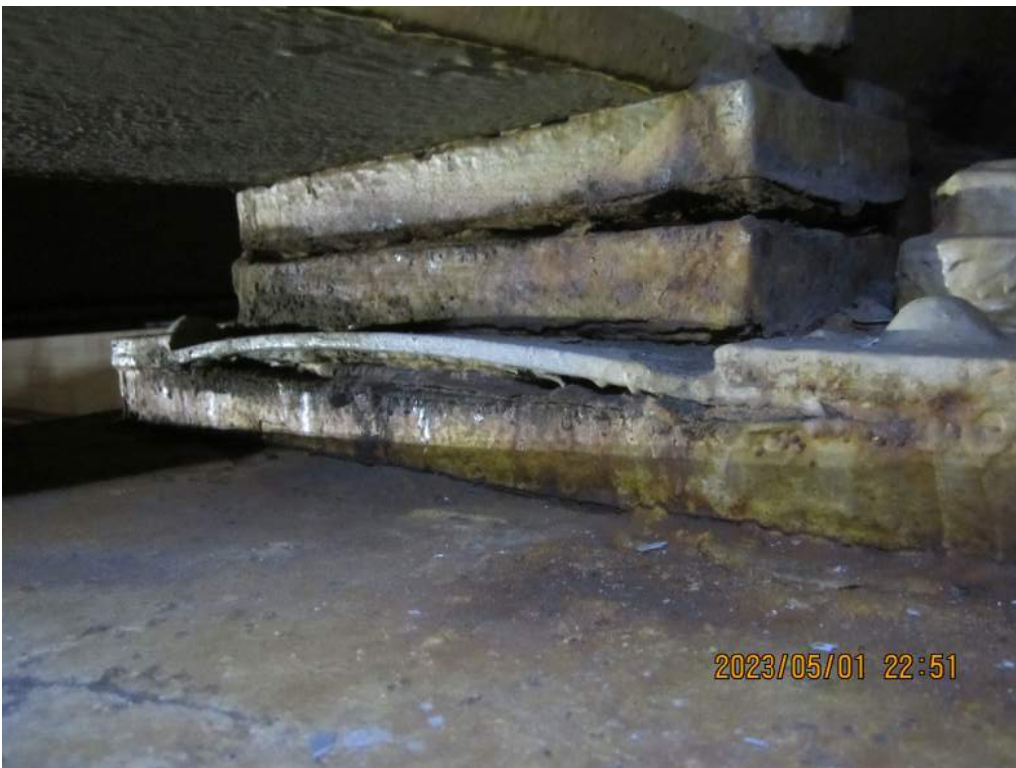
PHOTO 6

- Several expansion bearings had pack rust between plates causing the plates to bow upwards in the center. Based on the pictures in the 2022 inspection report, this condition has gotten slightly worse.

LOCATION:
G4 IN SPAN 1 AT PIER

DESCRIPTION:
TYPICAL BEARING
CONDITION, PACK RUST
CAUSING PLATES TO
BOW UPWARDS

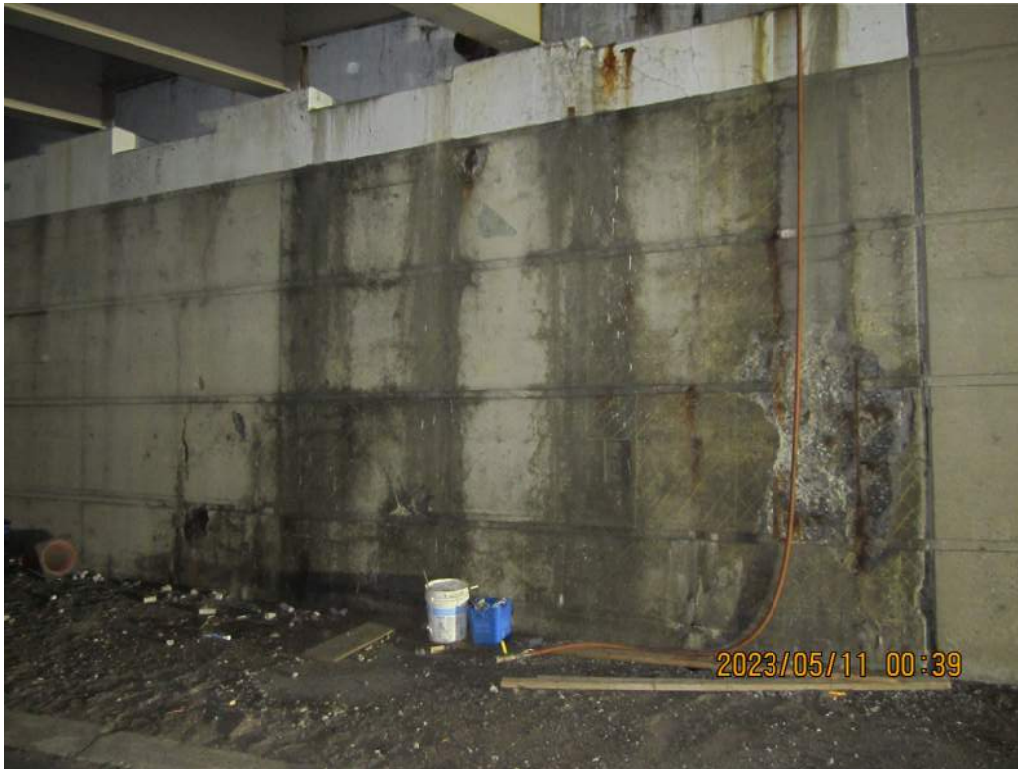
PHOTO 7

LOCATION:
BEGIN ABUTMENT

DESCRIPTION:
LARGE SPALL WITH
EXPOSED REBAR,
WATER LEAKAGE FROM
ABOVE

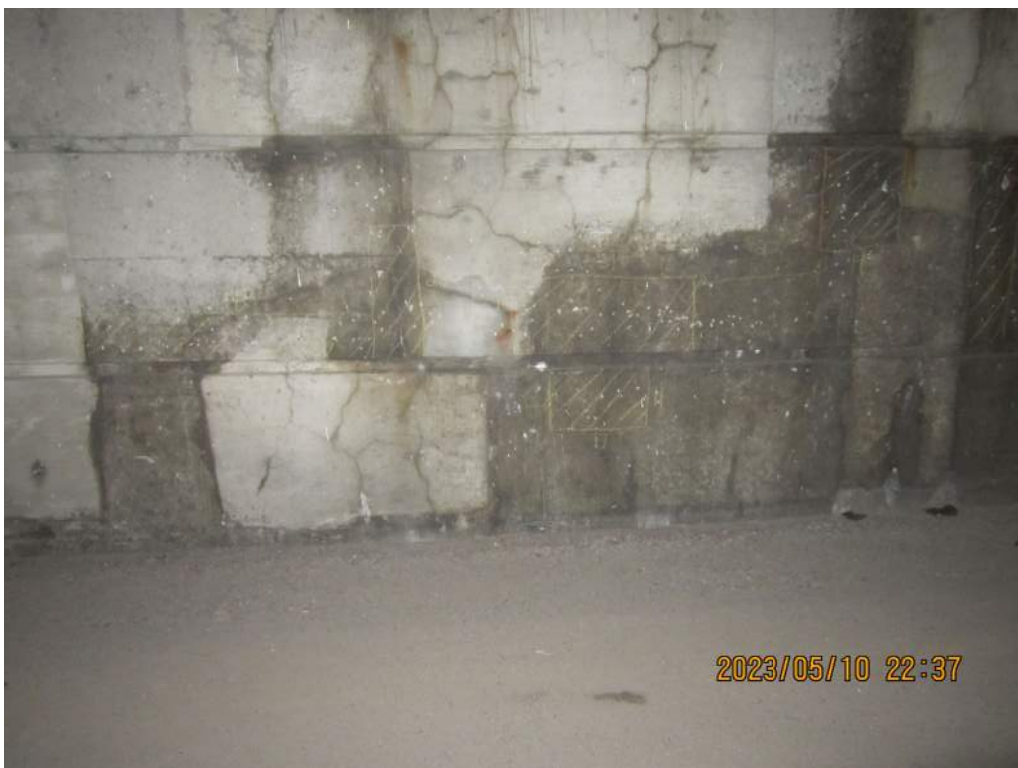
PHOTO 8

LOCATION:
END ABUTMENT

DESCRIPTION:
TYPICAL CONDITION,
MAP CRACKING WITH
MINOR DELAMINATION

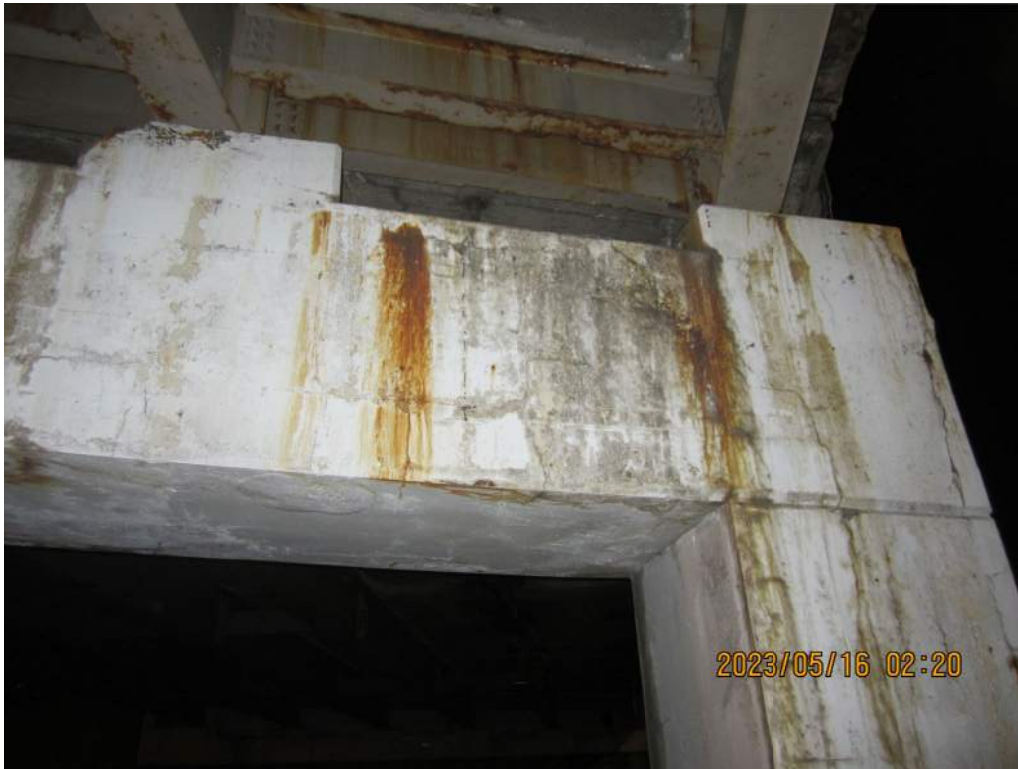
PHOTO 9

LOCATION:
PIER FROM SPAN 2

DESCRIPTION:
CRACKS TO CONCRETE
PIER WITH RUST
STAINING

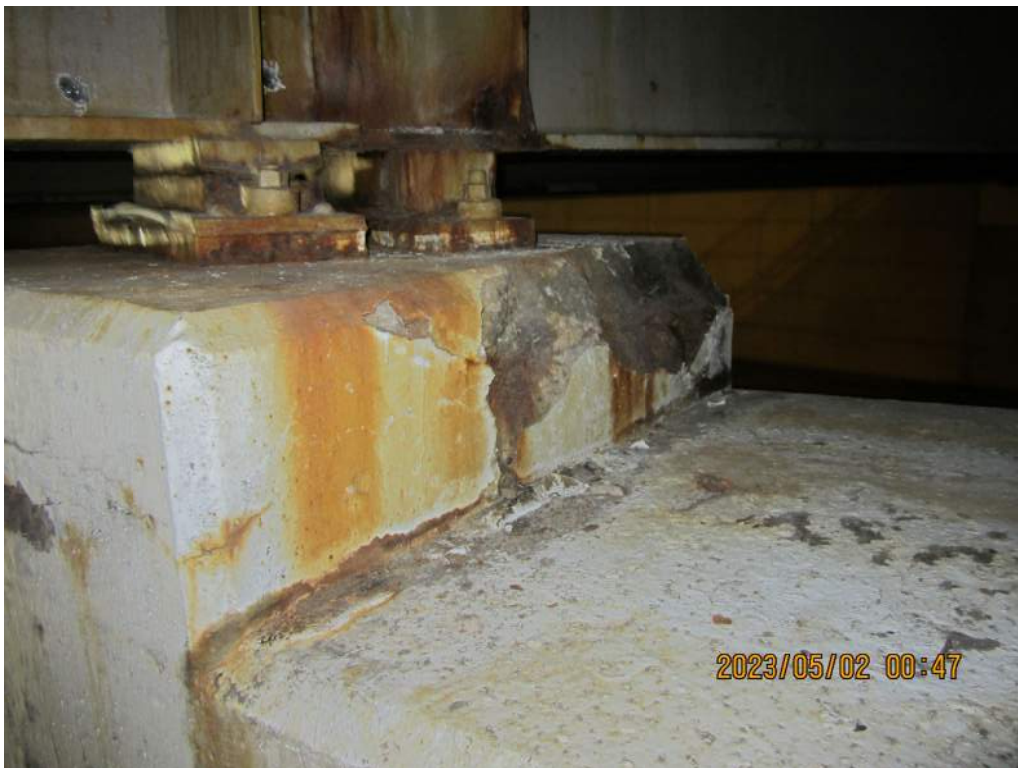
PHOTO 10

LOCATION:
PIER PEDESTAL

DESCRIPTION:
SPALLS ON CONCRETE
PIER PEDESTAL

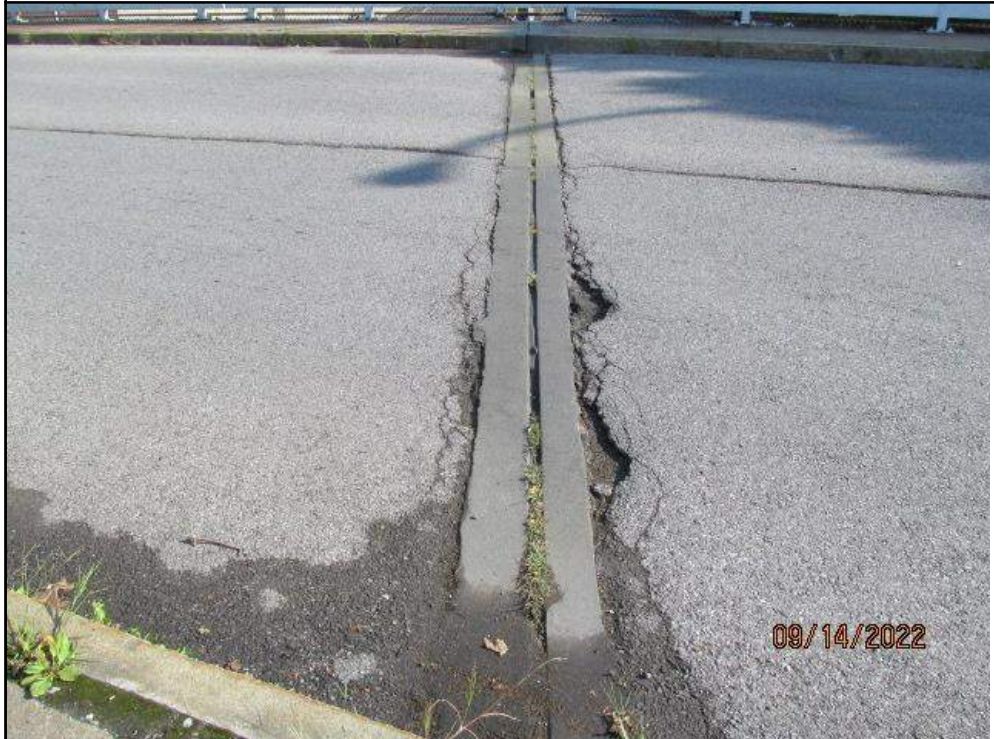
Photo Number: 4 Photo Filename: 22 4 WSSp2LeftaneNearEnd.JPG

Attachment Description:
Wearing surface in the Left travel lane of Span 2 looking toward the End Right.

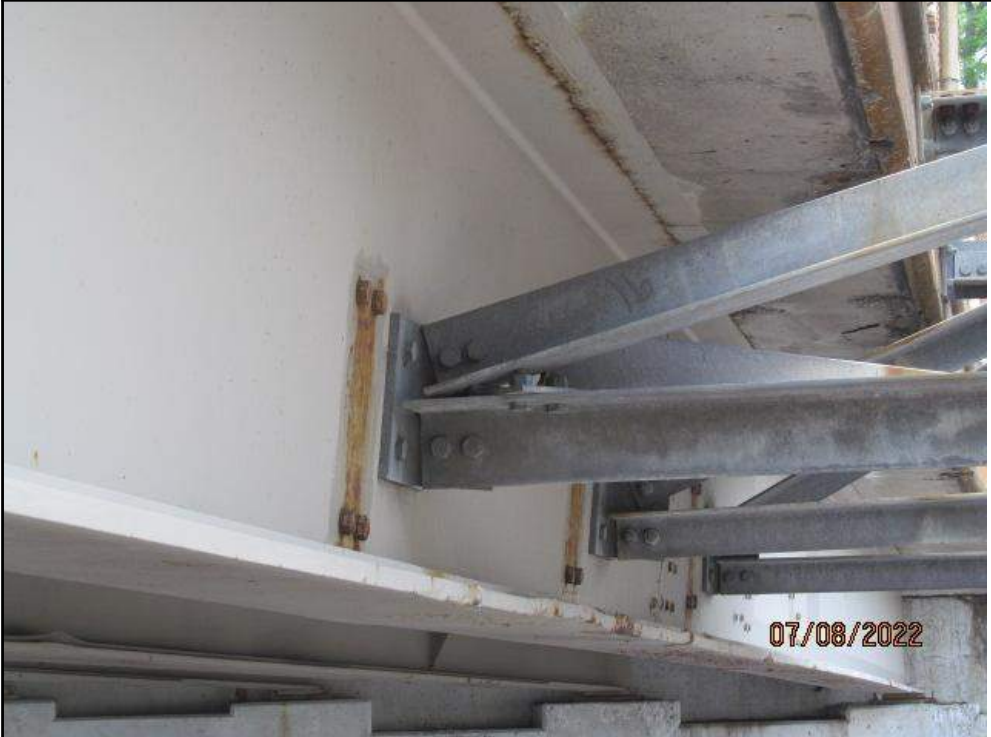
Photo Number: 8 Photo Filename: 22 8 SSSoatSp1FromBeginLeft.JPG

Attachment Description:
Superstructure coating in
Span 1, from the Begin Left.

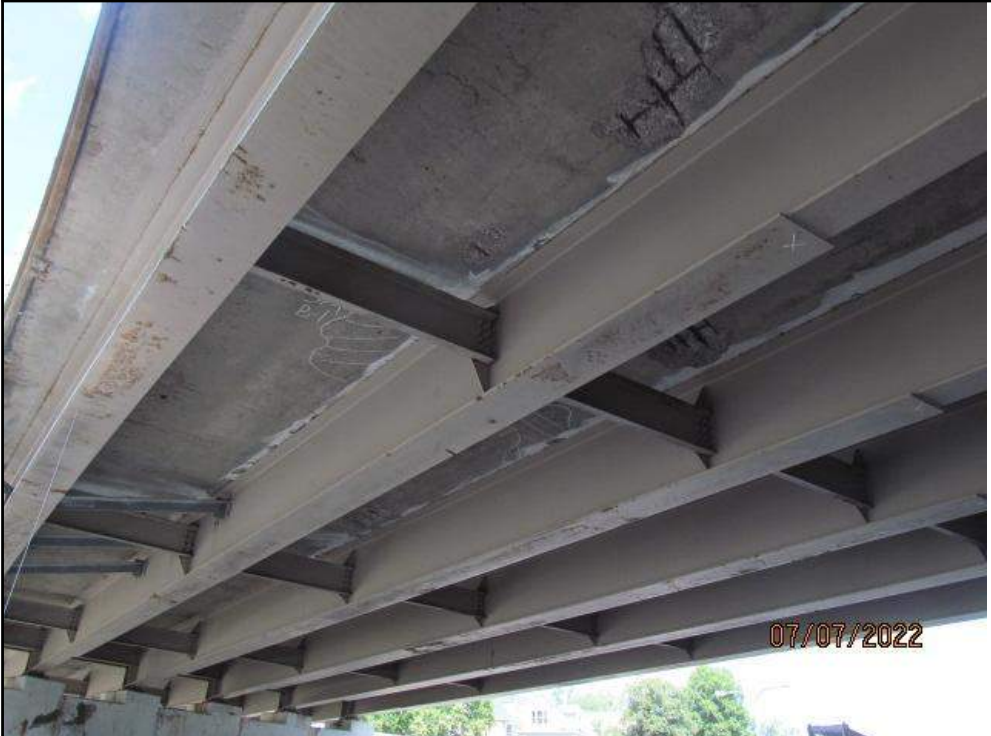
Photo Number: 9 Photo Filename: 22 9 SScCoatSp2FromEndRight.JPG

Attachment Description:
Superstructure coating in
Span 2, from the End Right.

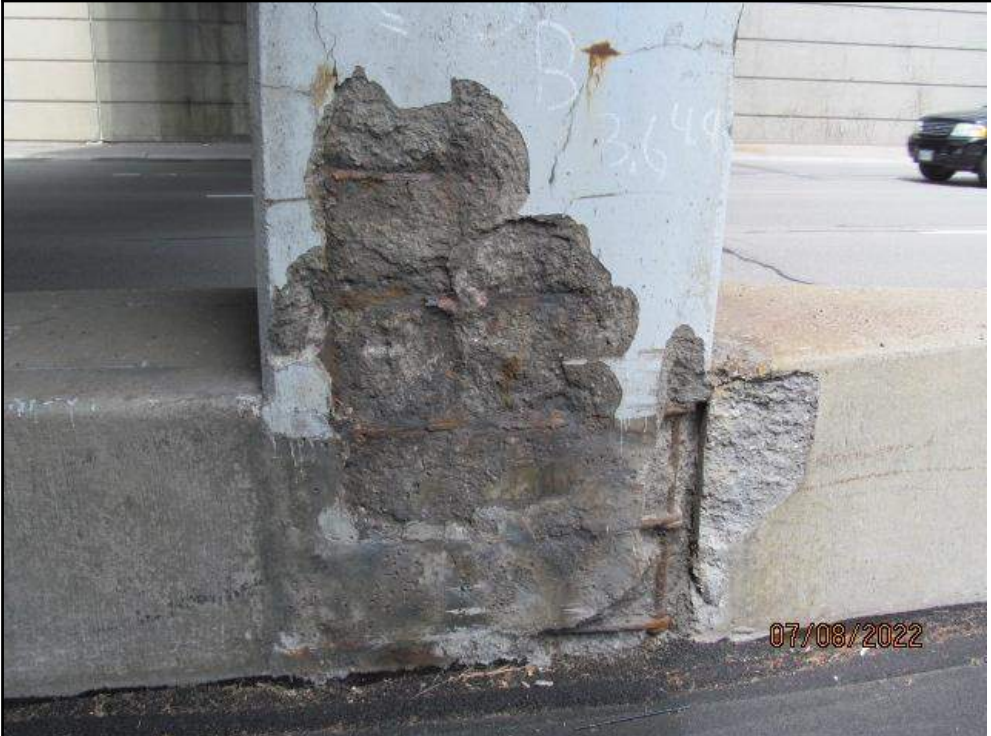
Photo Number: 11

2022 – The Begin abutment exhibits 20 foot wide area of delaminated concrete with 3 separate spalls between the Left end and to below the G-2 pedestal. The affected widths of the spalls are 3.7 feet, 1.7 feet and 1.9 feet reaching between 1-1/4” and 2” deep. There is exposed corroded bonded reinforcement within all three spalls. (Photo No. 11)

Attachment Description:
Begin abutment at the Left end.

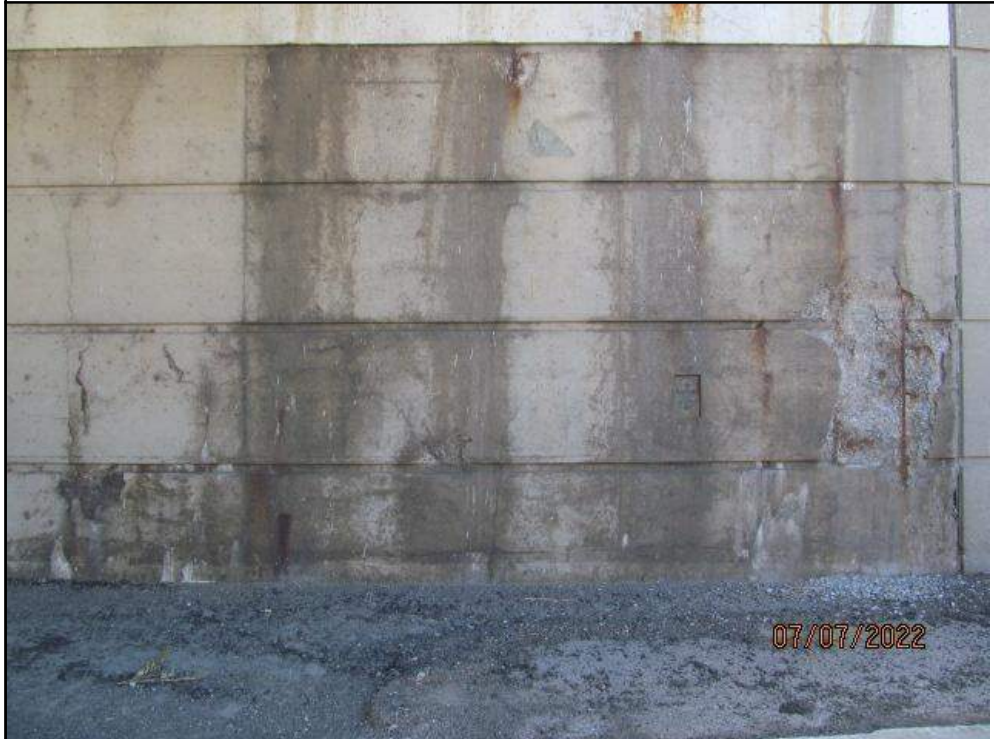
Photo Number: 12

Attachment Description:
Pier cap, begin face below girder G-2.

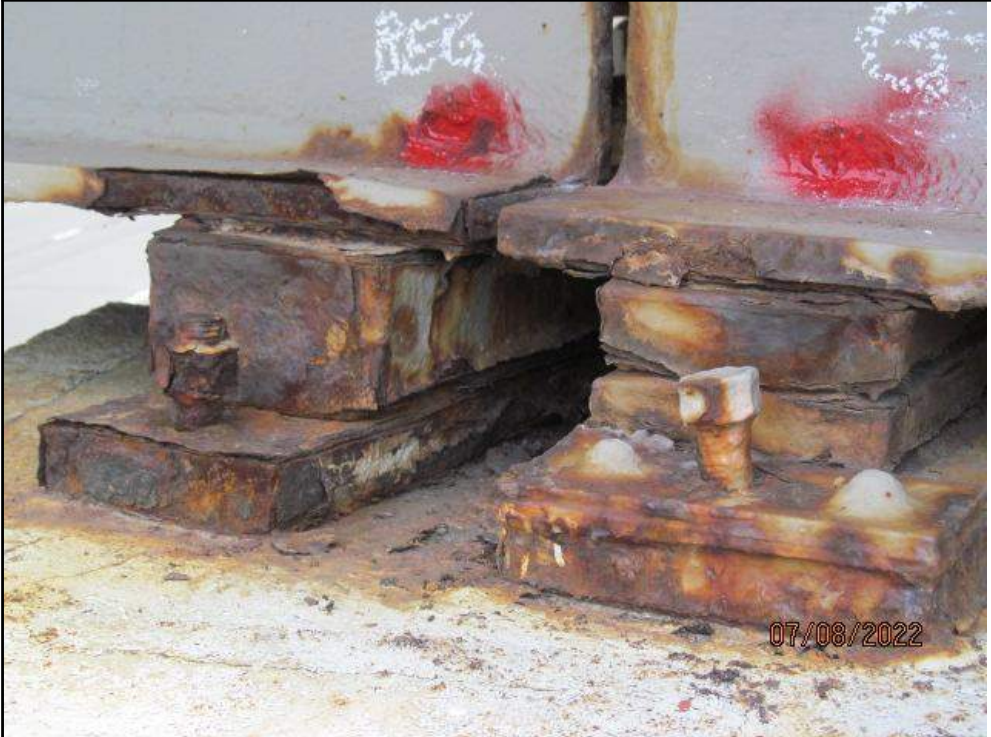
Photo Number: 18

2022 – The End abutment expansion bearings are all typically shifted toward the Right. All six bearings exhibit pack rust between the bronze slide plate and the masonry plate. The bronze plates are bowed upward between 1/4" and 5/8" inhibiting proper thermal movement. Additionally, the bearings below girders G-4 thru G-6 are in contracted positions at 80 degrees F. (Photo No. 18)

Attachment Description:
End bearing below girder G-
1.

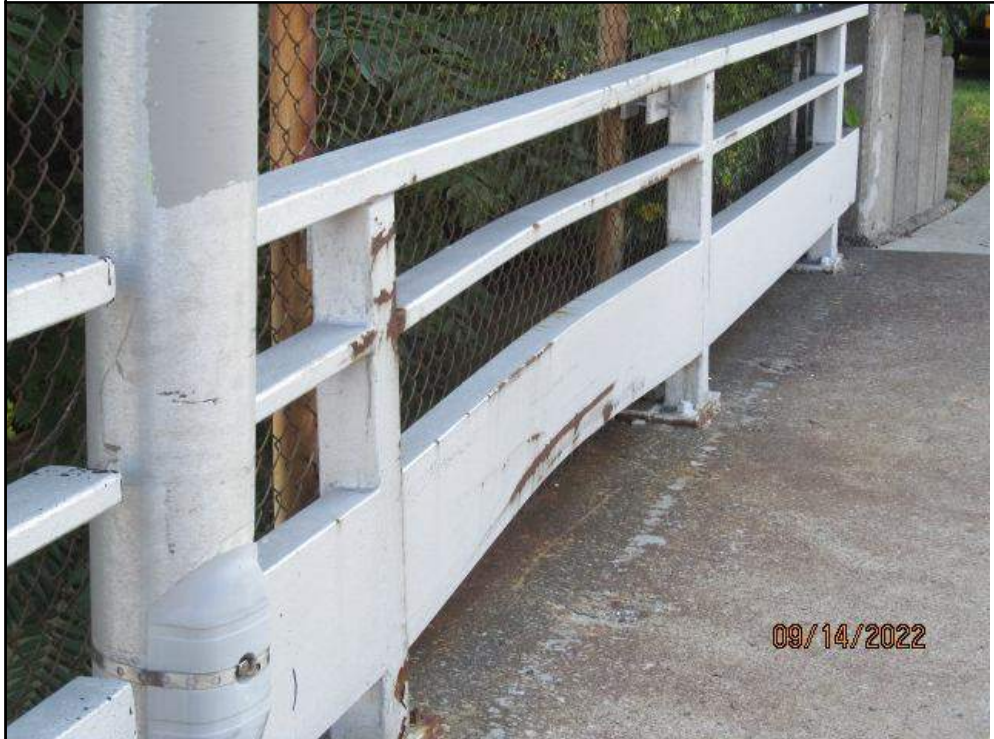
Photo Number: 20

2022 – The Right side bridge rail exhibits impact damage affecting the Begin-most 2 LF of the rail. Additionally, the bottom rail on the Left side is bent adjacent to the 9th post. (Photo No. 20)

Attachment Description:
Bridge rail in Span 2 at the
Begin Right.

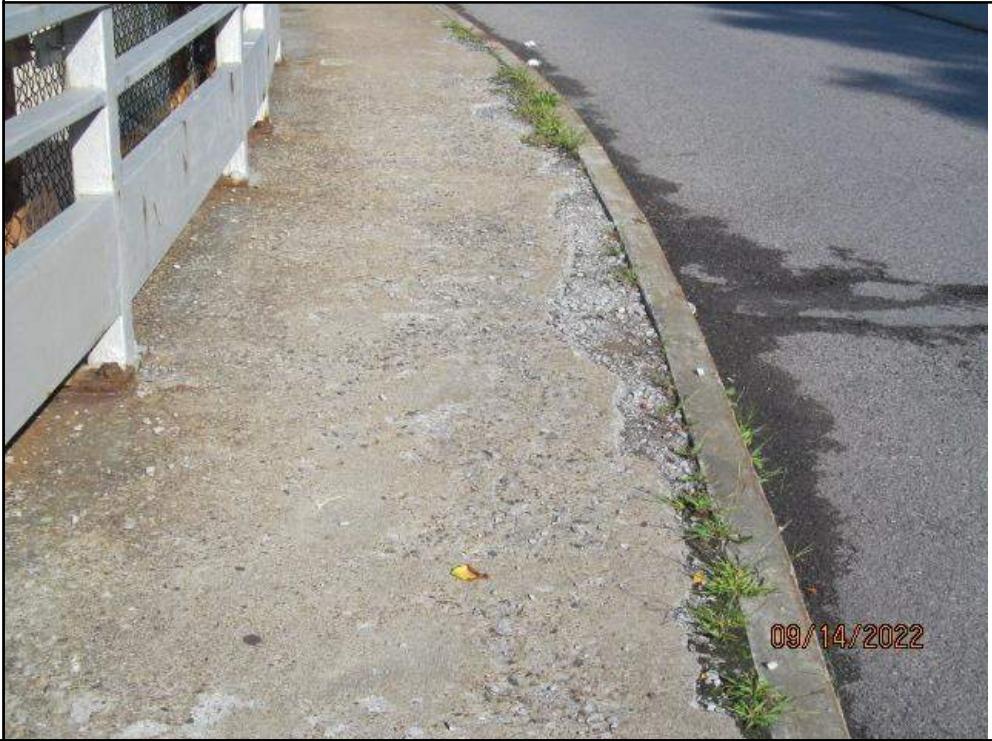
Photo Number: 22

found in any of the spalls. (Photo No's. 21 and 22)

Attachment Description:
Sidewalk in Span 2, Right
side from the End.

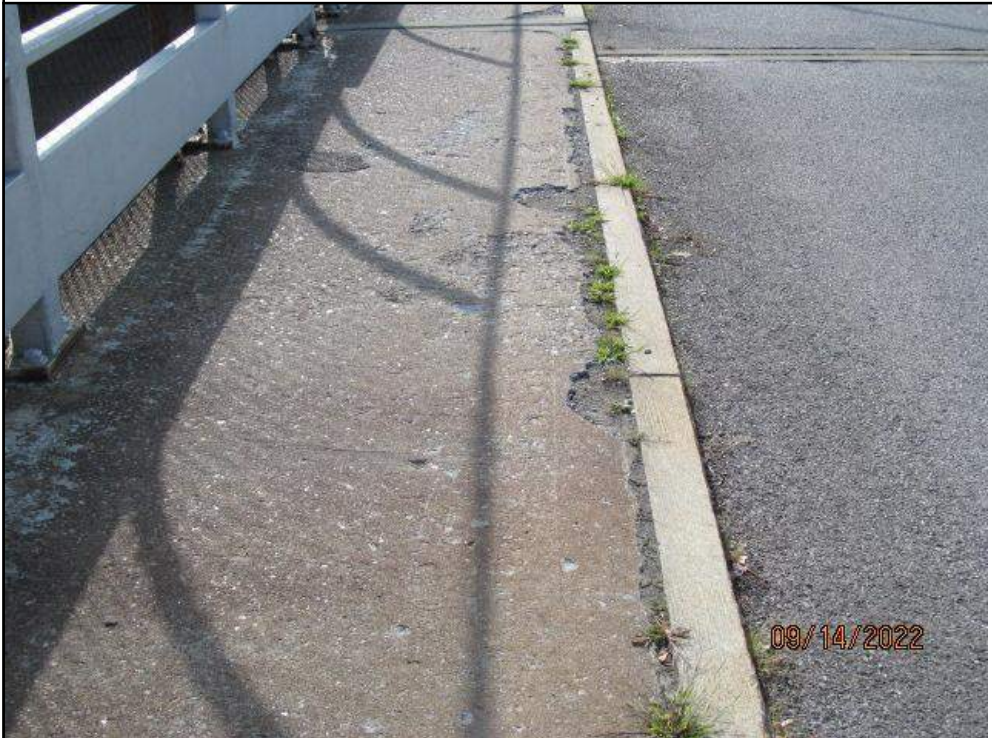
Photo Number: 23

Bay 1 – There are two areas of spalling affecting a total of 5.5 feet wide by 2" to 6" deep with exposed corroded debonded reinforcement affecting the backwall from the Left end and Bay 1. (Photo No's. 23 and 24)

Attachment Description:
End backwall to the Left of
girder G-1.

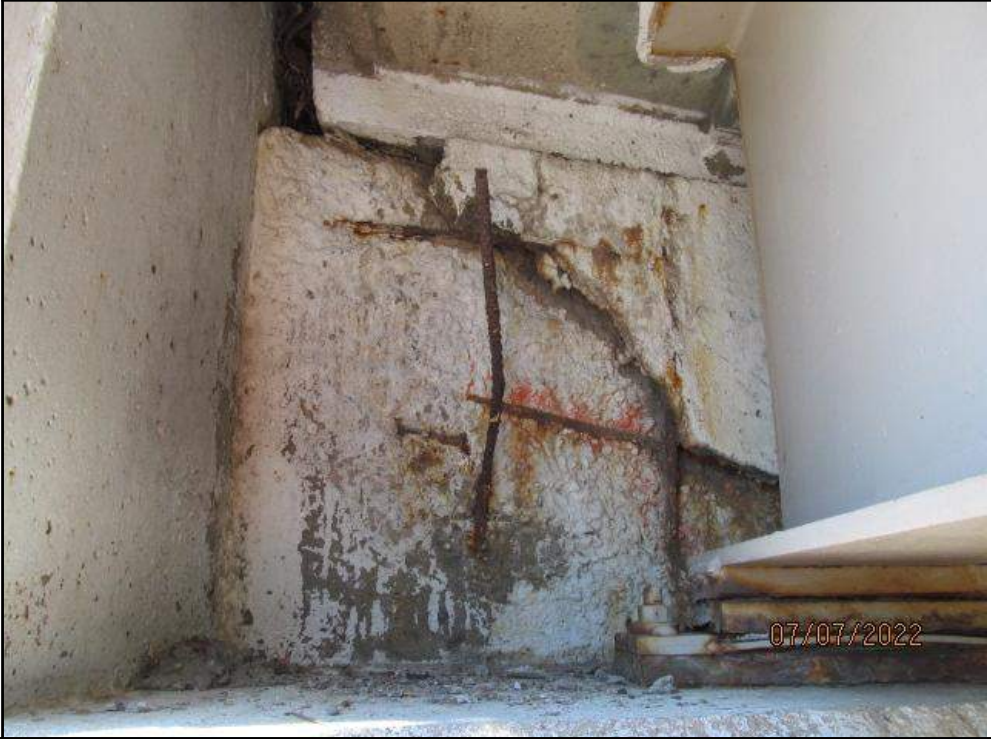
Photo Number: 24

Attachment Description:
End backwall in Bay 1.

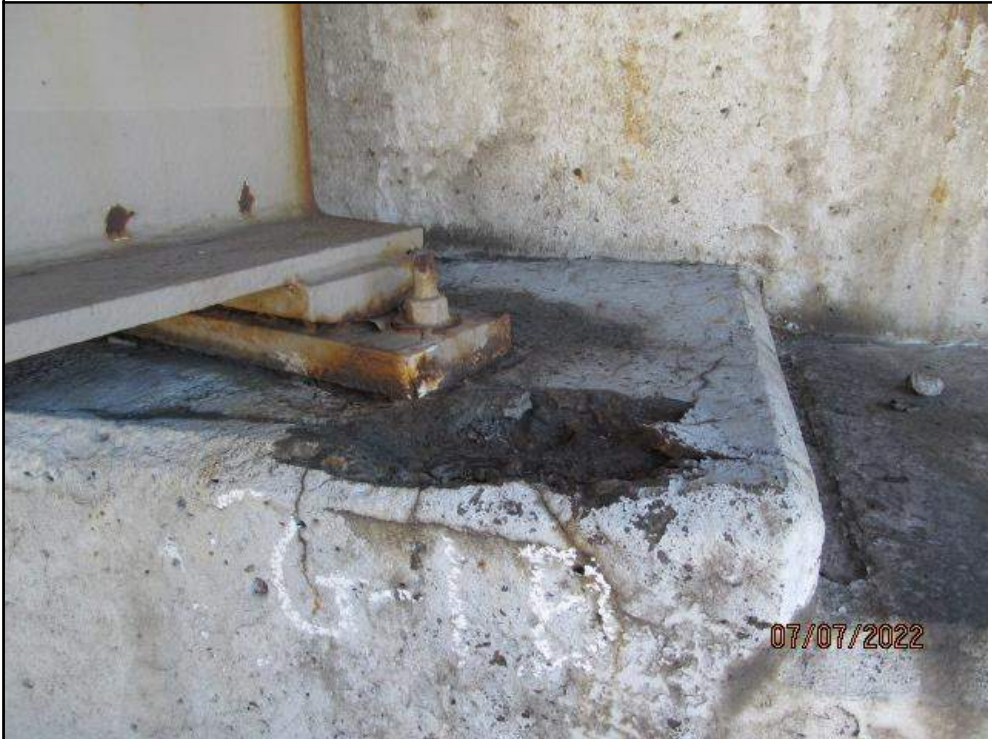
Photo Number: 26

G-4 – The Right side of both G-2 pedestals exhibits spalling that measures 2.4 feet wide by 0.8 feet high by 2" to 2-1/2" deep with exposed corroded bonded reinforcement. (Photo No. 26)

The concrete adjacent to both spalls is cracked and hollow sounding.

Attachment Description:
Pier pedestal below girder
G-4, Right side.

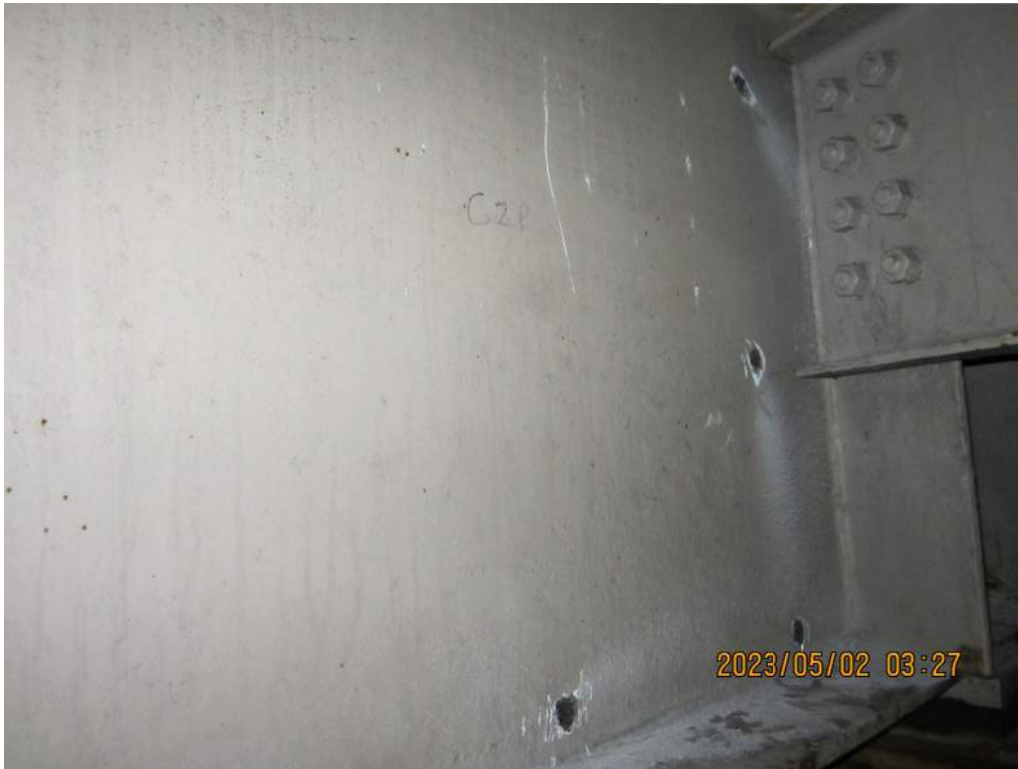
PHOTO 1:

- The average full height section loss was found to be minor for all girders (range = 7% - 18%). The maximum average section loss was observed at G2 in span 2 at the pier with 18% loss.

LOCATION:
G2 IN SPAN 2 AT PIER

DESCRIPTION:
GIRDER END CONDITION
PHOTO (WORST CASE
FULL HEIGHT LOSS)

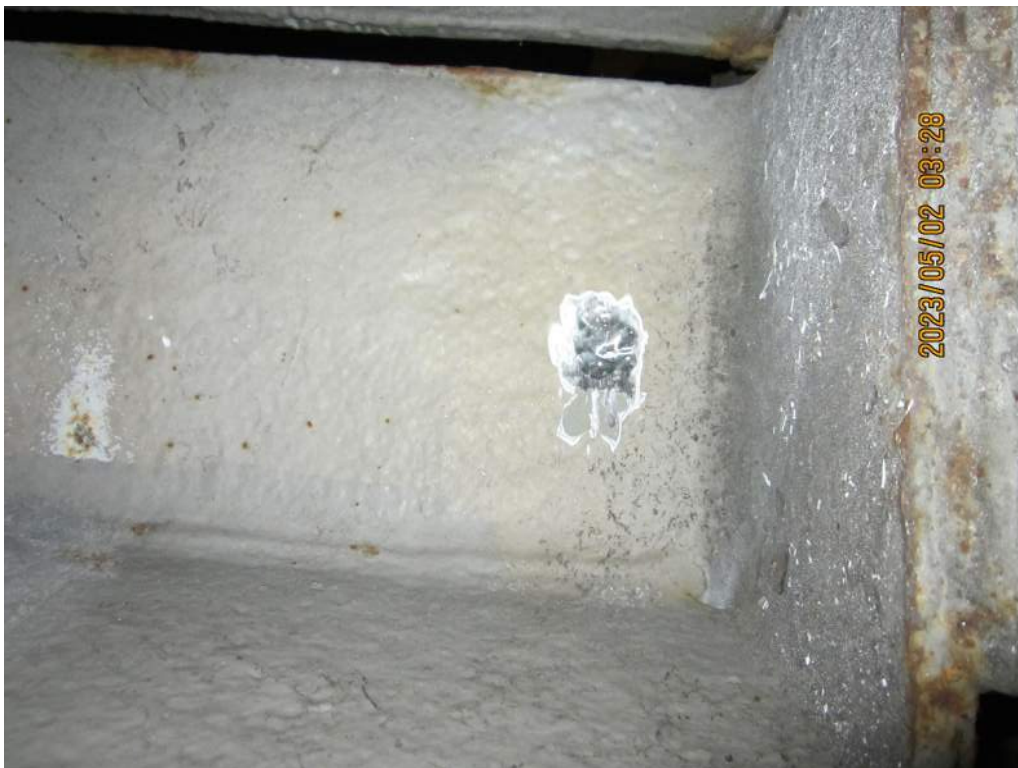
PHOTO 2:

- The bearing area loss ranged from 9% to 47%, excluding the previously mentioned repair plate locations. The maximum loss was observed at G2 in span 2 at the pier with 47% loss in bearing area.

LOCATION:
G2 IN SPAN 2 AT PIER

DESCRIPTION:
GIRDER END CONDITION
PHOTO (WORST CASE
BEARING AREA)

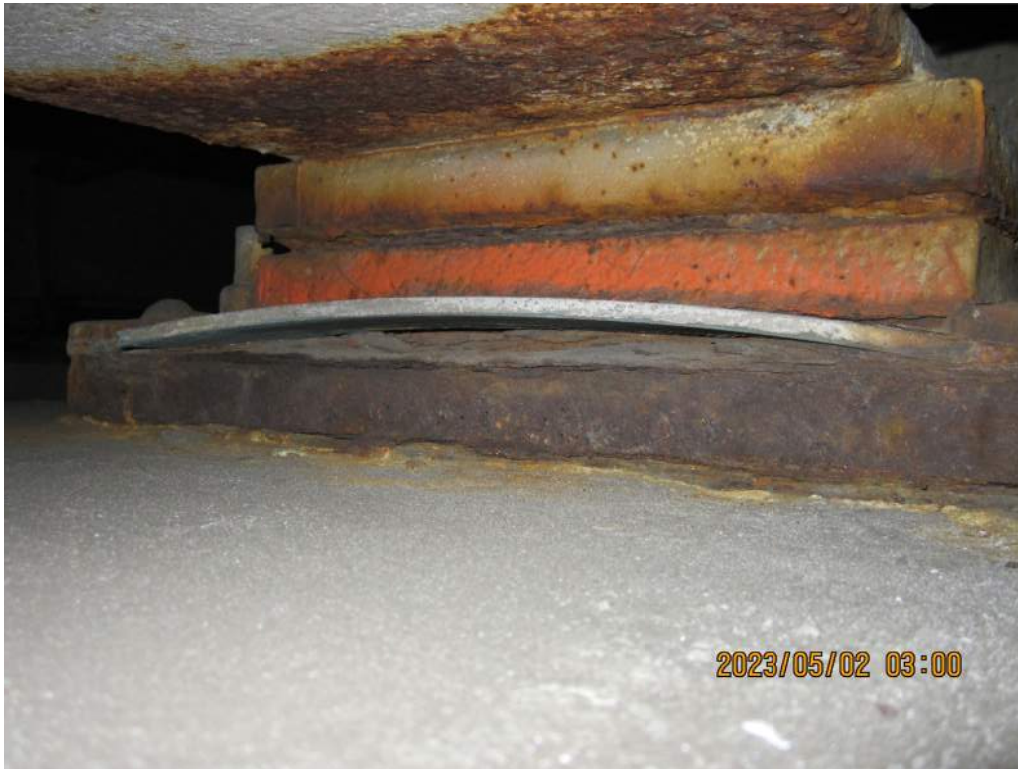
PHOTO 3:

- Several expansion bearings had pack rust between plate causing the plates to bow upwards in the center. However, this has not appeared to restrict movement.

LOCATION:
G4 IN SPAN 2 AT PIER

DESCRIPTION:
TYPICAL BEARING
CONDITION, PLATE
BOWED UPWARDS

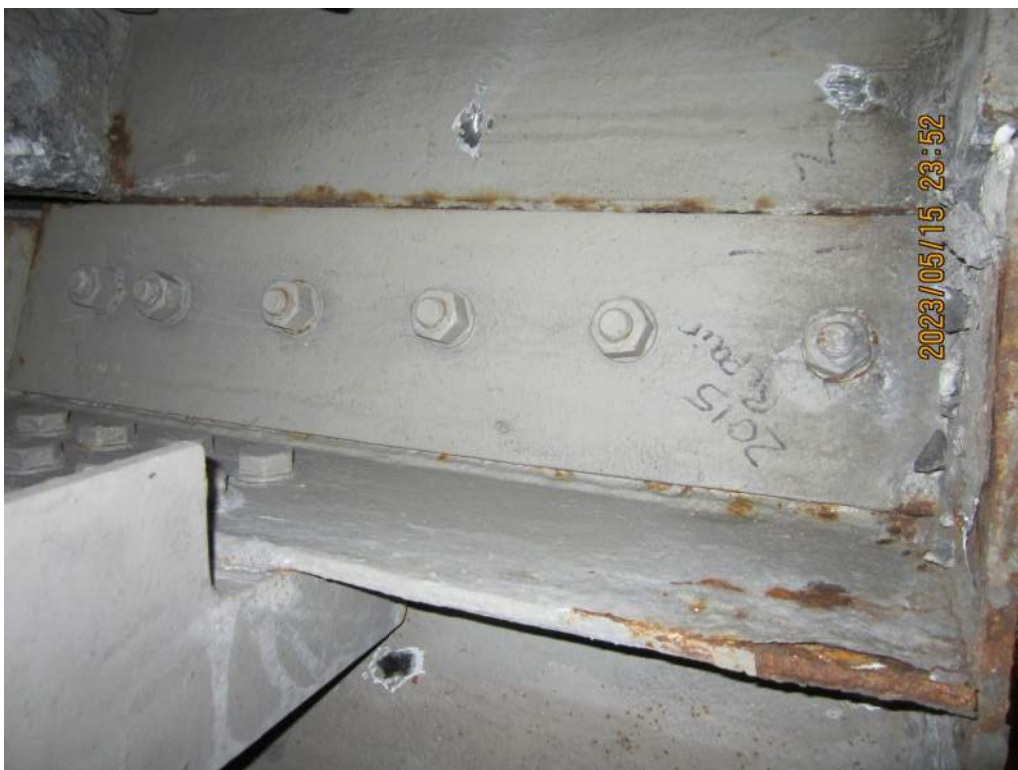
PHOTO 4:

- Repair plates (1/2" thick) have previously been installed on several girder ends at the pier in span 2. These plates were installed behind the connection plate and were only considered in the bearing area calculations. At all of these locations, there is a negative bearing area section loss meaning that the repair plate thickness was greater than the original web thickness.

LOCATION:
G1 IN SPAN 1 AT PIER

DESCRIPTION:
REPAIR PLATE LOCATED
BEHIND BEARING LINE,
ALL OTHER REPAIR
PLATES SIMILAR

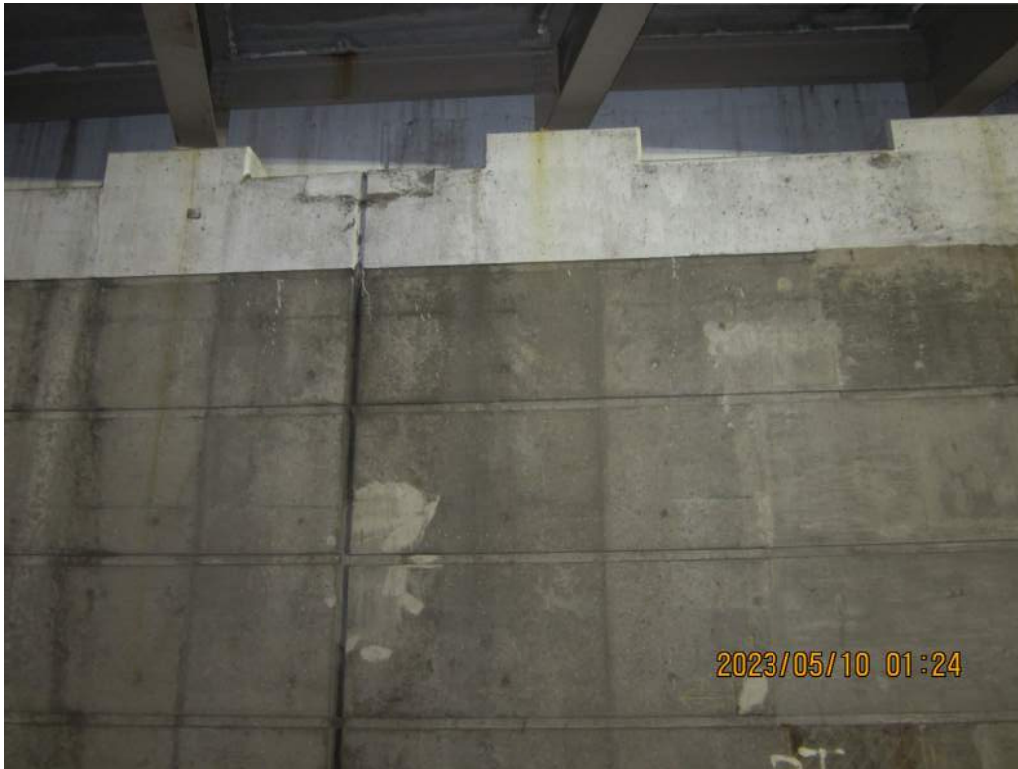
PHOTO 5:

LOCATION:
BEGIN ABUTMENT

DESCRIPTION:
GENERAL CONDITION
PHOTO

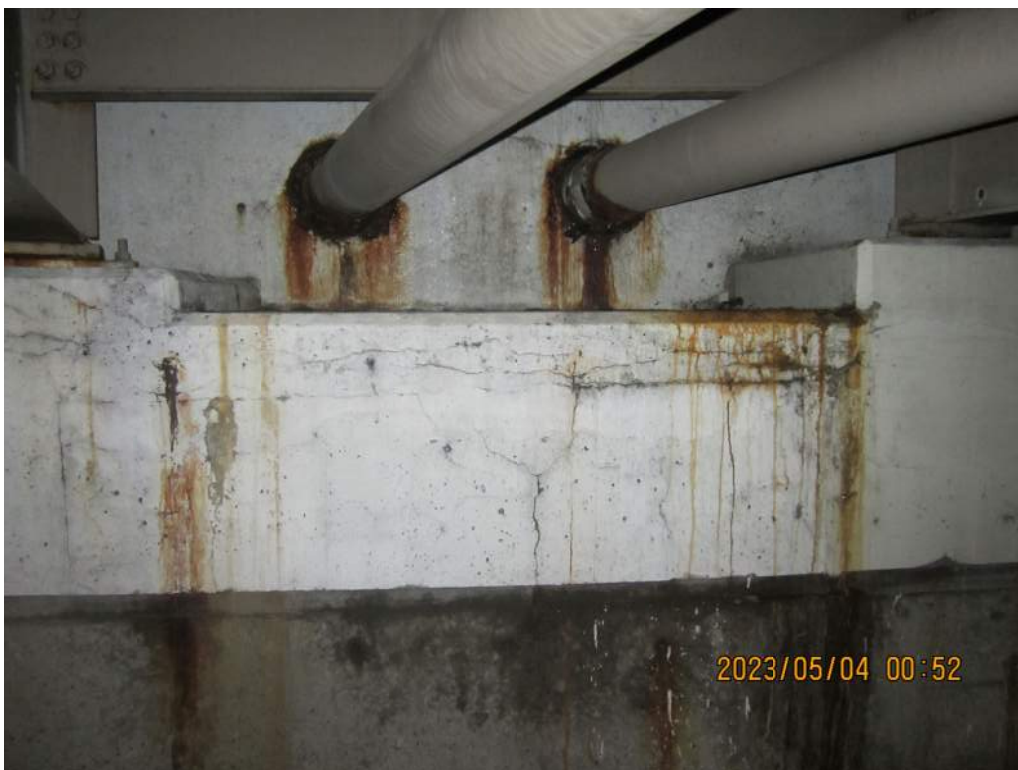
PHOTO 6:

LOCATION:
END ABUTMENT

DESCRIPTION:
MAP CRACKING TO
CONCRETE, LEAKAGE
WITH RUST STAINING AT
UTILITY LOCATIONS

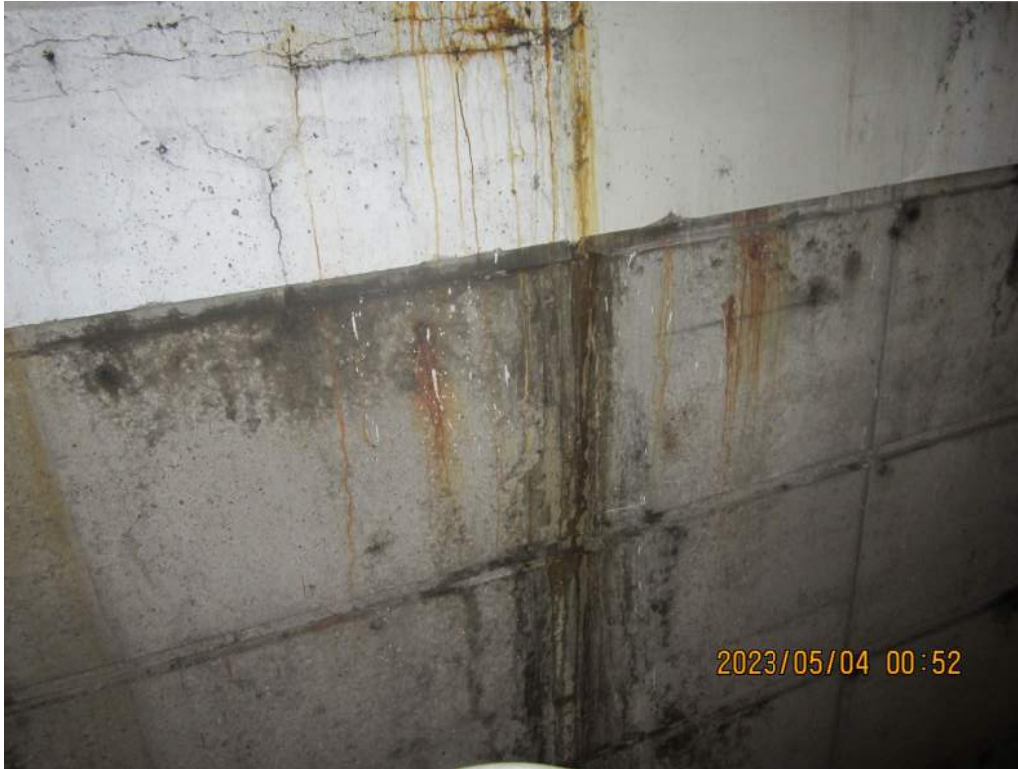
PHOTO 7:

LOCATION:
END ABUTMENT

DESCRIPTION:
VERTICAL CRACKS
COMING DOWN FROM
BRIDGE
SEAT/PEDESTALS

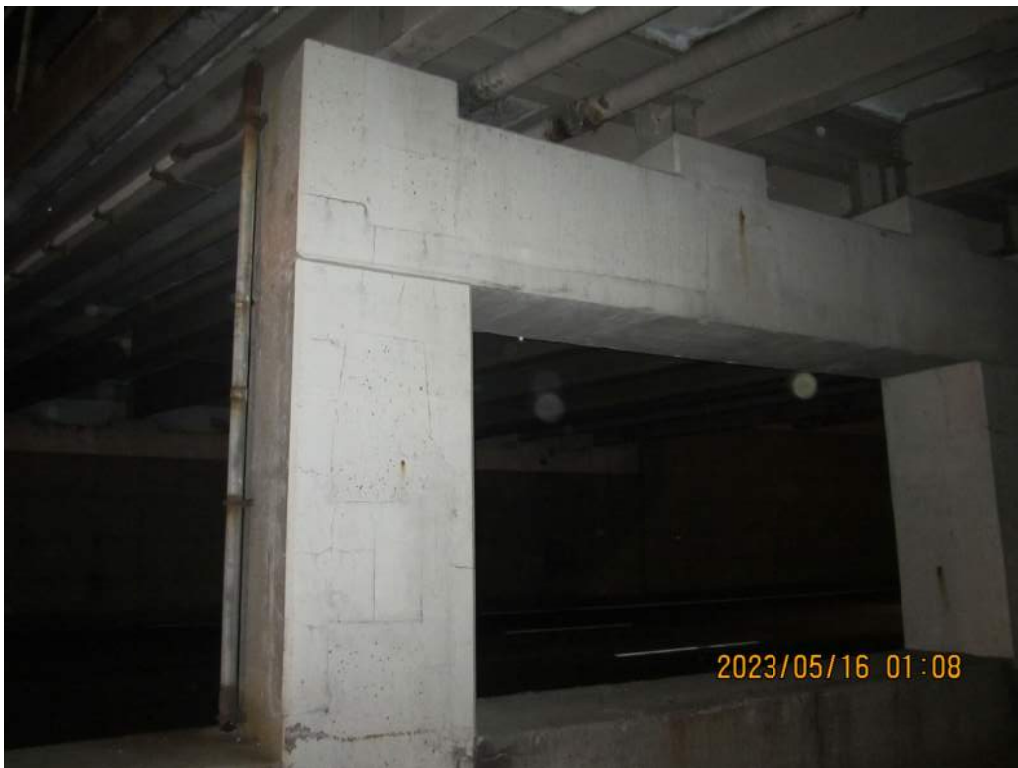
PHOTO 8:

LOCATION:
PIER FROM SPAN 1

DESCRIPTION:
GENERAL CONDITION
PHOTO, MINOR MAP
CRACKING

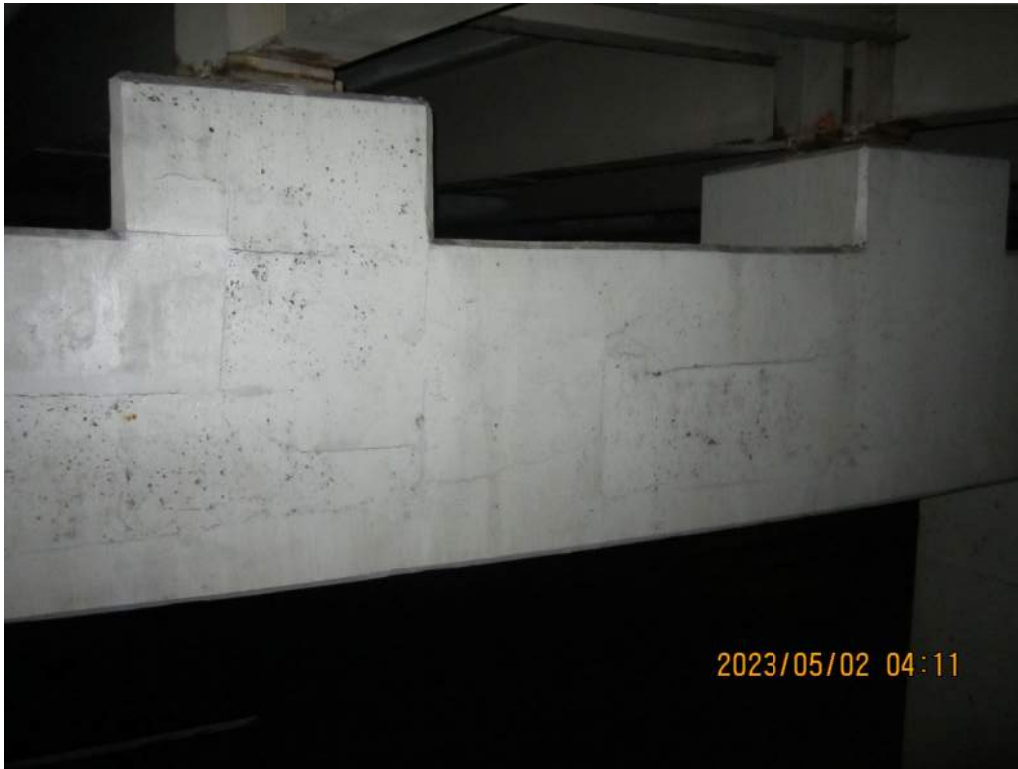
PHOTO 9:

LOCATION:
PIER FROM SPAN 2

DESCRIPTION:
GENERAL CONDITION
PHOTO, MINOR MAP
CRACKING TO CONCRETE
CAP BEAM AND
PEDESTALS

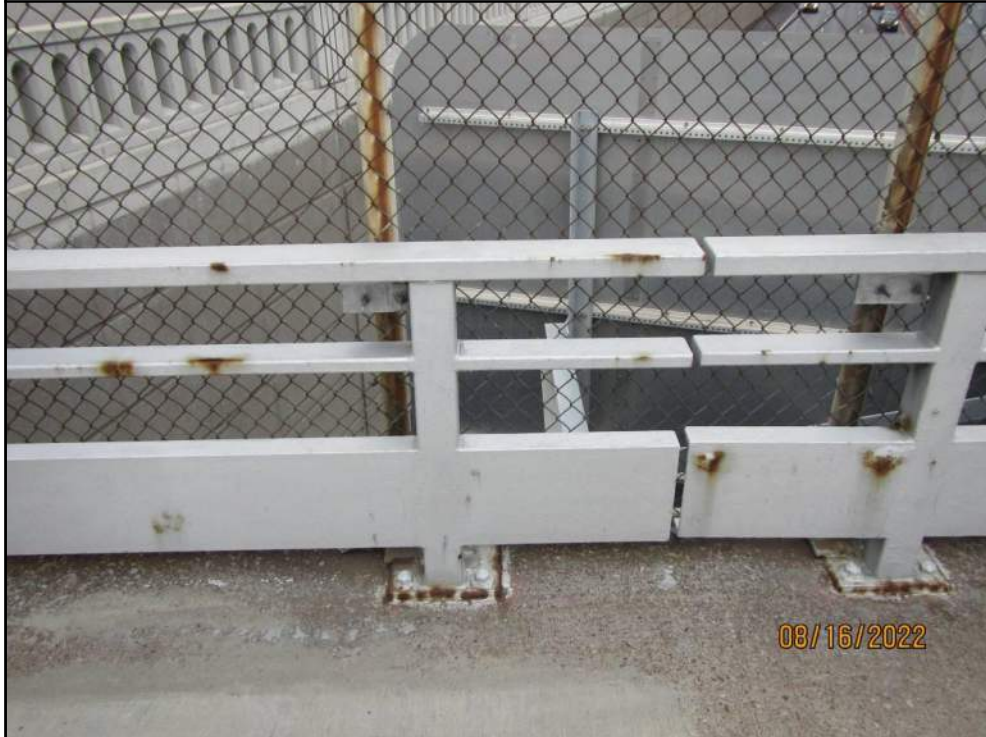
Photo Number: 1 Photo Filename: 22_001.JPG

Attachment Description:
End Right Railing, Paint
Failure

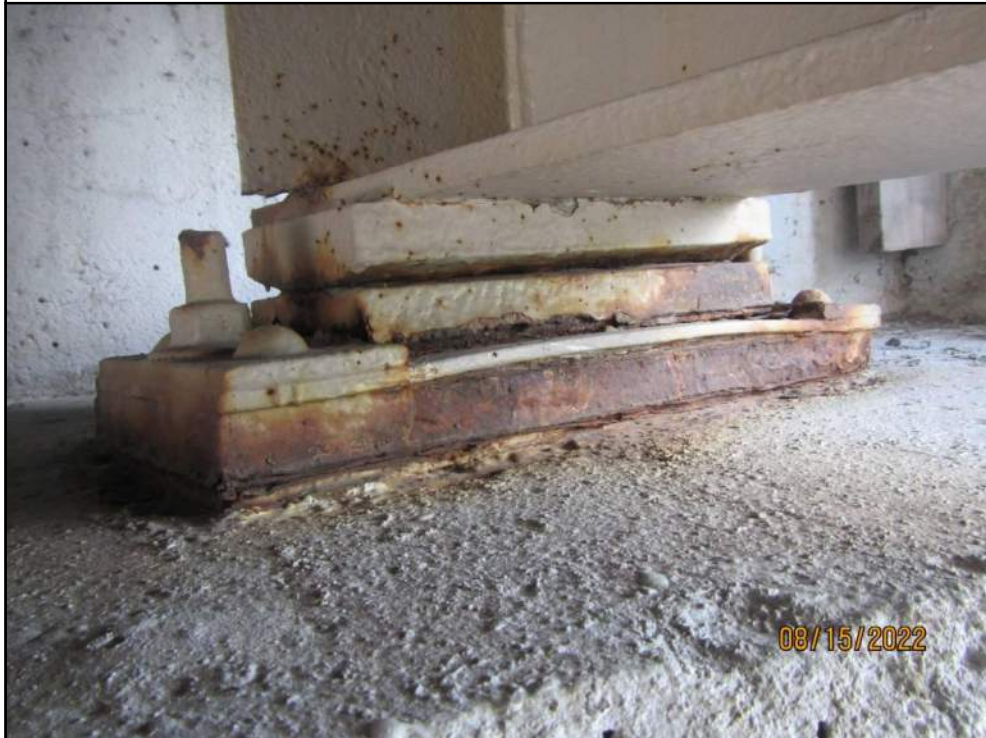
Photo Number: 2 Photo Filename: 22_002.JPG

Attachment Description:
Begin Bearing 1, Pack Rust
Under Sliding Plate and
Paint Failure

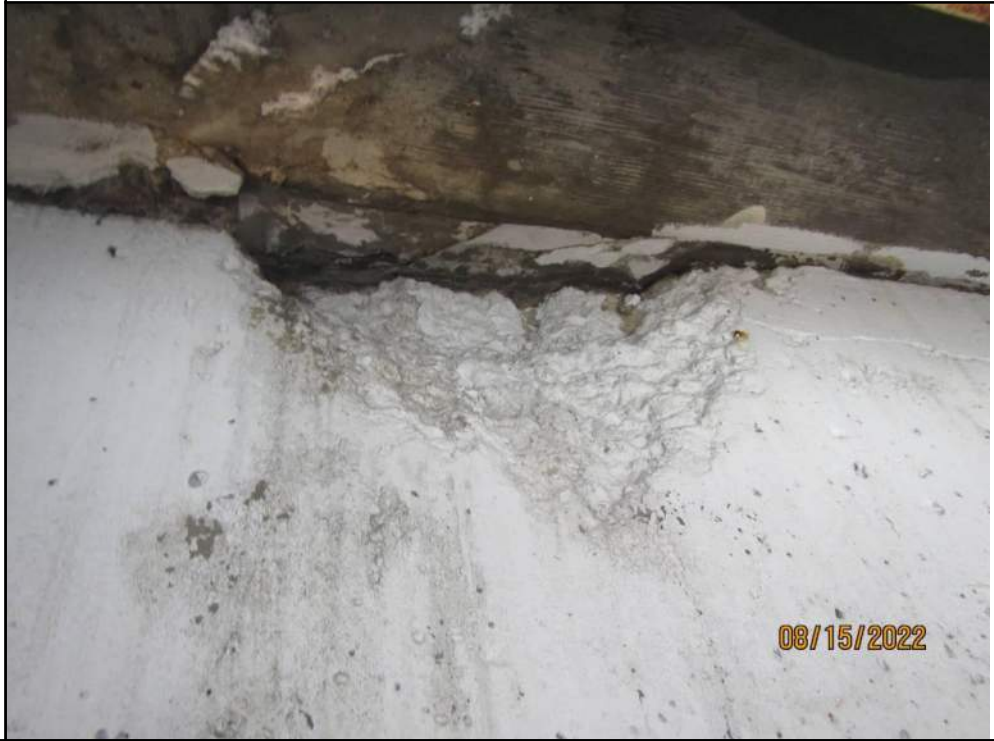
Photo Number: 3 Photo Filename: 22_003.JPG

Attachment Description:
Begin Backwall, Bay 7,
Spall
