Appendix A4

Bridge Inspection Reports and Work History Summaries

**NY33 BRIDGE CONDITION VERIFICATION 2023
KENSINGTON EXPRESSWAY PROJECT
PIN 5512.52
CITY OF BUFFALO, ERIE COUNTY
BIN 1022609**

STRUCTURE: BIN 1022609 - Best Street on NY33 Kensington Expressway

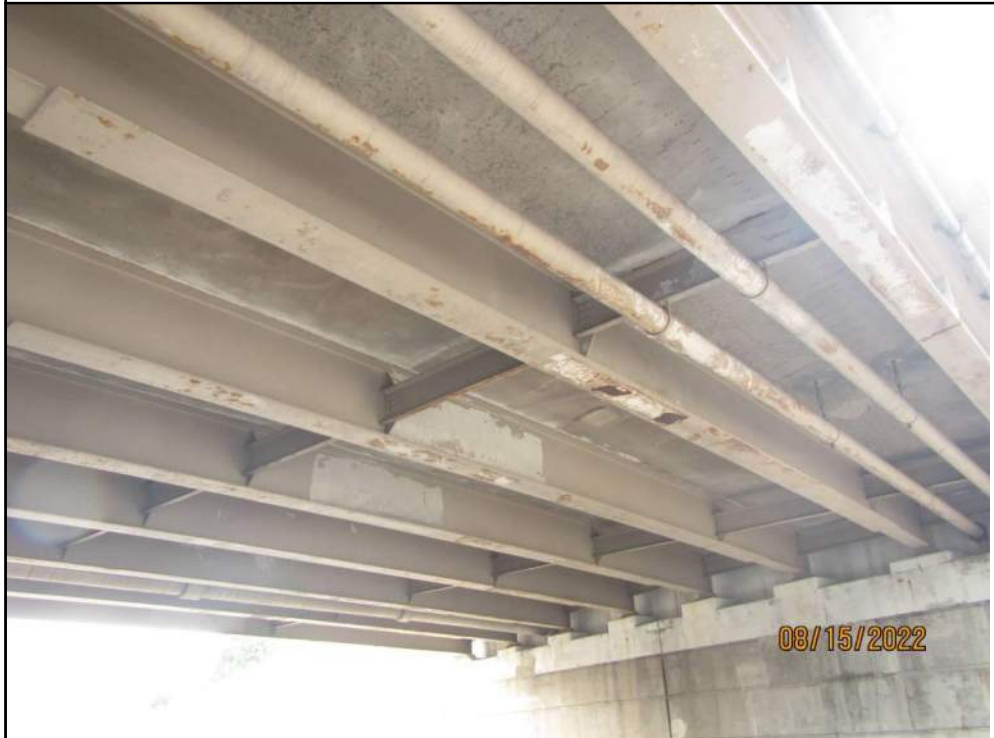
Photo Number: 4 Photo Filename: 22_004.JPG

Attachment Description:
Span 1 Framing, Paint
Failure

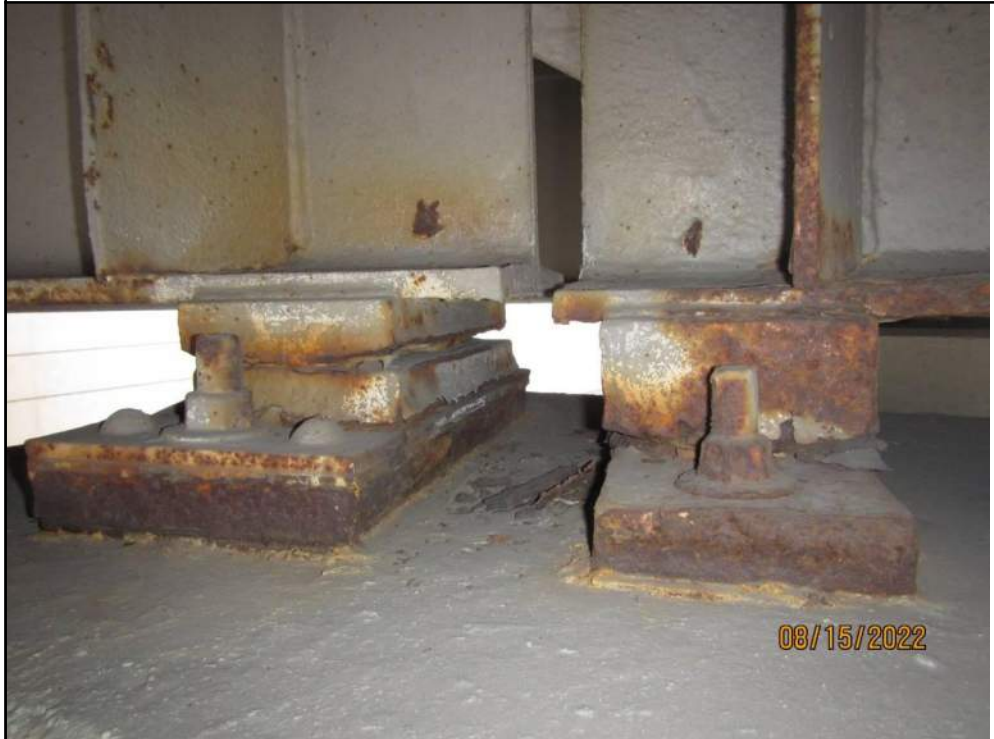
Photo Number: 5 Photo Filename: 22_005.JPG

Attachment Description:
Pier, G4 Beam Ends,
Section Loss; Bearing 4,
Paint Failure

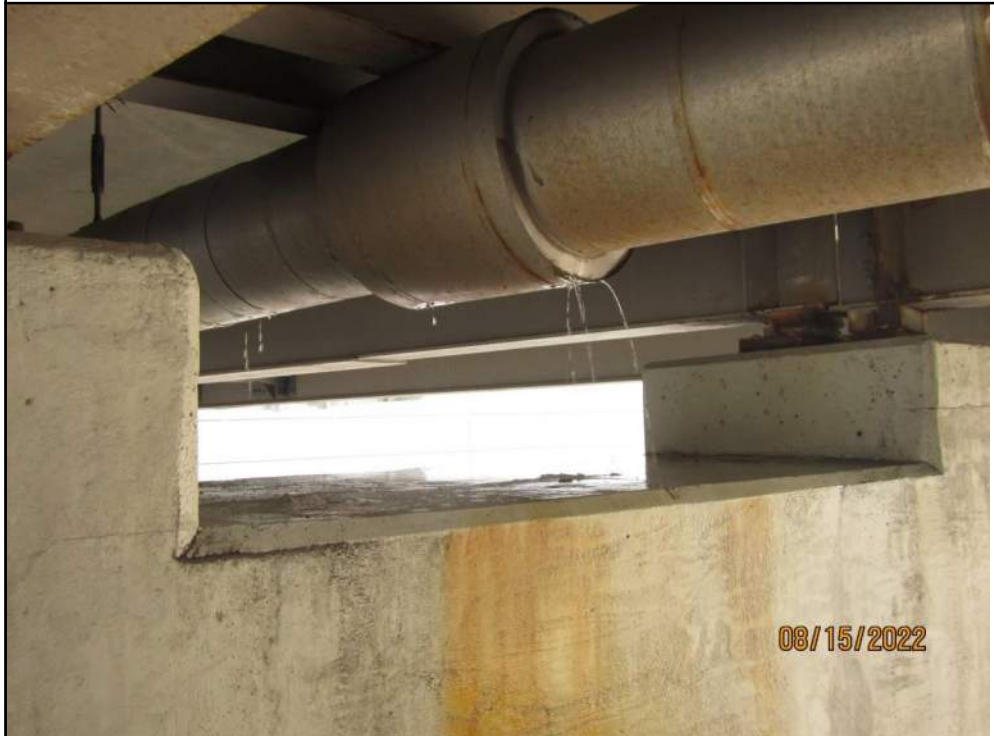
Photo Number: 6 Photo Filename: 22_006.JPG

Attachment Description:
(NSCO) Utility, Bay 6 at
Pier, Leaking

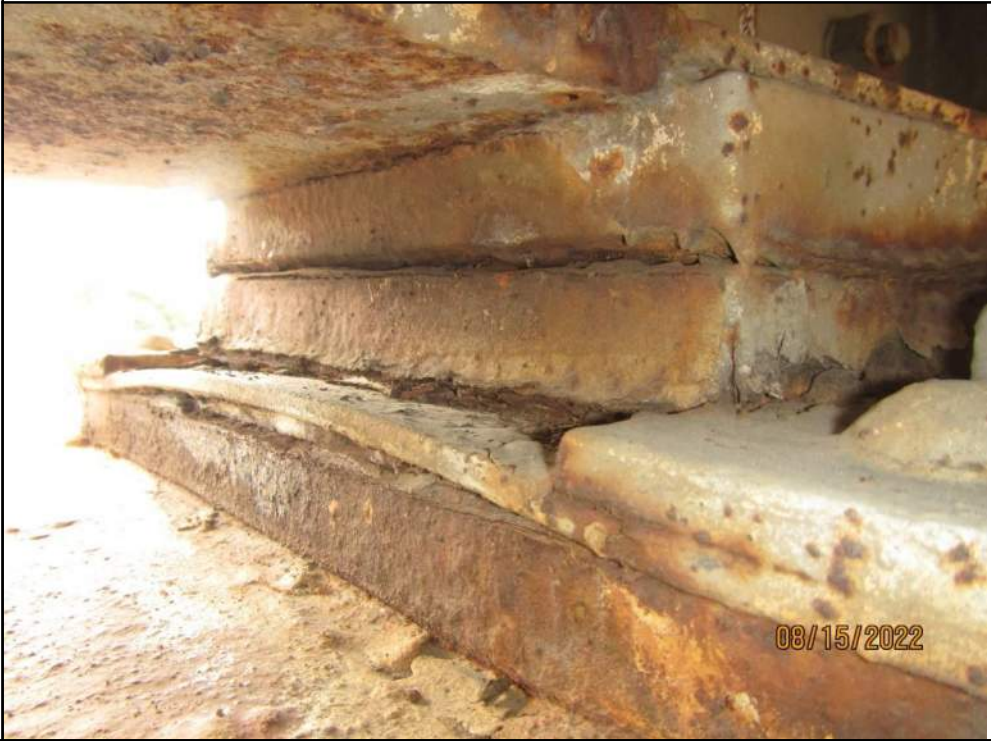
Photo Number: 7 Photo Filename: 22_007.JPG

Attachment Description:
Begin Span 2, Pier Bearing
8, Pack Rust Under Sliding
Plate and Paint Failure

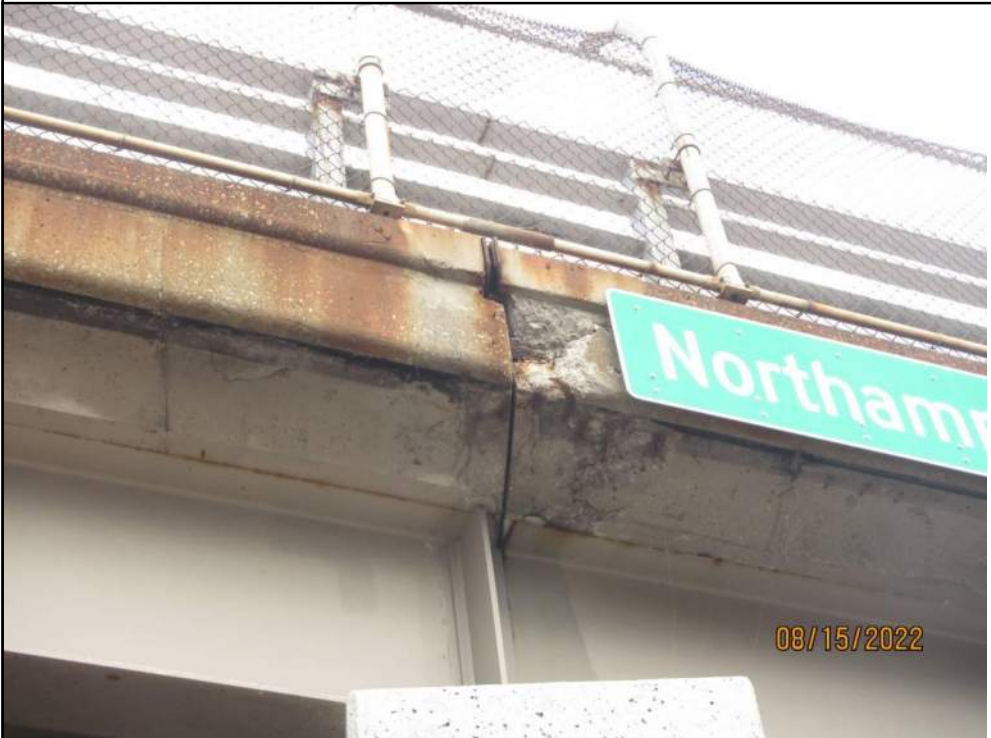
Photo Number: 8 Photo Filename: 22_008.JPG

Attachment Description:
Begin Span 2, Right Fascia,
Spall to Rebar

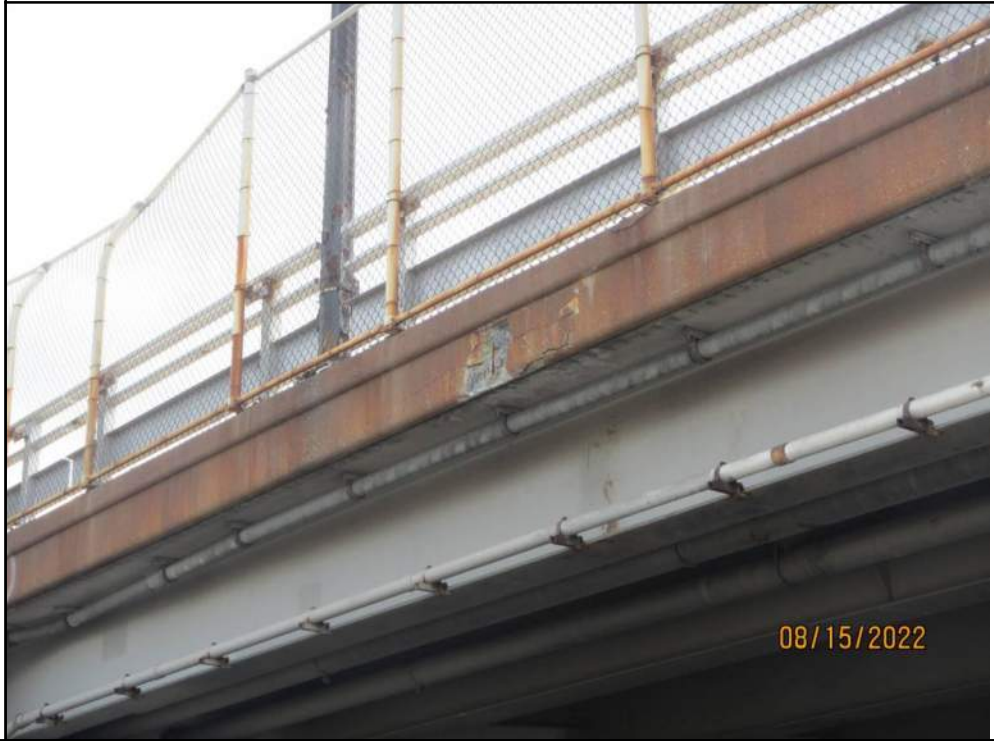
Photo Number: 9 Photo Filename: 22_009.JPG

Attachment Description:
Span 2, Midspan, Left
Fascia, Spall to Rebar

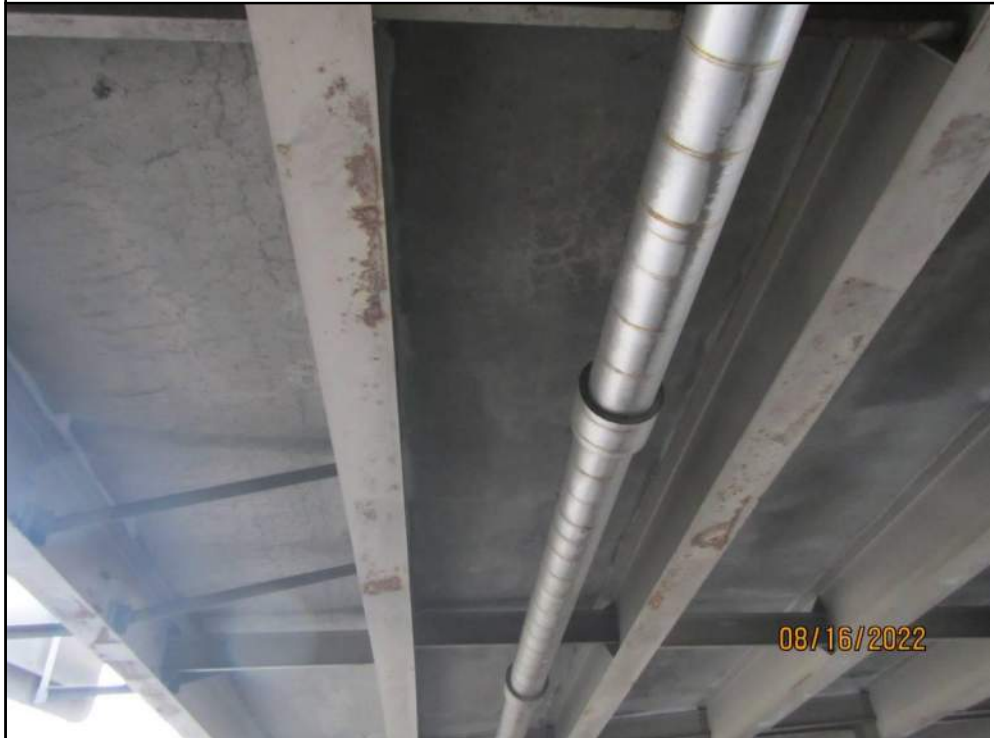
Photo Number: 10 Photo Filename: 22_010.JPG

Attachment Description:
Span 2, G6 - G8, Bottom
Flange, Paint Failure

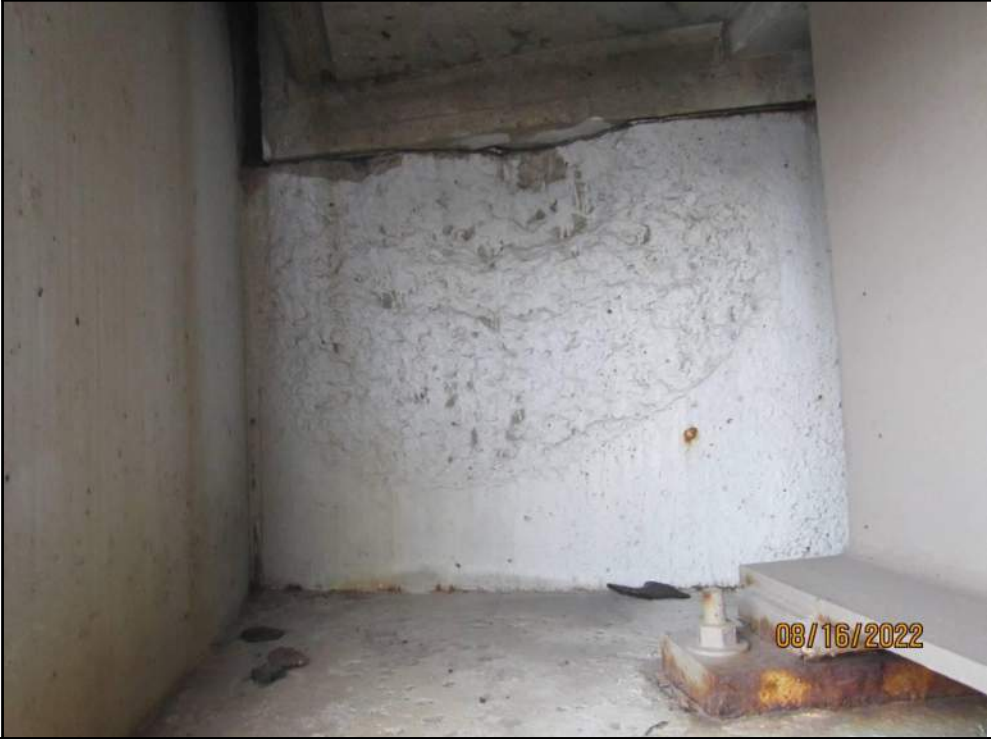
Photo Number: 11

Attachment Description:
End Abutment, Left of G1,
Spall; End Bearing 1, Paint
Failure

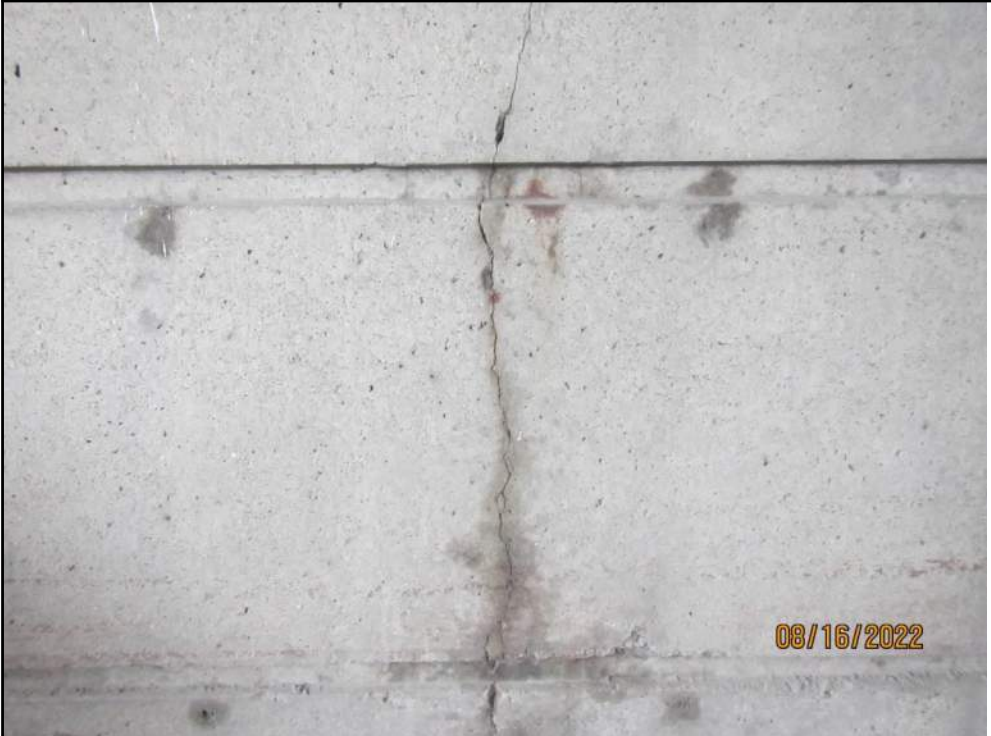
Photo Number: 12

Attachment Description:
End Abutment, Bay 2,
Crack

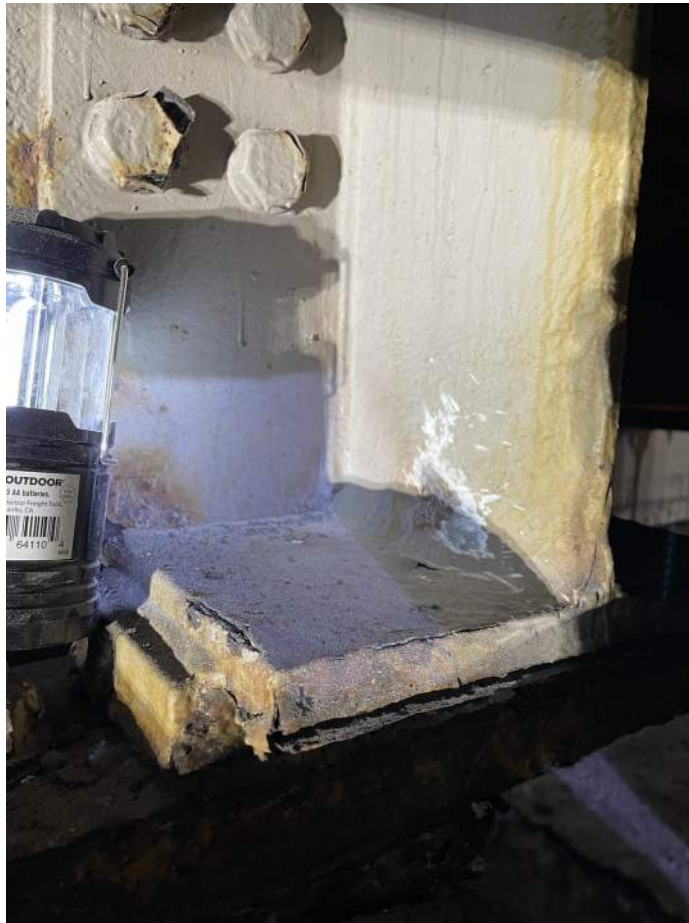
PHOTO 1

LOCATION:
G4 IN SPAN 1 AT
PIER

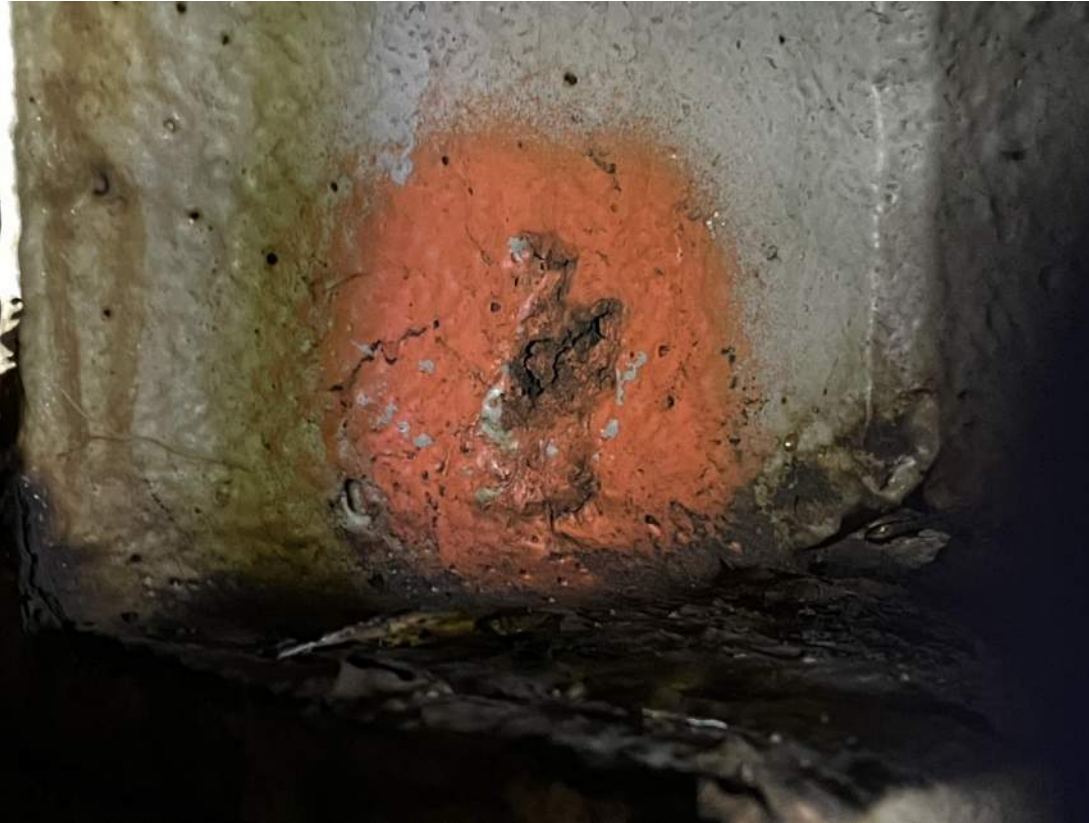
PHOTO 3

LOCATION:
G6 IN SPAN 1 AT
PIER

DESCRIPTION:
HOLE IN LOWER WEB
AT GIRDER END

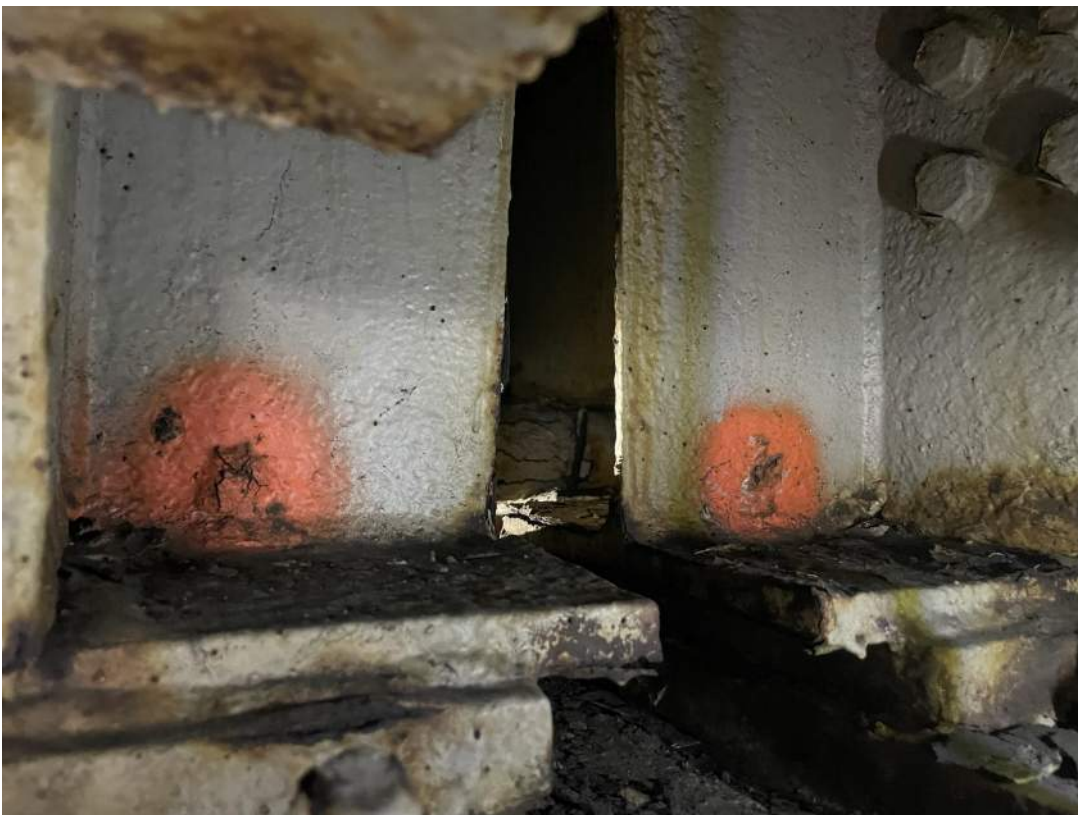
PHOTO 4

LOCATION:
G6 IN SPANS 1 & 2 AT
PIER

DESCRIPTION:
HOLES IN LOWER
WEB AT GIRDER
ENDS

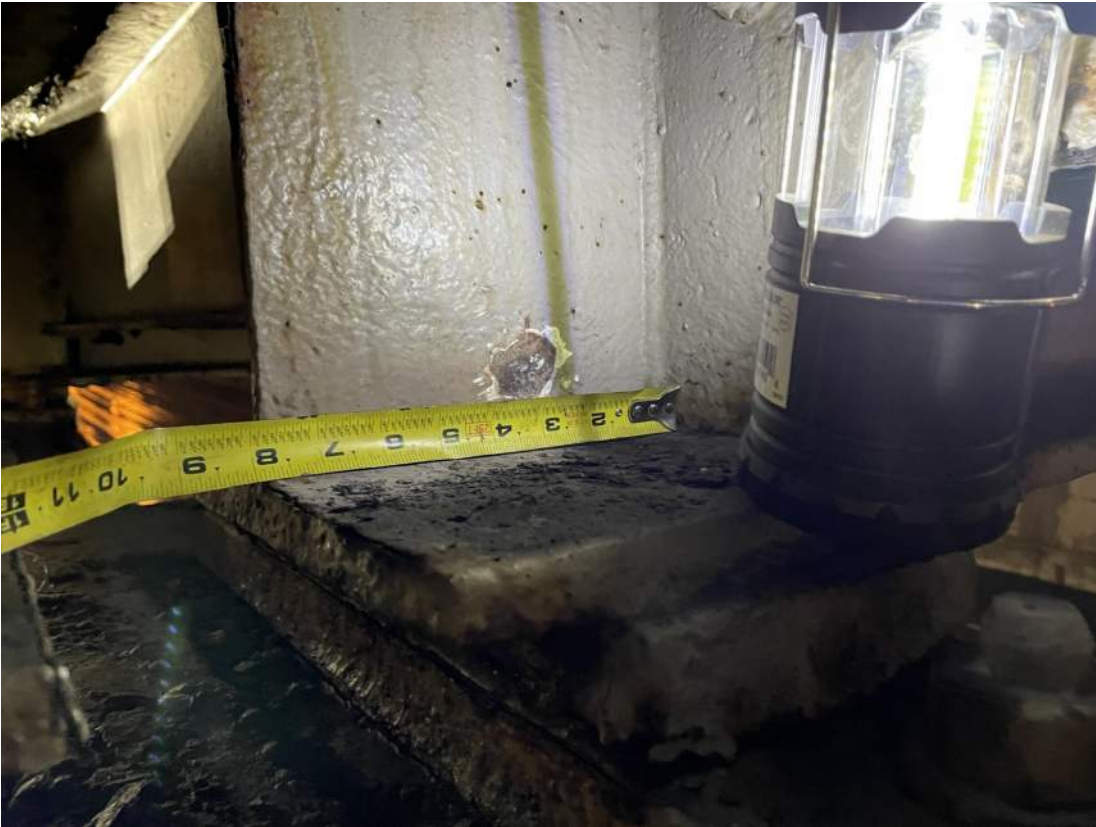
PHOTO 5

LOCATION:
G8 IN SPAN 1 AT
PIER

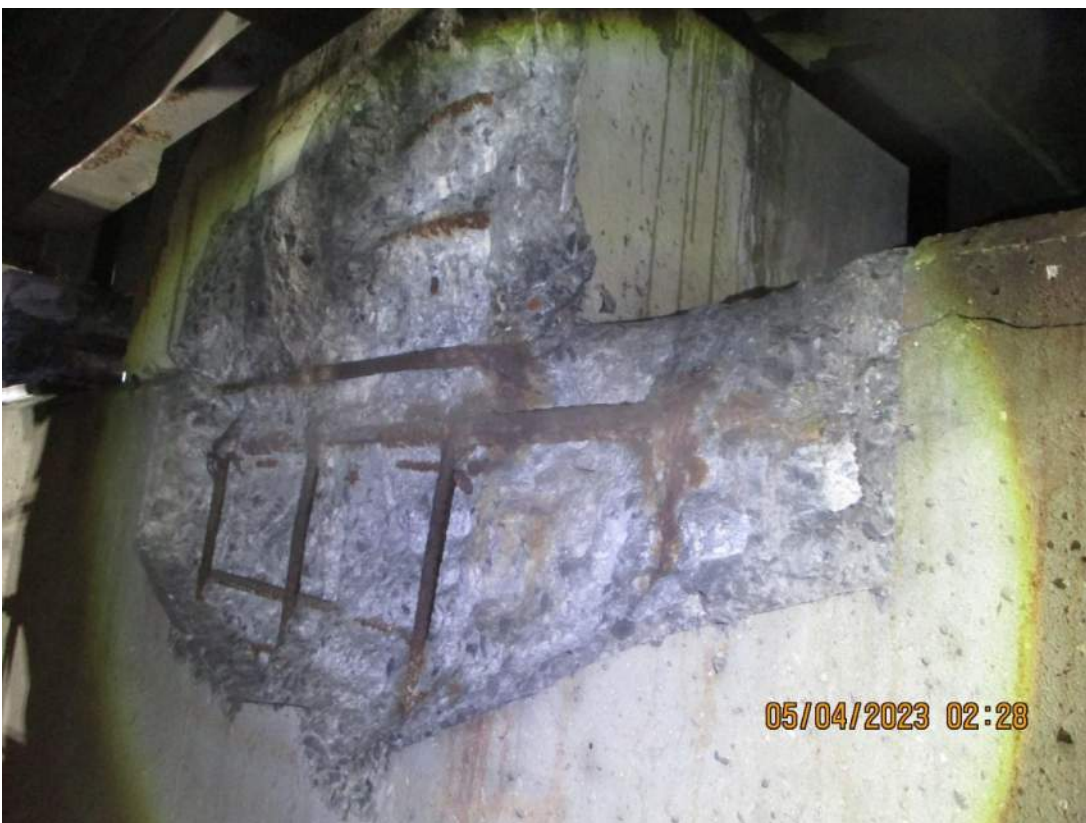
PHOTO 8

LOCATION:
END FACE OF PIER
CAP AND PEDESTAL
P5

DESCRIPTION:
SPALL TO
CORRODED REBAR

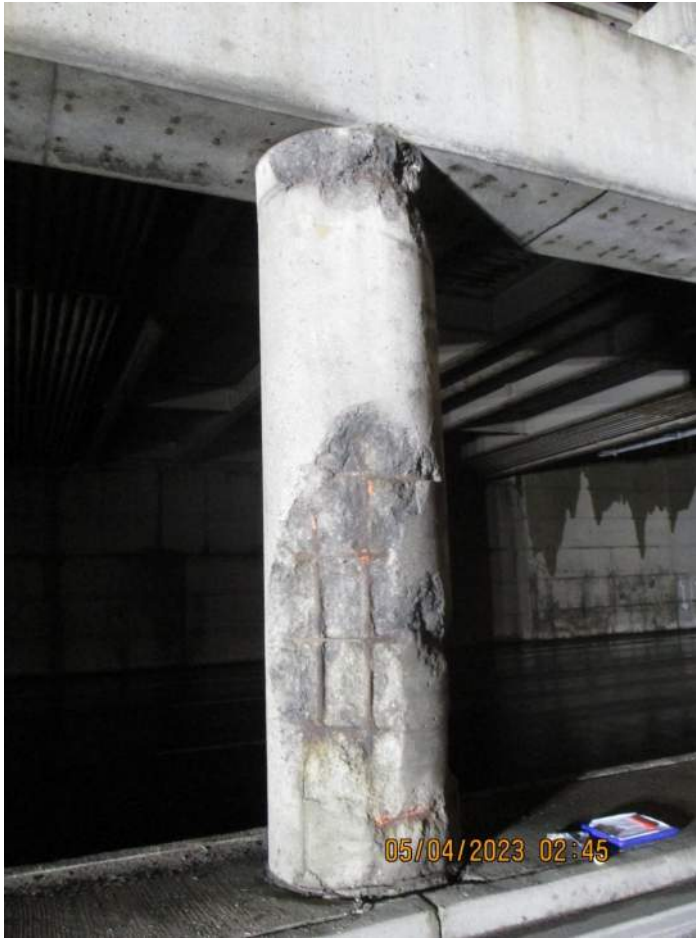
PHOTO 9
LOCATION: COLUMN 3 END FACE LOOKING WEST
DESCRIPTION: SPALL TO CORRODED REBAR THROUGHOUT THE COLUMN HEIGHT; TYPICAL FOR ALL COLUMNS

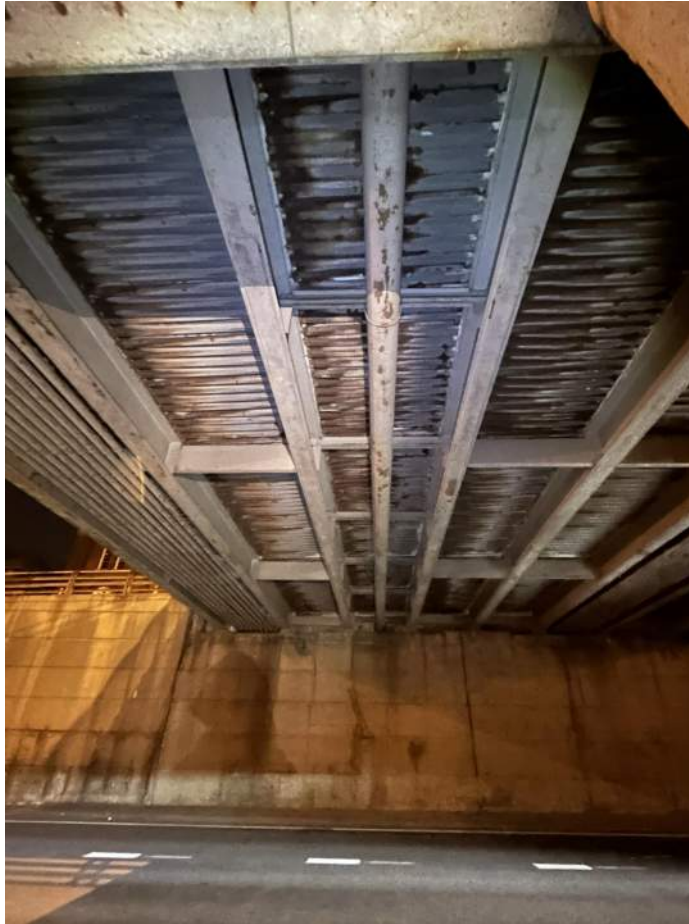
PHOTO 11

LOCATION:
SPAN 1 & BEGIN
ABUTMENT LOOKING
EAST

DESCRIPTION:
GENERAL DECK
CONDITION,
CORROSION IN
STAY-IN-PLACE
FORMS; TYPICAL
ABUTMENT
CONDITION, MAP
CRACKING WITH
MINOR
DELAMINATION

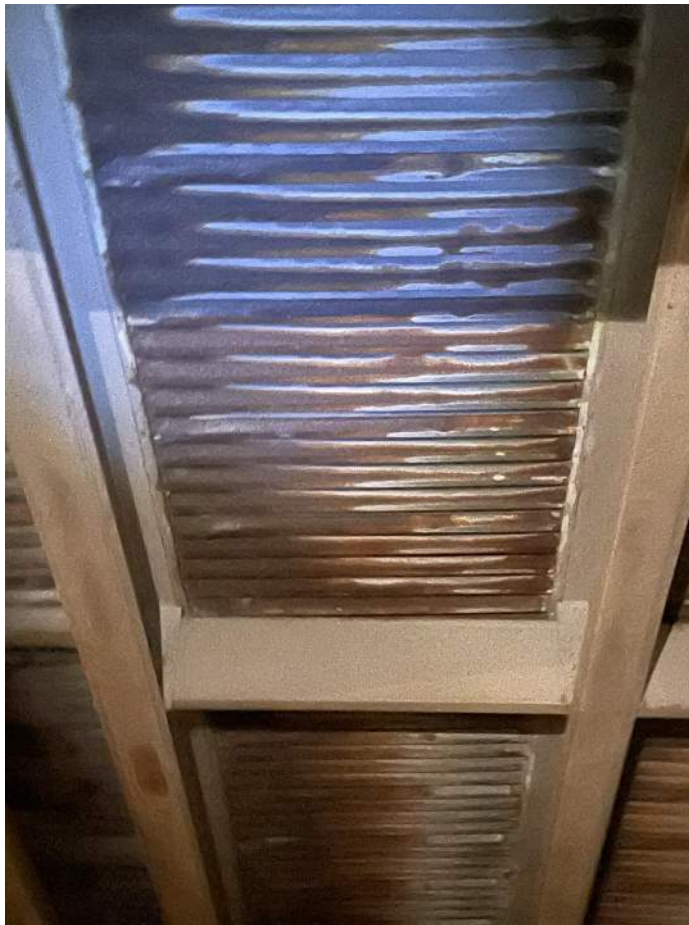
PHOTO 12

LOCATION:
SPAN 1 LOOKING
EAST

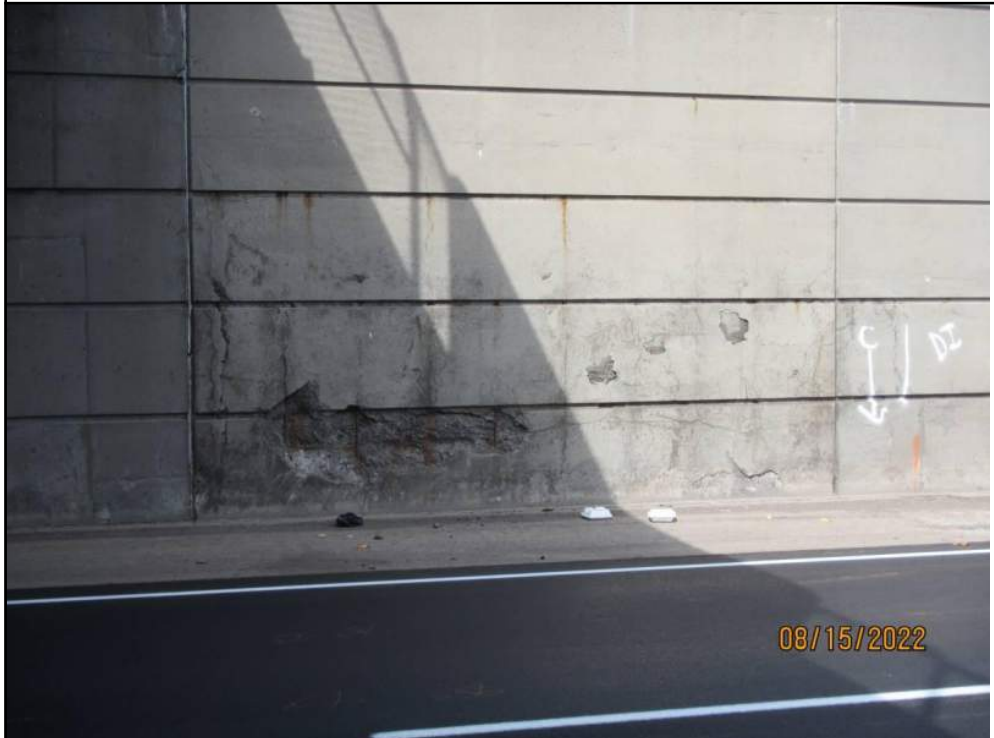
Photo Number: 5 Photo Filename: 22_005.JPG

Attachment Description:
Begin Left Cheekwall, Spall
to Rebar

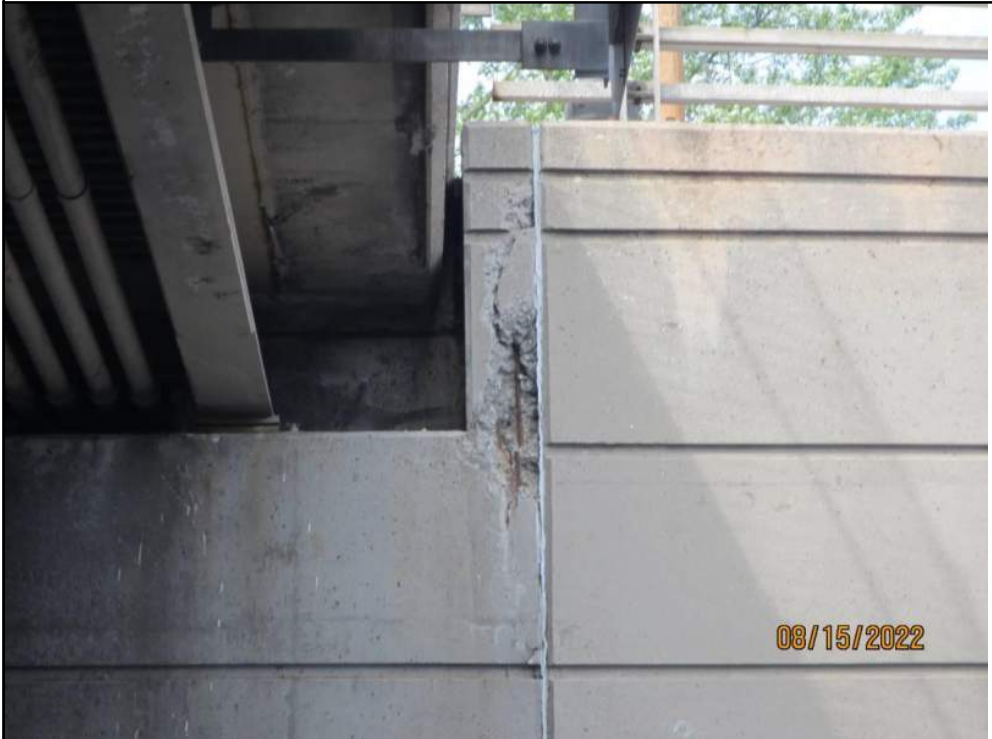
Photo Number: 6 Photo Filename: 22_006.JPG

Attachment Description:
Begin Backwall, Bay 1,
Spall

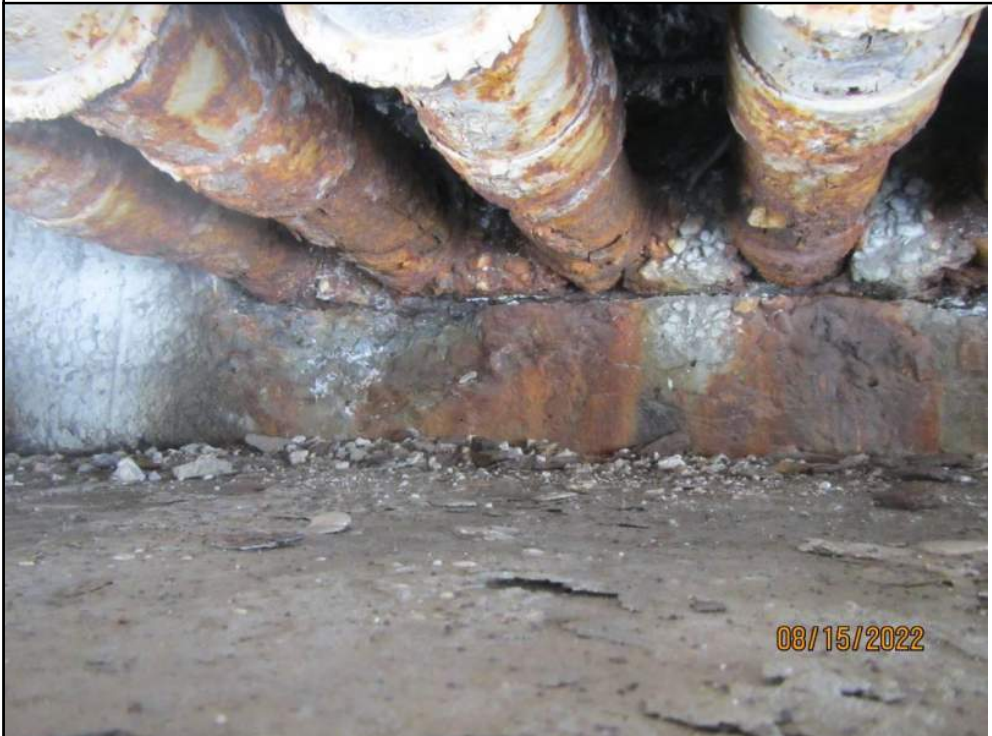
Photo Number: 7 Photo Filename: 22_007.JPG

Attachment Description:
Begin Abutment at G2,
Crack w/ Delamination;
Begin Bearing 2, Pack Rust
(Typical)

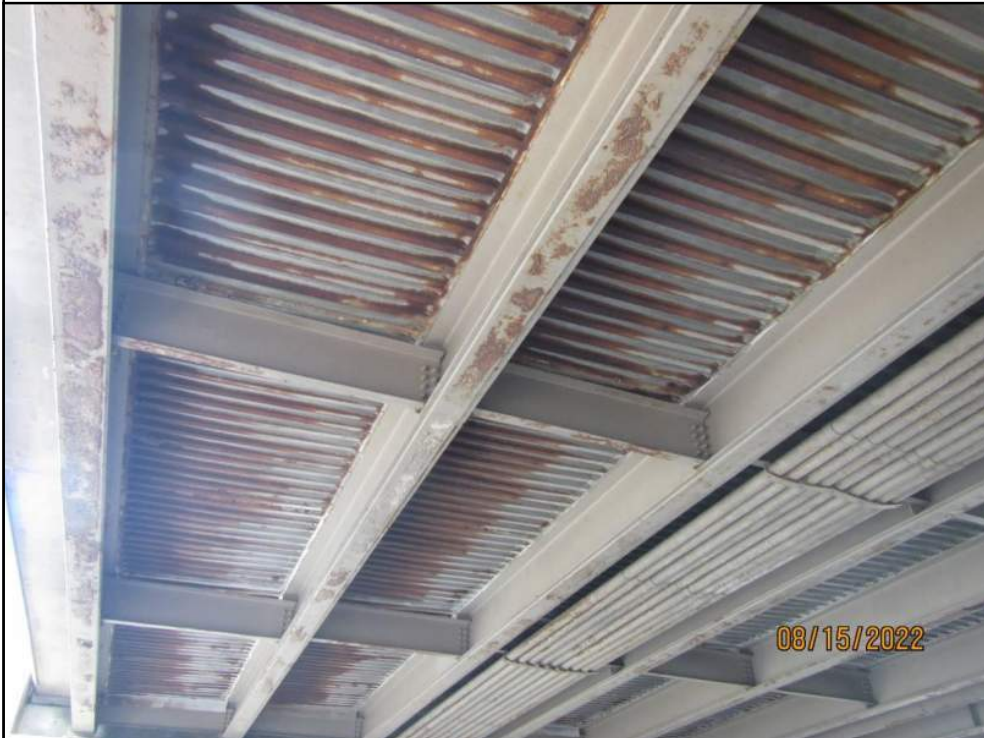
Photo Number: 10 Photo Filename: 22_010.JPG

Attachment Description:
Span 1, Bay 7 and 8, SIP
Form, Corrosion; G8 and
G9, Bottom Flange, Paint
Failure

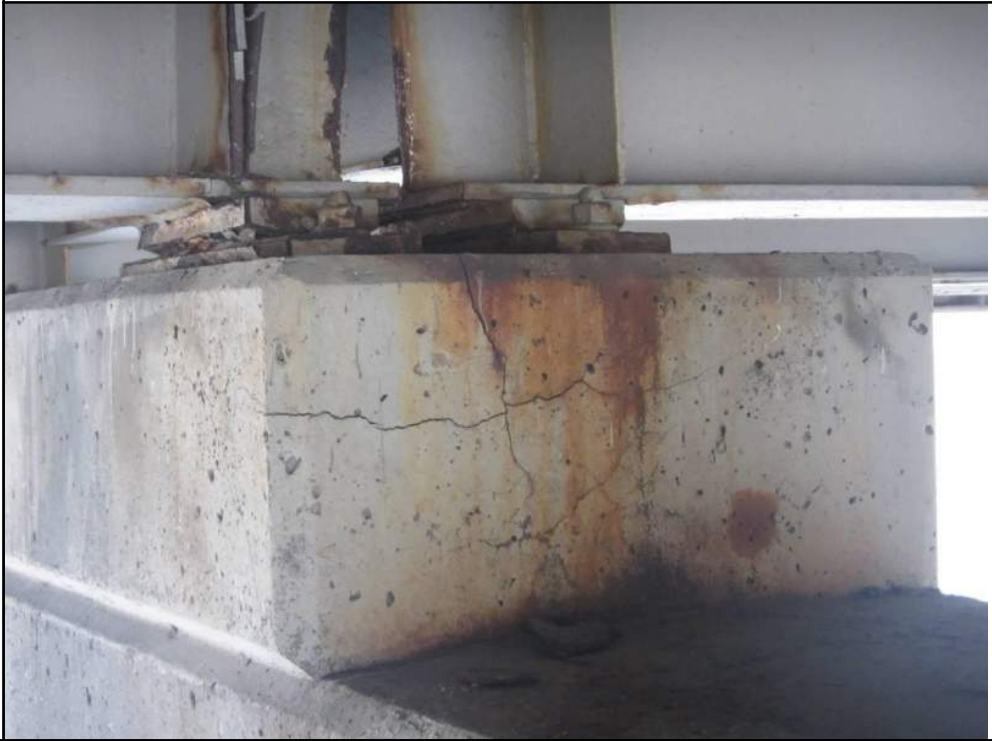
Photo Number: 11

Attachment Description:
Pier Pedestal 3, Right,
Cracks (Typical on Left)

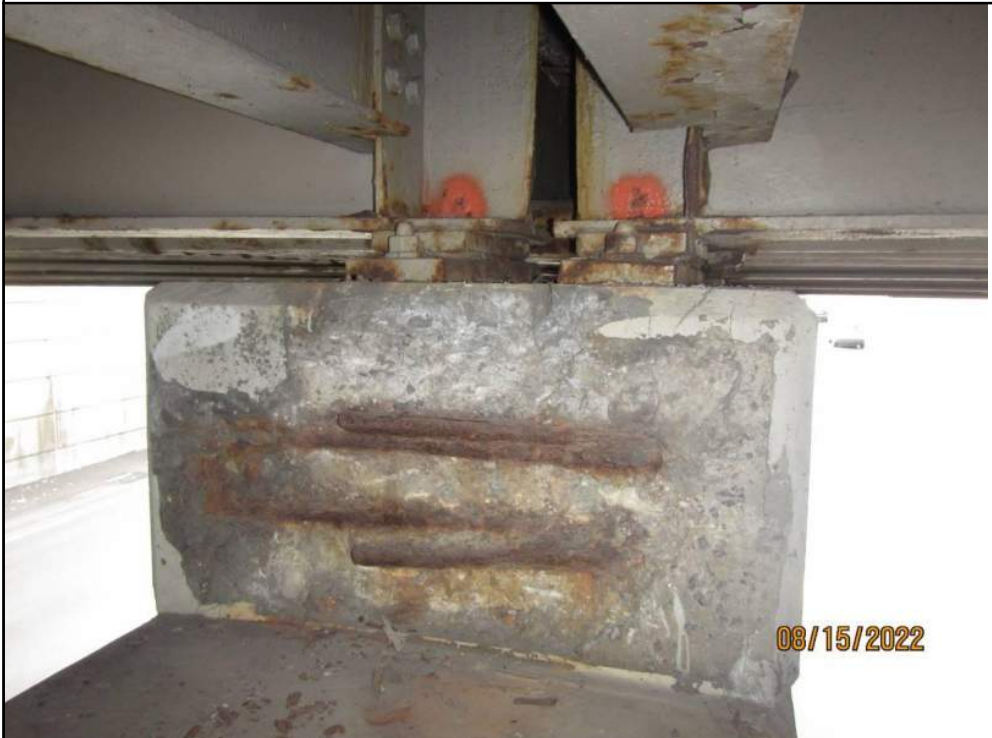
Photo Number: 12

<i>Referenced Photo(s): 11, 12, 13</i>						
<i>Referenced Sketch(es): 11</i>						
Section loss percentages at beam ends vary from 0% to 29%, refer to lower web section loss measurements sketch for precise measurements and locations. Girder 7 at the pier is not accessible for inspection.						
Span 1: BA850 - Backwall	TQ	CS-1	CS-2	CS-3	CS-4	CS-5
	64	47	16	1	0	0
Span 2: EA850 - Backwall	64	35	18	11	0	0
Condition State 3 Note						
<i>Referenced Photo(s): 6, 19</i>						
<i>Referenced Sketch(es): None</i>						
The begin and end backwall at bay 1 below the utility ducts has a 1'x6"x2" and a 6'x6"x4" spall. The end backwall at bay 6 under the utility ducts has a 5'x6"x2" spall.

Attachment Description:
Pier Pedestal 6, Left, Spall
to Rebar; G6, Pier Beam
Ends, Section Loss

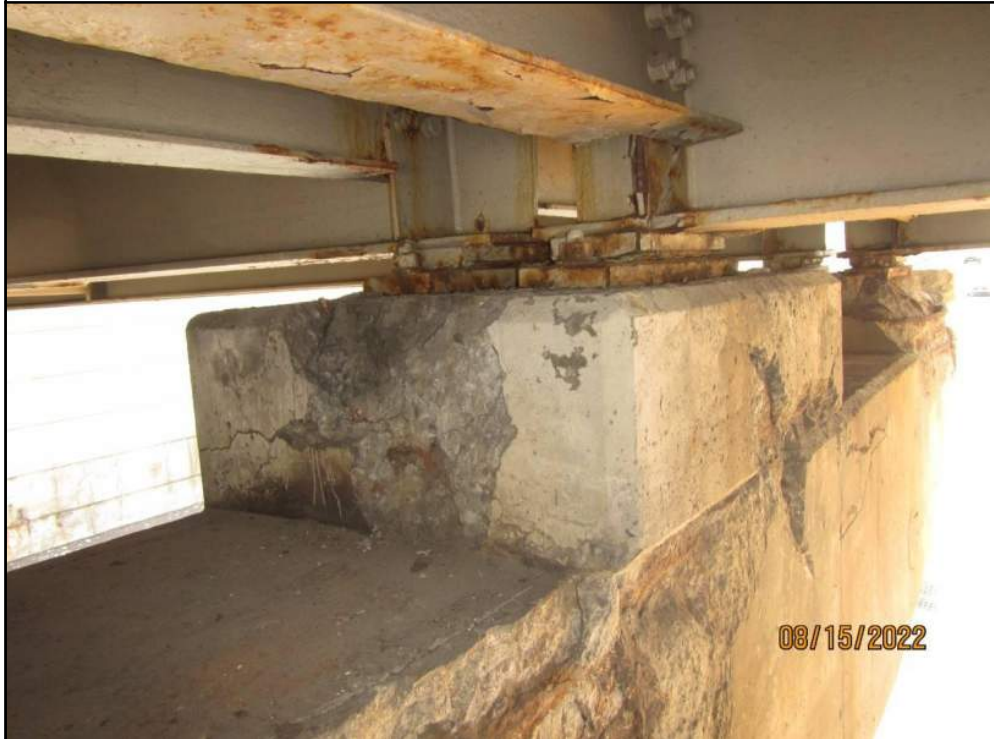
Photo Number: 13

Attachment Description:
Pier Pedestal 8, Left, Spall
to Rebar

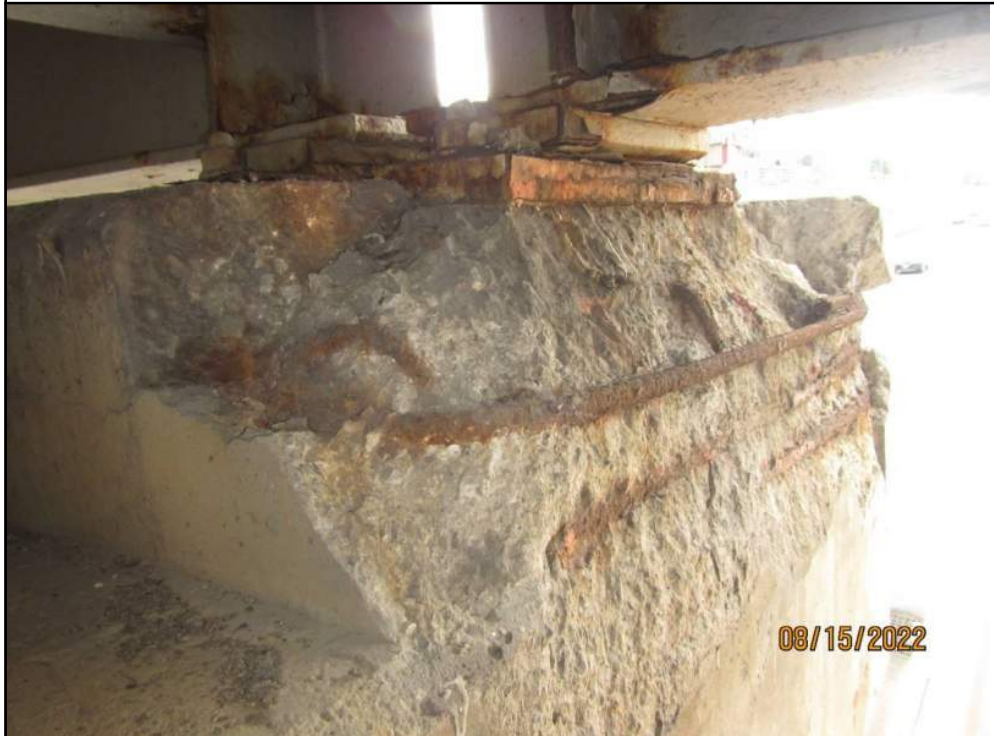
Photo Number: 14

Attachment Description:
Pier Pedestal 9, Begin
Face, Spall to Rebar

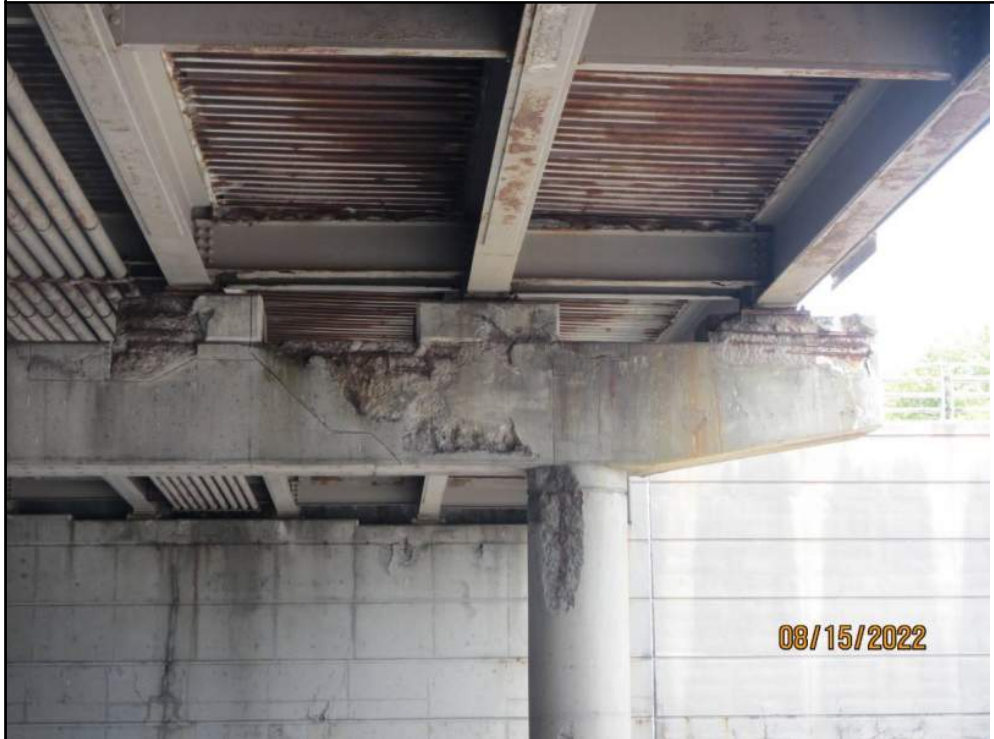
Photo Number: 15

Attachment Description:
Pier Cap, Begin Face,
Column Bay 3, Spall to
Rebar; Pier Pedestals 7 – 9,
Spall to Rebar; Pier Column
4, Spall to Rebar (Typical)

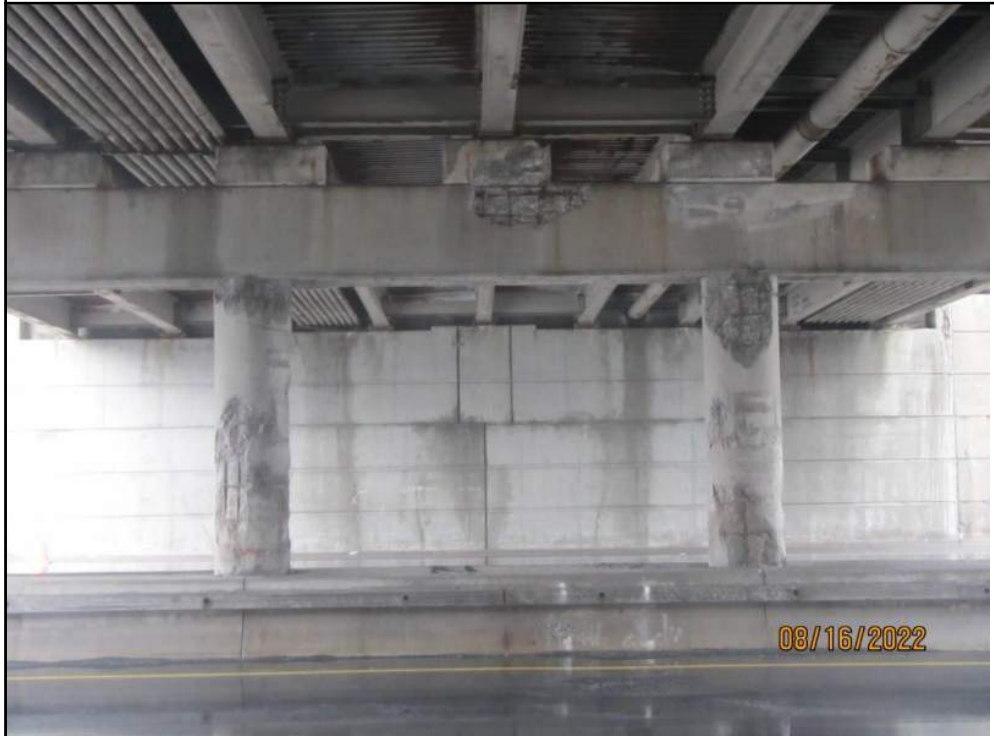
Photo Number: 16

Attachment Description:
Pier Cap, End Face,
Column Bay 2, Spall to
Rebar; Pier Pedestal 5,
Spall to Rebar; Pier
Columns 2 and 3, Spall to
Rebar (Typical)

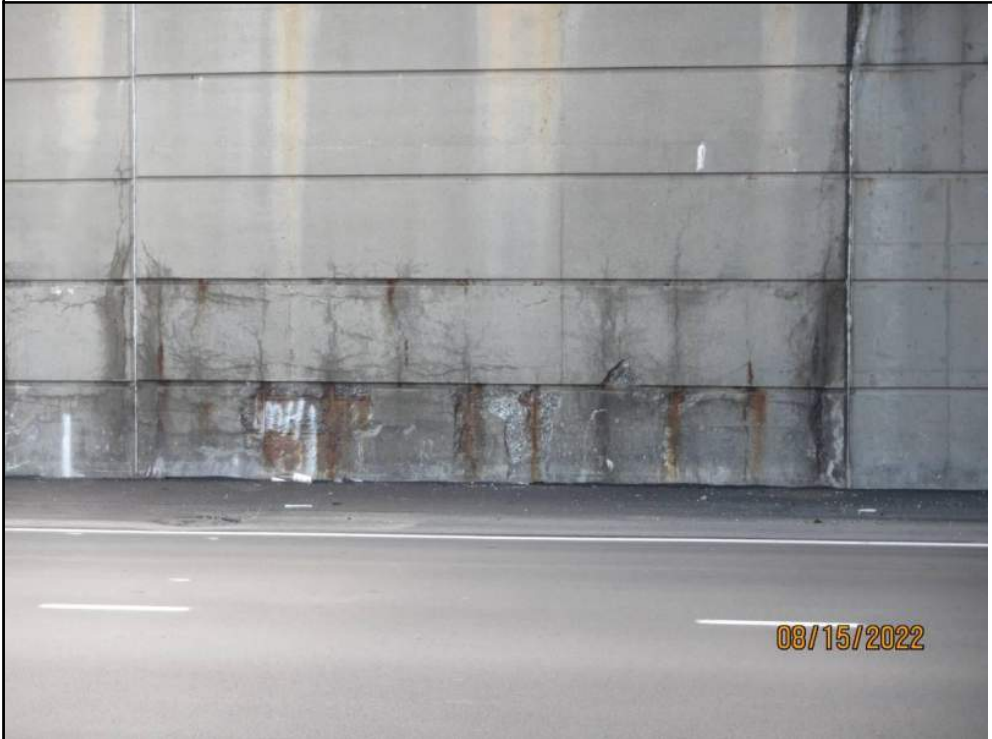
Photo Number: 17 Photo Filename: 22_017.JPG

Attachment Description:
End Left Wingwall, Cracks
and Spall to Rebar

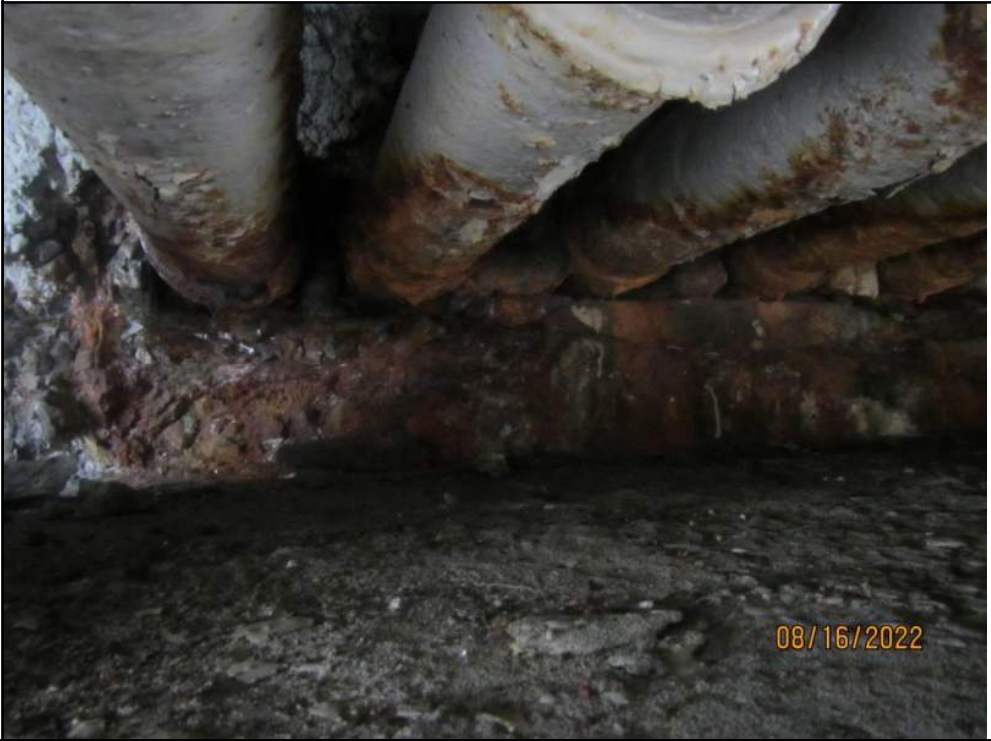
Photo Number: 19

Attachment Description:
End Backwall, Bay 1, Spall
to Rebar (Typical Bay 6)
