Appendix A4

Bridge Inspection Reports and Work History Summaries

**NY33 BRIDGE CONDITION VERIFICATION 2023
KENSINGTON EXPRESSWAY PROJECT
PIN 5512.52
CITY OF BUFFALO, ERIE COUNTY
BIN 1022609**

STRUCTURE: BIN 1022609 - Best Street on NY33 Kensington Expressway

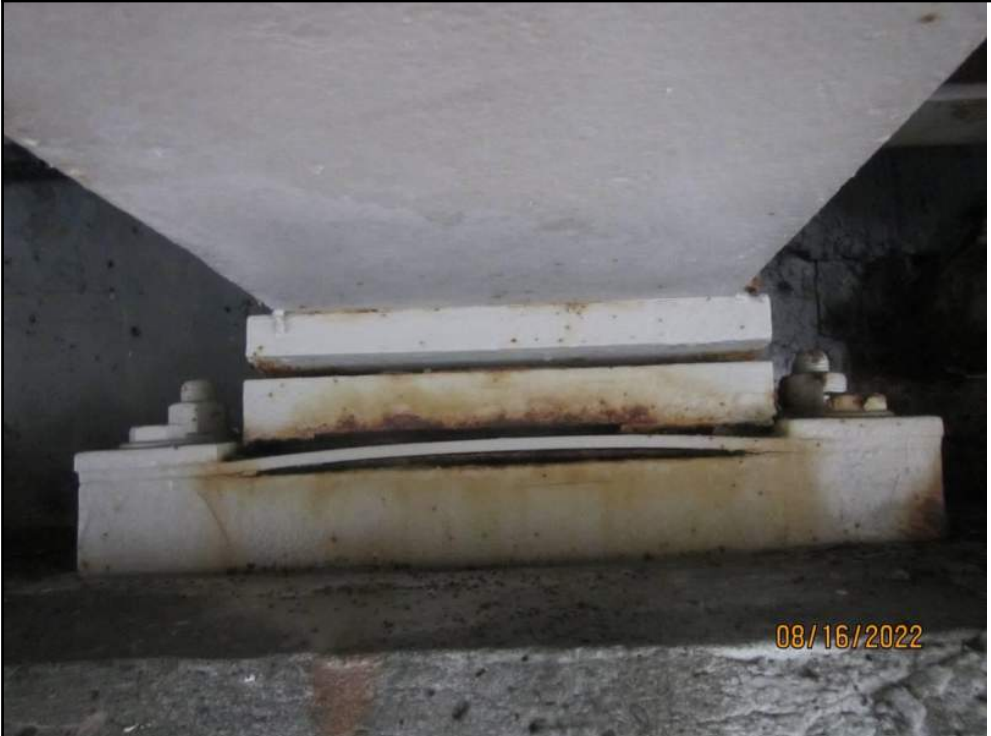
Photo Number: 20

Attachment Description:
End Abutment Bearing 6,
Pack Rust (Typical)

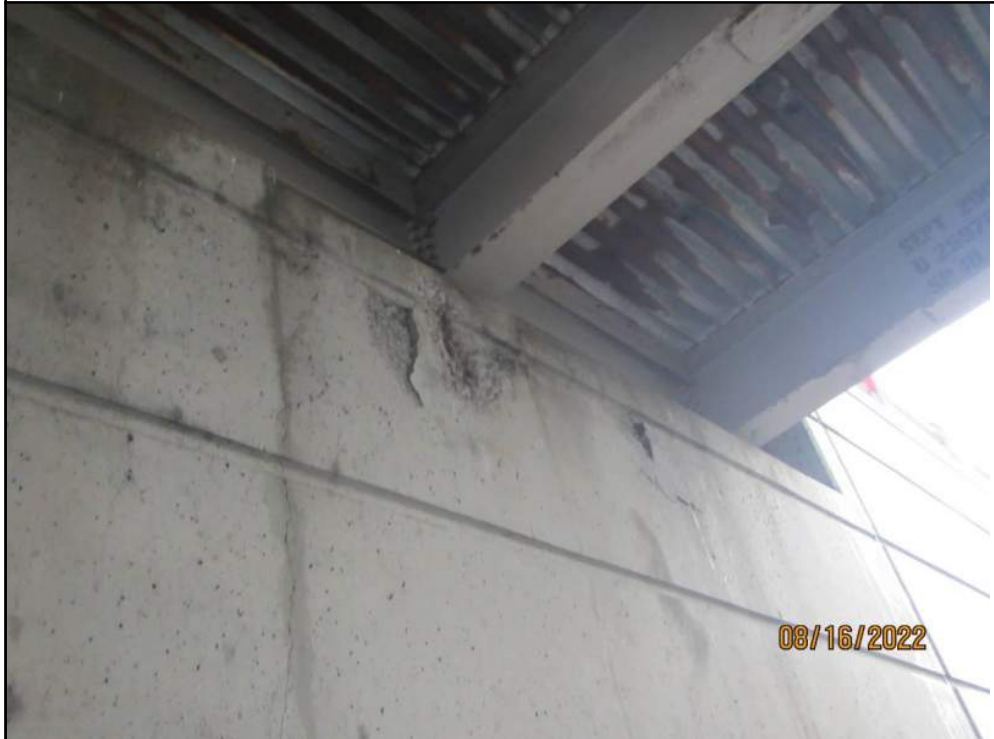
Photo Number: 21 Photo Filename: 22_021.JPG

Attachment Description:
End Abutment, Bays 7 – 8,
Spall to Rebar and
Delamination

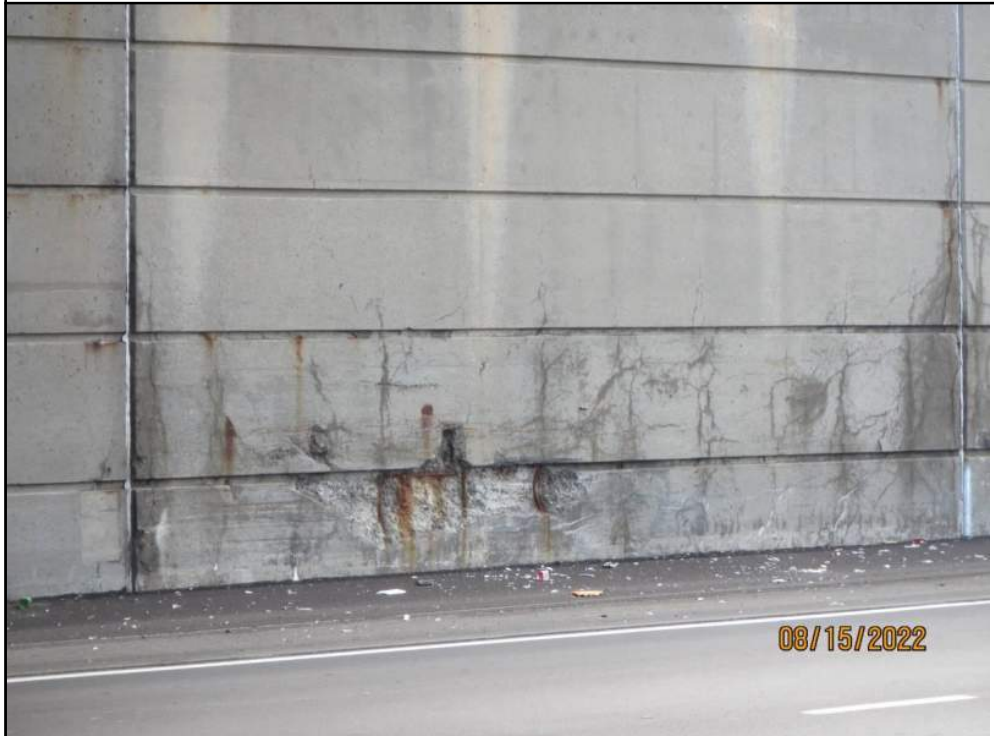
Photo Number: 22 Photo Filename: 22_022.JPG

Attachment Description:
End Right Wingwall, Cracks
and Spall to Rebar

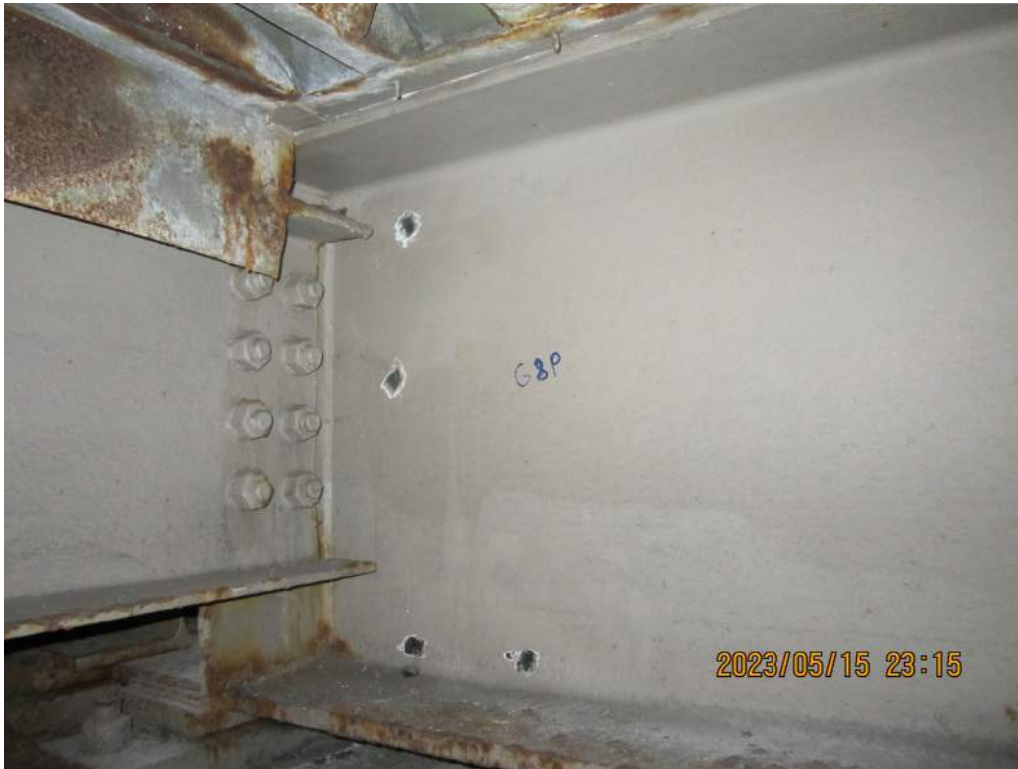
PHOTO 1:

LOCATION:
G8 IN SPAN 1 AT PIER

DESCRIPTION:
GIRDER END CONDITION
PHOTO (WORST CASE
FULL HEIGHT)

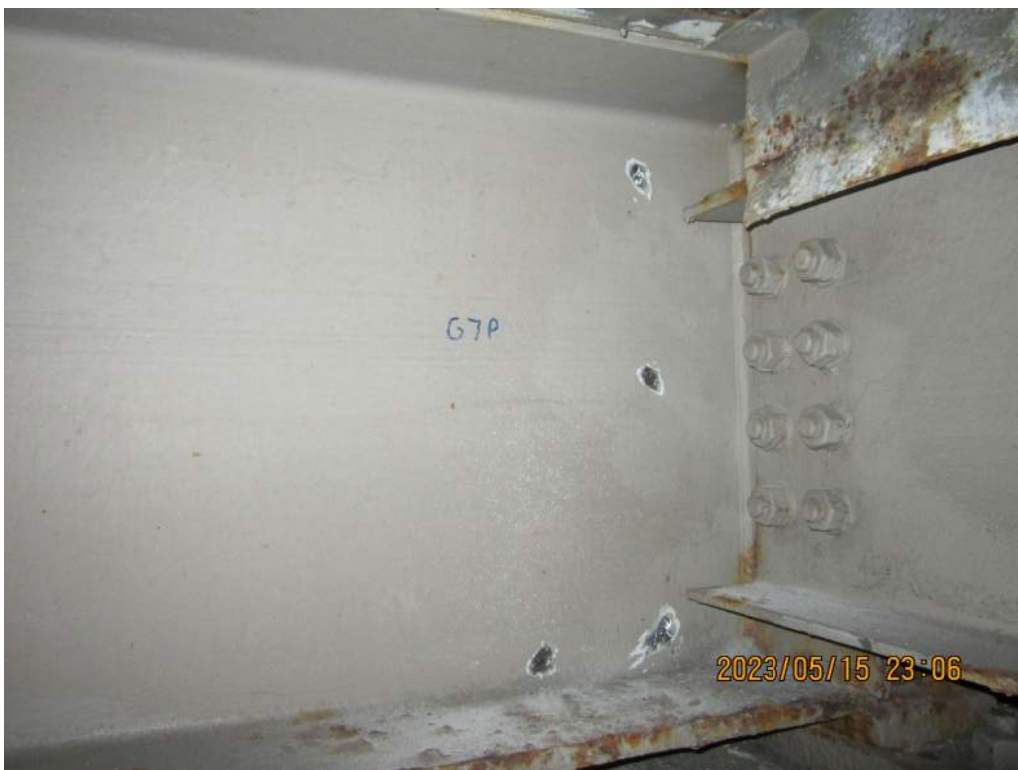
PHOTO 2:

LOCATION:
G7 IN SPAN 1 AT PIER

DESCRIPTION:
GIRDER END CONDITION
PHOTO (WORST CASE
BEARING AREA)

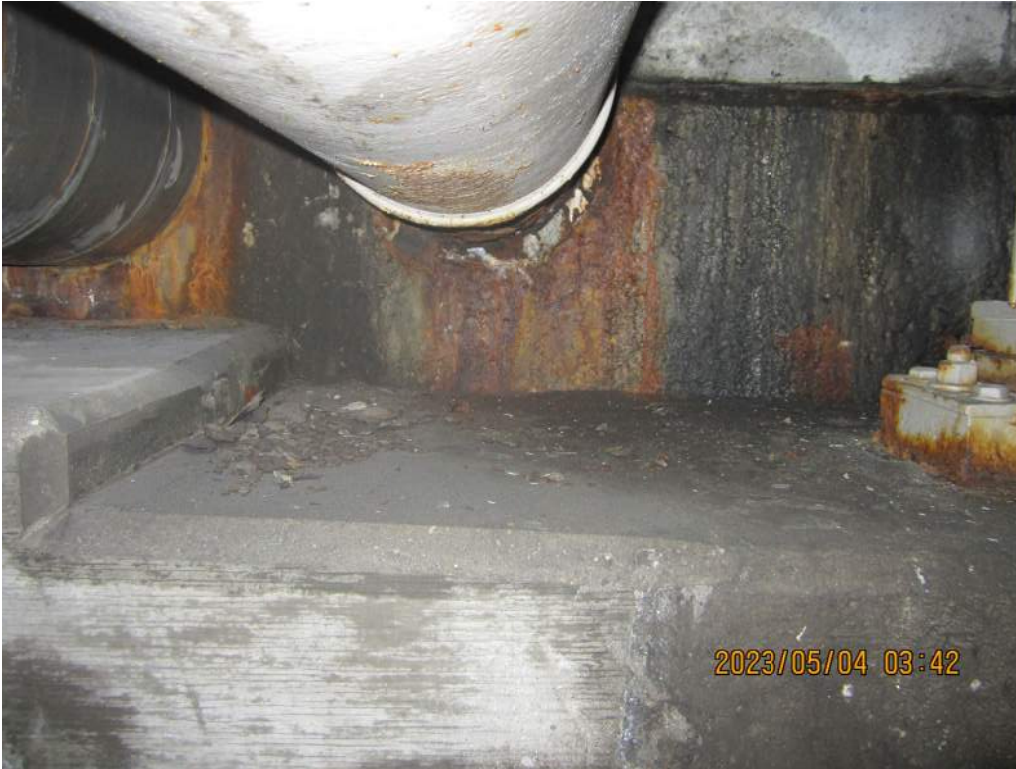
PHOTO 3:

LOCATION:
END ABUTMENT

DESCRIPTION:
LEAKAGE AND RUST
STAINING TO
CONCRETE
ABUTMENT/BACKWALL
AT UTILITY LOCATIONS

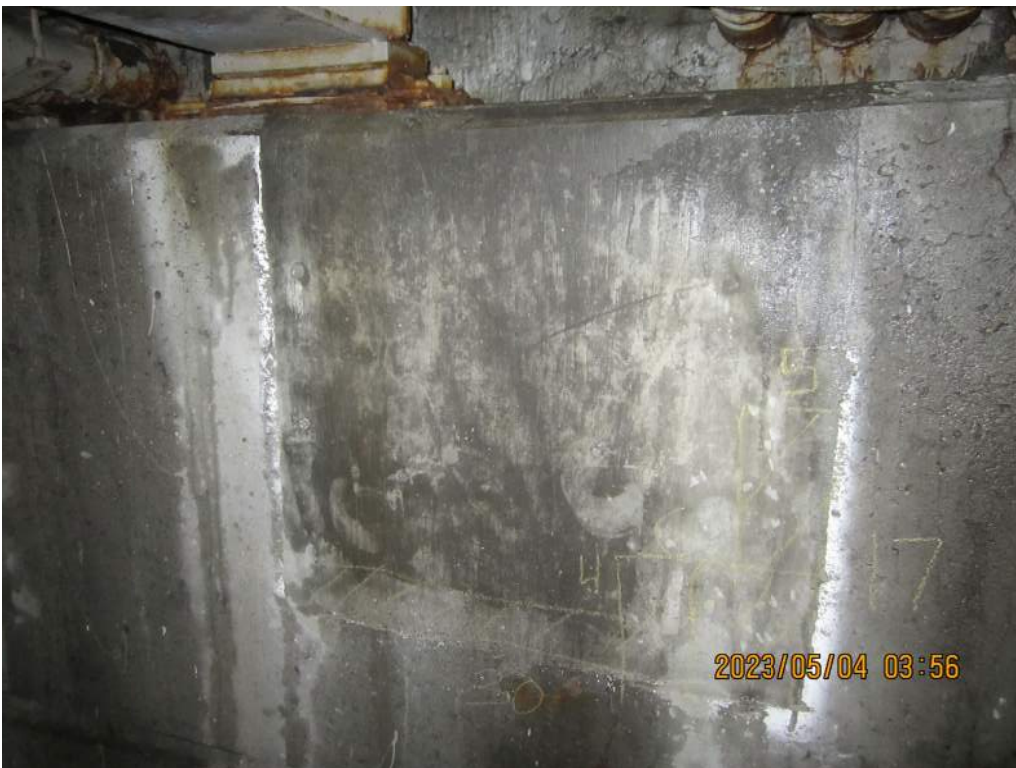
PHOTO 4:

LOCATION:
END ABUTMENT

DESCRIPTION:
GENERAL CONDITION
PHOTO, PREVIOUS
REPAIR AREA

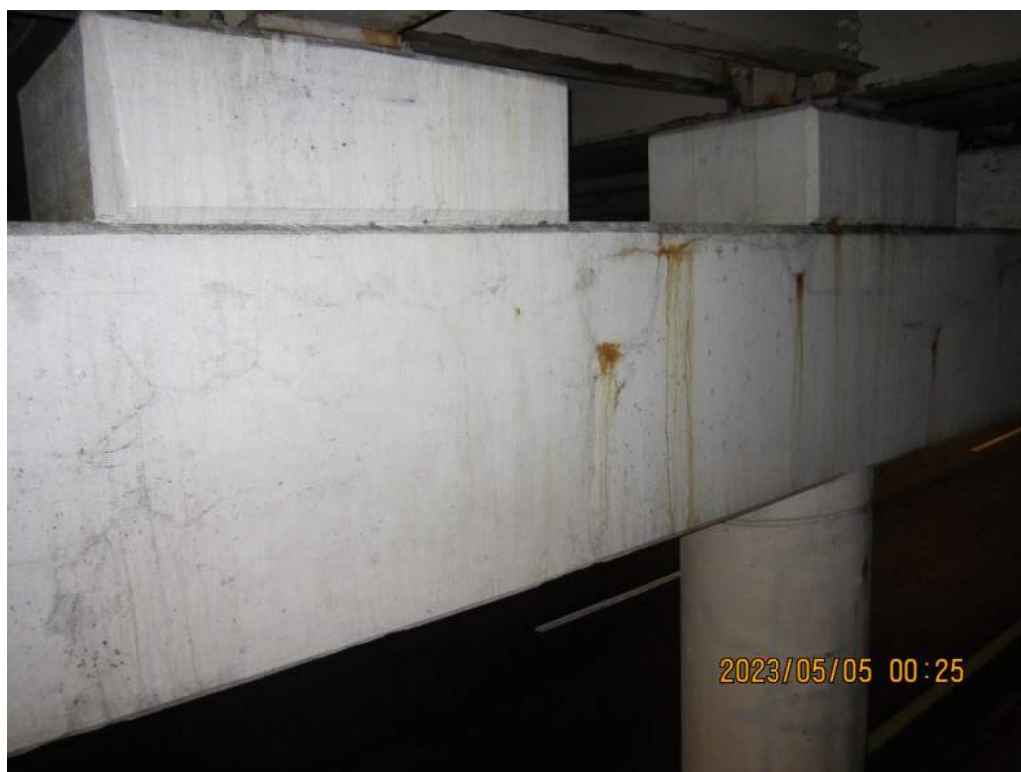
PHOTO 6:

LOCATION:
CONCRETE PIER CAP
AND PEDESTALS

DESCRIPTION:
MINOR MAP CRACKING
TO CONCRETE FACES

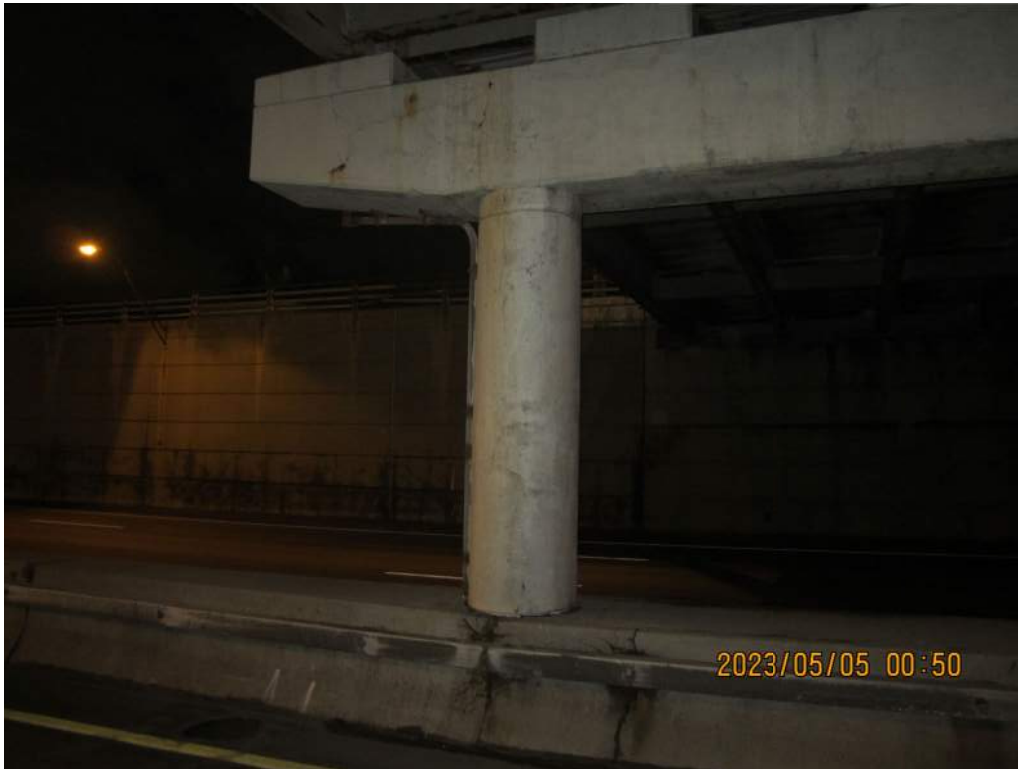
PHOTO 7:

LOCATION:
PIER

DESCRIPTION:
GENERAL CONDITION
PHOTO

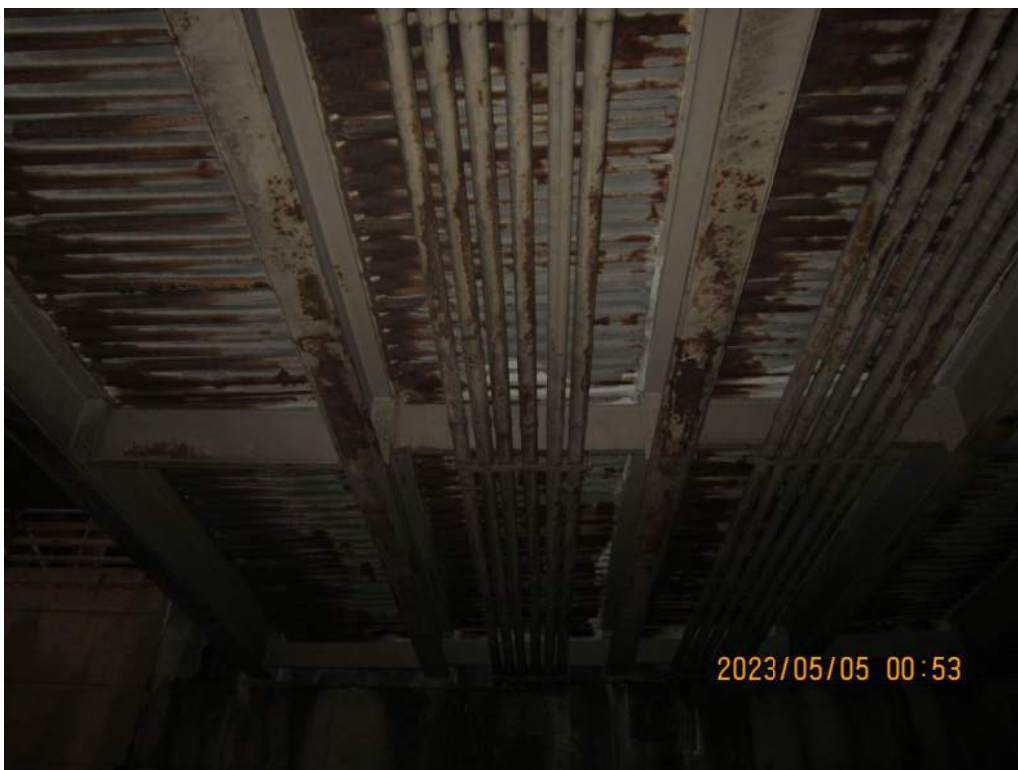
PHOTO 8:

LOCATION:
UNDERSIDE OF DECK IN
SPAN 2

DESCRIPTION:
TYPICAL DECK
CONDITION PHOTO,
SIGNIFICANT RUSTING
TO STAY-IN-PLACE
FORMS

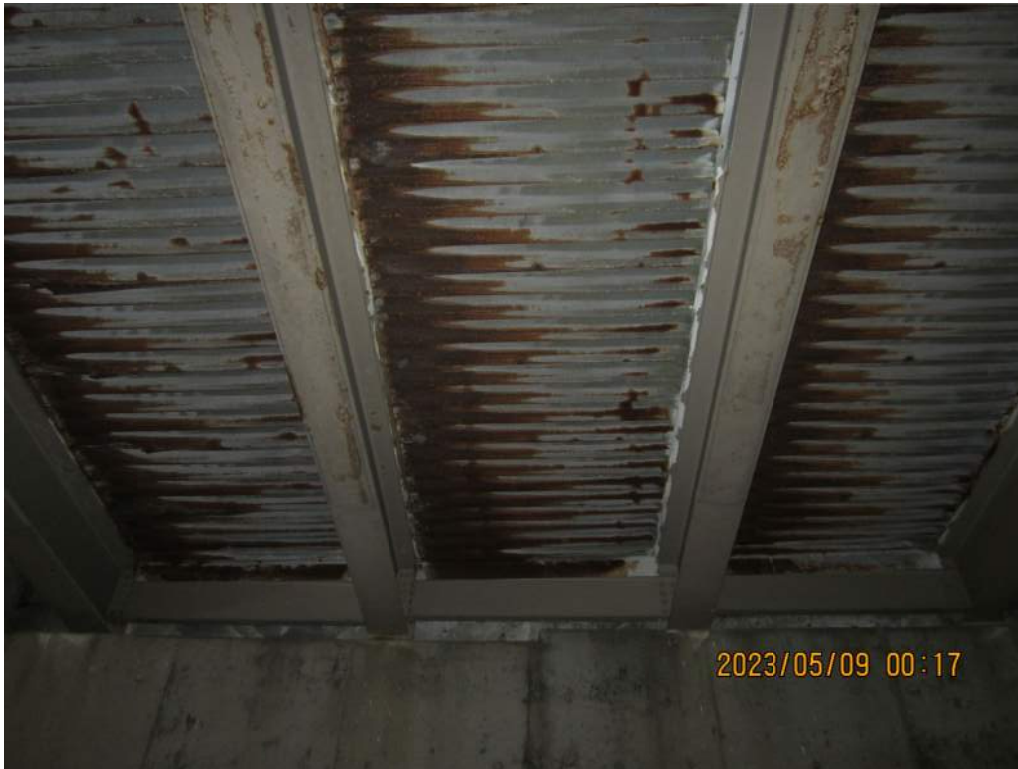
PHOTO 9:

LOCATION:
UNDERSIDE OF DECK IN
SPAN 1

DESCRIPTION:
TYPICAL DECK
CONDITION PHOTO,
SIGNIFICANT RUSTING
TO STAY-IN-PLACE
FORMS

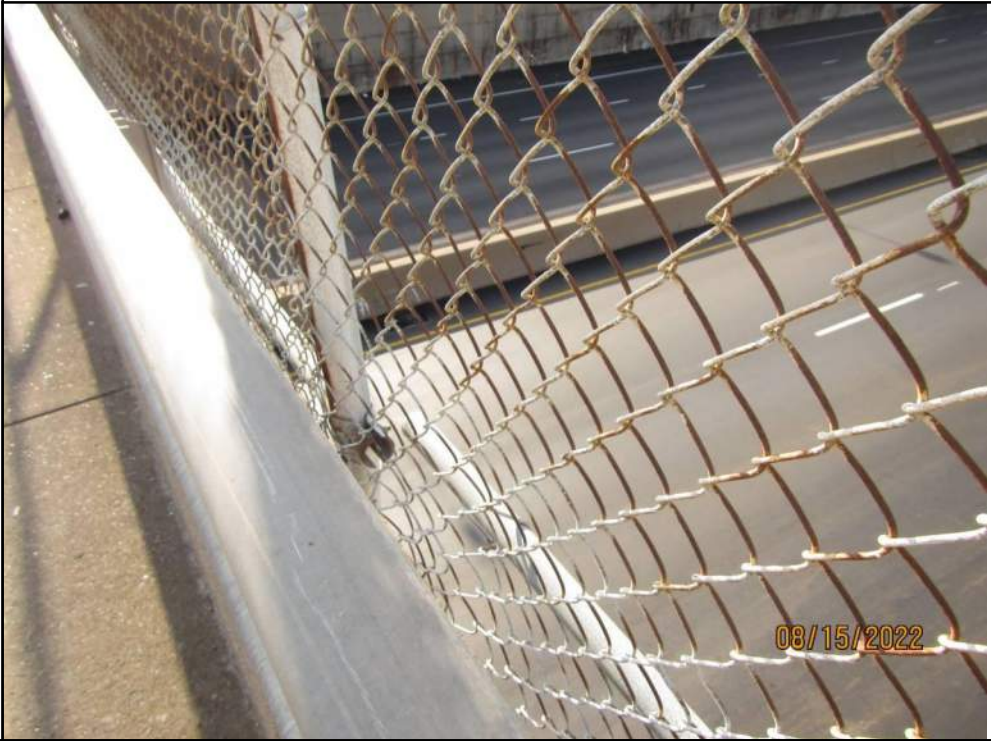
Photo Number: 4 Photo Filename: 22_004.JPG

Attachment Description:
(NSCO) Approach Light
Post, End Right, Wires
Exposed
